Orchard Mount, Chorlton Fold, Eccles, Greater Manchester

Archaeological Evaluation Report

Oxford Archaeology North

August 2007

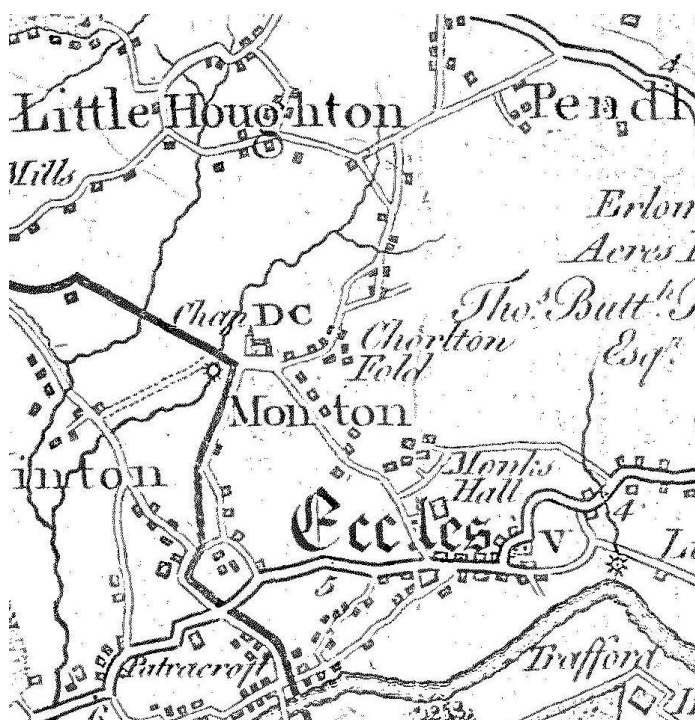
Extract from Yates' map of Lancashire, 1786

3.1.6 Chorlton Fold is marked on William Yates’ map of Lancashire, which was produced in 1786 and provides the earliest available cartographic source for the hamlet, although the scale is too small for detailed analysis. The map nevertheless depicts a cluster of buildings around and to the east of Rocky Lane, north of Monton, indicating that Chorlton Fold was an established hamlet by the end of the 18th century. The 1848 Ordnance Survey map similarly identifies Chorlton Fold as a cluster of three buildings to the east of the road (Fig 3), representing Chorlton Fold Farm.

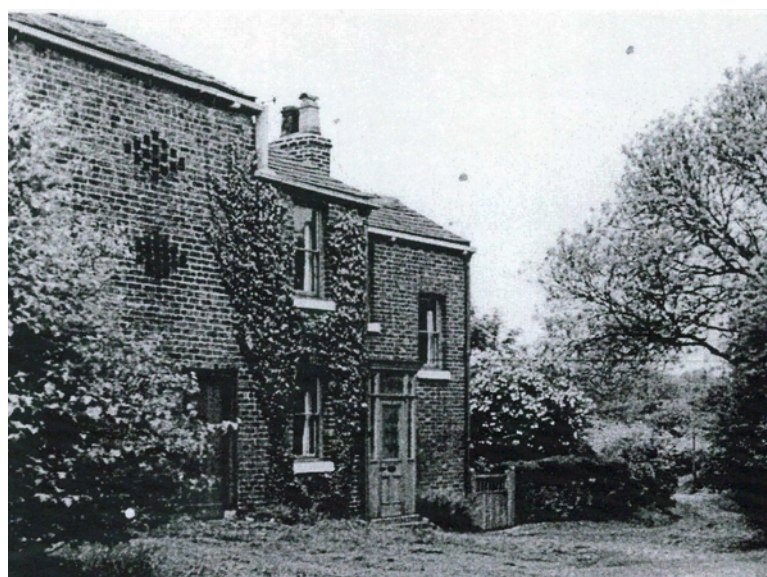
View of Orchard Mount Farm in c 1955

- 3.1.9 The farm complex is shown partially on a photograph dating to the 1950s, which depicts Orchard House and an adjacent barn, which formed the core of the farm complex. It is interesting to note that the layout of the farm, with the farmhouse and barn forming a contiguous range, contrast with the layout of Chorlton Fold Farm (OA North 2007). The owners of Orchard House also owned Laburnum Cottage, located along the eastern side of Chorlton Fold, used as accommodation by the Banister family (J Rabbitt pers comm).

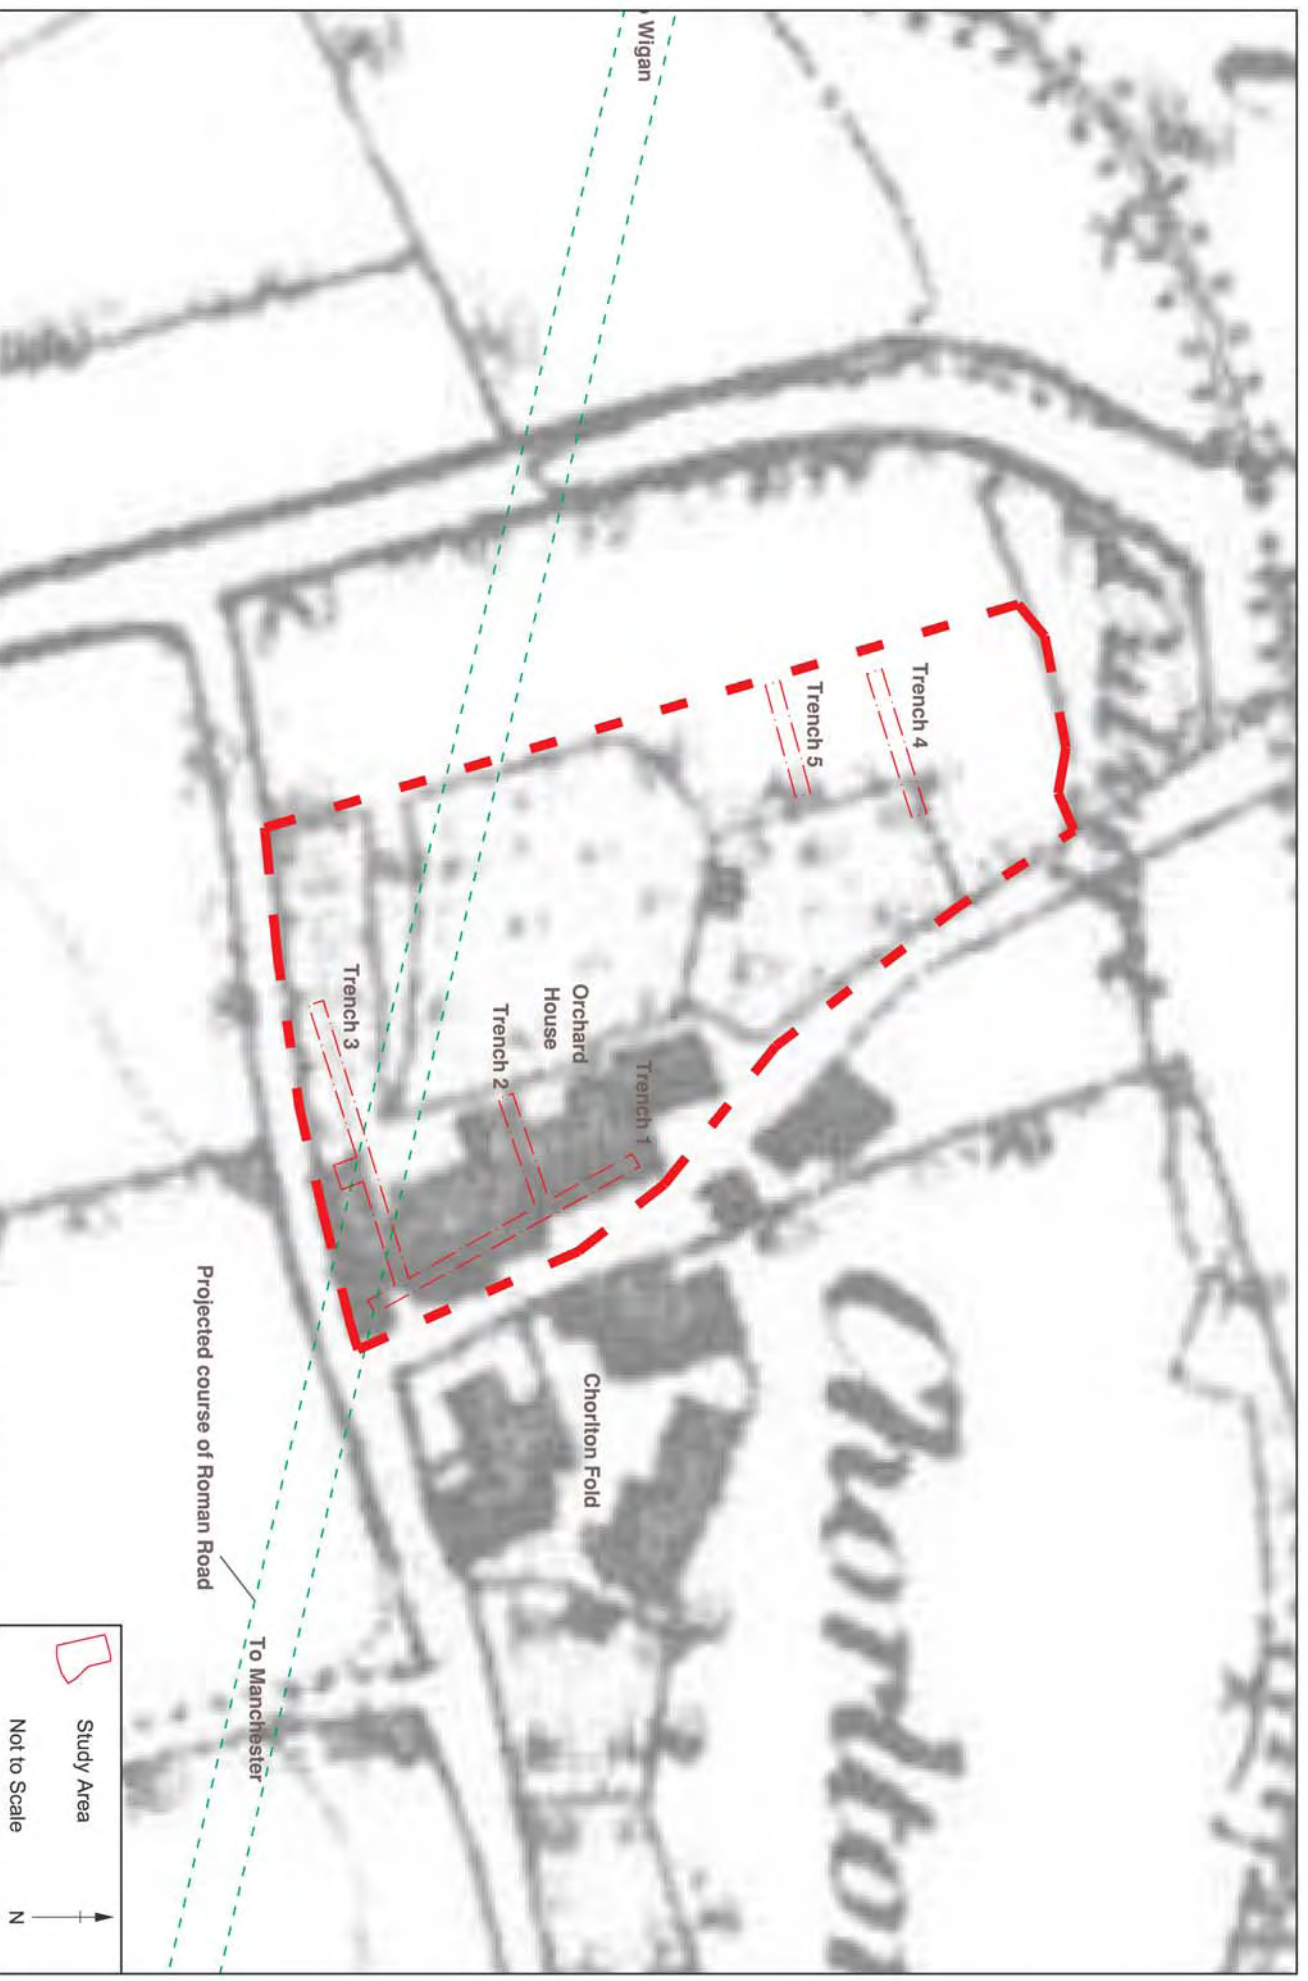
Figure 3: Trenches superimposed upon the 1848 Ordnance Survey map, showing the projected course of the Roman road

- 4.5.1 The trench was intended to evaluate archaeological activity within the north-western part of the site, and was placed across a plot boundary depicted on the 1848 Ordnance Survey map (Fig 3). The trench was devoid of archaeological features, although buried soil horizons containing early post-medieval pottery was observed throughout the trench. The trench measured 15m long, and was excavated to a maximum depth of 1m into saturated sticky yellow clay (**240**). This deposit sloped east/west across the central part of the trench, and clearly represented the natural geology. Another probable natural clay horizon occurred within the western part of the trench, represented by light red friable clay (**244**), which was recorded at a depth of 0.50m beneath the modern turf level.

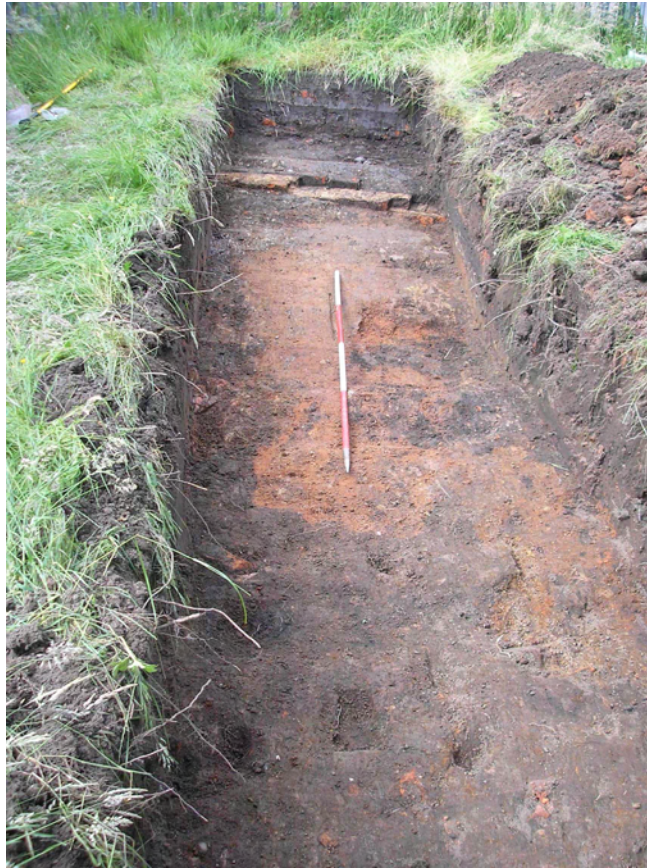
Plate 1: View of the northern end of Trench 1, looking north

- 4.2.1 The trench measured 40m in length, and was aligned north-west/south-east, parallel to the western side of Chorlton Fold Lane (Plates 1 and 2). It was excavated to the surface of the natural geology (**220**), which was exposed at a maximum depth of 1.3m in the central part of the trench, but within 1m below the modern ground surface at both ends of the trench. No evidence for Roman or medieval activity was encountered, although several brick walls surviving across many parts of the trench correspond to the position of structures shown on the 1848 Ordnance Survey map, and almost certainly represented the vestiges of the Orchard Mount farm complex.

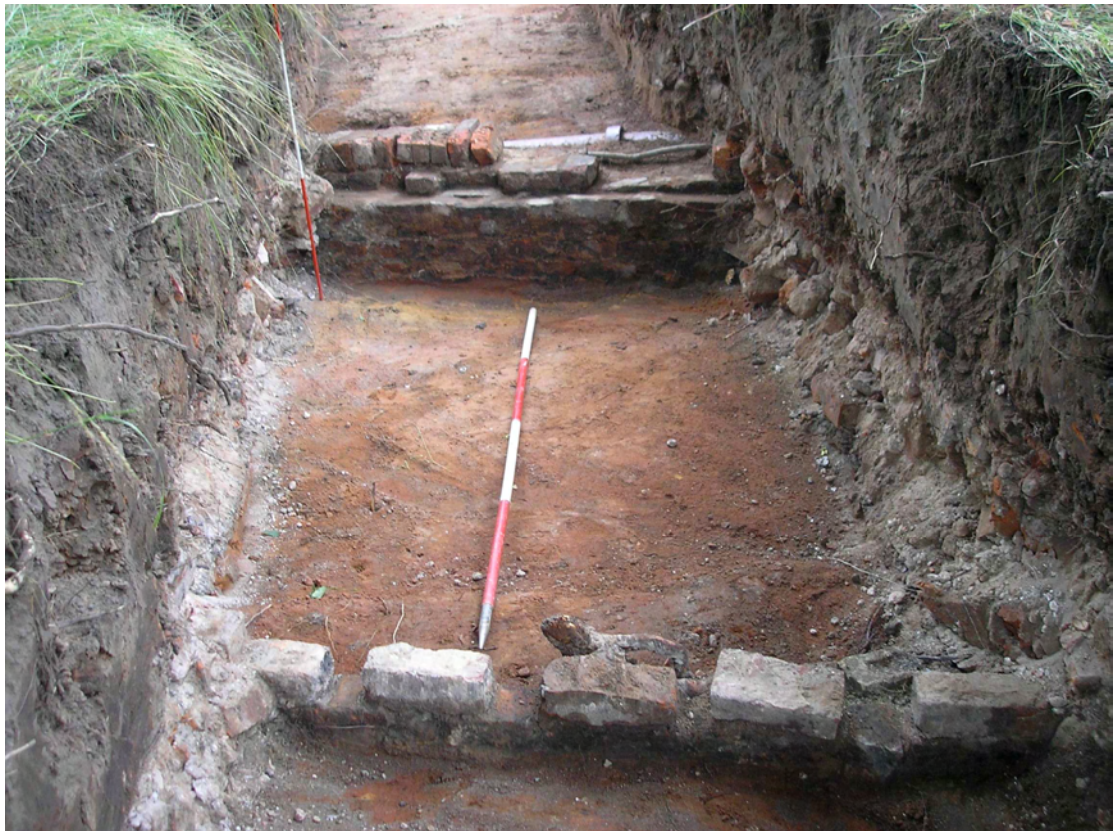
Plate 3: Walls **221** and **222** within Trench 1

- 4.2.3 In total, the remains of five walls were exposed in the trench, of which three (**214**, **221**, and **222**) survived in close proximity, representing the remains of a single building (Plate 3). Walls **212** (Plate 4) and **225** (Plate 5) represented external wall remains of buildings along the northern and southern row of structures shown on the 1848 Ordnance Survey map. All the wall components comprised thin-cut hand-made orange brick of probable 18th century origin,

many of which retained a residue of pale red sand lime-speckled mortar. The bricks varied in size between 230mm by 110mm by 55mm, to 260mm by 140mm by 70mm. The walls were all cut into the natural geology.

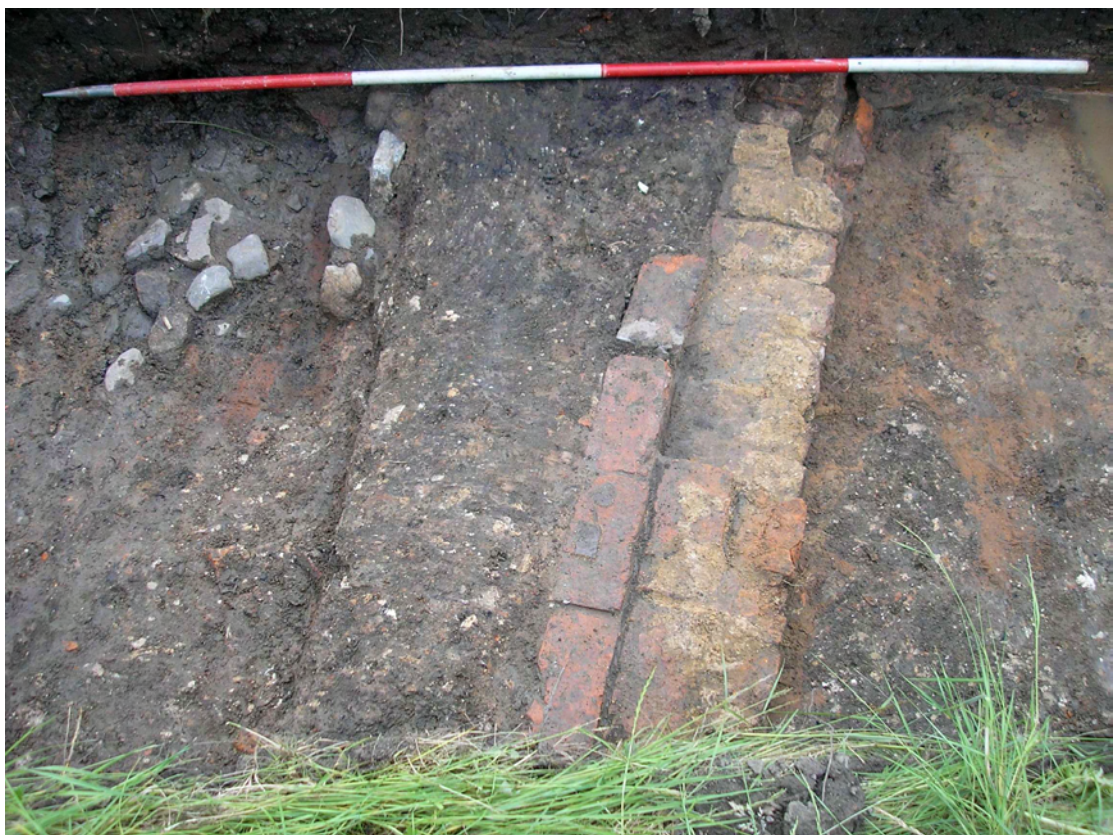
Plate 4: Wall **212** at the northern end of Trench 1

- 4.2.5 Wall **212** located at the northern end of the trench possibly represented the external boundary of a building. It was aligned north-east/south-west, measured three brick skins wide and three courses high, and was laid in courses of stretchers and headers with the upper surviving course of stretchers laid side on. The brick components in the wall measured 230mm by 110mm by 55mm. The thinness of the component bricks resembled a type of brick commonly used in Tudor building construction, although the size may be a result of economy rather than age. The wall was butted along its southern edge by a firm mixed clay (**213**), which yielded fragments of pottery and clay tobacco pipe dated to the 19th century. The northern edge of the wall was bordered by a cobble surface (**215**), which comprised medium-sized water-worn granite and quartz pebbles, extending 0.5m from the northern face of the wall to the trench edge, and was laid above yellow clay (**216**). It is possible that the surface represented a yard or entrance into a building.

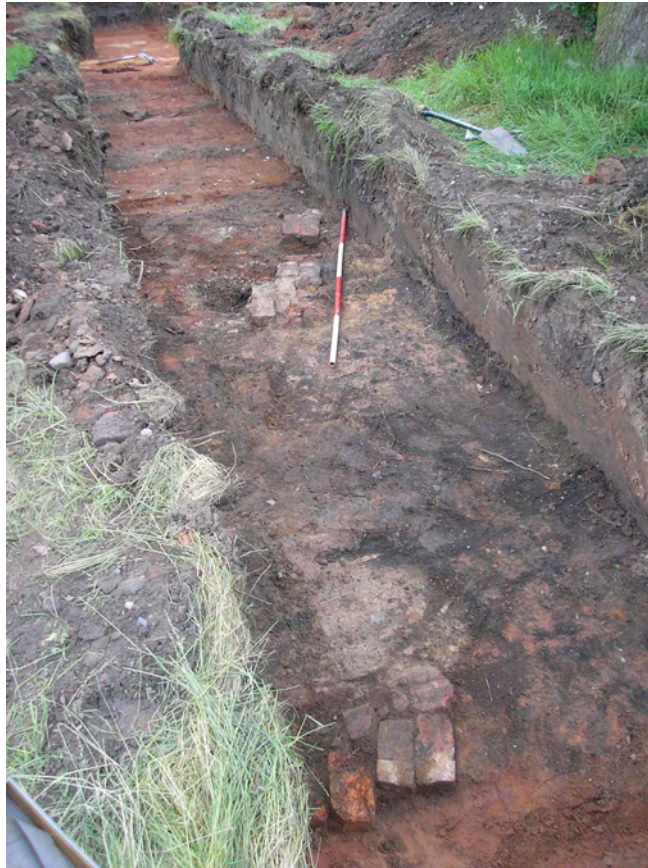
Plate 5: Wall **225** within the central area of Trench 1

- 4.2.4 Wall **225** was aligned north/south across the central part of the trench. It survived for a total length of 1.8m, with an average width of 0.4m, and depth of two brick courses. It was two brick skins wide at the southern end, and three brick skins at the northern end, suggesting the wall was load bearing. Traces of a wall measuring 0.3m long was located 2.3m north of wall **225**, and was likely to represent a continuation of the same wall. Both sections of wall were laid above a dark brown silty-clay layer (**217**), spread over a distance of 2m, representing a redeposition of natural clay horizon **216**.

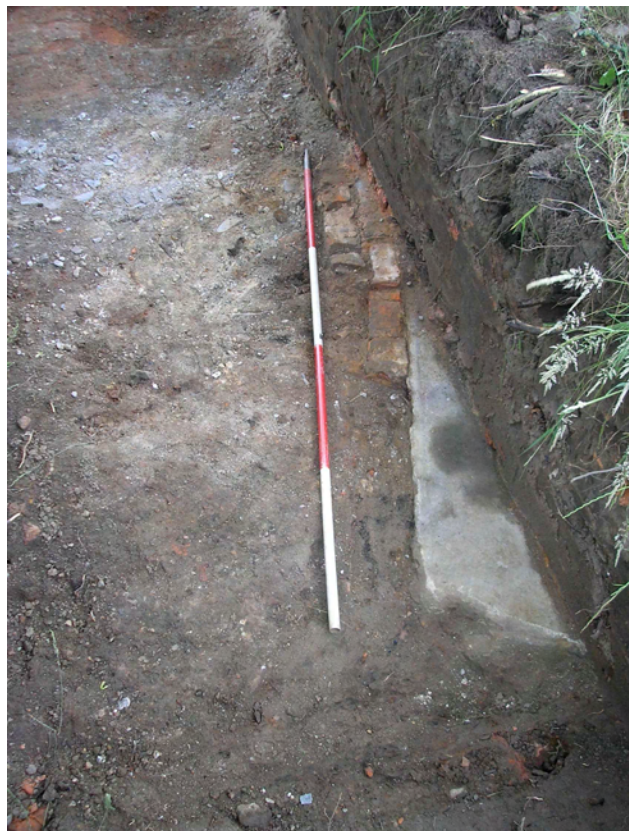
Plate 6: Wall **214** in Trench 1, looking south west

- 4.2.6 Wall **214** was aligned north/south, and was exposed along the western side of the trench, and continued south beyond the trench section edge (Fig 5). It was exposed for a distance of 1m, and was abutted along its western face by the remnants of a stone-flagged floor. The wall (Plate 6) was extremely degraded with just a single course surviving, with no visible mortar. It is probable that the wall represented a continuation of a north/south-aligned wall (**209**) revealed in Trench 2 (4.3.2 below). Wall **221** was aligned east/west across the trench comprising a single skin thick construction that probably represented a partition dividing a room, possibly within the same building. It survived to a height of two courses, although much of it was badly disturbed by tree roots and the truncation level created by the buildings demolition (**219**). A similarly aligned wall (**222**), located 2m south of wall **221** (Plate 7), represented the external wall of a building. The fairly substantial construction of three brick skins (0.45m) wide survived to a height of five courses above natural sand **220**. The wall incorporated a layer of slates in its uppermost surviving course, seemingly representing an attempt at damp-proofing. Further drainage associated with this building was exposed along its southern face, bordered with a 20mm-diameter lead water pipe, which was in turn was lined by a 150mm-diameter ceramic drain pipe.

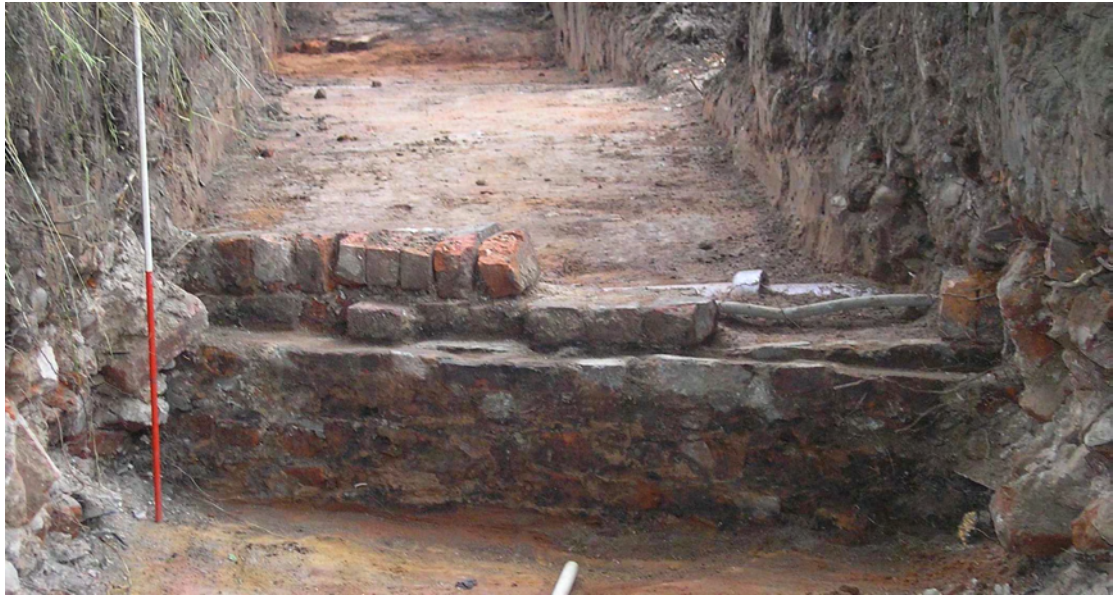
Plate 7: Wall **221** in Trench 1

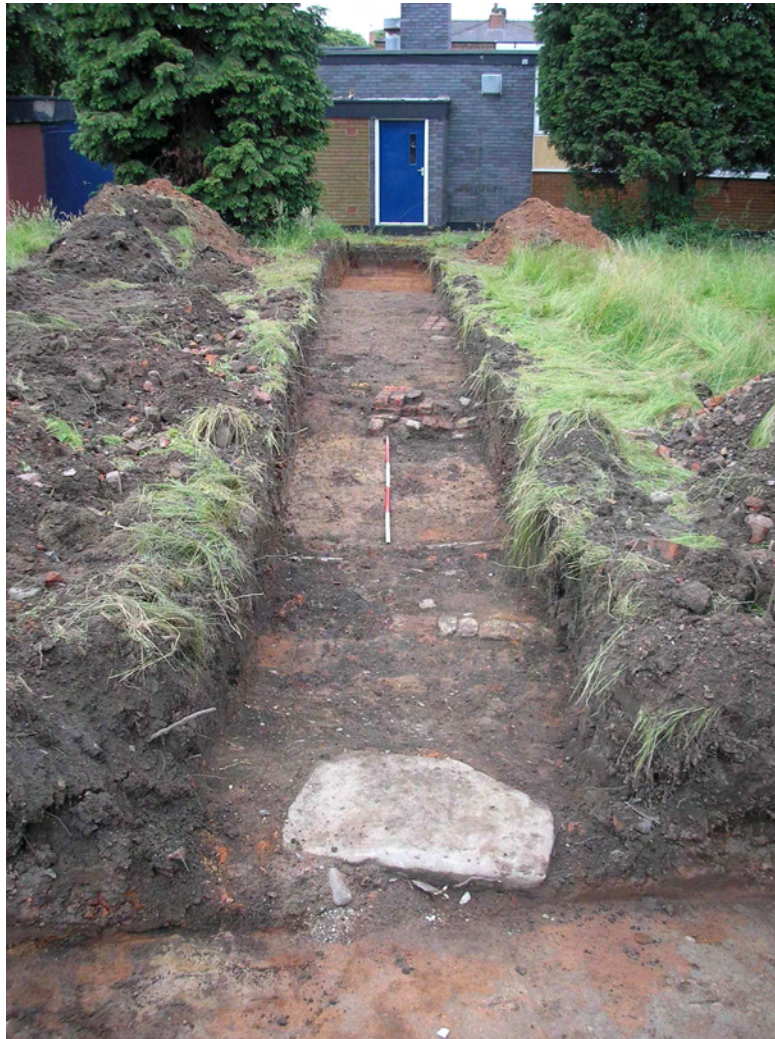
Plate 8: View of Trench 2, looking west

- 4.3.1 The trench was aligned east/west (Plate 8), extending from the western edge of Trench 1 to form part of the F-shaped plan of Trenches 1, 2 and 3 (Fig 2). It measured 15m in length, and was excavated to a maximum depth of 0.87m. The natural geology comprised friable red/orange sandy-clay (**202**), which was overlain by a thin layer of light brown clay-silt (**201**). No evidence of the Roman road or medieval activity existed in the trench, although structural remains that correspond to farm buildings shown on the 1848 Ordnance Survey map were uncovered.

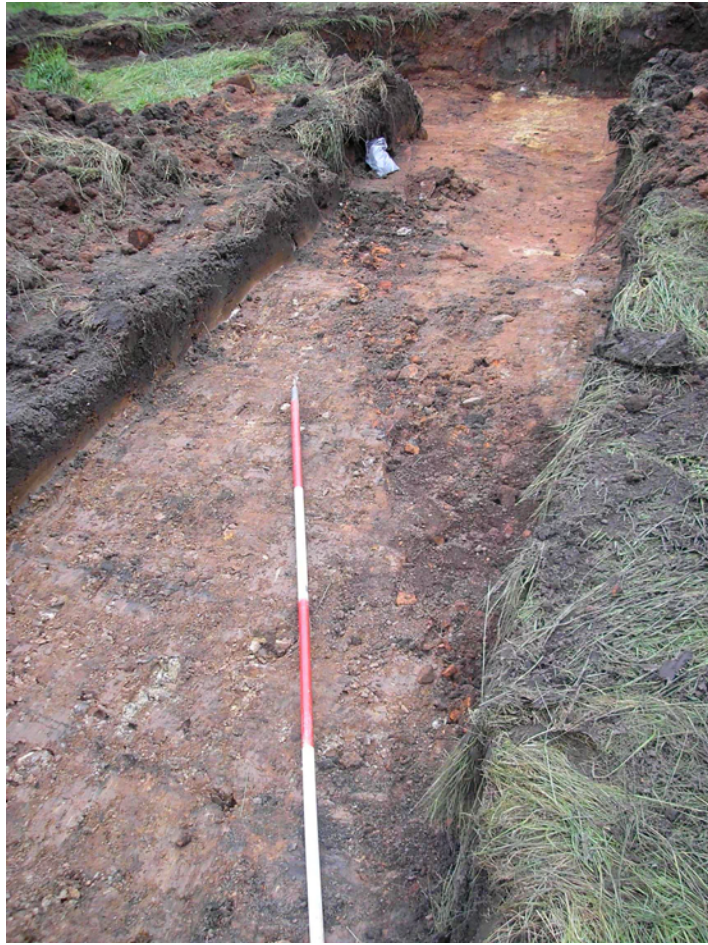
Plate 9: Drain 226 in Trench 3

- 4.4.6 Drain 228 measured 1.7m long by 0.31m wide, and was aligned east/west across the eastern end of the trench (Fig 4). It comprised two single-skin thick walls constructed from two courses of hand-made brick (210mm by 120mm by 60mm), which were loosely bonded with pale reddish-brown mortar. The western end of the drain was terminated with a brick laid north/south across the surviving upper surface of each wall. The entire drain was contained

within a vertical-sided and flat-bottomed linear trench (**226**), which had been excavated into natural geology **232**. Trench **226** had a uniform width of 0.40m and depth of 0.18m, and was exposed for a distance of 3.86m (Plate 9). It was filled with a matrix of rubble and silt (**227**), which yielded numerous sherds of 18th- and 19th-century pottery. Another brick drain (**237**), which had been seemingly abandoned, was located along the central part of the trench. Drain **237** comprised two parallel brick walls aligned north/south and set 0.15m apart, surviving as a single course foundation.

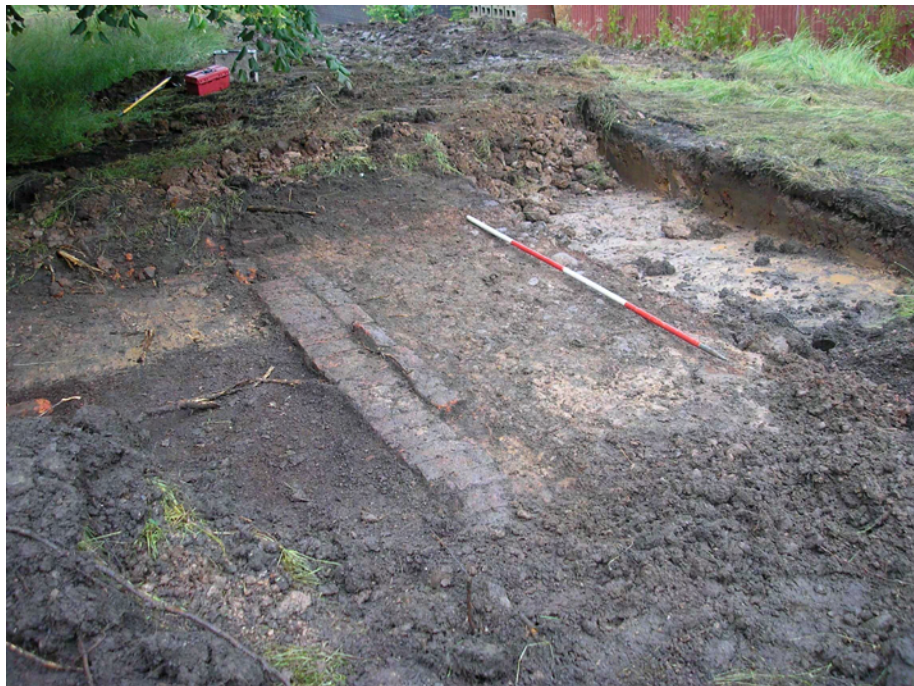
Plate 10: Southern extension of Trench 3, showing cobble spread 235 and wall 239

- 4.4.3 A spread of cobbles (235) across the southern edge of the trench resembled the type of material used in the make-up for a stretch of road recently excavated nearby at Ellesmere Park. However, upon investigation, brick rubble, fragments of pottery, and other inclusions sealed securely below the cobbles demonstrated that the surface could not have been laid earlier than the late 18th/early 19th century. Cobble spread 235 measured 3m in length, and was seemingly contained within a 0.20m deep hollow in the topsoil. The spread comprised poorly sorted water-worn cobbles of varying sizes, which had been deliberately laid to form an even, level surface. The trench was extended 3.5m by 2.5m beyond the southern area of surface 235 in order to investigate its extent (Fig 4). Further traces of the cobbles were encountered 0.05m beneath the turf (Plate 10), extending for a maximum distance of 2.5m by 1.5m, dissipating to the east and abutting an east/west-aligned wall (239) to the south.

- 4.4.4 Wall 239 was two brick skins wide, and was composed of hand-made bricks measuring 230mm by 120mm by 60mm, which were bonded with lime-speckled pinkish-red sandy mortar. The position of the wall corresponds to a building depicted on the 1848 Ordnance Survey map, and represented the only structural remains of the post-medieval farm buildings encountered within the trench.

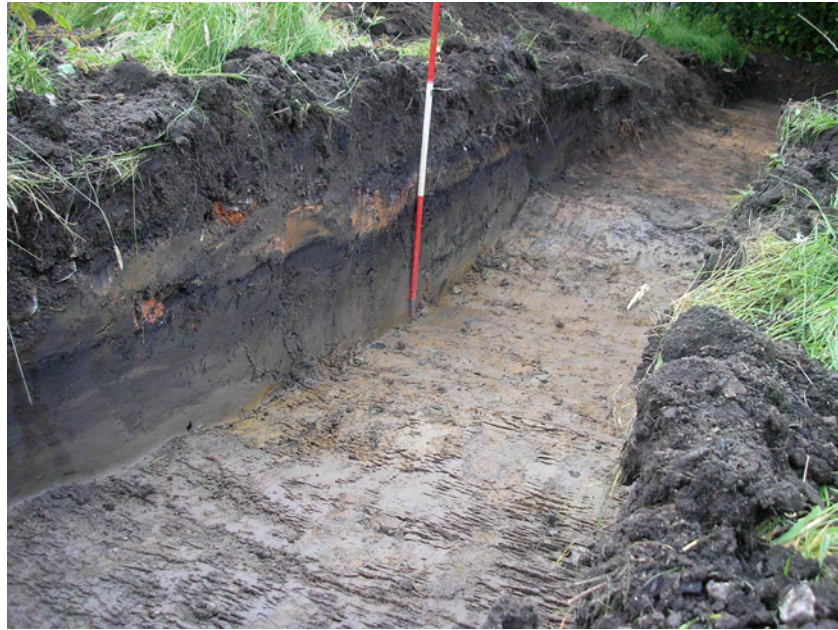
Plate 11: North-facing section of Trench 4, looking south-west showing layer **241**

- 4.5.2 Clay **240** was overlaid by 0.80m thick deposit of grey-brown humic clay (**241**), which extended for a distance of 12m along the trench (Plate 11). The western extent of deposit **241** decreased to 0.50m in thickness where it diffused with clay deposit **244**. Several sherds of pottery dating to between the late 17th and early 18th centuries were recovered from the lower part of the deposit, although modern 20th-century glass was also recovered.

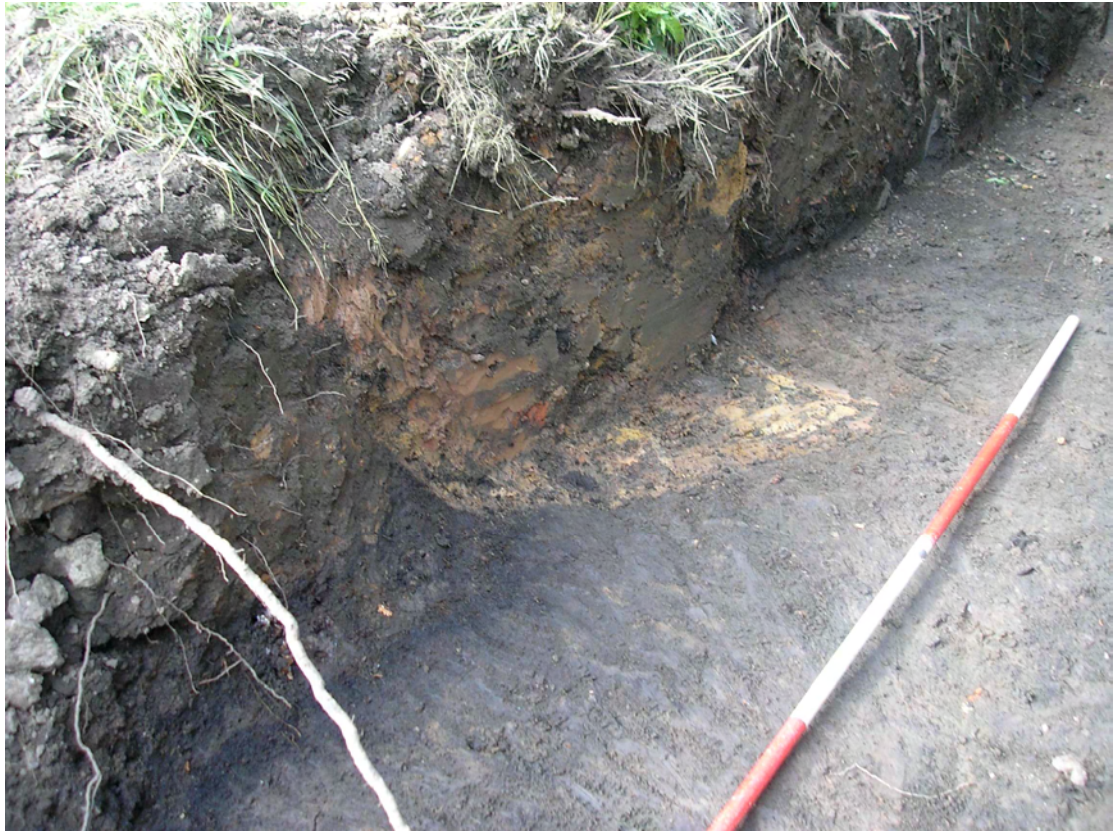
Plate 13: Feature **247** within the north-facing section in Trench 5, looking south-west

- 4.6.3 Both layers were cut by a rectangular-shaped feature (247), which was exposed at the western end of the trench within the north-facing section (Plate 13). The exposed dimensions measured 1m long by 0.5m wide, with an estimated depth of at least 1m, although the feature was not fully excavated. Its fill (248) comprised stick yellow clay and, whilst it did not contain any finds, it was clearly of modern origin.
