BLACKBURN STATION BUILDING, BLACKBURN Lancashire

Archaeological Building Investigation

Document Type: Archaeological Building Investigation Report

Client Name: Lancashire Constabulary

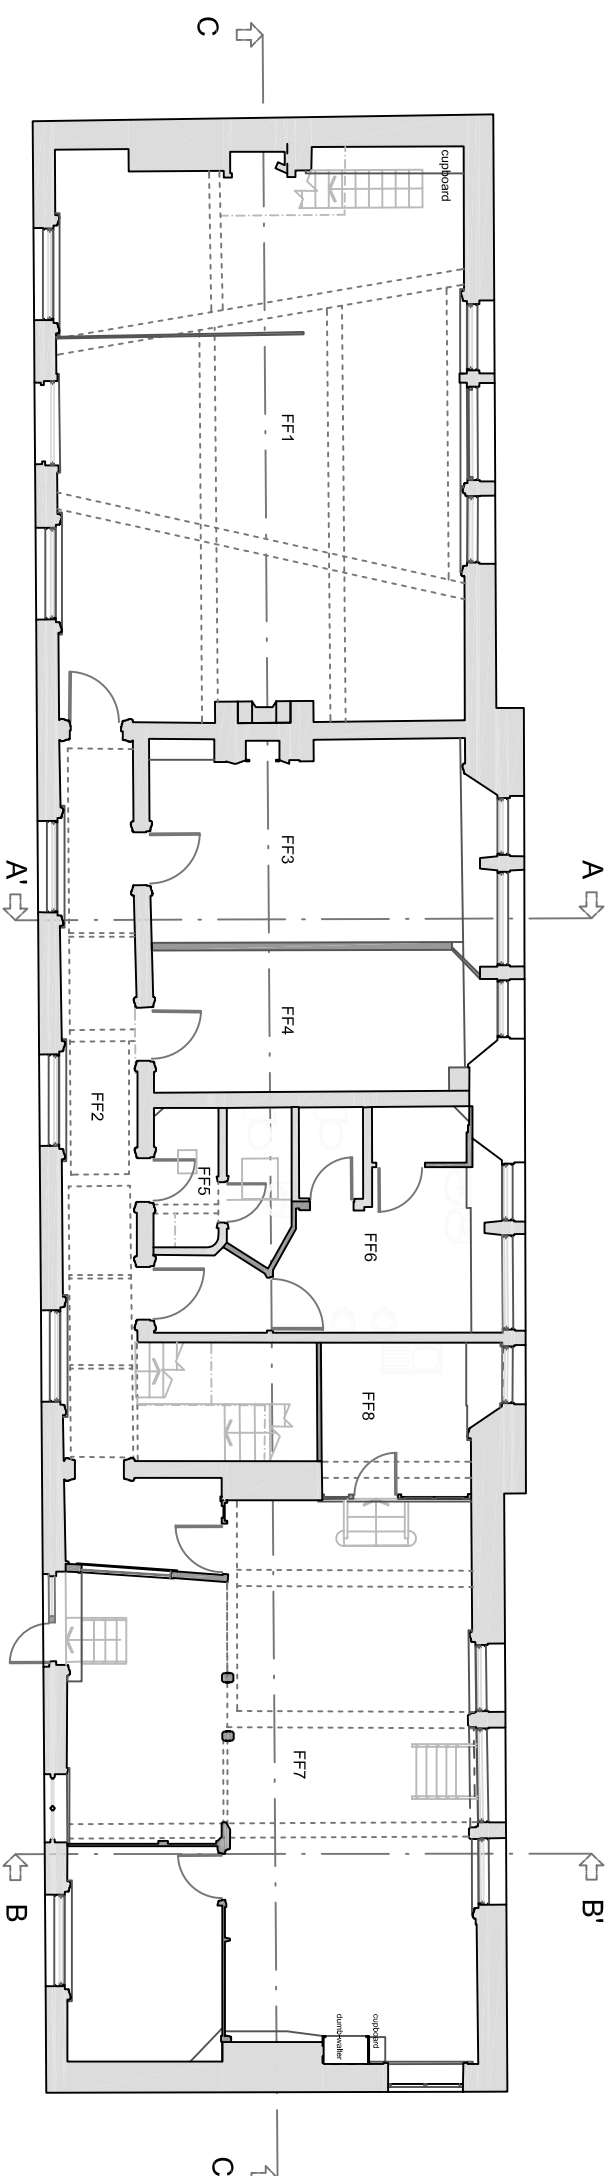
Figure 2 : First and second floor plans

- 3.2.2 **First Floor and Second Floor Plan (Fig 2):** there are three principal divisions to the first floor, an arrangement that is repeated above on the second floor. This comprises a large office space at either end of the floors (FF1, FF7, SF1/2, SF6/7/8), with smaller rooms offset from a rear corridor (FF2 and SF4), in the centre of the building (FF3-6, FF8, SF3-5).

- 3.2.1 **Main stair:** access to the offices on the first floor is gained via a central stair, positioned within an enclosed lobby at ground floor level (Fig 2). It is an open well timber stair with landings, and has five flights, comprising eight steps in the three main flights, with three steps between the half-landings. The stair is suprisingly ornate for the status of the structure and matches the decorative style of the façade rather than the interior offices above. Presumably it was originally visible from outside (the present late twentieth century doors are dark-tinted), which would explain its decorative nature. It has a curtail step at its base and has open strings, the strings being decorated with detailed fretwork in repeating cyma and ogee patterns. The newels are turned, having squared sections separated by roll and torus mouldings, and project above the handrail and below the string, where they are finished with unusual pointed turned pommels on all but the top banister (Fig 5); (Plate 2). Here they were omitted for the addition of a service stair above. The slender balusters are positioned two per tread, except for that immediately above the newel, which only has a single baluster, and are also turned, but with squared heads and octagonal-section bases. The tread ends project beyond the string the same distance as the nosing. The handrail has a simple hourglass profile, with projecting wide fillet on its upper surface. At the top of the stair, on the first floor landing (FF2), is a banister comprising six balusters closing the stair to the wall to the north.

- 3.2.5 **First floor corridor FF2:** access to all rooms of the first floor from the main stair was via a corridor along the north-eastern side of the building (Fig 2). As elsewhere, the walls were plastered and the floor covered with linoleum. The ceiling was longitudinally tongue-and-groove panelled, with a stop-chamfered rail along the north-eastern side. Light was provided by three sash windows in the north-eastern elevation, identical to those on the same wall within FF1. The window heads projected above the panelling of the ceiling, into the floorspace above. Four doorways along the north-western elevation allow access into the small offices and toilets of the first floor (FF3-FF6), whilst doorways at either end of the corridor lead into the larger offices (FF1 and FF7).

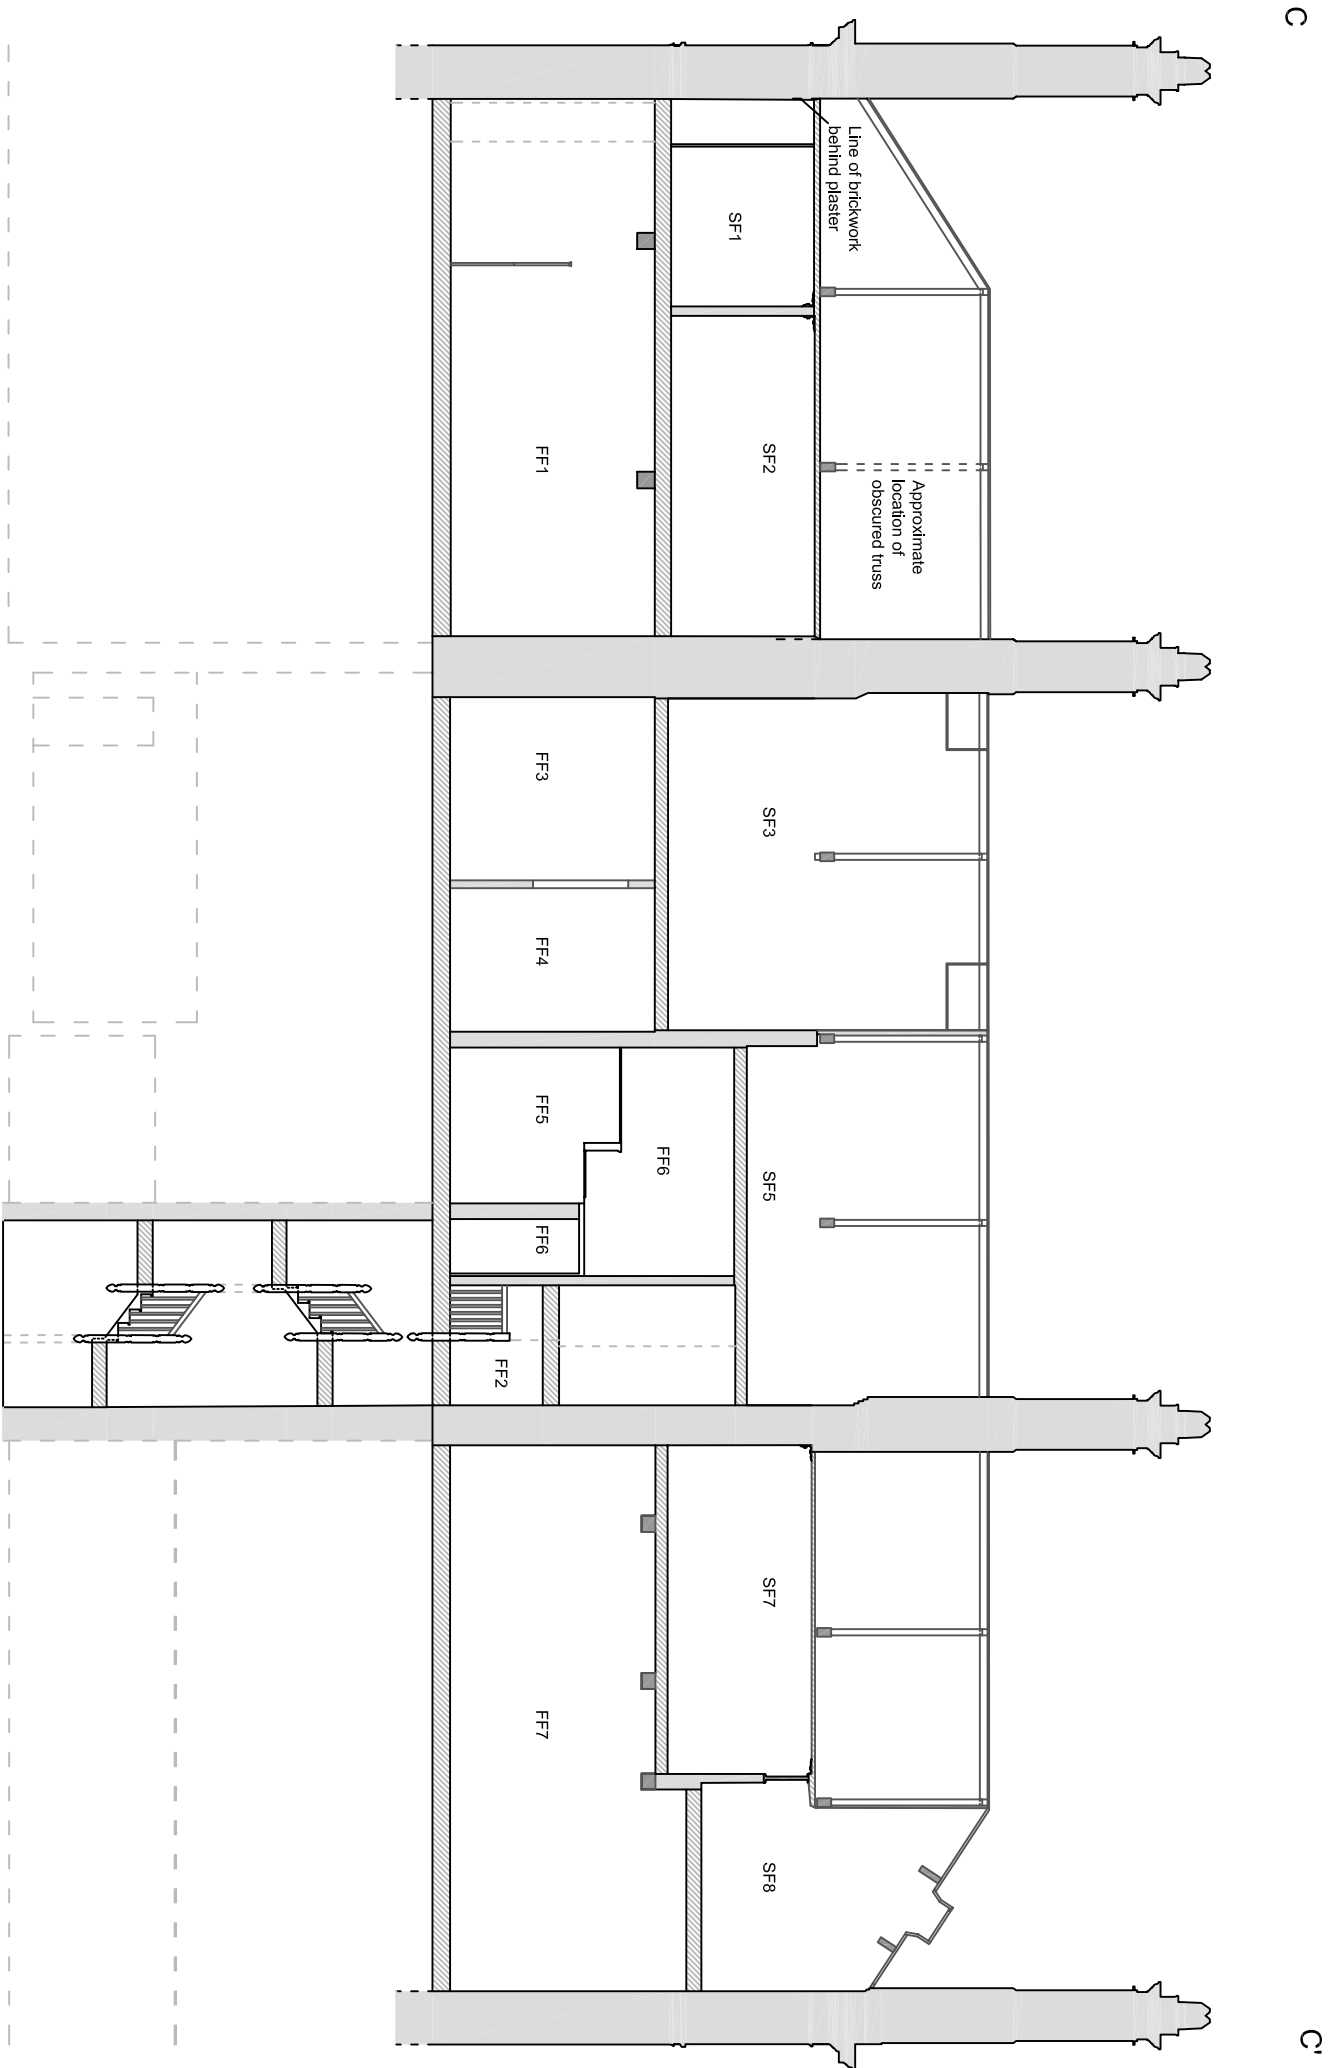
Figure 3 : Long cross-section

- 3.2.2 The station building is Italianate in style built from red brick in Flemish bond (Plate 1). The main north-western façade has sandstone quoin dressings, a plain sandstone frieze, and a prominent moulded cornice. There are four large Venetian windows; those in the two-bay centre are modified with pediments over square-headed centre lights. Mounted over the centre is a large clock, located within a pedimented upstand with carved enrichments. The building has four tall panelled and corniced brick chimney stacks (Fig 3), above the recently replaced metal roof.

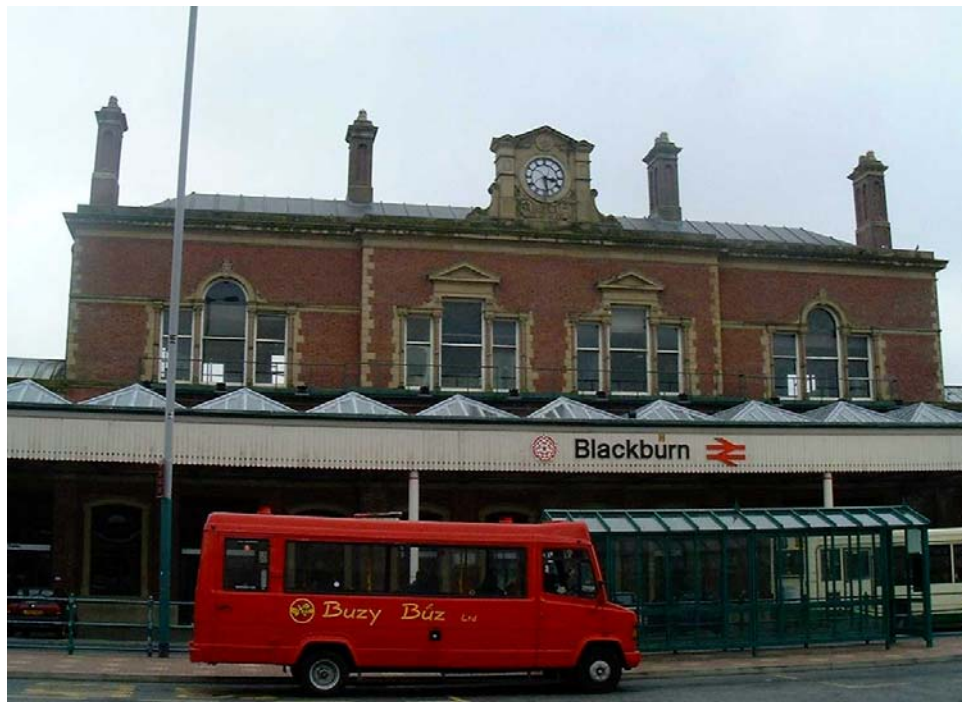
Plate 1: North-west façade of Blackburn station

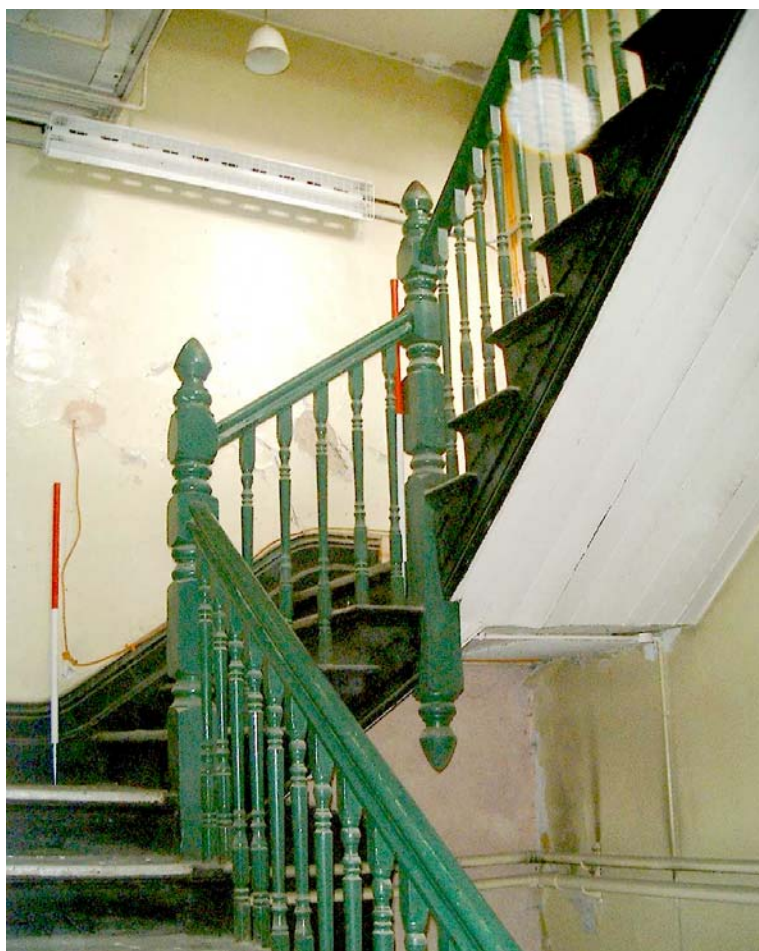
Plate 2: Detail of main stair

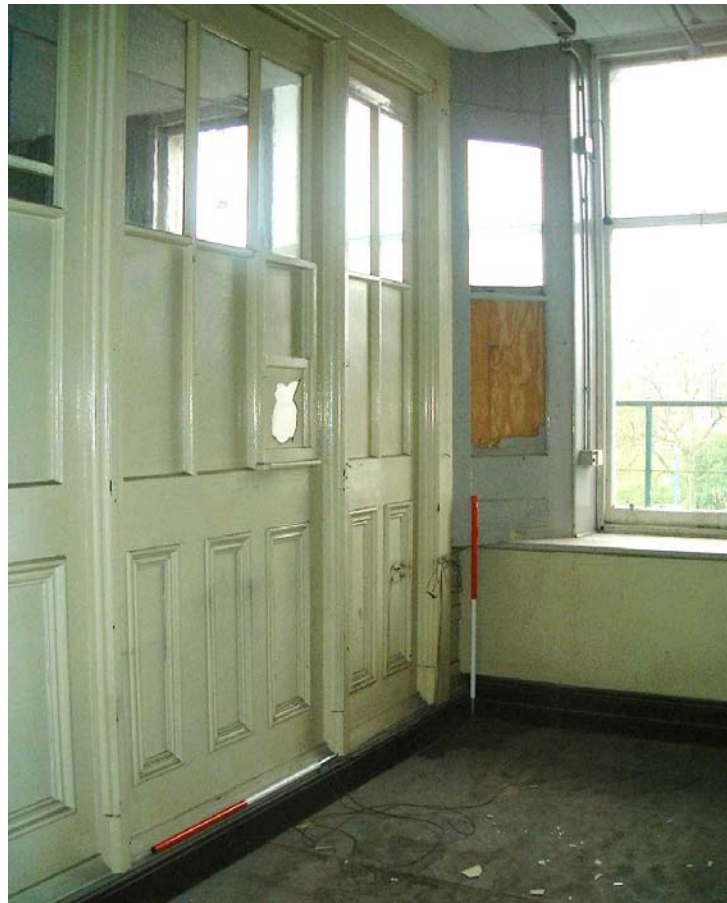
- 3.2.7 **First floor office FF4:** this lies to the north-west of the partition in FF3, and the room is of a very similar style. The awkward junction of the partition with the external elevation is less pronounced in this room, as it is panelled to the mullion, mirroring that on the northern jamb (Plate 4). Pipework to the north-east of the window is boxed within lath and plaster. The doorway to FF2 appears to be of the same style as that from FF3, suggesting that they are contemporary.

Plate 4: Timber partition between FF4 and FF3 from east

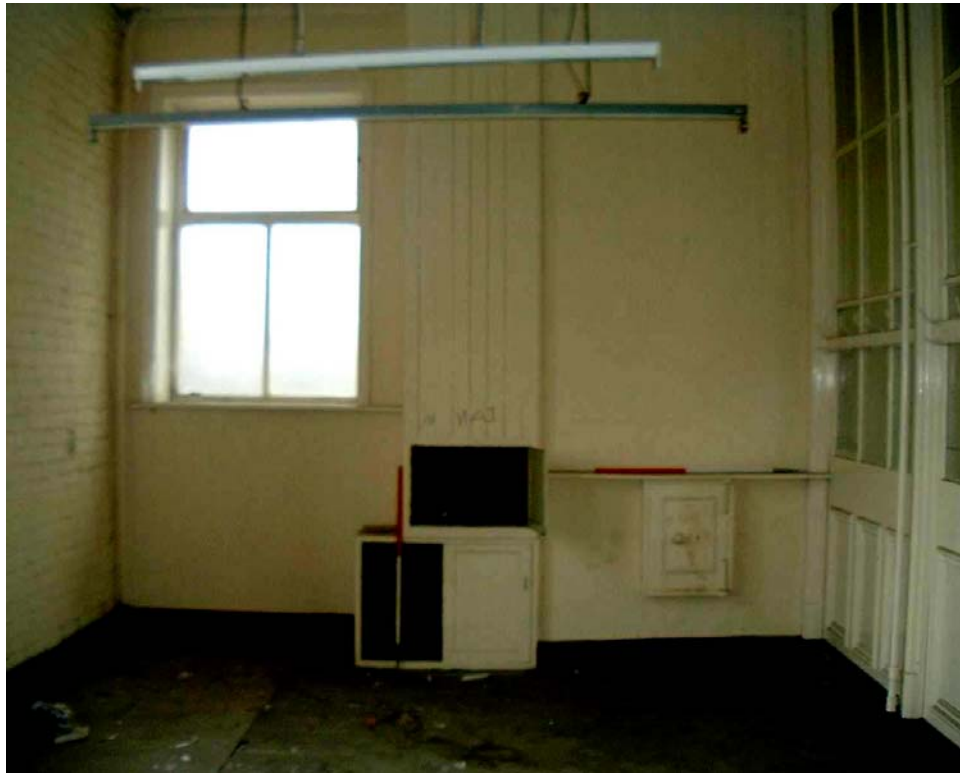
- 3.2.10 **First floor office FF7:** the room to the north-west of the staircase is of similar size to FF1 at the south-western end of the floor. It is similarly well lit, with three sash windows in the north-west elevation and two in the south-east elevation. It also has a later inserted window in the south-east elevation, although smaller than that in FF1, and offset slightly to the north-east. There is also an inserted window in the north-eastern gable, to the north-west of the chimney breast. There is no fireplace within the chimney breast, instead it houses a safe to the south-east of the flue leading from the ground floor fireplace. A dumb-waiter, leading to SF8 above, is located immediately to the north-west of the chimney breast and has fitted cupboards below (Plate 5). The room has a partitioned office in the north-east corner, the partition being very similar in style to that between FF3 and FF4, and most probably original (Fig 5). A partition in the south-east corner of the room, constructed of vertical tongue-and-groove panelling, forms a lobby, and is probably of later date, as it cuts the moulding around the south-eastern sash window. Between the two partitions are two vertical posts. Both are stop-chamfered and appear to be original supports for the ceiling. Steps have been added to the southern window of both north-west and south-east elevations, giving access onto external walkways above the canopies on either side of the building. A further short three-step stair in the south-west corner, without handrail and with wide curtail step, gives access into FF8.

Plate 5: Dumb-waiter, safe and inserted window in gable of FF7

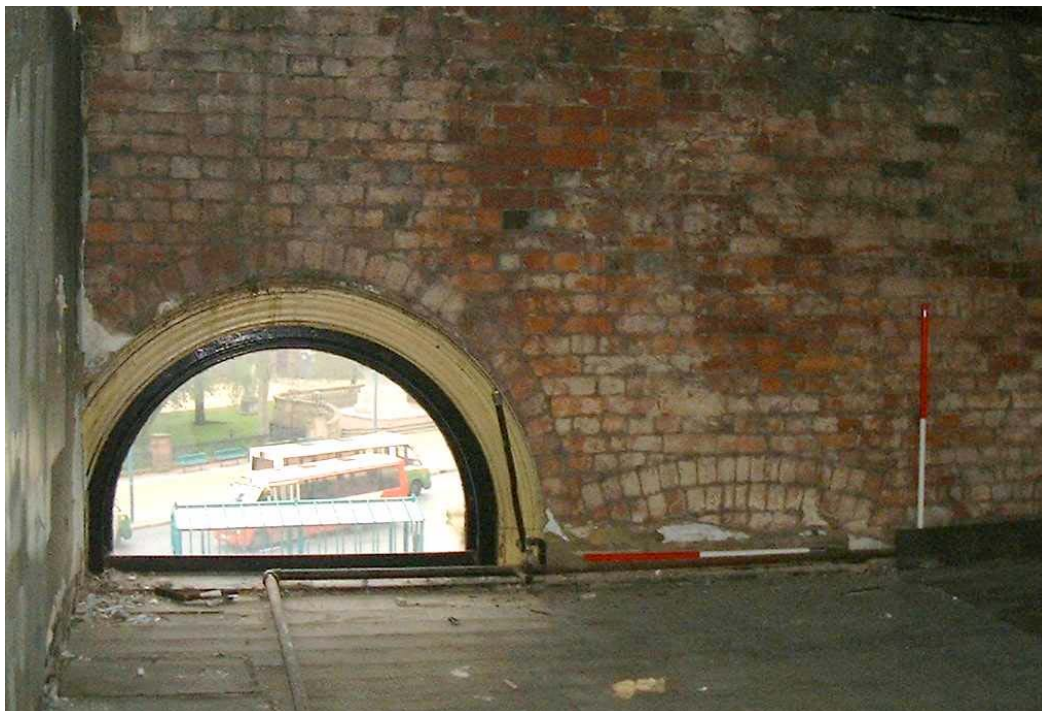
- 3.2.14 **Second floor office SF2:** this room is also plastered in a similar style to SF1, and also with an exposed north-western elevation. This contains the head of a large sash window projecting above the floor level, and an arch-head in the brickwork to the north-east, identical to that observed in SF1 (Plate 6). There are two inserted four-light casement windows in the south-eastern elevation, presumably replacing at least one original sash window. The ceiling is of similar style to SF1, but without roofspace access. There is no evidence for a fireplace within the chimney breast on the north-eastern elevation.

Plate 6: Arch-heads of first floor windows within SF2

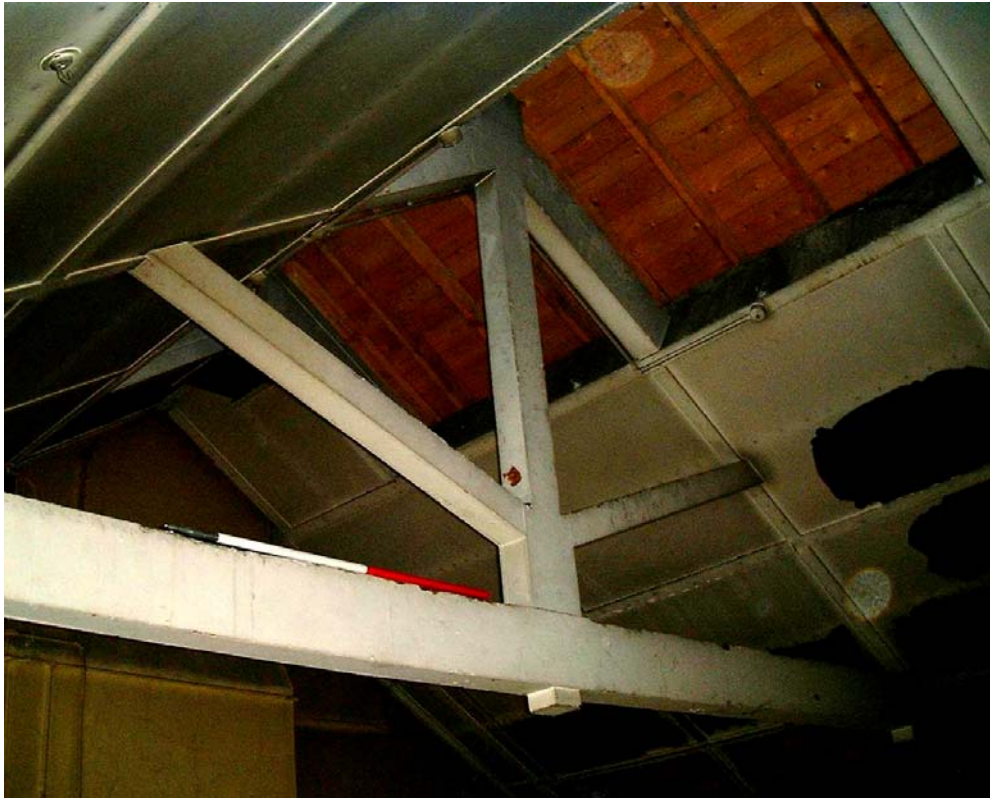
- 3.2.15 **Second floor office SF3:** the room is again plastered in the manner of SF1, with exposed English Bond brickwork in the north-western elevation. The upper squared head of the central window of the north-western façade projects above floor level within this elevation, and is boarded over. The room has three four-light sash windows in the south-eastern elevation, similar in style to those on the first floor, but smaller. The room is open to the upper surface of the principal rafters, where it is boarded below the upper purlin on each pitch. The upper space has been recently re-roofed, with new rafters, and it is likely that this originally formed a skylight. The truss is exposed within the room, and is the same as all others observed within the roofspace (Plate 7). It is an unusual king-post truss, with the principal rafters meeting above the post and with a short king-block clasping the ridge-board above. The king-post itself is not

shouldered to support the braces, but instead has a vertical butt joint with them. The king-post and principal rafters are bolted onto the tie-beam, which appears to sit, unjointed, on the wall-plates. The north-eastern elevation is brick to wall-head height and is a lath and plaster stud partition above. There is no evidence of a fireplace within the chimney breast on the south-western elevation.

Plate 7: Detail of second floor trusses (exposed within SF3)

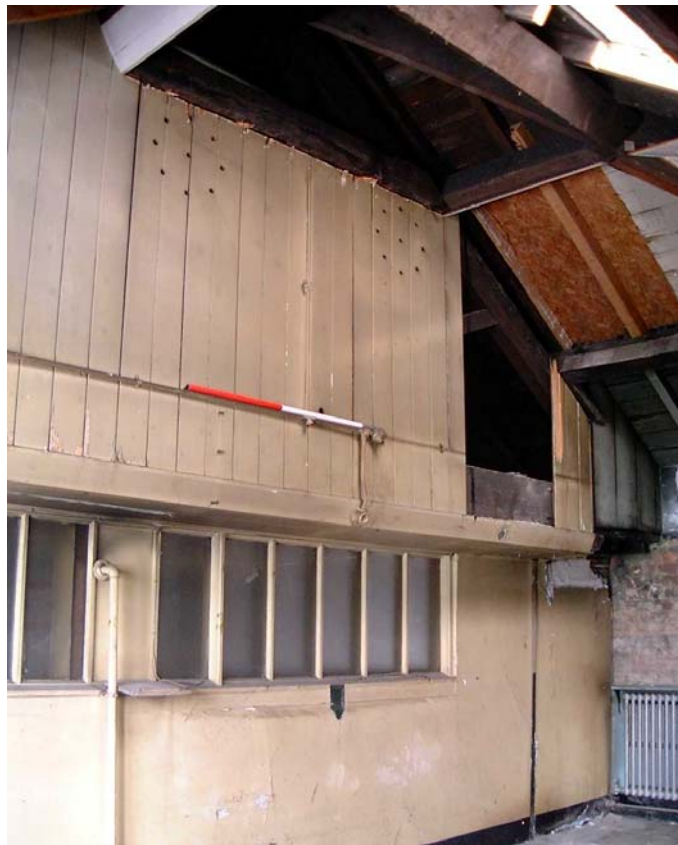
- 3.2.20 **Second floor office SF8:** the north-eastern room of the second floor is 0.56m higher than SF6/7. The walls are plastered, as elsewhere, and the roofspace is open to the north-east of the apex of the hipped roof. The truss supporting the apex is tongue-and-groove boarded on its north-eastern face, and is jettied into the room above the partition wall, which stands to ceiling height within rooms SF6/7 (Plate 8). The roof has a new late-twentieth century skylight within the hip to the chimney breast, which contains a small fireplace with cast-iron, leaded surround. The dumb-waiter from FF7 is located within a fitted cupboard to the north-west of the chimney breast, and has its pulley mechanism housed

on top of the cupboard. A four-light sash window located in the south-eastern elevation has been re-glazed north of the mullion with a single pane in the late twentieth century.

Plate 8: South-west elevation of SF8
