LOWTHER CASTLE GARDENS CUMBRIA

Archaeological Survey Report

Oxford Archaeology North

June 2007

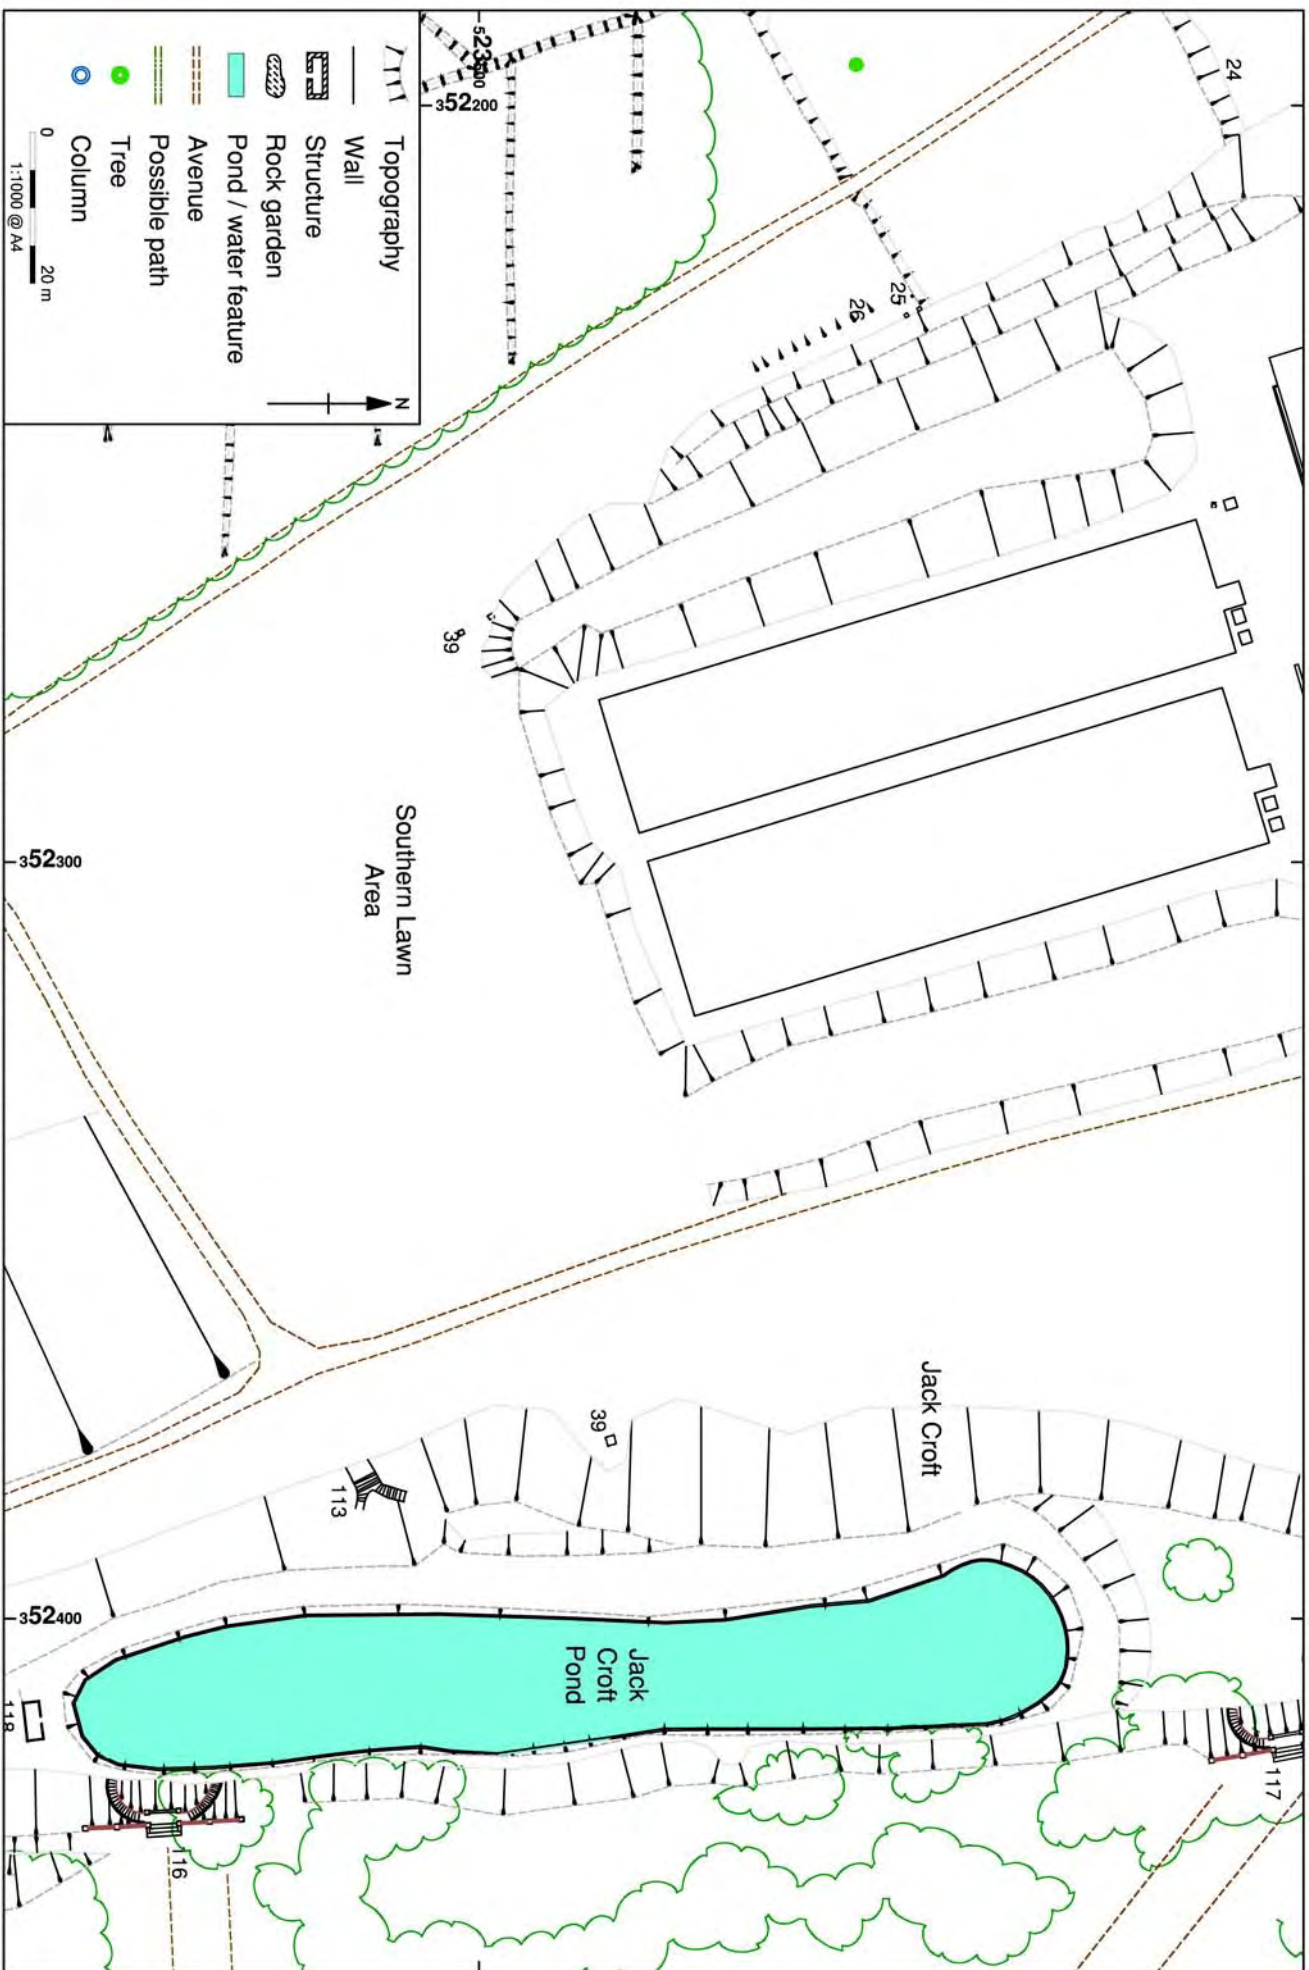
Figure 10: Lower garden Survey - Detail of Southern Lawn and Jack Croft areas

- 4.7.1 This former area of lawns to the south of Lowther III (Figs 3, 9,10) has now largely been given over to the chicken sheds. At the southernmost extent are two modern sheds aligned north/ south, which appear to have been cut into the slope of the former lawn area, and have generated two large spoil heaps which lie next to each shed. The remaining sheds, to the north, are aligned east/west and are of slightly older construction. Various tanks and feeders have been installed, and the majority of the area is covered in concrete hard standing or tarmac. There is a small square area of plantation on the central-eastern edge of this area. The only features recorded within this area were two identical sets of square stone pillars (Site 36, Figs 8 and 10) at the southern end of the area, along with two modern concrete

water management features (Site **41**, Fig 9) in the centre of each section of plantation directly in front of the current standing castle.

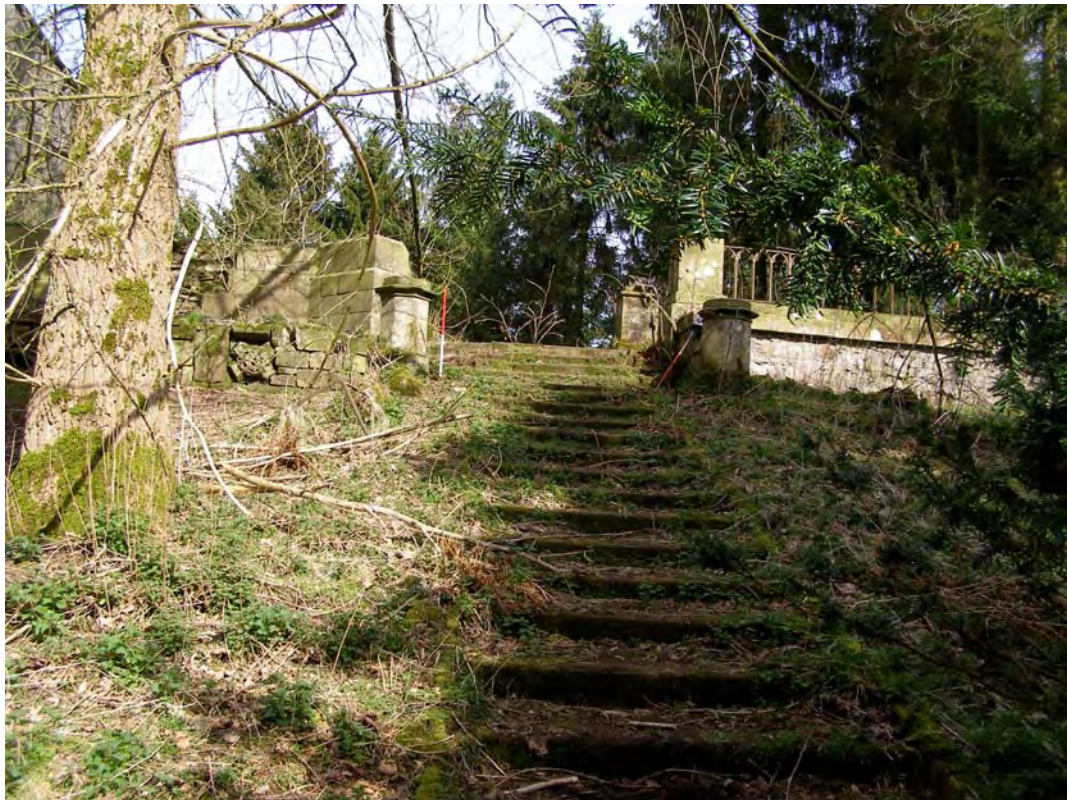
Plate 1: Site **57**, Stairs to the south-east of the Winter Garden

- 4.4.8 Stairwell **59** is identical to its counterpart **57**, which is 40m to the north, but in a poorer state of repair and only having a short flight of five steps descending into the garden. The south-east pillar has been knocked over, and there was an *ex-situ* stone capital in the vicinity, which would suggest that both this and Site **57** would have had stone capitals on all the pillars. Immediately north of this stairwell is an *ex-situ* block of masonry (Site **61**) (0.5m square) with the remains of iron connection bolts, on its upper surface, which is likely to be displaced from the damaged stairwell.

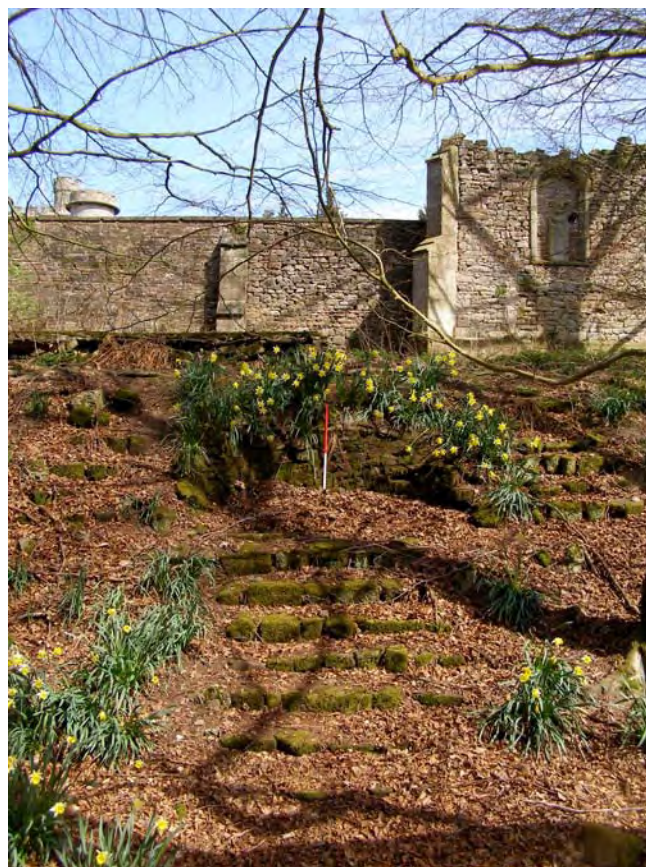
Plate 2: Site **9**, An ornamental alcove in the Countess's Garden

Site Number	9
Site Name	Lowther Castle, Countess's Garden, Alcove and Access Steps
NGR	NY 52118 23769
Site Type	Steps
Period	Early Twentieth Century
Condition	Good
Source	Garden Survey
Description	Decorative alcove and steps located centrally on the south-eastern bank of the Countess's Garden (Site 20) Semi-circular alcove and stone retaining wall 3m long, 1.9m wide and 1m

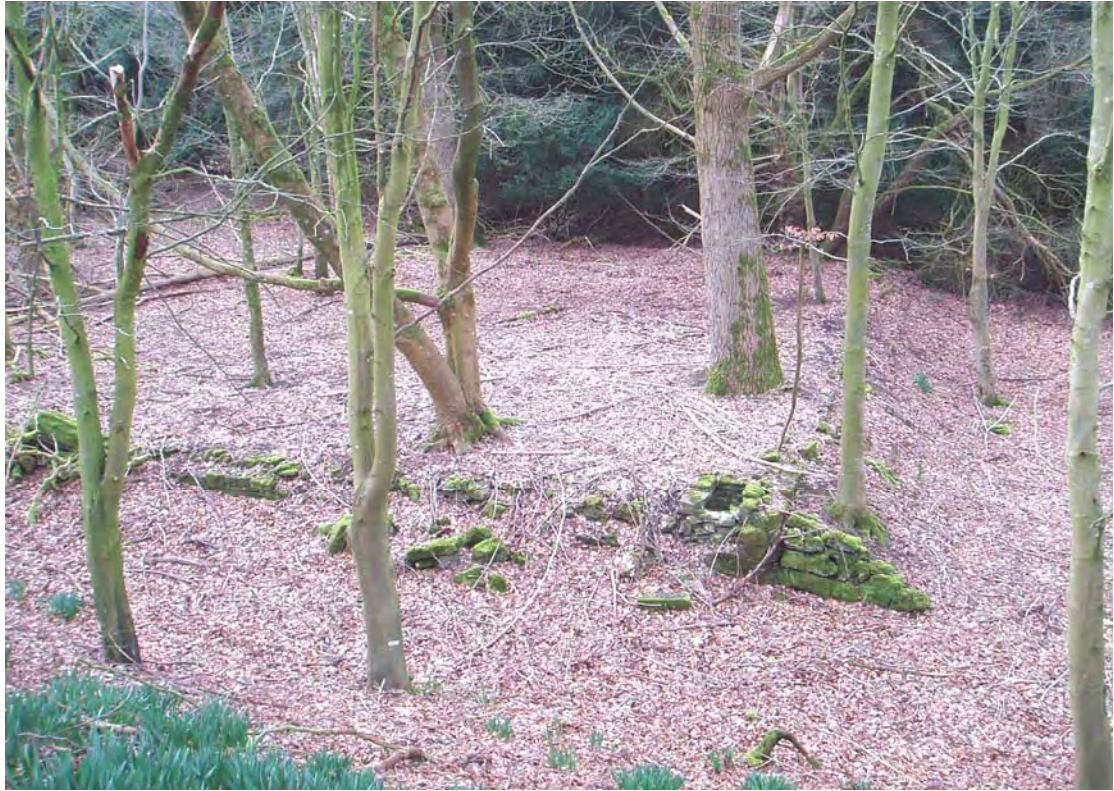
Plate 3: Site **14**, the raised platform in the Countess's Garden, believed to be a tennis court

- 4.2.7 The southern half of the Countess's Garden is dominated by a large rectangular, level topped platform (Site **14**, Fig 5, Plate 3), which is not shown on the 1915 map (presumably its construction post-dates that map). The platform was edged by a mortared retaining wall of rustic dressed stone, which is still evident on the north, east and west sides of the platform but not to the south, where it was slightly cut into the slope. The surface of the platform was gravel and clinker and the level area is 39m x 16m in extent (and 1.3m high to the north). It is conjectured that it was possibly a tennis court, which were typically 36m x 14m in size. A square-shaped water housing of stone with a standpipe was located in the north-east corner of the platform, possibly a disused drinking fountain. The northern side was a sloped retaining wall, roughly 2m wide with small abutting end walls and two flights of steps providing access on to the structure. Immediately north of this was a small, two-celled earthwork (Site **15**), which was a sub-rectangular feature with low, barely perceptible, earthen banks that were seen to contain some stone and corrugated iron.

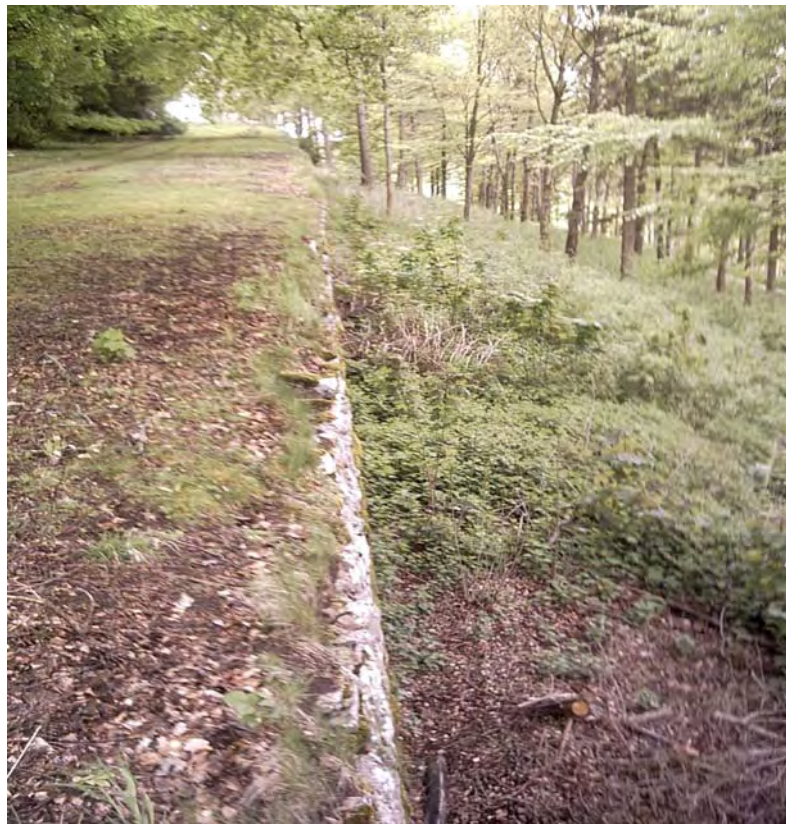
Plate 4: Site **79**, the perimeter wall created to enhance the limestone outcrop 'Burtree Scar', looking south

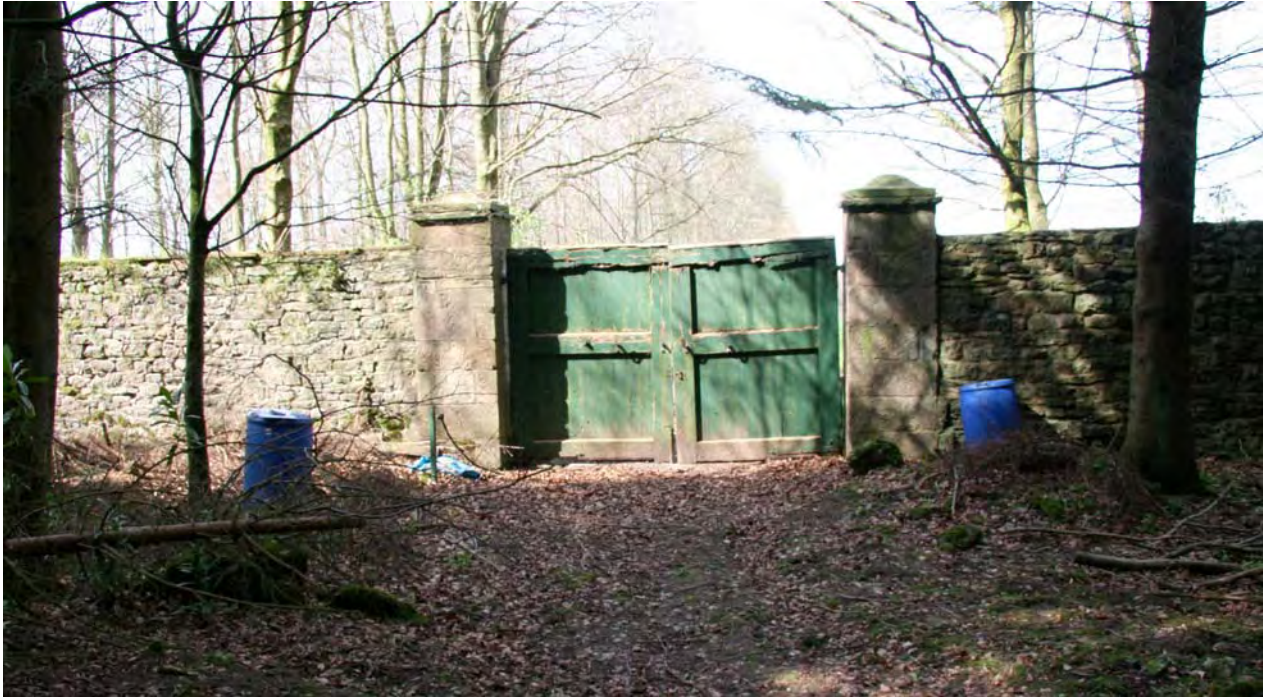
Plate 5: Site **114**, the cart entrance in the north perimeter wall

- 4.2.12 The northern garden wall (Site **76**) has two entrances through it, one in the centre (Site **114**), which is a service entrance large enough for a cart and a western pedestrian entrance (Site **78**, Plate 6). The eastern section of wall is built in stone but has a repair to the lower part of the wall in hand-made brick. The westernmost section is again in stone, but there are two rebuilt sections, one in hand-made brick and the other in modern brick; overall it is 2.5m - 3m high. There is an embankment (Site **82**) running parallel to the central section of wall **76**, to the west of entrance **114**, which is 1.5m wide and 0.5m high; it appears to have edged pathway **97** that extended against the wall. The pedestrian entrance (Site **78**), has a wooden door and a plain internal face, but the external side is very ornate and has two columns on either side each with Corinthian capitals. There are steps leading up to it from the outside and the path (Site **97**) leading south into the garden is wide and runs along the top of the perimeter retaining wall (Site **79**, Plate 4), which extends along the western perimeter of the garden. The northern section of this perimeter wall survives as a well-built, upstanding mortared wall with scarring evidence suggesting a former building, running south for 7m, from the perimeter wall return. A lower and thinner dry stone wall butted up against the southern end of the building, and continued south for c 30m. Thereafter, it continues as a very substantial terraced retaining wall. The path is defined between this and a 46m long section of earthen embankment (Site **77**), which has a hedge planted on top.

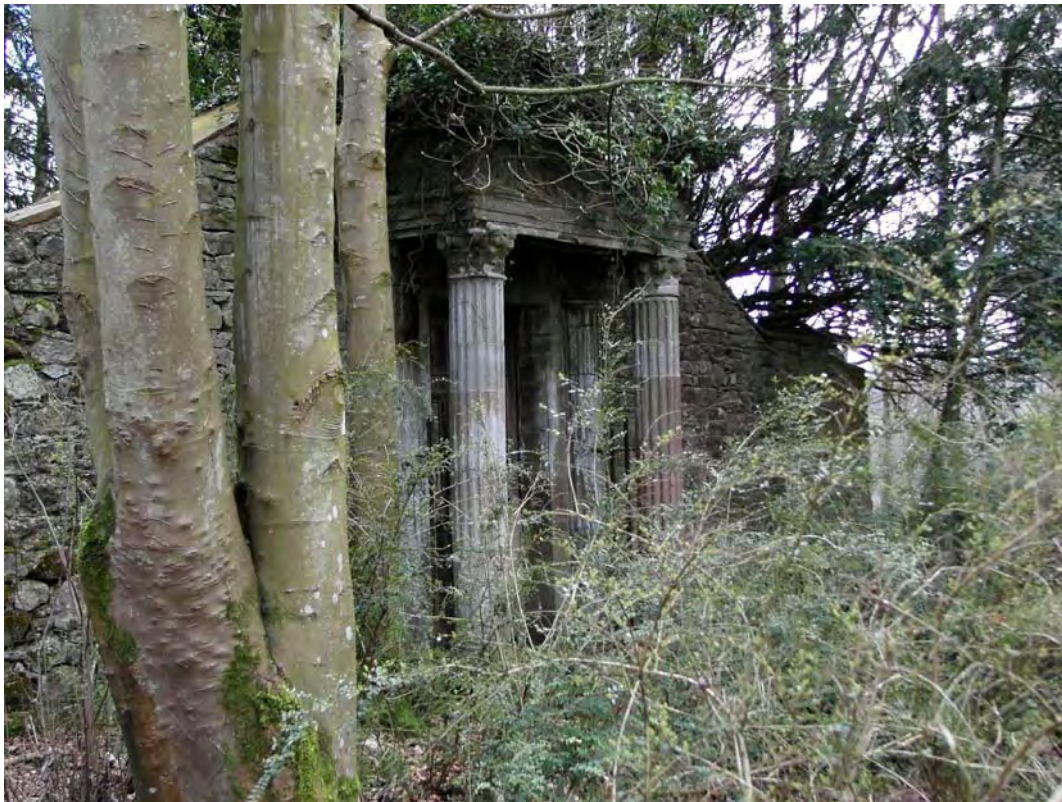
Plate 6: Site **78**, the northern exterior of the north west entrance to the inner gardens, showing the ornamental pillars

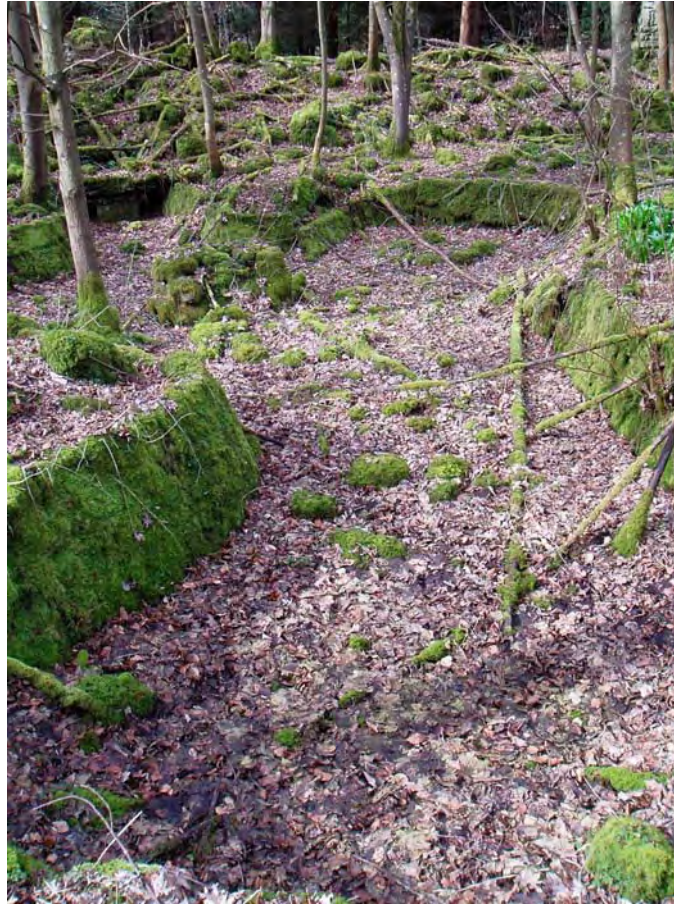
Plate 7: Site **48**, the Rock Garden, looking west across the central pond

- 4.3.1 Located in the next plot south of the above plantation is a trapezoidal Rock Garden area (Site **48**, Fig 4, Plate 7), roughly 70m x 45m, enclosed by a bank (Site **84**, Fig 6) upon which sit four buildings (Sites **85-88**, Plate 17). Each of these is a shelter built in the same style, they are stone-built and seem to be rusticated. They have wooden roofs and are open to face into the gardens and would presumably have contained benches and been viewing platform and/or shelters for garden visitors. They are in varying states of repair, ranging from intact to fully collapsed roofs.

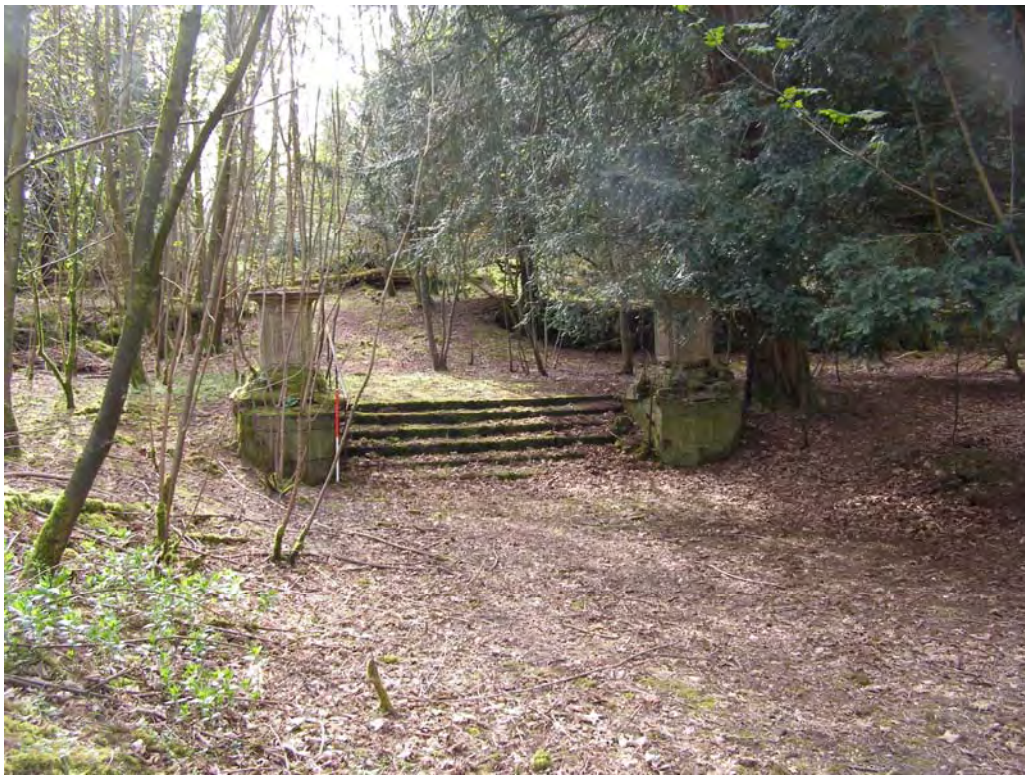
Plate 8: Site **49**, the set of steps leading up to the Rock Garden (**48**) from Yew Grove (**68**).

- 4.4.7 Located 5m east of Site **107**, on the eastern side of the lower lane of the avenue (Site **119**), is a set of stone steps and pillars (Site **49**, Plate 8), which are contemporary with wall **22**. The pillars are damaged showing them to be constructed of brick cores with decorative stone cladding, not solid pieces of stone. This feature marks the western end of an east/west aligned avenue (Site **60**) which is approximately 4m in width and is confidently thought to be part of the earliest garden layout. The avenue extends to connect to garden entrance stairwell **59**. It continued 20m east from here as a shallow, slightly sunken, linear feature, which is seen to extend east towards the present day chicken sheds.

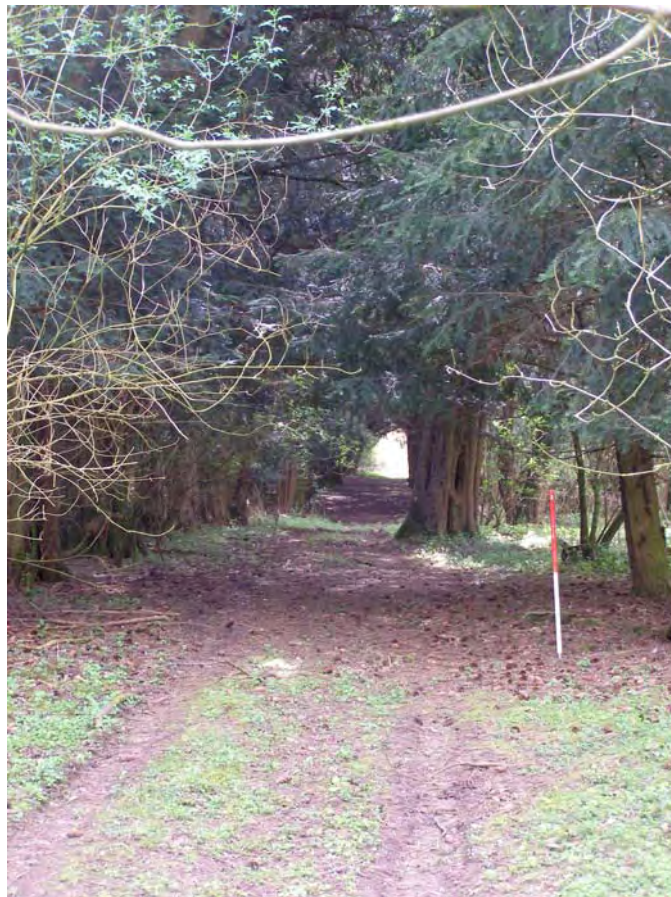
Plate 9: Site **68**, Yew Grove looking south

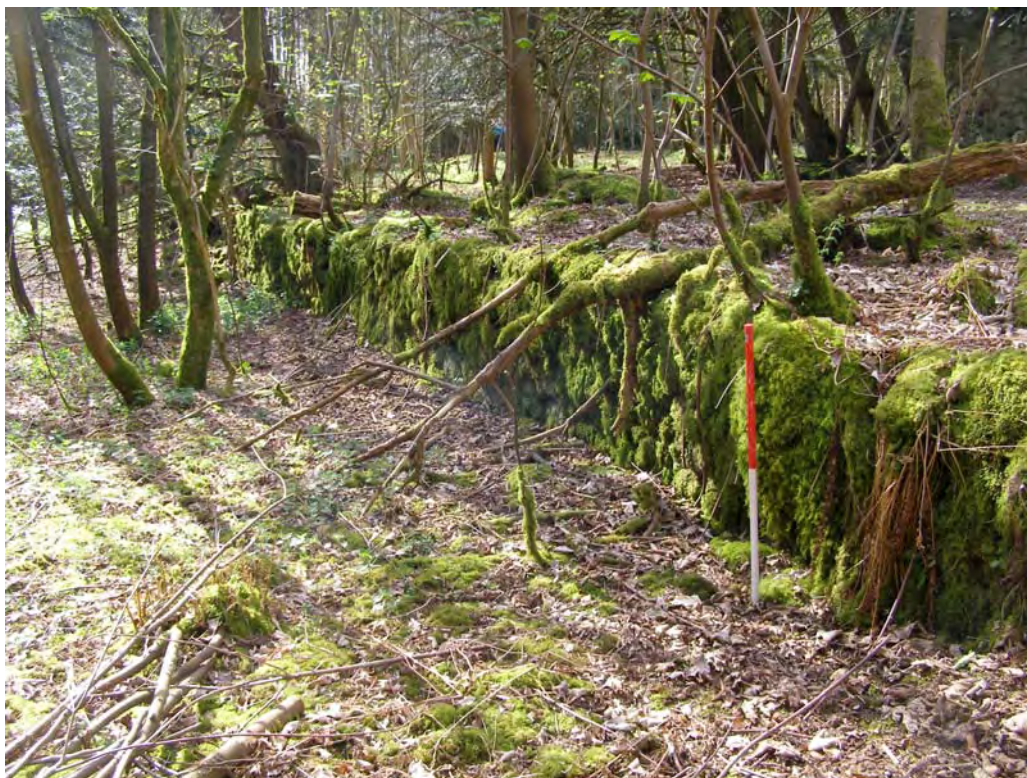
Plate 10: Site **22**, the retaining wall, running to the east of the Rock Garden, Japanese Garden and Scented Garden

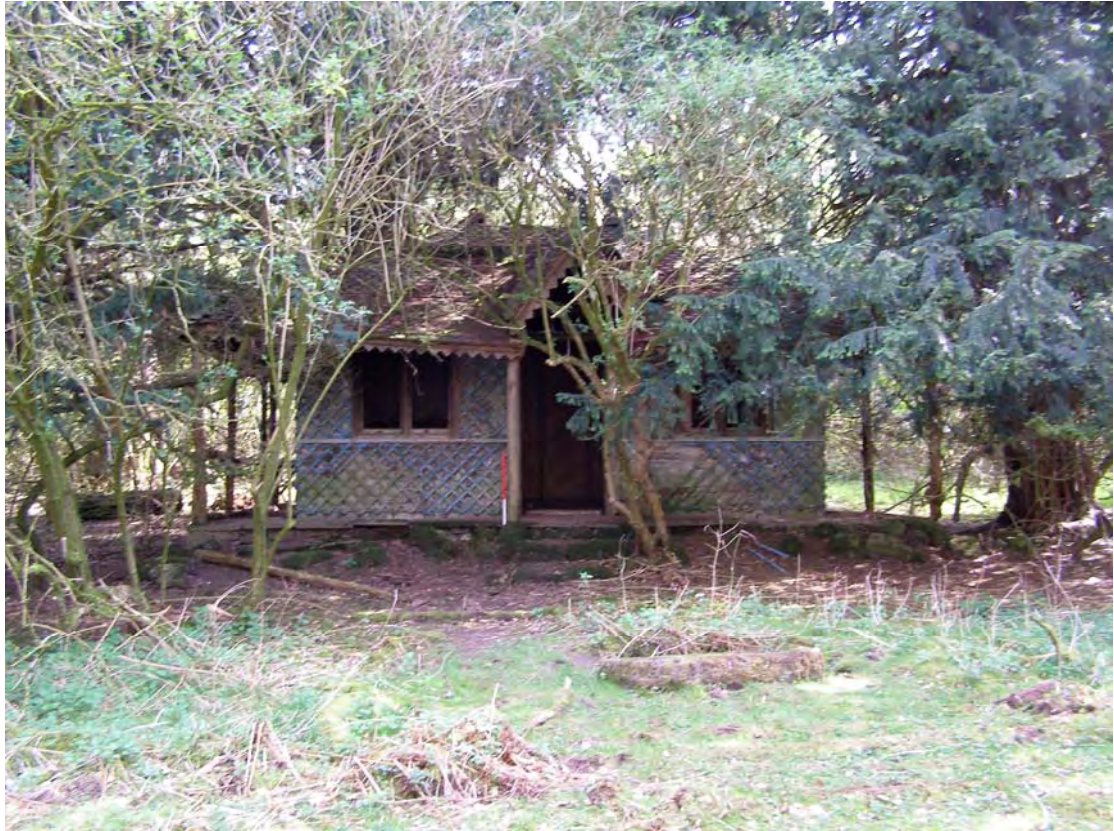
Plate 11: Site **64**, the summerhouse to the south of the Countess's Garden

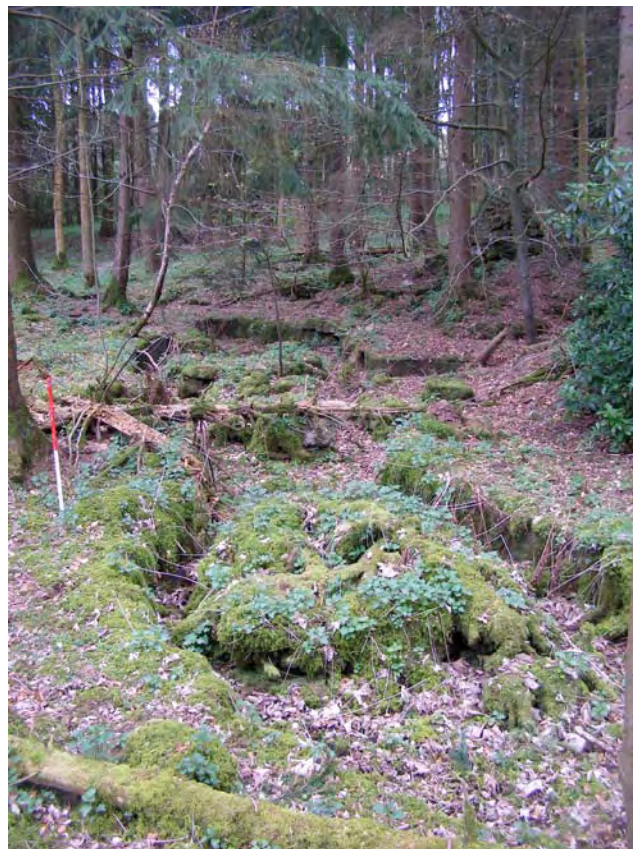
Plate 12: Site **21**, the Japanese Garden looking south.

Site Number	21
Site Name	Lowther Castle Gardens, The Japanese Garden
NGR	NY 52113 23598
Site Type	Japanese Garden
Period	Early Twentieth Century
Condition	Good
Source	Garden Survey
Description	Ornamental garden area comprising water features, a pond area and surrounding embankments, extending approximately 40m north/south and 20m east/west. A reverse 'S' shaped path, 1.5m wide and kerbed in stone at its southern extent, leads into the garden from the direction of the shelter to the north (Site 66). The main pond area is 0.5m deep and irregular in shape. It is lined with concrete, with some capping stones <i>in situ</i> . Several structures are in place in the pond which may have originally been stepping stones or bridge piers but there was no definite evidence for their function. On the western side of the pool is a pointed arch-shaped enclave with no obvious water feature. In the south-west corner of the pond stands a 'waterfall effect' fountain consisting of a cairn structure 1.5m high and built on top of the embankment in irregular stone similar to those found in the Scented Garden (Site 27). The water would have disgorged from near the top of the cairn down its eastern face into a water channel leading to the main pool. This channel is stone-lined and is crossed by a bridge / capstone at the edge of the pool. To the south-east of the main pool is a stone-built fountain base approximately 3m diameter and standing to a height of 1m, enclosed within the surveyed embankments.

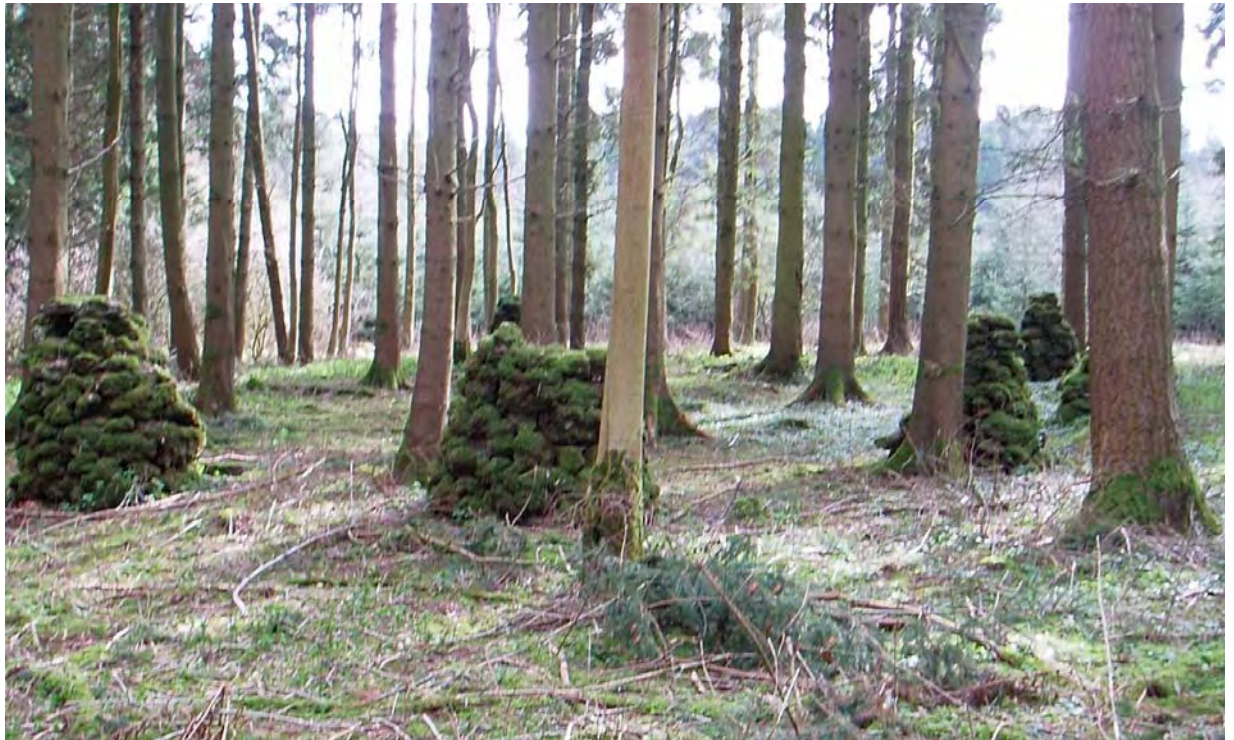
Plate 13: Site **27**, the Scented Garden looking north-west

- 4.6.1 This is an ornamental garden to the south of the Japanese Garden and east of the Yew Grove area, and is sat in the centre of a slight raised terrace surrounded by a bank (Site 29); it is named as the Scented Garden (Site 27, Figs 3 and 7, Plates 13 and 24) on the tourist map of 1939 (D/LonsL5/3/2/Low10/1939). It consists of six 'bee-hive'-shaped, rough-faced dry-stone fountains, standing to a height of 1.5m. A group of four fountains are arranged at the north end in a rough semi-circle and two stand opposite each other 12m to the south. Between these groups are two opposing rectangular recesses that would appear to be former bench platforms. At the base of each fountain is a 0.5m deep, semi-circular pool, edged in stone. At the north and south ends of the bench platforms there are disused water (or gas?) pipes, which were upstanding to a height of c0.2m.

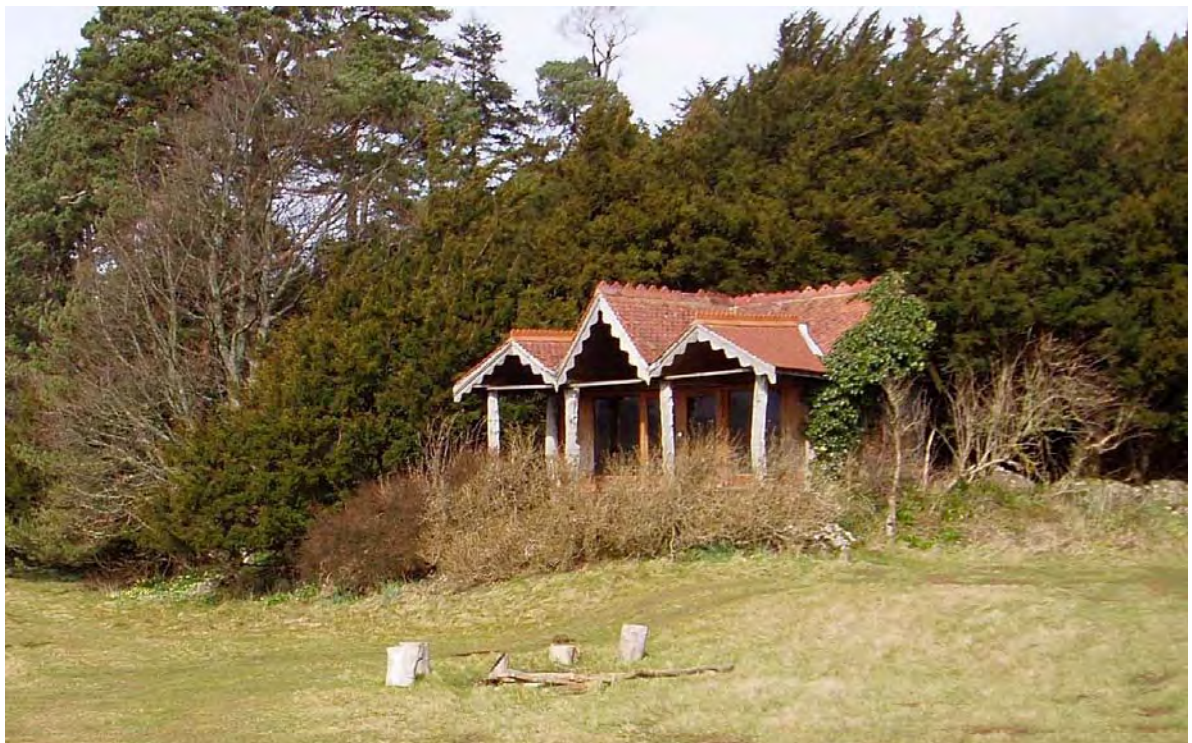
Plate 14: Site **33**, 'Jubilee Hall' summerhouse

- 4.8.2 At the bottom south-west corner of this area is 'Jubilee Hall' summer house (Site **33**, Plate 14) and is roughly 5m x 3m and built in red brick with a wooden trellis cover. The roof is single pitched and tiled with red ceramic tile. The windows in the north and south elevations appear to be original, although the front south-west-facing window is clearly a later insertion. A veranda has been added to the front of the building, with a porch roof edged in a white decorative covering. This is supported on wooden poles and was floored with rubble overlaid by paving slabs. The steps leading off the veranda to the north-west were constructed of re-used masonry and appear to be of some antiquity.

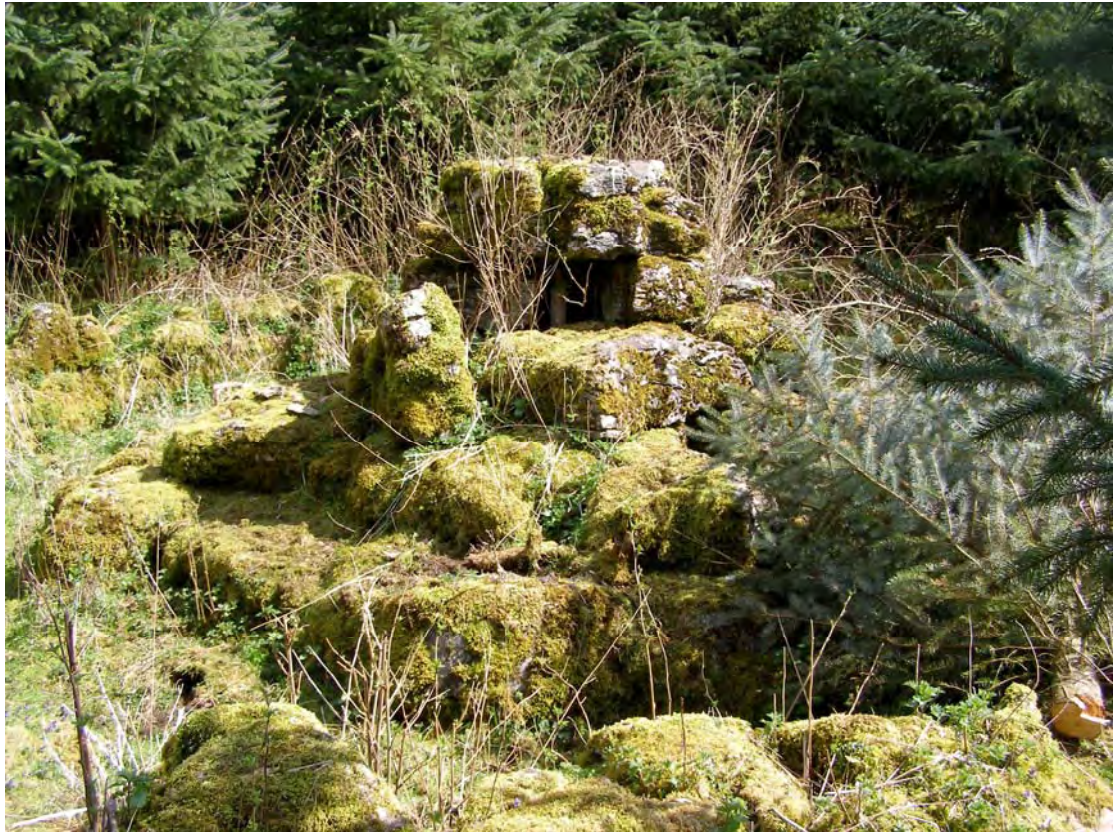
Plate 15: Site **31**, the central fountain of the Rose /Fountain Garden area, from the west

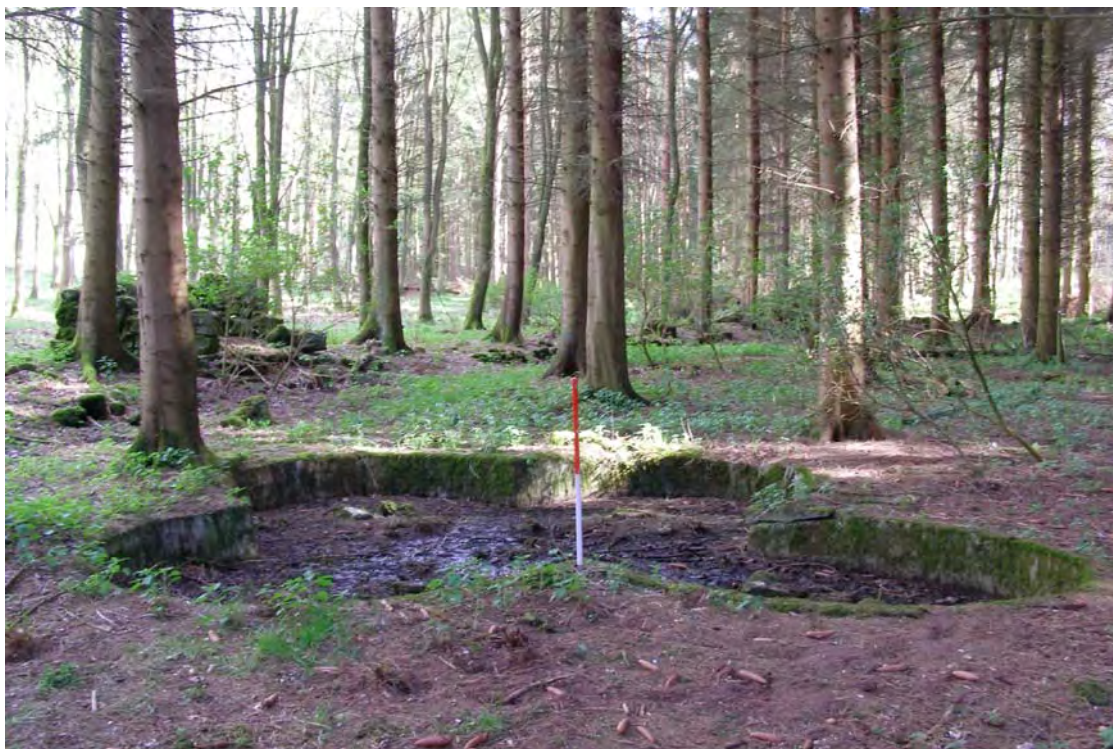
Plate 16: Site **35**, the Lily Garden looking south, showing one of the quatrefoil ponds and a shelter in the background

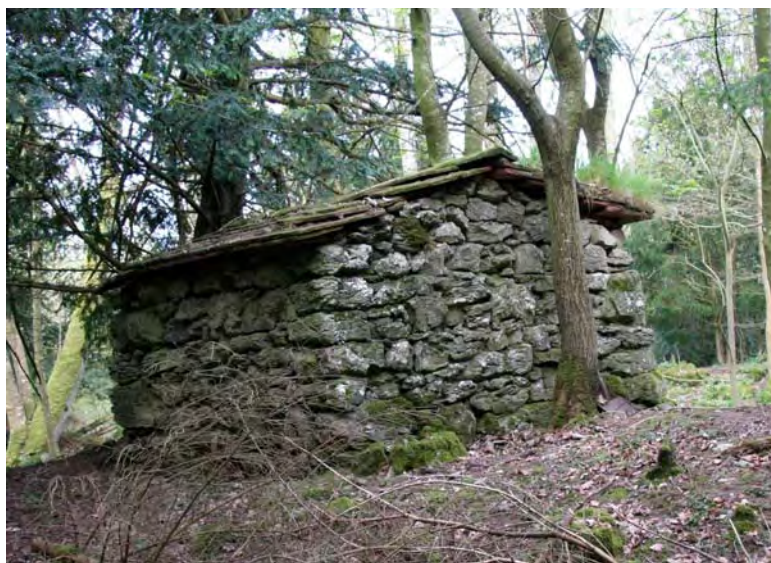
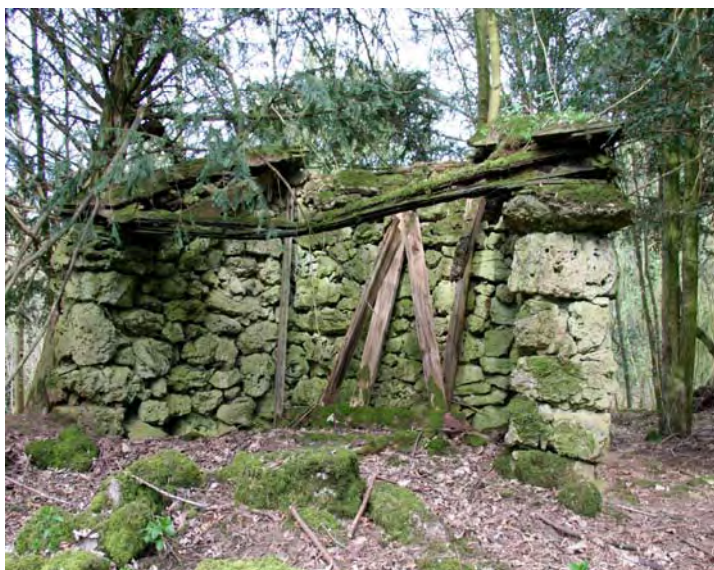
Plate 17: Two examples of shelters in the castle's landscaped grounds, illustrating their various states of repair

- 4.10.2 The eastern part of this bank contains the remains of two three-sided, randomly-coursed dry-stone shelters (2m x 3m), which have two-three steps up onto a 'viewing platform'. The southernmost shelter is in generally poor repair and is mostly collapsed, remaining as little more than a pile of stones. The northern shelter is in better condition, but is still heavily overgrown.

- 4.10.3 To the west of the garden area is a third shelter, which is in better repair than the others. This is of a similar dry stone construction, standing up to 2.5m on three sides with the rear (western) wall higher than the others and the original pitched roof line is visible. At the front of the shelter are two large sandstone gate pillars, 2m high by 0.4m square, with protruding metal hinge pins. In front of these were two ornate capitals, possibly carved in stone (rather than moulded in concrete). Within the garden are four ornamental concrete-lined ponds (between 0.5 and 0.75m deep), which have no coping stones.

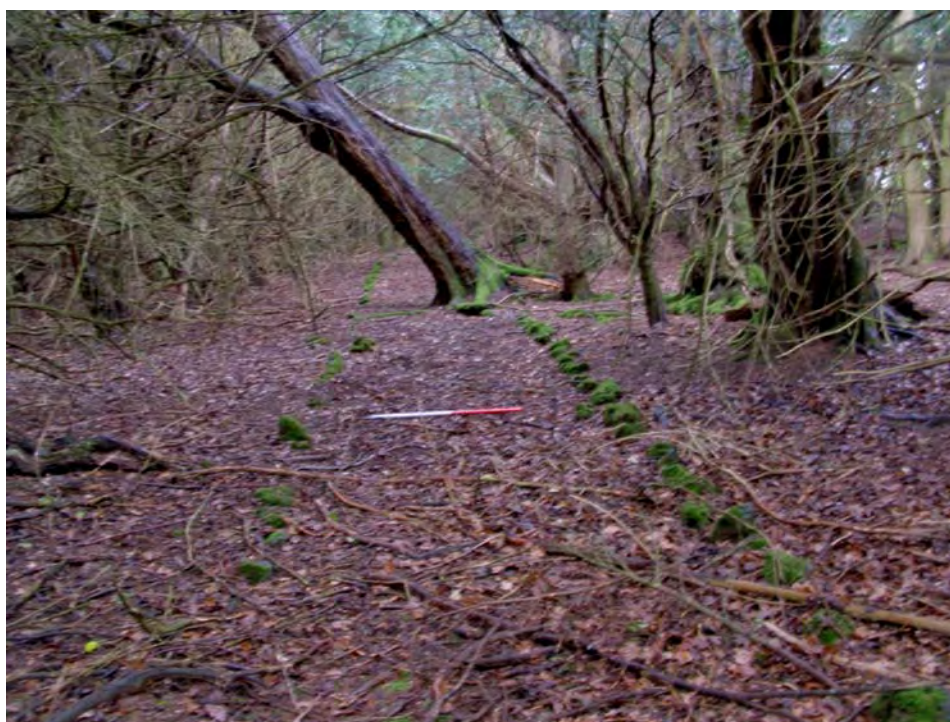
Plate 18: Site 37, the kerbed path discovered in the wooded area to the west of the Lily Gardens, looking south.

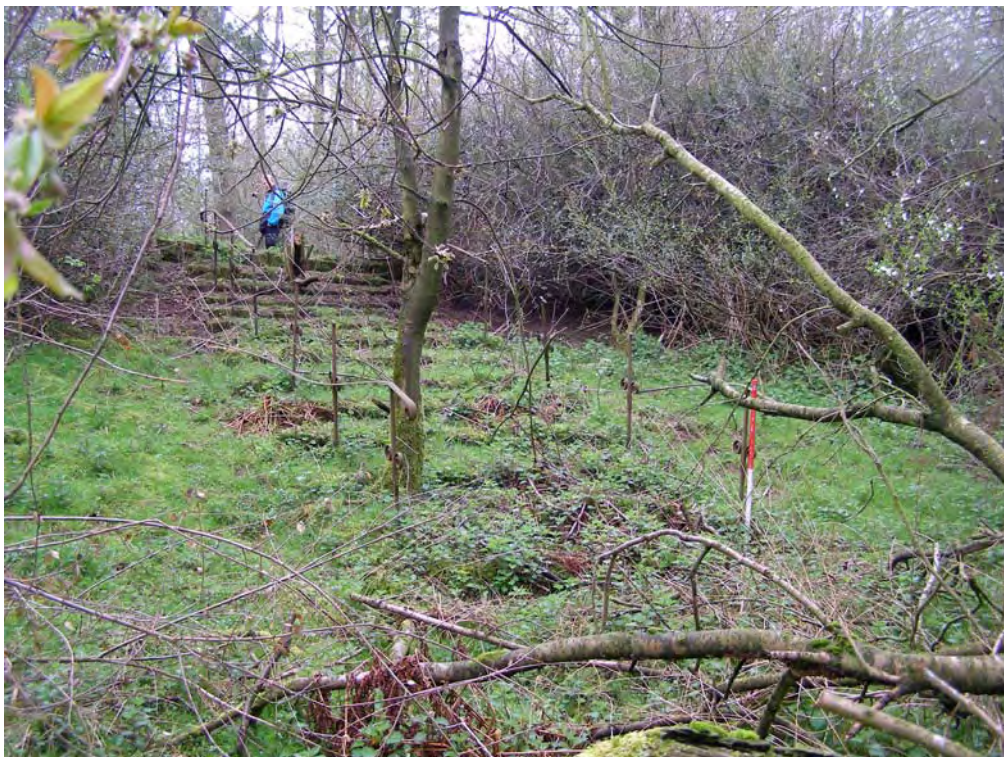
Plate 19: Site **45**, the stairs leading up the west side of the covered reservoir, showing the level of overgrowth and the state of repair of the handrails

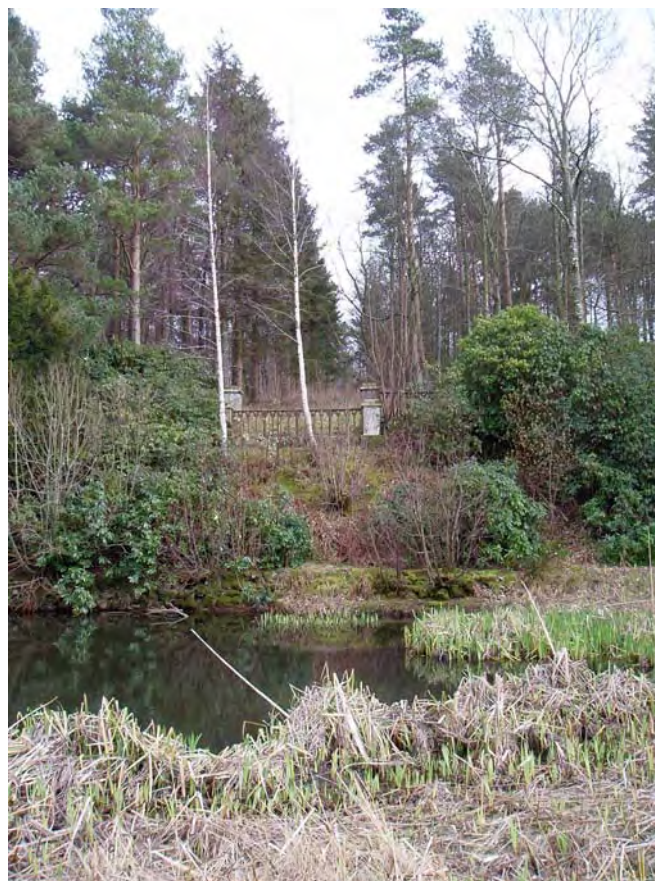
Plate 20: Site **116**, the viewing platform located to the south-east of Jack Croft's Pond

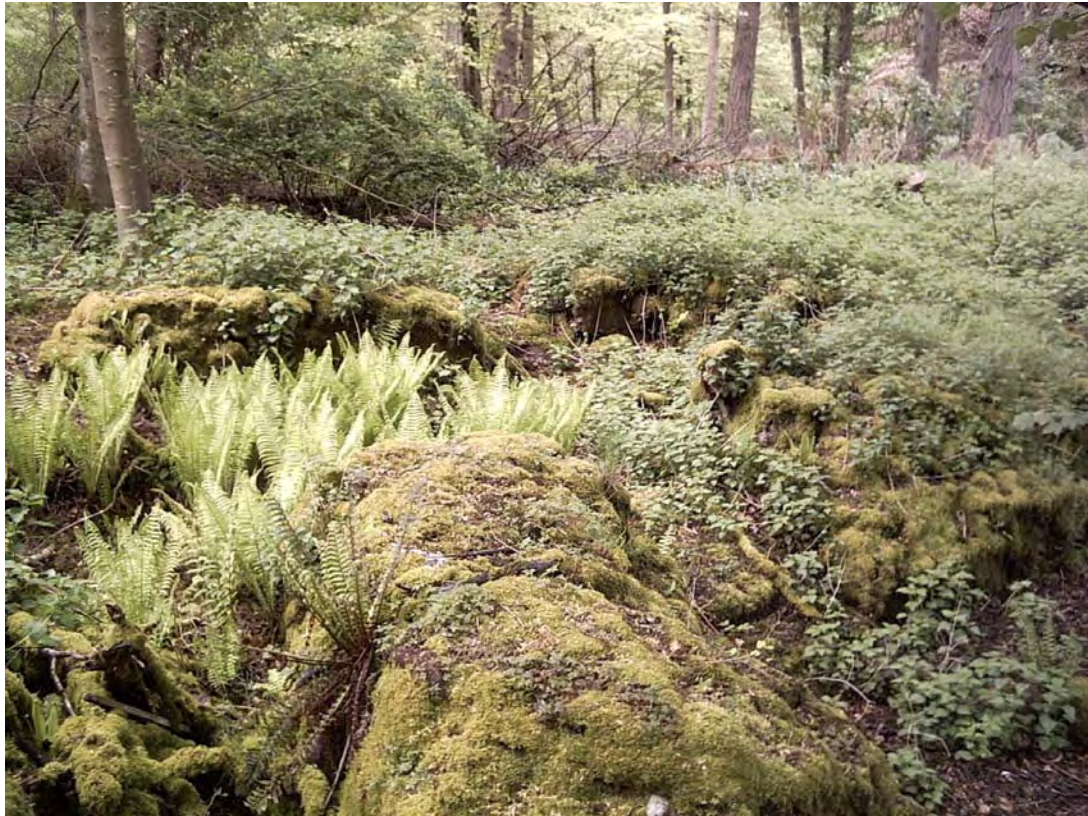
Plate 21: Site **46**, the western entrance to the northern section of the Alpine garden, (looking north).
