LOWTHER CASTLE GARDENS CUMBRIA

Archaeological Survey Report

Oxford Archaeology North

June 2007

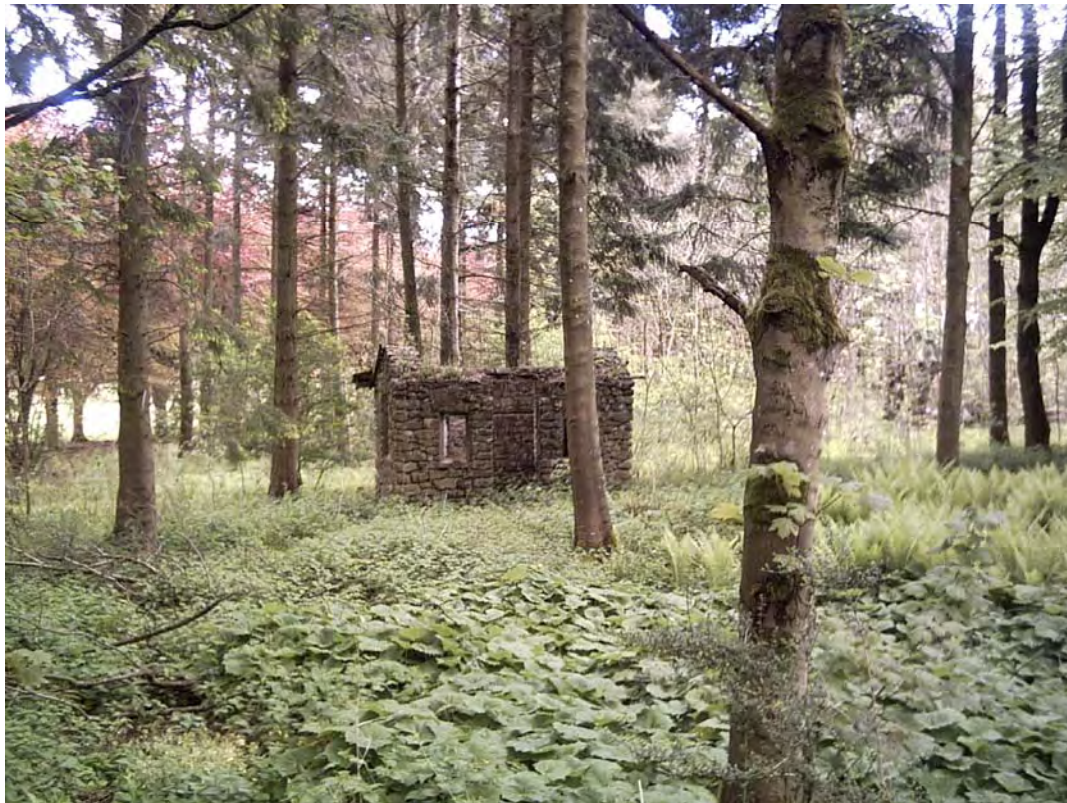
Plate 22: Site **46**, the icehouse to the north west of the Alpine Garden, looking east.

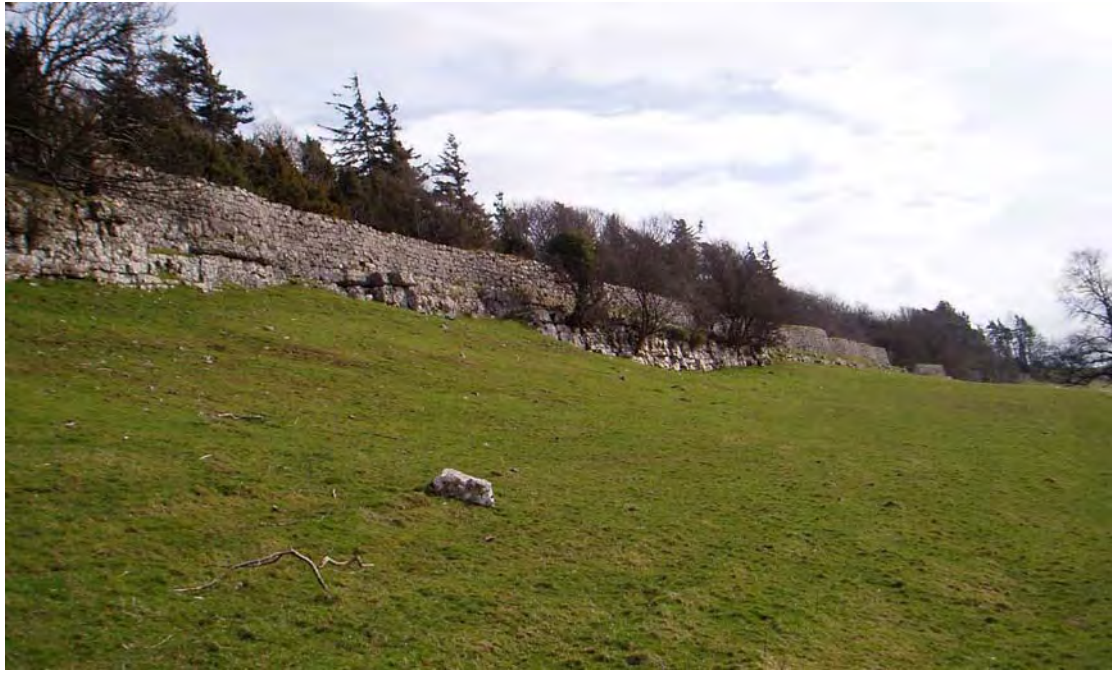
Plate 25: 'Burtree Scar' looking south-east. The natural outcrop has been enhanced to form the perimeter wall of the gardens.
