St Paul's Church Forton Lancashire

Building Investigation

Oxford Archaeology North

January 2002

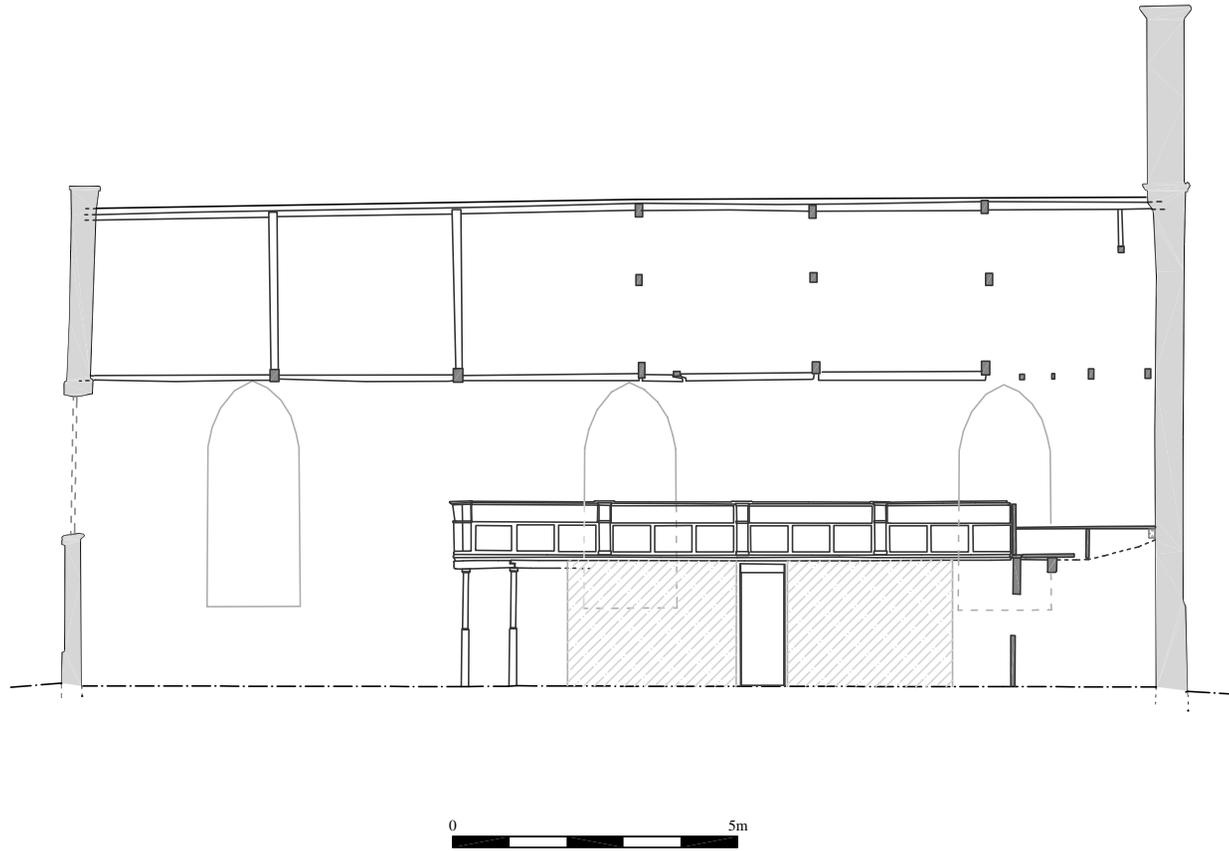
- 3.1.2 **Church Plan:** the church is aligned east/west (Fig 2) and consists of a nave, with, unusually, a chancel on the north side of the nave, and an outshut on the east side of the chancel. Extending along the western side, and two-thirds of the southern side of the nave was a first floor gallery, with small ancillary rooms beneath. Both galleries are supported on pillars with partition walls added to form rooms beneath. The main entrance to the church was from the west, via two entrances, one at either side of the principal facade; these led through short corridors, beneath the gallery, and in between the ancillary rooms (Rooms 3 and 4), to provide access to the nave.

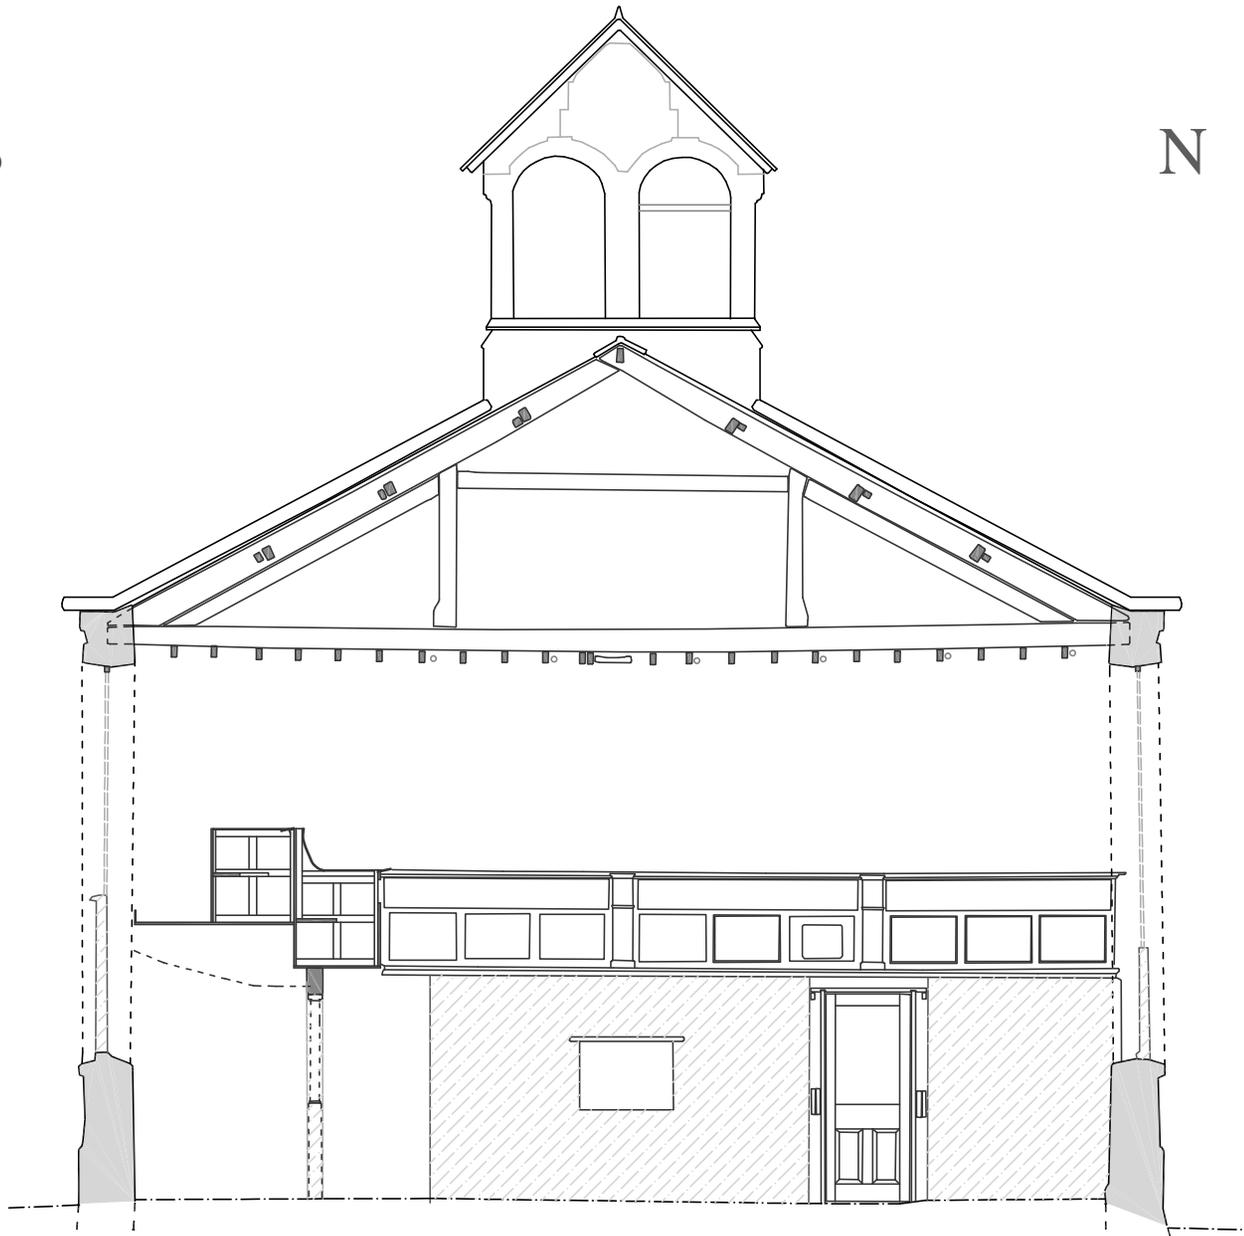
Figure 3 : North / South Cross-Section through Church

- 3.4.3 The beams in turn support a frame of roughly-worked joists, which create two levels of floorboards for the tiered seating above (Fig 3). The front level is 1.05m wide and extends out from the main beam, while the rear floorboard level is 0.26m higher and bonded to the wall. Below all of this is a series of larger, curved joists supporting the structure of the frame. A layer of lathe and plaster has been added to the base, with extra support from several small battens, to produce a smooth curve covering the frame (Plate 4). The floor of the gallery consists of floorboards placed over the frame. In the south-west corner a flight of stairs leads up into the gallery, from an access point beside the southern principal entrance; part way up the stairs turn at a right angle from north/south to east/west to facilitate access to the gallery. The lowest four steps are concrete, the remainder are of timber.

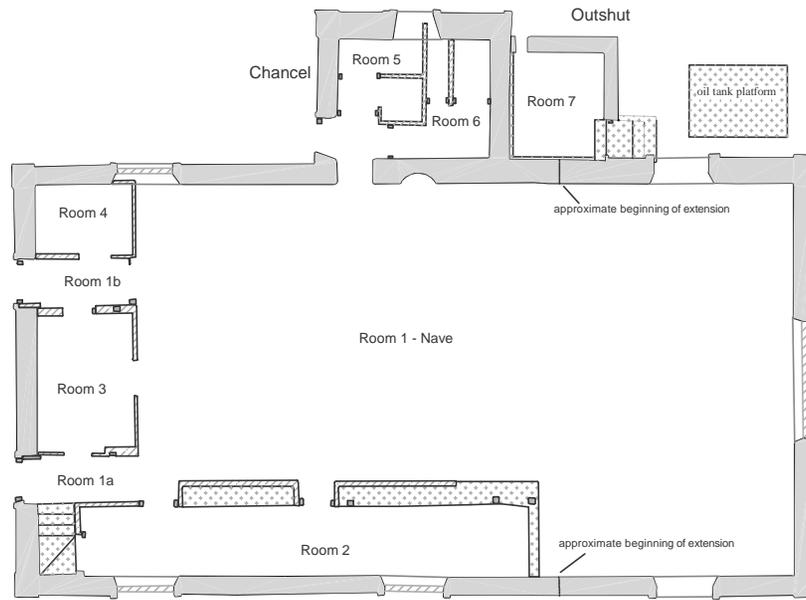
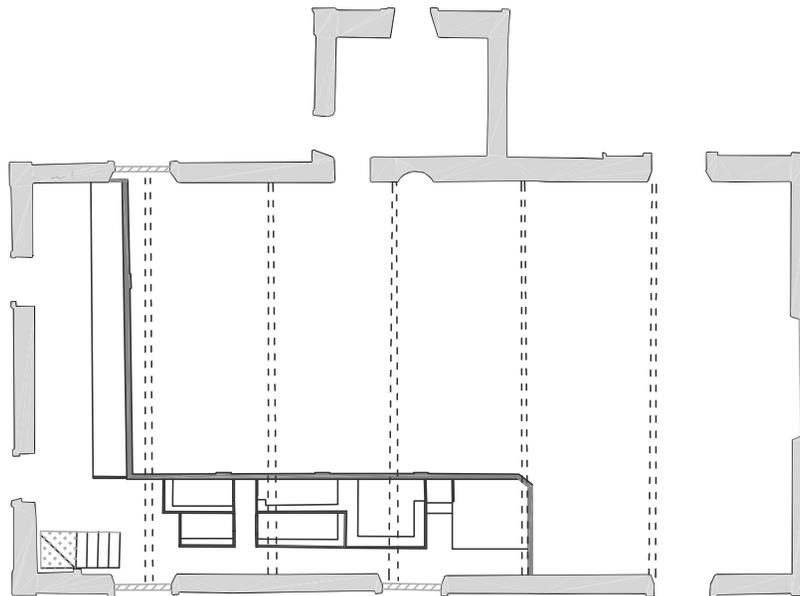
Figure 4 : Ground Floor Plan and Roof Space/Gallery Plan

- 3.4.8 **Room 1 – The Nave (Fig 4):** small, hard, wooden tiles, which have been painted to form a badminton court, cover the floor. Around the edges, the floor has been painted with a thicker, harder wearing, rubber indoor sports surface, obscuring any original flooring.

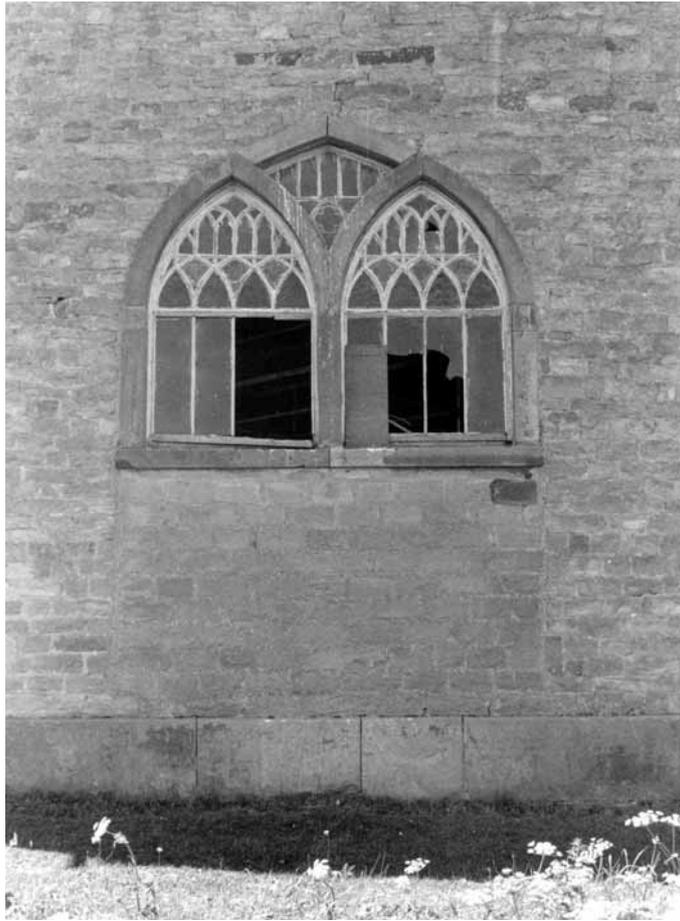
Plate 1: East window, external, showing partial blocking

- 3.2.5 **External East Elevation:** the east external elevation is dominated by a large window comprising two gothic arches sharing a central stone mullion, with a smaller, possibly inserted, segmental arch above (Plate 1). The window has dark yellow sandstone jambs, sills and arches throughout and decorative timber tracery survives in the upper sections. The central arch is constructed of more greyish-yellow sandstone. The window formerly extended down to the level of the plinth as there is a 1.75m high blocking with roughly coursed, dark orange-yellow sandstone between the window sill and the plinth. There has been some repointing below the roofline.

- 3.4.8 **Internal East Elevation:** the internal east elevation is built in roughly coursed and finished yellowish-grey limestone, although it is almost totally covered by plaster and paint. The north end has been deliberately exposed and the stonework has been repointed to serve as what appears to be a rock climbing wall. There is a central window comprising a pair of two-centred gothic arches with a smaller, segmental arch above. The central mullion between the larger arches has been clad with timber internally, and decorative timber tracery survives throughout, with a moulded dowel around the edge of the window. The window has been blocked below its current sill to ground level.

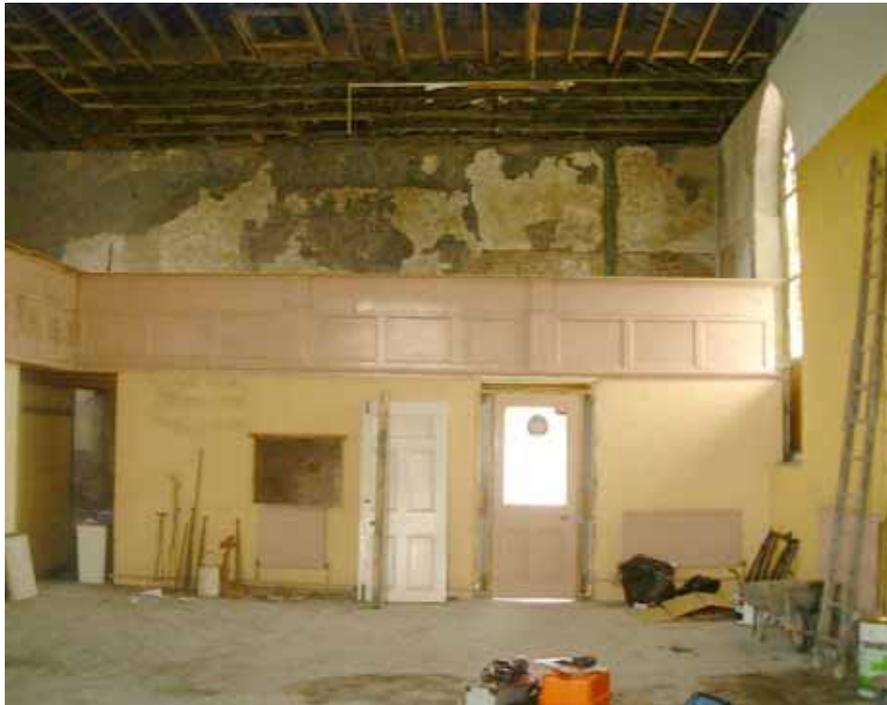
Plate 2: East-facing wall of the gallery

- 3.4.2 **Gallery:** the gallery is entirely within the nave, and is L-shaped, running along the whole of the west internal elevation of the nave, and the western three bays of the south elevation (Fig 2). It has a timber frame supported at the front by a single timber beam running east/west which joins a beam running north/south in the south-west corner of the nave; at the back the frame is built directly into the wall of the nave. The beams are covered by a thin panel of moulded timber, and are 0.14m wide and 0.2m deep in section. The galleries are supported by five timber posts at the front which have square bases, 0.13m by 0.13m and 1m tall, a round centre of 0.12m diameter with moulded decoration at the top and bottom, and a smaller square piece below the beam, only 0.04m thick (Plate 4). In the western

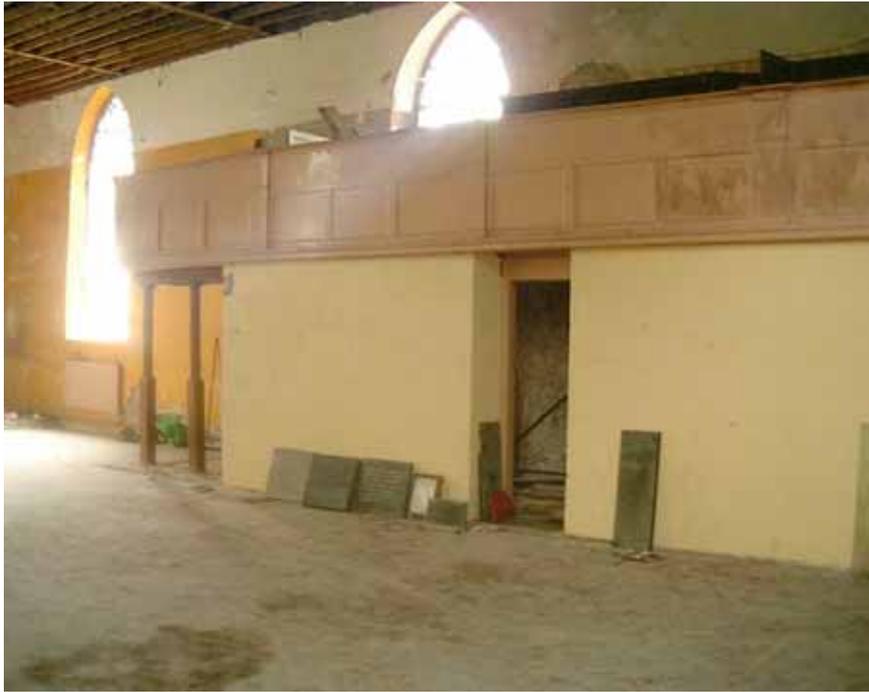
Plate 3: North-facing wall of the gallery

- 3.4.4 The gallery shares the same roof as the nave (*Section 3.4.6*) and on the south and west sides it is set into the walls of the nave. The north and east sides (ie the front of the gallery) are edged by a parapet of thin timber wainscot panels with raised, moulded, frames, and pilasters with moulded rails on both sides (Cocke *et al* 1984). These panels are no more than 0.04m thick and 1m high, with a flat rail (0.14m wide) across the top. They are divided into three frames between a pair of pilasters, with three such groups in the west arm and five in the south (Plates 2 and 3; Figs 2 and 3). The space between the top of the panels and the top rail was originally open, with a row of spindles filling the gap. There would originally have been 28 spindles to each three-frame section, but many are now missing, and the gap has been boarded over with hardboard throughout.

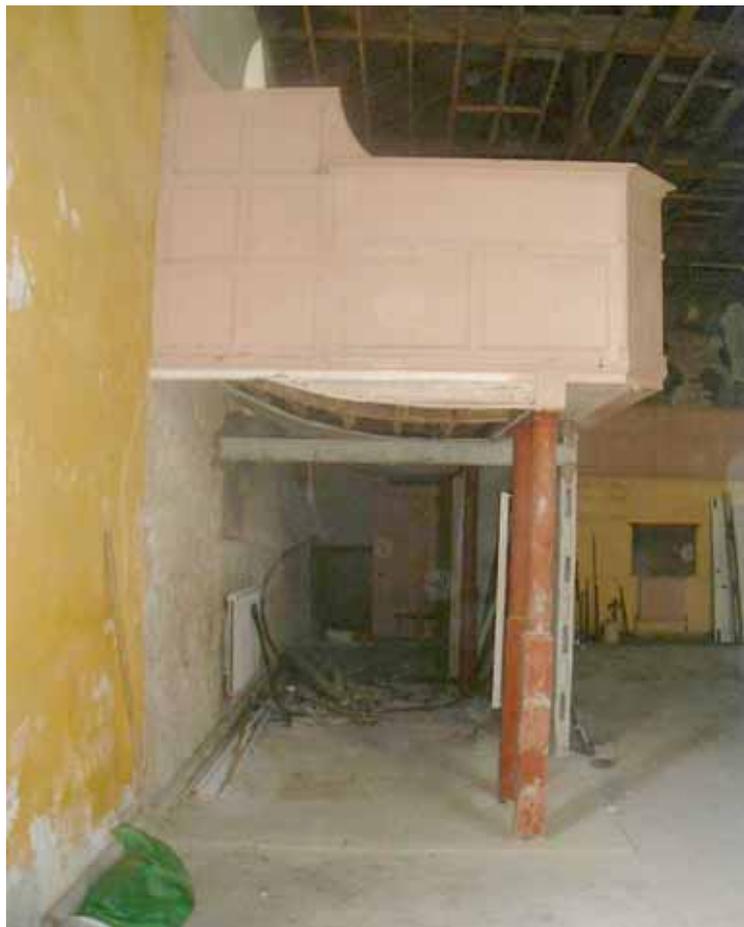
Plate 4: East end of the south side of the gallery

leg of the gallery a later cinder brick partition has been built around two of these posts, and the square bases have had the corners cut off, so that they are now octagonal, as is the westernmost of the three along the south elevation.

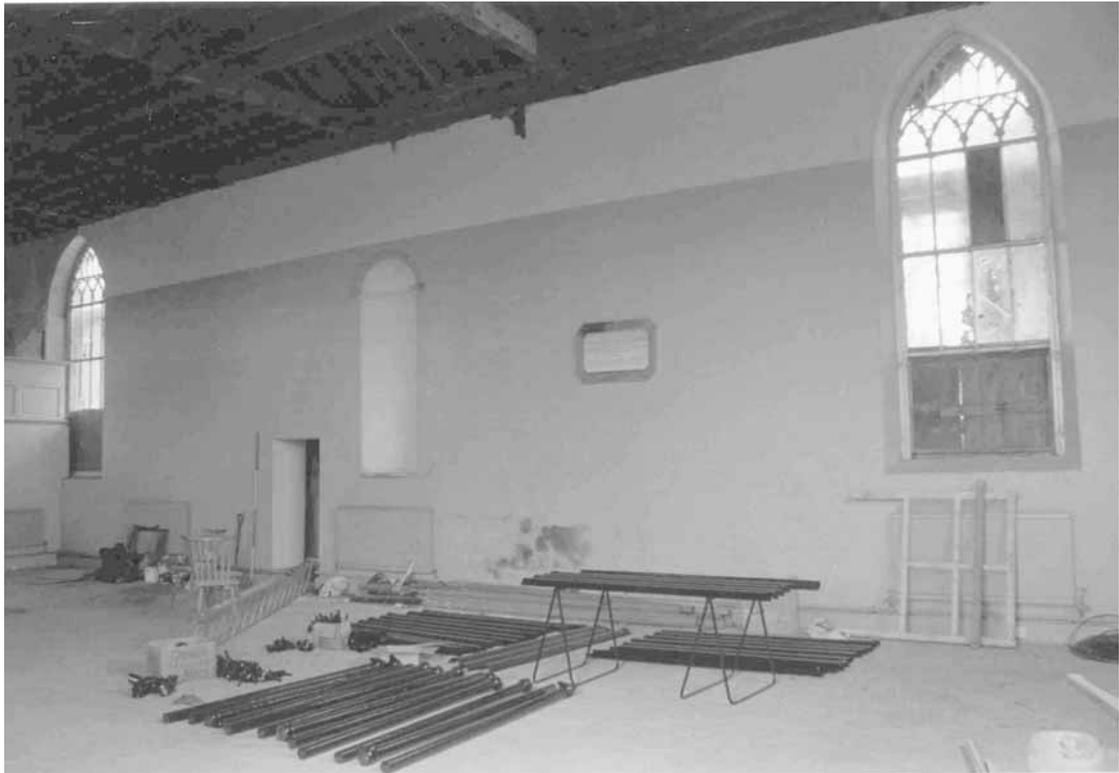
Plate 5: South-facing internal elevation of the nave

- 3.4.11 **Internal South Elevation:** as with the west elevation, the cinder brick partition walls below the gallery mostly cover the southern elevation. There are two doorways giving access to Room 2 and at the east end a section of the partition wall has been removed, exposing two of the timber pillars that support the gallery (Fig 2). The remainder of the elevation, above the gallery and at the east end, is stone built and covered in decaying render and paint. There are three windows, all with two-centred arches, with some floral decoration around them. The gallery half

obscures the eastern two, while the westernmost has been recently refurbished; all have timber tracery remaining.

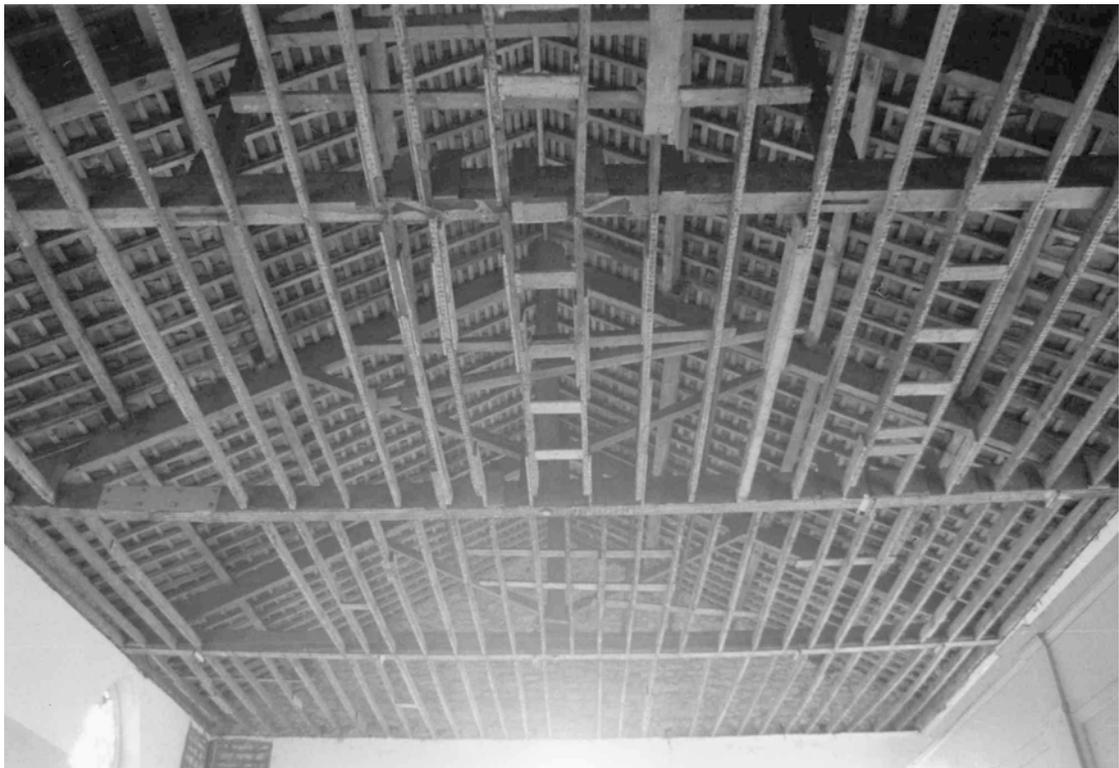
Plate 6: Roof Structure, facing East

metal reinforcing plates added very recently. The two eastern trusses consist of a king post, bolted to the tie beam, which is again built into the wall head, with inclined struts running between this and the principal rafters (Plate 6). The westernmost of these two has had a metal plate bolted to the tie beam, reinforcing a crack in the timber. A large number of joists have been nailed to the tie beams, which, at some point, supported a flat roof. The majority of these are orientated east/west, but in the most westerly bay they mostly run north/south around the point at which an access hatch has been added. Scaffold poles have also been fixed to the tie beams at this end, providing additional support.

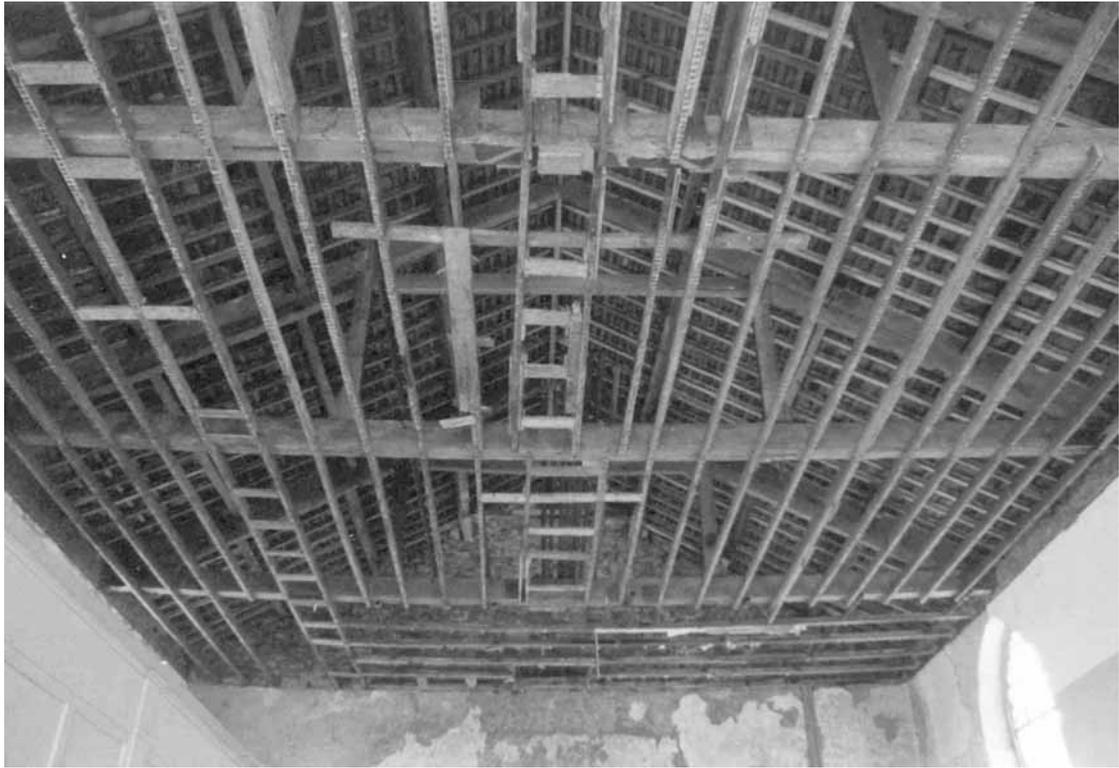
Plate 7: Roof Structure, facing West

- 3.4.6 **Roof Structure:** the roof of the church has five machine-cut, timber trusses dividing it into six bays. The three westernmost trusses consist of a pair of queen posts attached with mortise and tenon joints to the tie beam, which is built into the wall head (Plate 7). Further large braces run between the queen posts and the tie beam, parallel to and butting the principal rafters, which overlap, north over south, below the ridge purlin; there they appear to be jointed and pegged. The purlins overlap at each truss, and there are three in each pitch. There are carpenters' marks on at least two of these trusses, in the form of Roman numerals (III and IIII).

- 3.4.7 There is a further collar at the west end, between the uppermost purlins on each pitch, which supports a short king post. This has presumably been added to provide extra support for the bellcote above; both purlins and the collar have had

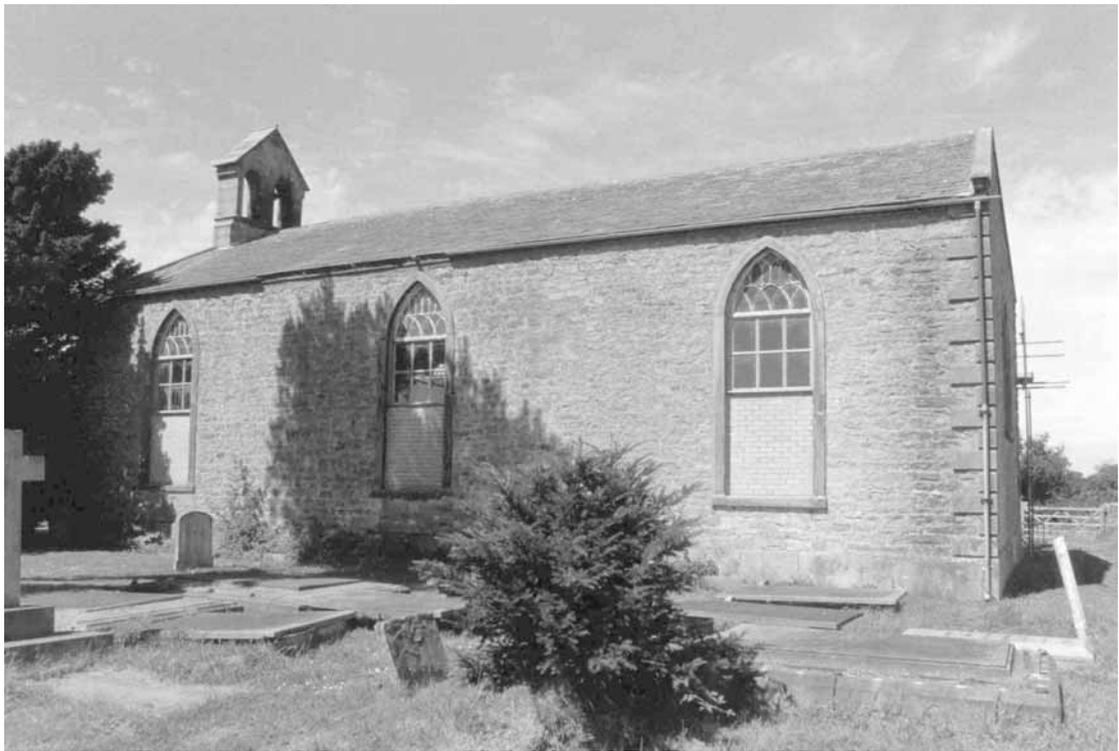
Plate 8: South-facing external elevation

- 3.2.4 **External South Elevation:** the external south elevation was constructed of the same yellowish-orange sandstone seen elsewhere in the church, although the easternmost c6.5m has been extended in yellowish-grey limestone with some fine-grained sandstone (Plate 8). There are three large, two-centred gothic arched windows; the western two have dark yellow sandstone jambs (made out of several pieces), sills and arches, with some of the smaller jamb blocks bonded into the wall masonry. The lower parts of all three windows have been blocked with a single skin of grey bricks to a height of 1.5m, and below the westernmost two windows the masonry has been repointed. The eastern window is of almost identical construction but is built of greyish-yellow sandstone, and none of the jambs are bonded into the walls, there is no repointing below the window and there is much less weathering. Decorative timber tracery remains in the upper section of all three windows.

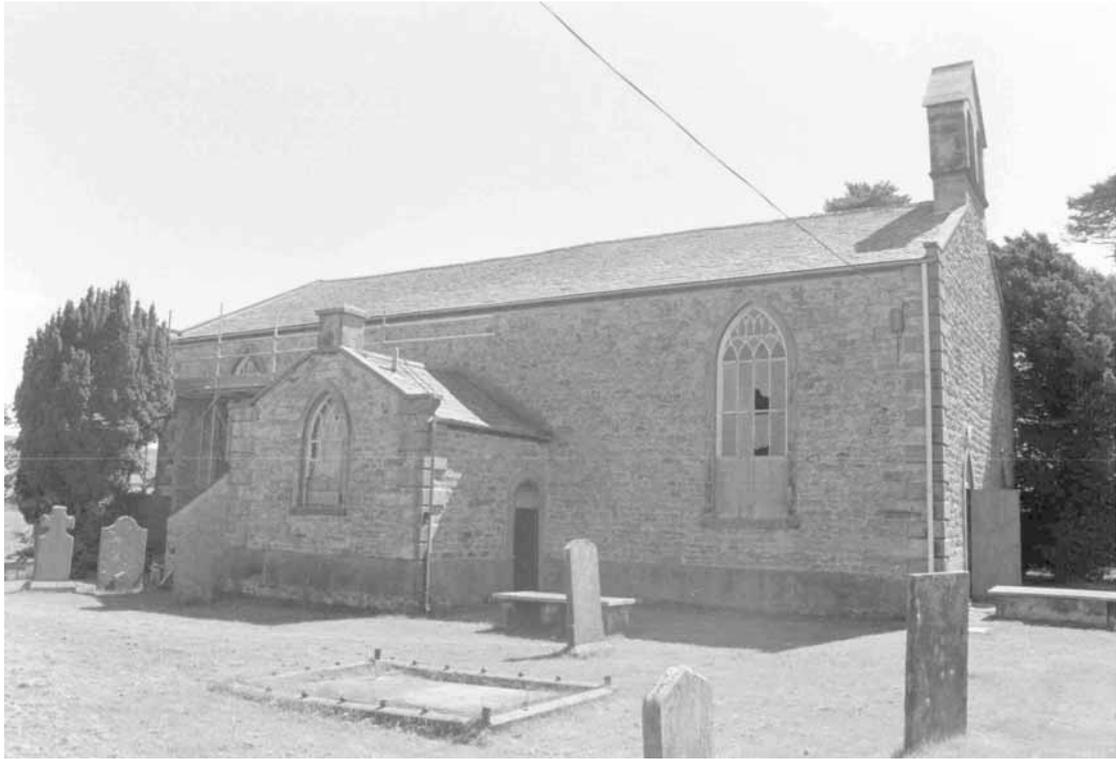
Plate 9: North-facing external elevation

- 3.2.6 **External North Elevation:** the chancel largely covers the centre of the north elevation (Plate 9). Like the south elevation, the east end of the elevation has been extended from a point to the east of the chancel. There is a two-centred gothic arched window on either side of the chancel, identical to those in the south elevation, the easternmost window being within the extension. The western window has been blocked up to a height of 1m with modern timber boards and both windows retain their decorative timber tracery in the upper sections. There is a benchmark set into the lowest quoin at the south-west corner.

- 3.3.3 **External North Elevation:** the north elevation is the gable end of the chancel (Plate 9) and it has a single gothic arched window in the centre, now partially boarded up, which retains some of its timber tracery in the upper section. The window has sandstone sills, jambs and arch and the smaller sill pieces are keyed into the chancel wall. There are kneelers supporting the roof at both sides of the gable, and there is some evidence of repair work below the roofline on the east side and some repointing below the roof on the west. There is an ashlar, sandstone plinth above the roof of the chancel, which is approximately 0.7m tall and 0.4m square and has the appearance of a chimney; however, there is no evidence for an internal fireplace or flue in the rooms below and it may therefore be a rather substantial finial.
