# **HOLE HOUSE MILL, KENYON STREET, BLACKBURN, LANCASHIRE**

**Archaeological      Building  
Investigation**

**Oxford Archaeology North**

March 2015

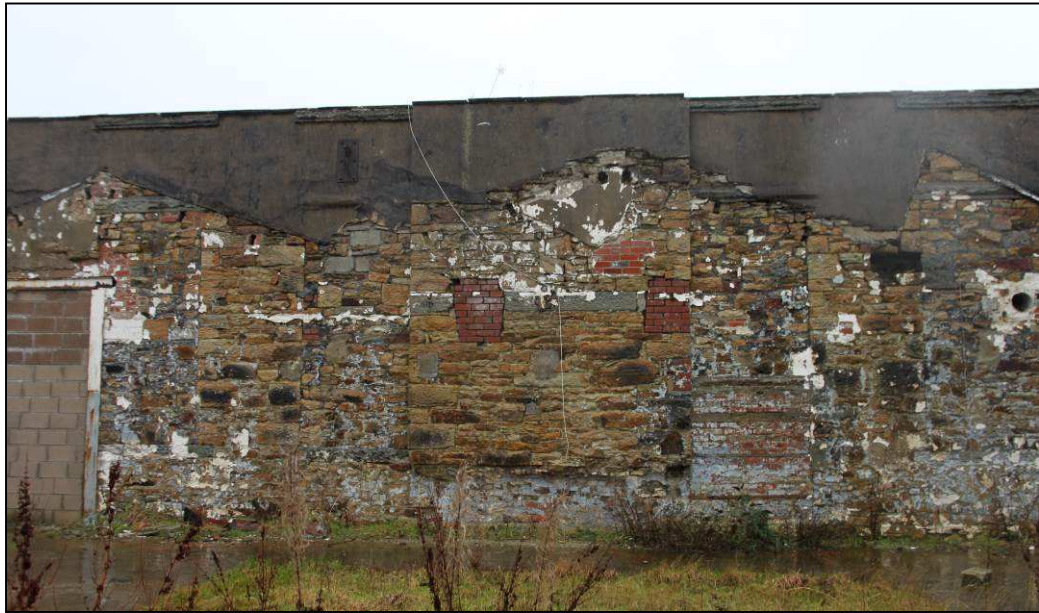
*Plate 9: Projecting pilaster in centre of west external façade of original spinning block*

- 3.2.3 Either side of the pilaster, the remains of seven tall ground floor windows survive, but were stone blocked during the addition to the west (Plates 9 and 10), and have flush dressed grey sandstone lintels and sills. Immediately below the head of the extant wall, five sandstone sills of first-floor windows project through the render, with a further window to the south, and two to the north almost certainly concealed beneath it (Plate 10).

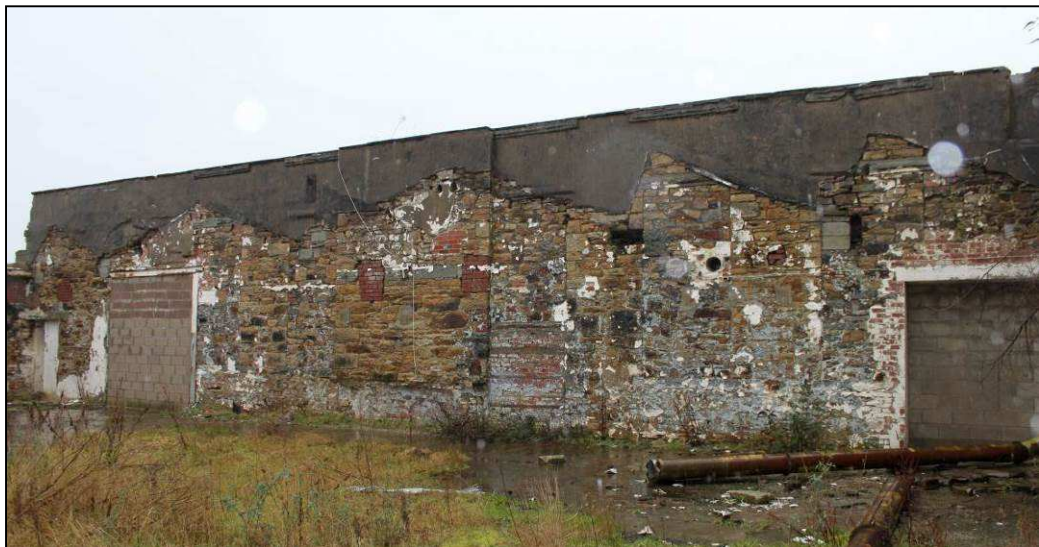
*Plate 10: West external façade of spinning block with blocked tall ground-floor windows and sills for first-floor apertures*

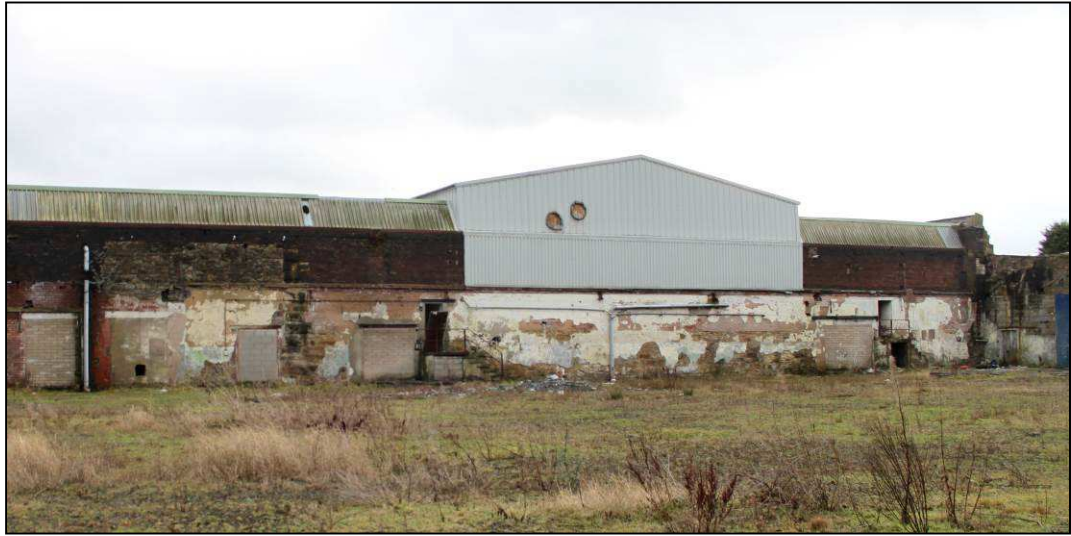
- 3.2.4 The spinning block was terraced into the hillslope with a stone-built part-basement surviving in the extant north wall (Plate 11), and with blocked apertures into the basement in the two bays at either end (Plates 11 and 12). However, Projecting rusticated quoins between the two eastern doorways probably represent the return of the original spinning block, with the additional half bay representing a narrow attached structure, presumably of later date, and shown on the Ordnance Survey plans of 1893 and 1894 (Fig 2; Plate 12). This

*Plate 11: External stone north face of spinning block, with red brick of later weaving shed above*

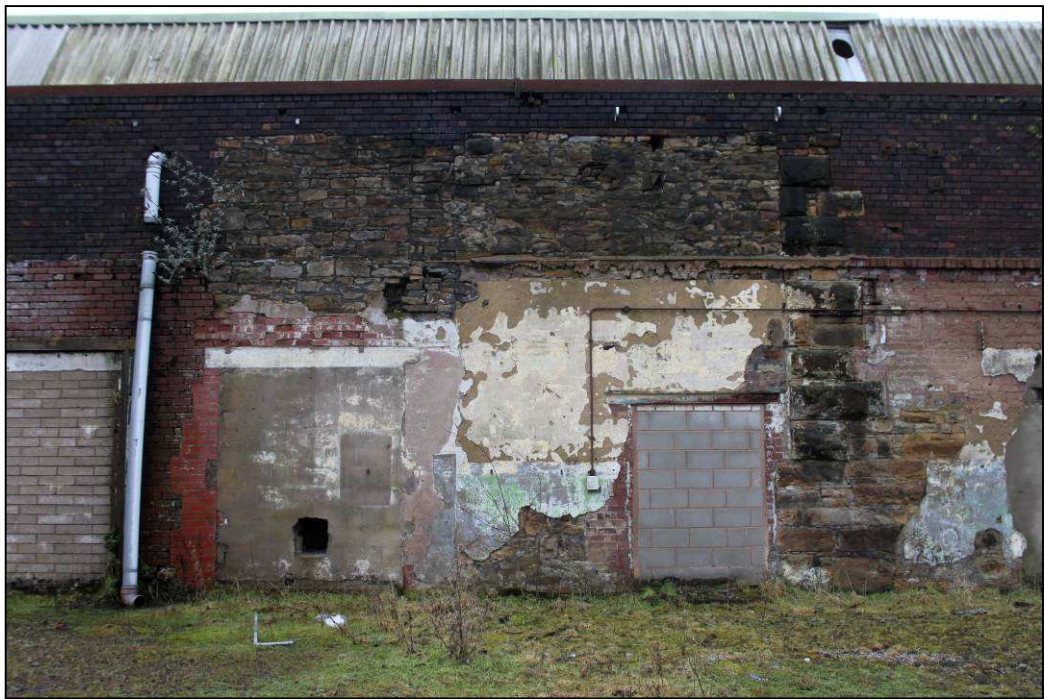
*Plate 12: Quoined return of spinning block, with wall scar for first weaving shed to left*

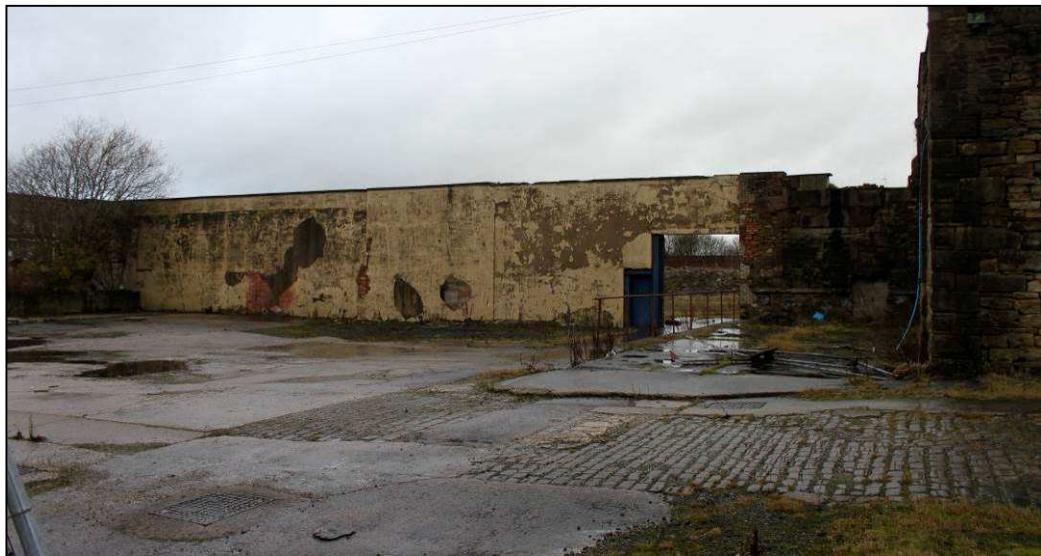
- 3.3.1 No evidence survives for the original power plant for the spinning block, which appears to have been of insufficient power for its intended purpose, being replaced in 1869 shortly after manufacture finally commenced (*Section 2.2.1*). The replacement power plant was cited at the north-western corner of the spinning block, adjacent to the weaving shed, which appears to have been under construction by this time, but which was not completed until considerably later (*Section 2.2.3*). The new structure measured approximately 50 x 20', and housed two coupled horizontal engines, of 35 and 27hp. A concrete platform marks the footprint of the structure (Fig 5; Plates 13 and 14), which was only recently demolished, being shown extant on satellite imagery in 2011 (Plate 1). The southern and eastern walls however, form part of extant structures, and retain important details.

*Plate 13: Concrete base denoting position of 1869 engine house with weaving shed wall to left*

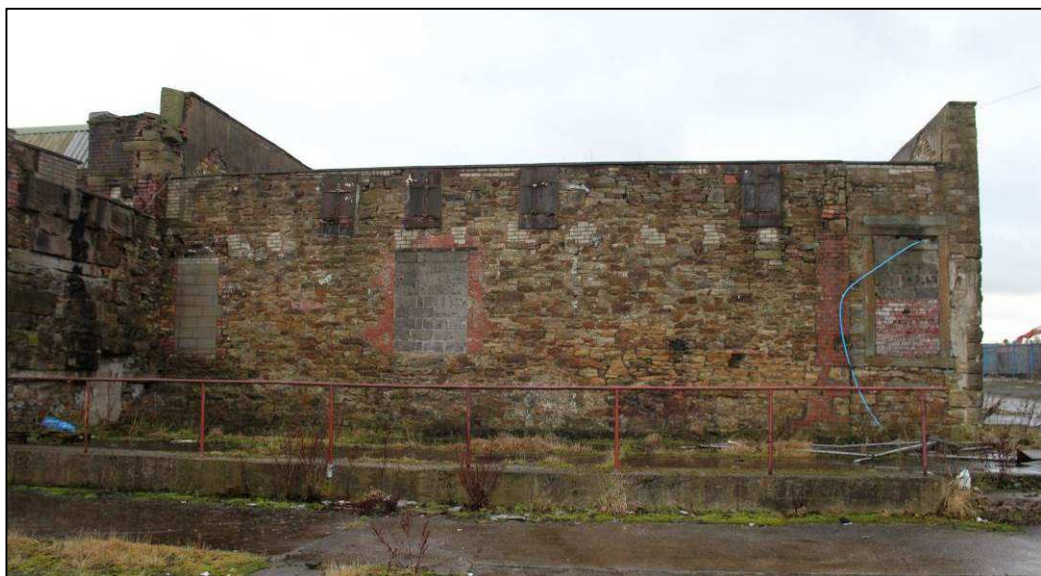
*Plate 14: Raised concrete base of 1869 engine house and extant reduced south wall*

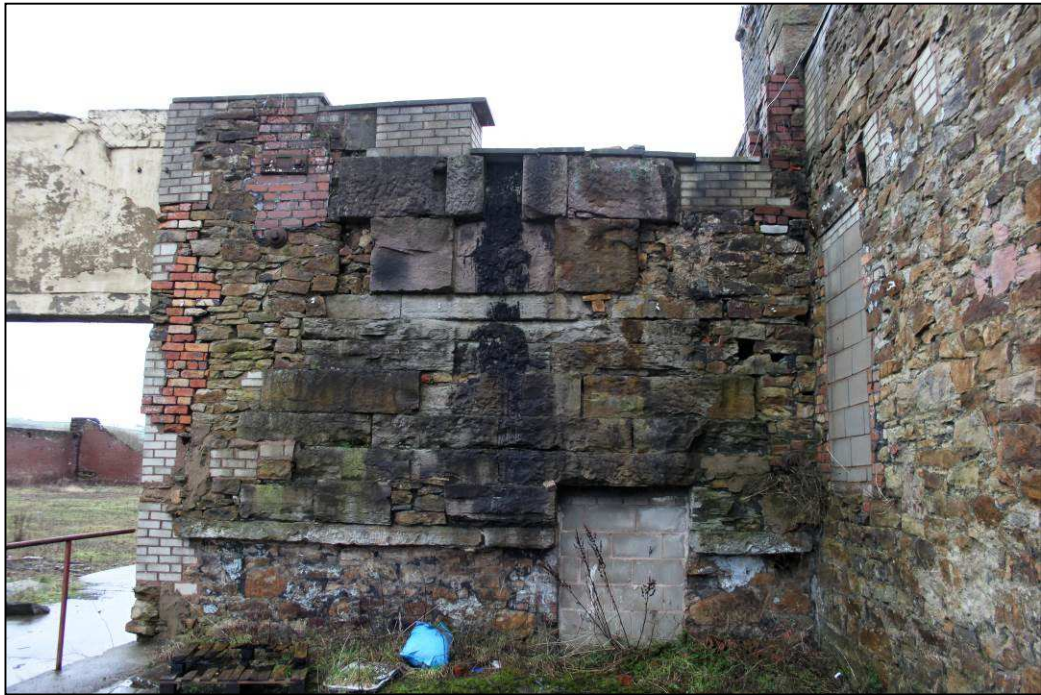
- 3.3.3 The east wall of the engine house also retains significant detail relating to the engines and power transfer (Plate 16). An oversailing string course of sandstone block, approximately 5' above floor level forms the base of an area of roughly dressed sandstone blocks (Plate 16), below two courses of larger dressed blocks in the centre of the top of the extant wall (Plates 16 and 17). The central block has a cut-out on its internal, western, face, with grease and oil staining within the rebate and in the wall below (Plate 16). Power appears to have been translated from the northern side of the wall at this height into the weaving shed to the south through a bearing box immediately to the east, which although removed, retains the majority of its dressed sandstone surround (Plate 17).

*Plate 16: East wall of 1869 engine house with dressed sandstone blockwork*

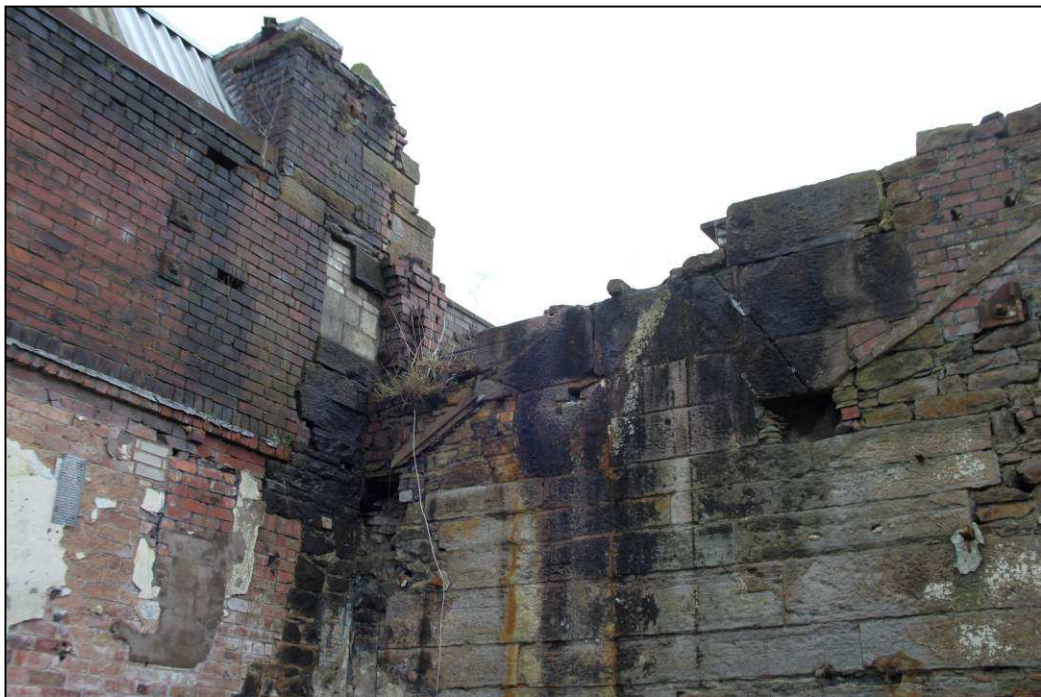
*Plate 17: Upper east external elevation of 1869 engine house with bearing box position into weaving shed to left*

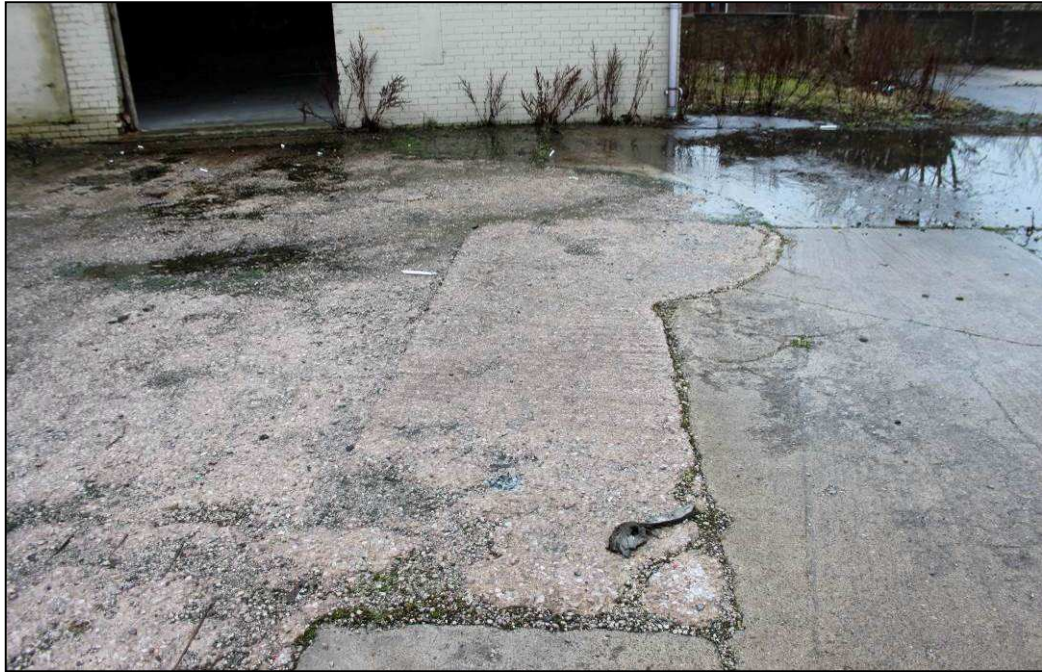
position of the chimney (Plate 18), which is depicted clearly on the Ordnance Survey mapping (Figs 2-4). The boiler house originally lay to the north of the chimney, against the canal, and is clearly depicted on the Ordnance Survey plan of 1894 (Fig 2). The lower part of its northern elevation survives as the retaining wall to the canal (Plate 19) and is of sandstone rubble construction, with the boundary wall continuing to the west in a slightly darker stone (Plate 19). Its eastern return retains quoins above the single-piece sandstone jamb to a landing stage from the canal, the eastern jamb also surviving, but the aperture infilled with stone (Plate 20). This part of the complex is currently occupied by a late single-storey brick shed with lattice-framed steel roof (Plates 19 and 21).

*Plate 18: Joints in concrete slab denoting possible position of chimney and flue*

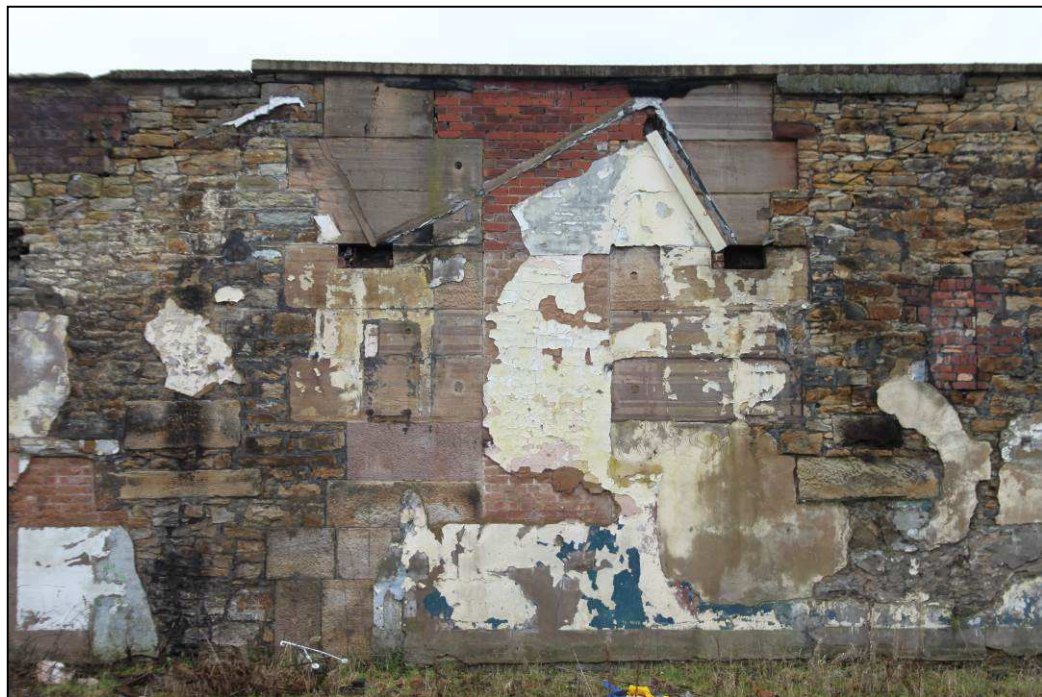
- 3.4.1 The 1869 pair of engines was replaced in 1905, with the installation of a horizontal cross compound engine by Clayton, Goodfellow & Co Ltd, within a new power plant (*Section 2.2.6*). Nothing survives of the new structure, but the Ordnance Survey 25" edition of 1911 shows an expansion of the complex at the northern end on the western side of the mill, opposite the chimney (Fig 3). Remodelling of the original west wall of the weaving shed to incorporate the new engine house and its associated rope drive does, however, survive within the extant fabric. This comprised the insertion of a 16'6" width of ashlar block sandstone, placed centrally within a 20' wide projection within the external face of the wall (Plate 13), and flush with the internal wall face, with a central 4' wide aperture in the centre, blocked with brick subsequently (Plate 22). Bolt holes on alternate courses adjacent to either side of the aperture almost certainly fixed the housing for a rope drum or pulley, placed at the eastern end of the engine house, overlapping into the weaving shed, to allow the first motion shaft to run along the western internal wall, in an extension from the shaft from the earlier engine house to the south. However, the engine itself became redundant, possibly after the cessation of weaving, with the rope drive being removed, and the northern light roof of the weaving shed replaced across what was presumably originally a small rope race to the rear of the engine house, projecting slightly above the roof of the shed.

*Plate 22: Ashlar blockwork of bearing for rope drum, with bolt holes and infilled wheel pit*

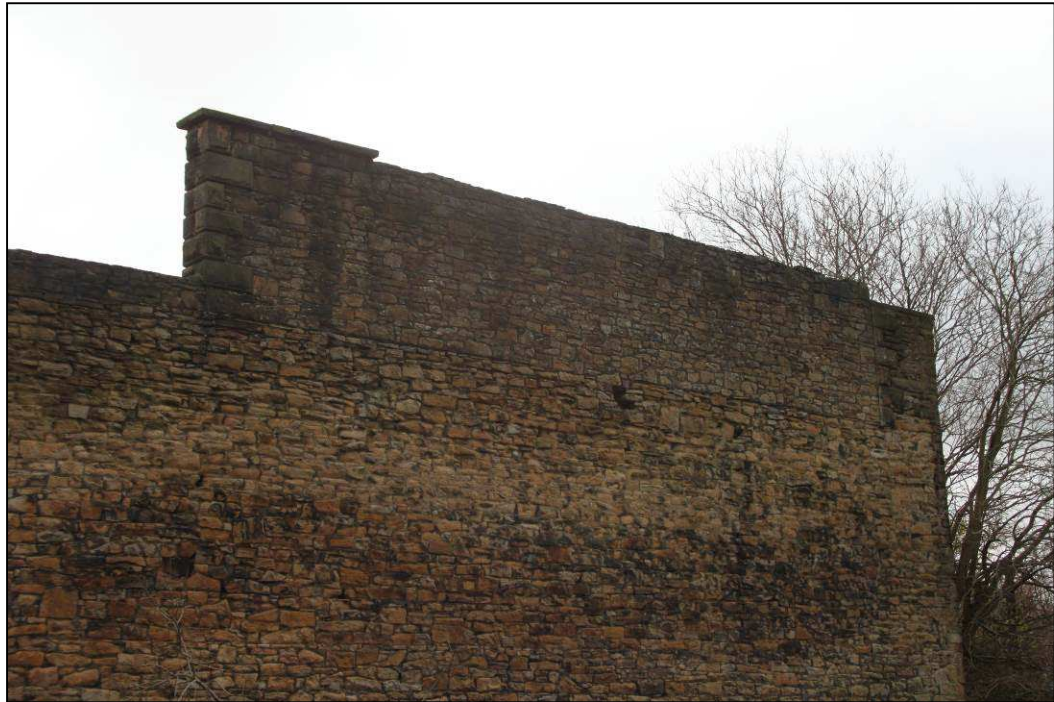
- 3.5.5 On the canal-side northern elevation, the western 11.75m are raised higher than the remainder of the wall (Plate 26), corresponding to a re-entrant in the weaving shed, shown on the historic mapping (Figs 2-4) and externally can be seen to comprise a stone pier at its western end at first-floor level, with random stone to the east, clearly bonded in a different mortar (Plate 26). The inner edge of the pier has rusticated quoins and probably represented the outer jamb of a first-floor level window in tower above the weaving shed. Similar quoins at the opposite end of the wall appear to form part of the rebuild, but probably denote the width of the original structure.

*Plate 26: Rebuild at top of external north wall of weaving shed*

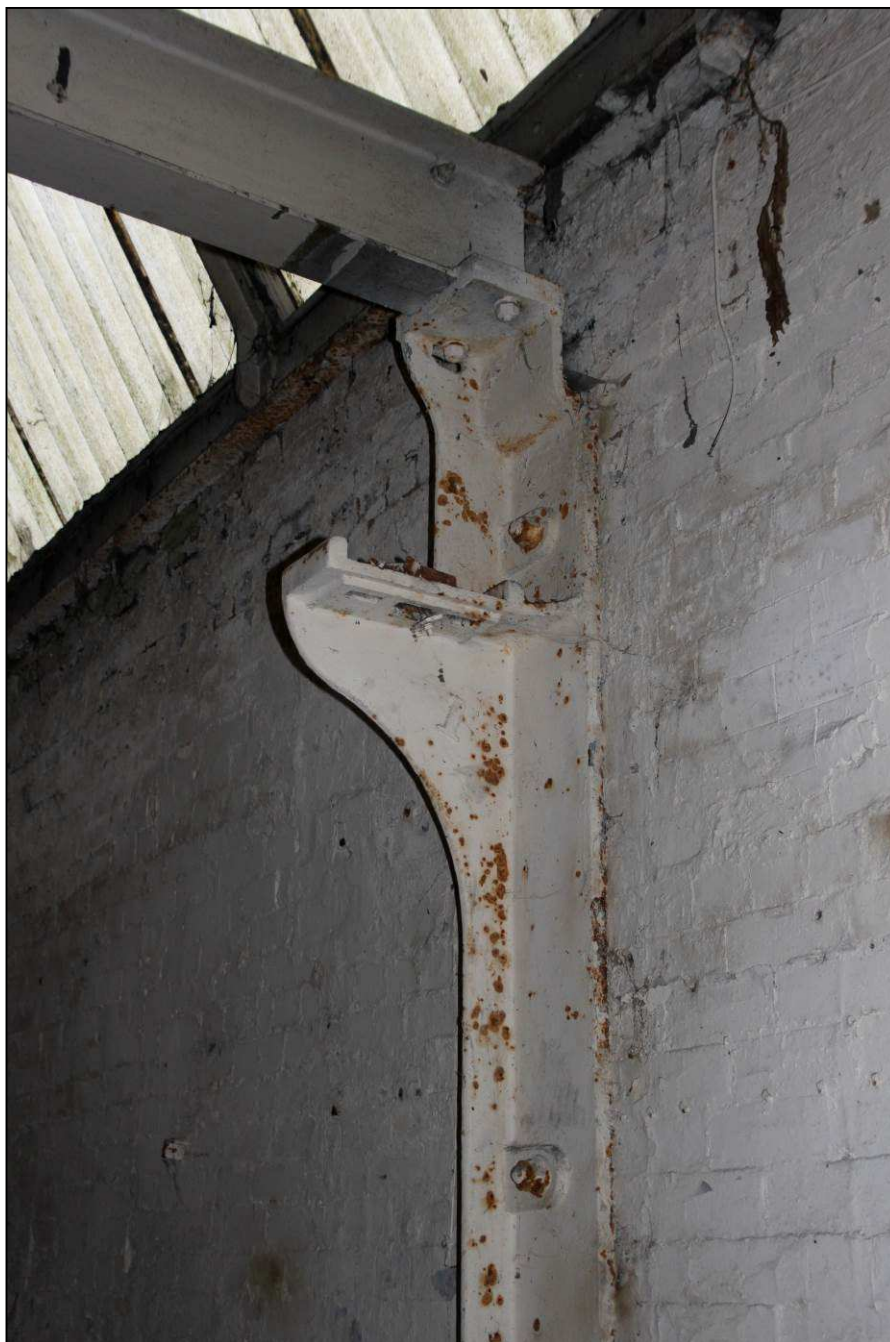
- 3.6.3 Further evidence for a rebuilding of the structure can also be seen in the north external elevation, where the stone rubble wall of the original shed is capped with engineering brick in five-stretcher English Garden Wall bond (Plate 11). The southern wall of the shed, which presently forms an internal partition to Unit 9, which appears to represent a preparation block, added between 1894 and 1911, when it is depicted on the Ordnance Survey 25" map (Fig 3), and almost certainly representing the extension of 1909. The partition between the two structures appears to date to the extension, comprising machine-made red brick, built in five-stretcher English Garden Wall bond and of 1½-brick thickness (Fig 5). Both the north and south walls retain tall cast-iron pillars against the internal face (Figs 5 and 6; Plate 35), each with a rib to carry a pillow bearing for an east/west aligned line shaft placed on the inner face of the wall (Plate 35). The north wall retains two pillars, whilst the south has only one, with an additional pair of more conventional line shaft hangers, and a large angled cast-iron bearing supporting a brick pier in the south-west corner of the room (Fig 5; Plate 36). Both the southern pillar, and the western of the two northern pillars are stamped with a number 1 on the eastern face of the rib (Plate 35).

*Plate 35: Cast-iron pillar for line shaft bearing, Unit 5*

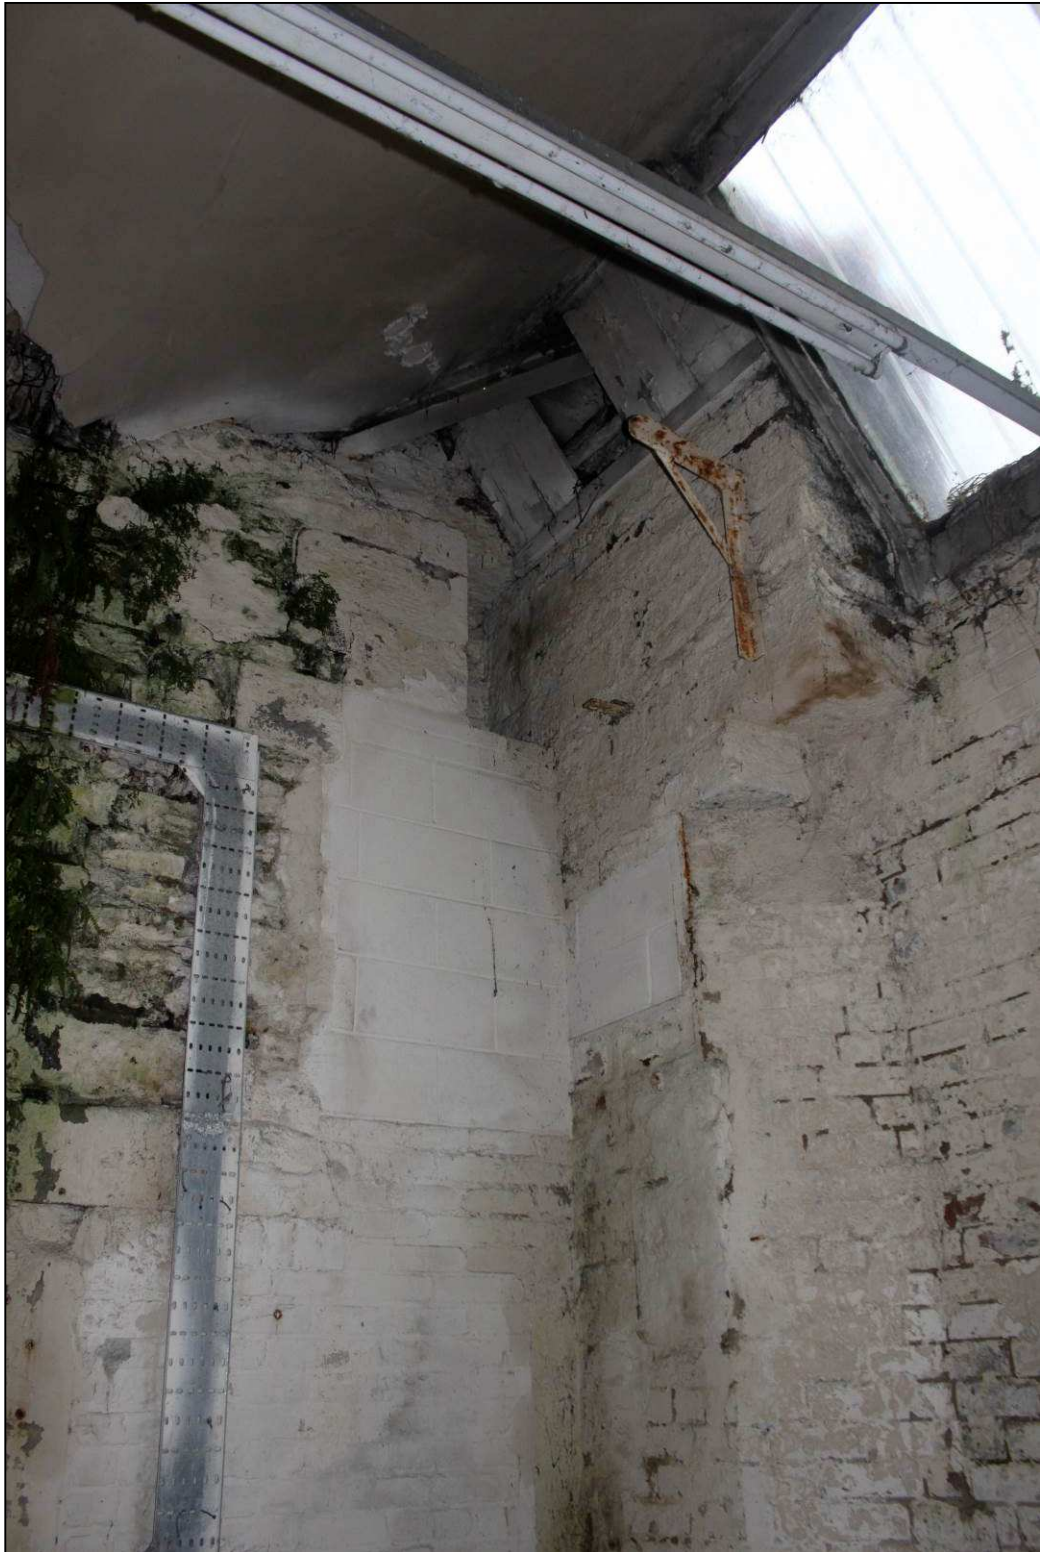
- 3.6.4 Power appears to have entered the shed from an aperture in the north wall, adjacent to the west wall, where a further brick pier probably carried a bevel gear (Plate 37). The pier against the south wall may have carried an end bearing for the primary drive shaft, or possibly the footstep bearing for an upright shaft associated with the earlier three-storey spinning block. No evidence for end bearings for east/west aligned line shafts or bevel gear housings survive within the west wall, with the exception of a clinker-blocked aperture at its northern end which presumably transferred power into the later Unit 4 to the west (Plate 37). The translation of the line shafting through 90° from the original structure allowed for the looms to be arranged more efficiently within the shed, placed in longitudinal rows powered by longitudinal line shafts.

*Plate 37: Angled brick pier with blocked bearing boxes, north-west corner of Unit 5*

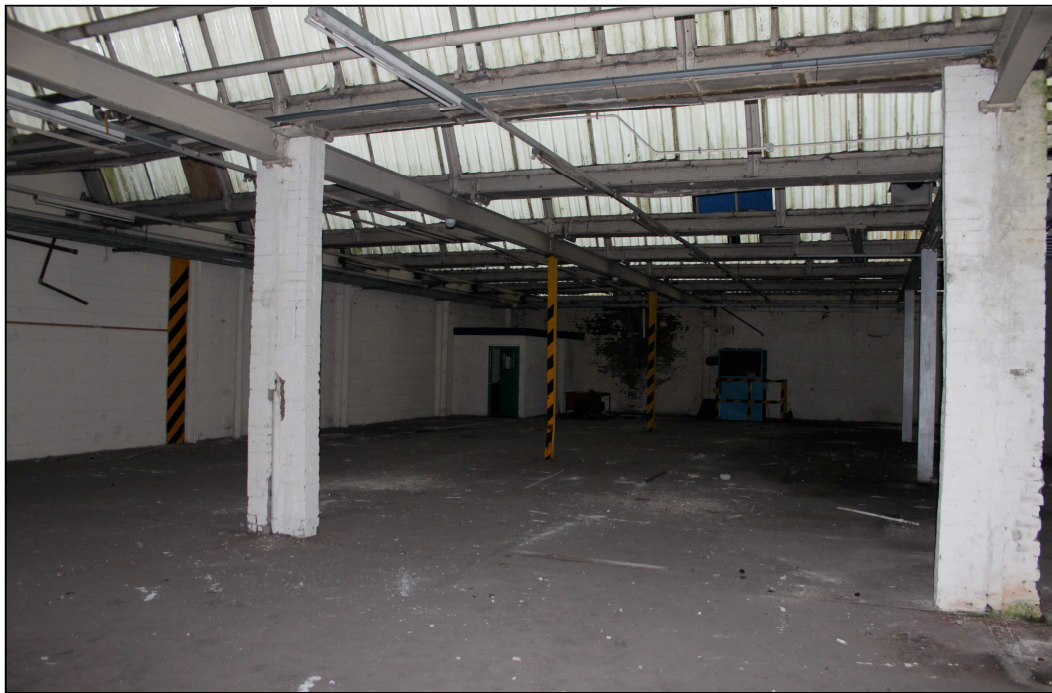
- 3.6.6 Unit 7 is slightly larger than Unit 5, and formed the eastern extent of the original weaving shed. It retains two columns, similar to those within Unit 5, within the dividing wall to Unit 6 (Fig 5; Plate 40), and also two further columns encased within brick (Plate 40) forming part of a southern column row (Fig 5). Elsewhere, the columns have been replaced with I-section steel stanchions. Three cast-iron pillars against the south wall are numbered 5, 6, and 7, whilst a solitary pillar against the north wall is aligned with the central of the three column rows (Fig 5; Plate 41). Immediately to the east, the wall projects forwards into the room by 0.2m, and is of stone rubble construction beyond, with a return to the east wall which (Plate 41) is entirely of stone rubble construction. This represents the joint between the position of the original spinning block, which was rebuilt to the west in brick, and a narrow structure placed on its western side, level with the eastern extent of the first weaving shed, and probably of broadly contemporary late-nineteenth century date (Fig 2; Plate 2). The eastern ceiling beam is carried at its northern end by a sandstone corbel, with shallow convex base (Plate 41), with an adjacent, blocked rectangular aperture (Plate 41) possibly representing a bearing box.

*Plate 40: General view of Unit 7, looking north*

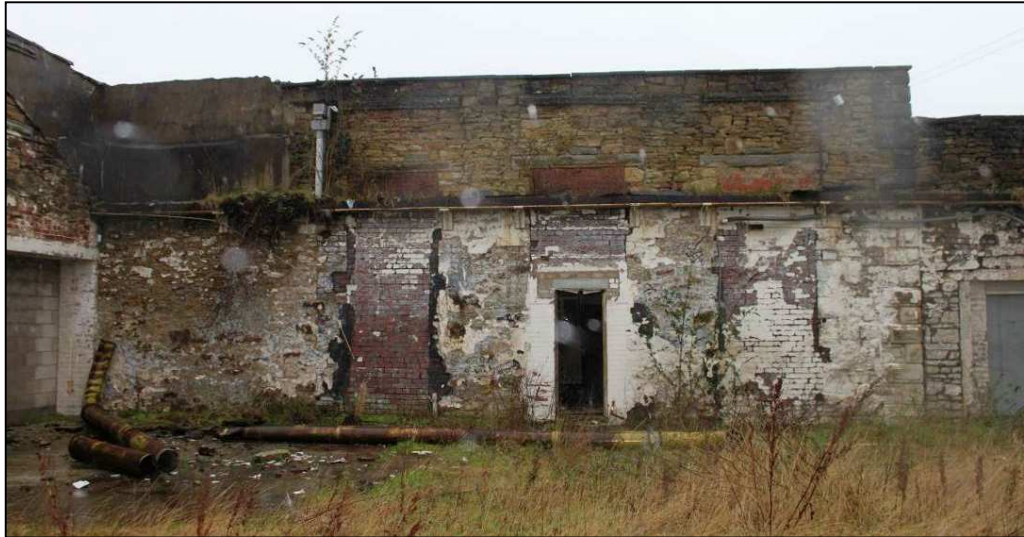
- 3.8.3 The north wall, however, was enclosed subsequently, within an addition to the preparation block and is presently exposed, revealing it to be of sandstone rubble construction, with rusticated quoins to each return (Plates 42, 43, and 44). Windows to each of the three bays in the north wall were remodelled into full-height doorways, and blocked subsequently (Plate 44), with the extant projecting sills and jambs of first floor windows above (Plate 44) demonstrating the building to have originally been of at least two-storey height. The structure has been heavily remodelled internally with brick and stud partitions forming offices below a flat concrete roof, and with a large roller-shutter loading door inserted into the west wall (Fig 5; Plate 45), and an electricity sub-station inserted into its south-western corner, with Flemish bond brick partitions (Fig 5).

Plate 44: North wall of south-west preparation block, with first-floor window apertures at wall head

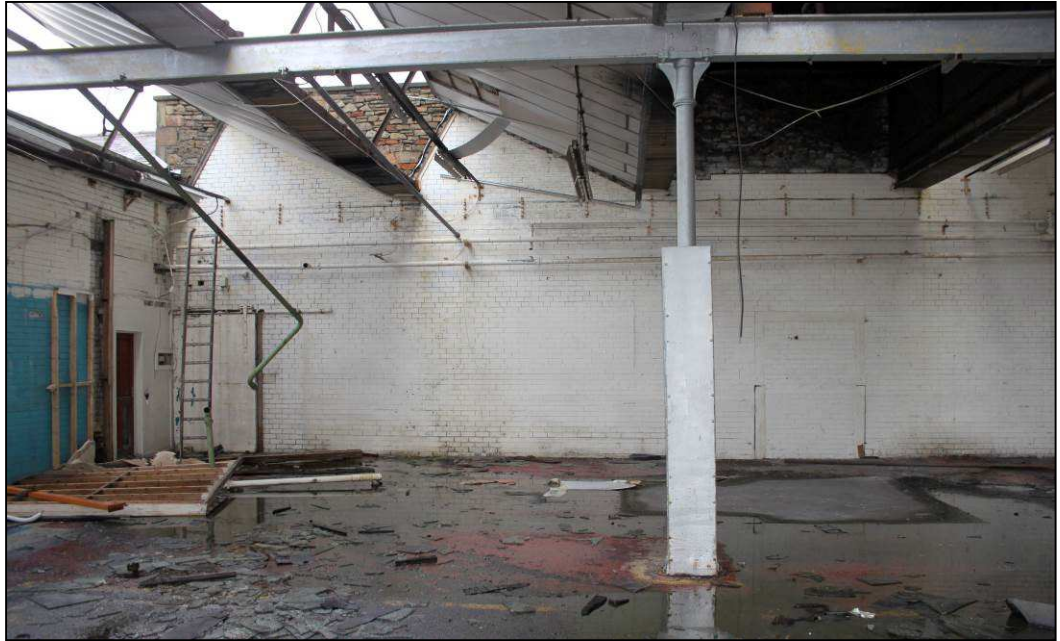
3.11.2 Internally it differs, having white tile-glazed brick in five-stretcher Flemish Garden Wall bond (Plate 54), manufactured by Place & Sons Ltd, Darwen (Plate 55), who's brickworks was located at Hoddlesden Colliery, approximately 5 miles to the south. It also has a much greater roof height than the earlier sheds (Fig 6; Plates 54 and 56), reflecting its use as a warehouse, comprising I-section steel beams by Dorman Long, Middlesbrough, supported beneath alternate valley gutters by columns of similar style to those used elsewhere, but without bolting faces for line shafting (Plate 54). No evidence for power survives within the shed, with the exception of a blocked bearing box in the southern end of the west wall, suggesting that a single line shaft was sufficient to power machinery within the warehouse. The structure of the roof also replicates that of the earlier sheds, with several sections having been replaced with raised lattice steel frames (Plates 54 and 56).

*Plate 54: White-glazed brick wall of warehouse, with column detail and ceiling beam*

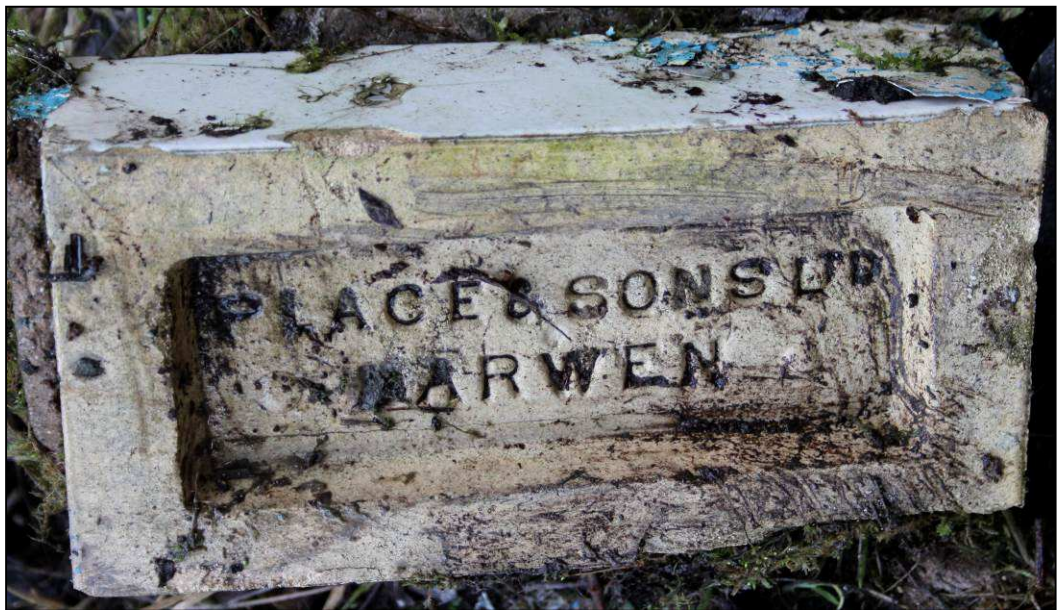
*Plate 55: Frogged and stamped brick from warehouse*

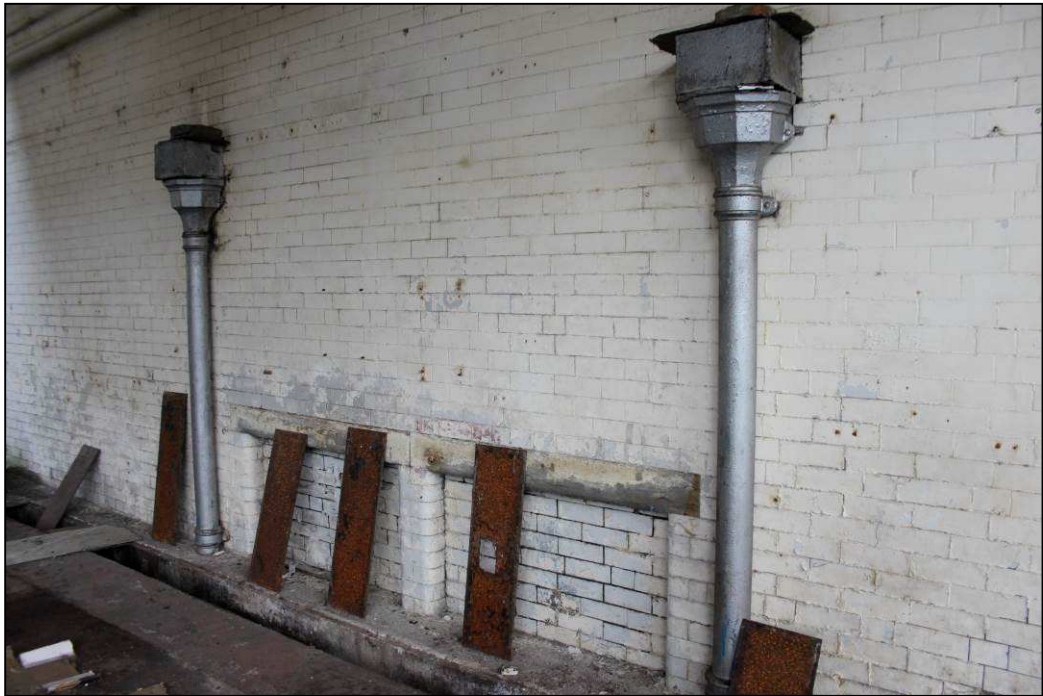
3.11.3 The internal face of the western wall retains octagonal-section hoppers and downpipes, inserted into the shed following the enclosing of the yard to the west (Plate 57), the roof of which was significantly lower than that of the warehouse. A bull-nosed rebate to the low level opening, also into the yard, and almost certainly into a privy block therein (Plate 57). The east wall has a doorway with dressed sandstone surrounds at its northern end retaining a fireproof sliding door into an external loading bay (Fig 5; Plate 54), with a further door of similar style into the southern end of the loading bay being blocked with brick (Plate 54). The north wall appears to have originally housed a pair of nine-light vertical windows to each of the eastern three bays (Fig 5), with three having been converted into doorways subsequently (Plate 58). The western part of the western bay has a doorway to a straight sandstone stair (Plates 59 and 60), affording access to an open yard to the north via a narrow two-bay, two-storey tower (Plate 30), which also had an entrance into the half-basement of Unit 8 (Fig 5). This structure is probably contemporary with the weaving shed, and was certainly in place by 1920, but pre-dates a privy block added to the northern side of the adjacent two bays of the weaving shed between 1939 and 1956 (Fig 5; Plate 59), and which blocks windows in the east wall of the earlier structure. This was itself extended further to the east, to the end of the weaving shed, and comprising offices at weaving shed-level above a lower level store/workshop with a row of I-section stanchions carrying a concrete plank ceiling on BSC Steel 15" I-section beams (Plate 60).

*Plate 57: Blocked doorways to yard and internal downpipe hoppers*

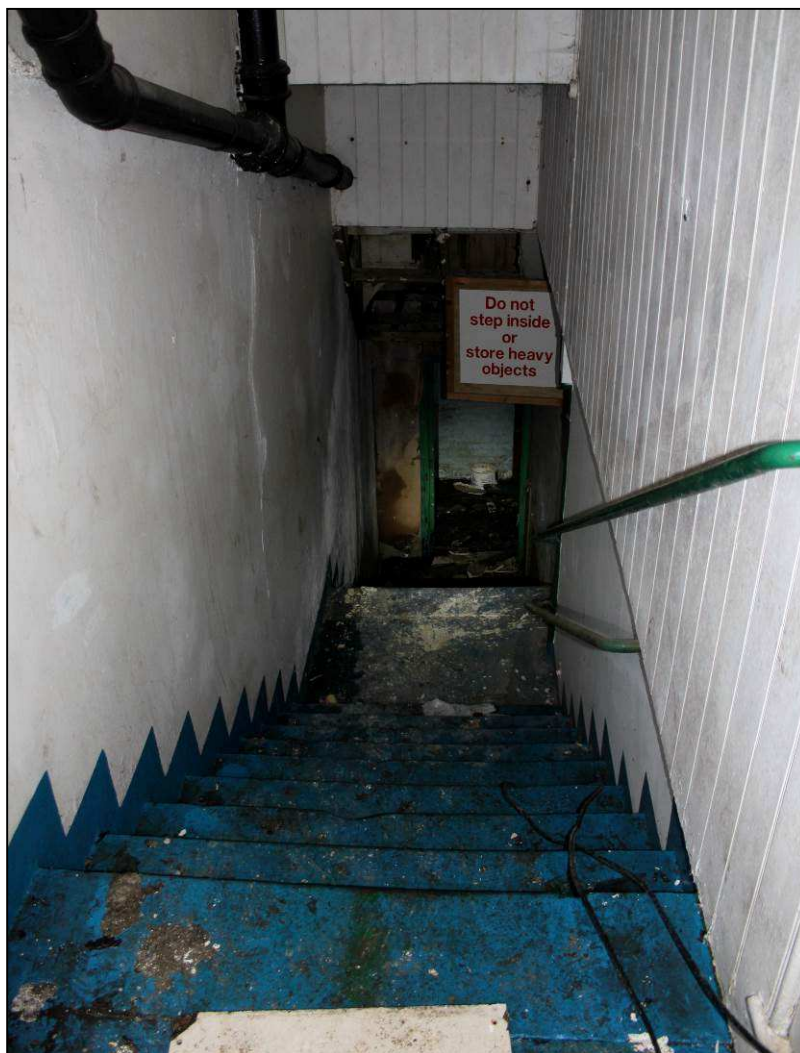
*Plate 60: Stairs to open yard to north from warehouse, and to basement of Unit 8*

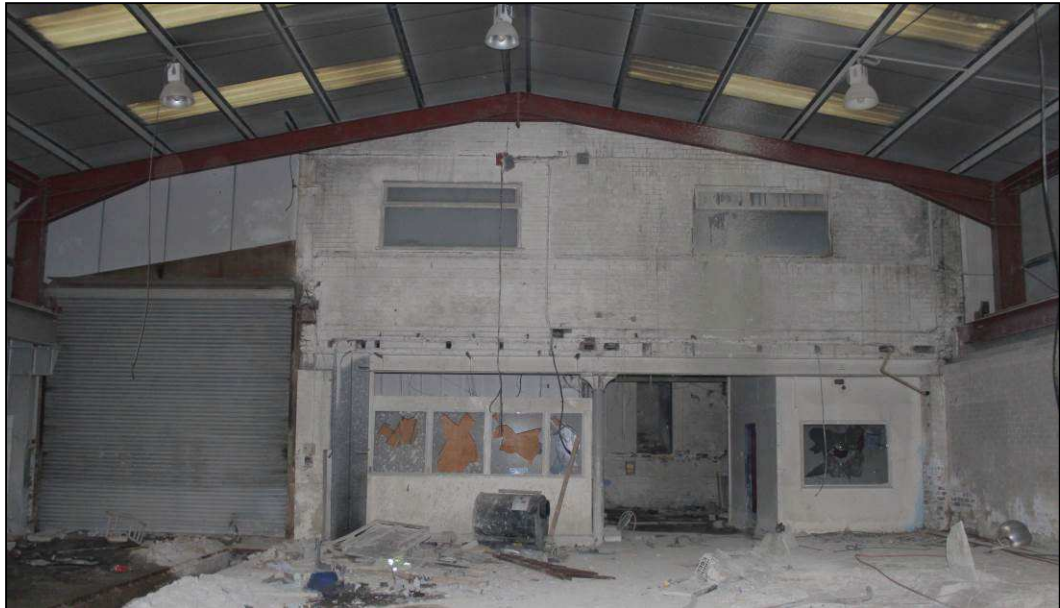
- 3.12.6 A much larger column, placed in the centre of the north wall, supports a transverse I-section steel beam, manufactured by Erskine Grove, England, carrying the wall of the upper floor over a full-width opening into the contemporary warehouse to the north (Fig 5; Plate 68). This column is of 7" diameter, with a projecting plate on its northern side to carry the I-section central, longitudinal beam of the new warehouse (Figs 5 and 6; Plate 69). This was removed subsequently within the southern few bays of the new warehouse during the insertion of a loading bay on its eastern side and the replacement of that part of the roof with a wider, taller pitched roof of corrugated metal sheet on a steel frame (Plate 68).

*Plate 68: North wall of office block and replacement steel roof of north-east warehouse*

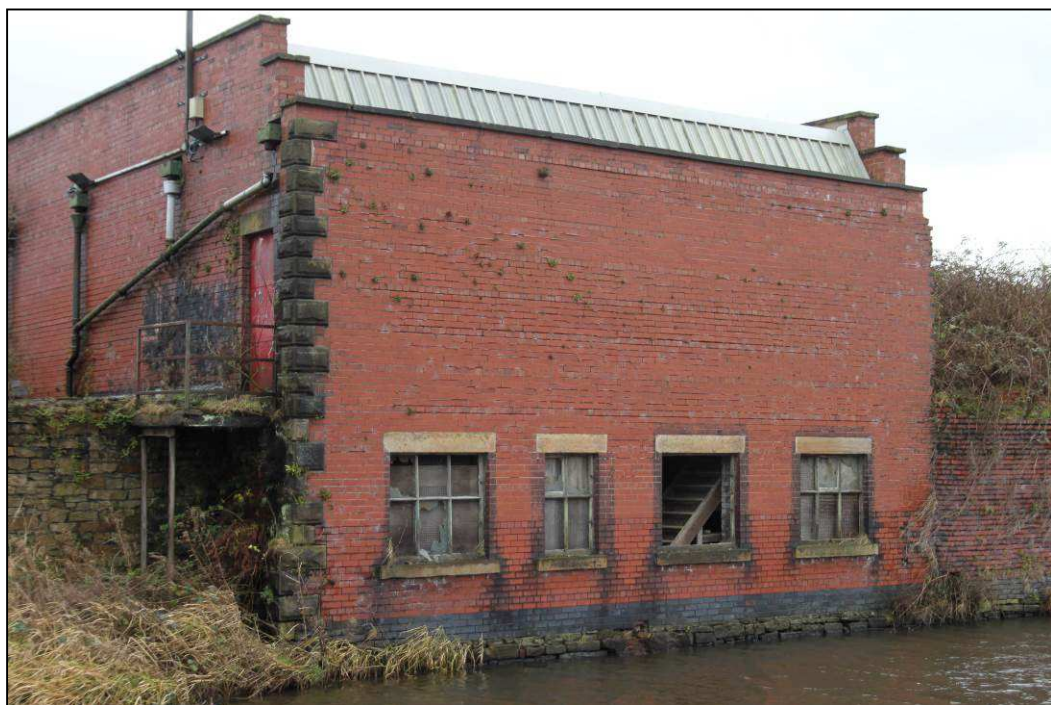
3.12.7 **North-East Warehouse:** the northern part of the range comprised a single-storey 7x2 bay warehouse, with a narrow asymmetrical northern-light roof (Fig 6; Plate 1). It was intended to form part of the construction of a much larger weaving shed to the west, but appears to have been the only part of the architects plan, submitted by W Grundy in February 1920 (Plates 3 and 4), that was ever constructed. It was not externally faced in sandstone rubble, unlike the earlier extensions to the complex, but was instead of machine-made brick in five-stretcher English Garden Wall bond, with rusticated quoins to the returns of each elevation, and with a basal string of four courses of Staffordshire Blue engineering brick above the stone base of the canal wall (Plate 70). The channel-section valley gutters of the saw-toothed roof were carried on a row of 12x6" I-section steel beams (Plate 71), supplied by Dorman Long of Middlesbrough. The columns that supported this central longitudinal beam were not placed beneath alternating valleys (Fig 6; Plate 71), as would have represented a standard construction technique, but were instead placed on 22'6" centres from the north wall of the two-storey brick warehouse, where the inserted column at lower ground floor level had a projecting corbel to receive the end of the beam. This is clearly depicted on the original architect's drawings (Plate 4), with the northern two bays being reduced in length to accommodate this unusual arrangement (Fig 6). The cross-section of the proposed extension also shows a stair to a half-basement of five shorter bays (Plate 4), erected as a timber stair extant within a timber planked stairwell in the north-west corner of the warehouse, with an external doorway at the northern end of the east wall onto a flagstone slab landing (Plate 70).

Plate 70: View of warehouse across the Leeds and Liverpool Canal, with stone-built fuse room to left

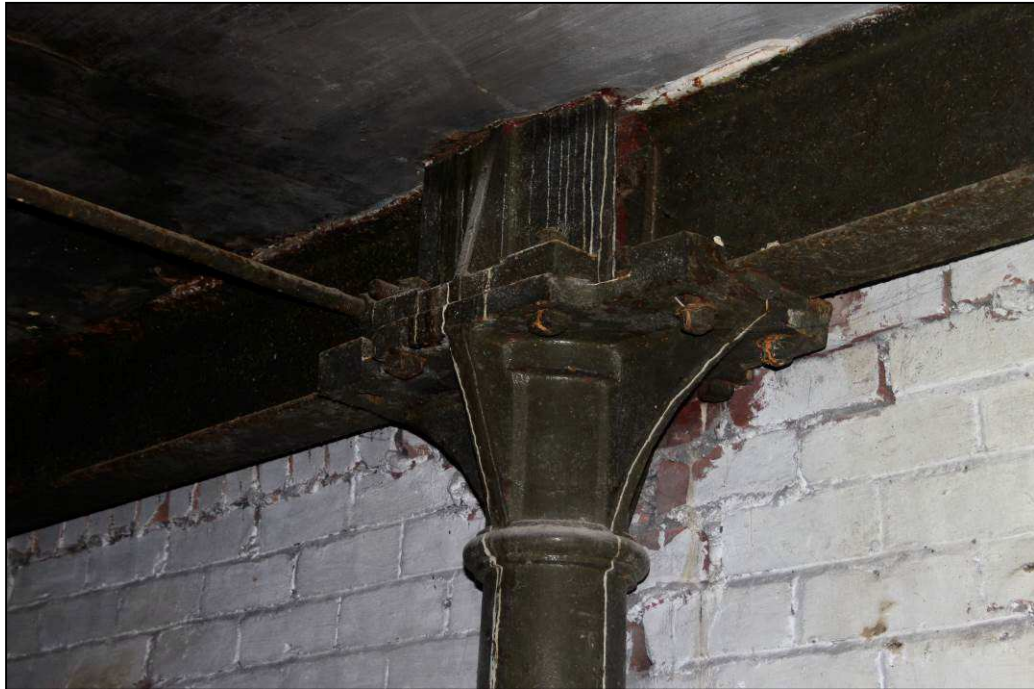
3.12.8 The basement has four windows in its canal-side elevation, three housing six-light horizontal timber frames, with the penultimate eastern window, at the foot of the stair being significantly narrower, and housing a four-light frame (Plate 70). All windows have flush sandstone lintels and projecting sills (Plate 70). The concrete basement ceiling is carried on a single row of columns (Plate 72), similar in style to those above, but with cruciform-shaped head-plates to carry a ribbed crush box around the I-section ceiling beam to attach to the baseplate of the column above (Plate 73). A transverse 1½-brick thickness partition wall placed 30' from the north wall is probably inserted, being placed almost adjacent to a supporting column (Plate 73).

*Plate 73: Detail of column capital and crush box in basement*
