ALBION SQUARE, WHITEHAVEN, CUMBRIA

**Archaeological
Evaluation,
Excavation,
and Watching Brief**

**Oxford Archaeology
North**

March 2013

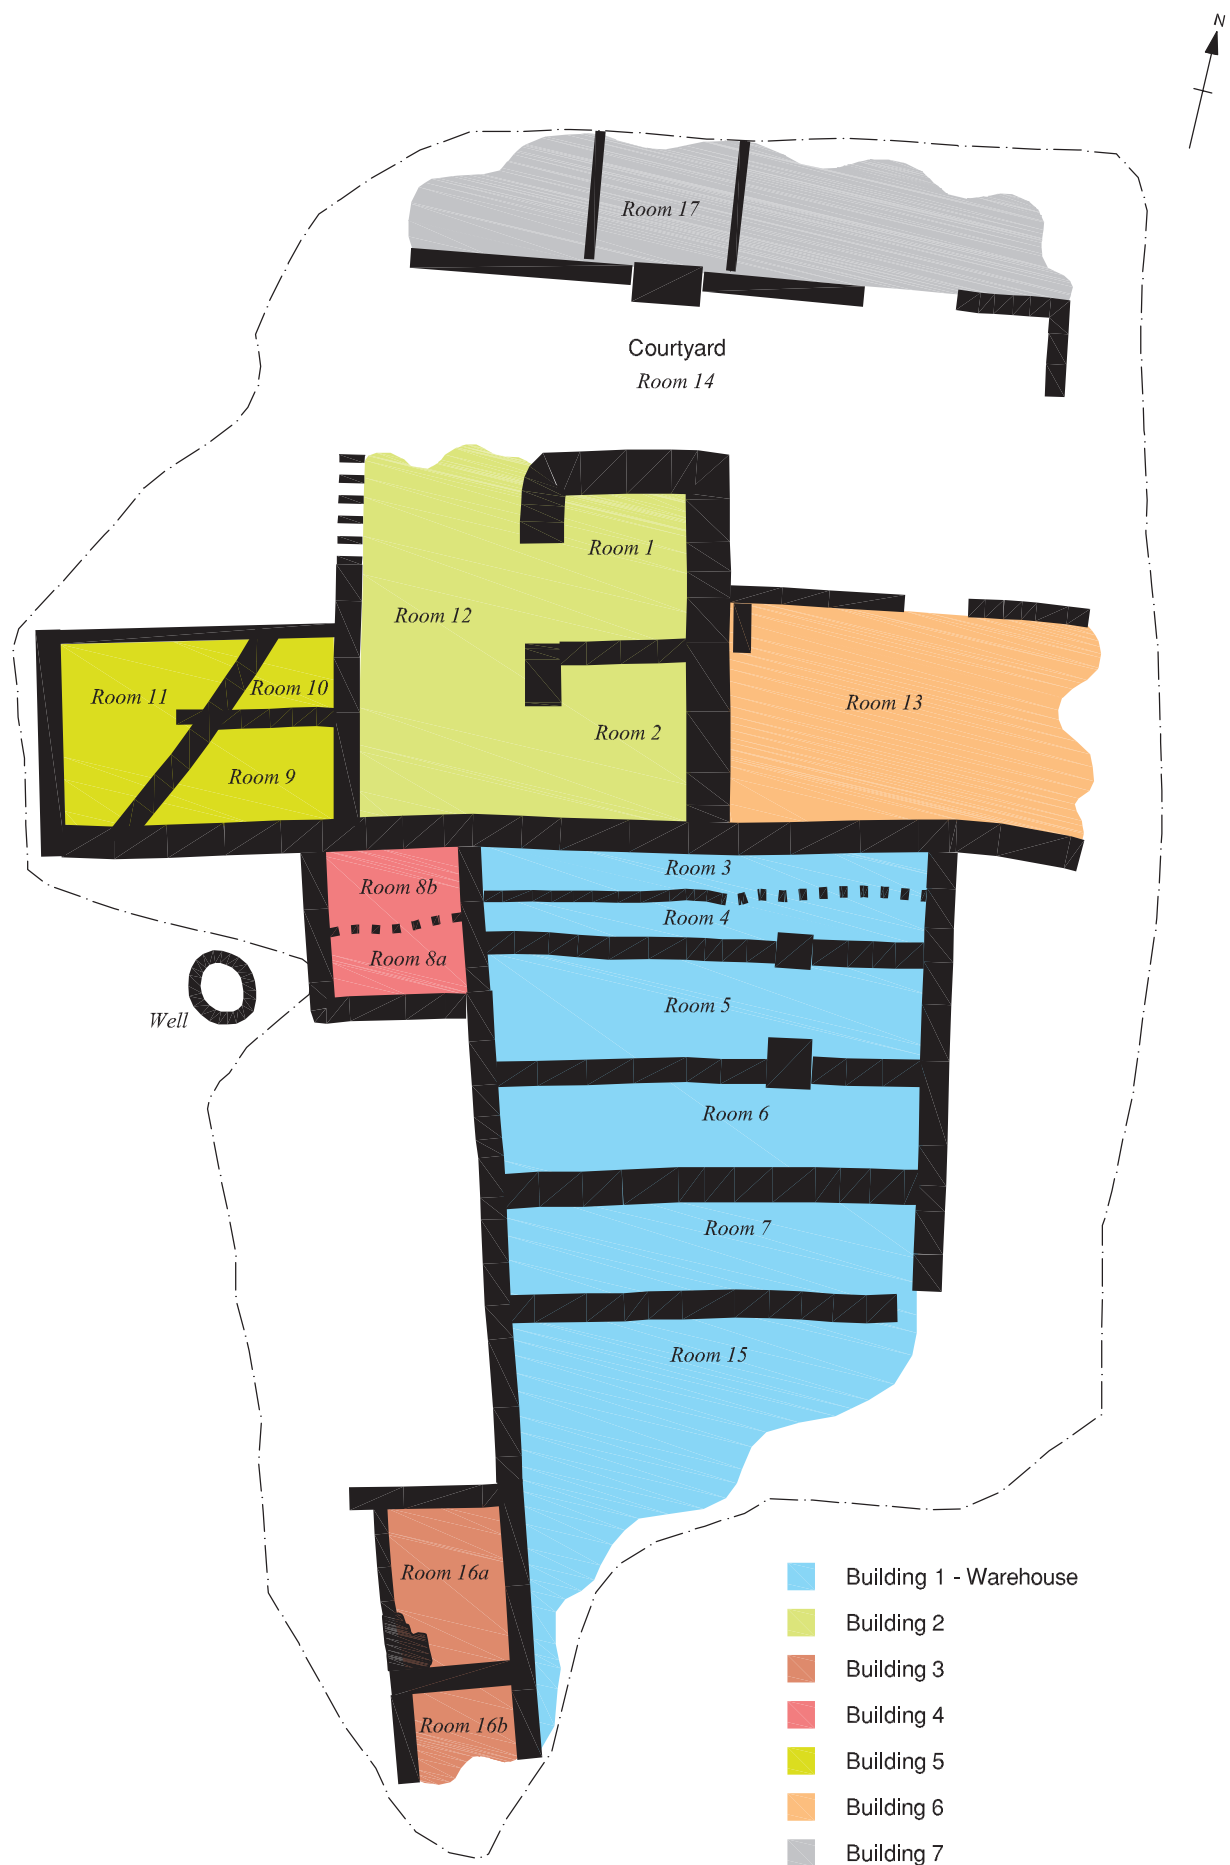
Figure 3: Plan of Buildings and Rooms within the excavation area

4.1.3 The majority of the structural remains comprise brick and sandstone walls associated with the remains of the soapery and the Phoenix Foundry. The 'rooms' within these structures form a convenient means of directing the reader around the site (Fig 3; Table 2).

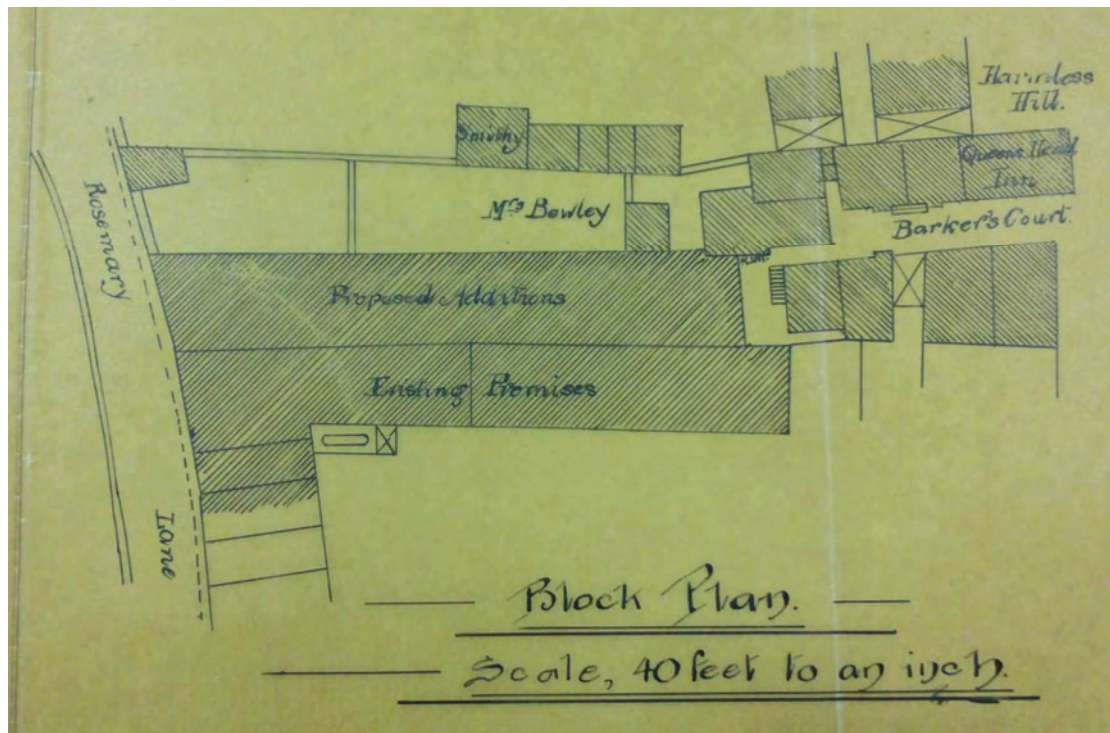
Plate 8: Plans by architect JS Moffat, 1892, showing proposed alterations to the north range of the Phoenix Foundry

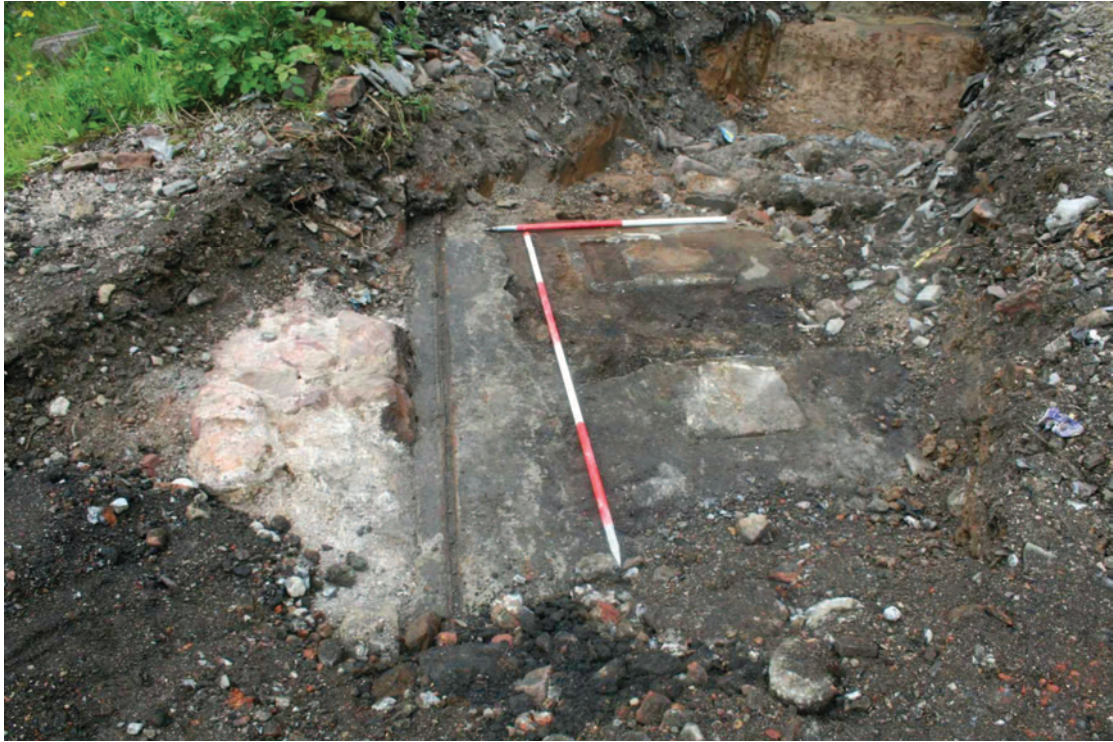
Plate 10: Evaluation Trench 1, showing machine base

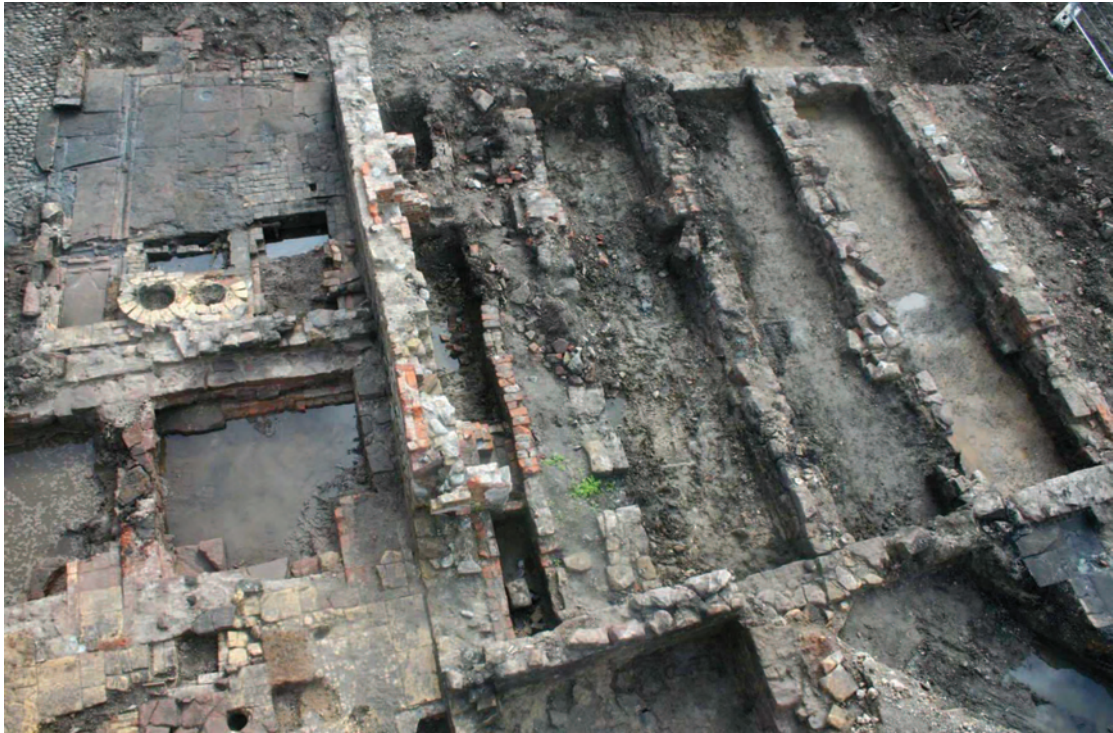
Plate 22: East-facing aerial view of warehouse Building 1

- 4.4.3 The warehouse (Building 1; Fig 9; Plates 3 and 22) covered a broadly rectangular area of 260m² (of which 159m² was exposed) and was seen to be broadest at its northern end (8.9m wide, narrowing along its full length towards the unexposed street front portion). Internally, the building was divided into a series of east-west-aligned cells by walls **1068**, **1075**, **1079**, **1019** and **1020**, that were bedded without foundations cuts directly onto the natural sandy clay. Although it is possible that these walls may have defined individual basements, they had not been keyed into the axial walls, and there was no evidence of surfacing materials; it is thus likely that they supported a sprung timber floor. The only entrance identified lay half-way along the length of western wall **1022**, with a corresponding pink sandstone riser giving pedestrian access into the courtyard to the west.

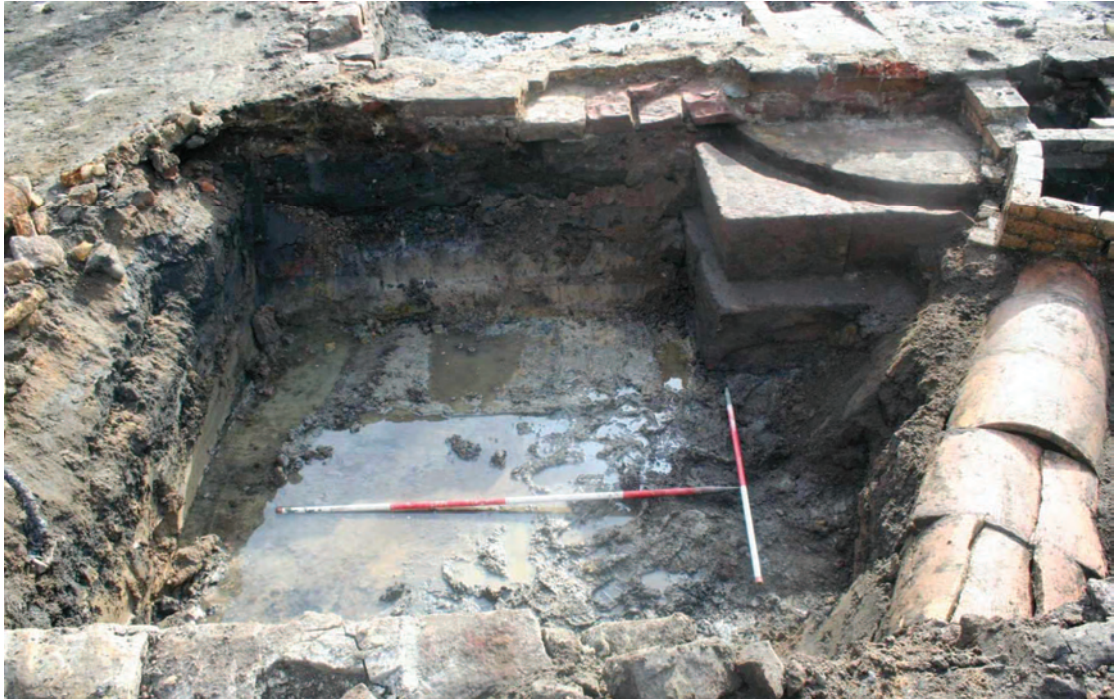
Plate 24: Building 2; pink sandstone block **2007** (possibly a support for the ash mill) and flue **2029**

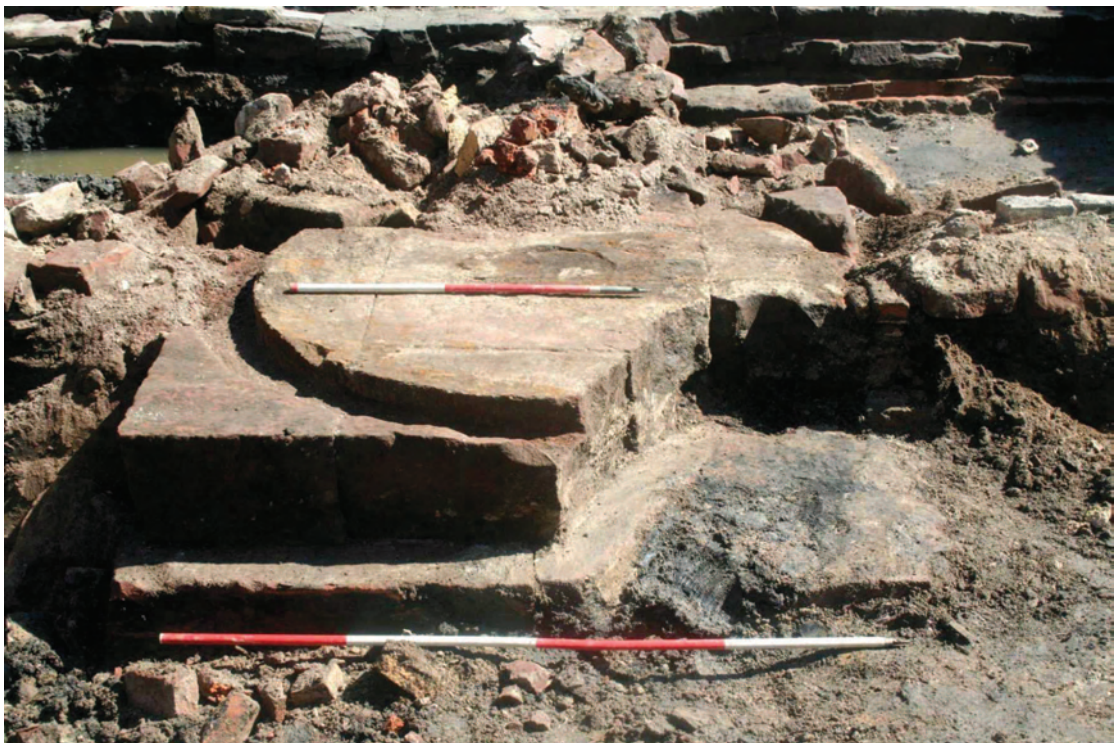
Plate 25: Sandstone block **2007** showing damage caused by insertion of foundry flue

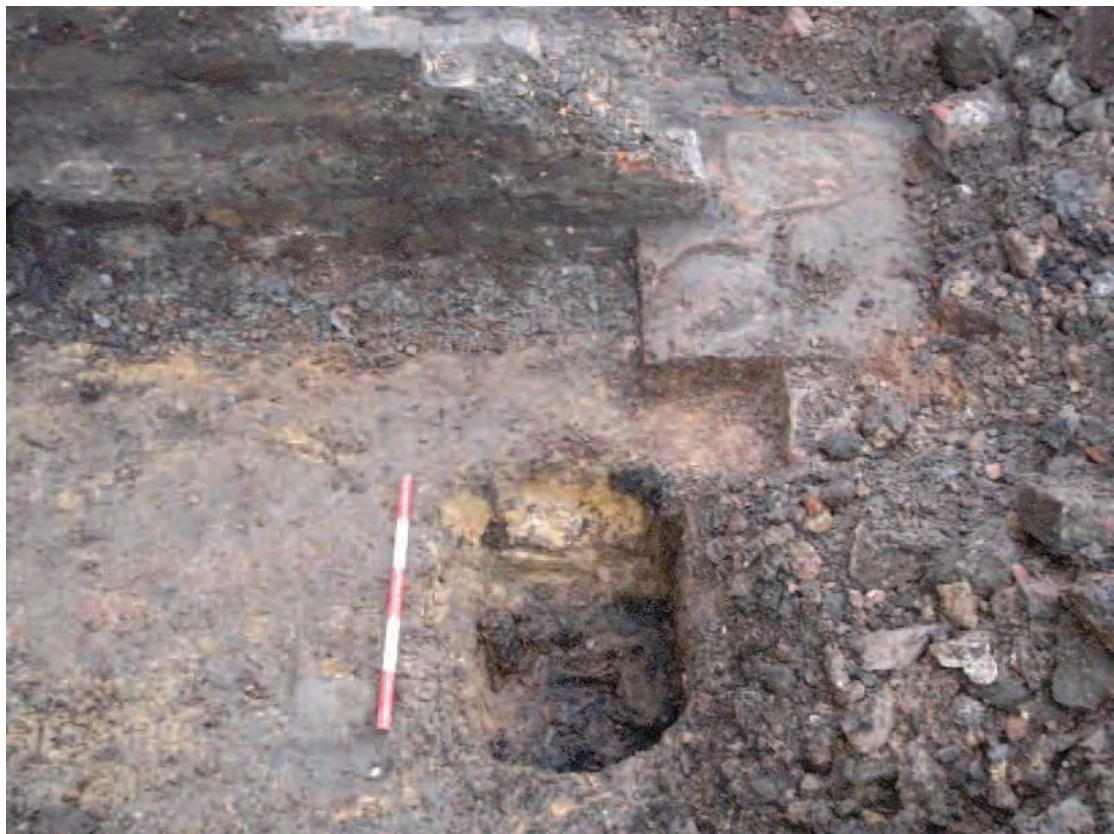
Plate 29: Sandstone plinth **2501**, wooden post **2512** and iron plate **2515** in floor **2508**, north-facing view (0.5m scale)

- 4.6.9 At the centre of the intervention, the northern part of flag floor **2516** was stress fractured, suggesting that it received heavy use at this point, and appeared to have been cut by the rectangular construction cut for a robbed-out feature, perhaps a machine base. This measured some 1.5m wide by 2m long and was filled with a very compact layer of clay **2517** (0.05m thick), above **2518**, a friable silty clay layer (Plate 39). This, and the eastern edge of flue **2520**, were butted by surface **2519**, which formed the floor in the northern part of the intervention. It comprised a mixture of sandstone flags and refractory brick, suggestive of modifications at various times. A truncated squared wooden post **2512** (0.5 x 0.4m) was found to cut surface **2508** (Plate 29), whilst nearby iron plate **2515** (0.4 x 0.3m, 0.1m thick) had an indeterminate function.

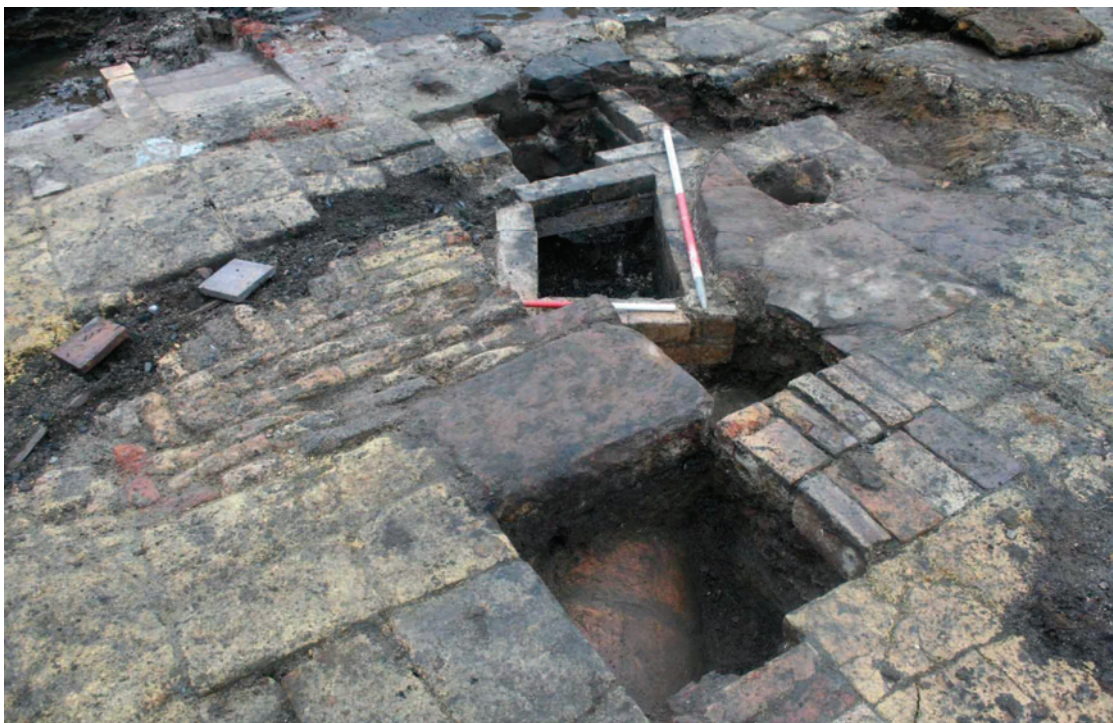
Plate 35: Flue system including brick box chamber and ceramic flue **2029** beneath foundry floor **1044**

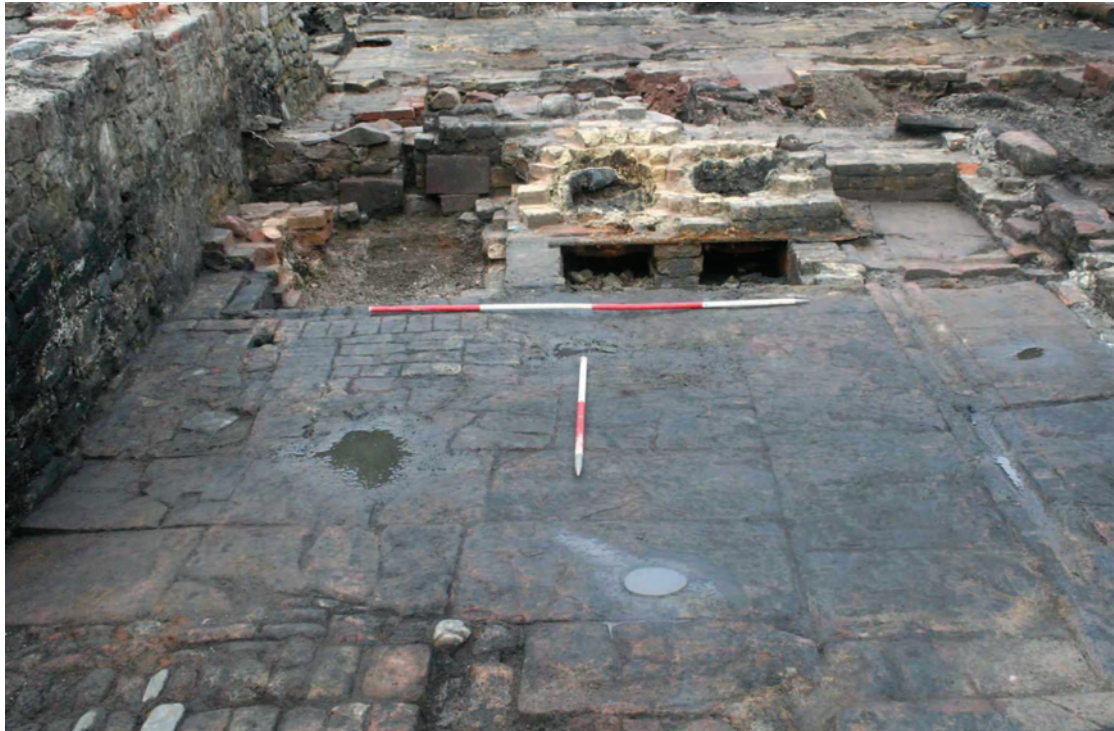
Plate 36: Room 13, Building 6, showing floor surfaces and the cupola furnaces

- 4.6.3 To the east, Room 13 (Building 6; Fig 8; Plate 36), contained the best-preserved elements of the foundry, comprising the remains of three cupola furnaces built against the walls at its western end. Correspondingly, the flooring (**1060**) within the room largely comprised refractory brick and tile at the 'hot' western end, and the retained soapery sandstone slabs elsewhere. Close to the furnaces, the floor featured a T-shaped shallow channel of uncertain function, although it may have helped to support apparatus for manipulating the crucibles or for fuelling the furnaces, or may instead have related to the soapery. Two of these furnaces, **1055** and **1056**, were paired over a central rectangular pit with a third, less well-preserved example, **1058**, located in a recessed bay at the southern corner of the room. The paired furnaces both had an internal diameter of 0.8m and were constructed of wedge-shaped yellow refractory brick (no makers mark was observed). The interior iron grill in both furnaces was obscured by the residual slag from the last casting (Plate 37), the composition of which indicated that both had been used for brass working in the area adjacent to the cupola furnaces. Although the pits beneath the furnaces would originally have formed hearths, the introduction of more modern technology was represented by the remnants of a gas pipe, **1066**, which cut through the edge of the furnace base and also through the foundry floor **1060** and its channel (which was not repaired).

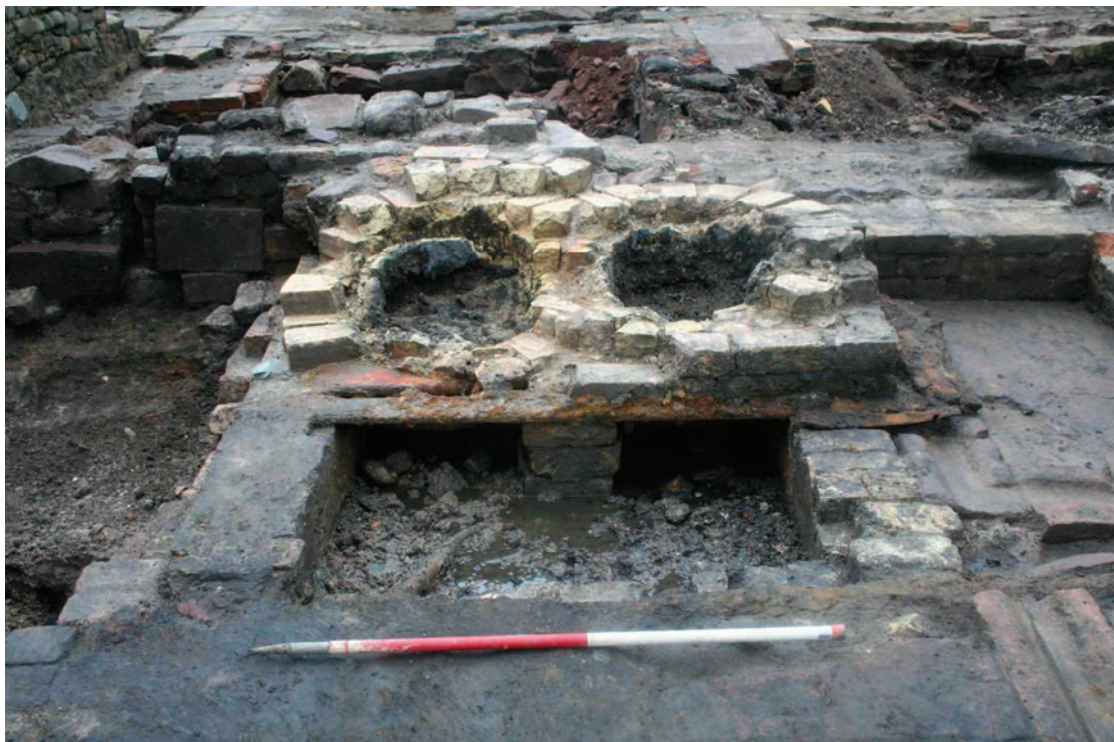
Plate 37: Paired cupola furnaces

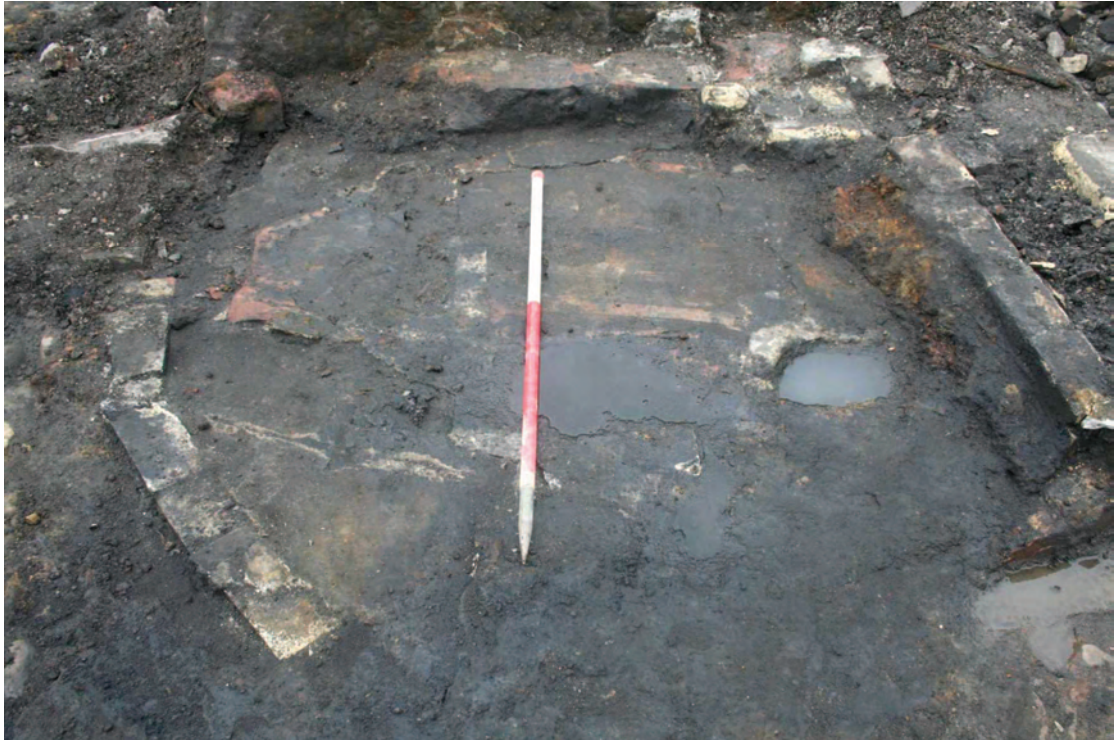
Plate 38: Brick-lined channel **1107** and brick-edged arch-shaped base **2045** in courtyard 14

- 4.6.5 To the north of these structures, Courtyard 14 would have continued in use throughout Phase 4. The sealing deposits of laminated spent moulding sand, **1003**, probably developed over time as such material was removed from the casting rooms. It could represent material dumped from the last few moulding episodes, although it is unlikely that this was normal practise, as the courtyard would have quickly filled with sand. Two features possibly relating to the operation of the foundry were identified at the north-east corner of the courtyard, both built against wall **1101**. These comprised a brick-lined arch-shaped platform, **2045**, and a brick-lined channel **2046** (Plate 38).

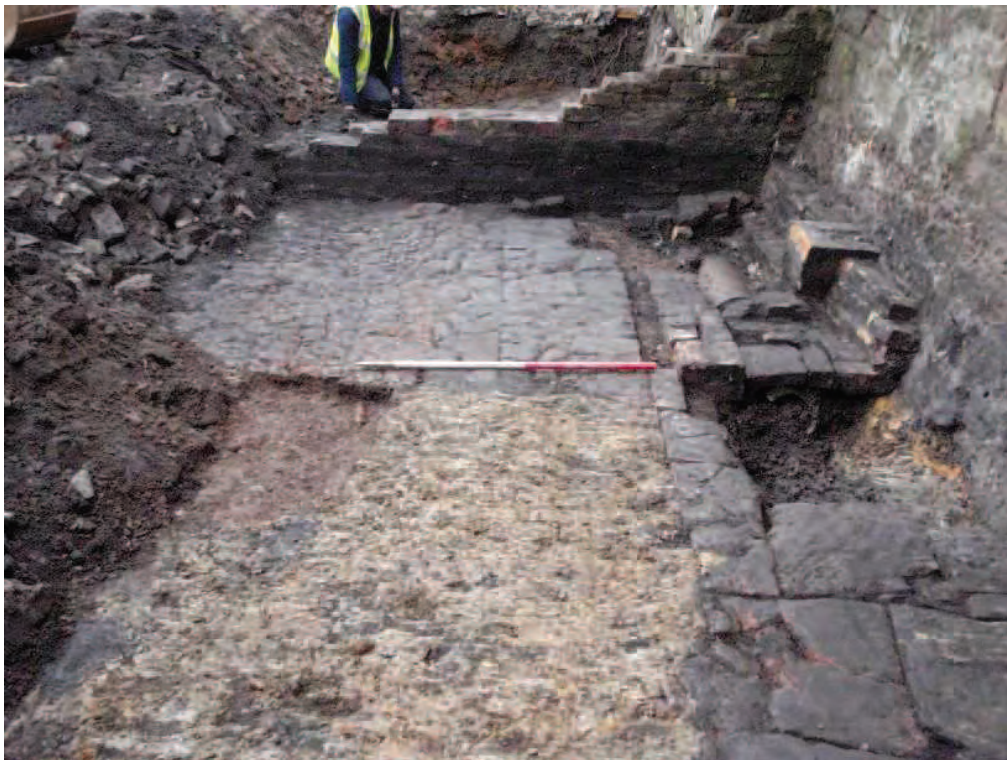
Plate 39: South-facing view of foundry remains observed in the watching brief

- 4.6.8 The west range, including the base of the foundry chimney, was investigated by Evaluation Trench 6 and during the watching brief (Fig 11). These revealed extensive evidence of the foundry (Plate 39), and comprised the aforementioned floors **2516** and **2508**, as well as flue structure **2520**, the putative location of a machine base (robbed out, leaving deposits **2517-8**), and, most obviously, the chimney. Sand at the base of a 2m-deep sondage may have represented the natural geology, but no other such deposits were identified in the area. Indeed, the westernmost part of the trench encountered bedrock at a shallow depth. The roughly hewn sandstone blocks of the chimney foundations were bedded on the sand, whilst flue **2520** (0.5m wide) was situated along the western retaining wall (**2514**), running up to the chimney to the north. The flue appeared to have been partially carved into bedrock **2511** (which exhibited signs of being heat affected) and had brick sides, capped with sandstone slabs (**2521**; Plate 40). The flue did not go straight into the chimney; instead, a raised brick column filled with clay suggested that the flue was angled up into a hole (subsequently bricked up) in the south side of the chimney.

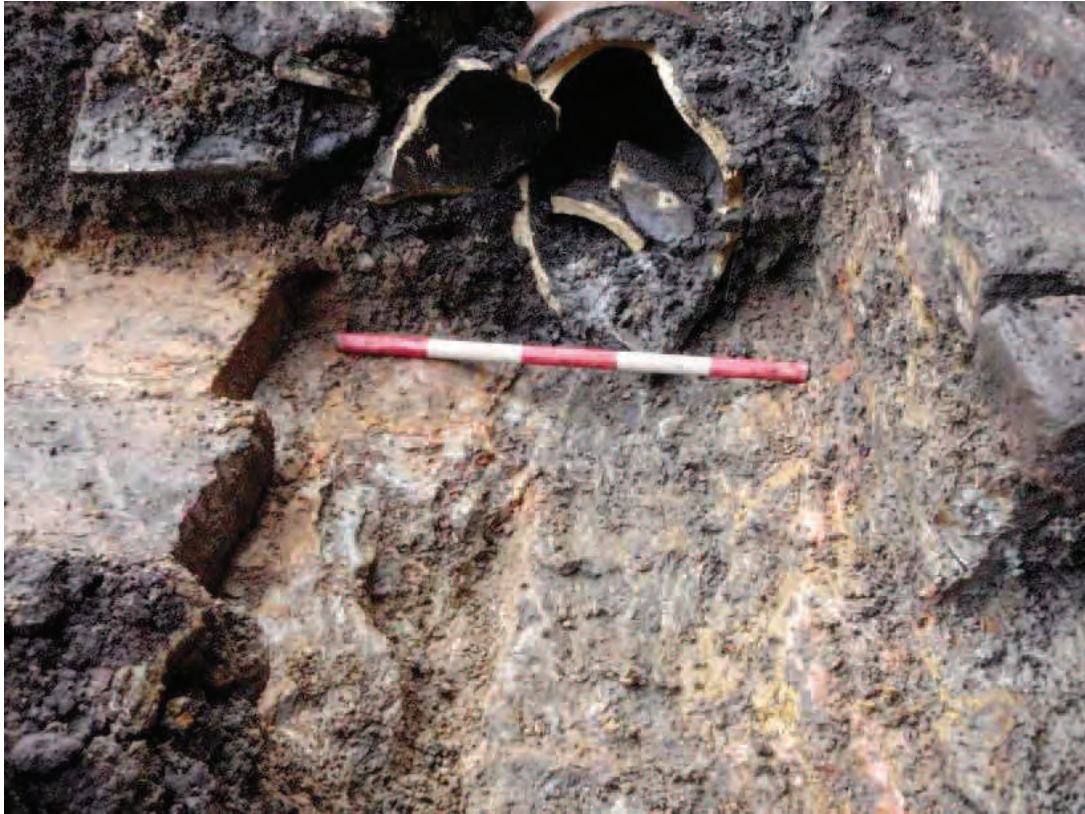
Plate 40: South-facing view of flue **2520**, later sewer pipe within

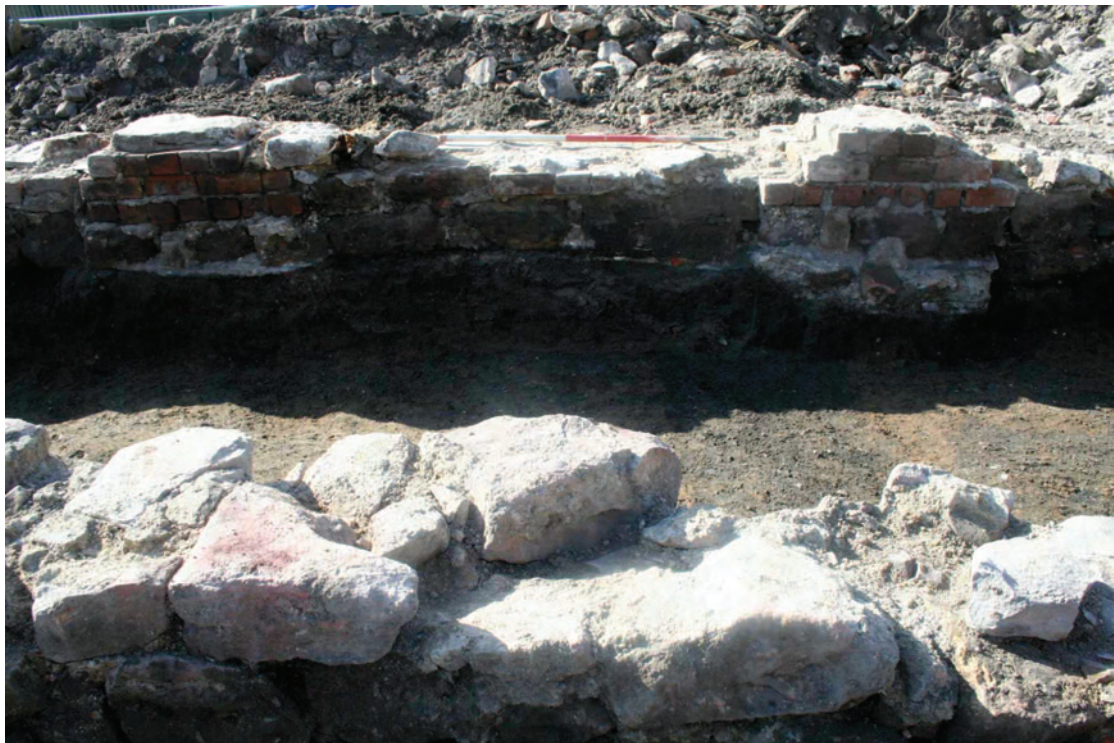
Plate 41: North-facing elevation of wall **1020** showing inserted brick column bases **1023** and **1024**

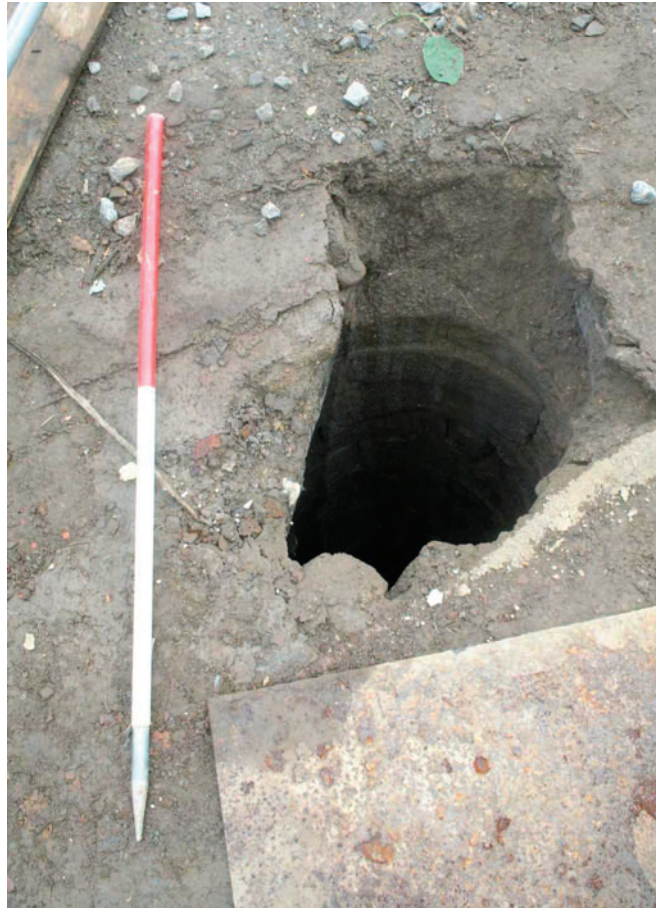
Plate 42: Sandstone-lined well 530

- 4.8.2 Well **530** (measuring 8-9m deep) with an aperture of 0.8m, was identified at the western limit of excavation and was found to be constructed of neatly shaped curved sandstone blocks (Plate 42). Without further investigation it is not possible to accurately phase this structure (which is absent from historic mapping) but the presence of a possible cistern room (Room 8A) attached to the western side of the central range, between the well and the warehouse, might indicate that they were contemporary in their use, if not necessarily their origin. It is also possible that the well pre-dates the Soapery and acted as a principal water source for the gardens and the allotments which occupied the site prior to 1799. This same well was later covered and forgotten during the occupation of the yard by the Hanratty family.

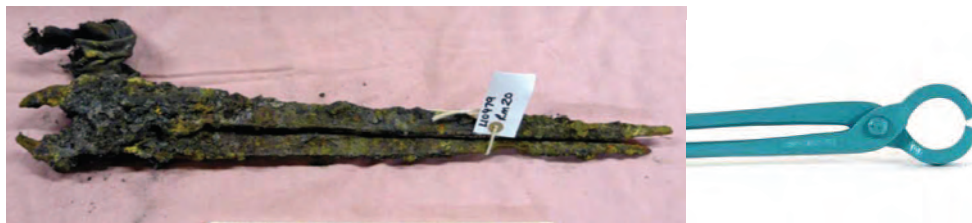
Plate 47: Possible bow tongs, with fragments of coarse fabric adhering to corrosion products on one side (marked scale 300mm)

the material (56 objects), is generally poorly preserved ironwork which has not been x-rayed. The site was at some point thought to have been associated with metal recycling, and much of the ironwork can therefore be regarded as of little significance in charting its development. Nonetheless, three large iron objects were recovered in relatively good condition during the watching brief on the western range. All three can be associated with secondary iron-working: two (Tools 1 and 2) are clearly intended for working hot metal, used for shaping and possibly cutting hot iron in the course of the production of other iron objects, the third (Tool 3) is a pair of tongs, used to hold or transport metal hot objects during their production.
