St Dunstan's Church Cranford Park London Borough of Hillingdon

Archaeological Watching Brief Report

Document Title: New Vestry, St Dunstan's Church, Cranford Park, Hillingdon

Document Type: Archaeological Watching Brief Report

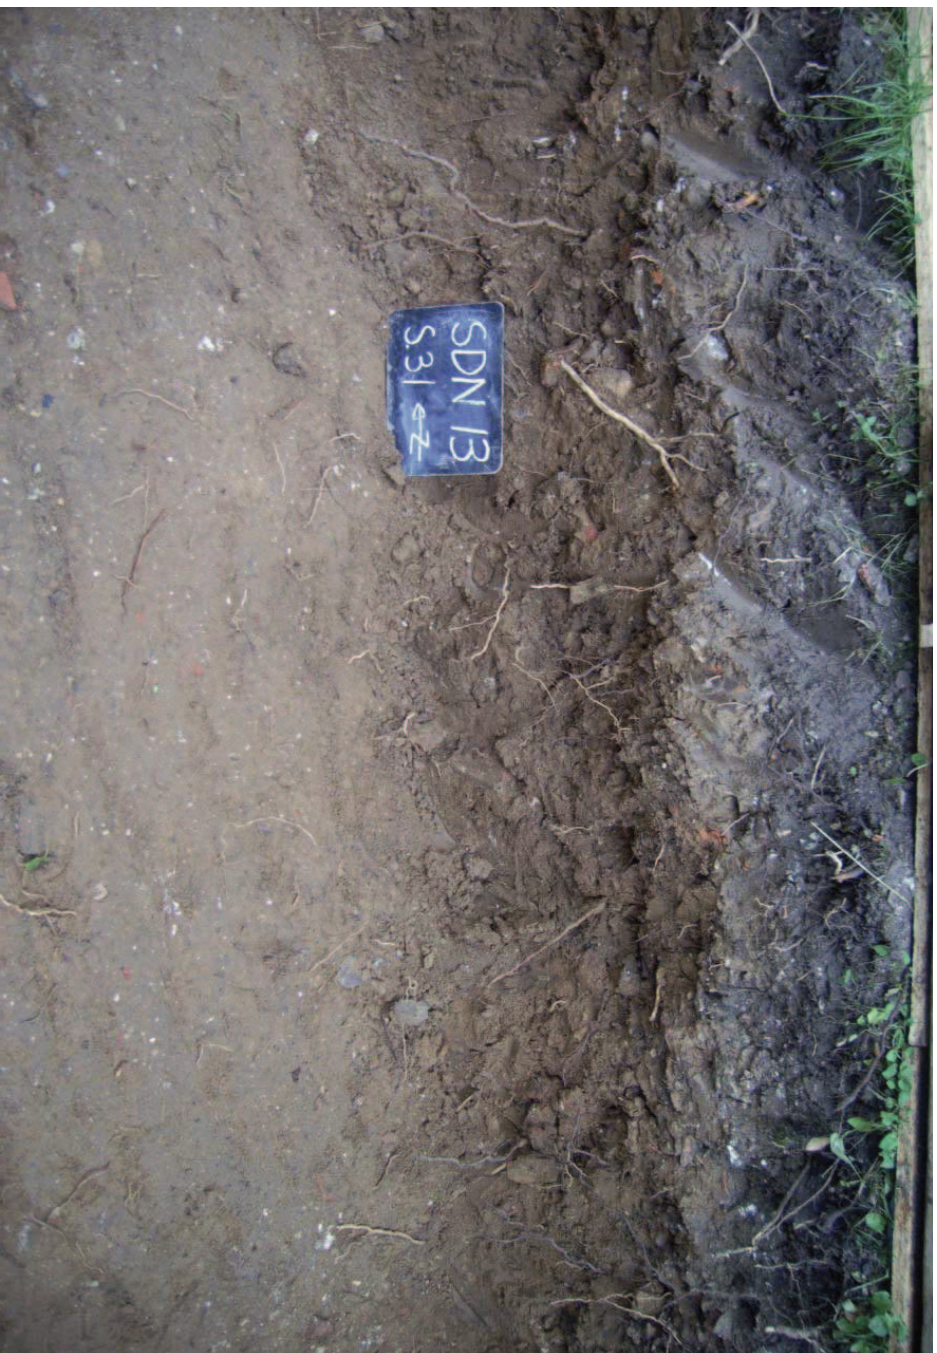
Plate 1: Section 31

- 3.1.14 Exposed throughout the base of the reduced area was a dull orange-brown silty clay (36). This was same as layers 14 and 23 recorded within the test pits. Exposed within the surface of this deposit were several east-west aligned rectangular grave cuts (Fig. 3 and Fig. 4, Section 31). These varied from 0.55m to 0.75m in width and 1.6m to 1.8m in length. The features were similar and a sample description can be applied to all. The

feature (38) could be seen to have vertical sides and to be in excess of 0.3m in depth (Fig. 3 and Fig. 4, Section 31). Backfilling it was a grey-brown clayey silt containing angular fragments of red roof tile and gravel inclusions (37).

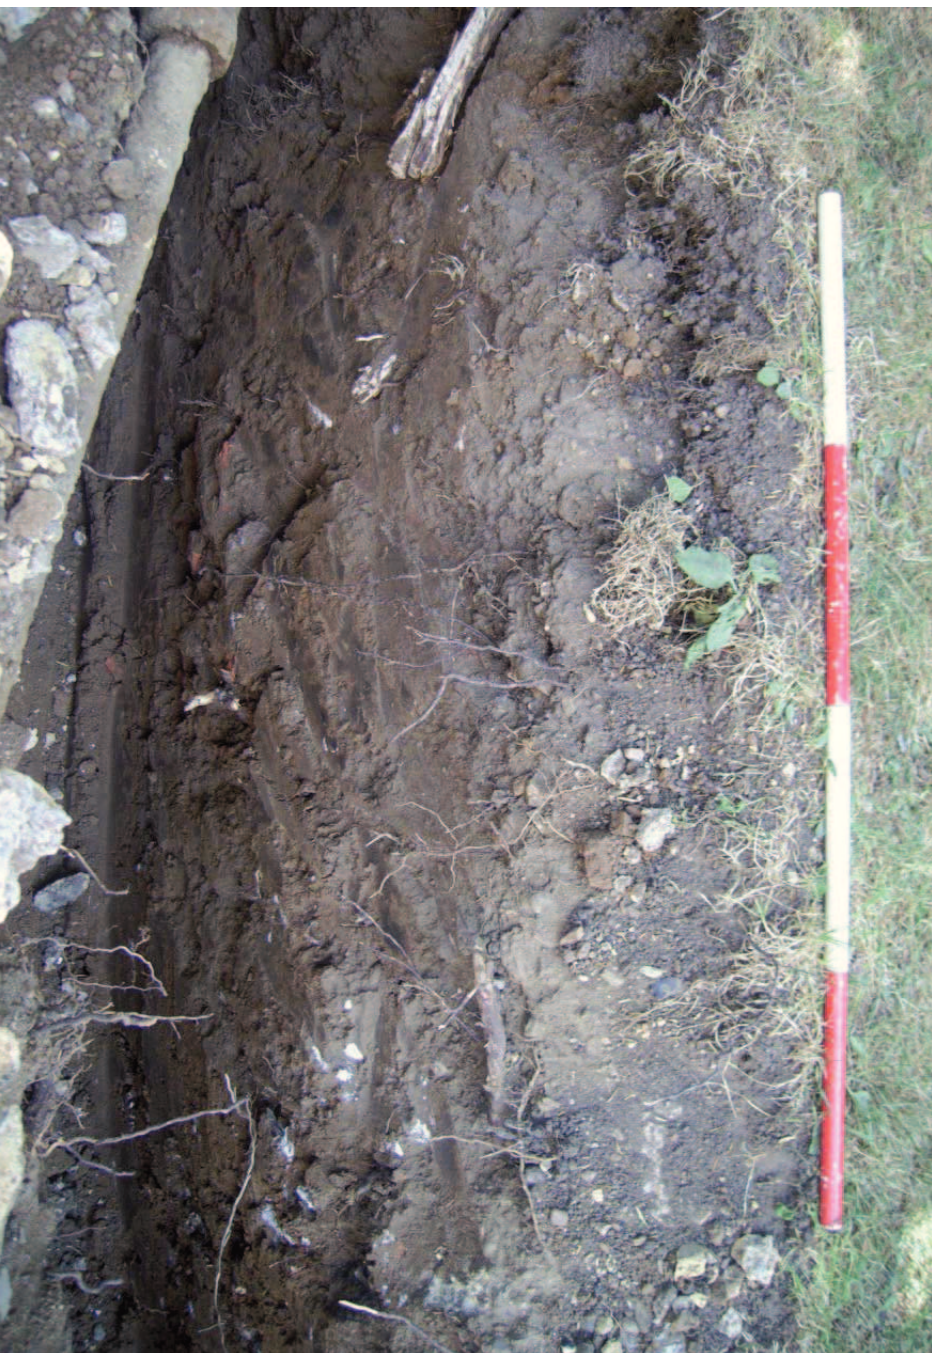
Plate 2: Section 33

- 3.1.25 The dark orange-brown silty clay (36) was exposed within the base of the trench along its length (Fig. 4, Sections 32 and 33), with depths in excess of 0.45m being recorded. Above layer 36 was a continuation of the lighter orange-brown silty clay, 35, measuring between 0.25m and 0.3m in depth.

- 3.1.27 Elsewhere layer 35 was overlain by a 0.1m deep layer of grey-brown clayey silt loam mixed with angular pieces of broken stone and tile. This is similar to and a probable continuation of layer 34 (Section 33).

- 3.1.28 A 0.22m deep layer of the present day topsoil and turf, 33, completed the section.
