Cranwell Booster Station Byard's Leap, Sleaford Lincolnshire

Archaeological Watching Brief Report

OA East Report No:1484

Date of Works: April-June 2013

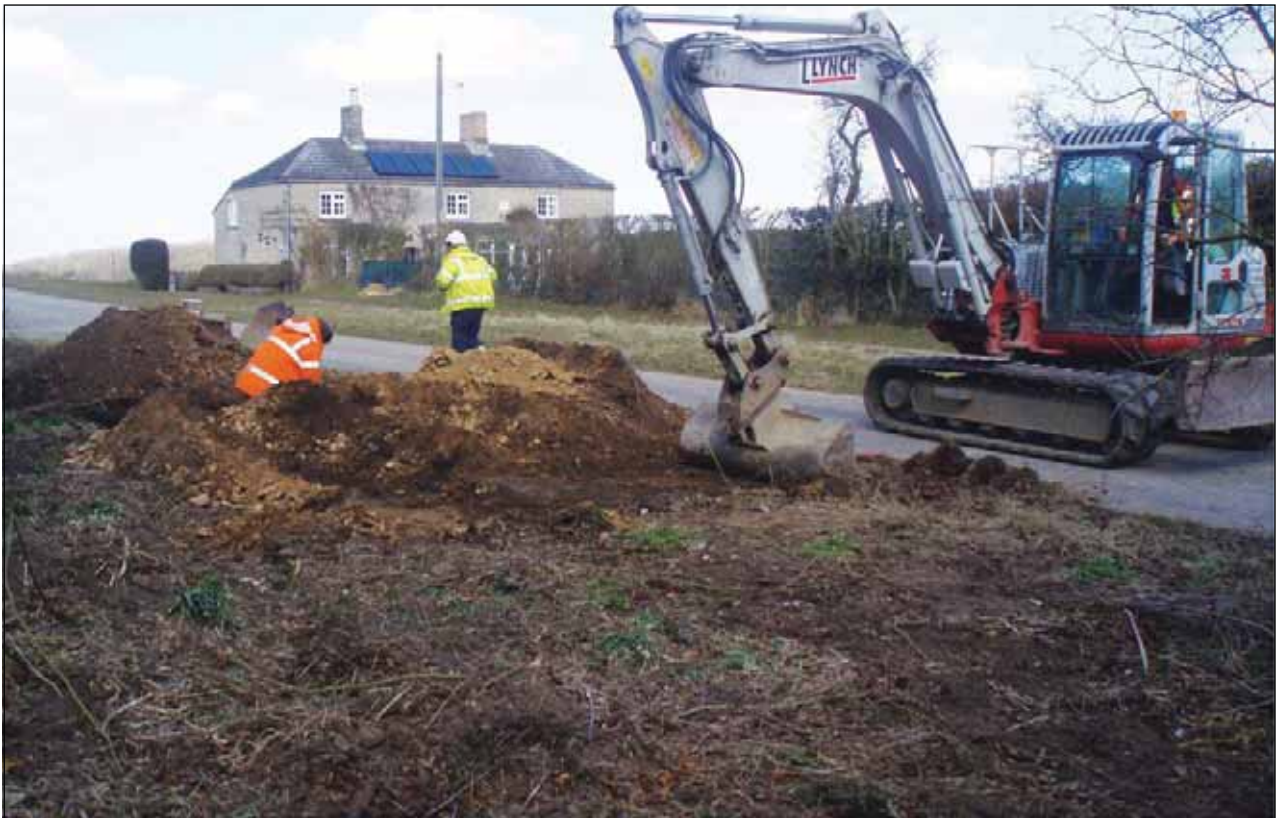
- 4.2.1 Two 4m x 1.6m trenches were excavated immediately to the west of Ermine Street to expose existing water main pipes. The only deposits encountered were 'made ground', the backfills of pipe trenches associated with the water main. Much of the made ground comprised of limestone rubble.

Plate 1: Trench 1 and 2 excavations

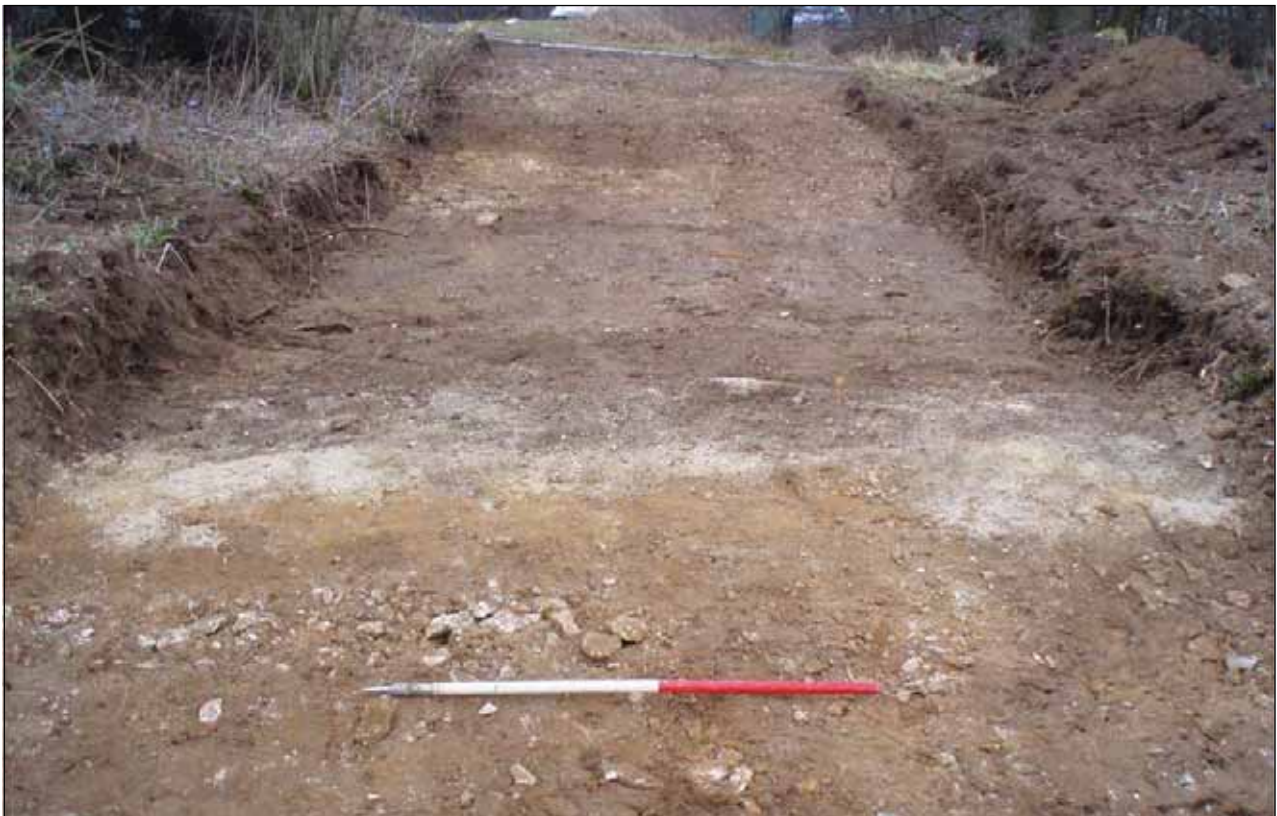
- 4.3.1 Trench 3 comprised a topsoil strip (1) for the compound area to the east of the Roman road, and over the access road to the compound. The access road lead west from the compound area onto the Roman road. Only weathered natural limestone (8) was

encountered in the eastern part of the strip (the compound). A wall (**5**) was encountered running north to south along the current eastern boundary of Ermine Street / High Dyke. This was built of limestone blocks (4). Its now ruined extent could be seen extending on the surface to both north and south (see Fig.2). Immediately to the east of this wall, between it and the natural limestone, two thin deposits were encountered, extending 0.75m to the east. This comprised a reddish brown sand (7) overlain by yellowish brown limestone fragments (6) of 0.08m and 0.12m thickness respectively. The base of these deposits lay at 70.79m OD. To the west of the wall modern made ground was encountered (3) overlain by modern hardcore (2) raising the ground level at the western end of the strip for the modern tarmac track.

Plate 2: Trench 3 looking west with Roman Road deposits in foreground

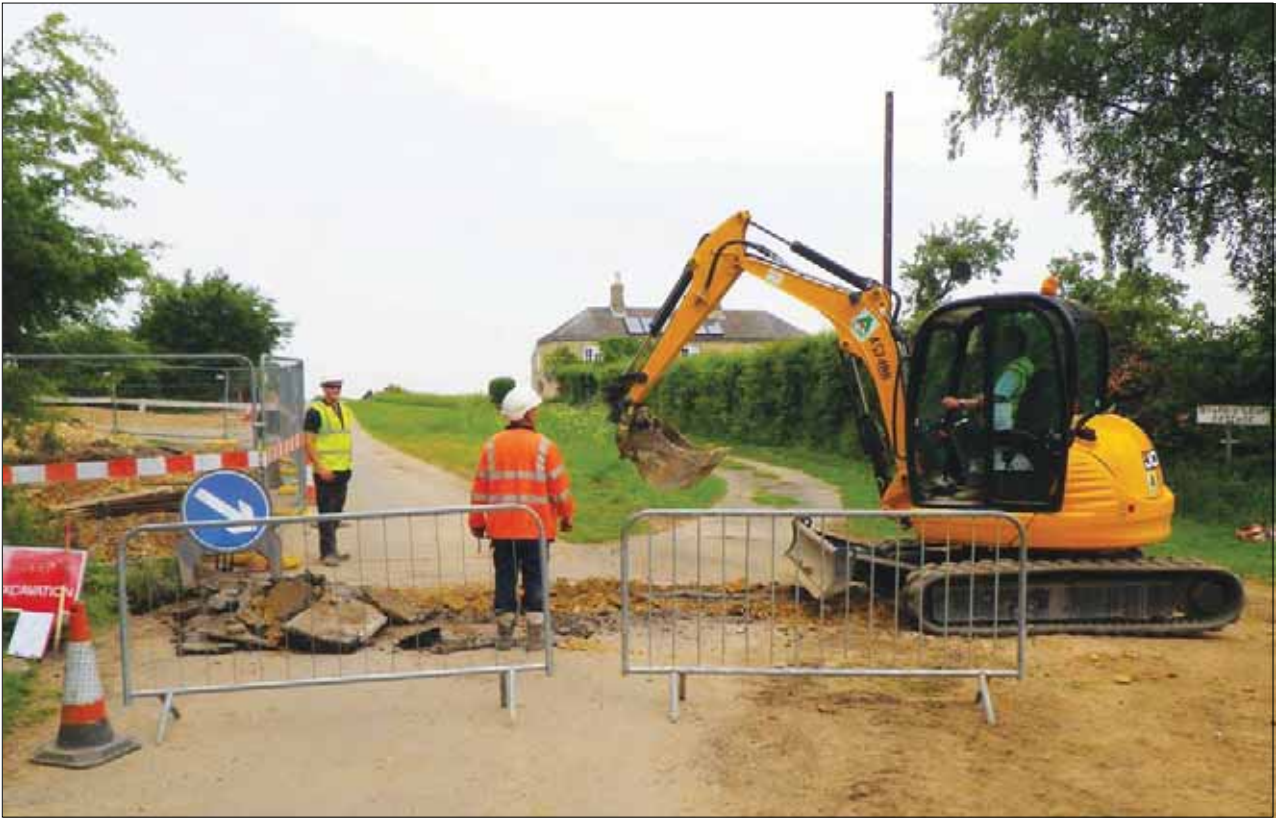
- 4.4.1 Trench 4 comprised a 0.45m wide and 0.8m deep excavation across the line of Ermine Street to connect the work in trench 1 and 2 with the compound. Natural limestone (15) was encountered at a depth of 0.6m below ground level (71.79m OD). This was overlain by Limestone rubble with a reddish brown sand (14), 0.3m thick, under a thin 0.05m thick horizon comprised of greyish brown sand with frequent rounded to angular gravels (13). This was overlain by limestone rubble (12) 0.08m thick. These deposits were truncated on the western side by the cut **11** of the existing north-south water main, backfilled with limestone rubble (10). This section was surfaced by tarmac (9).

Plate 3: Trench 4 looking north
