New Playing Fields and Athletics Track Stowe School Buckinghamshire

**Archaeological Watching Brief**

July 2009

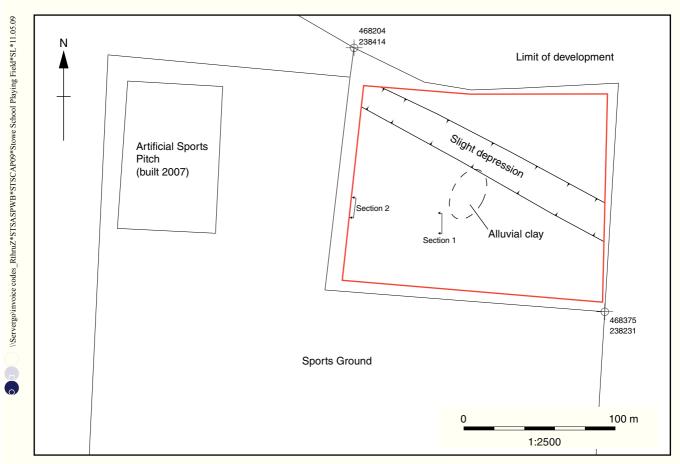
Figure 2: Plan of new playing field

3.1.1 This area measured approximately 170 m by 170 m and was previously used as arable farmland (Fig. 2). There was a general gentle underlying slope towards the north-east. A shallow dip approximately 40 wide and 1 m deep ran south-east to north-west across the site. No other features were visible prior to stripping.

- 3.1.2 The underlying natural, a light yellow-brown sandy silt clay (3), was encountered throughout the area at a depth of between 0.2 m and 0.3 m below the original ground level. This layer represents the underlying natural glacial deposits. Within the centre of the site it was overlaid by an area of blue-grey clay (2), of unknown depth. This material is a probable lens of glacial deposits. A series of land drains composed of both machine-extruded ceramic pipes and plastic piping could be seen cut into the surface of these layers. In areas the ceramic drains were visibly disturbed and broken in the surface of the glacial deposits (these were old fractures, not due to this phase of activity). No other features were observed cutting into these deposits. Sealing 2 and 3 was a grey orange-brown silt clay loam (1) measuring between 0.2 m and 0.3 m in depth. Many fragments of red ceramic land drain were observed within this context. This layer represents the current ploughsoil. No intervening subsoils or earlier plough soil were observed between the ploughsoil and the natural, this combined with the disturbance to the ceramic land drains suggests that deep (modern) ploughing has occurred throughout the area.

- 3.1.3 At the western edge of the site the ploughsoil (1) was overlaid by a 0.25 m deep lens of light reddish brown silty clay (4). This material was very mixed, with lenses of buried topsoil and turf visible within its make up. It is probable that this deposit represents the surplus material from the excavation for the artificial pitch in 2007 spread out over the western edge of the development area. This lens was sealed below a grey-brown clay loam (5), a landscaping layer of redeposited topsoil, also presumably from the 2007 excavations.

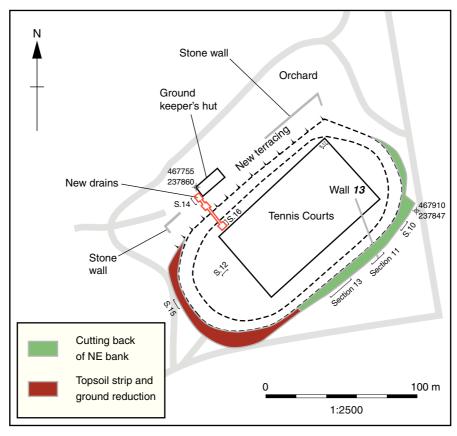
Figure 3: Plan of athletics track

3.1.9 The bank was cut back approximately 5 m exposing a face measuring 2.7 m high at the north-eastern corner tapering down to the west and south (Figs 3 and 4, sections 10, 11 and 13).

3.1.19 Within the centre of the running track the concrete and tarmac tennis courts, together with the long jump and high jump pits, were removed, the ground was reduced in depth in areas and an access chamber for the rainwater run-off excavated (Figs 3 and 4, sections 12, 16 and 17).

- 3.1.20 This was located at the south-western end of the track (Fig. 3) and was exposed during the reduction of the ground level.
- 3.1.21 The natural red-brown sandy silt (18) was encountered at a depth of 0.6 m below the original ground level. This was overlaid by a 0.2 m deep layer of grey-brown silt loam (21), a buried soil horizon, probably the original topsoil layer prior to the construction of the athletics track.
- 3.1.22 Overlying layer 21 was a 0.2 m deep layer of red-brown silt clay (20), a layer of made ground associated with the construction of the athletics track. This was sealed by a 0.2 m deep layer of redeposited topsoil (19), a landscaping layer.

- 3.1.23 Section 16 was located at the western edge of the inside of the running track (Fig. 3) and was exposed during the excavation of the access chamber and a trench running across the running track.
- 3.1.24 The underlying natural (18) was encountered at a depth of 1.4 m below the current ground level. This was overlaid by a 0.35 m deep layer of grey-brown silt loam, a probable continuation of the buried soil horizon (21). This deposit sloped noticeably down to the north-east, probably reflecting the original topography of the ground prior to the construction of the athletics track.
- 3.1.25 This was sealed by a 1.15 m deep layer of made ground, a continuation of layer 20. A 0.2 m deep continuation of the landscaping layer 19 completed the section.

3.1.26 This was located at the north-western corner of the tennis courts (Fig. 3), and was exposed when the tennis courts were broken out.

3.1.28 In order to widen the track, a small bank running around the southern curve of the track was cut back after the felling of a yew tree (Section 15) and a deep soakaway pit was dug on the lower edge of the terrace (Section 14 and Fig. 3).

- 3.1.31 This was excavated at the base of the terrace forming the western edge of the athletics track adjacent to the groundkeeper's building, measured 2 m by 2 m and was excavated to a depth of 3.3 m (Fig. 3).

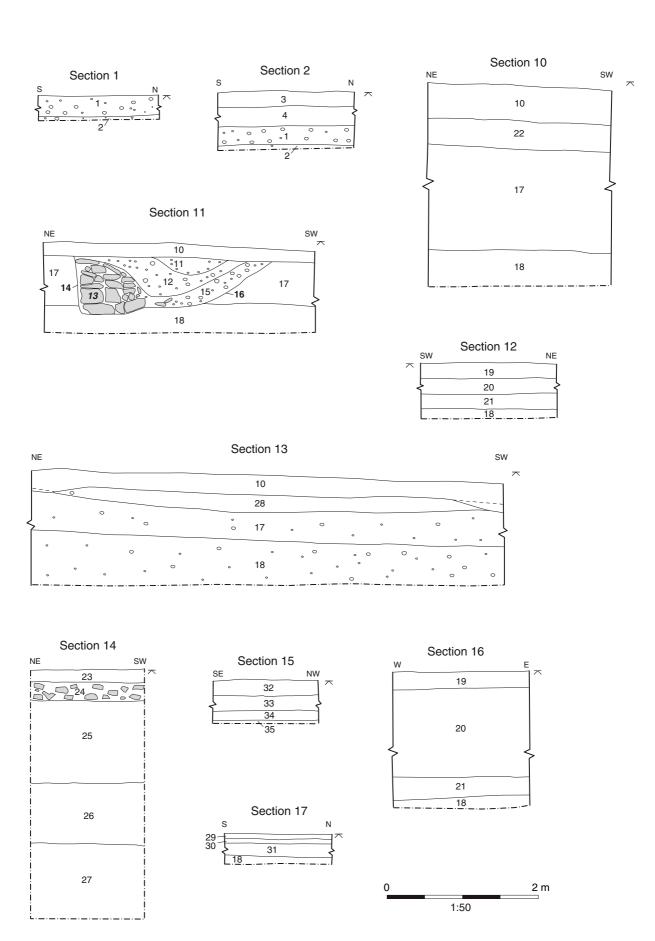
Figure 4 : Sections

- 3.1.10 A layer of dull orange brown sandy silt clay (18) was observed at the base of the section. This contained many small rounded pebbles and could be seen to be in excess of 0.5 m deep. This was overlaid by a 1.4 m deep layer of reddish brown silt clay containing many sub-angular river flints (17). This deposit was very clean and represents a layer of colluvium. Overlying this was a 0.3 m deep layer of dark redbrown sandy clay silt (22), also a probable layer of colluvium.
- 3.1.11 Layer 22 was sealed by a 0.4 m deep layer of grey-brown clay silt loam (10). This is a probable layer of landscaping material.

- 3.1.12 A continuation of the natural orange-brown sandy silt (18) was observed at the base of the section. This was overlaid by a 0.6 m deep continuation of the red-brown colluvium (17). Cut into this deposit was a 2.6 m wide by 0.7 m deep ditch (16) running approximately north-south across the site. Cut into the northern edge of the ditch and also cutting layer 17 was a 0.75 m deep by 0.8 m wide foundation trench (14).

- 3.1.13 A dry stone wall (13) was built within cut 14 using rough-dressed limestone forming a revetment along the northern edge of the ditch. The wall could be traced running in a straight line across the northern part of the site before being buried under made ground. The ditch and wall are suggestive of a ha-ha, although they may also form a boundary wall and associated ditch.

- 3.1.14 It would appear that the ditch was backfilled as part of a later landscaping scene. The southern edge of wall 13 seems to have been partially dismantled (or collapsed) with fragments of stone appearing in section south of the wall. The base of the ditch and the southern face of the wall were sealed by a 0.2 m deep layer of red-brown silt clay (15) containing many fragments of limestone similar to that used to construct wall 13.

- 3.1.15 Overlying this was a 0.5 m deep layer of red-brown clay silt (12). Filling the top of the ditch was a small lens of dark yellow-brown clay silt (11), measuring 1 m wide and 0.2 m deep. (It is probable that both 12 and 11 had been truncated as part of the terracing when the athletics track was originally constructed.)

- 3.1.17 The natural (18) was exposed in the base of this section, overlain by a 0.4 m deep continuation of the red-brown colluvium (17). Laid directly onto this layer was a 5.6 m wide by 0.2 m deep band of dark yellow gravel in a clay matrix (28). The composition of this material suggests that it may have been a path.
- 3.1.18 Sealing this deposit was a 0.25 m deep continuation of the landscaping layer 10.

3.1.27 A continuation of the underlying natural, a red-brown clay silt (18) was encountered at a depth of 0.28 m below the current ground level. This was overlaid by a 0.18 m deep layer of crushed stone (31). Overlying this was a 0.05 m deep layer of concrete (30), forming a base for the 0.05 m deep tarmac tennis court surface (29).

- 3.1.29 A patchy layer of yellow-brown gravel (35), in excess of 0.05 m deep, was exposed both within the section and in the surface of the exposed ground. This deposit is very similar to layer 28 within section 13 which has been identified as a possible path. This layer ran in a general south-east to north-west direction but no positive edge could be established.
- 3.1.30 This was sealed by a 0.13 m deep layer of light orange brown sandy clay (34). This is a probable layer of made ground forming a bank around the southern end of the track. Overlying this was a 0.2 m deep layer of dark orange-brown silt clay (33), another layer of made ground. The bank was covered with a landscaping layer of grey-brown silt loam (32), 0.2 m deep.

- 3.1.32 At 2.3 m below the current ground level a layer of stiff pale brown clay (27) was encountered. This deposit became increasing more grey with depth, changing to pale grey at the base of the section. This was overlaid by a 0.8 m deep layer of very pale pinkish brown sandy silt clay (26). Overlying this was a 1.1 m deep layer of light redbrown sandy clay silt (25). All these layers were natural deposits.

- 3.1.33 Sealing layer 25 was a 0.25 m deep layer of mid brown clay silt (24). This contained numerous fragments of a hand moulded brick measuring 0.224 m x 0.109 m x 0.07 m. This may have originally formed a layer of hard standing outside the groundkeepers building. Overlying this was a 0.15 m deep layer of grey-brown silt loam (23), probably material washed down off the terrace and over the hardstanding.

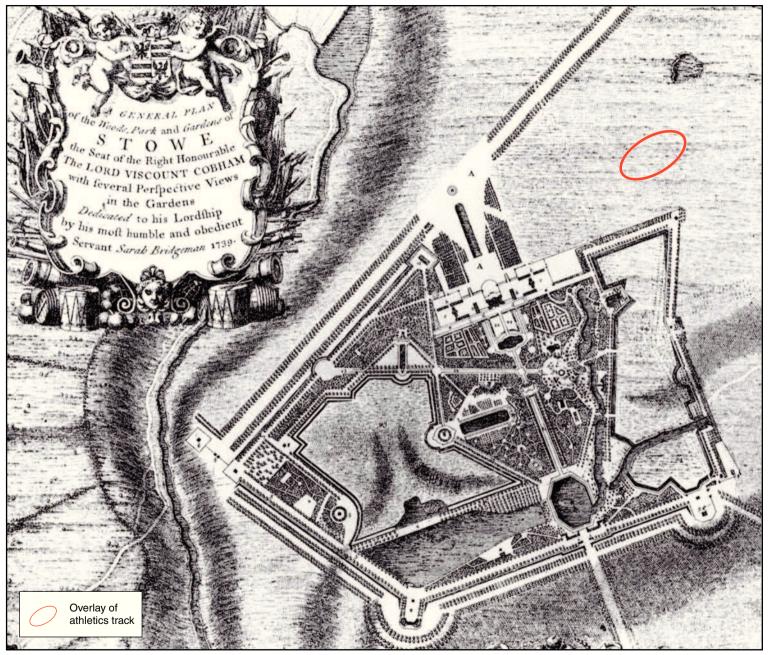
Figure 5: 1739 Plan of Stowe Gardens

- 4.1.5 The location of the track was superimposed onto key plans of the gardens (Figs 5, 6 and 7).
- 4.1.6 In Sarah Bridgeman's plan of 1739 (Fig. 5) the athletics track is located in open land north-east of the house, with no evidence of any landscaping.

- 4.1.4 The provision of a map regression of Stowe Gardens by Gary Marshall, the National Trust's resident archaeologist, allowed the impact of the athletics track on the earlier gardens to be accessed.
