WORSLEY METHODIST CHAPEL AND SCHOOL, BARTON ROAD, WORSLEY

Historic Assessment Report

Oxford Archaeology North

February 2015

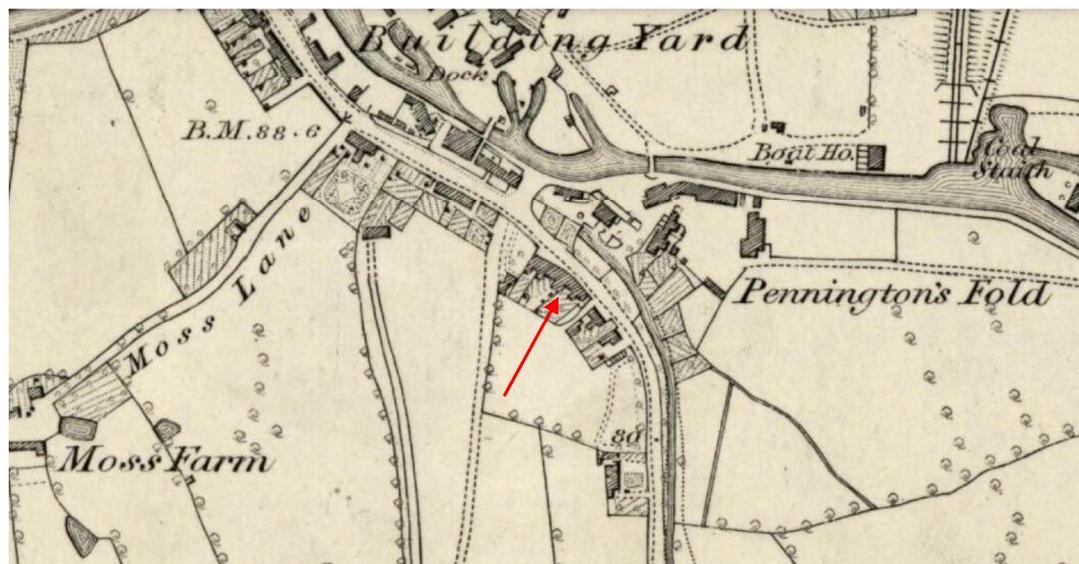
Plate 2: OS first edition 1:10,560 map (1848)

- 3.3.1 **1848 1:10,560 OS map:** the first edition OS map of 1848 (Plate 2) showed a development of buildings on the south side of Barton Road on, what was seen in an earlier 1799 map (Salford City Council 2007, Map 4) as, Mr Bagot's Land (the writing for Bagot is unclear (Hassall 2000, 25, 11). This development appeared to have been a row of cottages fronting Barton Road with extensions or porches to the rear, and gardens, and the old chapel occupying a plot here (*ibid*). Antecedents of Methodist chapels were often found in cottages or reading rooms and as congregations increased and funds were raised purpose-built chapels could then be constructed (Jobson 1850). The present-day Worsley Methodist Church is on a plot east of Granary Lane and was probably on the site of the 1801 chapel. On this map was marked the Bridgewater Canal, and the Building Yard, Dock and Boat House, which are all north of Barton Road.

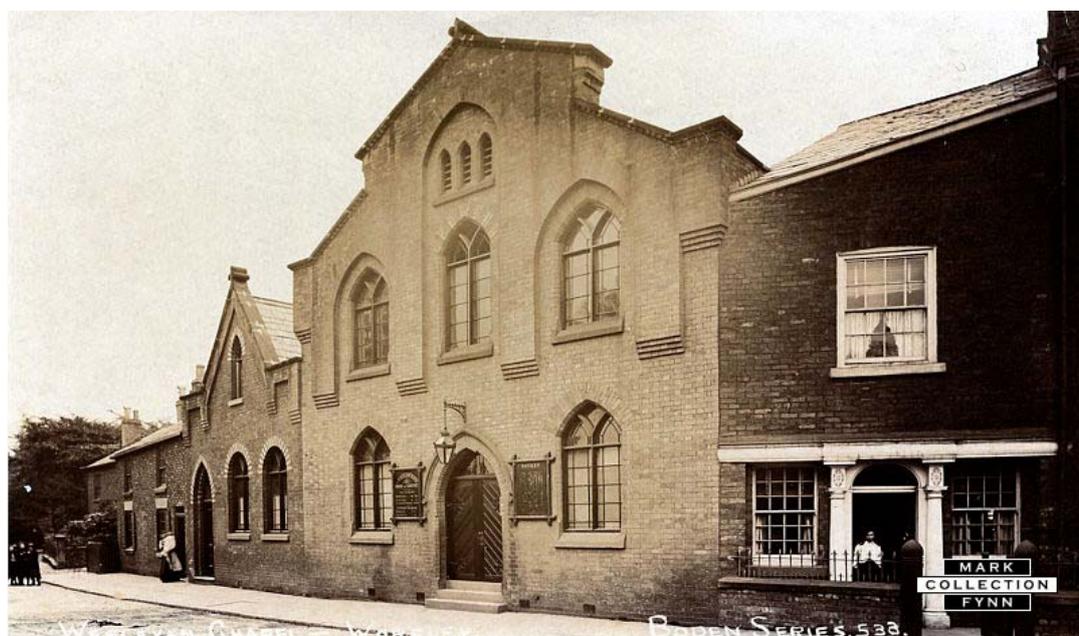
Plate 9: undated photograph (perhaps early twentieth century) from Mark Flynn Collection (www.manchesterpostcards.com)

3.3.15 **Undated photograph:** an undated photograph (Plate 9), which was perhaps dated to pre-World War I or the turn of the century, showed the facade of the chapel and adjoining building. There had been changes to the building to the west of the chapel: the open alley or passageway seen on the photograph of 1889 has now been replaced by a new window (Mark Flynn Collection).

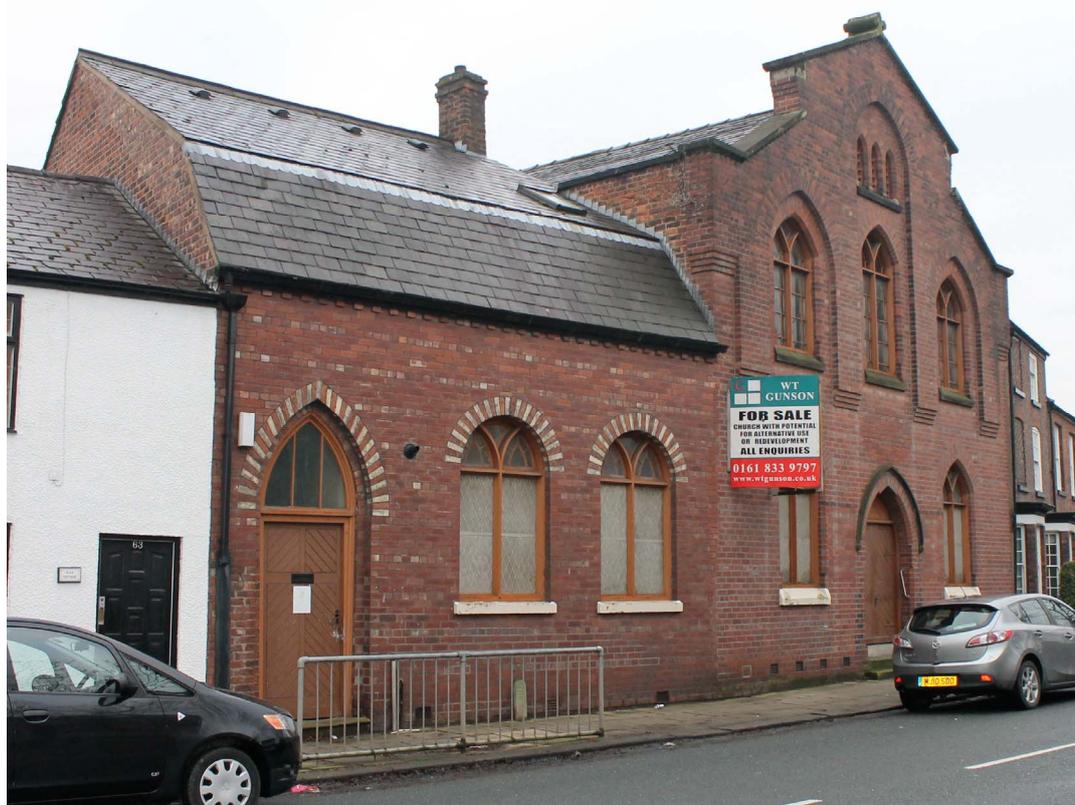
- 3.3.20 **Photograph of 2015:** a present day photograph (Plate 12) shows that the roof of the adjoining building to the church (referred to as a Sunday school in the Locally Listed Heritage Assets), had been rebuilt again as a Mansard roof. The front elevation of the church seems to have been unaltered.

Plate 12: General view of the chapel taken during the present survey

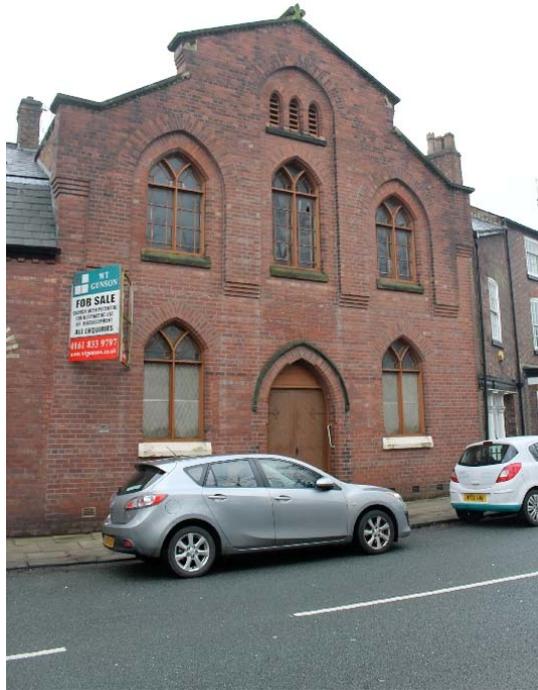
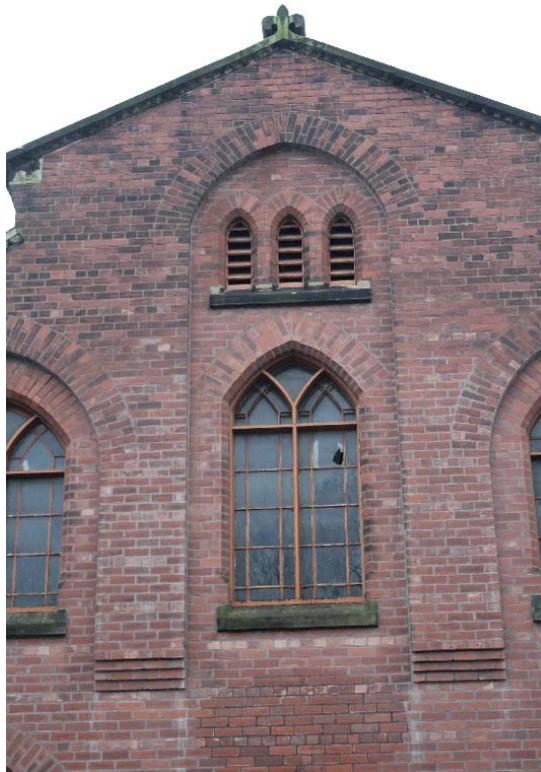
Plates 13 and 14: Northern elevation of chapel, with a detail shot of the central first floor bay to the right

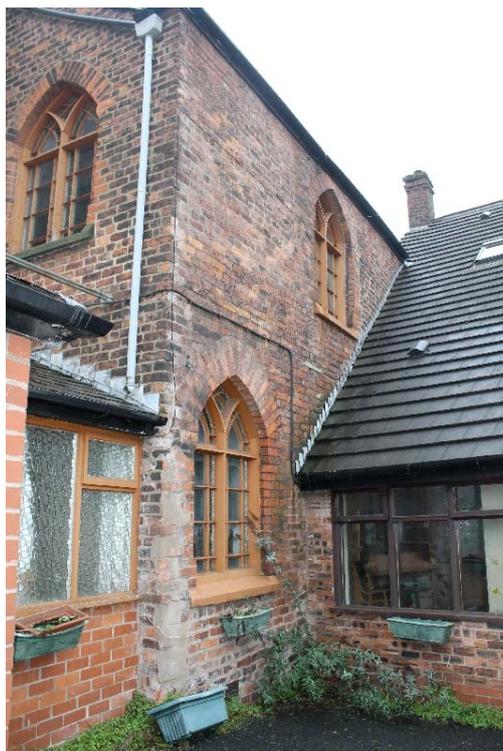
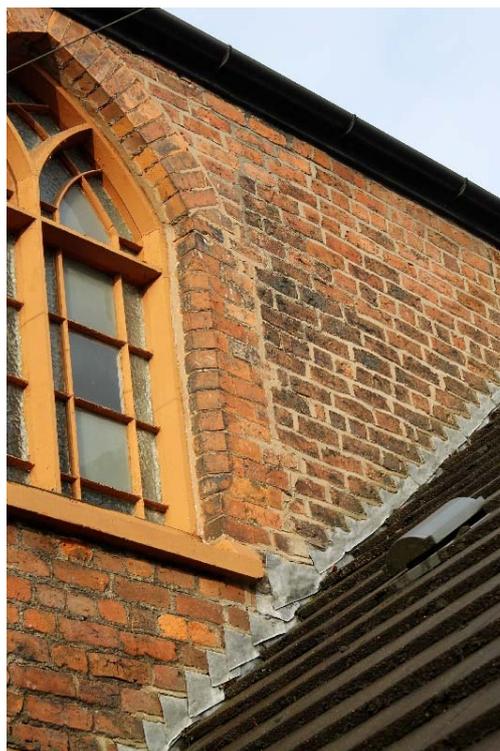
Plates 15 and 16: Eastern elevation of chapel, with Sunday school to the right of frame. The probable construction joint to the right of the window is visible in the photo to right; the joint coincides with a slight change in the character of the brickwork

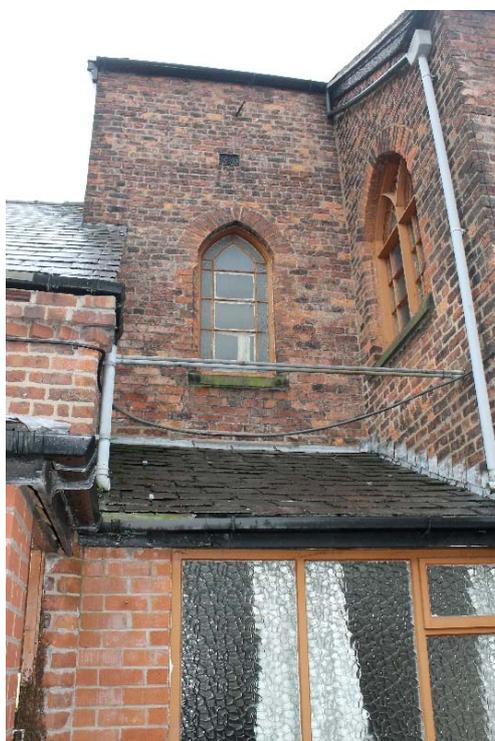
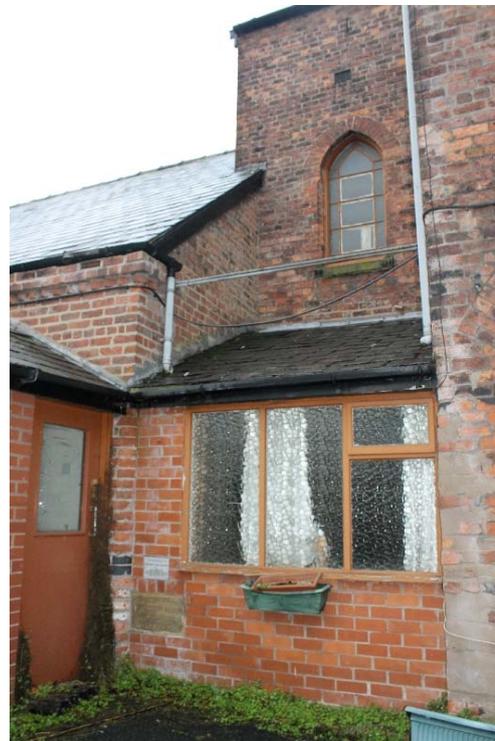
Plates 17 and 18: The first floor window on the eastern elevation of the square cell at the southern end of the chapel. The window to the right lights the gallery of the chapel. The photograph to the right shows the modern vestry extension

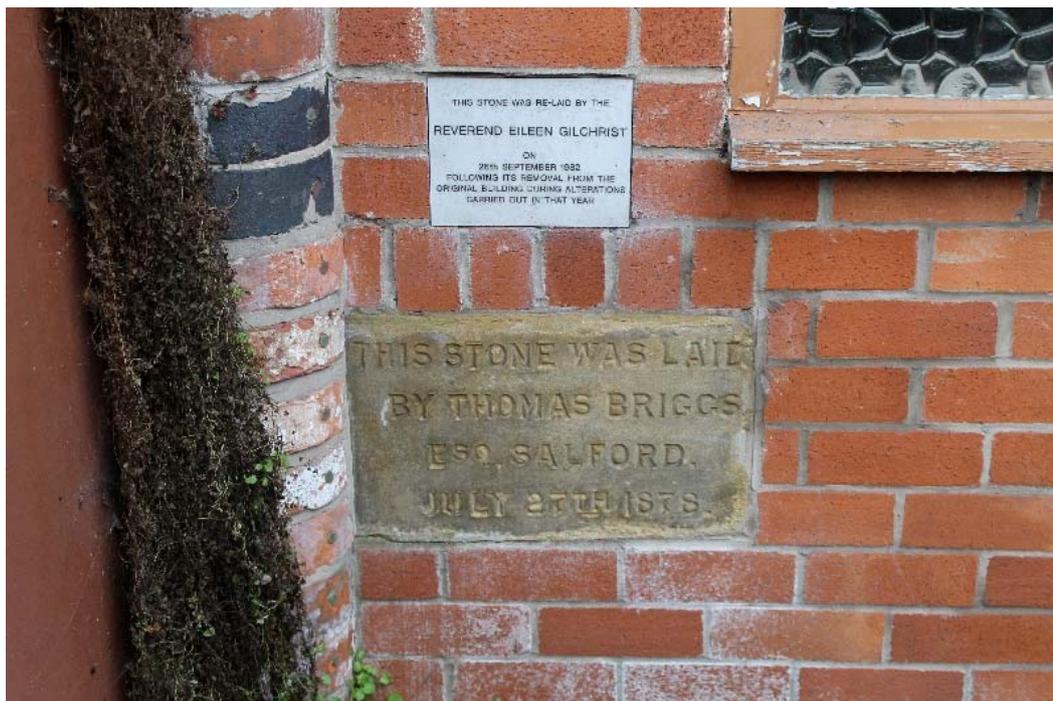
Plate 19: The repositioned foundation stone on the eastern wall of the single-storey vestry extension

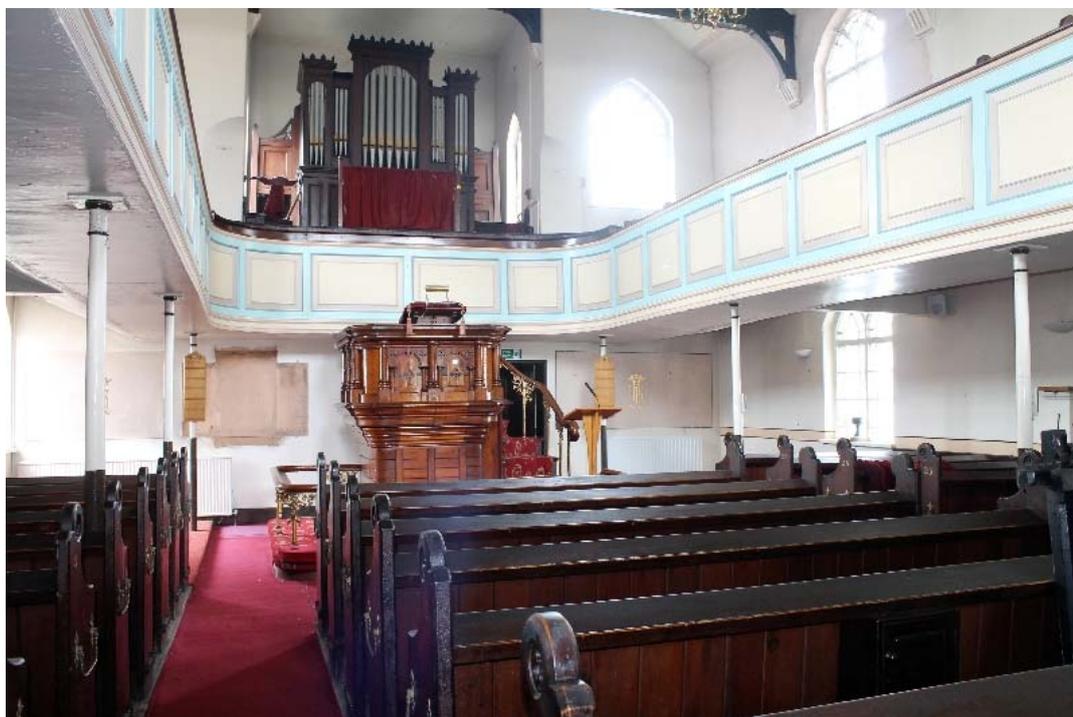
- 4.2.4 **Internal Appearance:** internally, the chapel walls and ceiling were painted white, with a narrow mid height cream border painted along the eastern and western walls (Plate 20). Three sets of south-facing wooden pews, with aisles between, divided the building into thirds across its width. The pulpit lay at the southern end of the floor, accessed via a set of timber stairs and a doorway in the southern wall behind and to the west of the pulpit led into the projecting square cell (Plate 21). At the northern end of the building a flight of stairs in the eastern corner was mirrored by another in the western corner, both rising through a quarter turn to the four-sided first floor gallery (Plate 22). A timber partition to the north of the central doorway in the southern wall created a vestibule area, with access to the main room through doorways at the eastern and western ends of the partition.

Plate 20: The interior of the chapel facing south

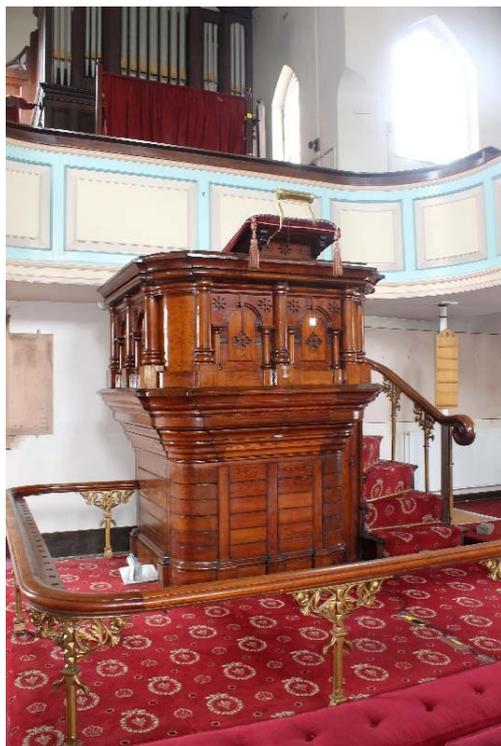
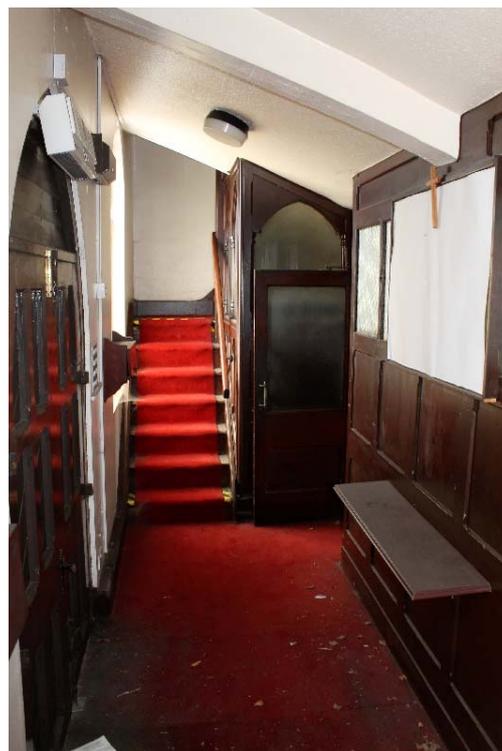
Plates 21 and 22: The pulpit at the southern end of the chapel with stairs to the right of frame. The right hand photograph shows the northern vestibule with the eastern staircase upto the gallery. The main entrance into the building can be seen to the left of frame

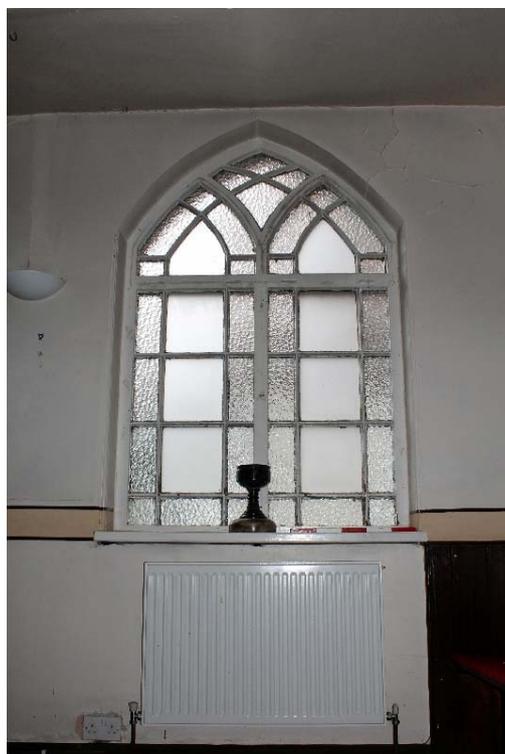
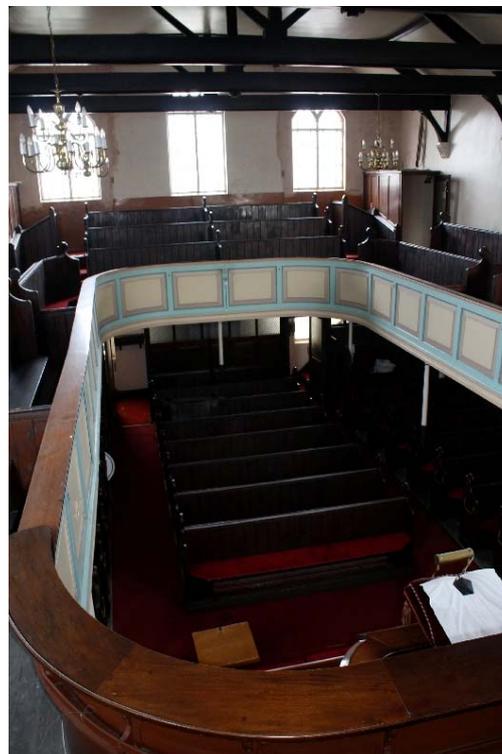
- 4.2.5 A doorway toward the northern end of the eastern wall gave access between the chapel and the Sunday school building, while at the southern end the ground floor window, described externally, lit the pulpit area. Another window towards the southern end of the opposing western elevation had not been observed externally due to access restrictions but was of a similar form (Plates 23 and 24).

Plates 23 and 24: The chapel window at the southern end of the western wall, facing west (0.5m scale). The right hand image shows the chapel from the first floor gallery, looking north

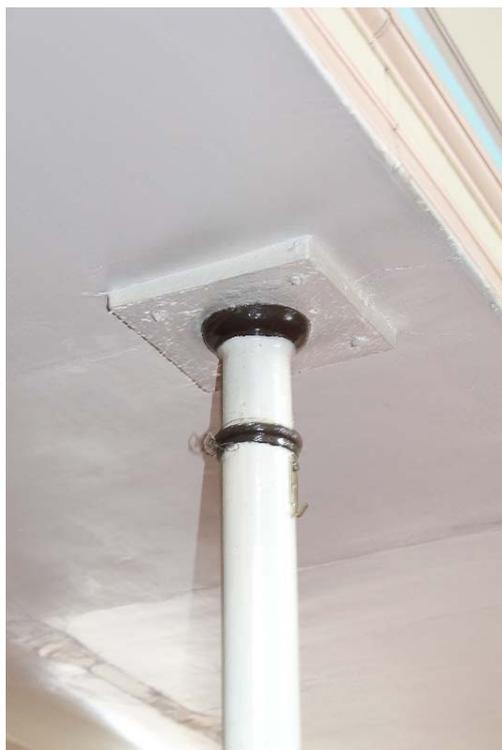
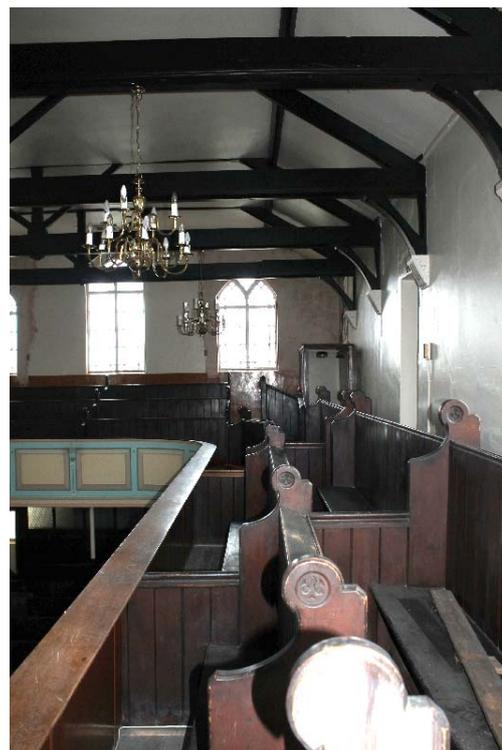
Plates 25 and 26: The capital of a cast iron column supporting the gallery above. The right hand image shows the ramped pews along the eastern gallery looking north

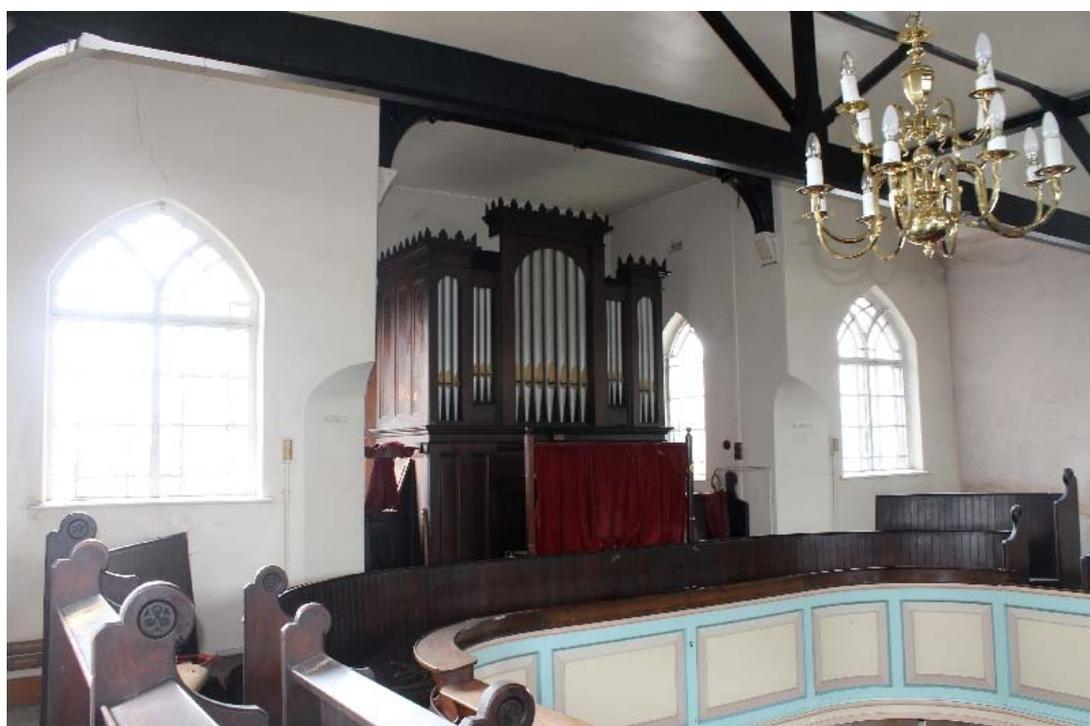
Plate 27: The southern end of the chapel at gallery level, showing the pipe organ to the centre

Additionally, the provenance of the organ may contribute considerably to the heritage value of the building and its inspection by an appropriate specialist could help determine its significance. Any proposal to demolish any of the structures should be accompanied by an historic building survey as mitigation against the loss of historic fabric.

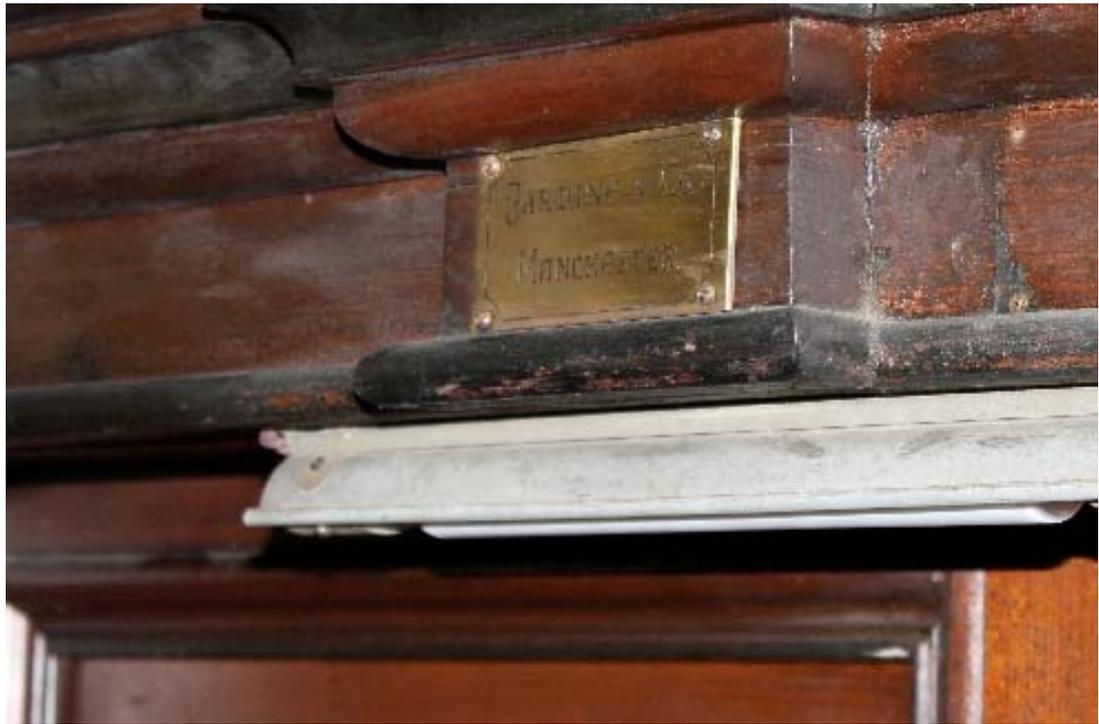
Plate 28: A name plate screwed to the front of the organ: 'Jardine and Co Manchester'

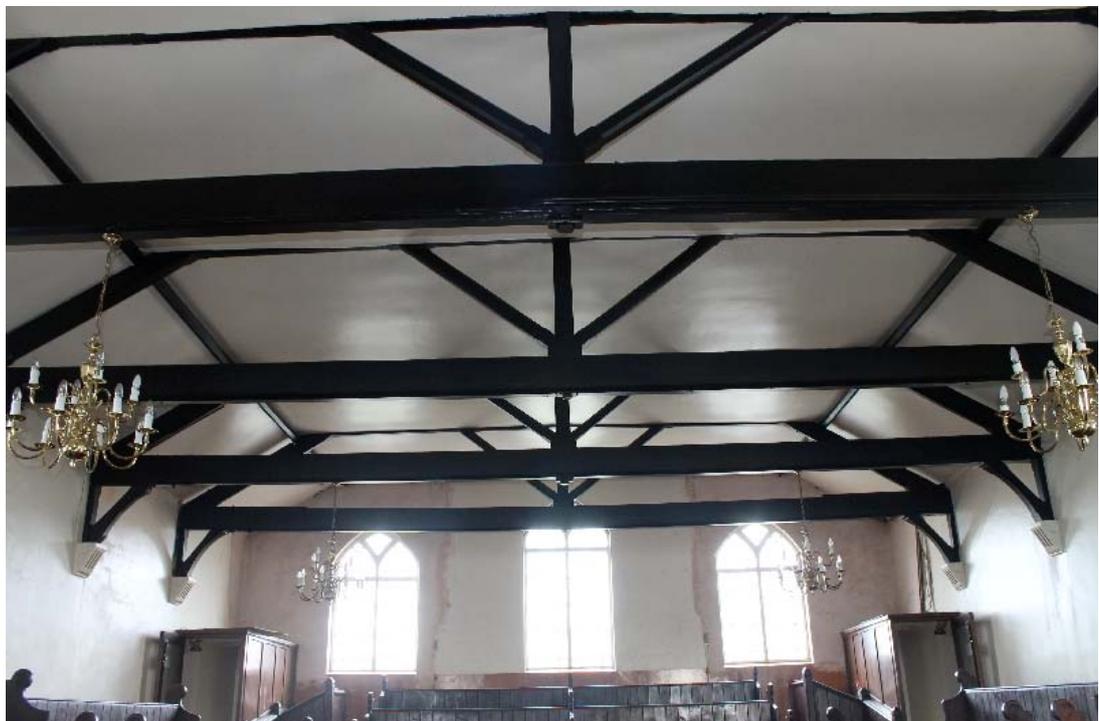
Plate 29: The king-post roof in the chapel, facing north

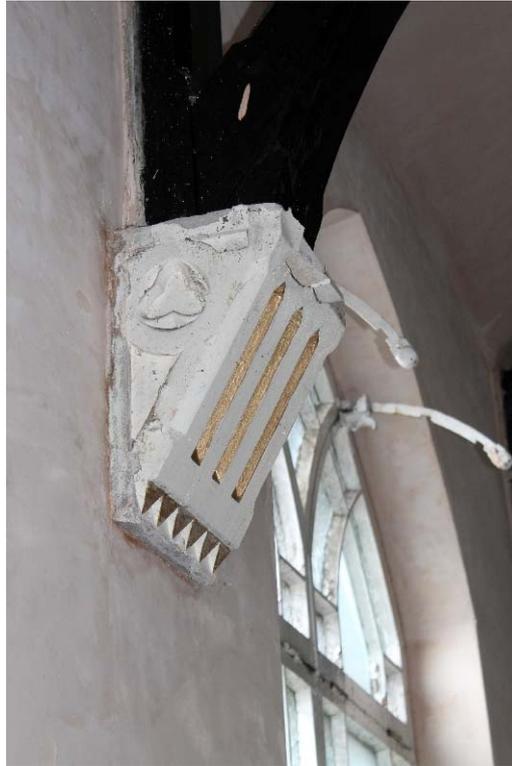
Plate 30: A decorative wooden corbel

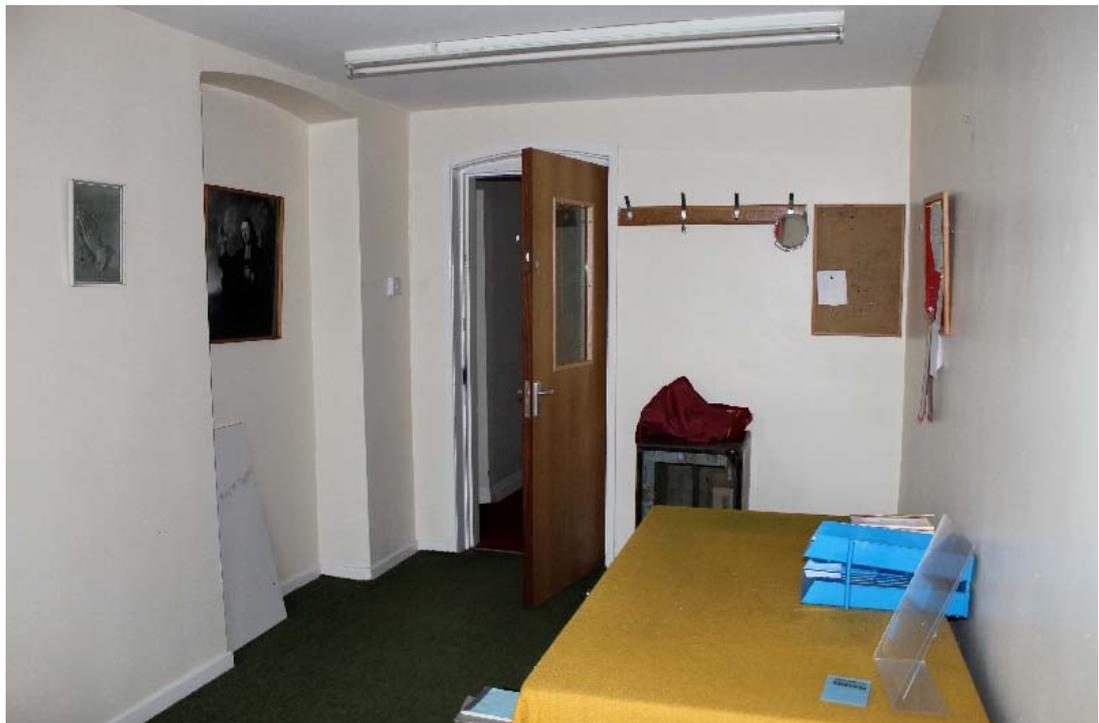
- 4.2.11 At the southern end of the chapel, the doorway behind the pulpit led into the ground floor of the square cell below the organ and from here a doorway to the south led into the school room. Another doorway to the east led into a modern toilet while a doorway in the opposite wall led into the modern vestry room. The only features of note were a blocked doorway in the southern wall of the vestry and a date stone in the same room, on what had previously been the eastern elevation of the two-storey square cell (Plates 31 and 32).

Plate 31: The modern vestry, facing west with a blocked doorway to the left

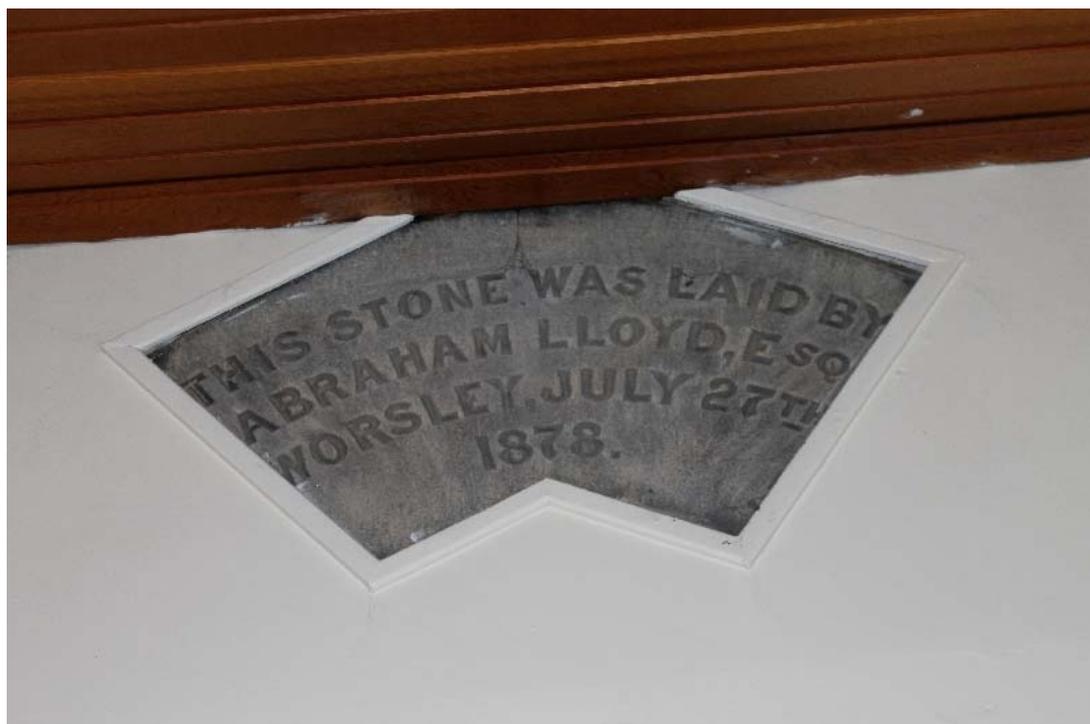
Plate 32: A date stone in the modern vestry

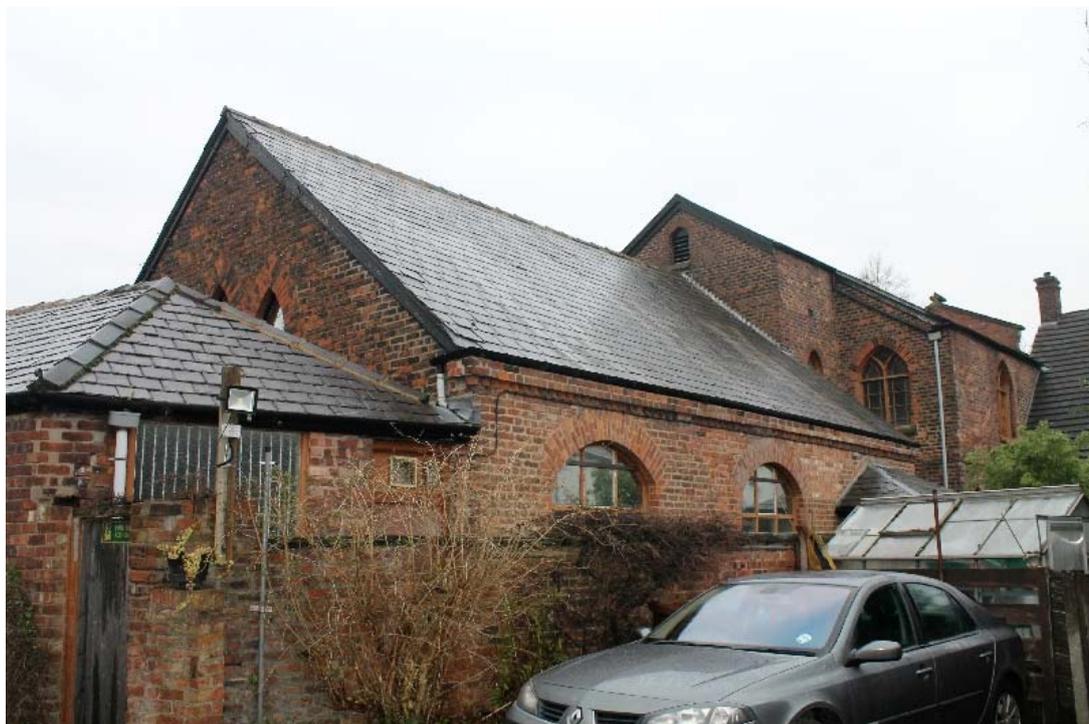
- 4.3.2 The lower half of the southern wall was hidden by the hipped extension to the south but three lancet-style windows were just visible to the centre of the upper gable above the line of the later building's roof (Plate 33). The western external elevation was again inaccessible for inspection but, internally, it revealed no openings of any kind.

Plate 33: School room, facing north-west, with the chapel visible to the right of frame and an ancillary building to the left. Two of the three lancet-style windows can just be seen on the southern gable elevation

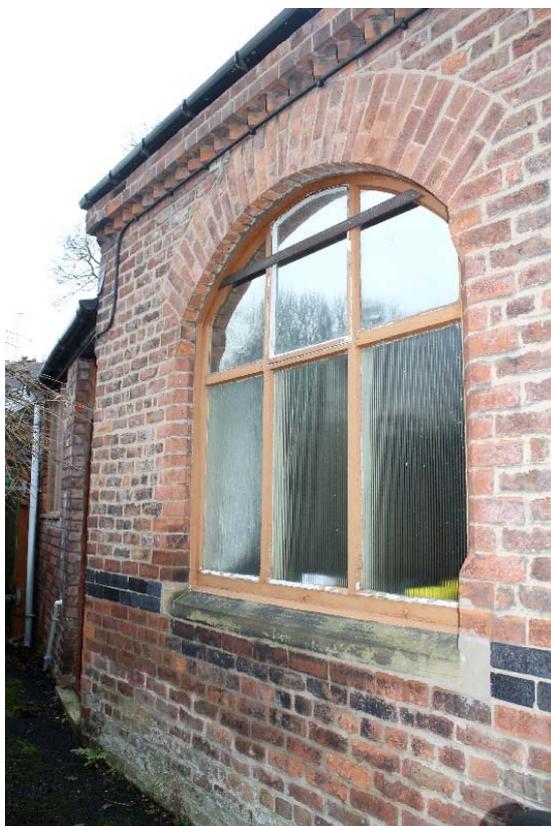
Plate 34: The southern window on the eastern elevation of school room, facing south-west. Note the dog tooth cornice and decorative use of engineering brick at sill height

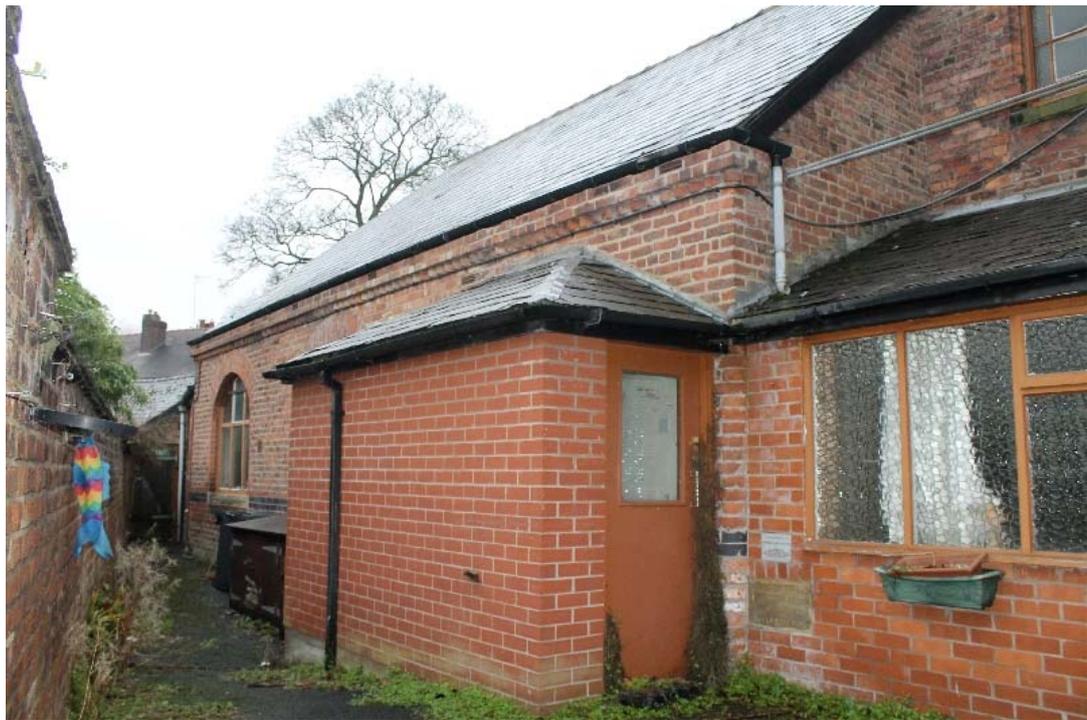
Plate 35: The modern porch extension with school room behind, facing south-west

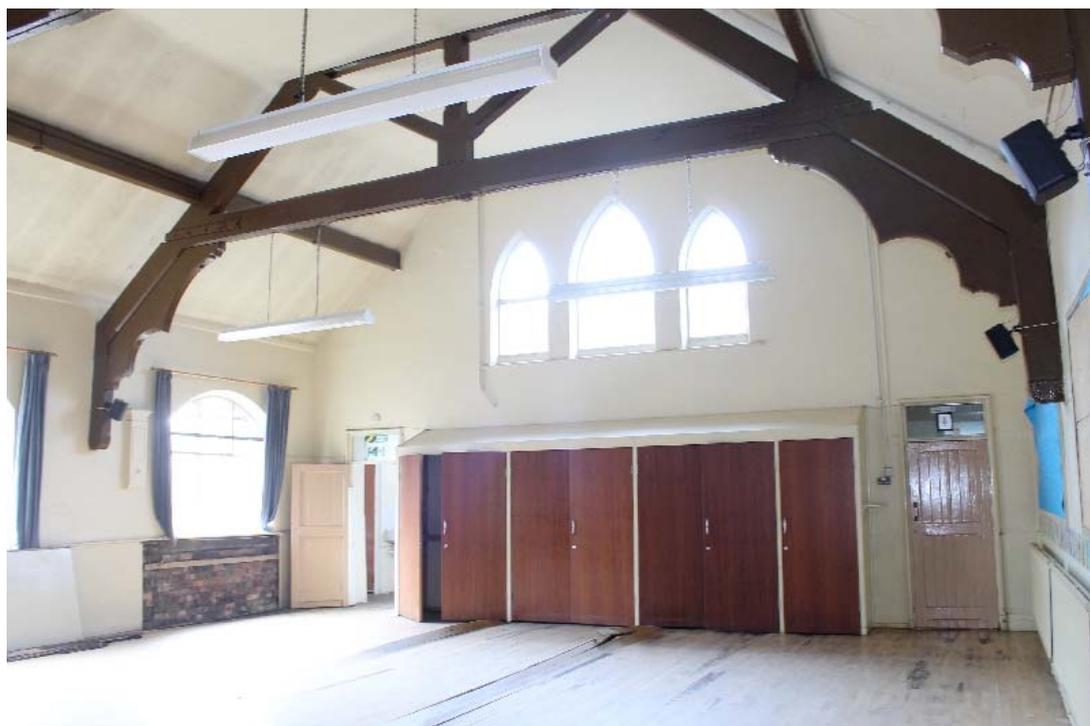
- 4.3.4 The king-post roof was also probably original and of similar construction to that described in the chapel, with its upper third hidden above the ceiling (Plate 36). Its tie beam, however, was raised above the height of the wall plates and the mid-height corbels carried wall piece posts up to the base of the rafters. A decorative brace with cusping along its underside was bolted to the underside of the rafter between the wall piece and tie beam. Doorways at the eastern and western ends of the southern wall led south into the ancillary structure at the rear of the building (Plate 36).

Plate 36: The interior of the school room, facing south; note the poor condition of the floor. The doorways at either end of the wall lead into the ancillary building

- 5.2.8 **Fragility/Vulnerability:** generally, the building is in reasonable condition and exhibits no signs of water damage or ingress associated with poor maintenance, however, the flooring in the school room has buckled and is in need of attention. Several cracks were also observed within the eastern and western walls of the chapel, although these appeared to be of minor concern. The building is currently disused and therefore inevitably at greater risk from vandalism and neglect.

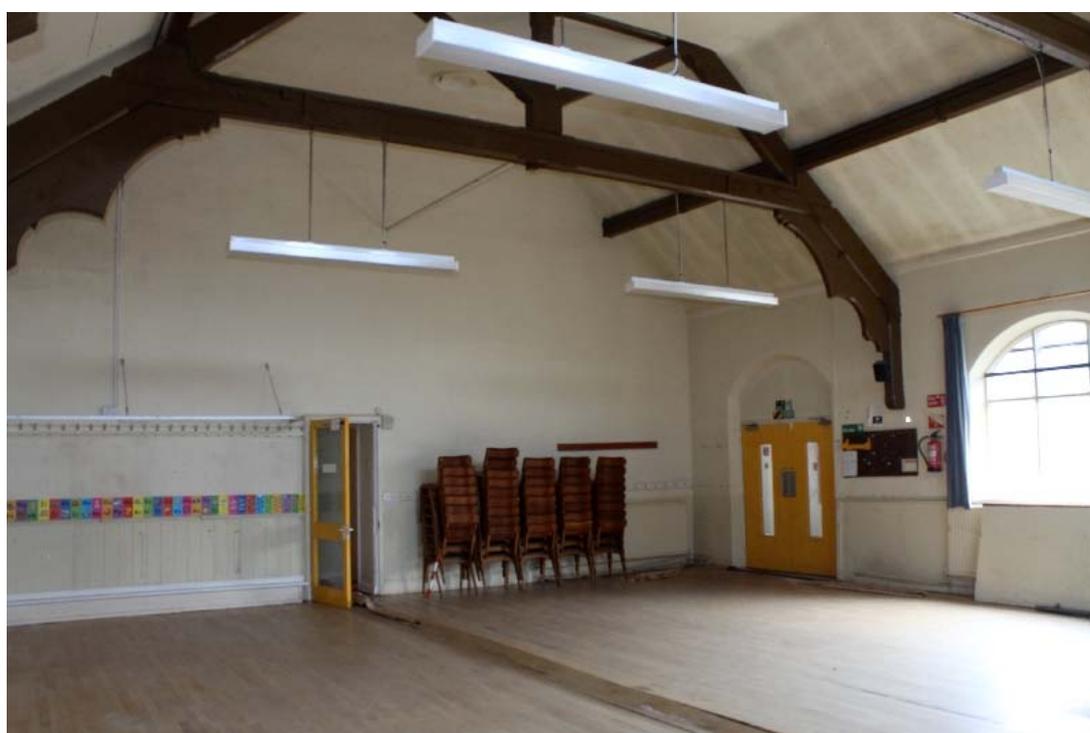
- 4.3.3 **Interior Appearance:** the hall was simply decorated with walls and ceiling coated in white paint and the floor was laid in narrow polished timber boards (Plate 36). The lower portions of the northern wall were clad in timber boards, but this was not repeated on the remaining walls (Plate 37). There were few additional features of historic significance, but a shallow rectangular box with a centrally placed brass knob towards the southern end of the eastern wall may have originally operated as a vent (Plate 38).

Plate 37: The interior of school room, facing north-east. The timber boarding of the northern wall can just be seen to the left of the doorway and behind the chairs

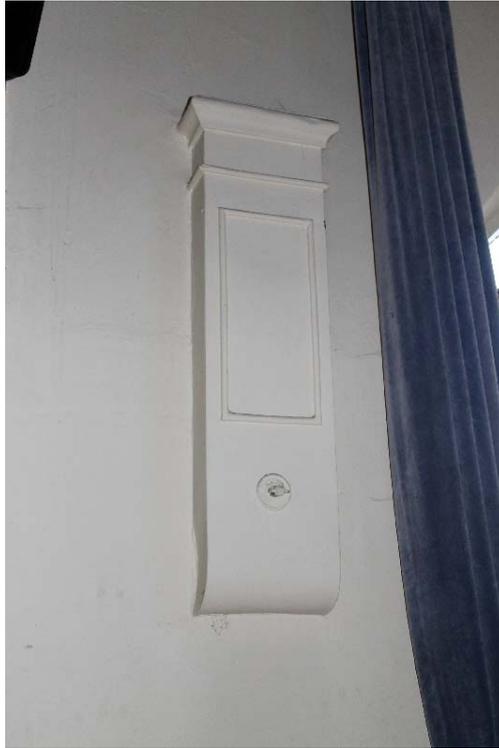
Plate 38: A vent on the eastern wall of the school room

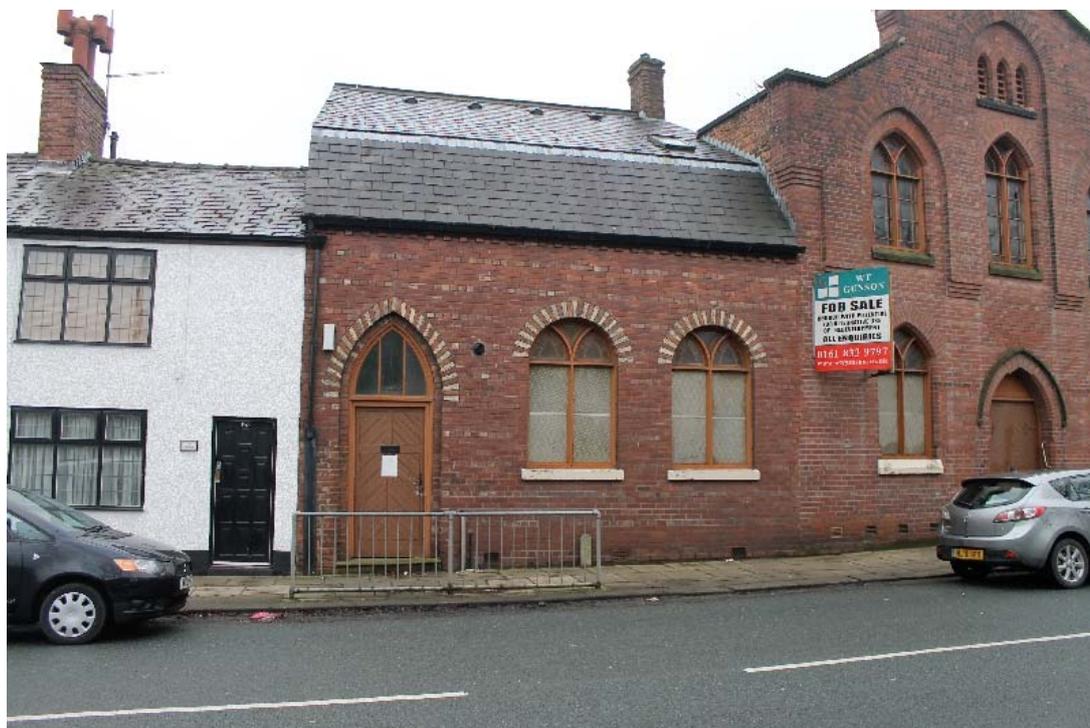
Plate 39: The northern elevation of the Sunday school

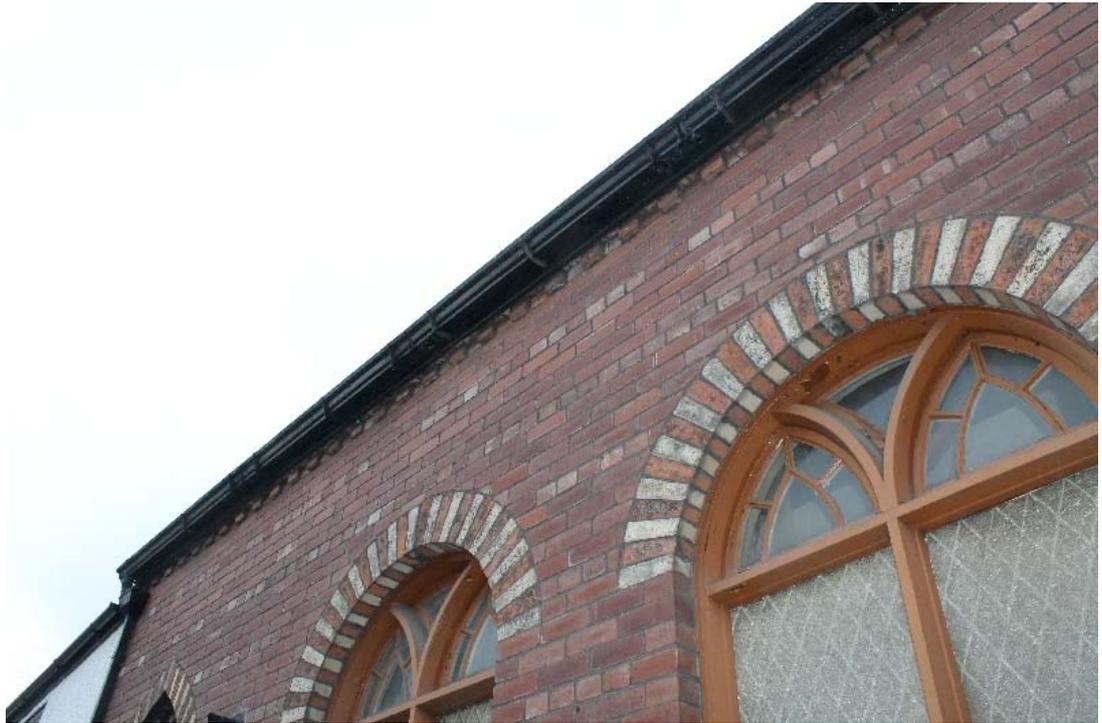
Plate 40: Polychrome window arches on the northern elevation, with dentil cornice visible at the head of the wall

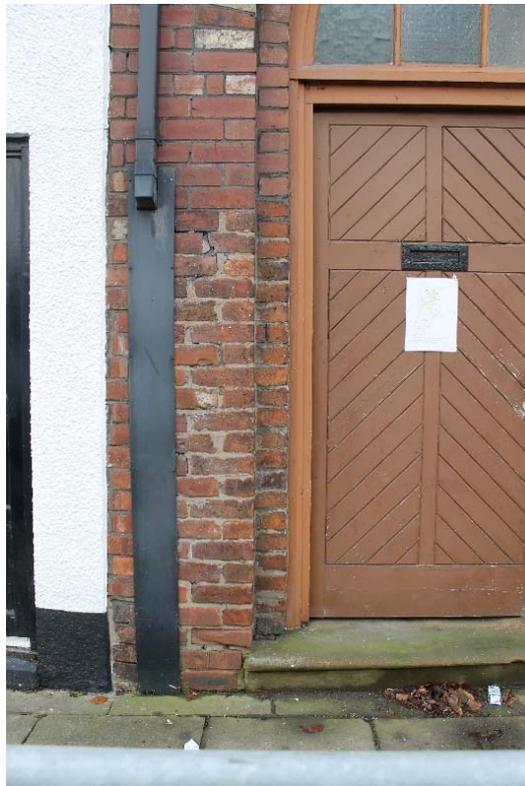
Plate 41: The variable character of brick work on the eastern jamb of the doorway on the northern elevation

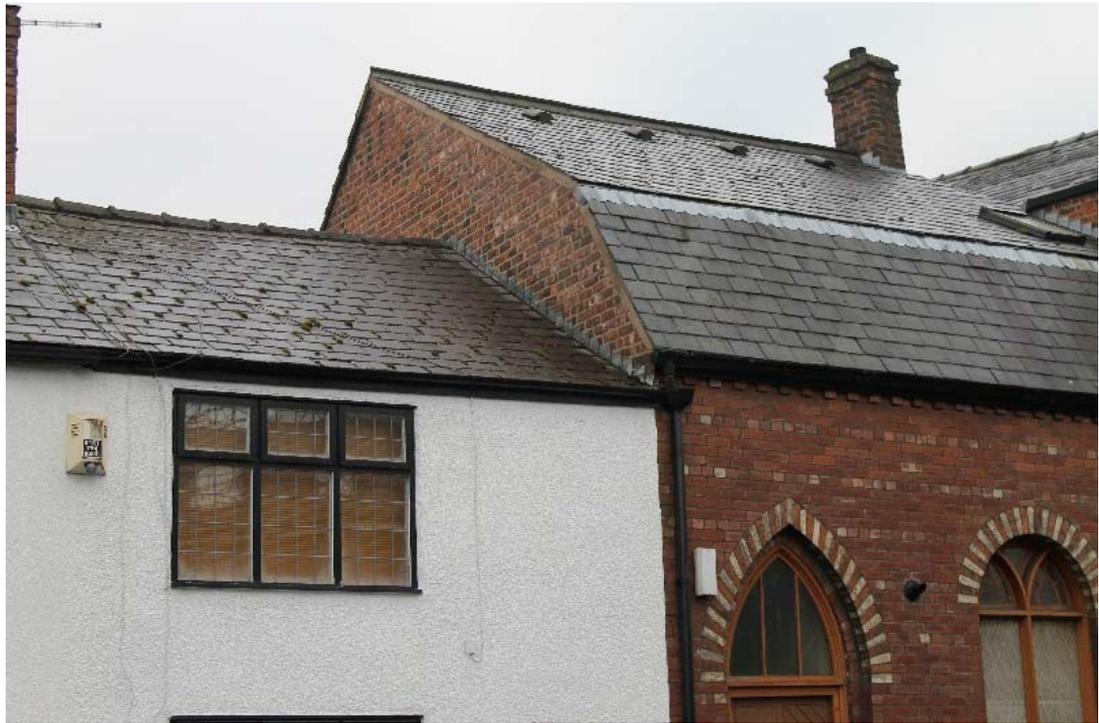
Plate 42: The eastern gable of the Sunday school visible above the roof of the attached cottage. A change in the character of the brickwork demonstrates that alterations have been carried out. Note the chimney stack on the opposing gable end

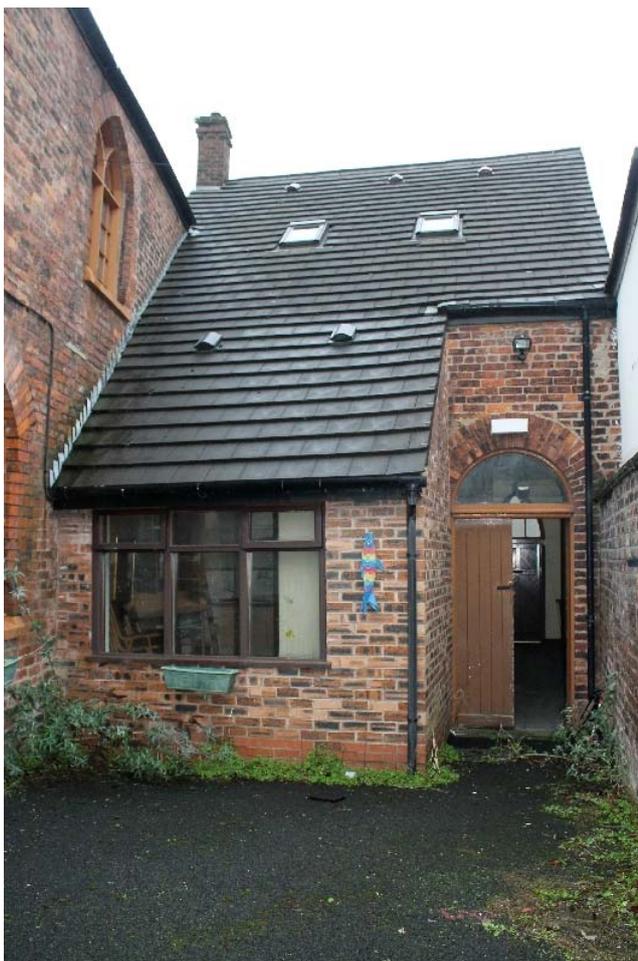
- 4.4.3 The original southern elevation had also been modified with the addition of a modern lean-to structure at the western end, with a triple-light modern rectangular window, incorporated beneath a cat-slide roof (Plate 43). Only the very eastern end of the original elevation remained, allowing just enough space for a doorway at south end of the enclosed side passage. Like the windows on the northern elevation the doorway had a semicircular arch above but it lacked the polychromatic brickwork. A single pane semicircular over-light lay above the doorway.

Plate 43: The southern elevation of the Sunday school with a modern extension lying beneath the cat slide roof. The original doorway with semicircular headed arch lies to the right of frame

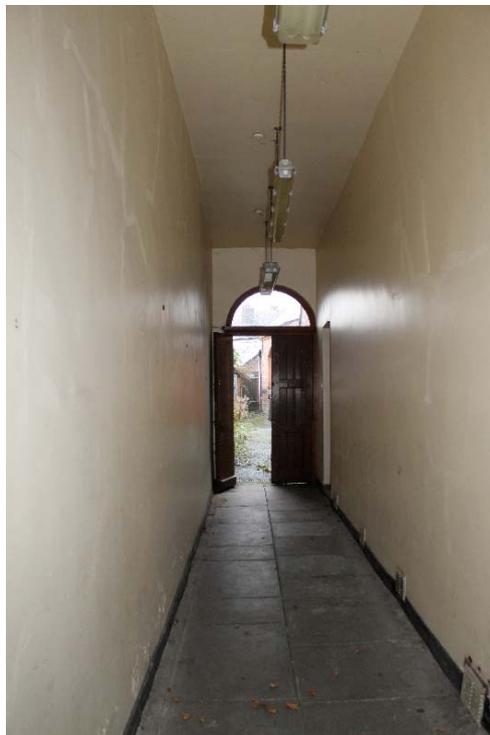
Plate 44: The enclosed passage, facing south with yard beyond
