WORSLEY METHODIST CHAPEL AND SCHOOL, BARTON ROAD, WORSLEY

Historic Assessment Report

Oxford Archaeology North

February 2015

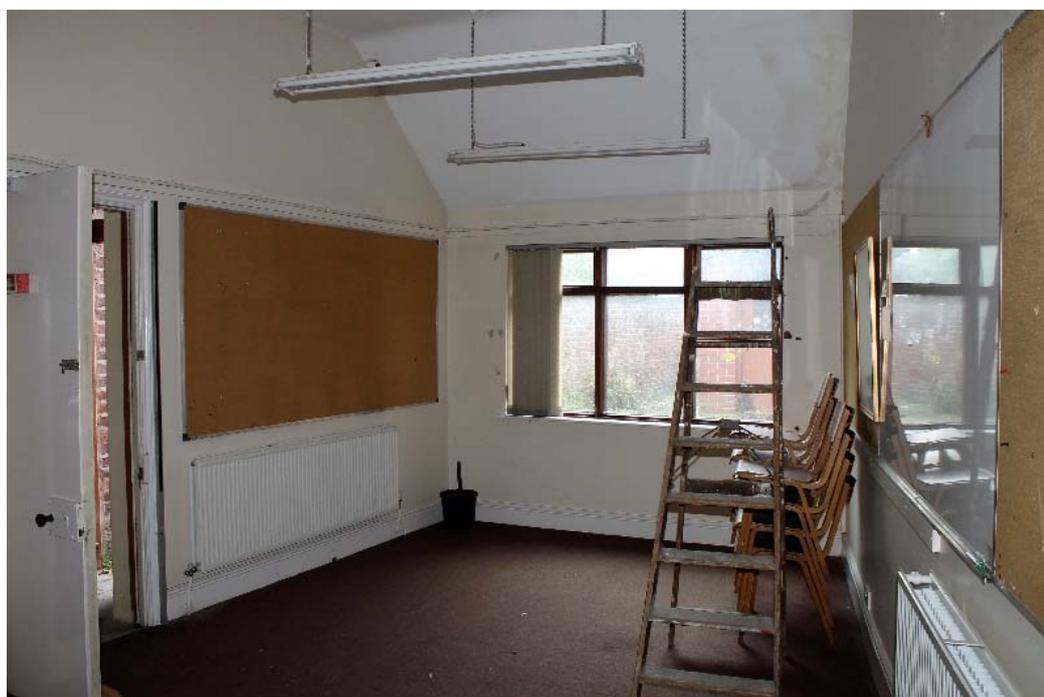
Plate 45: The interior of the southern cell, facing south into the extension

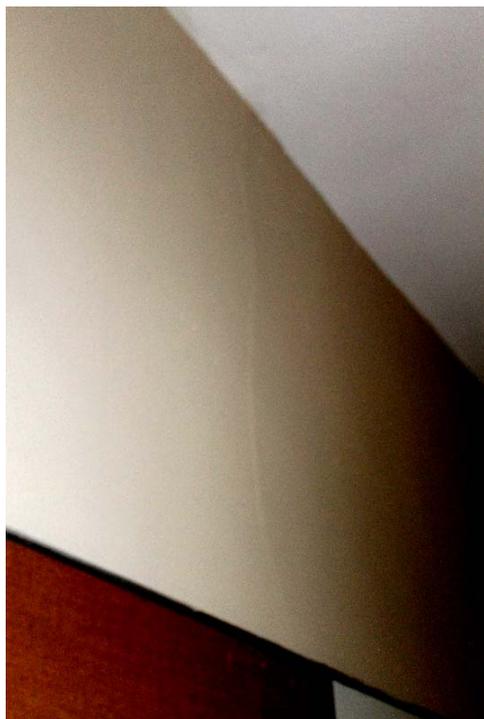
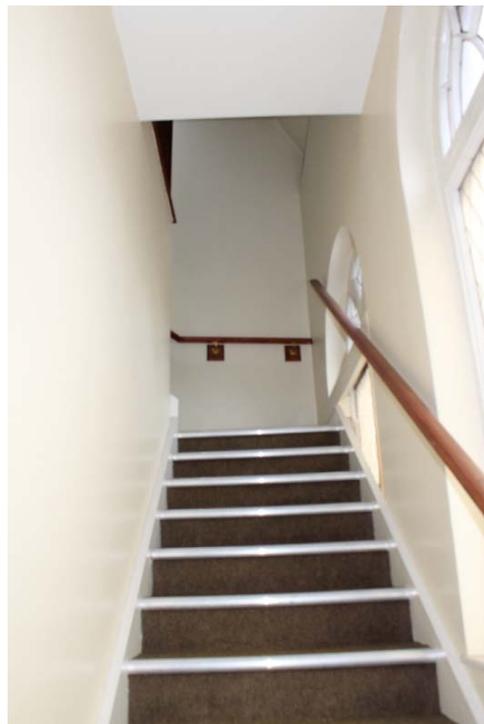
Plates 46 and 47: A crack on the western wall of the southern cell, which appears to line up with the construction joint observed externally (see Plate 16). The right image shows the staircase at the northern end of the northern cell. The windows on the northern elevation have been partially obscured by its insertion

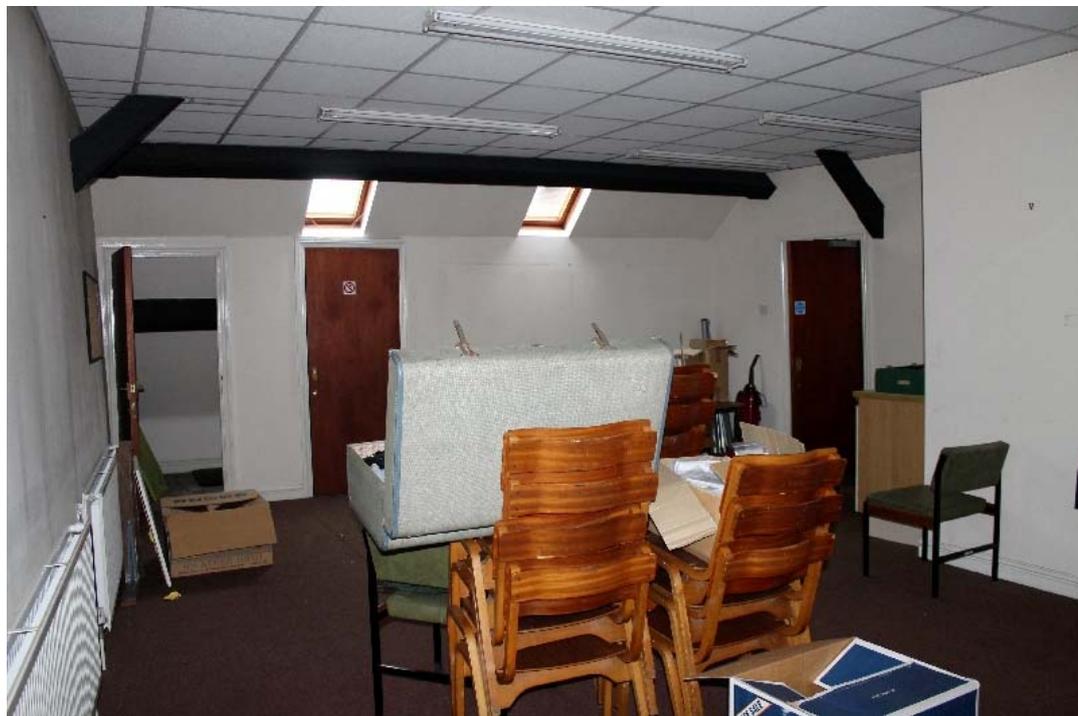
were all modern but it was apparent that the artificial ceiling hid, what appeared to be, a timber 'A' frame truss (Plate 48). The alignment of the truss placed it perpendicular to what might have been expected of the present mansard roof, perhaps suggesting that the modification of an earlier gable roof was at right angles to the current one.

Plate 48: The first-floor of the Sunday school, facing south. Note the feet of the earlier 'A' frame truss just visible beneath the artificial ceiling

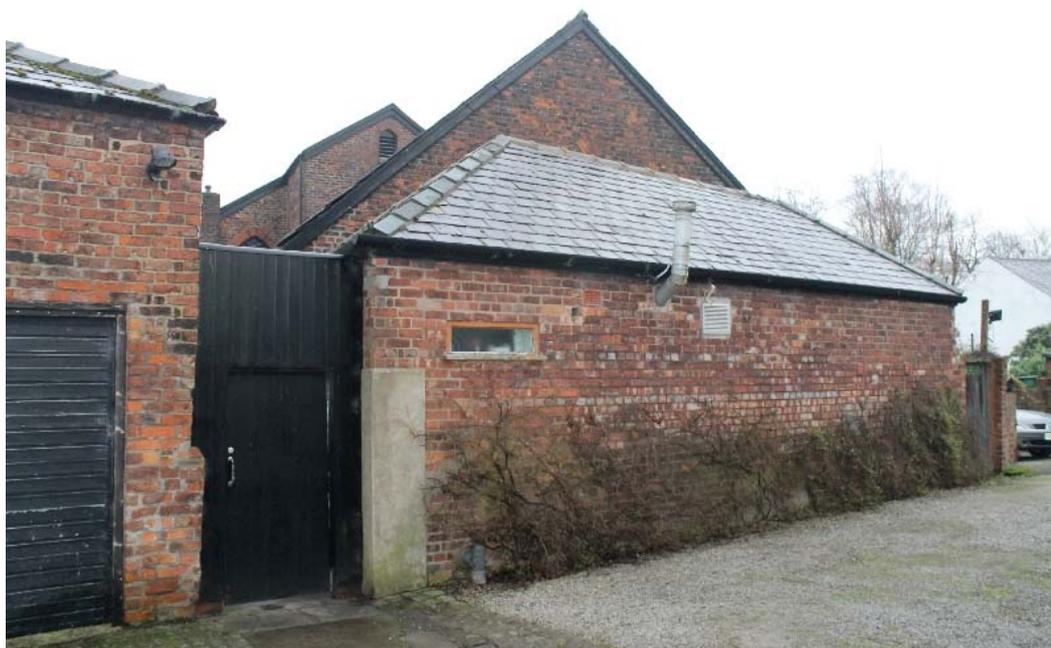
Plate 49: The southern elevation of the ancillary building, facing north-east

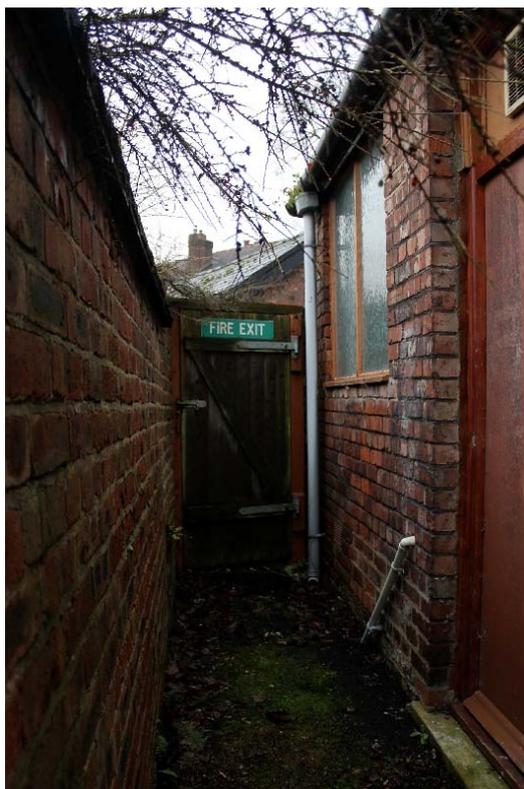
- 4.5.2 The western elevation was not observed, but internally gave no indication of any openings blocked or otherwise, while that to the east could be viewed from the southern end of the narrow yard (Plate 50). It had a simple doorway at the northern end with a blocked rectangular over-light above and a large rectangular two-light fixed timber frame window to the south.

Plate 50: The eastern elevation of the ancillary building, facing south along a narrow yard

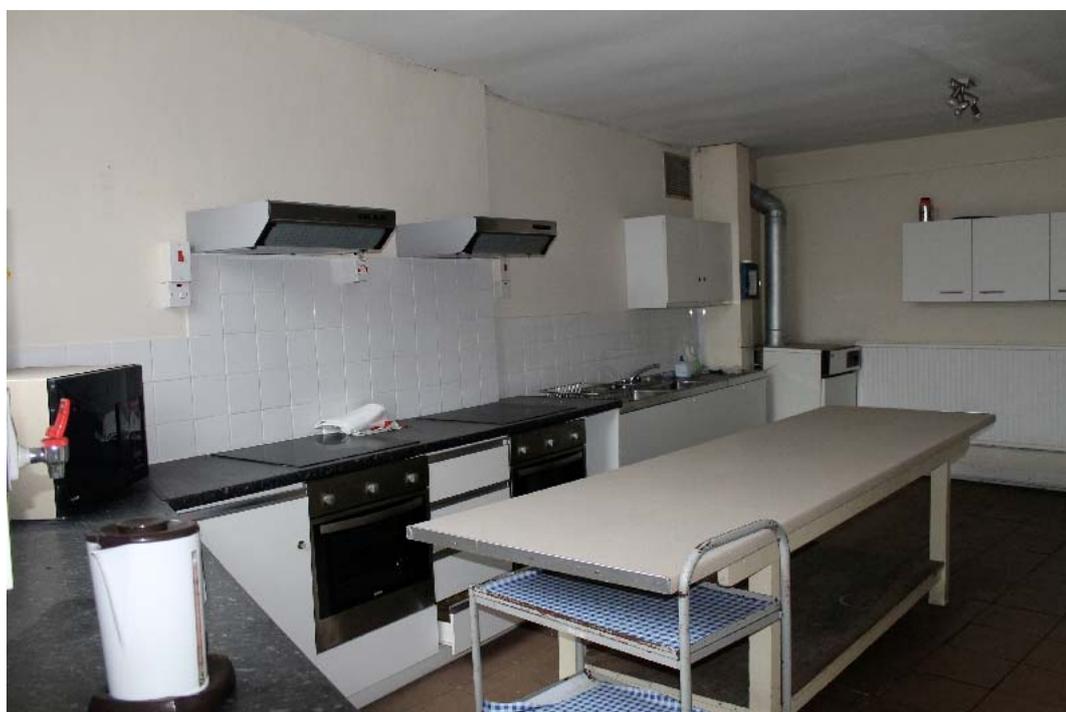
- 4.5.3 **Interior Appearance:** the interior had been subdivided into two cells, with a toilet block to the west and a kitchen to the east (Plate 51). Both could be accessed from the hall by one of the two doorways in the eastern and western ends of the adjoining wall. The kitchen could also be accessed from the narrow, external yard by the doorway at the northern end of its eastern wall. The finishes were wholly modern throughout with no surviving features of historic note.

Plate 51: The interior of the ancillary building facing south-west. The eastern cell was been converted into a modern kitchen
