# Land at Goxhill, Lincolnshire Flood Alleviation Scheme

## Archaeological Watching Brief Report

## **Land at Goxhill, Lincolnshire Flood Alleviation Scheme**

### *Watching Brief*

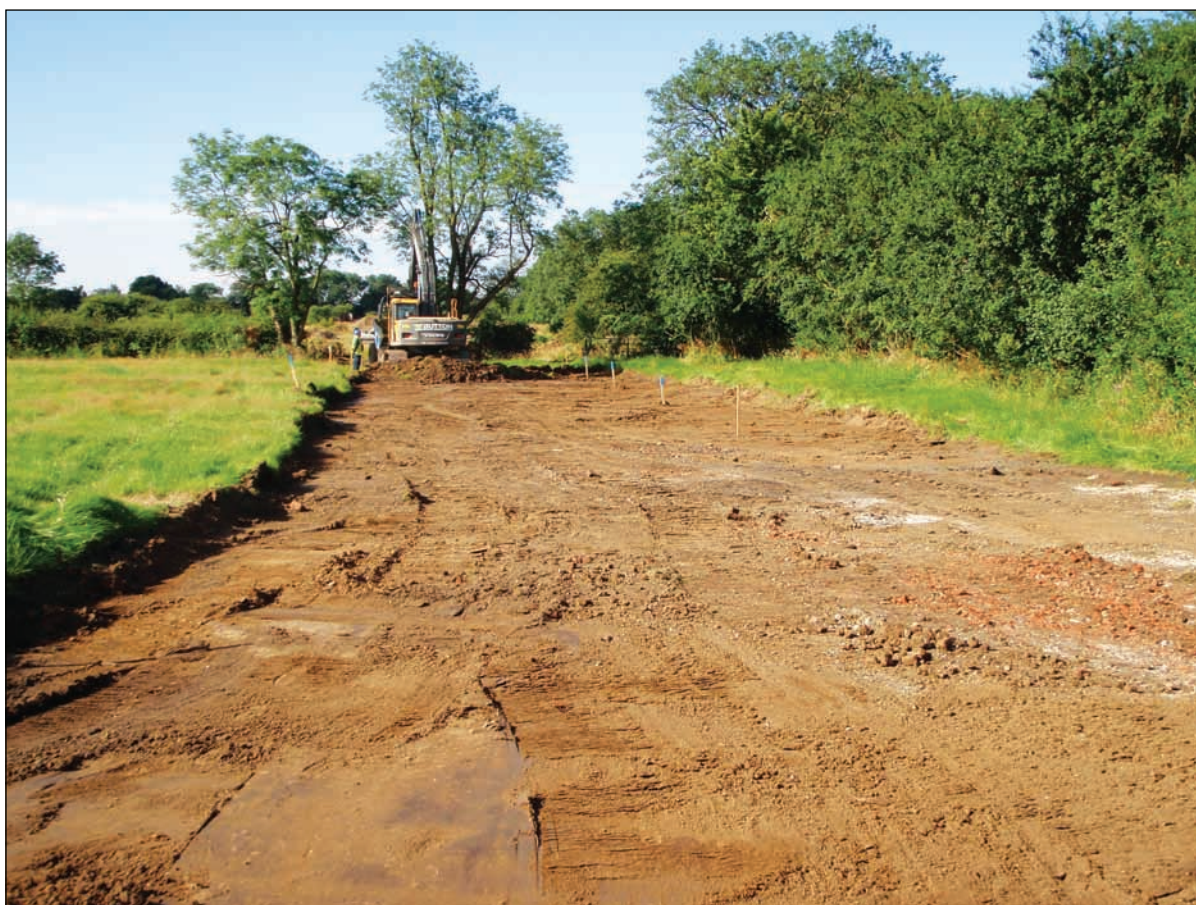
- 4.2.1 No archaeological features or artefacts were encountered. The ground conditions generally comprised of firm yellowish brown sandy clay natural ground overlain by a dark grey loam topsoil up to 0.3m deep.

Plate 1: Stripped field at northern end of flood alleviation scheme looking south

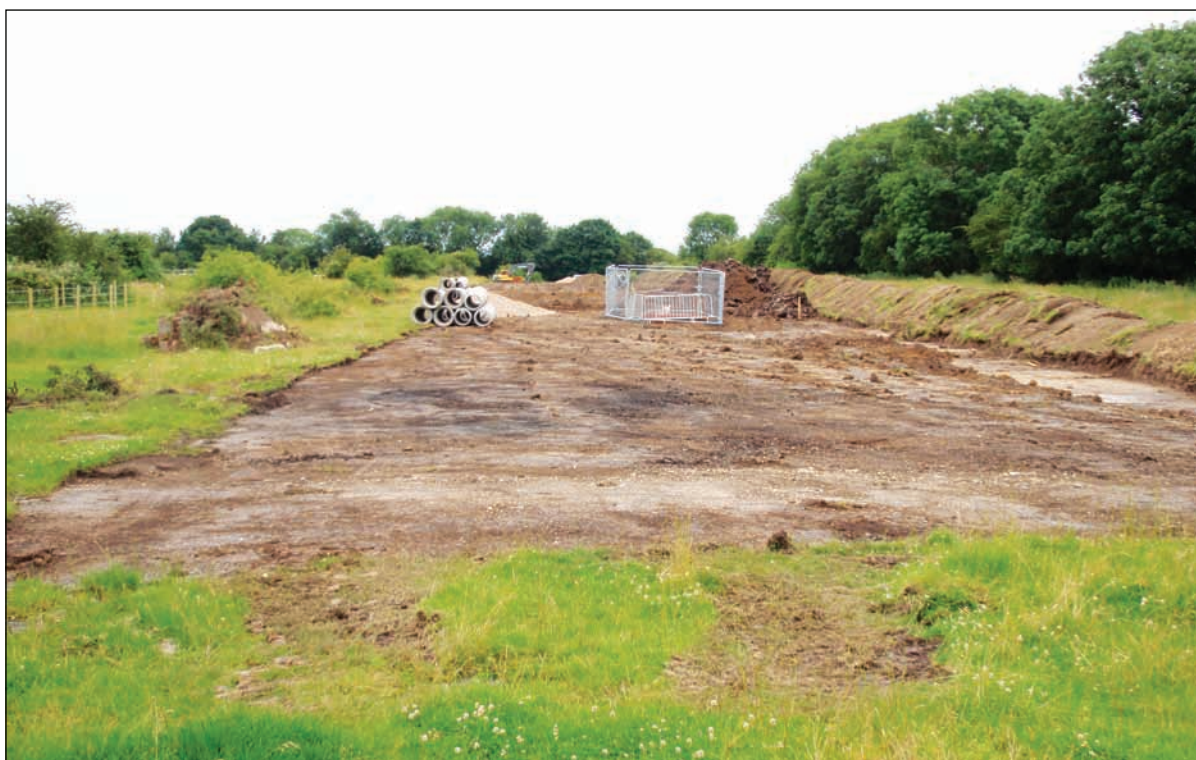
- 4.4.1 No archaeological features or artefacts were encountered. The ground conditions generally comprised of firm yellowish brown sandy clay natural ground overlain by hardcore and surfaced with tarmac.

Plate 2: Stripped route across the disused airfield looking south

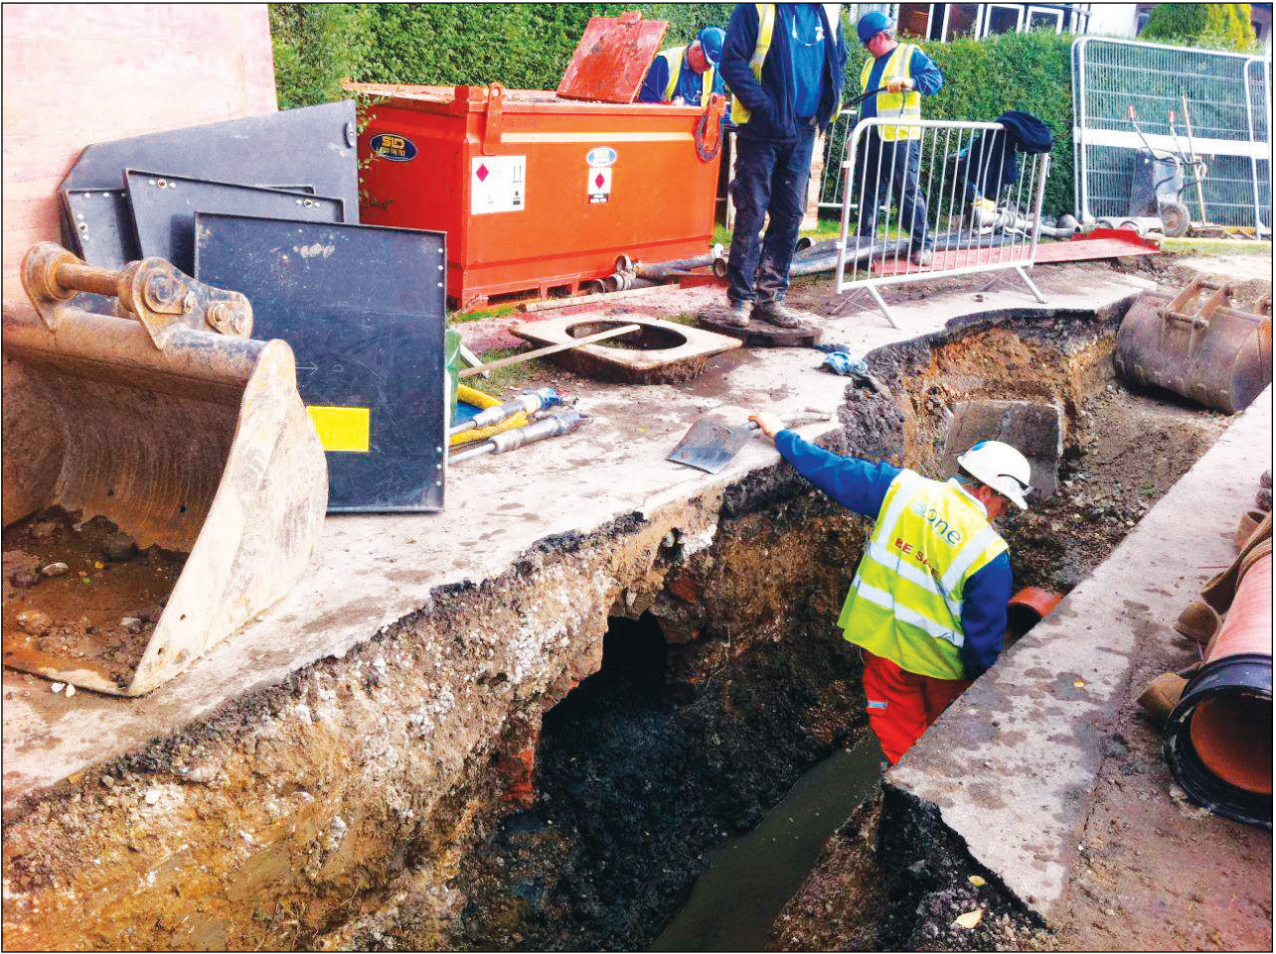
- 4.6.1 The pipe trench being opened was 1.2m wide and between 1.5m to 3m deep, running the length of Willow Lane. The ground conditions generally comprised of mid yellowish brown sandy clay natural overlain by 0.6m to 0.8m of modern hardcore, make up layers and tarmac. Any archaeological features that may have been in the area were most likely completely truncated by the modern activity in the area.
- 4.6.2 A brick culvert was uncovered during the excavation of the trench. The culvert was 1m wide, 0.6m in height and constructed of unfrogged red bricks and a dull yellow mortar. The culvert was known to be in the area and related to road water drainage

Plate 3: Pipe trench down Willow Lane showing 19th Century Culvert in section

- 5.1.1 No archaeological features or finds were observed during the excavation of the pipe trenches and top soil strip. Any features that may have been in the area of site would have been truncated by post-medieval and modern activity.
- 5.1.2 The ridge and furrow earthworks were not masking any features that may have been there, and no finds were recovered from the top soil stripping.
- 5.1.3 The brick culvert uncovered on Willow Lane was known to be in the area and relates to street water drainage throughout the village. Dating to the mid to late 19th Century it was still in good condition although heavily silted up and with some modern concrete repair work.
