Ribble to Bamber Bridge, Electricity Cable, Lancashire

Watching Brief

Oxford Archaeology North

November 2003

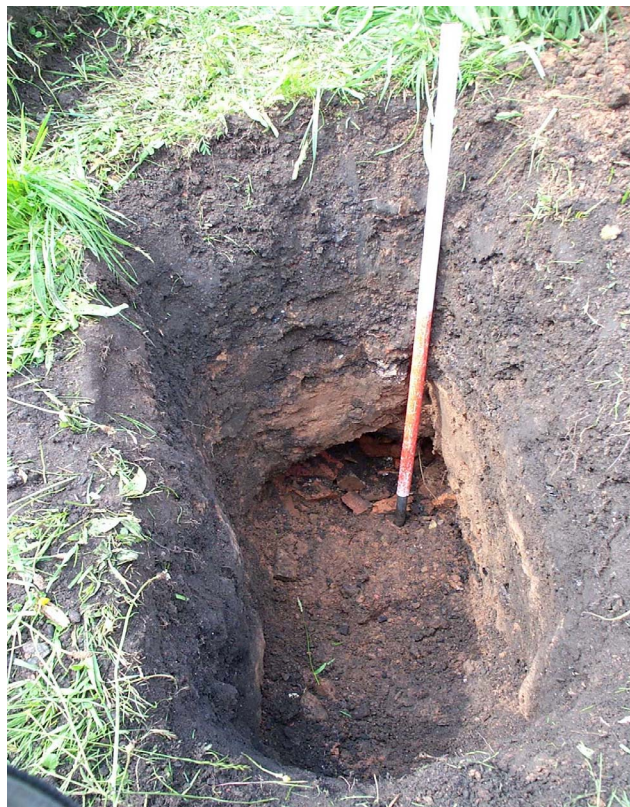
Plate 2: Test Pit **04**, looking west

Depth in m	Description
0 – 0.50	dark brown, gravelly sandy silt, with frequent clinker, slag and coal inclusions
0.51 – 0.75	mixed orange and brown sand, clean but occasional coal flecking
0.76 – 1.00	dark brown, gravelly sandy silt, with frequent clinker, mortar, bricks, and sandstone fragments with slag concretions

3.2.7 The test pits revealed successive layers of construction packing that included dark gravelly sandy silt layers, sand layers and a clay layer. Many of the layers had small amounts of demolition rubble, including crushed brick, coal fragments, clinker and slag. Only test pit **04** had substantial demolition rubble between 0.71 and 1.00m deep as a dumping layer but this had no evidence for the viaduct structure visible beneath it.

- 4.1.1 The results of the test pits show that there was no evidence for any structure of the viaduct within the build of the embankment to a depth of 1m from the top of the plateau. Test Pits **04** and **05** were placed just below the east side of the lip of the plateau but still did not uncover any viaduct structure. It is possible that the viaduct has been completely demolished before the embankment was built. However, the demolition rubble dumping layer in test pit **04** (Plate 2) could suggest that if the viaduct was not completely destroyed, the upper super-structure may have been removed and levelled before the embankment was built.
