# Whitstable Community College Whitstable Kent

## Archaeological Evaluation Report

**Document Title:** Whitstable Community College, Whitstable, Kent

**Document Type:** Evaluation

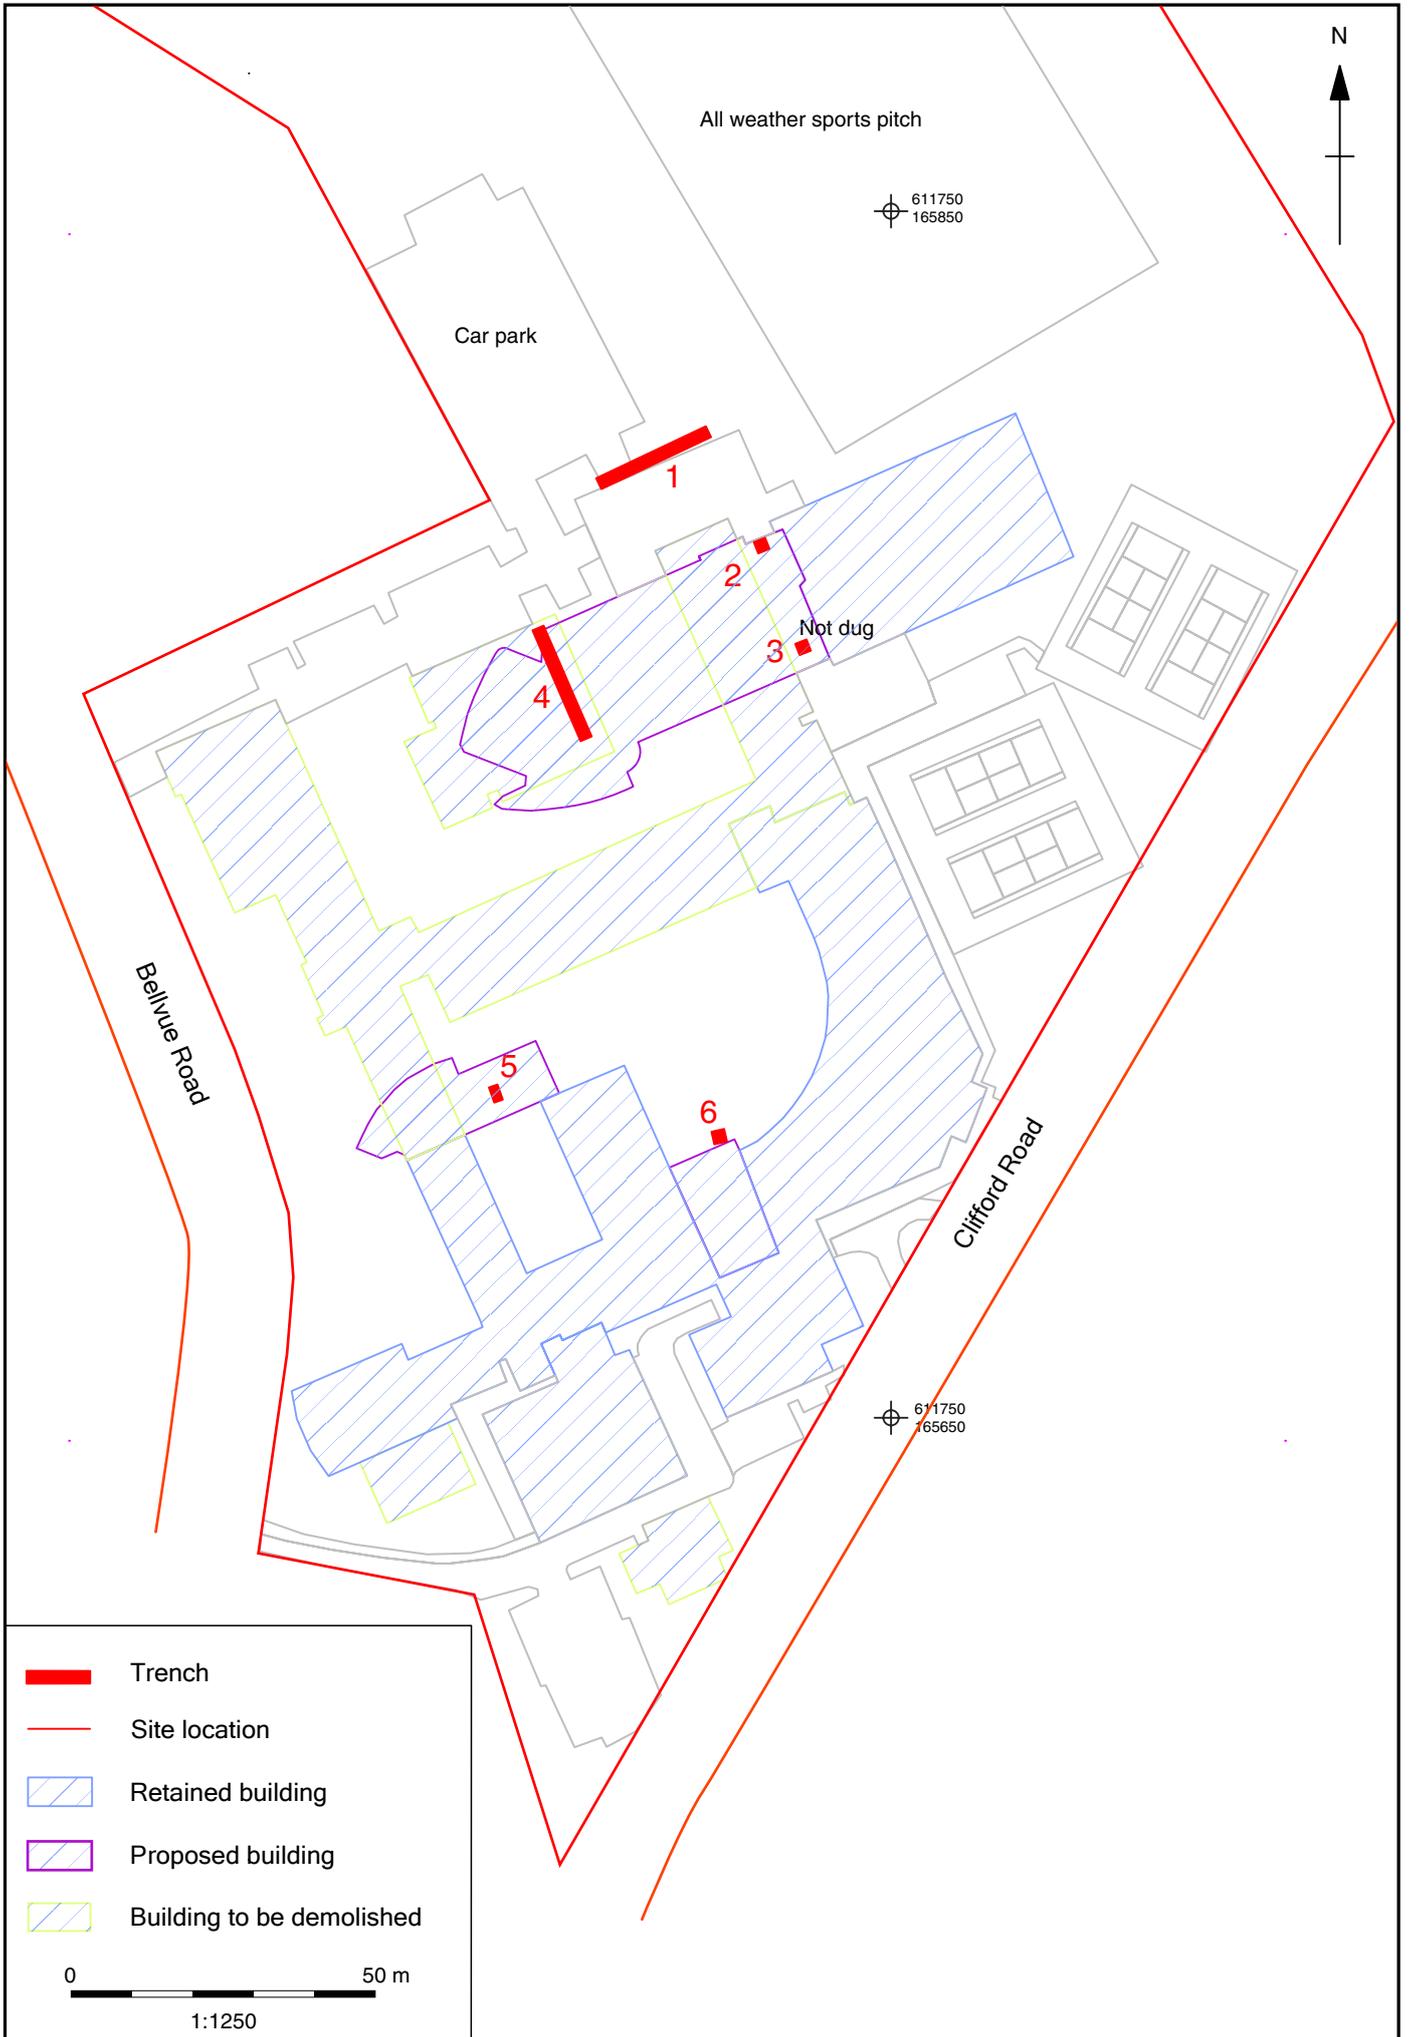
Figure 2: Trench location plan

- 4.1.1 The six trenches were located at various points across the site within the proposed new building footprints (Fig. 2). The trenches were intended to ascertain the density of the archaeological features and their overall condition in terms of survival and potential for further study. Below is a summary of each trench detailing the excavated stratigraphic sequence of deposits:

- 3.1.1 The evaluation was originally intended to comprise six trenches. Trenches 1 and 4 were machine excavated and Trenches 2, 5 and 6 were hand-dug. One of the hand excavations (Trench 3) was not completed, by agreement with the County Archaeological Officer (see section 4.1.5 below and Figure 2).

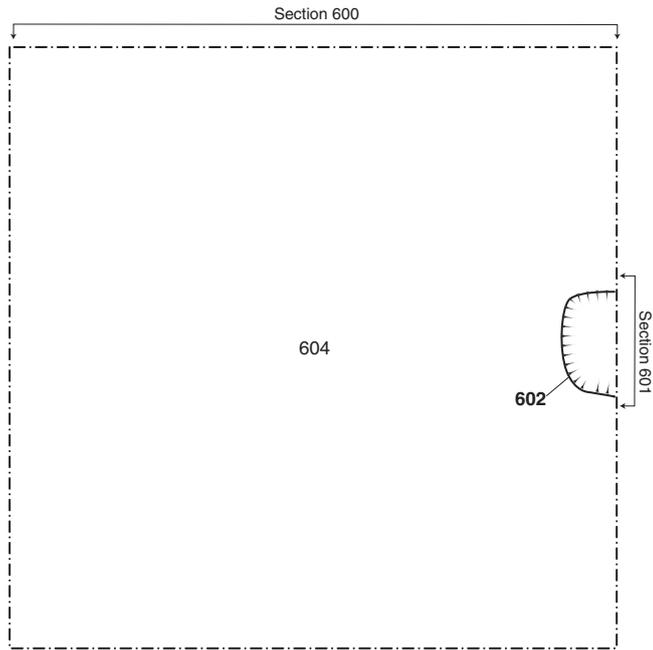
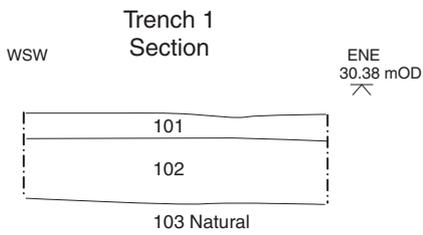
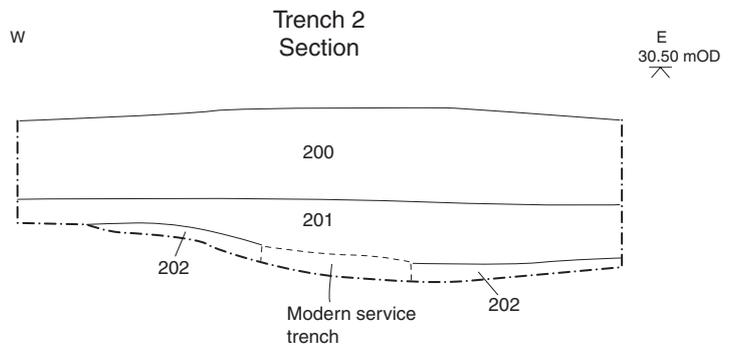
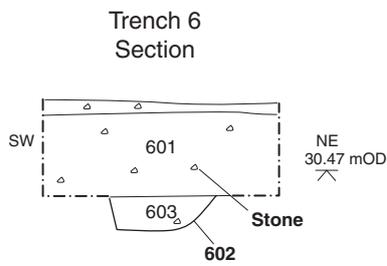
Figure 3 : Plan of trench 6 and sample sections

- 4.1.8 Trench 6 (Fig. 3) was hand excavated. It measured 2 m by 2 m and was dug to an average depth of 0.34 m to natural. In this trench, the natural (604) was a firm mid brown clay with flint inclusions. It was overlain by a green grey silty clay makeup layer (601) containing stones and ceramic building material, with a thickness of 0.29 m. This was overlain and sealed by a firm, turf-covered, dark grey brown silty clay topsoil (600) with a thickness of 0.05 m.
- 4.1.9 Cut into the natural (604) and sealed by the makeup layer (601) was a small square feature (602). This was filled by a green grey silty clay (603). While no finds were recovered from this feature, its very regular shape and near-vertical sides suggest it is most likely to be of modern date. It was also filled with the same material as the makeup layer (601).

- 5.1.2 In Trench 2, a clearly modern sand-filled service trench was exposed. The only other feature was uncovered along the northern edge of Trench 6. This was a relatively small, square and shallow feature 602. No finds were recovered from this feature but its shape and profile suggested a recent date. Its fill comprised the same material as the overlying makeup layer (601). The most logical conclusion is therefore that this feature was a post-pad, perhaps for scaffolding, created during the construction of the existing school buildings. It is likely to have become filled at the same time as makeup layer (601) was brought in prior to the laying of the present turf.

- 4.1.2 Trench 1 measured 18.5 m by 1.65 m. It was excavated to an average depth of 0.3 m where natural was encountered. In this trench, this consisted of a layer (103) of firm green / orange mixed gravel and clay. Directly above this was a makeup layer of loose light pink grey type one aggregate sub-base (102), with a thickness of 0.2 m. This was overlain and sealed by a solid black tarmac layer (101), with a thickness of 0.08 m, which formed the current car-park ground surface (Fig. 3).
