William St Car Park, Botchergate, Carlisle, Cumbria.

Archaeological Evaluation

Oxford Archaeology North

March 2014

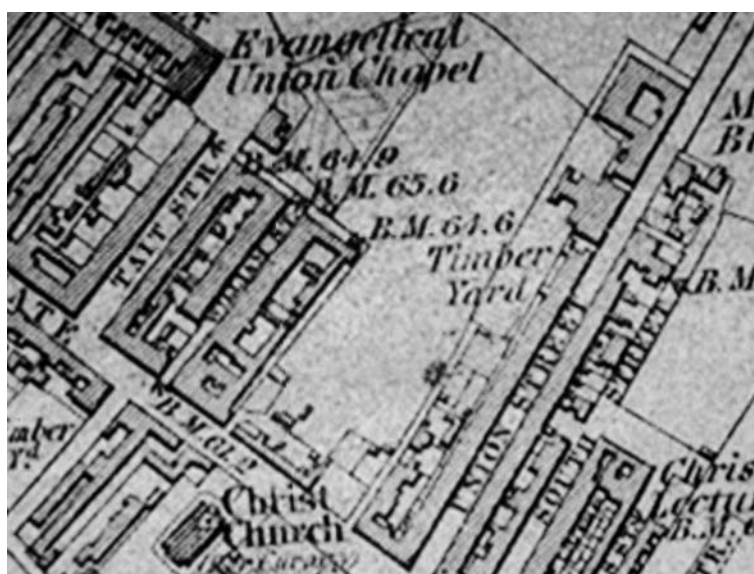
Plate 1: Detail of the development area taken from the OS First Edition map, 1865 (OS 1865)

- 3.1.6 By the time the first edition Ordnance Survey was published in 1865 substantive infilling had occurred behind the main street frontage over at least parts of the development site (Pl 1), and this continued to be the case during the later nineteenth century and the first half of the twentieth century. In 1877 the Carlisle Auction Market was built over much of the site and used into the 1970s, when it was demolished to make way for the present William Street/Cecil Street car parks.

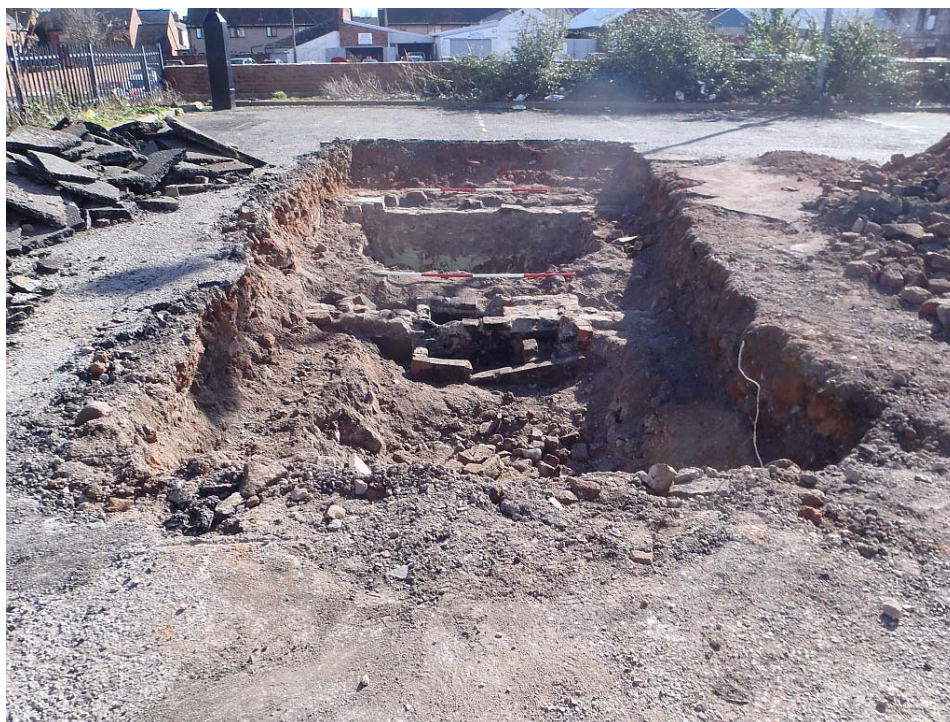
Plate 2: Trench 1 looking south-east

- 4.2.1 Trench 1 was located in the north-east corner of the car park (Fig 2) and was aligned north-west/south-east. The trench measured 10 x 4m, but, due to the unstable character and depth of the late post-medieval deposits encountered, which largely comprised the loose rubble fill of two adjoining nineteenth-century cellars (*Section 4.2.2*), the natural geology was reached only in a limited area, 1.6m wide, located towards the southern end of the trench, beneath the floor of the southernmost cellar. Elsewhere, excavation was taken to a depth of c 0.5m.

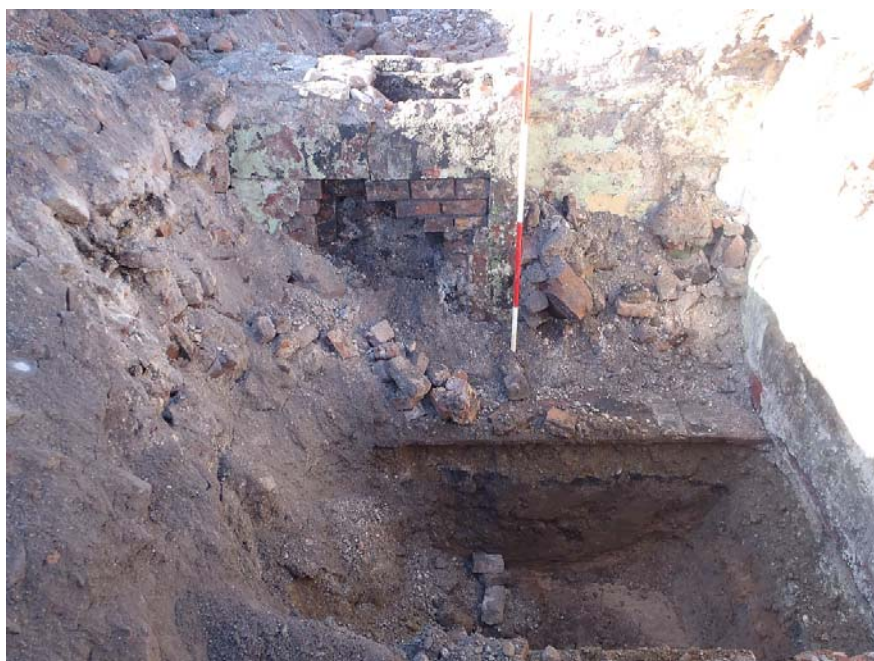
*Plate 3: Area of deeper excavation in Trench 1 looking north-west, showing the bricked-up fireplace in the north wall (**1003**) of cellar **1002***

deposits for the flagstone floor (**1007**) of a late post-medieval cellar (**1002**), the walls of which (**1002**, **1003**, **1004**; Fig 3) were constructed of roughly-hewn sandstone blocks bonded with a pale lime mortar. The internal wall faces were also covered with a thin layer of lime plaster, and the remains of a bricked-up fireplace survived in the north wall (Pl 3). Two openings, either doors or windows, were observed in the east wall (**1004**; Fig 3), but could not be investigated due to their proximity to the trench edge. Ultimately, the cellar was filled with loose sandstone, brick and mortar rubble (**1005**), as was the second cellar to the north (**1012**, filled with rubble **1006**). Though this feature was not investigated further, a bricked-up fireplace was observed in its south wall, essentially being a mirror-image of the fireplace in cellar **1002** (both fireplaces presumably used the same chimney). The rubble fill of both cellars, together with the levelled walls of the buildings (the tops of which lay c 0.5m below the modern surface), were sealed by a levelling deposit (**1001**) lying directly beneath the tarmac of the present car park.

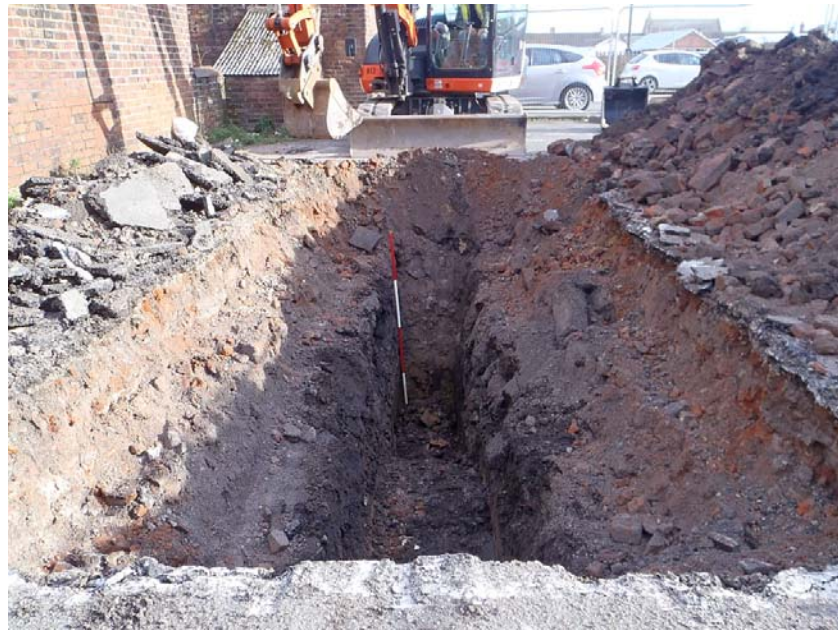
Plate 4: Trench 2, looking south-east

- 4.3.1 Trench 2 was located in the north-west corner of the car park (Fig 2) and was aligned north-west/south-east. It measured 7 x 3m and was excavated to a maximum depth of 2.25m, though, due to the poor stability of the ground in this area the trench was completely excavated by machine, with only a narrow slot, 0.6m wide, being excavated to the natural geology at the southern end of the trench (Pl 4).

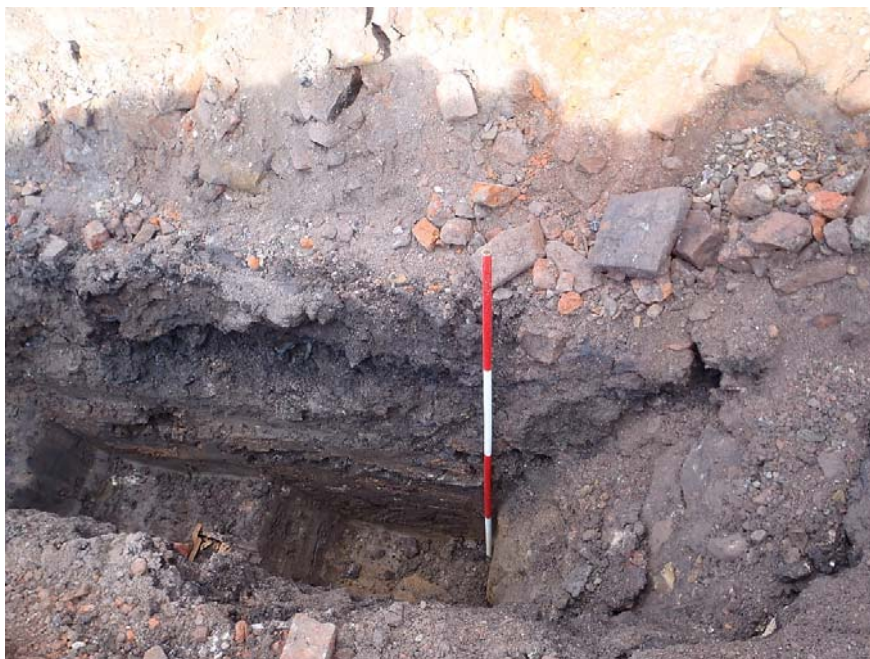
Plate 5: South-west-facing section of Trench 2, showing the natural subsoil (2006) at the base, overlain by buried soil 2005

- 4.3.2 The natural geology (2006), a pale yellow-grey sandy material, was encountered at the base of the deeper slot (PI 5), 2.25m below modern ground level. This was overlain by a buried soil horizon (2005), comprising a dark brown-black silt, c 0.85m thick, but, as in Trench 1, this proved difficult to characterise due to the limited nature of the exposure.

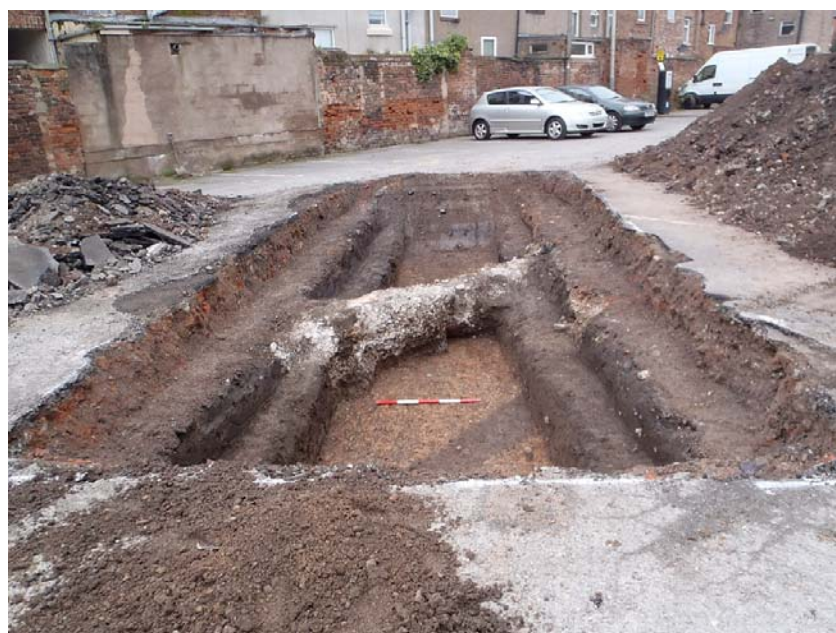
Plate 6: Trench 3, looking north

- 4.4.2 The natural geology (**3016**), a brownish-orange sandy clay, was reached 1.8m below the car park surface (Pl 6), and was seen to be cut by four earth-filled linear features (**3007**, **3010**, **3012**, **3014**; Fig 4). Feature **3007** was a north-east/south-west-aligned ditch or gully (Pl 7) that was exposed for a length of 1.34m at the northern end of the trench. It was 0.64m wide, survived to a maximum depth of 0.25m, and was filled with a dark grey-brown soil (**3006**), probably representing a gradual silting up of the ditch over time, which yielded fragments of pottery, bone and glass. The ditch was truncated by a modern drain (**3015**), which ran north-west/south-east through the northern half of the trench. Drain **3015** also cut through a second linear feature (**3014**), a shallow (*c* 70mm) gully or slot, 0.28m wide, with near-vertical sides and a flat base. It was filled with a single deposit of dark soil (**3013**) that contained fragments of pottery. At the southern end of the trench was another shallow gully or slot (**3010**, possibly the same as **3012**) (Pl 7), at least 0.6m wide and 0.14m deep, again filled with a dark soil (**3009**).

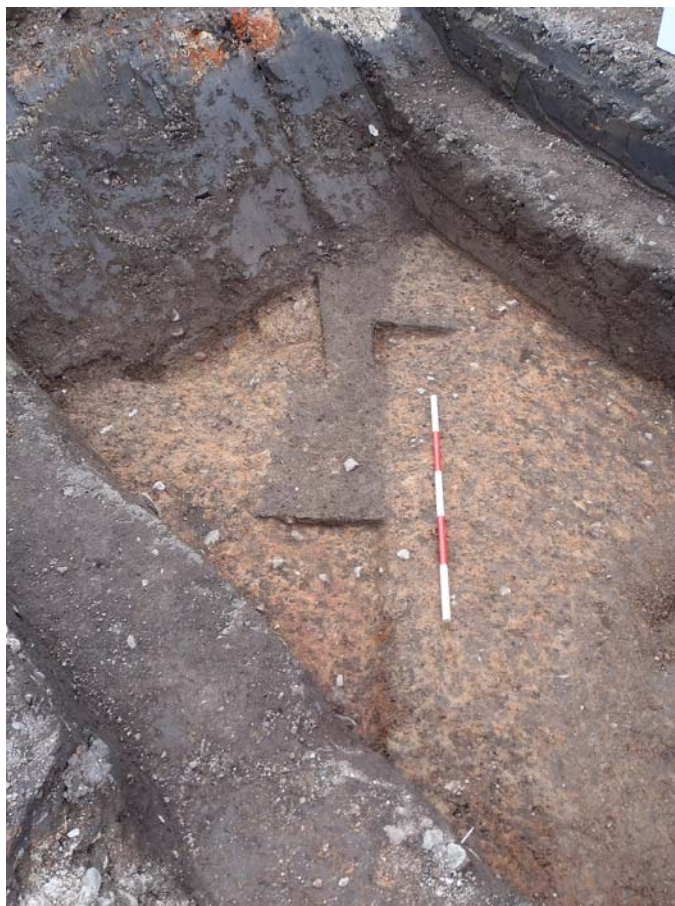
Plate 7: Linear feature **3007** in Trench 3, looking south-west

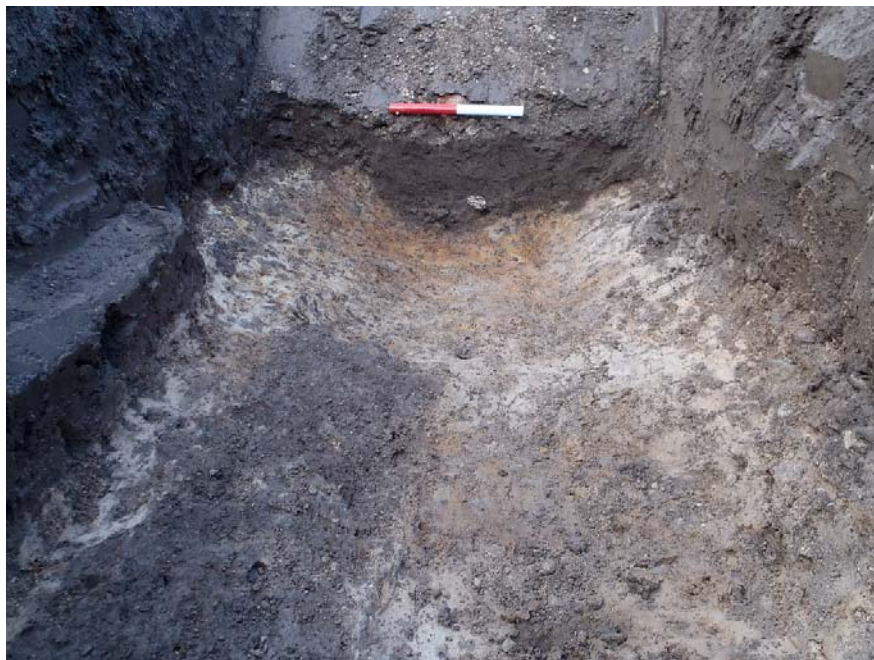
Plate 8: Trench 4: north-east-facing section of gully 4012

compact sandy clay, was recorded at a depth of 2.2m. It was cut by a shallow, north-east/south-west-aligned ditch (**4012**), 1.12m wide and 0.4m deep as it survived (Fig 5; Pl 8), filled with a dark grey sandy silt (**4011**).

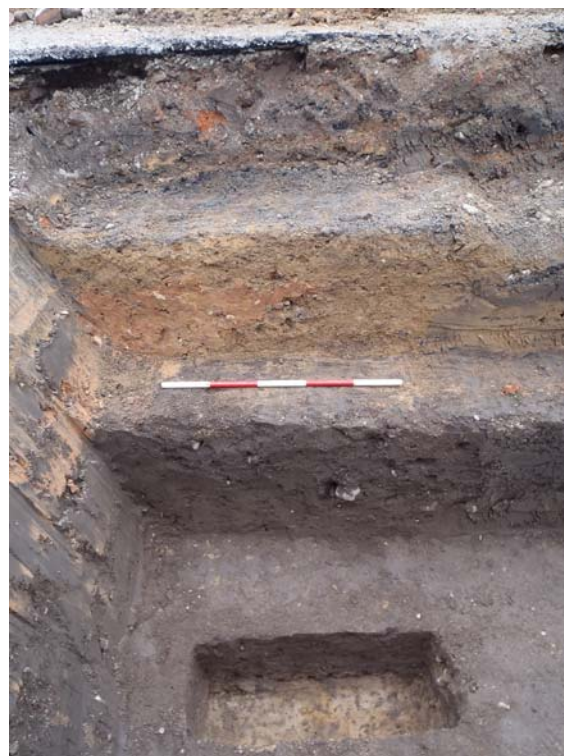
Plate 9: North-west-facing section of Trench 4, showing buried soils 4009/4010 overlying the natural geology and sealed beneath nineteenth-century levelling deposits

4.5.2 Feature **4012** was sealed by a build-up of dark grey-brown soils (**4010** below **4009**), up to 0.85m thick (Pl 9), very similar in character and depth to those recorded in Trench 3 (Section 4.4.4), the lower deposit again being cleaner

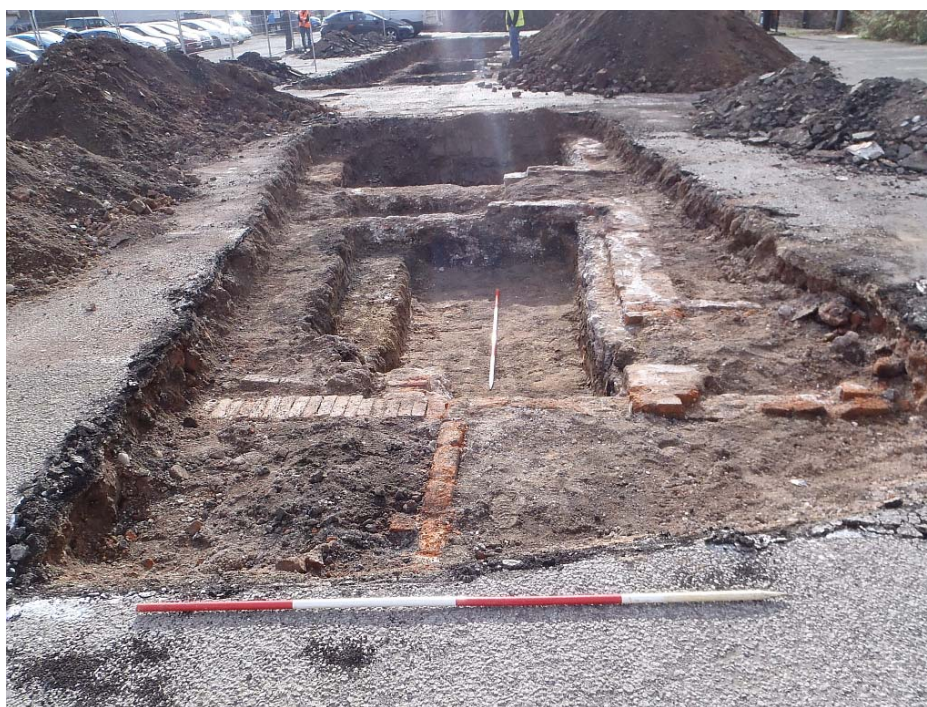
Plate 10: Trench 4, looking south-west, showing brick walls and concrete foundations for nineteenth-century buildings

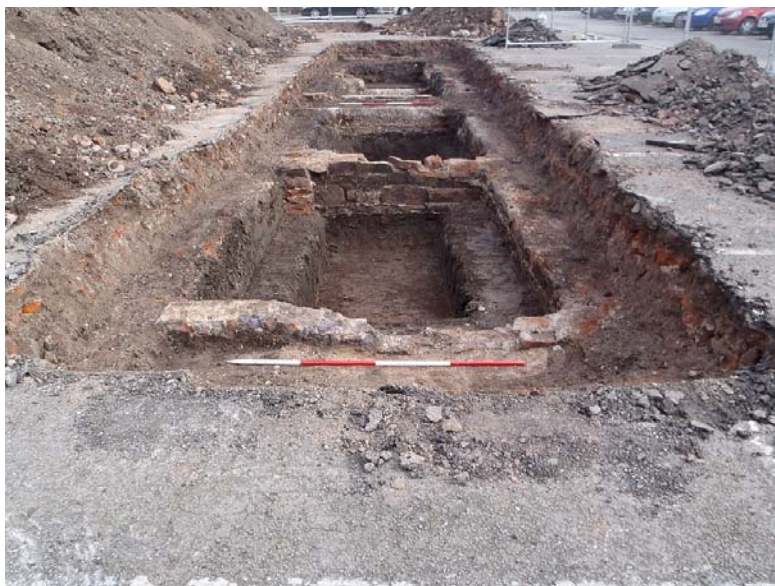
Plate 11: Trench 5, looking north-east

- 4.6.1 Trench 5 was located on the west side of the car park (Fig 2) and was aligned north-east/south-west. The trench measured 20 x 4m and was excavated to a maximum depth of 2.36m. The modern tarmac and underlying rubble were mechanically removed to the tops of several levelled late post-medieval walls, following which the area between the walls and their foundations was further reduced to the surface of the natural geology (Pl 11).

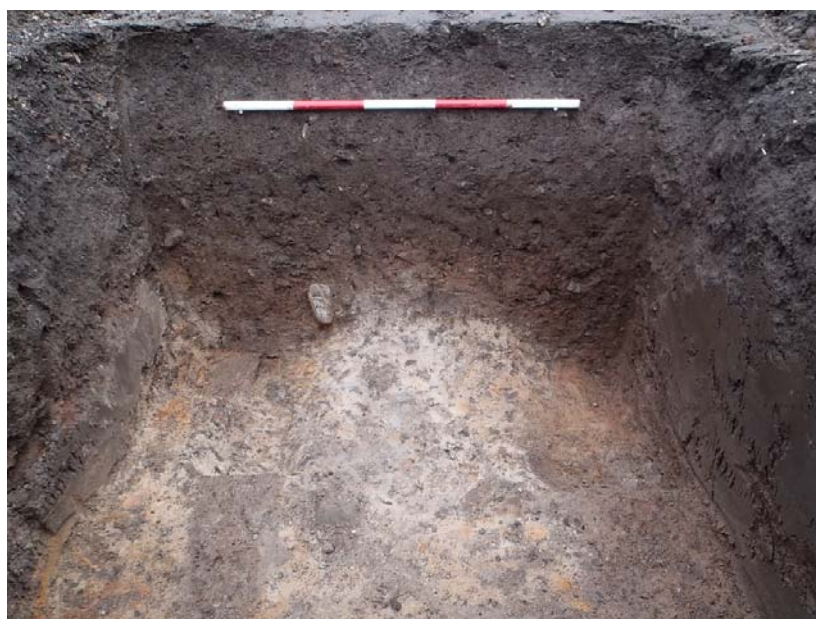
*Plate 12: Trench 5: gullies **5015/5017** and **5019**, looking north-east*

4.6.2 The natural geology (**5020**), a mixed orange and yellow sandy clay, was recorded at a depth of 2m below the modern surface, and several dark soil-filled linear features were visible, cutting its surface (Fig 6). At the northern end of the trench were a pair of near parallel, north-east/south-west-aligned gullies (**5015/5017**, **5019**) were recorded. The westernmost (**5015/5017**) was traced for 10m within the trench and was found to be up to 0.75m wide and 0.35m deep, and had been filled with a pale grey/reddish brown sandy silt (**5014/ 5016**). To the north, this feature converged with gully **5019** (Pl 12), and it could be proven that **5015/5017** was the earlier feature, since it was cut by **5019** (Fig 6). The later feature was 0.77m wide and 0.51m deep, and was filled with material (**5018**) similar to that filling the earlier gully.

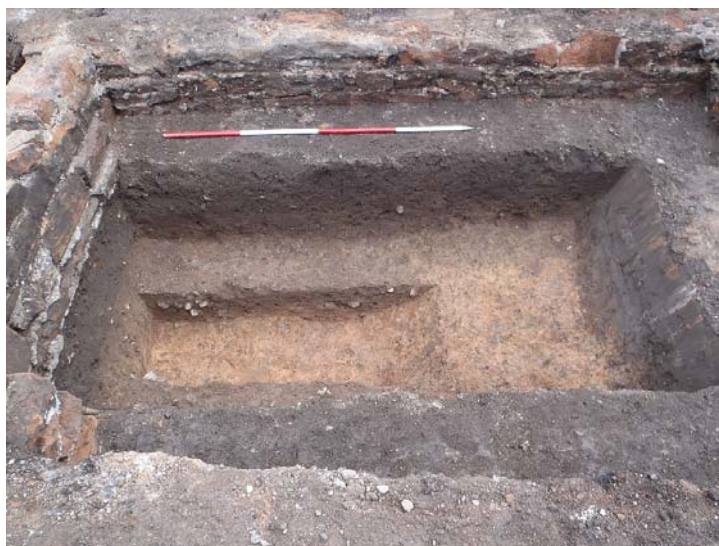
*Plate 13: Trench 5: ditch **5011**, looking south-east*

- 4.6.3 At the southern end of the trench, a shallow gully (**5013**), aligned north-east/south-west, was observed running along the eastern edge of the area excavated (Fig 6). This feature could be only partially investigated, but was 0.28m wide and 0.15m deep, and was filled with mid-brown silty sand (**5012**). It was cut by a considerably more substantial, north-west/south-east-aligned ditch (**5011**), 2.18m wide and 0.52m deep (Pl 13), filled with a mid-brown sandy silt (**5010**).

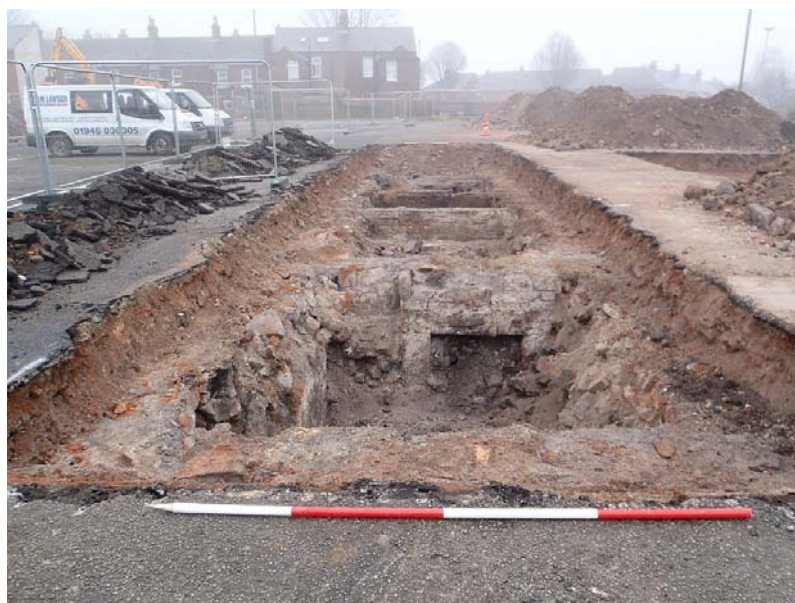
Plate 14: Trench 6, looking north-east, showing extensive cellaring

- 4.7.1 Trench 6 was located on the east side of the car park (Fig 2; Pl 14) and was aligned north-east/south-west. The trench measured 20 x 4m and was excavated to a maximum depth of 2.6m. As elsewhere, the tarmac and underlying rubble were mechanically removed to the tops of levelled late post-medieval walls, which seem to have represented the remains of a number of cellared buildings (Pl 14). At the south-west end of the trench, the rubble fill of one of the cellars was also removed mechanically to the level of the

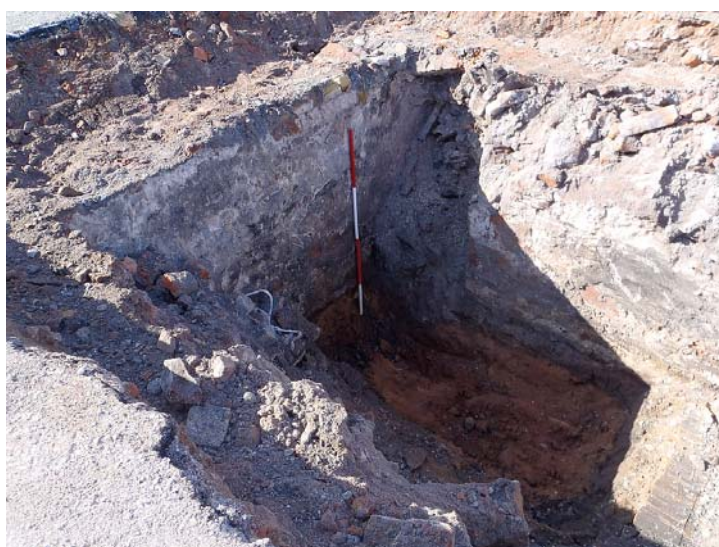
Plate 15: Trench 6: deeper excavation beneath the cellar floor at the south-west end of the trench, looking west

- 4.7.2 The natural geology (**6010**), a pale orange sandy clay, was recorded at a depth of 2.35m. Directly overlying this, beneath the cellar floor, was a levelling deposit of dark brown sandy gravel (**6009**), 0.2m thick, above this was the sandstone flagged floor (**6008**). The cellar walls (**6002**, **6003**, **6004**), which survived up to 1.6m above the level of the floor (Pl 15), appeared to have been built directly onto the natural clay. They comprised roughly-hewn sandstone blocks bonded with lime mortar, the internal wall faces being covered with a lime plaster. On both sides of wall **6004** were fireplaces, constructed using large sandstone blocks, and another fireplace (**6007**) was observed at the northern end of the trench. The excavated cellar was ultimately filled with loose sandstone and brick rubble (**6012**).

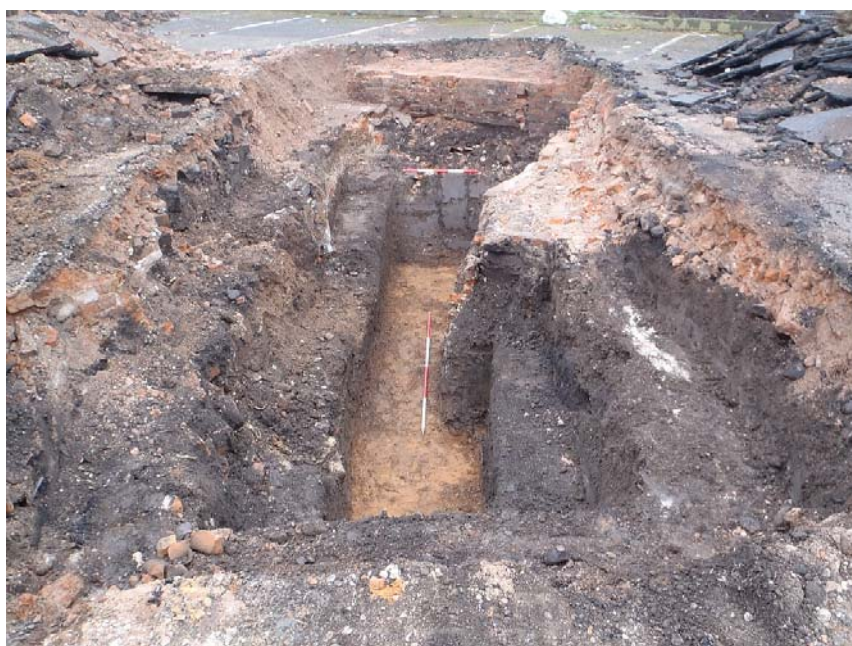
*Plate 16: Trench 7, looking west, showing natural geology **7018***

- 4.8.1 Trench 7 was located in the south-east corner of the car park (Fig 2) and was aligned east/west. It measured 10 x 4m and was excavated to a maximum depth of 2.5m. The tarmac and modern rubble beneath were mechanically reduced to the tops of surviving late post-medieval walls and other, contemporary, deposits, which were recorded before the area was reduced further to the level of the natural geology.
- 4.8.2 The natural geology (**7018**), an orange sandy gravel, was recorded at a depth of 2.5m below the car park surface (Pl 16). It was overlain by an accumulation of brown sandy silt soils (latest to earliest: **7017**, **7016**, **7015**), with a combined thickness of 0.8m (Pl 17).

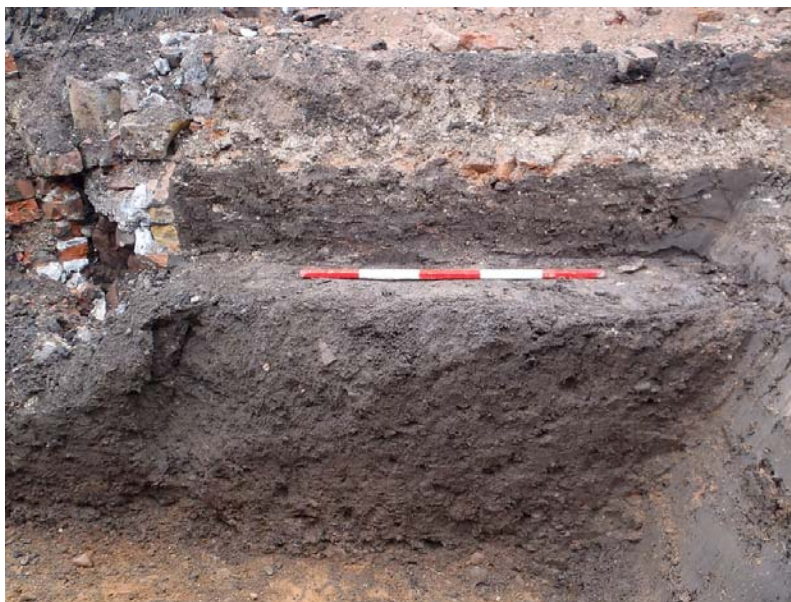
Plate 17: Trench 7: south-facing section, showing buried soils **7015-7017**

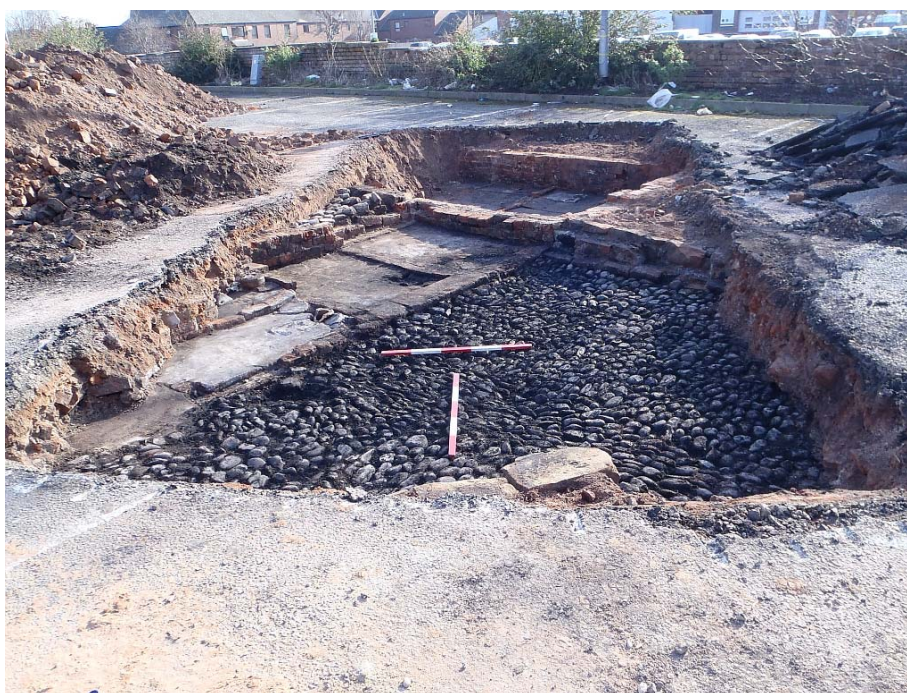
Plate 18: Trench 7 looking east, showing the remains of nineteenth-century buildings and associated external cobbled surfaces

- 4.8.4 Above the levelling deposits were the remains of several nineteenth-century structures and external areas (Pl 18). At the eastern end of the trench was a large room (**7006**) containing brick-walled cubicles and the remains of toilets. The walls of the room were constructed from bricks and mortar, for the most part, but there was also some sandstone block-work in some parts, possibly representing repairs or earlier elements of the building. The floor, of sandstone flags, was slightly lower than those of the other rooms in the trench, and was sealed by a layer of brick rubble (**7011**).

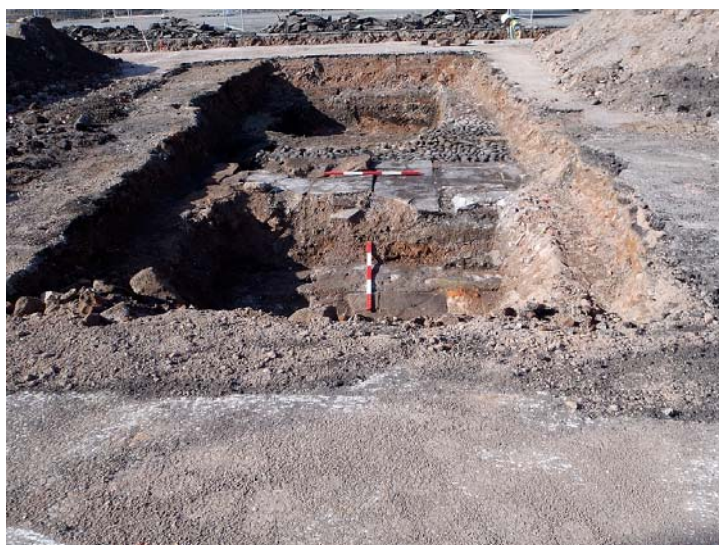
Plate 19: Trench 8, looking north-west

- 4.9.1 Trench 8 was located on the east side of the car park (Fig 2), to the east of Trench 6, and was aligned north-west/south-east. It measured 10 x 4m and was excavated to a maximum depth of 2.4m. As elsewhere, the tarmac and the underlying rubble were mechanically reduced to the tops of surviving late post-medieval walls, and associated deposits (Pl 18). These were then removed and the trench was reduced further to the top of the natural geology.

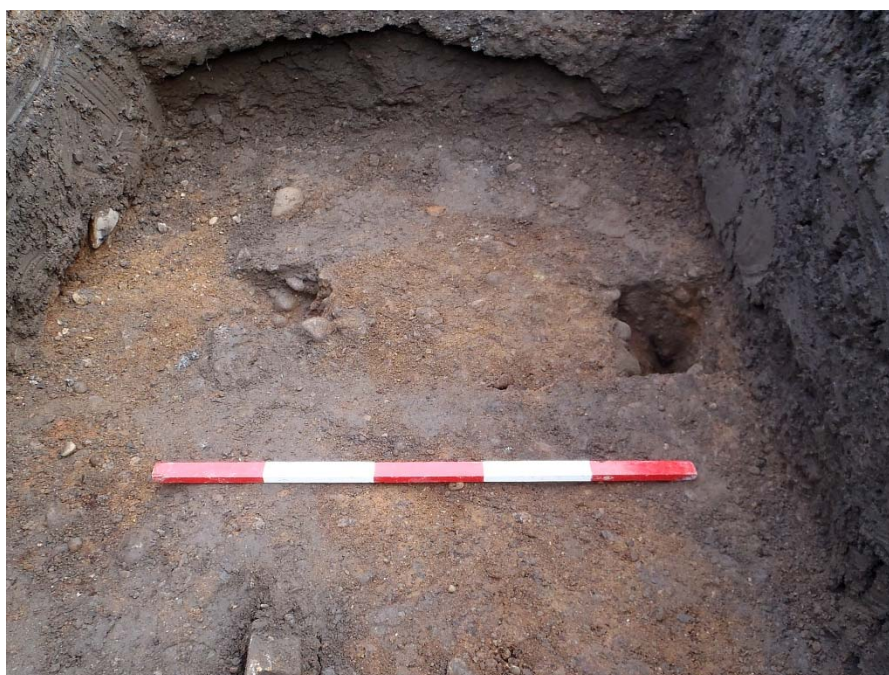
Plate 20: Trench 8: linear features **8020** and **8023**, looking south-east

Plate 20: Gullies **8020** and **8023** looking south-east

- 4.9.2 The natural geology (**8027**), an orange sandy gravel, was recorded at a depth of 2.36m, and was cut by several earth-filled features (Fig 7). At the south-eastern end of the trench were two parallel, north-west/south-east-aligned linear features (**8020**, **8023**; Pl 20). The full profile of **8020** was excavated, showing that it had steep sides and a fairly flat base, which would be consistent with its interpretation as a possible beam slot, rather than something like a drainage gully. It was 0.24m wide and survived to a depth of 0.1m, and was filled with a mid-dark brownish-grey sandy silt (**8019**). Feature **8023** was only exposed against the western edge of the trench, therefore a full profile could not be obtained, though it had fairly steep sides and survived to a depth of 0.41m. It was filled by two deposits, a primary fill of dark grey sandy silt (**8022**) below an orange-brown silty sand (**8021**), the latter possibly representing intentional back filling of the feature.

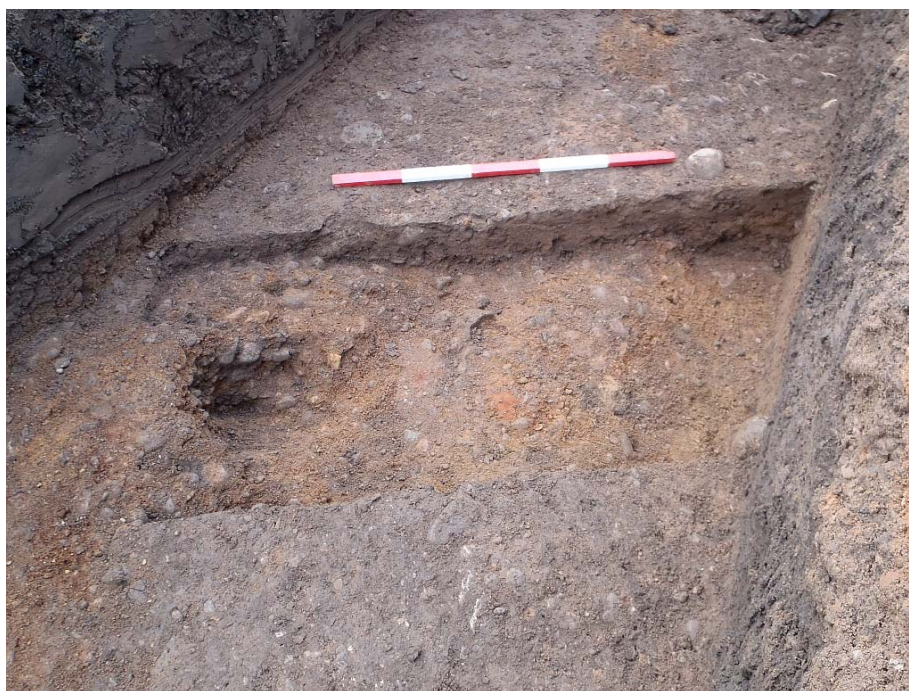
Plate 21: Trench 8: posthole **8012** and linear features **8014**, **8016** and **8018**, looking north-west.

Plate 21: Posthole **8012** and ditches **8014**, **8016** and **8018** looking north-west.

- 4.9.3 At the northern end of the trench, the natural clay was cut by several features (Pl 21), the earliest of which appeared to be a shallow, north-east/south-west-aligned gully (**8016**), 0.4m wide but only 80mm deep, and a second, north-west/south-east-aligned linear feature (**8018**), 0.5m wide and 0.25m deep. Both were filled with mixed grey-brown sandy silts (**8015** and **8017** respectively), and were cut by a shallow, north-east/south-west ditch (**8014**), 1.2m wide and 0.19m deep, filled with grey-brown sandy silt (**8013**). **8014** also appeared to cut a posthole (**8012**), located on its western edge. This was 0.27m in diameter and 0.26m deep, and was filled with mid-greyish-brown sandy silt (**8011**).
