# **FORMER MAZDA GARAGE, NEWTON DRIVE, BLACKPOOL**

## **Archaeological Building Investigation and Watching Brief**

**Oxford Archaeology North**

December 2014

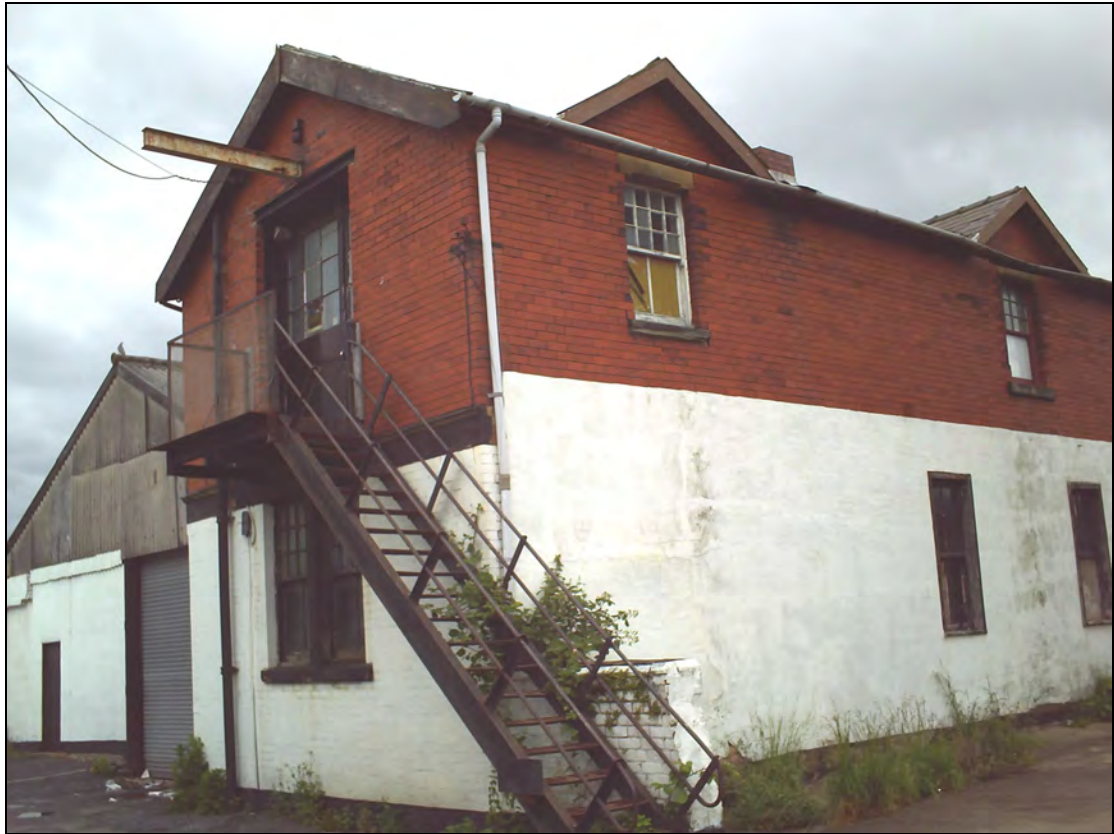
Plate 1: The west elevation of the stable block

4.2.1 The stable block was constructed from machine-cut, cinnabar-red brick laid in a stretcher bond, to which a whitewashed, cement render had been applied on the ground floor (Plate 1). The roof was moderately pitched with gablettes over the first-floor windows on the north and south elevations (Plate 2), and these gablettes, like the roof itself, were laid with regular-coursed Welsh slate and ceramic ridge tiles. Plain timber weather-boards dressed the eaves (Plate 3). In addition, a small, squat ridge-stack was just visible towards the west end of the building (Plate 2), but the presence of the gablettes obscured any evidence of further chimneys.

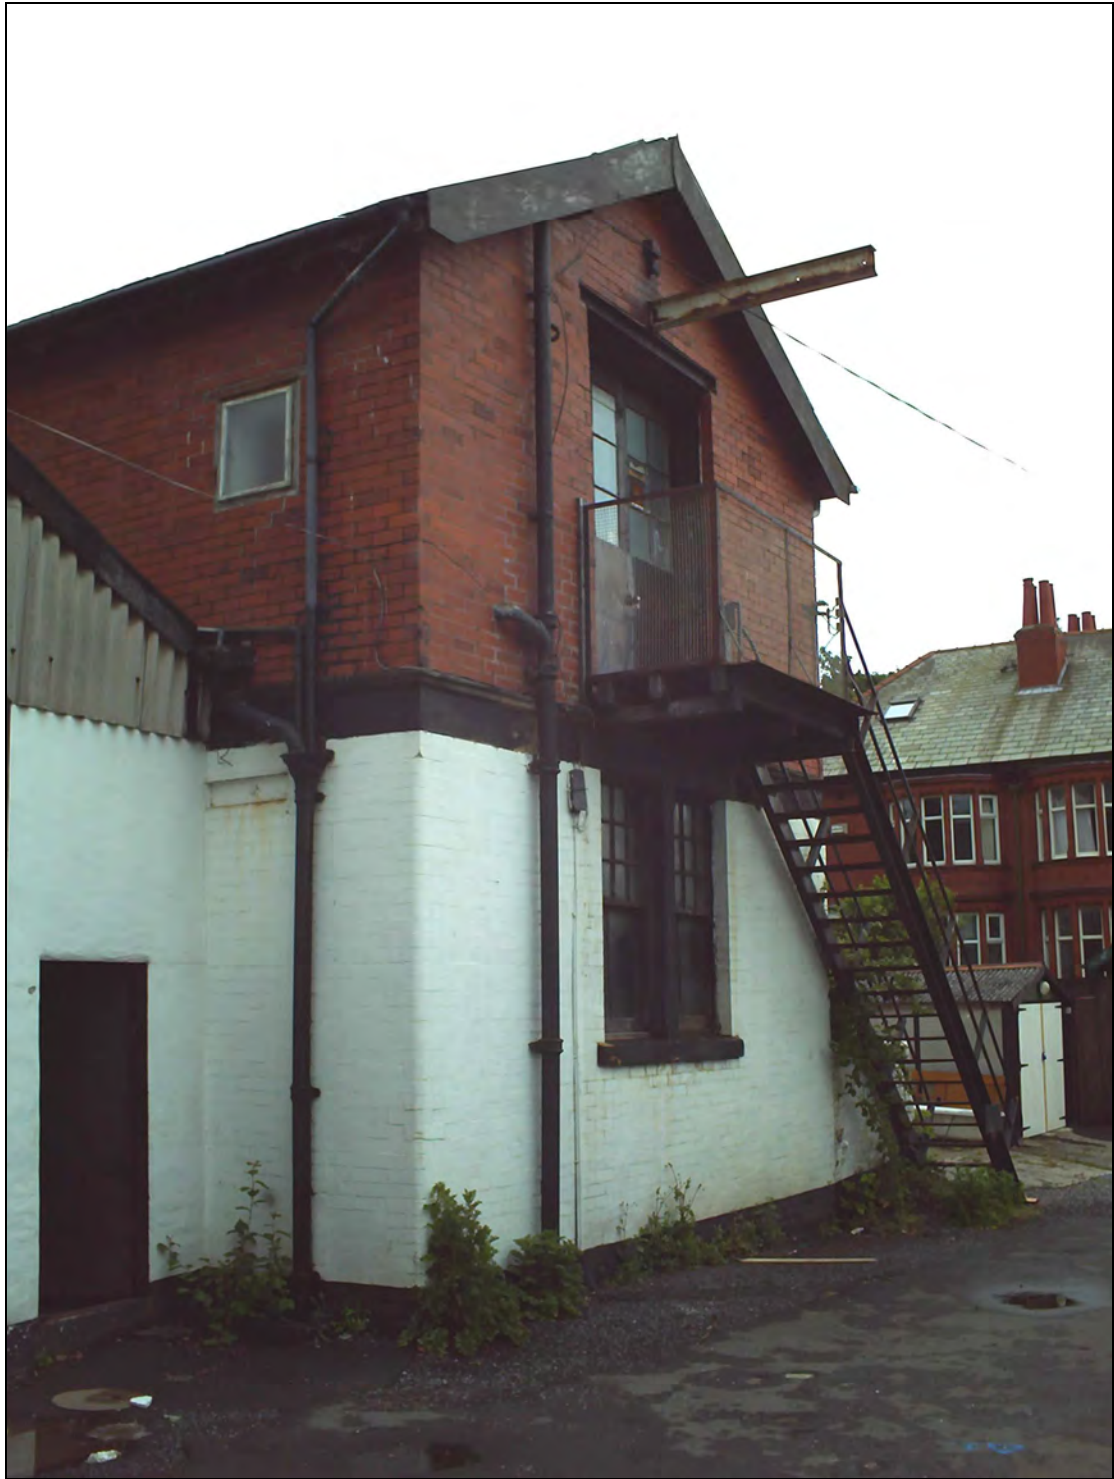
Plate 3: The west elevation

4.2.3 The main doors on the front (north) of the building were matchboard sliding doors, featuring chamfered glass panels and horse-shoe motif runners on the rails (Plates 7 and 8). In addition, there was a pair of glazed, matchboard fire doors on the west elevation, which provided access to a single-flight, iron fire escape. The presence of an RSJ, extending from the brickwork above the doorway by approximately a metre, would suggest that these fire doors were originally used as loading doors (Plate 3).

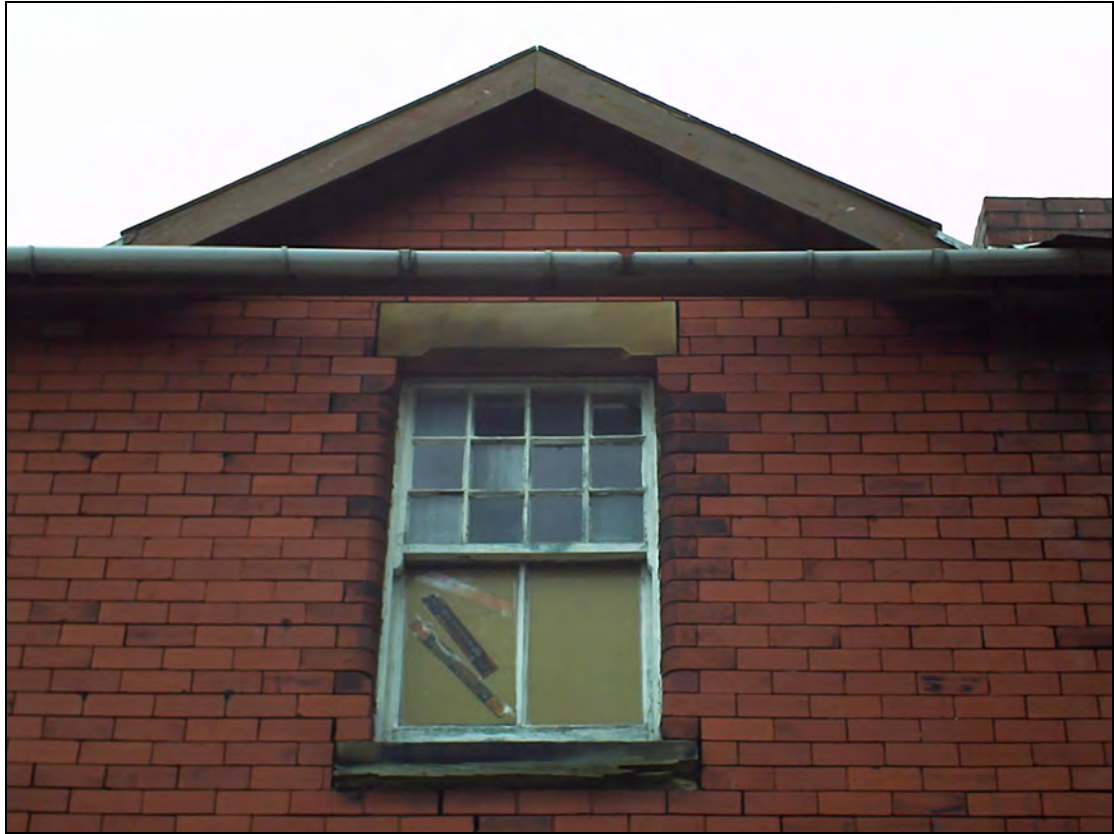
Plate 4: Typical first-floor window

4.2.2 The majority of the windows were twelve-over-two sashes with external horns, featuring stop-chamfered, sandstone lintels and projecting sandstone sills, as well as stop-chamfered jambs, comprising bullnose and bullnose-stop bricks (Plate 4). Of the pair of windows still visible on the north elevation, the more easterly had been converted into a top-hung ventilator casement, whilst the sash on the western gable elevation was mullioned with stop-chamfered detail and plain jambs (Plate 5). A further pair of sashes was located on the ground floor of the south elevation, but these had plain surrounds, with no lintels or sills to speak of (Plate 6).

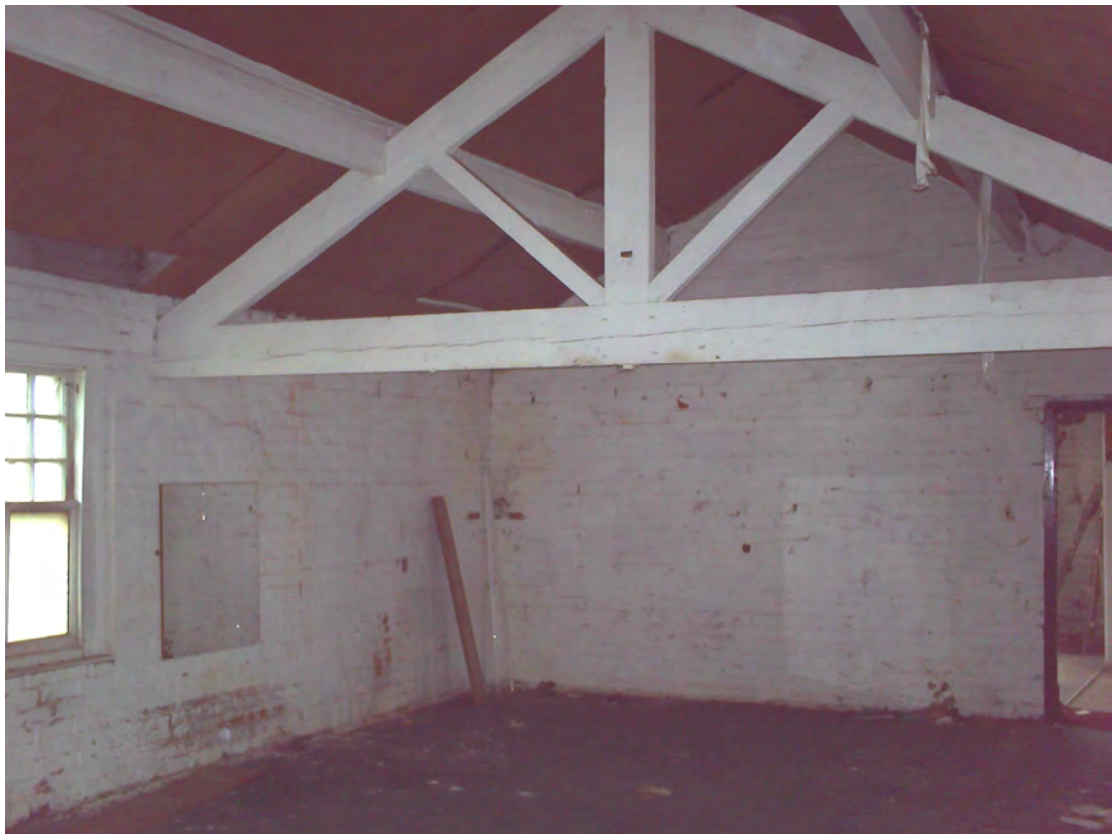
Plate 9: General view of the interior of the stable block

- 4.3.2 The internal walls were, for the most part, bare bricks laid in a stretcher bond and painted white (Plate 9), though some courses of headers were visible on the first floor towards the base of the south wall. The most notable exception to this, was room 2, one of the stable rooms, which was lined with mustard-coloured ceramic tiles featuring a stylised floral motif at ceiling level (Plate 10). In addition, the stalls themselves had been removed, but ogee facades of timber panelling, as well as iron posts with urn finials, adorned the west and east walls, and provided a clear indication of the stalls original design (Plate 11). Similarly, the adjacent room (3) was lined floor to ceiling with timber panels, and included a moulded timber cornice (Plate 12), whilst timber panelling had also been used to partition the stairs on the first floor, and to divide rooms 6 and 7. In the north-east corner of room 6, a small office had been created with the insertion of a plasterboard, timber and glass partition (Plate 13), whilst in room 9, a brick partition had been inserted into the north-west corner to create a small toilet.

- 4.3.3 The roof was constructed from four machine-cut king-post trusses, each of which supported a pair of trenched purlins and matching ridge plate (Plate 9). Three of these trusses were located within room 6 at the east end of the building, with the most westerly of the three forming part of the timber partition with room 7. The final truss was located in room 8, whilst the load-bearing brick walls of the same room provided the remainder of the roof's structural support. In addition, a small brace had been affixed to the purlins in room 9. Some of the machine-cut rafters and gablettes were exposed, but the greater part of the roof had been lined with hardboard sheeting.

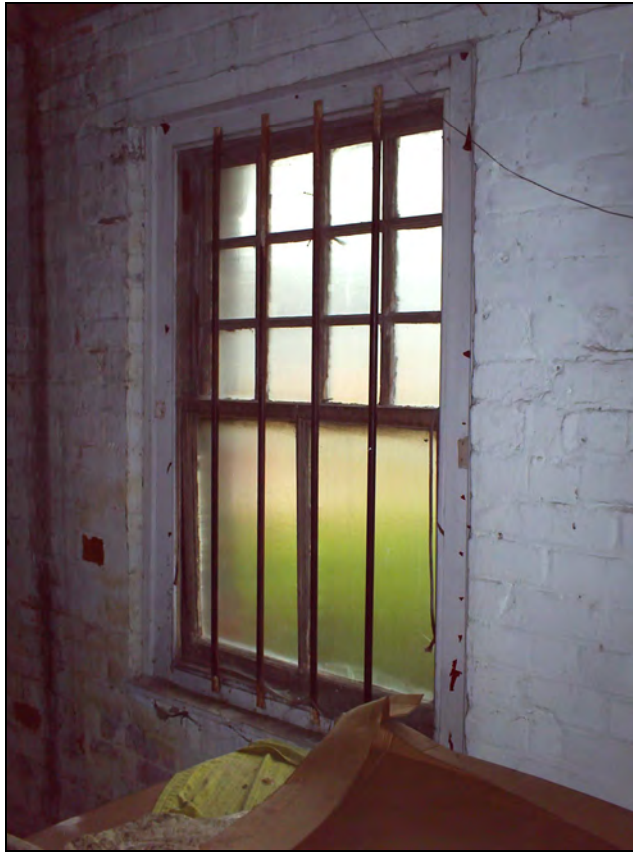
Plate14: South-facing first-floor window

- 4.3.4 The sash windows had square reveals, timber lintels and iron security bars (Plate 14), whilst at the east end of the first floor, there was a further window, bisected by the partition for the small office, and boarded with timber slats. At the east-end of the north elevation, there was a pair of mullioned, fixed-light windows with frosted glass, timber lintels, and square reveals. Modern matchboard shutters had been added to these windows, and nailed to the frames. A small fixed-light window was recorded at the western end of the northern elevation with a sash window to its east. Both lay within the area partitioned off as a first-floor toilet within room 9. A further large fixed-light window was also located on the ground floor, between rooms 4 and 5 (Plate 15).

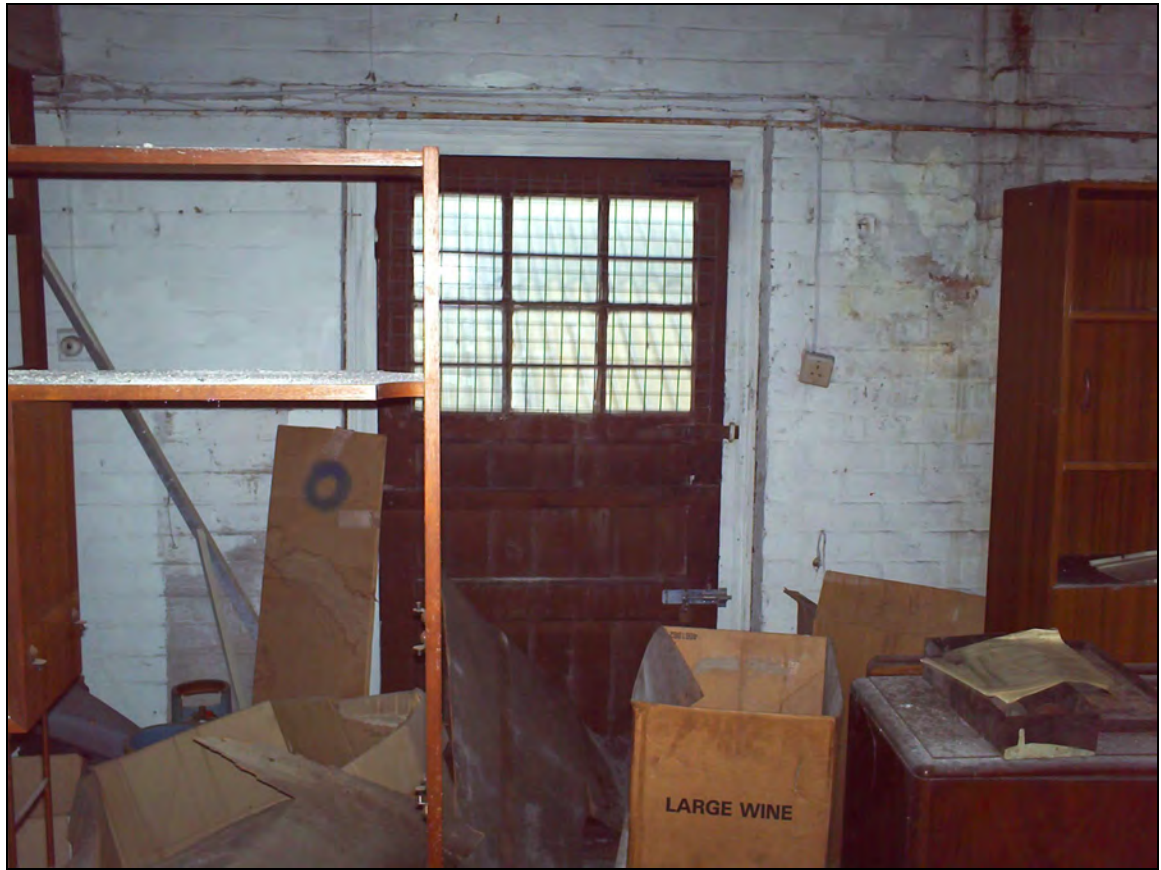
Plate16: Loading door on northern elevation, facing north

- 4.3.5 None of the internal doors survived, apart from a panel door on the partition of the small office (room 7). In addition, there was a series of loading doors on the north elevation, which were not visible on the exterior, following the addition of the extension on the northern elevation (Plate 16).
