143 Oundle Road
Woodston,
Peterborough

**Level 1 Historic Buildings
Photographic Survey**

OA East Report No: 1903

Level 1 Historic Buildings Photographic Survey

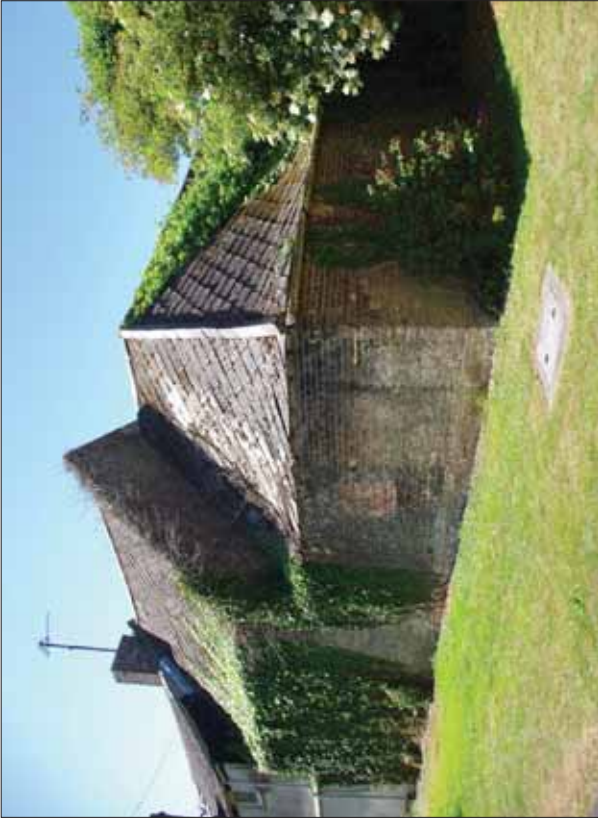
3.2.5 This elevation, in common with the south and east elevations, is constructed of hand made bricks. Brick repairs have been added to the lower roof line (Plate 2).

3.2.6 Evidence for two blocked windows are visible, these form part of a series of such features along the entire north elevation, and recorded in the separate room interiors of the building.

3.2.7 The roof is identical to that along the south facade, constructed of greyish blue asbestos diamond-shaped tiles with glass covered openings inserted. Along the eaves the roof slope shallowed giving the overall appearance of a Bell Cast type roof.

Plate 2: North and east elevation, from north-east

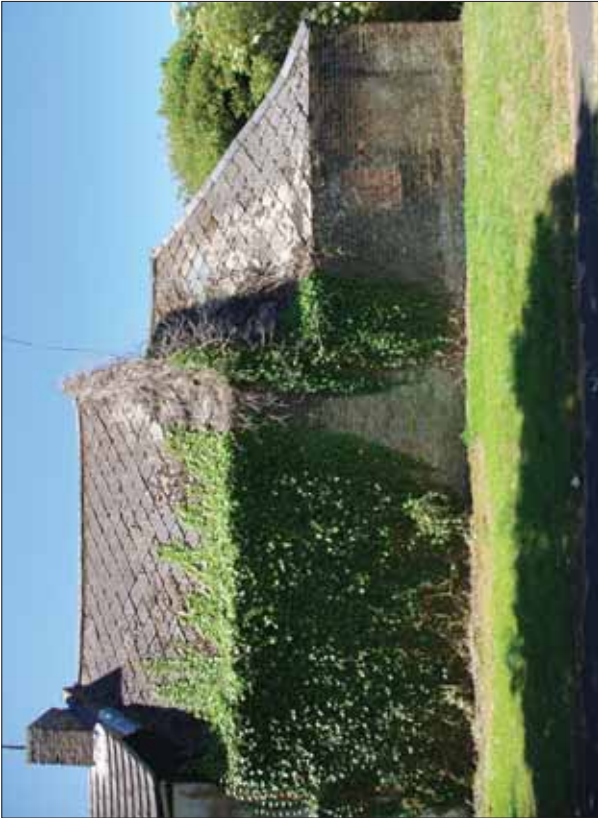
3.2.1 This elevation incorporated the east gable end of the building with a barn structure added against the south side of the building. The main building is a single storey structure (Room 1), with blocked window. The later barn comprises a two storey structure (Room 6) which contains a larger blocked window at first floor level.

3.2.2 The walls are constructed of hand-made brick, the respective roofs are constructed from greyish blue asbestos diamond-shaped tiles and grey slate tiles, parts of which have been repaired at various times. The roof of the main building is shallow sloping around its base, possibly suggesting a Bell Cast type of roof style, but its east end is of Hip roof style. The north end is of gable end style.

Plate 1: East Elevation showing blocked window, from east

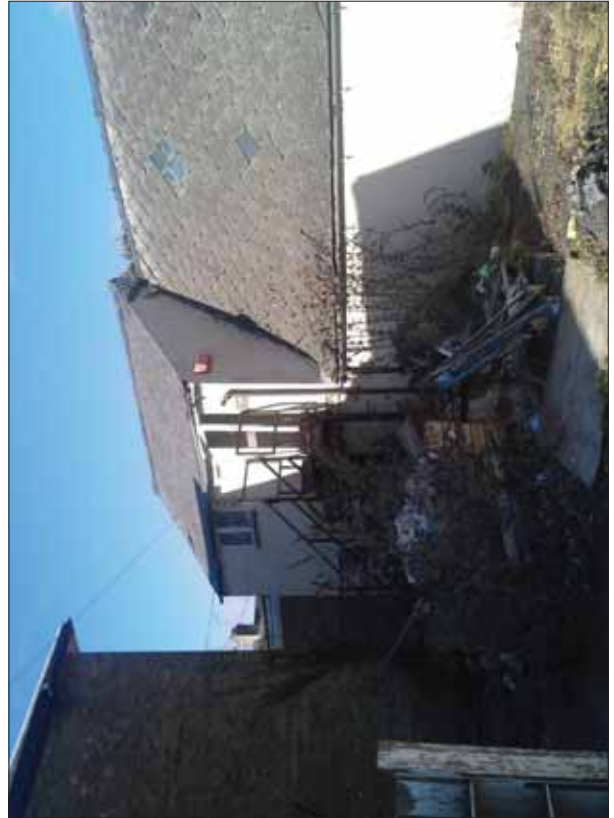
3.2.8 This aspect of the building is entirely constructed from hand-made bricks. A cottage of contemporary date at the west end of the building comprises two storeys, the upper floor being accessed by an external cast iron metal stair (Plate 3). Its lower space comprised Room 4. A mid-late 20th century brick extension, of single storey height, containing Room 5, had been added to the west end of the cottage.

Plate 3: South elevation of cottage at west end of building, from south-east

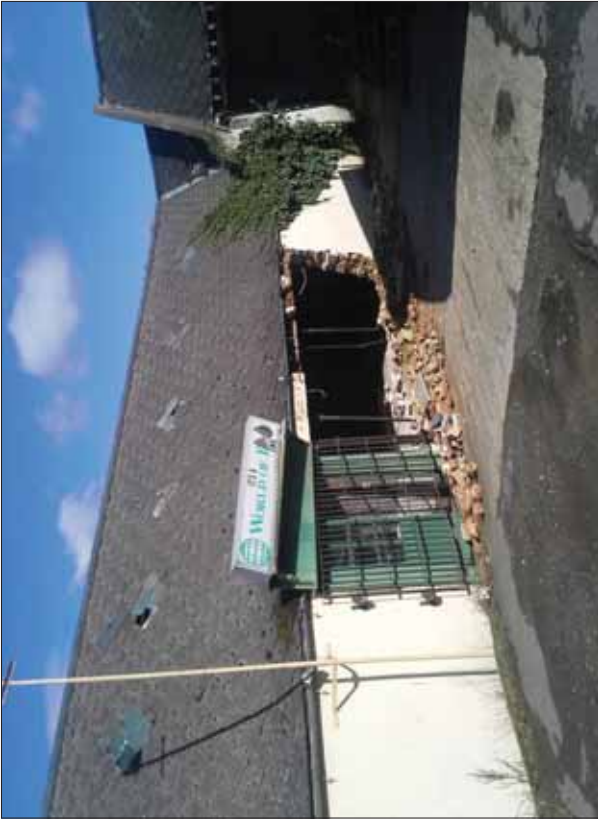
3.2.10 Towards the east end of the range part of the wall has collapsed (Plate 6). Where the wall survives a blocked window and doorway are present. These elements were possibly originally external openings but are now internal to the barn structure (Room 6).

Plate 6: East end of south elevation of building, from south-west

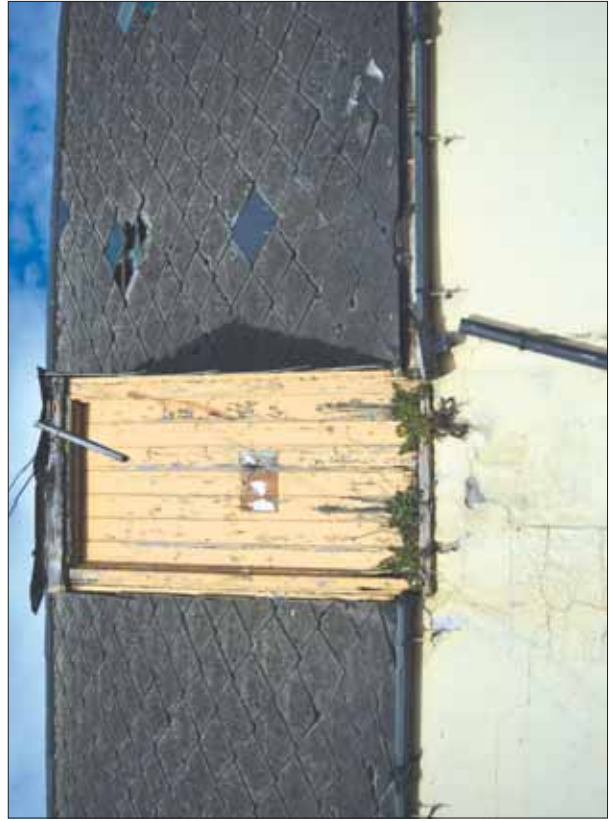
3.2.9 A double doorway accessing Room 1 (Plate 5) was recorded midway along the southern elevation. A door way in the roof space allowing access to Room 8 (Plate 8) was possibly used for loading and unloading goods.

Plate 8: Detail of door into roof space of south elevation, from south

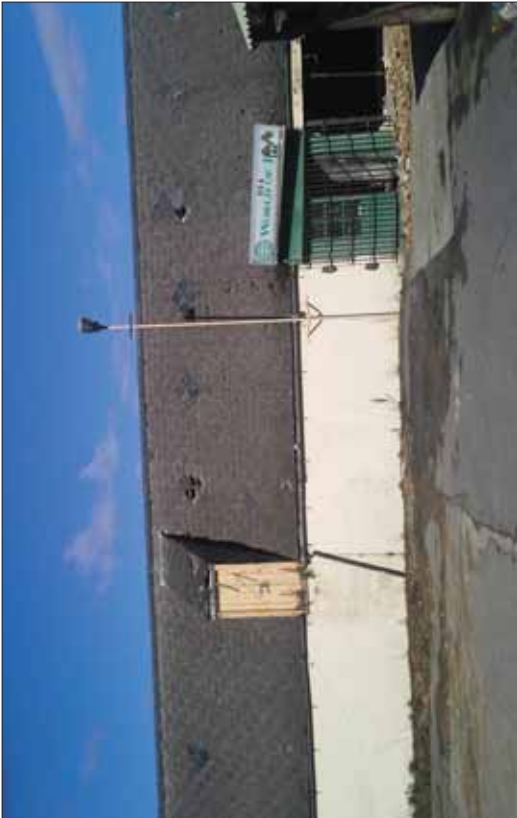
- 3.2.11 The roof is covered with large greyish blue diamond-shaped asbestos tiles with a series of glass covered openings which match the pattern of former (Plate 5).

Plate 5: Mid point of south elevation of building, from south

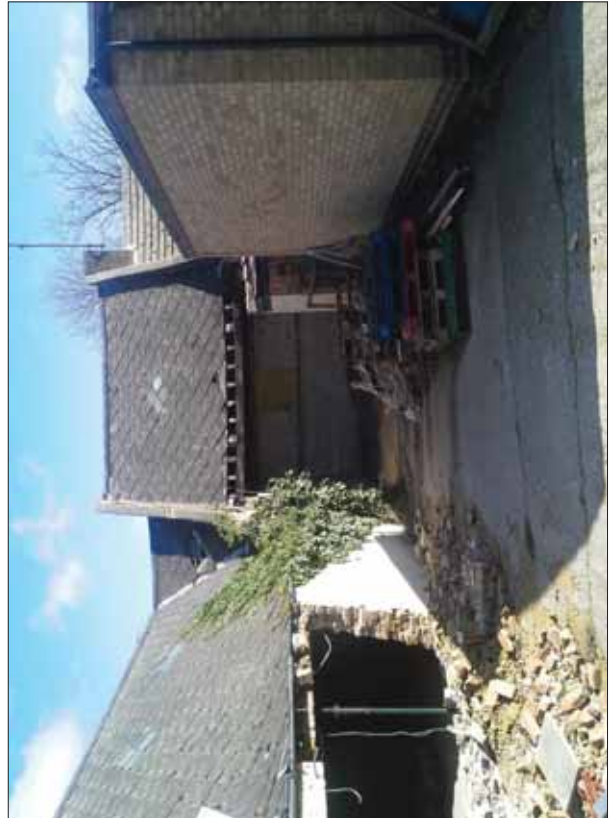
- 3.3.26 Room 6 comprised part of a two storey brick built shed or barn and formed a portion of the east elevation of the building (Plate 7).
- 3.3.27 The possible barn contains a door way at first floor level (Plate 32), and a blocked window (Plate 33).
- 3.3.28 The room measures 7.16m by 5.23m with an overall height at the apex of the pitched wooden beamed roof of 6.6m. The height of the ceiling to the ground floor is approximately 2m.

Plate 7: Room 6 west elevation, from west

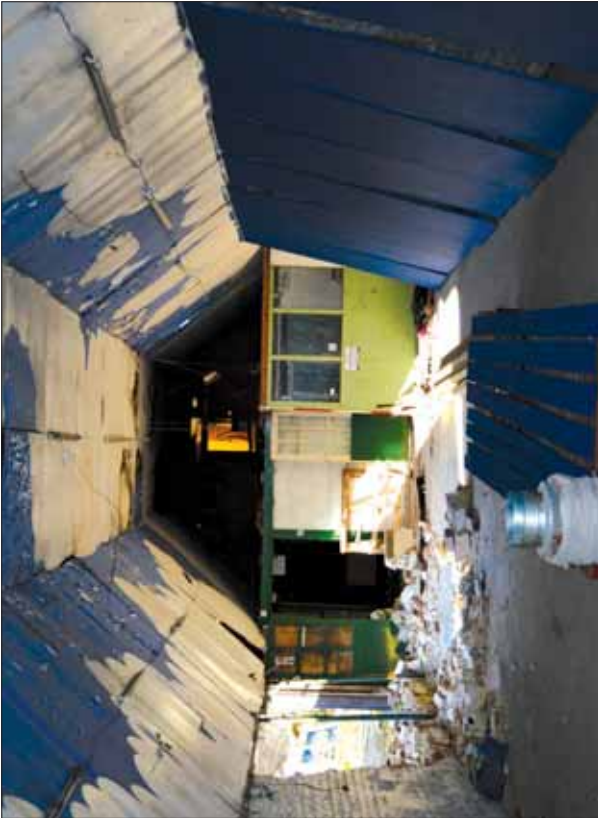
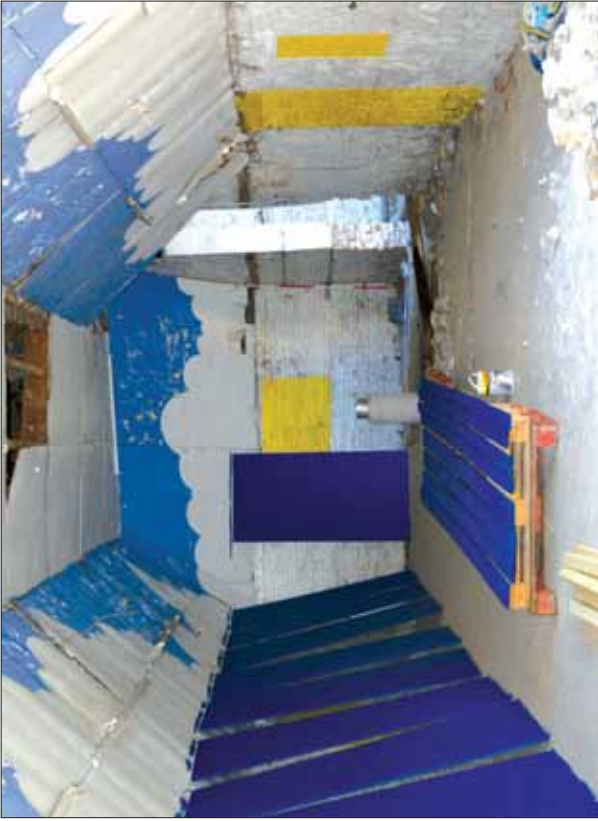
- 3.3.1 This room is the largest element forming the eastern part of building. (Fig. 3 and Plates 9 and 10). It is accessed by a double doorway in the south elevation (Plate 15). The present room measures 18.24m x 4.73m and has a ceiling height of 3.77m. At present the room is empty but may have been used as storage for goods relatively recently.

Plate 10: Detail of Room 1, from west

Plate 9: Detail of Room 1, from east

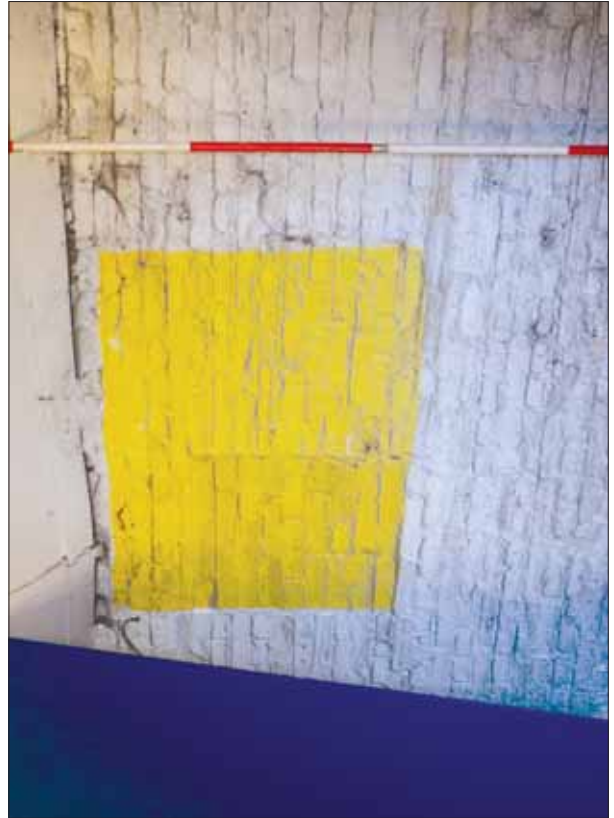
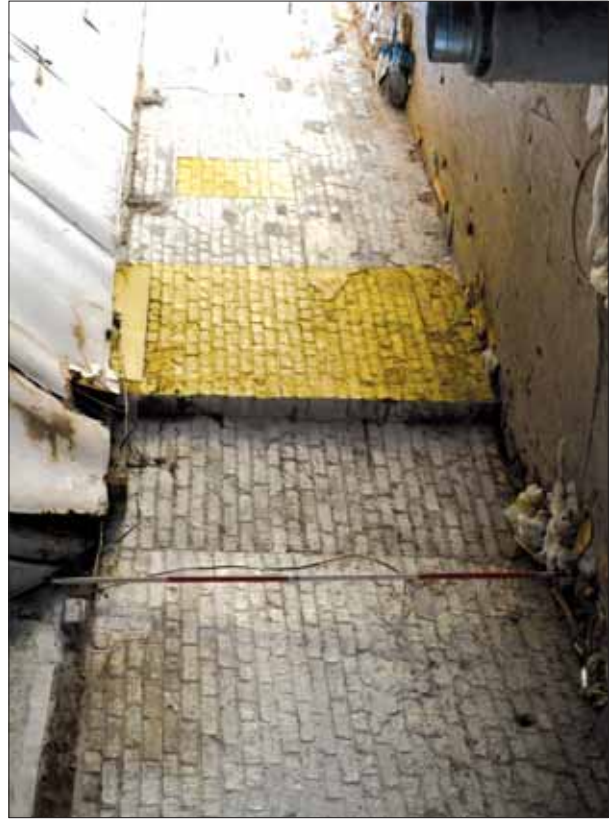
- 3.3.3 Small windows measuring 1.1m by 0.60m are located along the north, east and south walls (Plates 11 and 12). These too are most probably of a 19th Century date and reflect the building's utilitarian use.

Plate 12: Blocked door and window in south wall of Room 1, from north-east

Plate 11: Blocked window east wall of Room 1, from south-west

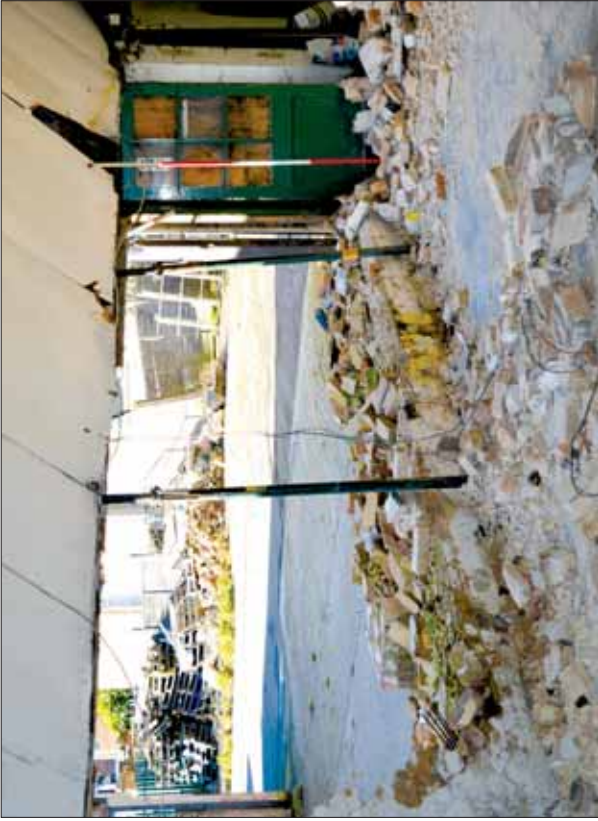
- 3.3.4 The south wall of the room fronts onto the open yard area but is partially collapsed. It is 0.35m thick and constructed from hand-made bricks of probably late 18th or early 19th century date.

Plate 14: Collapsed southern wall to Room 1, from north-east

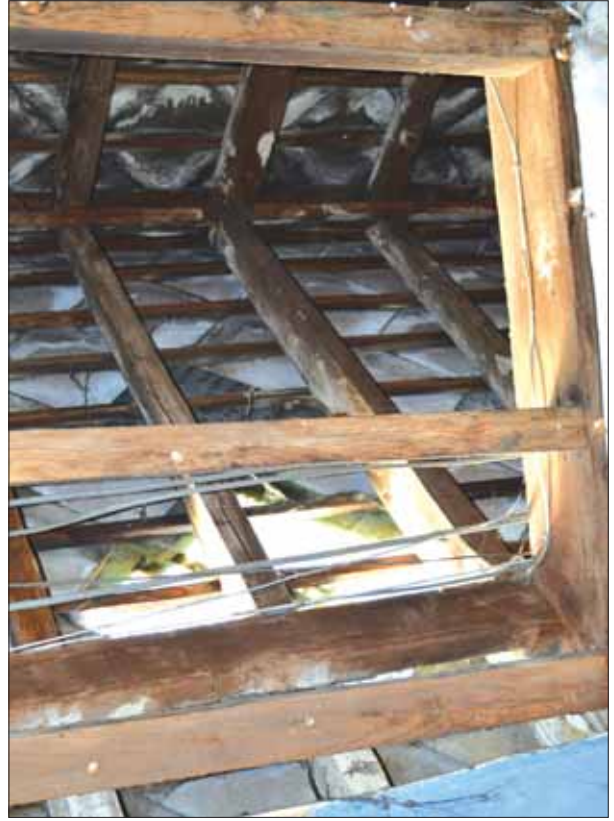
- 3.3.5 The floor of the room is constructed from a concrete slab which seals an earlier brick floor.
- 3.3.6 The ceiling comprises wooden boarding which is a later addition and hides a timber beamed roof (Plate 16).

Plate 16: Detail of exposed roof space in Room 1, from east

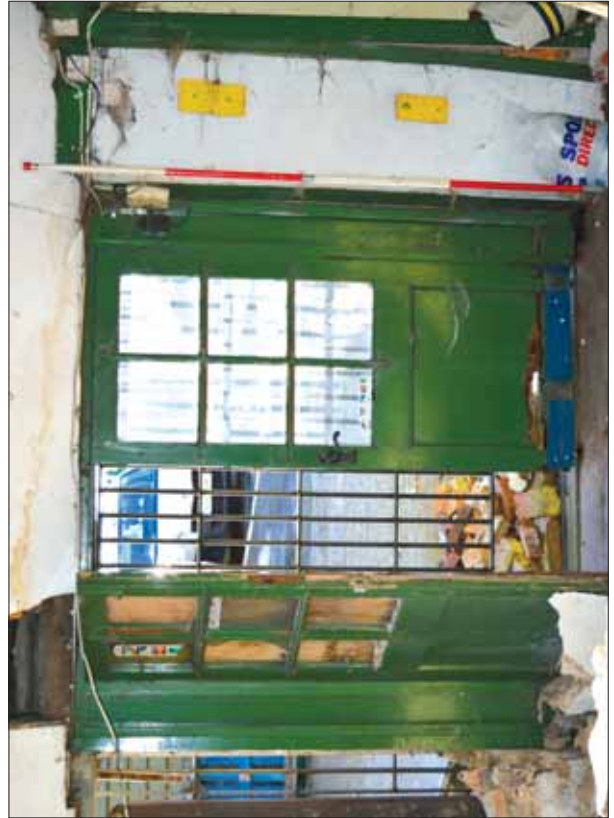
- 3.3.2 The exterior grounds (Plate 15) are accessed by late 19th Century timber double doors with decorative cast iron handles. Each door contains six small windows in its upper parts, while the lower parts comprise a wooden panel. Each door measures 1.85m by 0.91m.

Plate 15: Door detail in southern wall of Room 1, from north

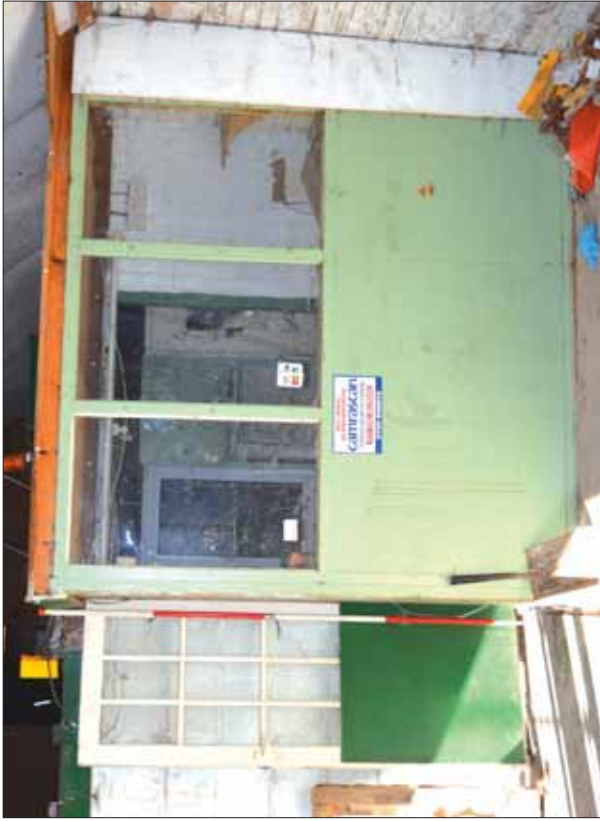
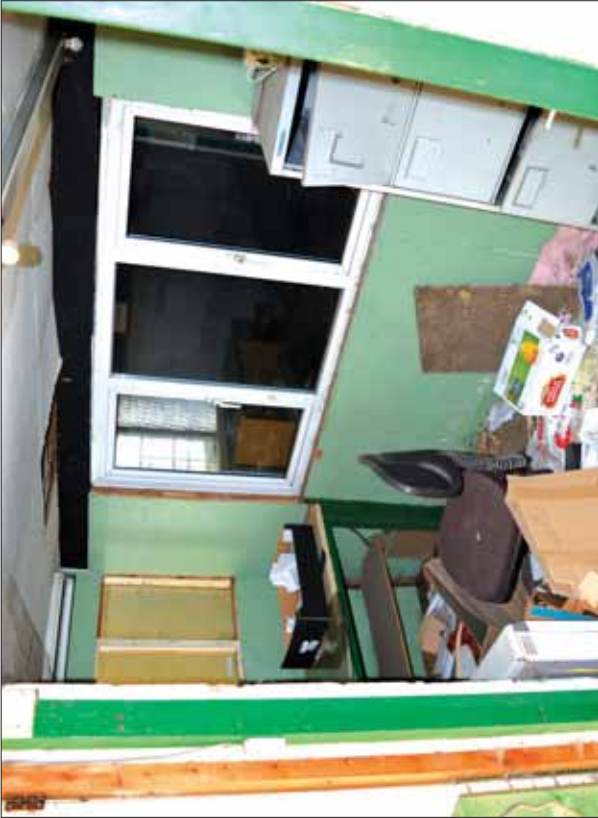
- 3.3.7 This room forms part of an office complex which is a later addition at the west end of Room 1 (Plate 18) and east end of Room 3 (Plate 22). The room was constructed by the insertion of ply board walls forming the east, south and west side of a two cell office (Plates 19, 20 and 21). Each of these walls is painted dark and pale green. The two cell rooms measure 1.04m by 2.13m and 1.64m by 3.79m respectively, the ceiling being at a height of 1.99m.
- 3.3.8 A timber door, measuring 1.85m by 0.91m and containing nine glass panels in the upper half, leads into Room 1. A second timber door leading into Room 3 is 1.85m by 0.74m and contains a single glass panel in the upper part.
- 3.3.9 Windows are present in the east, south and west walls. A blocked window is located in the external north wall.

Plate 18: Detail of east side of Room 2 and door, from east

Plate 22: General shot of office area in Room 2, from north-east

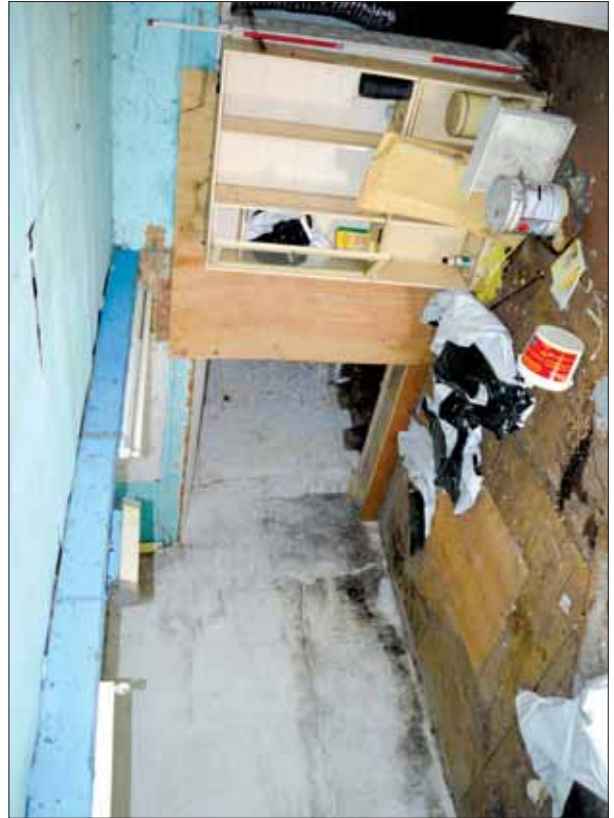
- 3.3.31 This room is a small sub-division of the west end of Room 3, against the east end of Room 4, (Plates 34 and 35). Room 7 measured 5.42m by 2.3m and was 1.89m high. The walls were of white washed bricks and the ceiling comprised chip board. A blocked window is located in the northern external wall.
- 3.3.32 The room sits directly below the west end of Room 8, where a brick archway is present (Plate 39). This archway may have acted as a relieving arch to support a large opening into the room from Room 4 (Plate 27)

Plate 27: Detail of Room 4, from south-west

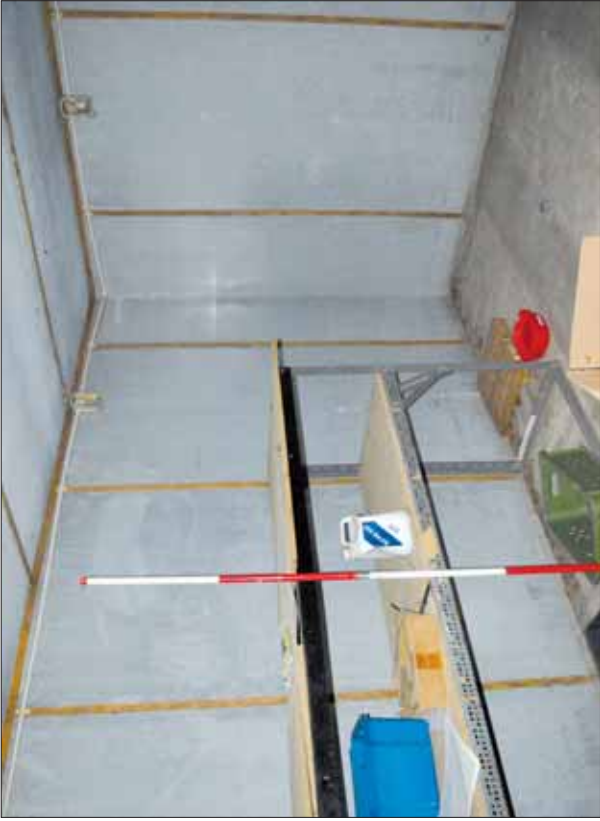
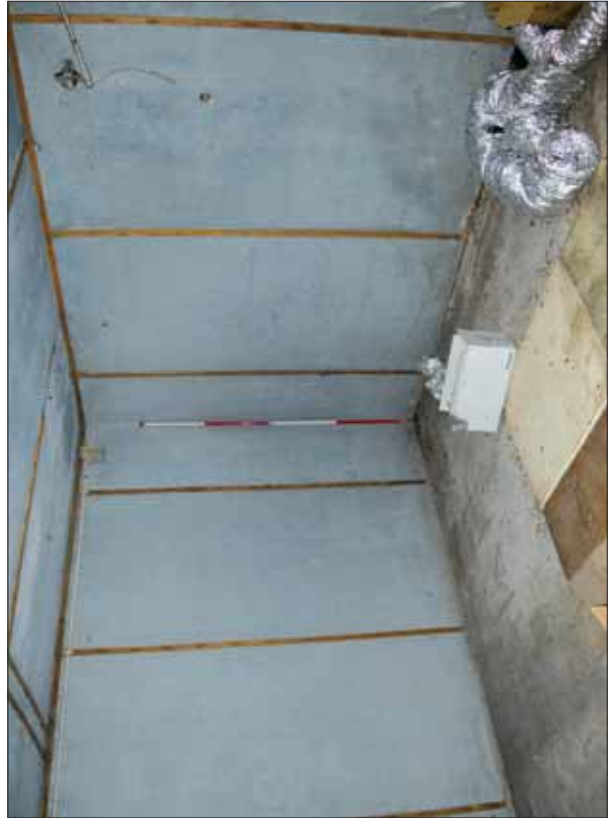
- 3.3.23 Room 5 is the most recent building in the complex, constructed of machine-made brick. It measures 5.22m by 4.95m with a ceiling height of 2.58m (Plate 30 and 31). The room contained no visible windows and may have been used for a storage room.
- 3.3.24 The ceiling and walls are plastered and white washed (Plate 30).
- 3.3.25 The floor surface consists of a covering of concrete screed (Plate 31).

Plate 30: Detail of north-west corner of Room 5, from south-east

Plate 31: Detail of north-east corner of Room 5, from south-west

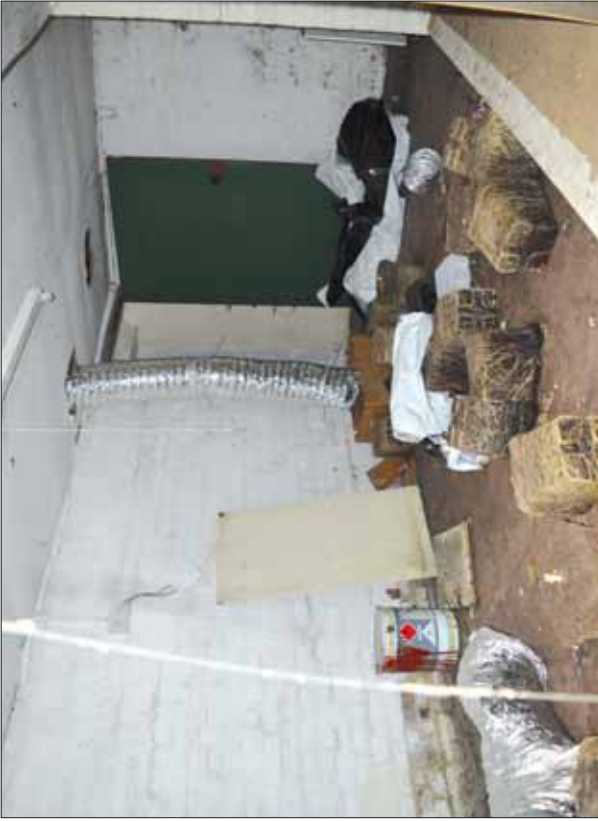
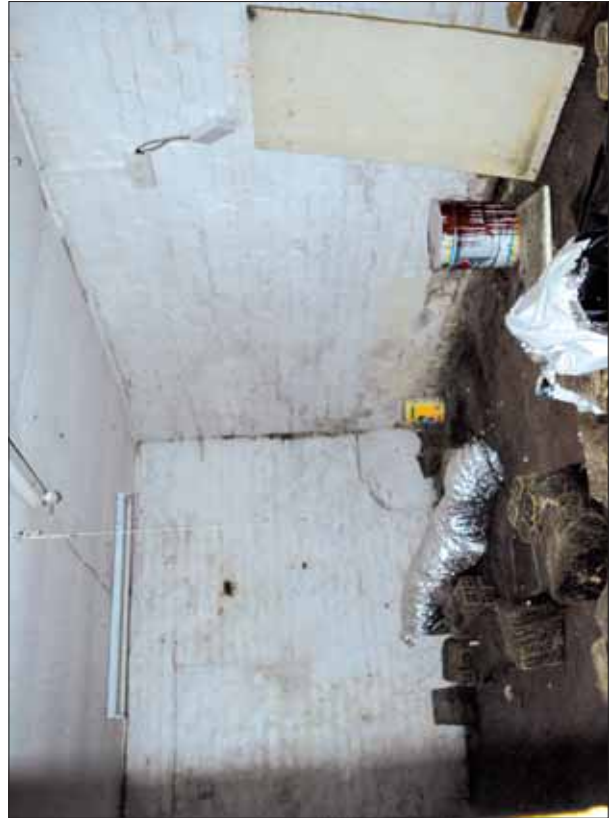
Plate 34: Detail of Room 7, from north-west

Plate 35: Detail of Room 7, from south-west

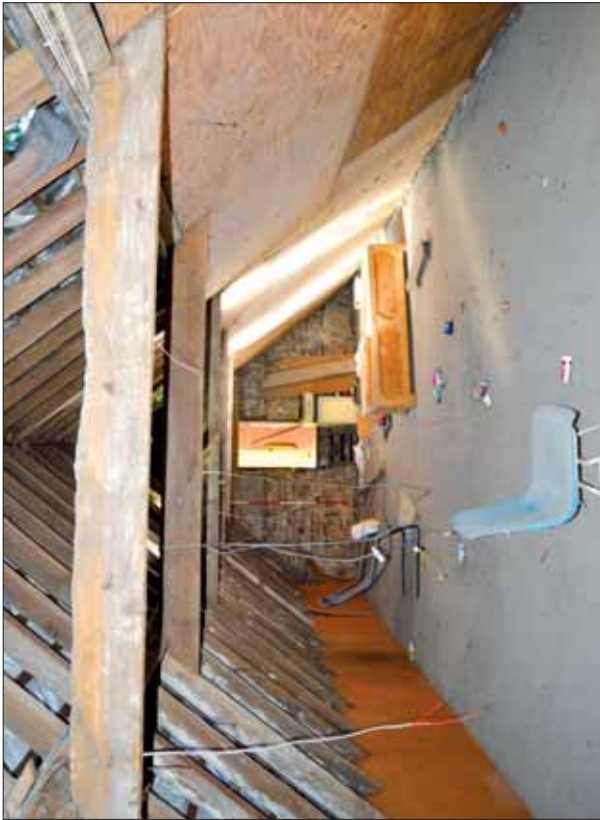
- 3.3.34 The room measures 11.13m by 4.66m (Plates 38 and 39) and is 3.61m high at the apex of the timber roof.
- 3.3.35 A ply board wall at the east end of the room has an opening accessing an extension of the first floor level towards Room 1 (Plate 37). This possibly proved that a wall at the east end of the first floor floor space has been removed.

- 3.3.36 The floor is constructed of wooden ply board suggesting a modern construction.(Plate 38).
- 3.3.37 The roof support comprises timber beams (Plate 41).

Plate 38: Detail of Room 8, from east

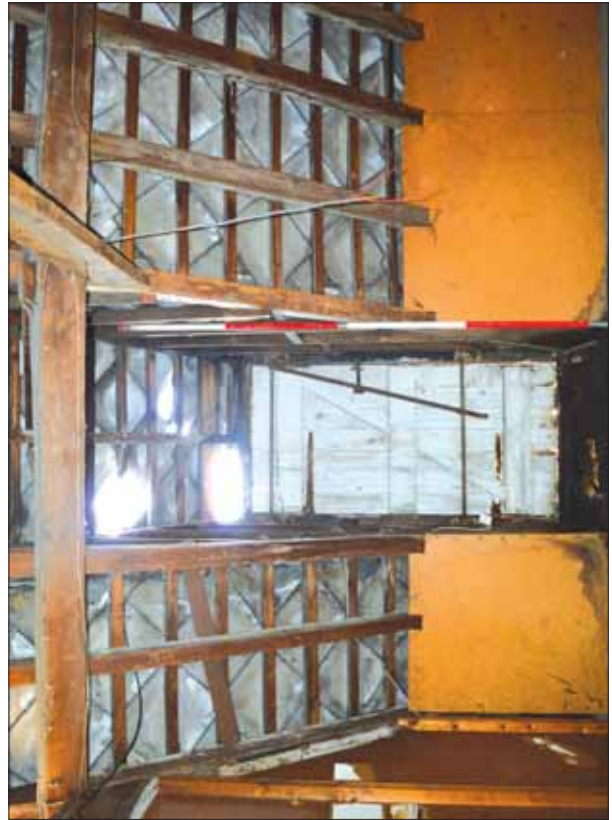
- 3.3.38 A doorway into the southern side of the roof space acted as a way of access for goods to be deposited at first floor level to avoid the stairs (Plate 40). The door measures 1.45m by 0.85m and is constructed from timber planks with iron brackets and handle, typical of a 19th century date.

Plate 40: Detail of door into south side of Room 8, from north

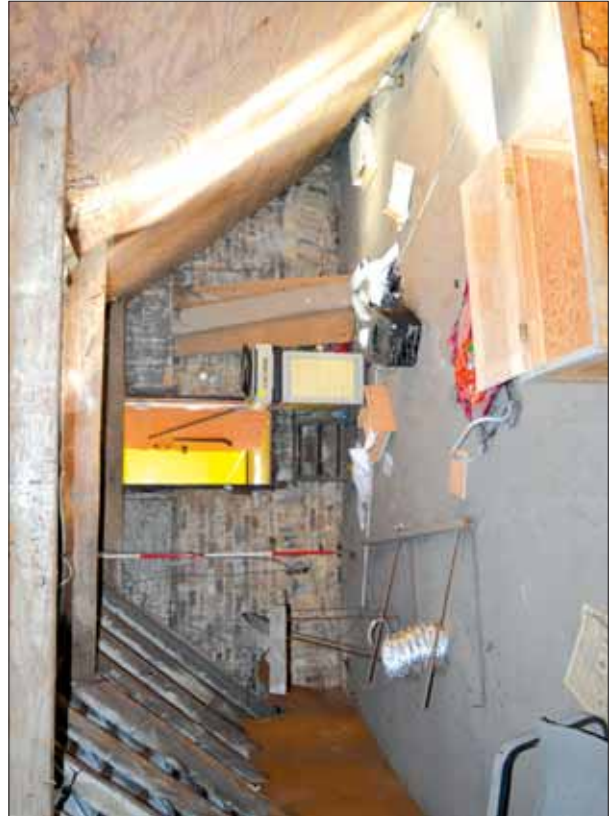
- 3.3.39 A large brick relieving arch, built into the west wall of the building, provides support above the opening into the west wall of Room 7, below (Plate 39).

Plate 39: Detail of west wall to Room 8 showing doorway and relieving arch, from east

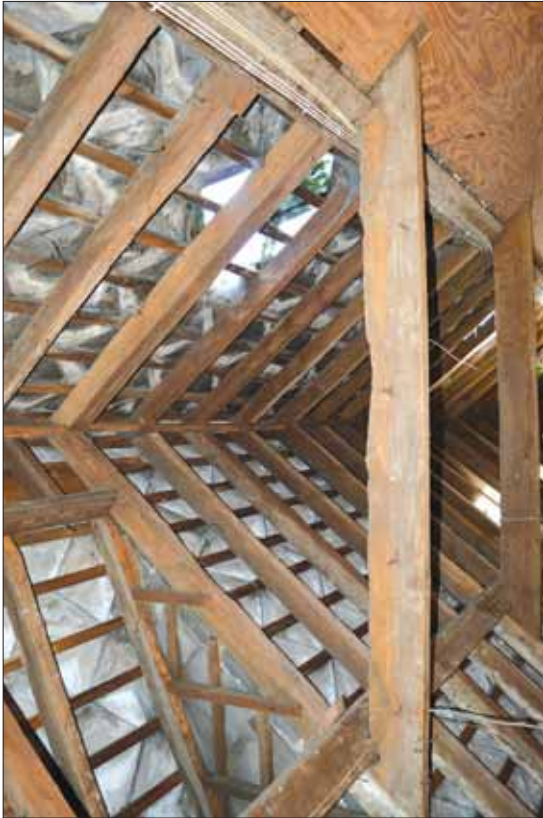
Plate 41: Detail of Timber roof Construction above Room 8, from east
