Chapter 7

The Late Medieval and Modern landscape

by Julian Munby

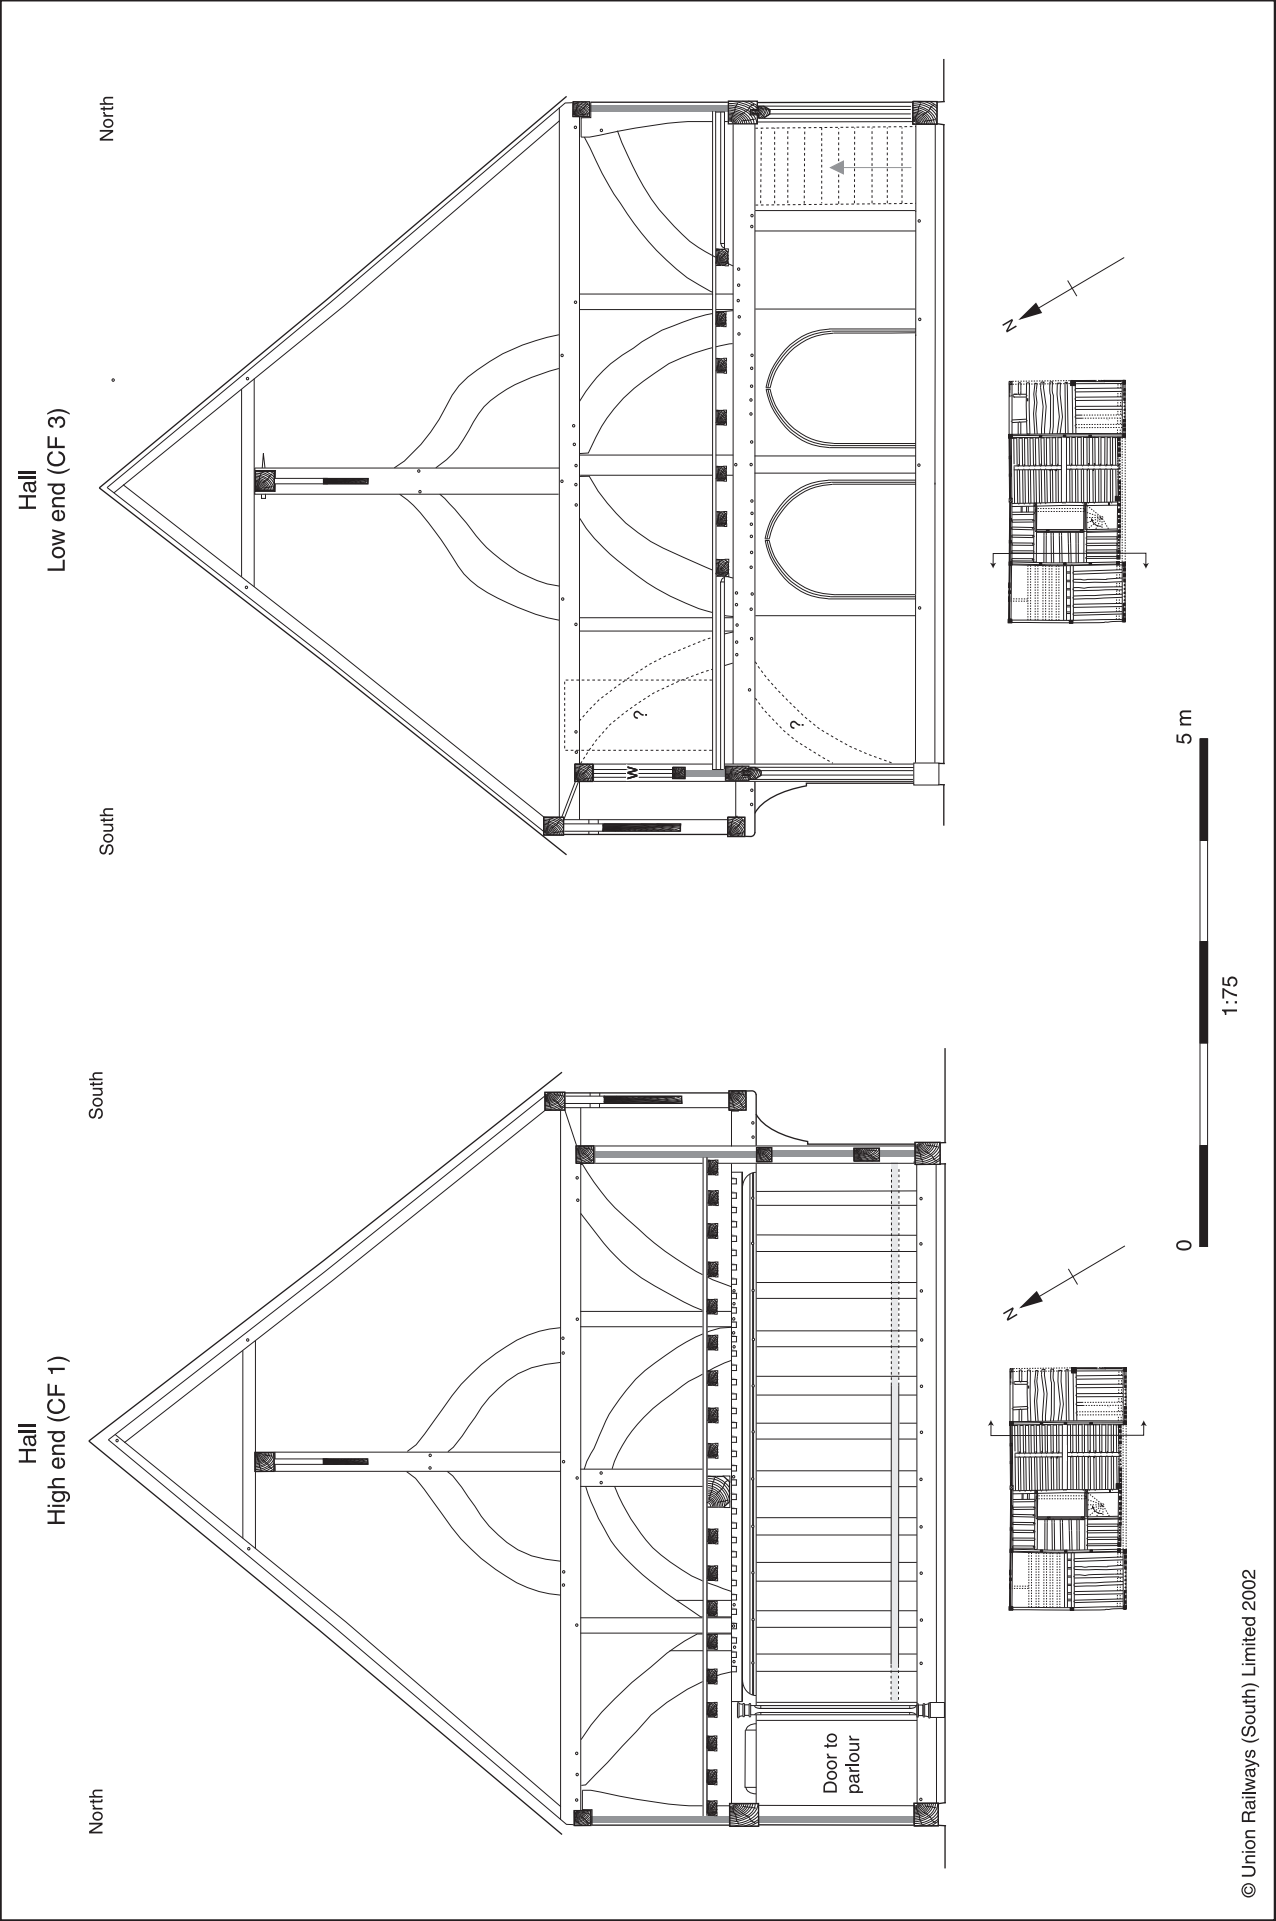
Figure 7.9 Talbot House: reconstructed transverse cross-sections in Phase II

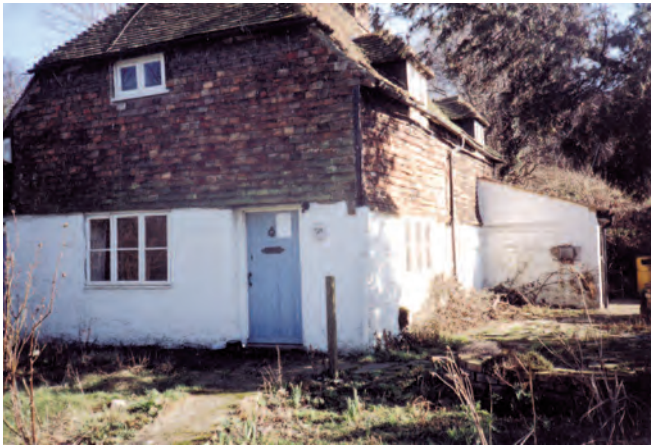
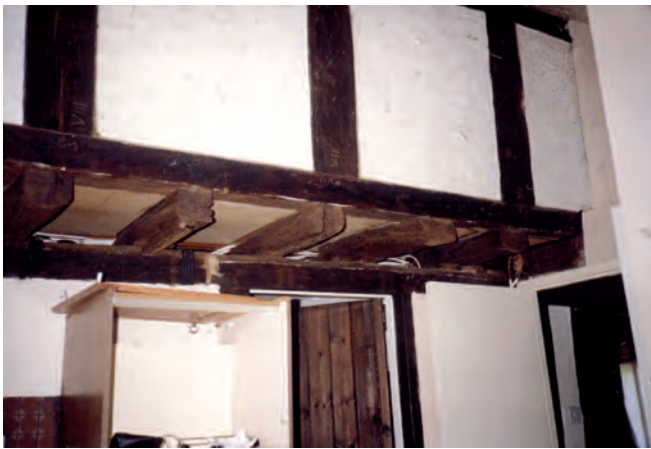
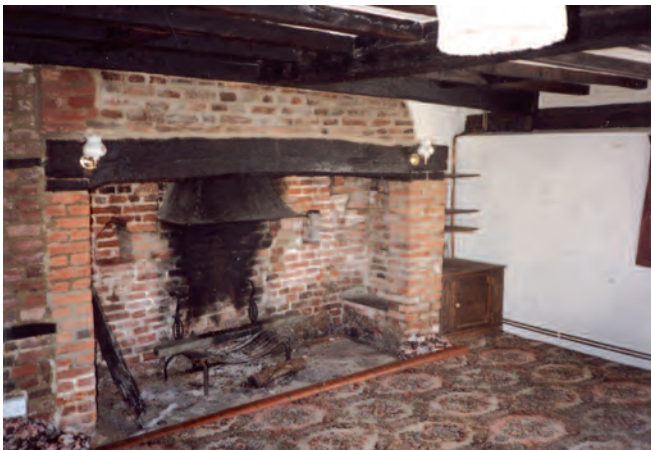
Figure 7.12 2 Boys Hall Road: photographs of (A) west elevation of the house, (B) internal view, jettied front to north, and (C) west room main fireplace

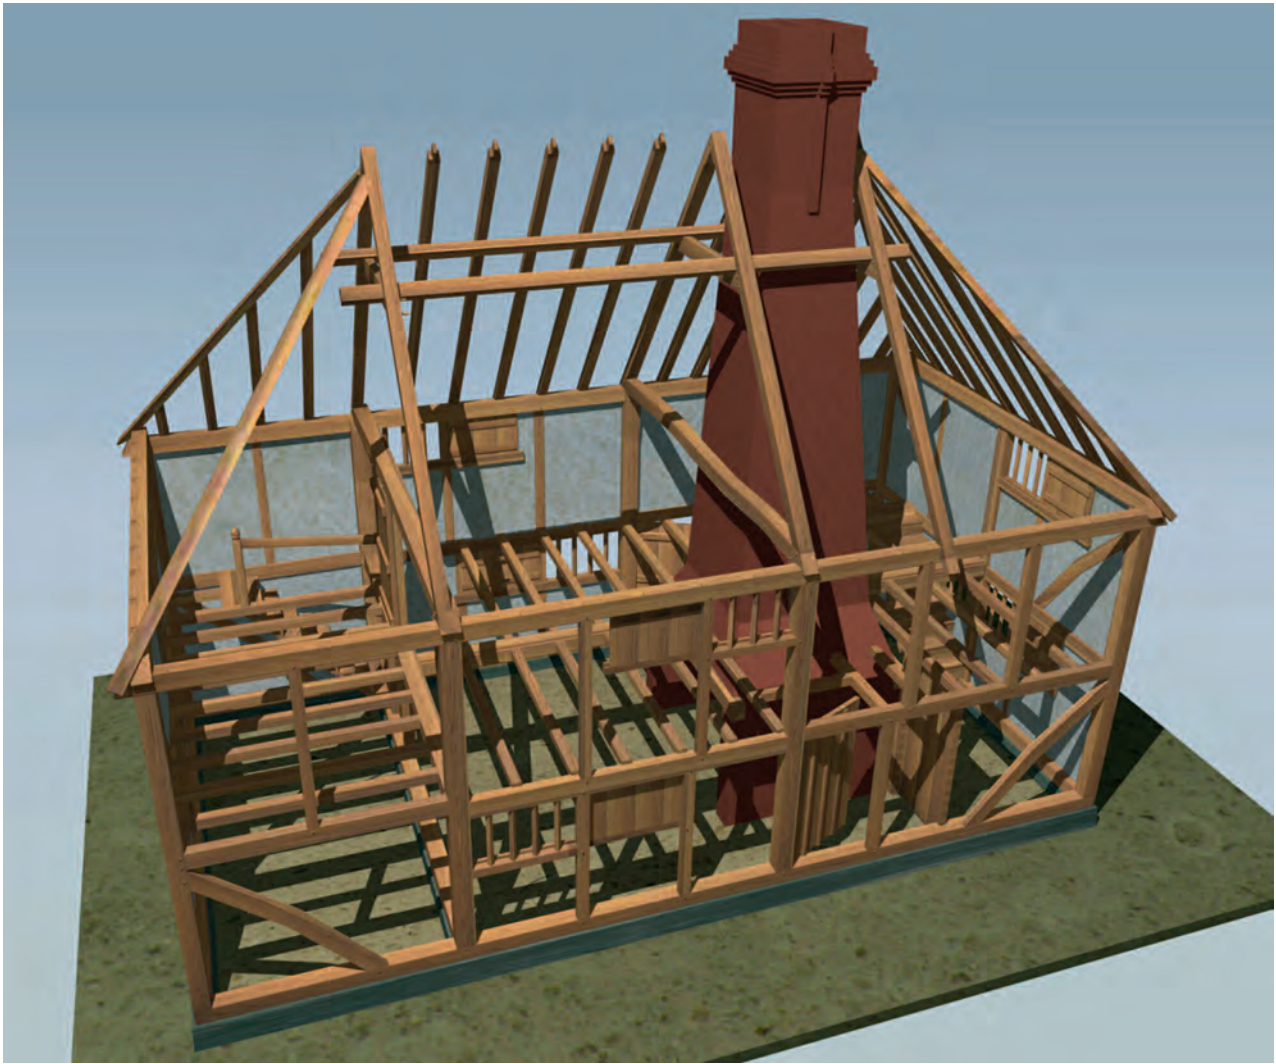
Figure 7.15 Old and Water Street Cottages: Phase I (model)

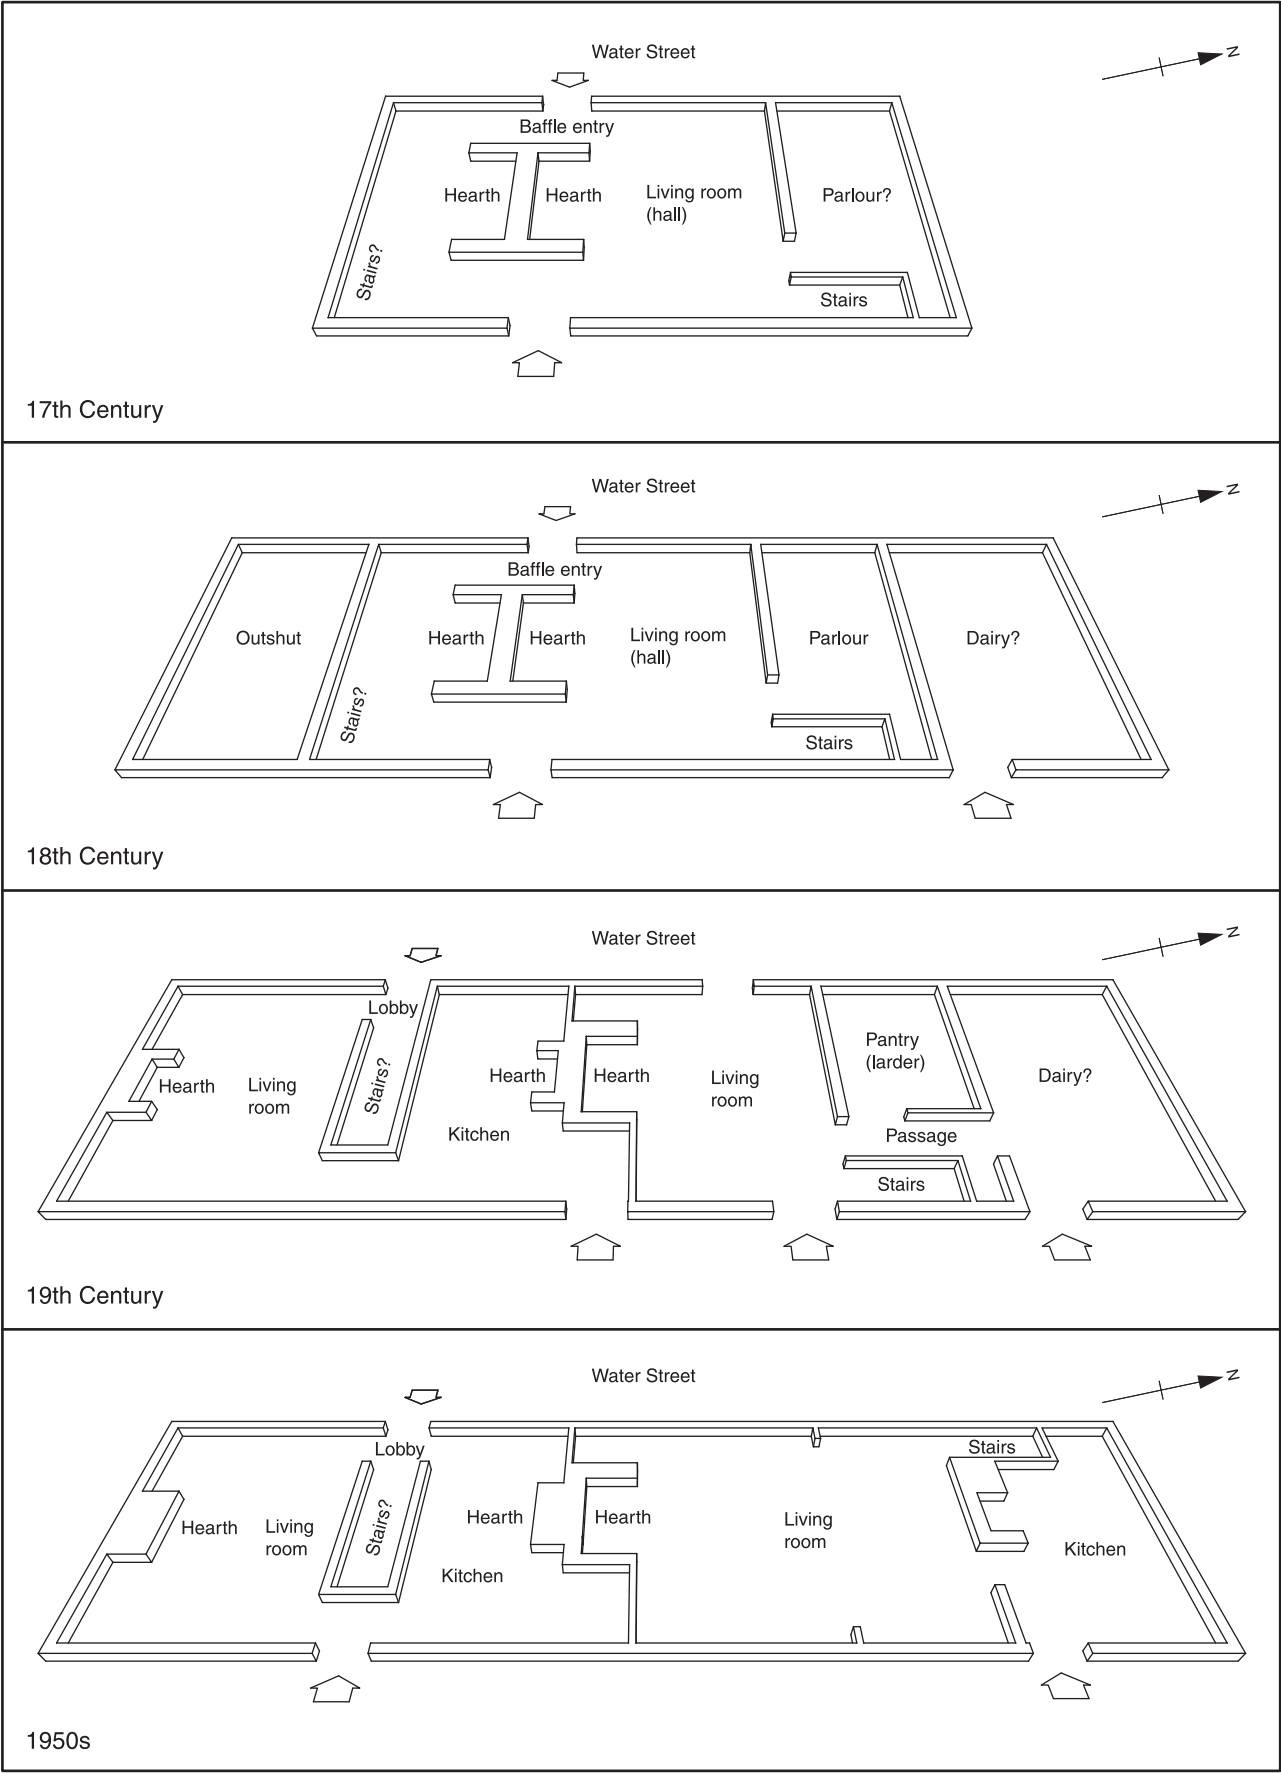
Figure 7.18 Old and Water Street Cottages: phase plans

front (Fig. 7.18). At various times the framing was underpinned with brick walling, no doubt as separate section failed, and the western wall was rebuilt in the mid 19th century.

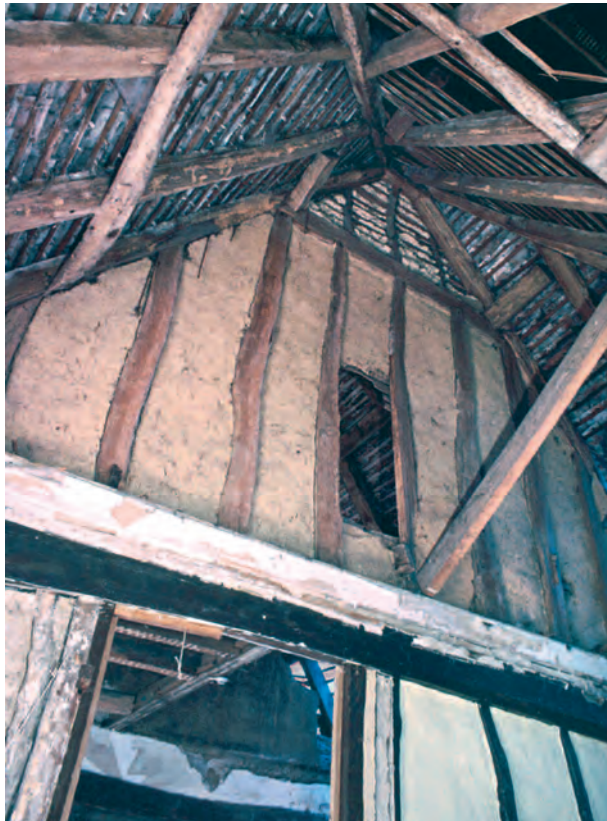
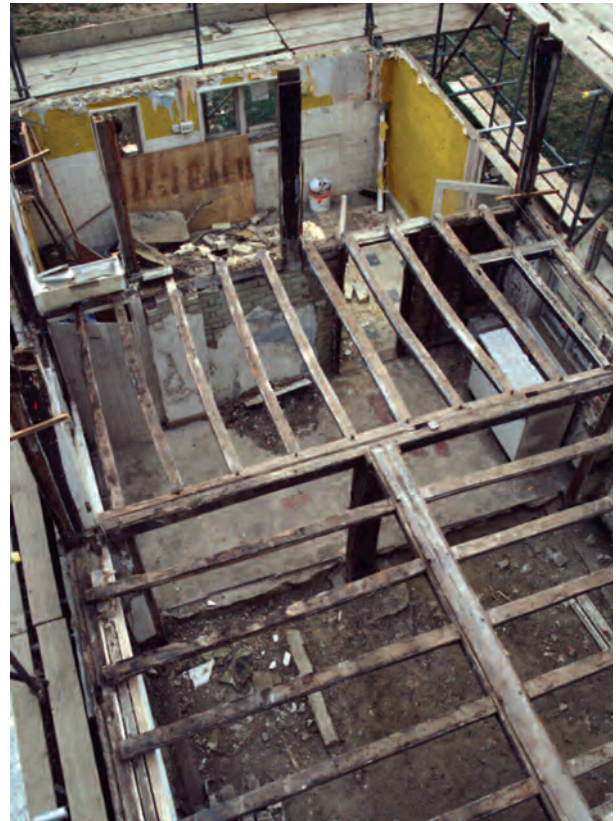
Figure 7.19 Old and Water Street Cottages: photographs of (A) internalised hip of 17th-century roof, and (B) 17th-century joists and beams during dismantling

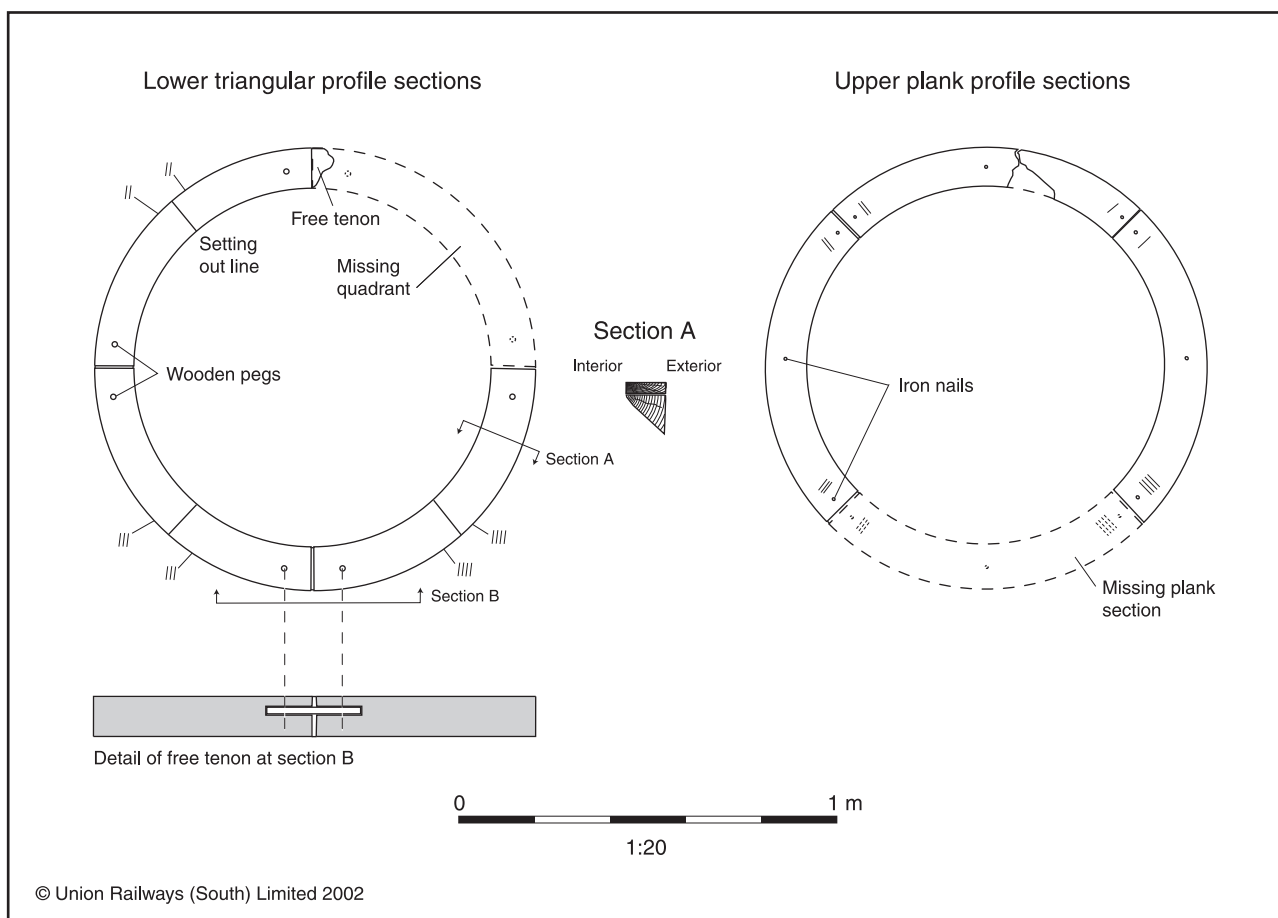
Figure 7.26 Brockton: details of timber well base

The most interesting single find was during the watching brief on the removal of a brick-lined circular well, located 4.30m east of the farmhouse (Fig. 7.26). At a depth of *c* 9m a circular timber object was retrieved which has been interpreted as a wooden cutting shoe associated with the digging of the well that had been preserved in the waterlogged conditions at the base of the well, having been abandoned when the construction was completed.

The complete object had an internal diameter of 92cm and an external diameter of 1.15m, formed of four quadrant sections, or felloes of triangular profile, further strengthened by a series of four curved plank sections nailed to their upper face, offset by 45° relative to the lower timbers. The upper planks were uniquely identified by paired numbers at each end corresponding to the adjacent timbers in their original arrangement. Thus the individual sections were numbered I-II, II-III, III-III, III-I, and the lower felloes were correspondingly marked I, II, III, and III on their outer face. The felloes were cut from the oak heartwood with only a little of their sapwood remaining, and the joints were free-tenons of elm single pegged to each felloe. The upper face of the plank sections retained traces of brick and mortar indicating their primary orientation, and their mode of use. The available

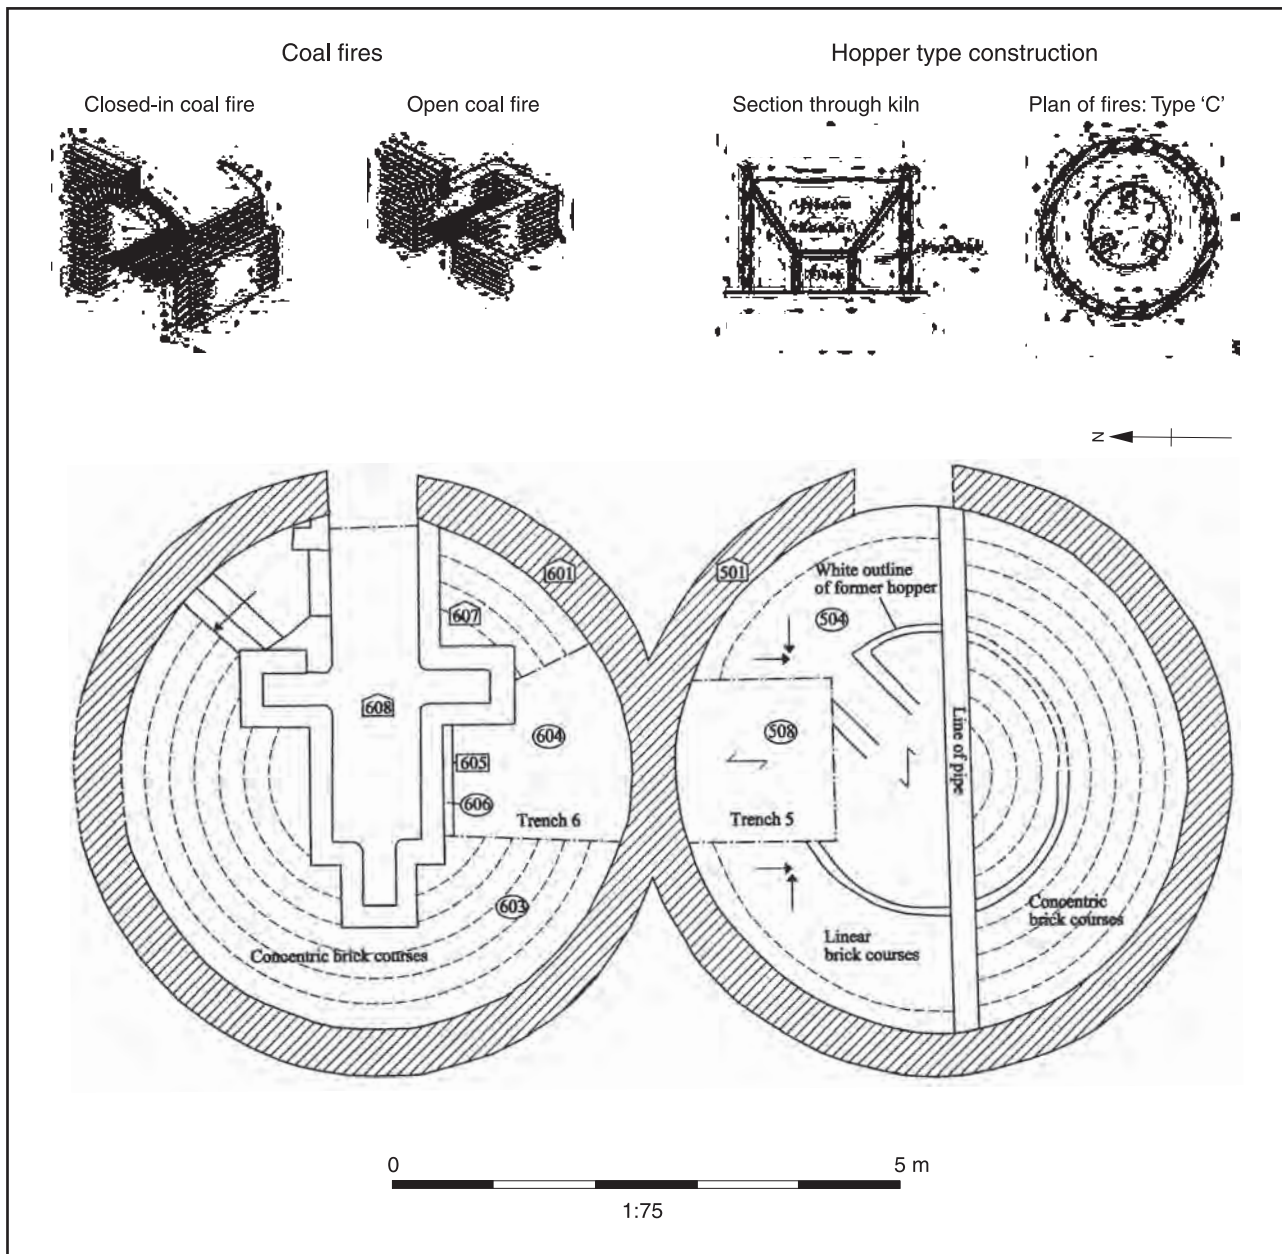
Figure 7.38 Yonsea Farm: plan of drying kilns within oast

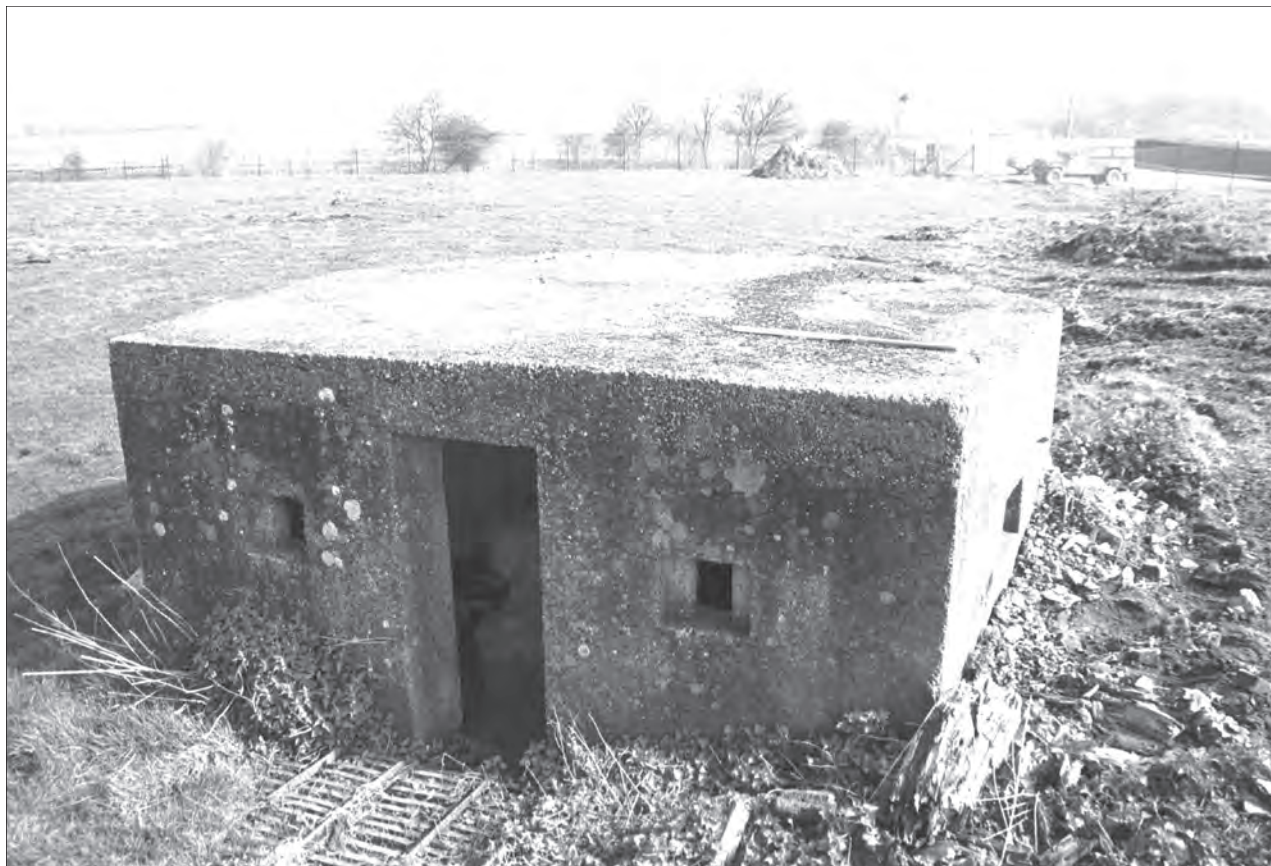
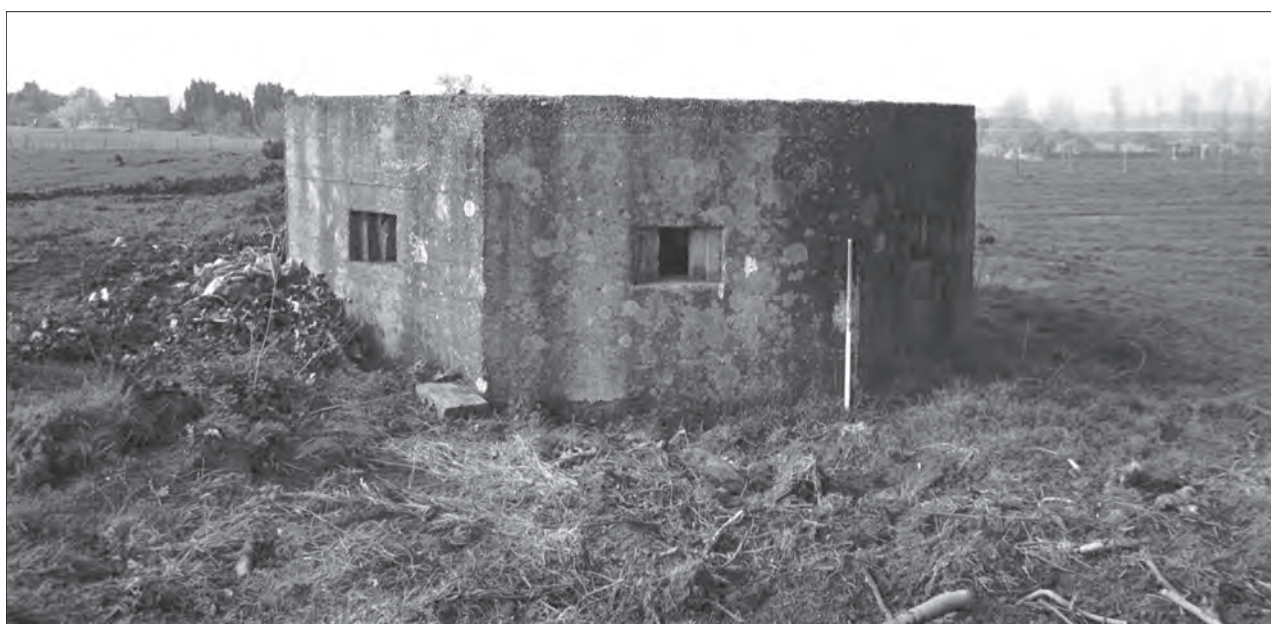
Figure 7.43 Westwell: photographs of (A) pill box A, south-west elevation and (B) pill box A south-east elevation

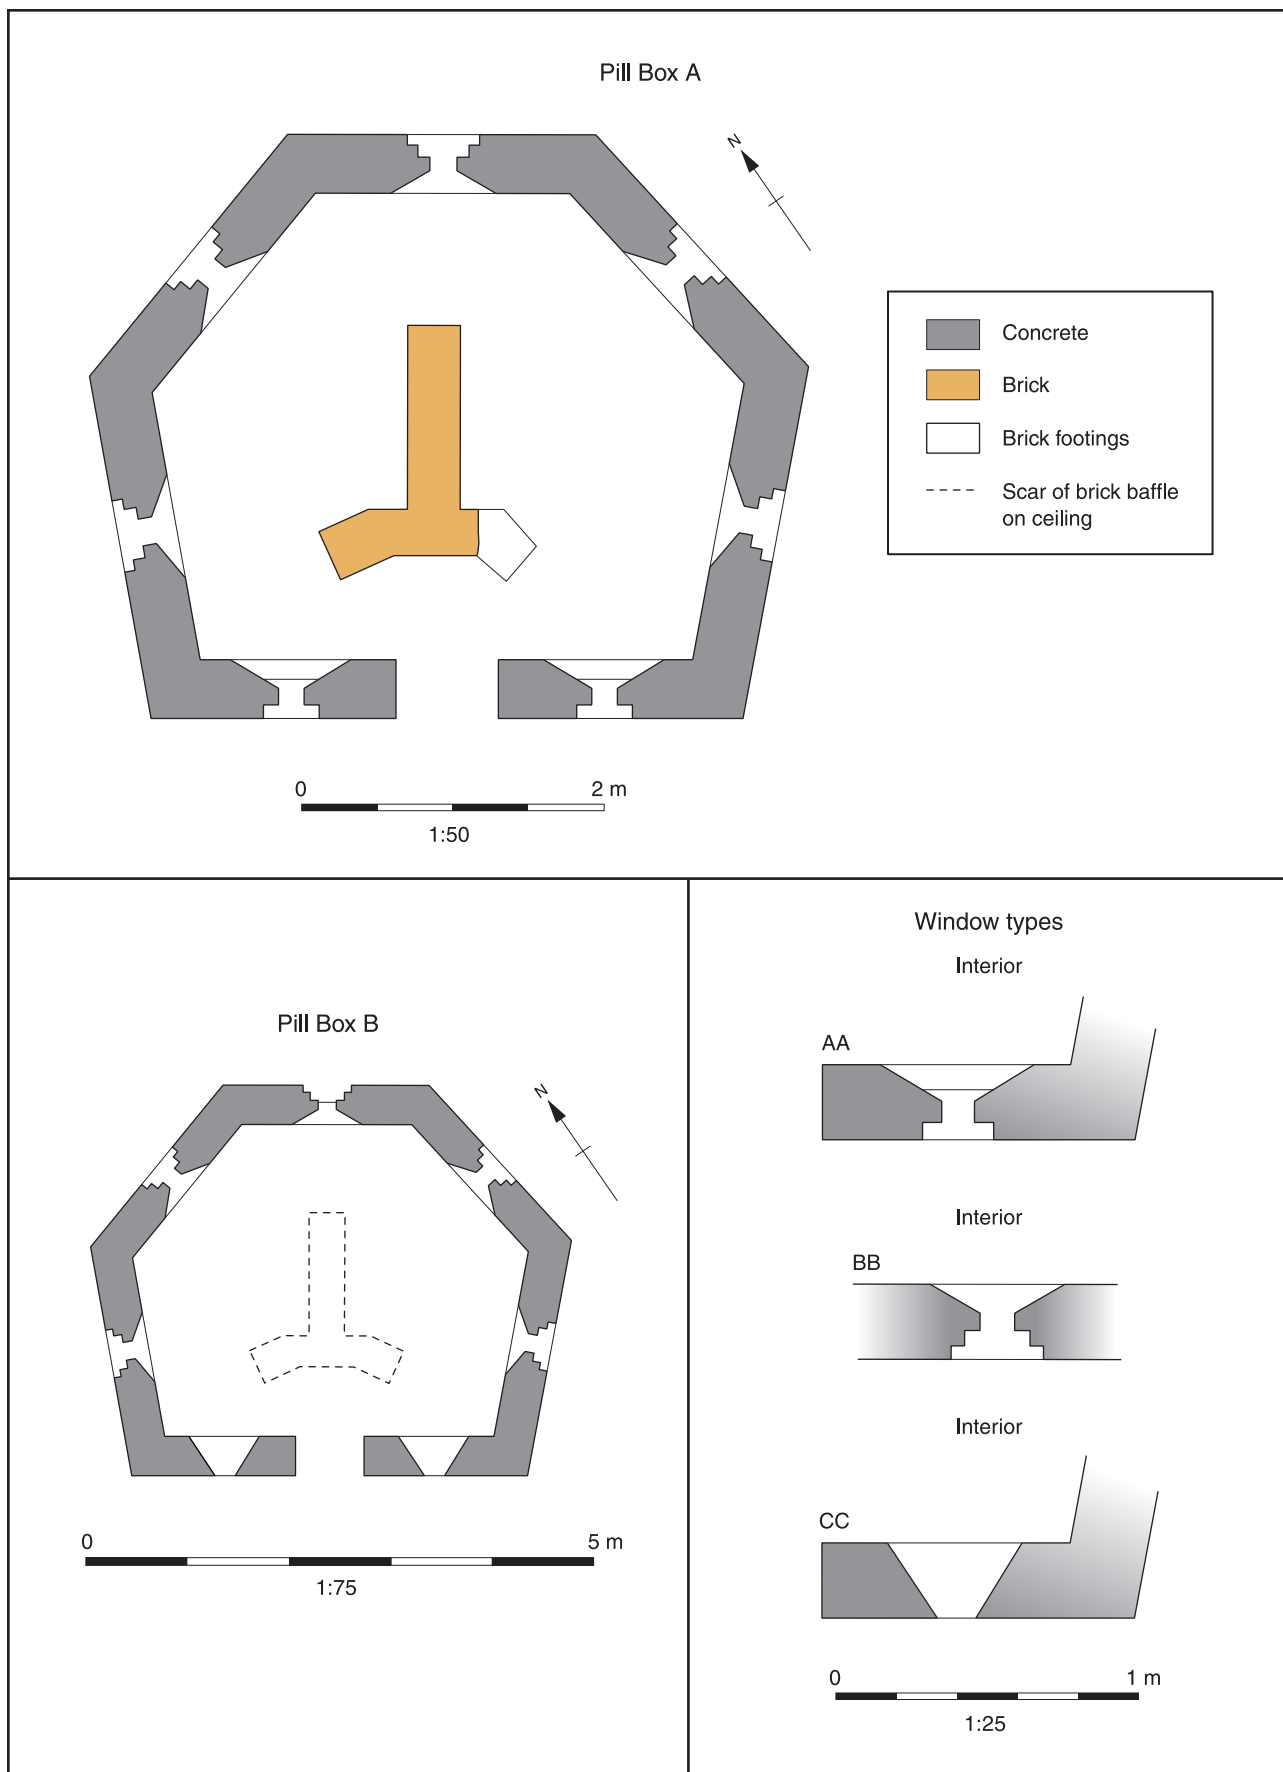
Figure 7.44 Westwell: plans of pill boxes A and B
