The Windmill and Cambridge Union Workhouse on Mill Road, Cambridge

Archaeological Monitoring & Test Pitting Report

Archaeological Monitoring and Test Pitting

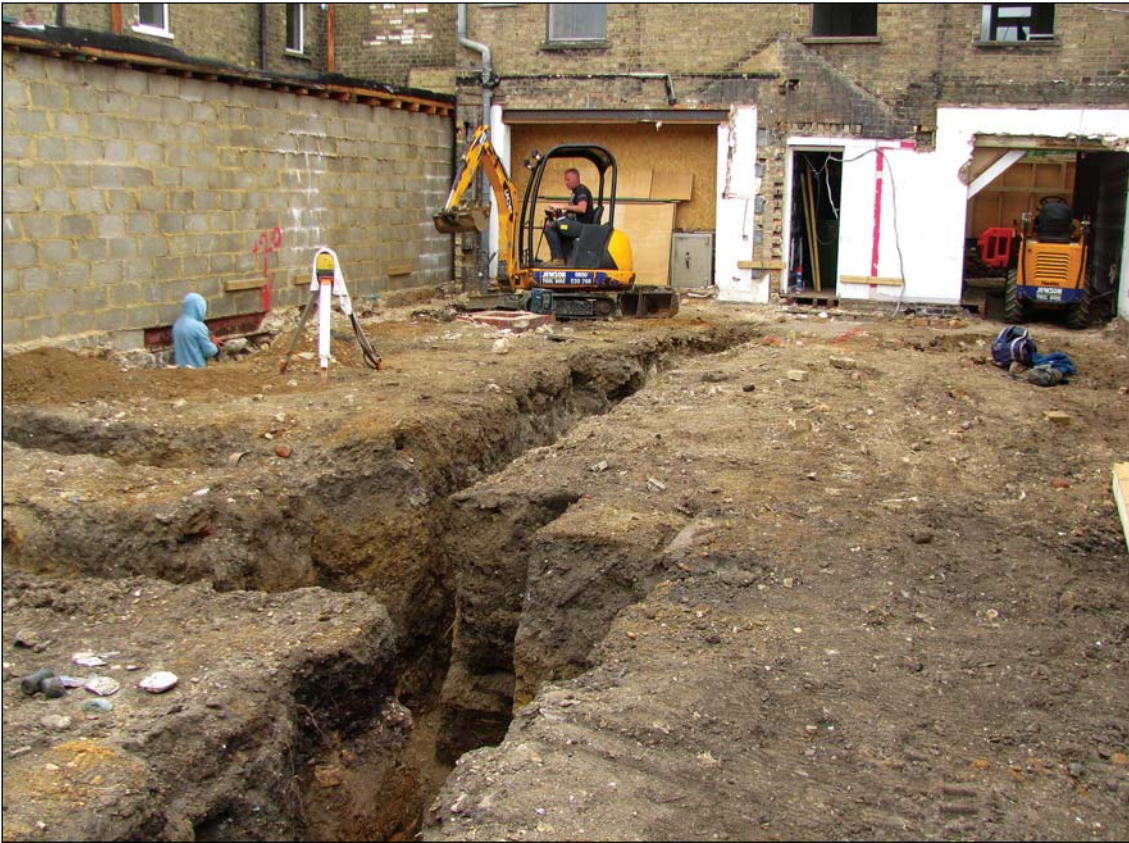
Plate 1: Footings under excavation at 56-56a Mill Road

- 3.2.3 The entire site was overlain by mixed overburden that was up to 0.30m thick. This was the result of on-going building works and plant movement (Plate 1). Two modern drains were also uncovered at the site, one to the south-west and one to the north-east. Sherds of post-medieval redware, including a fragment of stone-ware flagon and yellow ware ceramics, were recovered from the overburden. These indicate use of the site from the late 18th until the 19th-20th century (Appendix B). A corroded iron object of indeterminate function, along with a 19th century codd bottle, were also recovered from this layer (Appendix C).

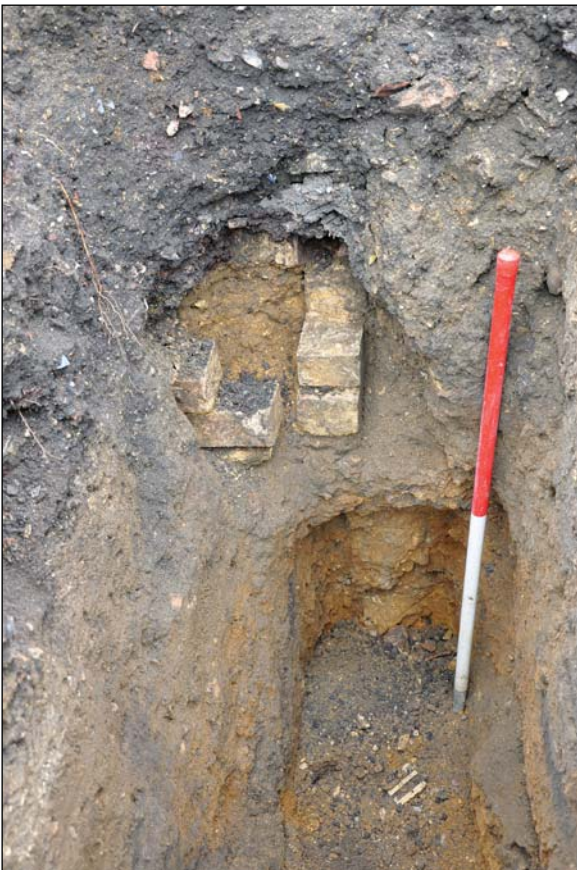
Plate 2: Brick feature 6, located to the south of the large pit

- 3.2.6 Located 3.17m to the north-east, wall 6 comprised up to four surviving courses of unfrogged bricks. These measured 220mm x 100mm 75mm and are most likely to date to the late 18th or 19th century, perhaps being locally produced at the Cambridge brick works (Plate 2; Rob Atkins pers. comm.).
- 3.2.7 The wall was overlain by the garden soil and appeared to have been truncated by a later pit (**4**). The corner of this wall was exposed in the modern foundation trenches, indicating that it was part of a structure orientated roughly north-east to south-west, parallel with the current alignment of the plot. It is possible that this may have been related to an out-building that could have been contemporary with the windmill.

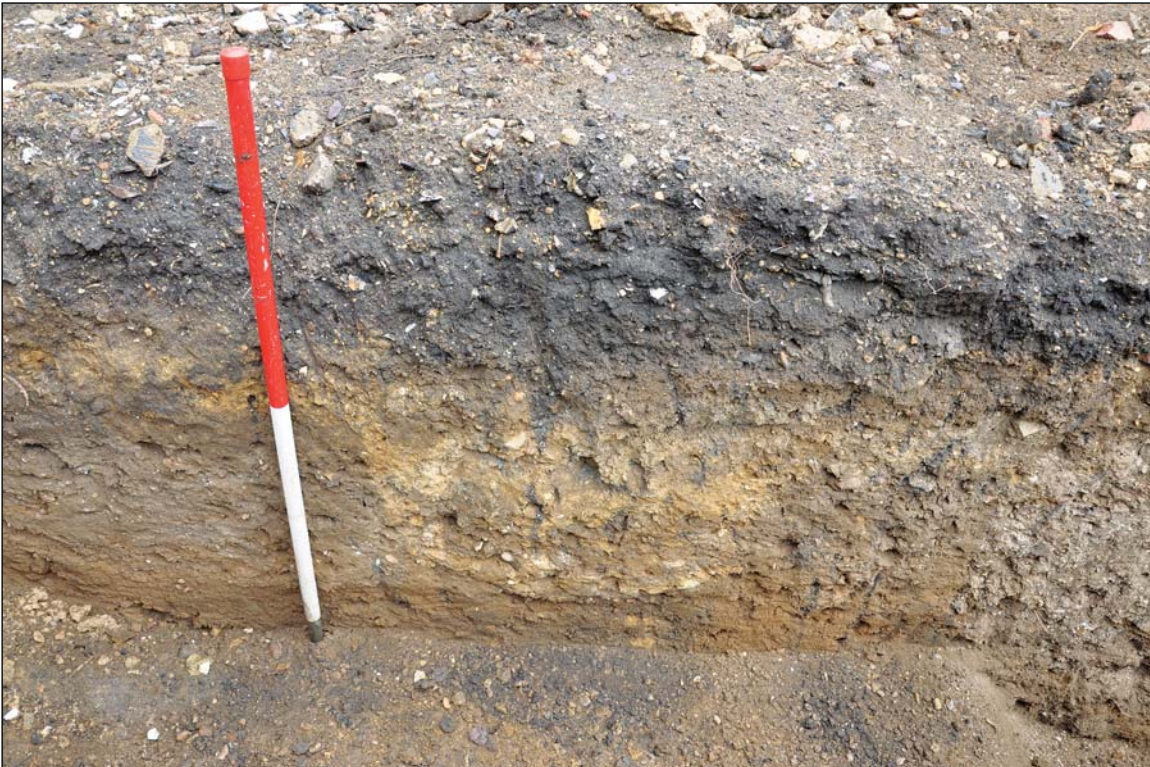
Plate 3: Feature 2 facing north east

- 3.2.8 Ditch 2 (Figure 7, Section 1; Plate 3) was 0.50m deep by 0.78m wide, with steep sides, a 'U' shaped profile and a concave base. It was filled by a light yellow-brown sandy-silt fill (1) with frequent gravel inclusions. No artefacts were recovered from this fill.

- 4.1.2 The ditch (2) located in the north-west of the site may have been a boundary ditch for a former backyard plot since it aligned with the current road and plot divisions. Its gravel fill may indicate that it was a foundation trench, but no structural material was found associated with it.

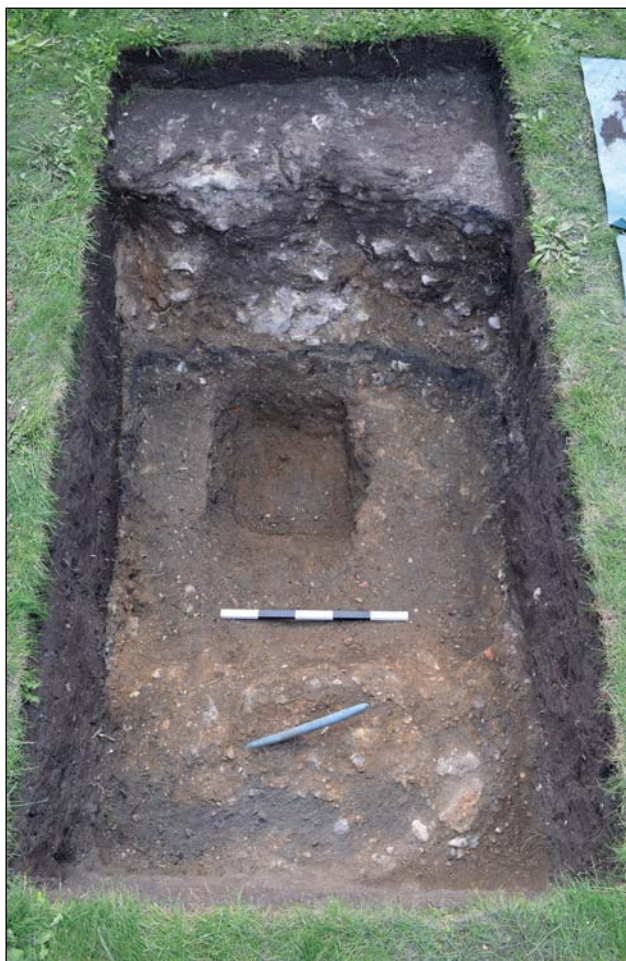
Plate 7: Test Pit 1 post-excitation, facing south-south-west

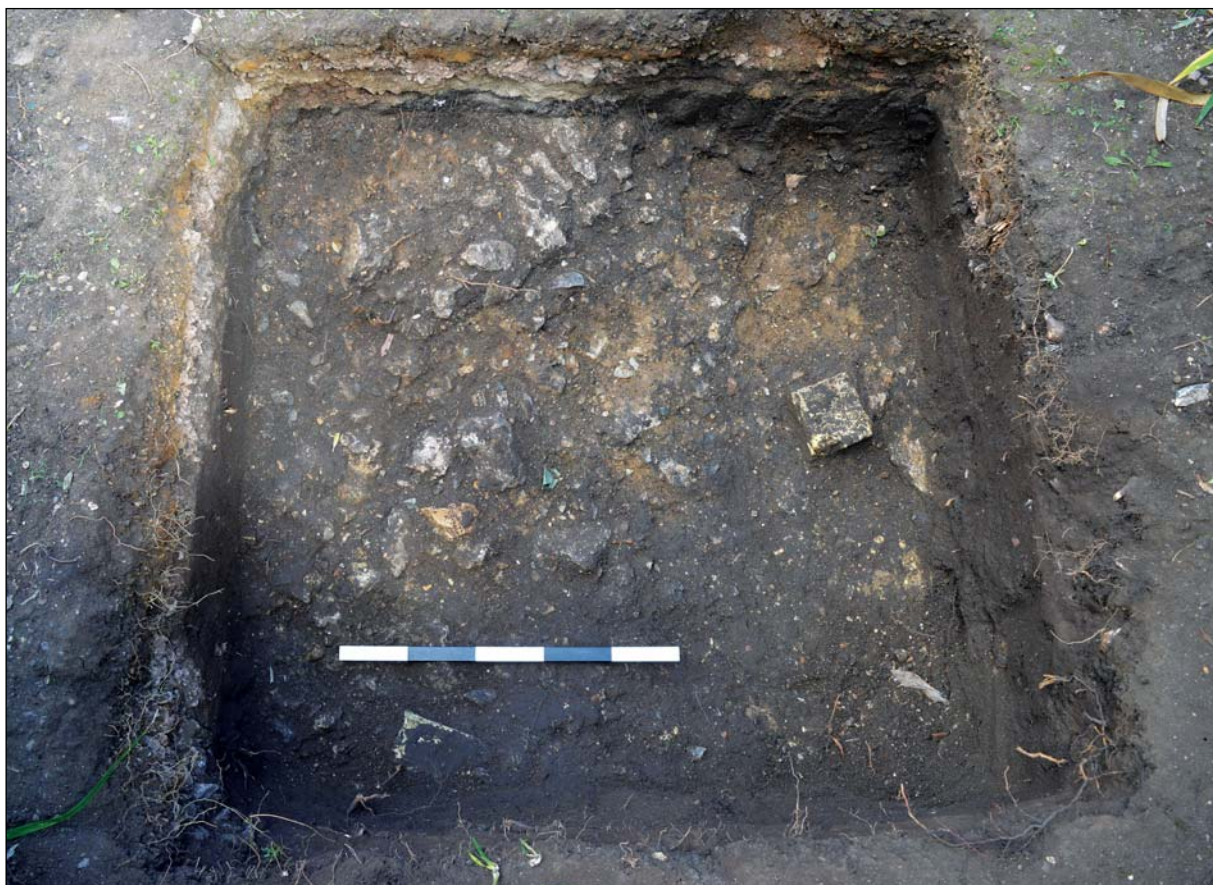
Plate 9: Test Pit 2 post-excitation facing north-east

- 3.3.8 No natural or geological deposits were uncovered in this test pit. The earliest deposit uncovered was a layer of compacted rubble (15) thought to be the remains of the car park foundation (Plate 9). This had been overlain by topsoil and sand and gravel lenses (11, 10, 8 & 7) in order to form the flower bed (Figure 9, Section 2). A wooden garden divide (4) was uncovered in the top layer separating the garden soil (5) from that formed over the modern path (3) (Plate 10).

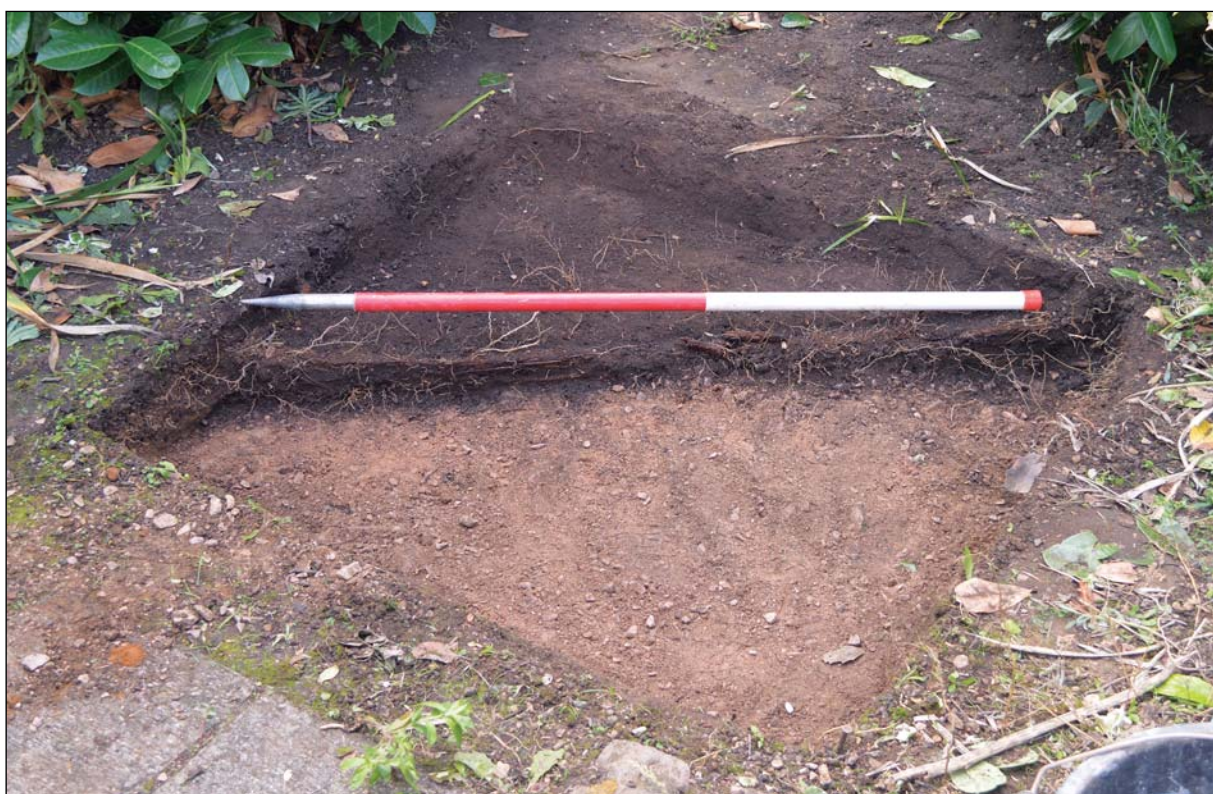
Plate 10: Test Pit 2 contexts 3 and 5, facing south

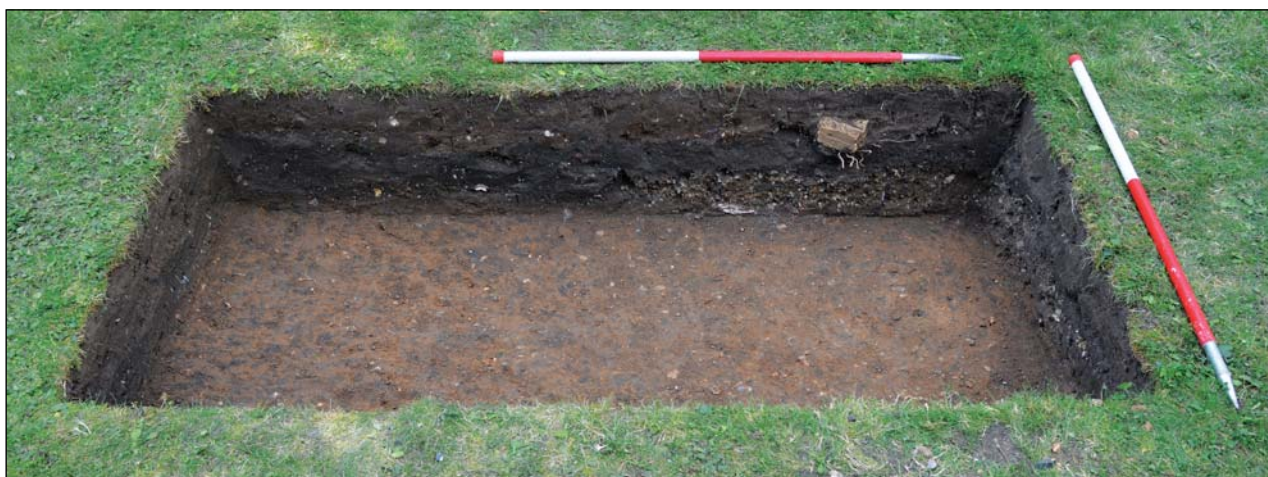
Plate 12: Test pit 3 post-excitation

- 3.3.10 Orientated north north-east by south south-west, this test pit measured 2m by 1m and was located in an enclosed part of the gardens close to the main entrance of the building (Figure 6). This trench was excavated to a maximum depth of 0.40m (14.85 O.D) (Plate 11).
