Archaeological Test Pits at Devil's Dyke, Ditches Farm Burwell, Cambridgeshire

Archaeological Evaluation Report

OA East Report No: 1879

Archaeological Test Pits at Devil's Dyke, Ditches Farm, Burwell, Cambridgeshire

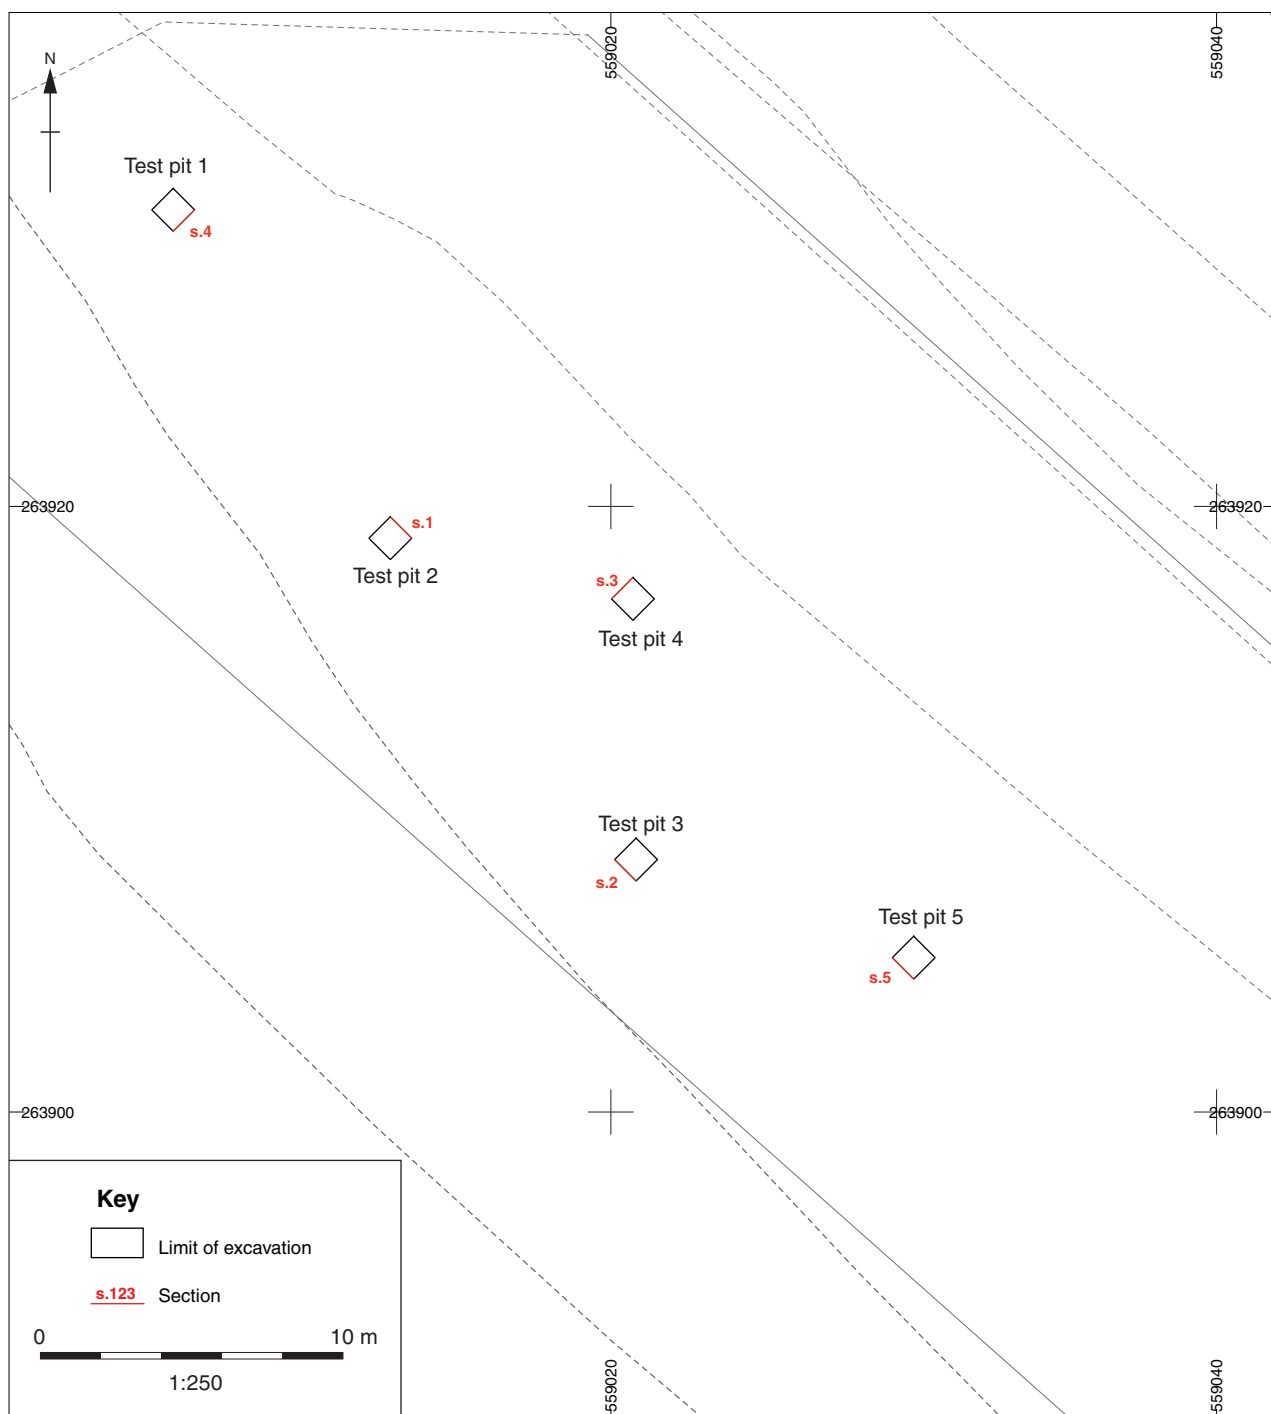
Figure 2: Test pit location plan

- 3.1.1 The test pits were positioned to sample the ditch fill materials (Figure 2 and 3), the results of each test pits are given below in numerical order, supported by test pit detail descriptions in Appendix A.

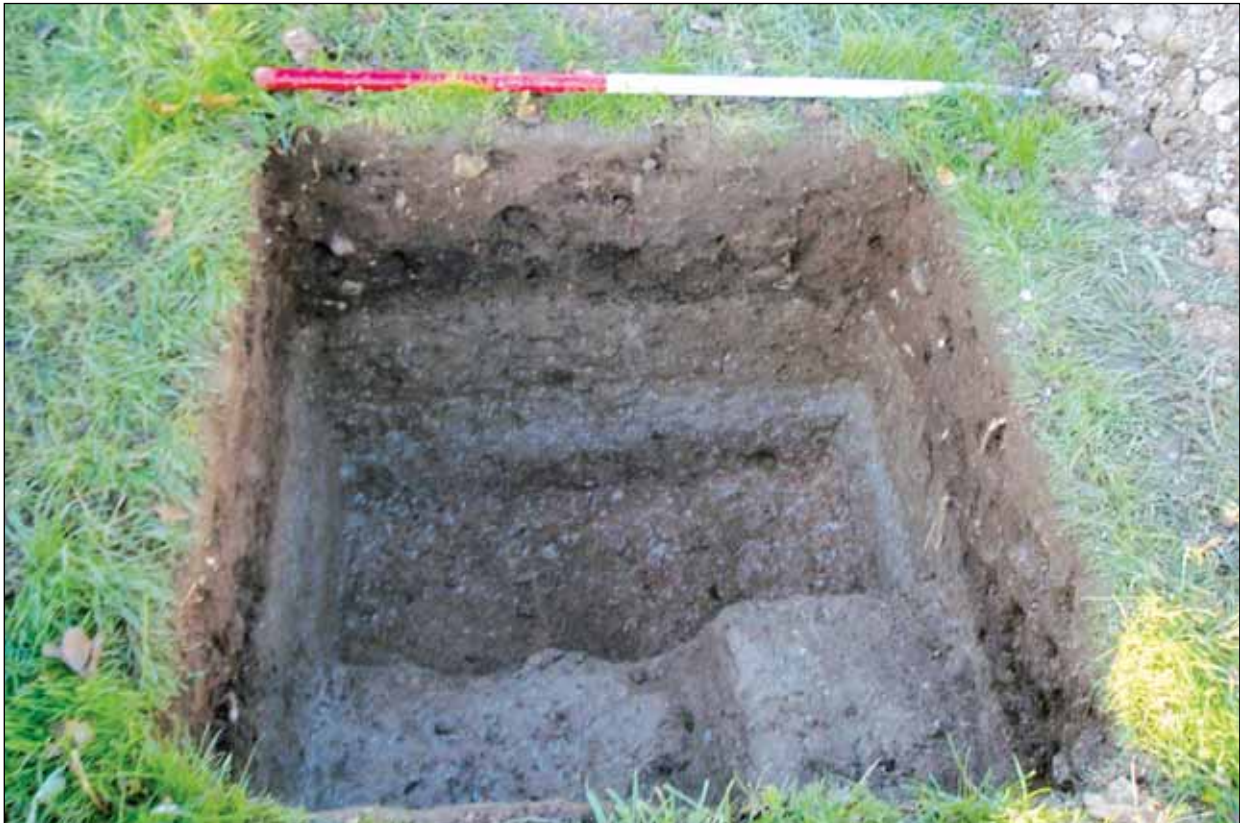
- 3.2.1 This test pit was positioned towards the northwestern limits of the backfilled ditch along the base of the southwestern side of the Devils Dyke. Test Pit 1 was excavated to a depth of 1m, it revealed no archaeological remains and no chalk deposits suitable for restoration of the bank.

Plate 1: Detail of section in Test Pit 1, looking north-west

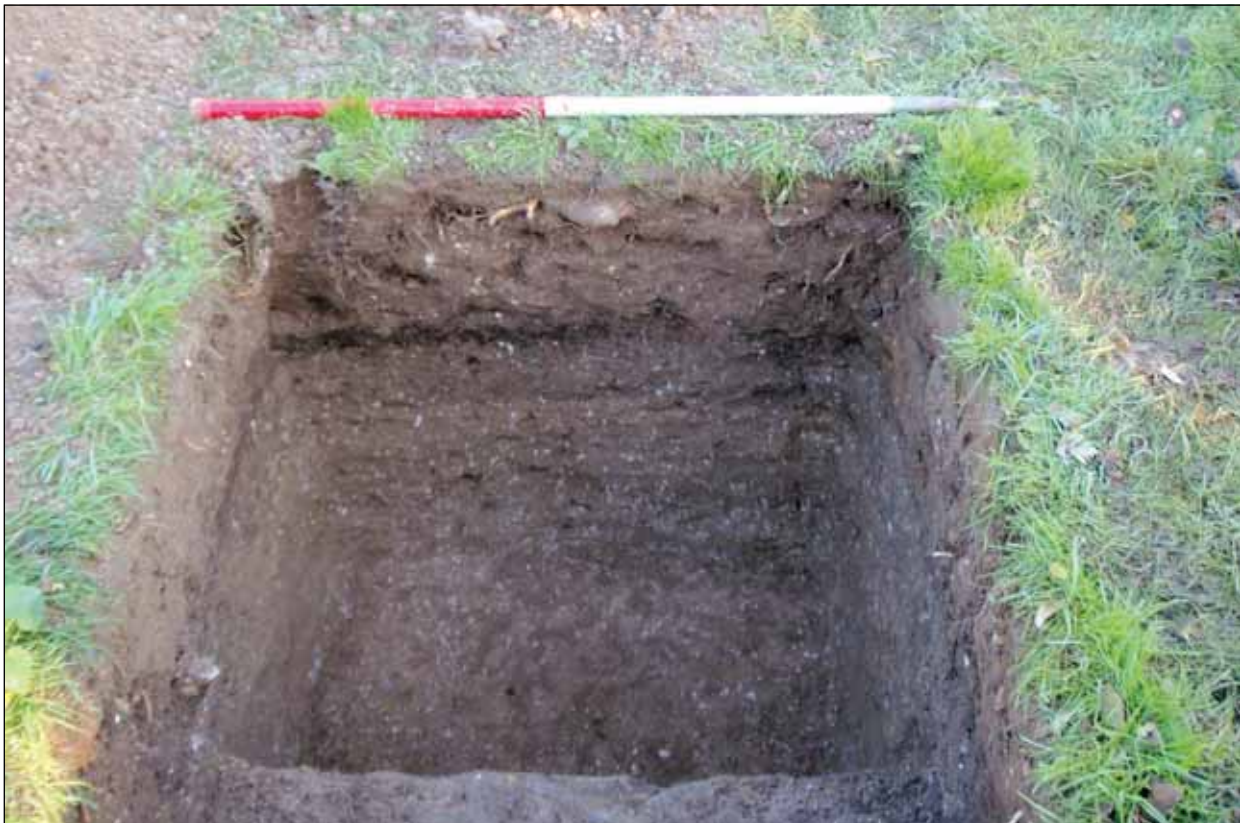
- 3.3.1 This Test Pit was located approximately 13m to the south of Test Pit 1. Test Pit 2 was excavated to a depth of 1m, revealed no archaeological remains or any chalk deposits suitable for the bank restoration.

Plate 2: Detail of section in Test Pit 2, looking north-east

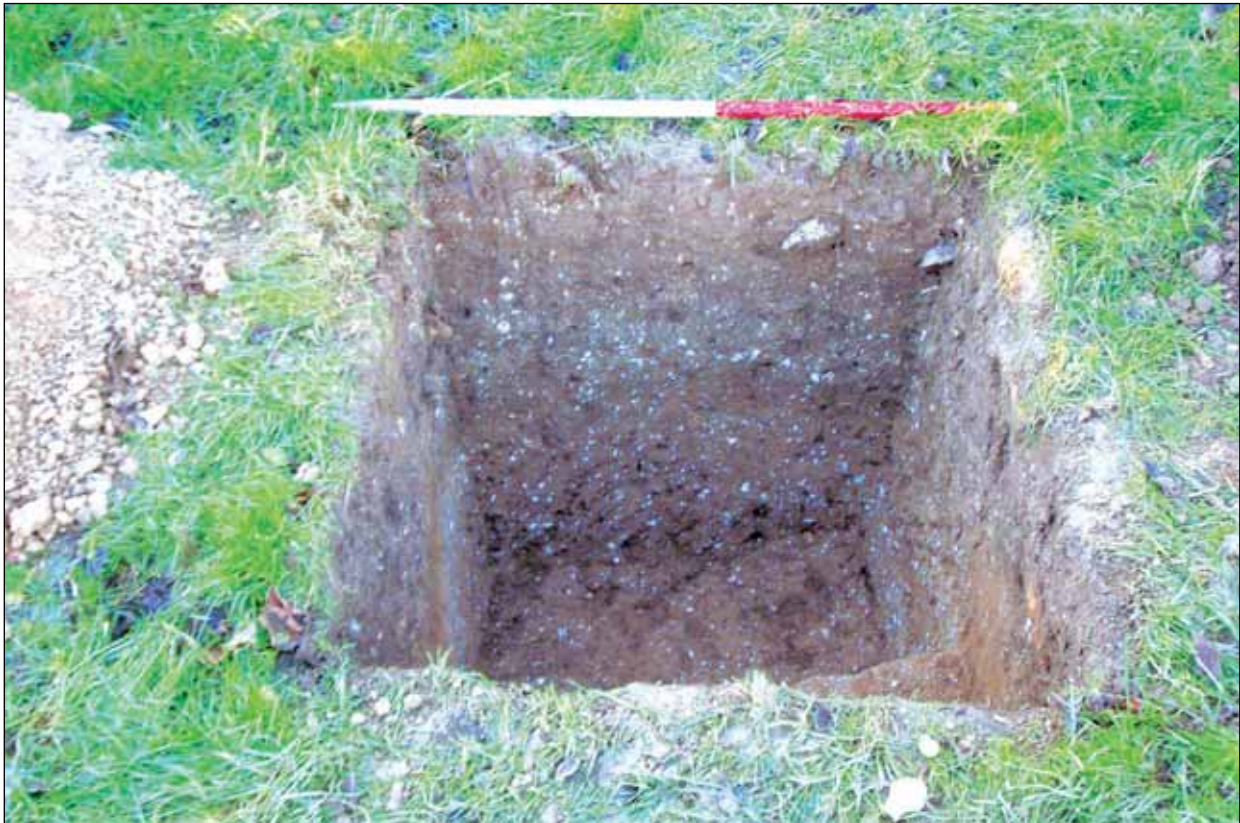
- 3.4.1 This Test Pit was located just over 13m south of Test Pit 2. Test Pit 3 was excavated to a depth of 1m, revealed no archaeological remains or any chalk deposits suitable for the bank restoration.

Plate 3: Detail of section in Test Pit 3, looking south-west

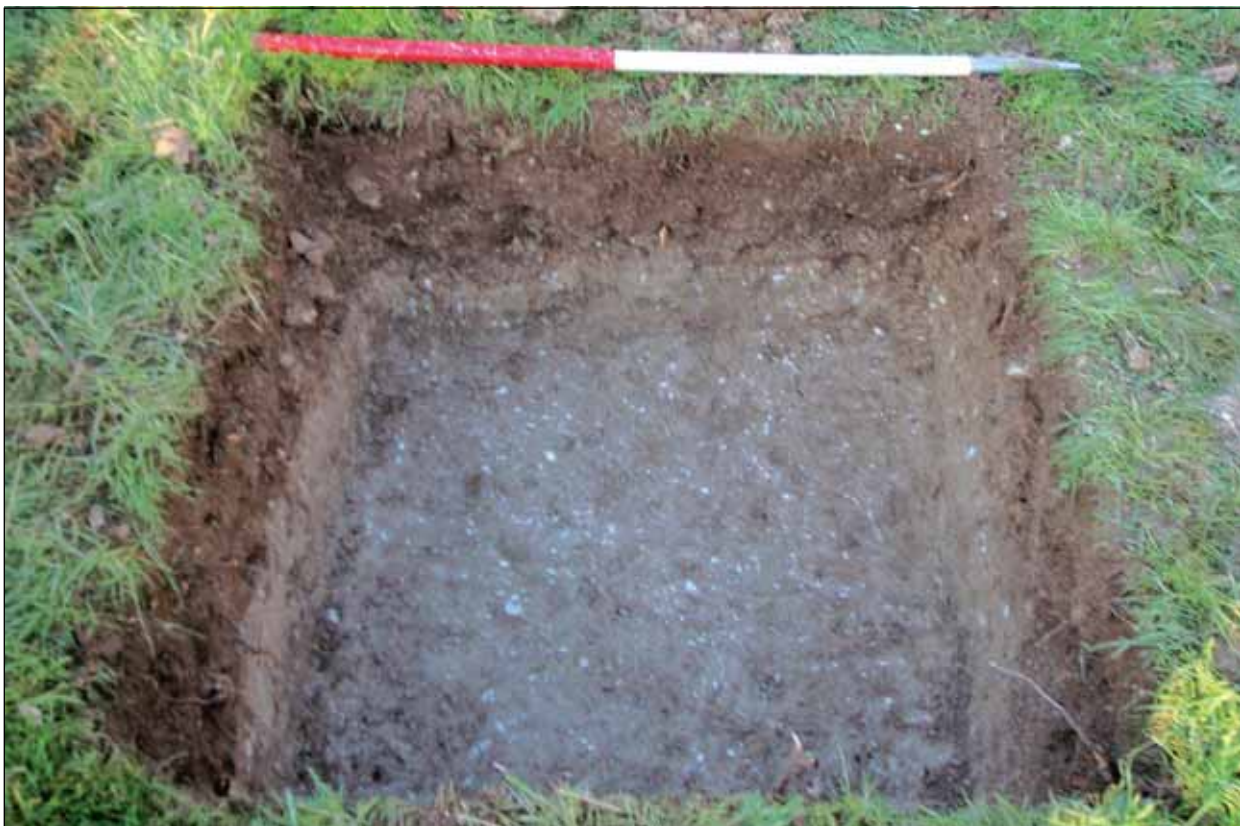
- 3.5.1 This Test Pit was located nearly 19.5m southeast of Test Pit 1. Test Pit 4 was excavated to a depth of only 0.45m, the test pit revealed no archaeological remains or chalk deposits suitable for bank restoration.

Plate 4: Detail of section in Test Pit 4, looking north-west

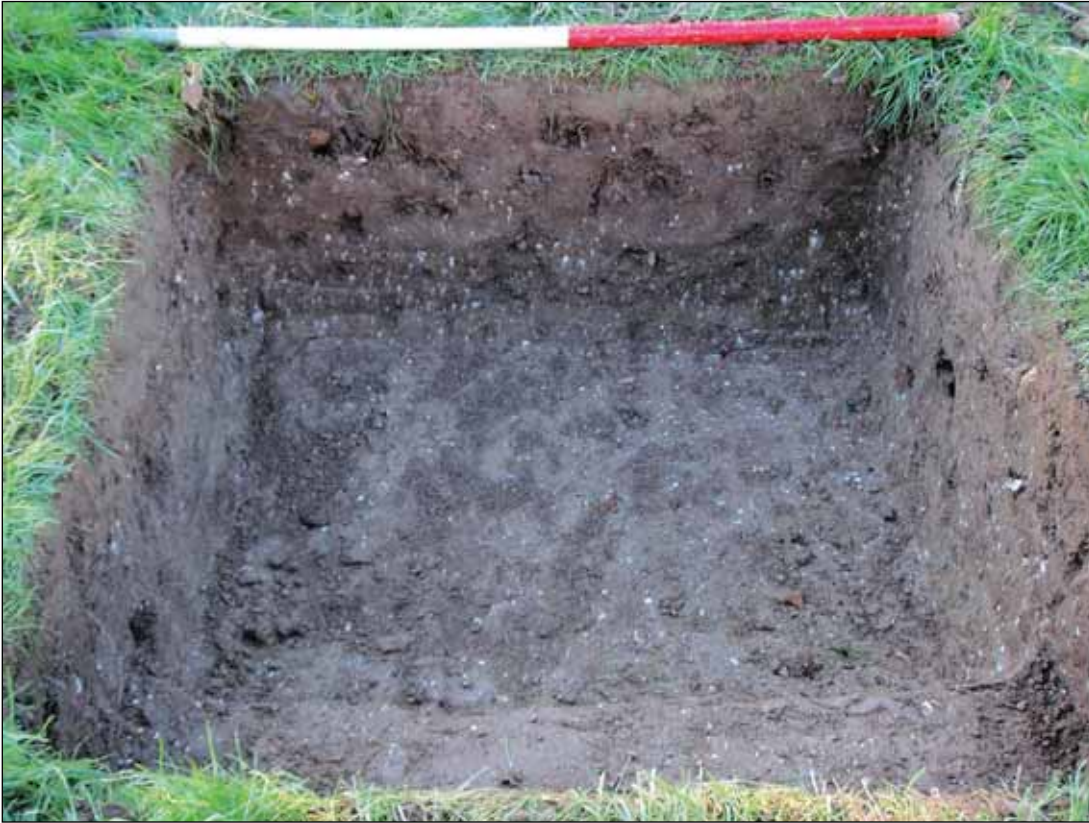
- 3.6.1 This Test Pit was located towards the southeast limits of the ditch fill, at just over 15m southeast of Test Pit 4. Test Pit 5 was excavated to a depth of only 0.50m, the test pit revealed no archaeological remains or chalk suitable for bank restoration.

Plate 5: Detail of section in Test Pit 5, looking south-west

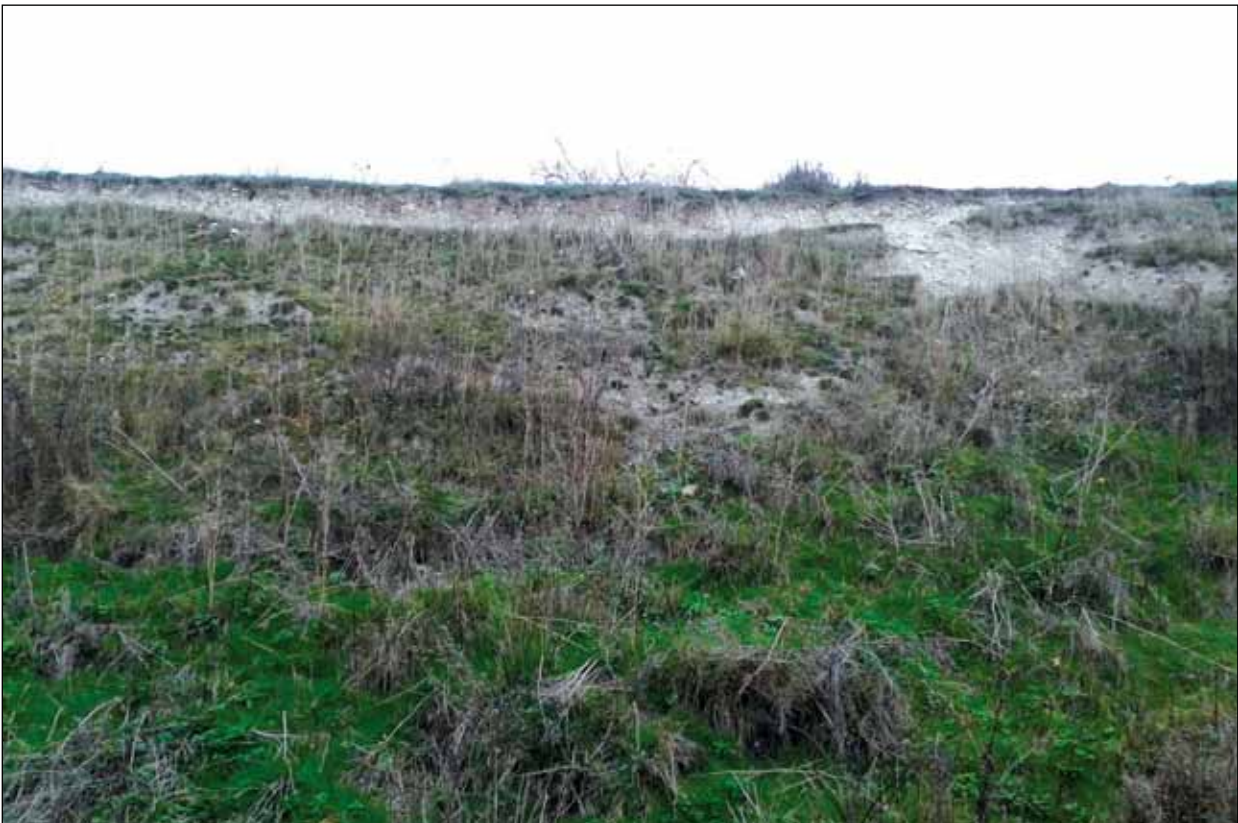
- 2.1.1 The objective of this Test Pit evaluation was to determine as far as reasonably possible the presence/absence of any redeposited chalk deposits within the ditch backfill that could be utilised to restore the eroded bank. (Plate 6)

Plate 6: Example of erosion to the bank, looking north-east

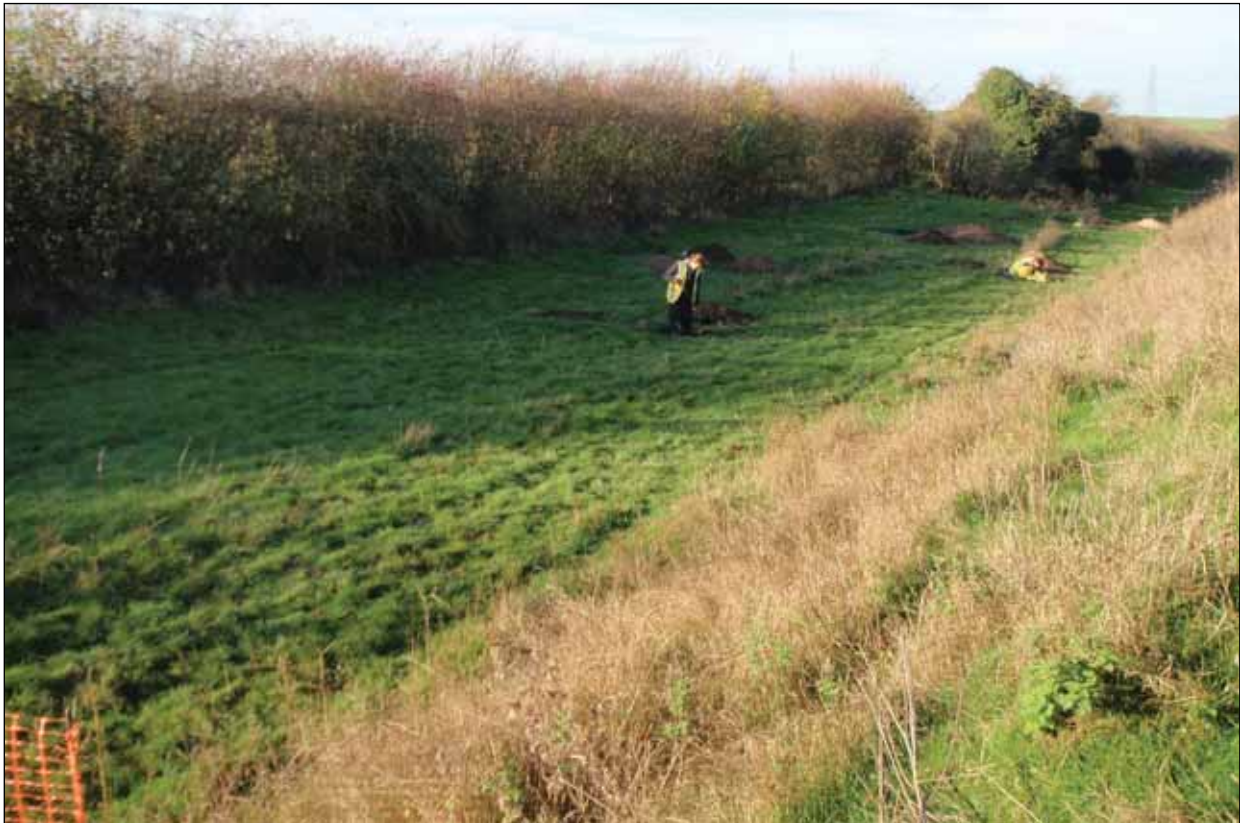
- 2.2.1 The Brief required that five test pits were hand excavated into the upper fills of the ditch. (Plate 7) Each test pit measured 1m square and was excavated to a maximum depth of 1m.
- 2.2.2 The site survey was carried out by Gareth Rees using Leica GS08 Smartnet DGPS
- 2.2.3 Spoil, exposed surfaces and features were scanned with a metal detector. No metal-detected or hand-collected finds were found, other than those which were obviously modern.
- 2.2.4 All archaeological features and deposits were recorded using OA East's *pro-forma* sheets. Trench locations, plans and sections were recorded at appropriate scales and high resolution digital photographs were taken of all relevant features and deposits.
- 2.2.5 The conditions were dry, sunny and very windy.

Plate 7: Excavation of Test Pits into top of ditch, looking west

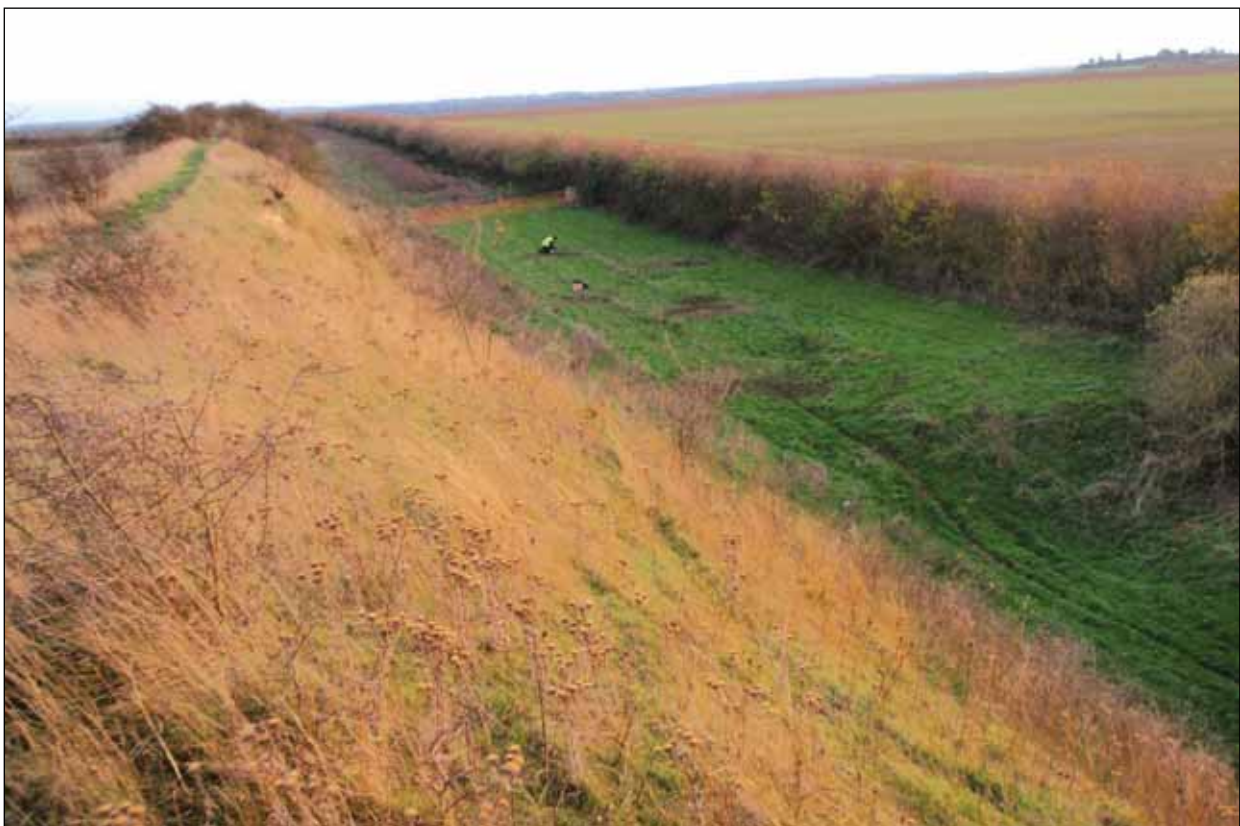
- 4.2.1 No archaeological deposits were found, the test pits were backfilled after recording (Plate 8).

Plate 8: Backfilled Test Pits, looking south
