# Weald Manor Farm, Bampton, Oxfordshire

## Archaeological Evaluation Report

**Client: John Colvile Will Trust**

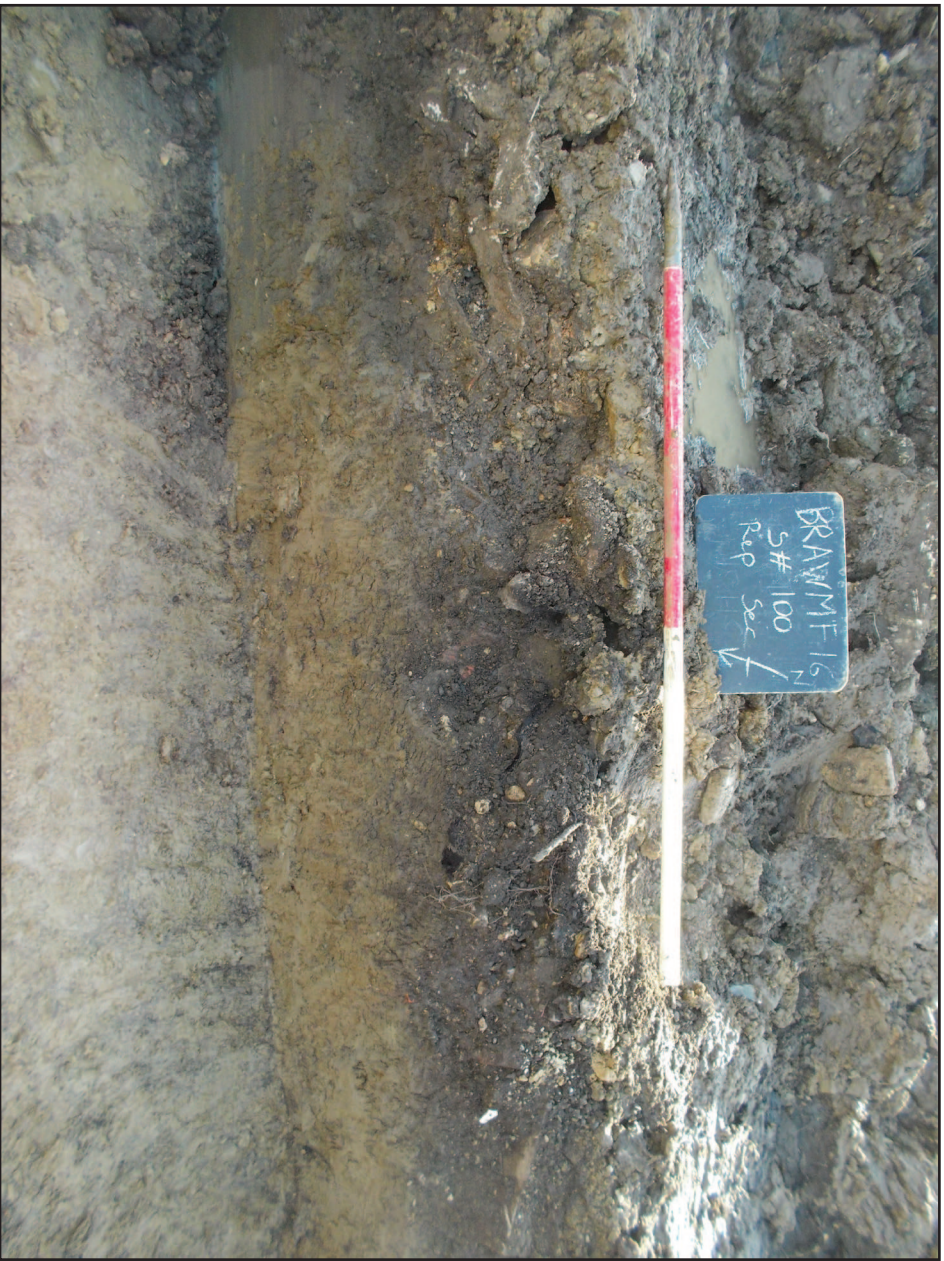
Plate 1: Trench 1 typical soil profile

- 3.4.1 A light brown silty clay natural (102) was exposed across the extent of the trench approximately 0.36m below the current ground level. This was stained to a greenish blue hue coinciding with the location of the former agricultural building. Directly overlying 102 was a mid brown silty clay subsoil (101) below a dark brown silty clay loam topsoil (101).

- 3.4.2 Two modern features were recorded cut from the surface level into the topsoil. Ditch 105 was recorded partially exposed in the southern end of the trench. This was also recorded in Trench 3 (304) and was clearly visible as an earthwork leading into a functioning boundary and drainage ditch to the east. Only the top of the sloping north edge was exposed and it was backfilled with late 20th century debris mixed within a humic soil (106). In the middle of the trench a 3.6m wide cut (103) was recorded. This had been cut through the topsoil and subsoil and was backfilled with topsoil mixed with demolition debris (104). This debris also sealed the topsoil horizon as a 0.10m thick layer beyond the extent of the trench. This feature and deposit derived from the demolition and removal of the former agricultural building.

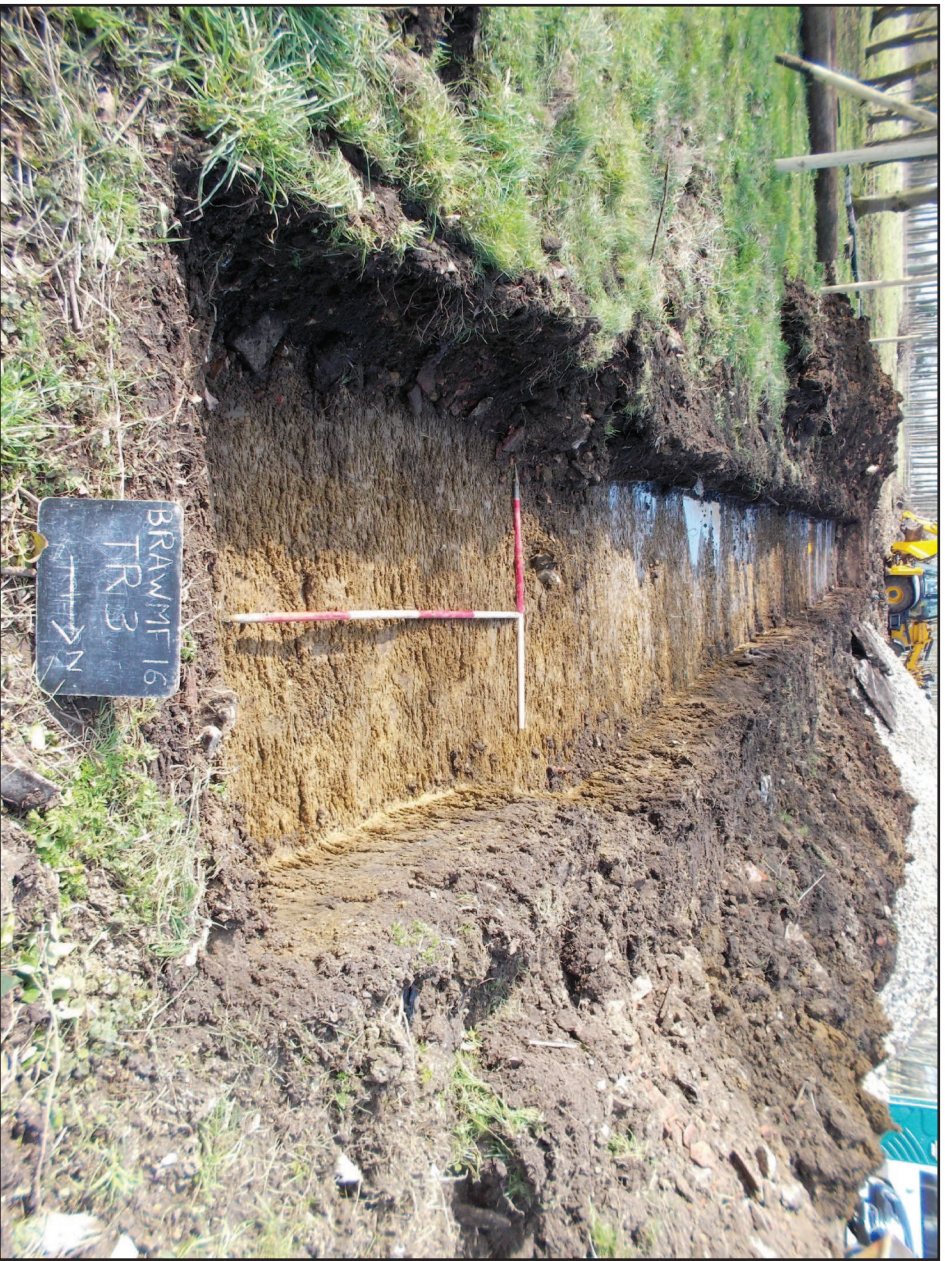
Plate 2: Trench 3 general view west

- 3.4.5 A light brown silty clay natural with gravel patches (303) was exposed across the extent of the trench up to 0.5m below the current ground level. This was overlain by a mid brown silty clay subsoil (302) below a dark brown silty clay topsoil (301).

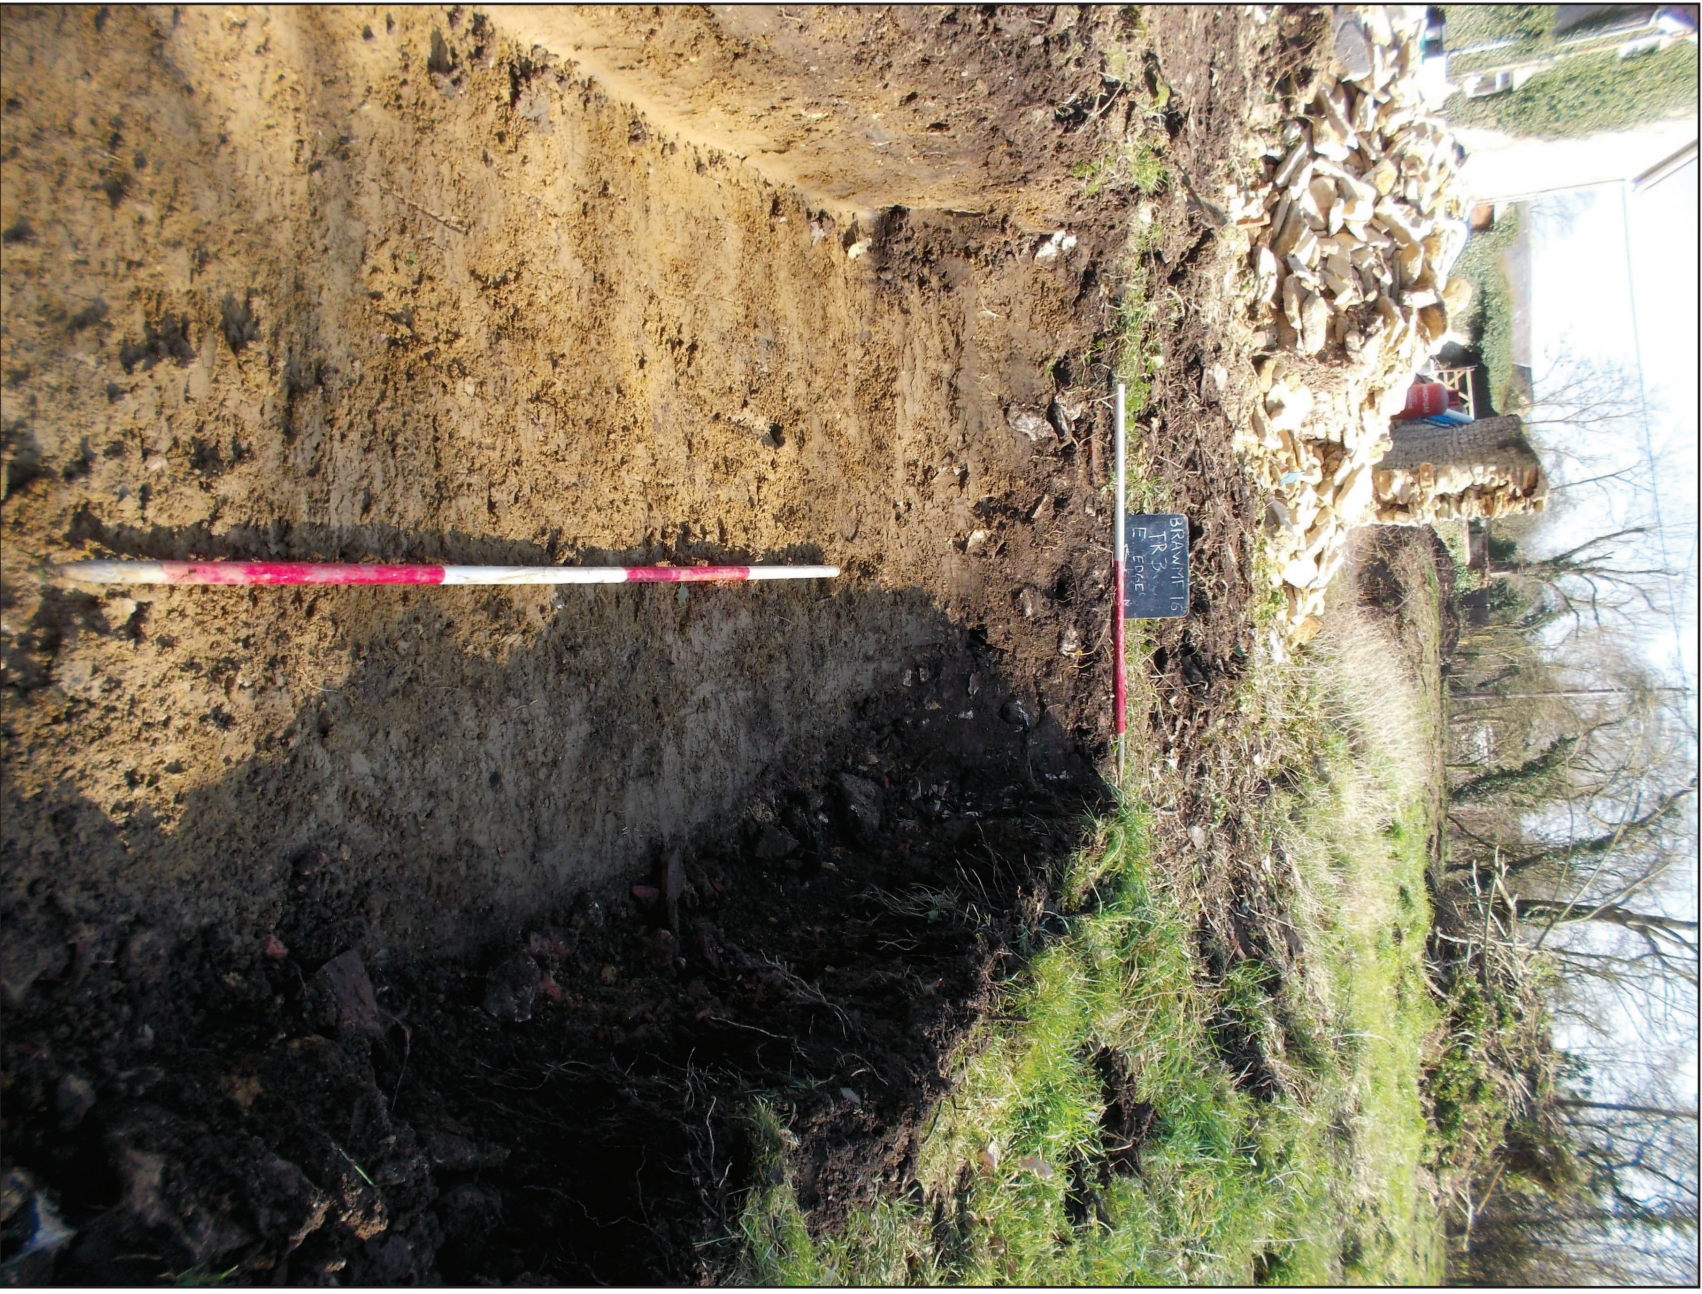
Plate 3: Trench 3 eastern end section and ditch 304

- 3.4.6 Three modern features, a pit (306), a post hole (308) and a ditch (304), were cut into the topsoil horizon. The ditch (304) formed the southern boundary of the old farm yard with steep sloping sides and was only seen within the east end of the trench. It had been filled in with modern building material and soil. Part of the trench at the eastern end was not excavated due to the presence of sheet asbestos containing material within the backfill of this ditch. This ditch is the same as that recorded in Trench 1 (105) and continues to the east towards Weald Street as an active boundary and drainage ditch.
