Music Room Extension
Corpus Christi College
Oxford

Archaeological Evaluation Report

March 2007

**Client: Rick Mather Associates/
Corpus Christi College**

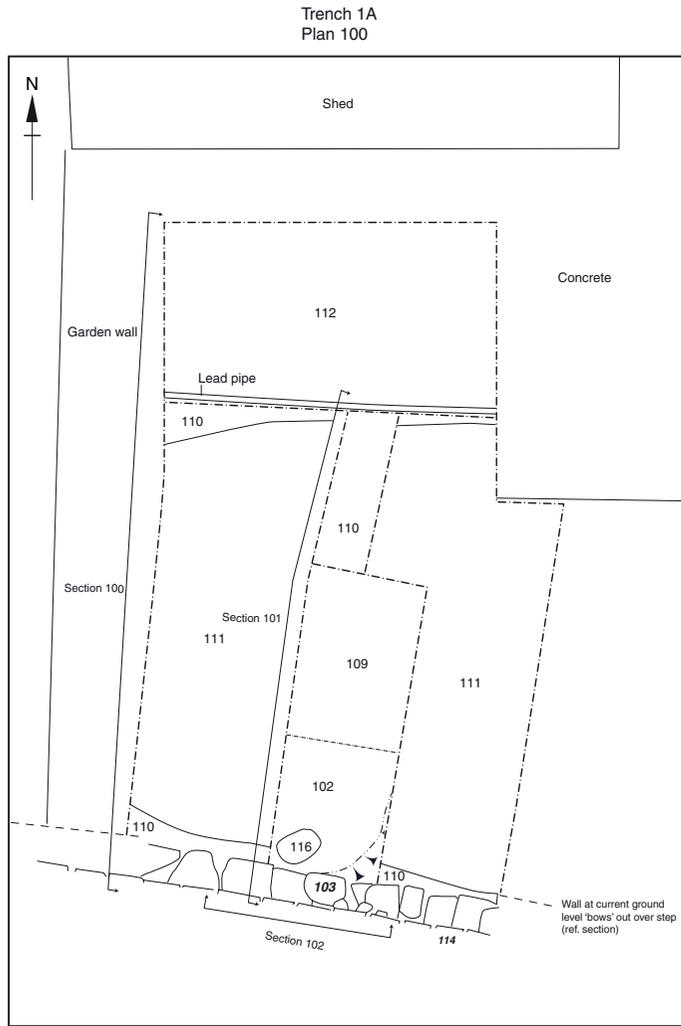
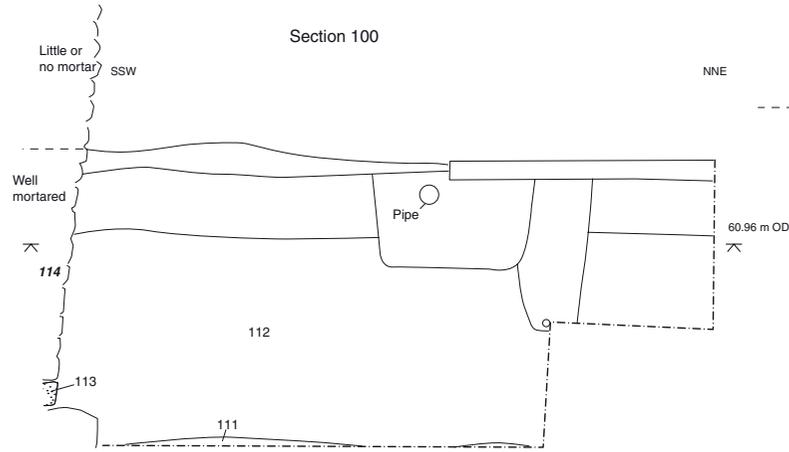
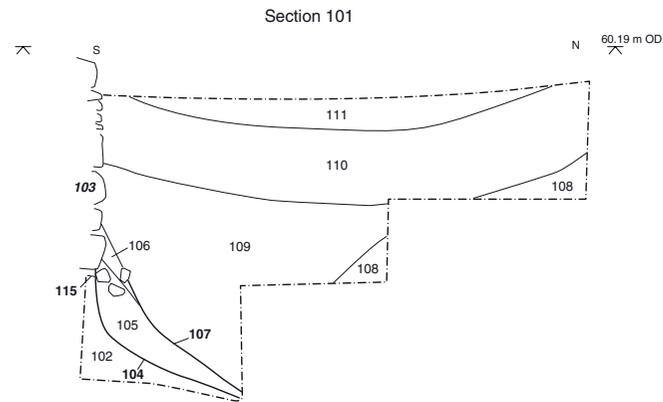
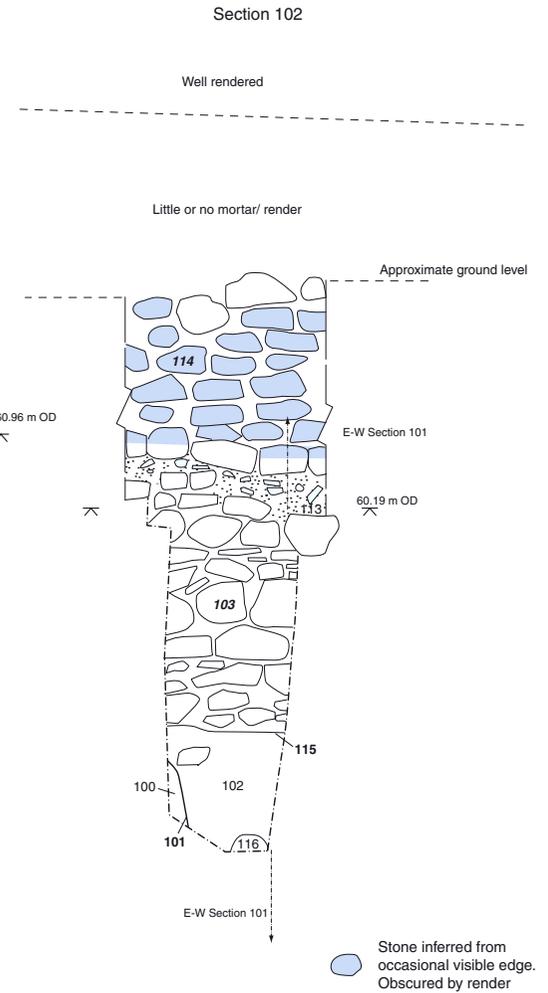
Figure 3 : Trench 1A , Plan 100, Sections 100-103

- 4.1.2 Trench 1A was an east-west aligned trench c. 1.5 m wide x 3 m long and was excavated against the eastern face of the Christ Church wall to the south of the President's Lodgings. The trench incorporated a hand excavated engineering test pit to test the foundations of the standing wall.

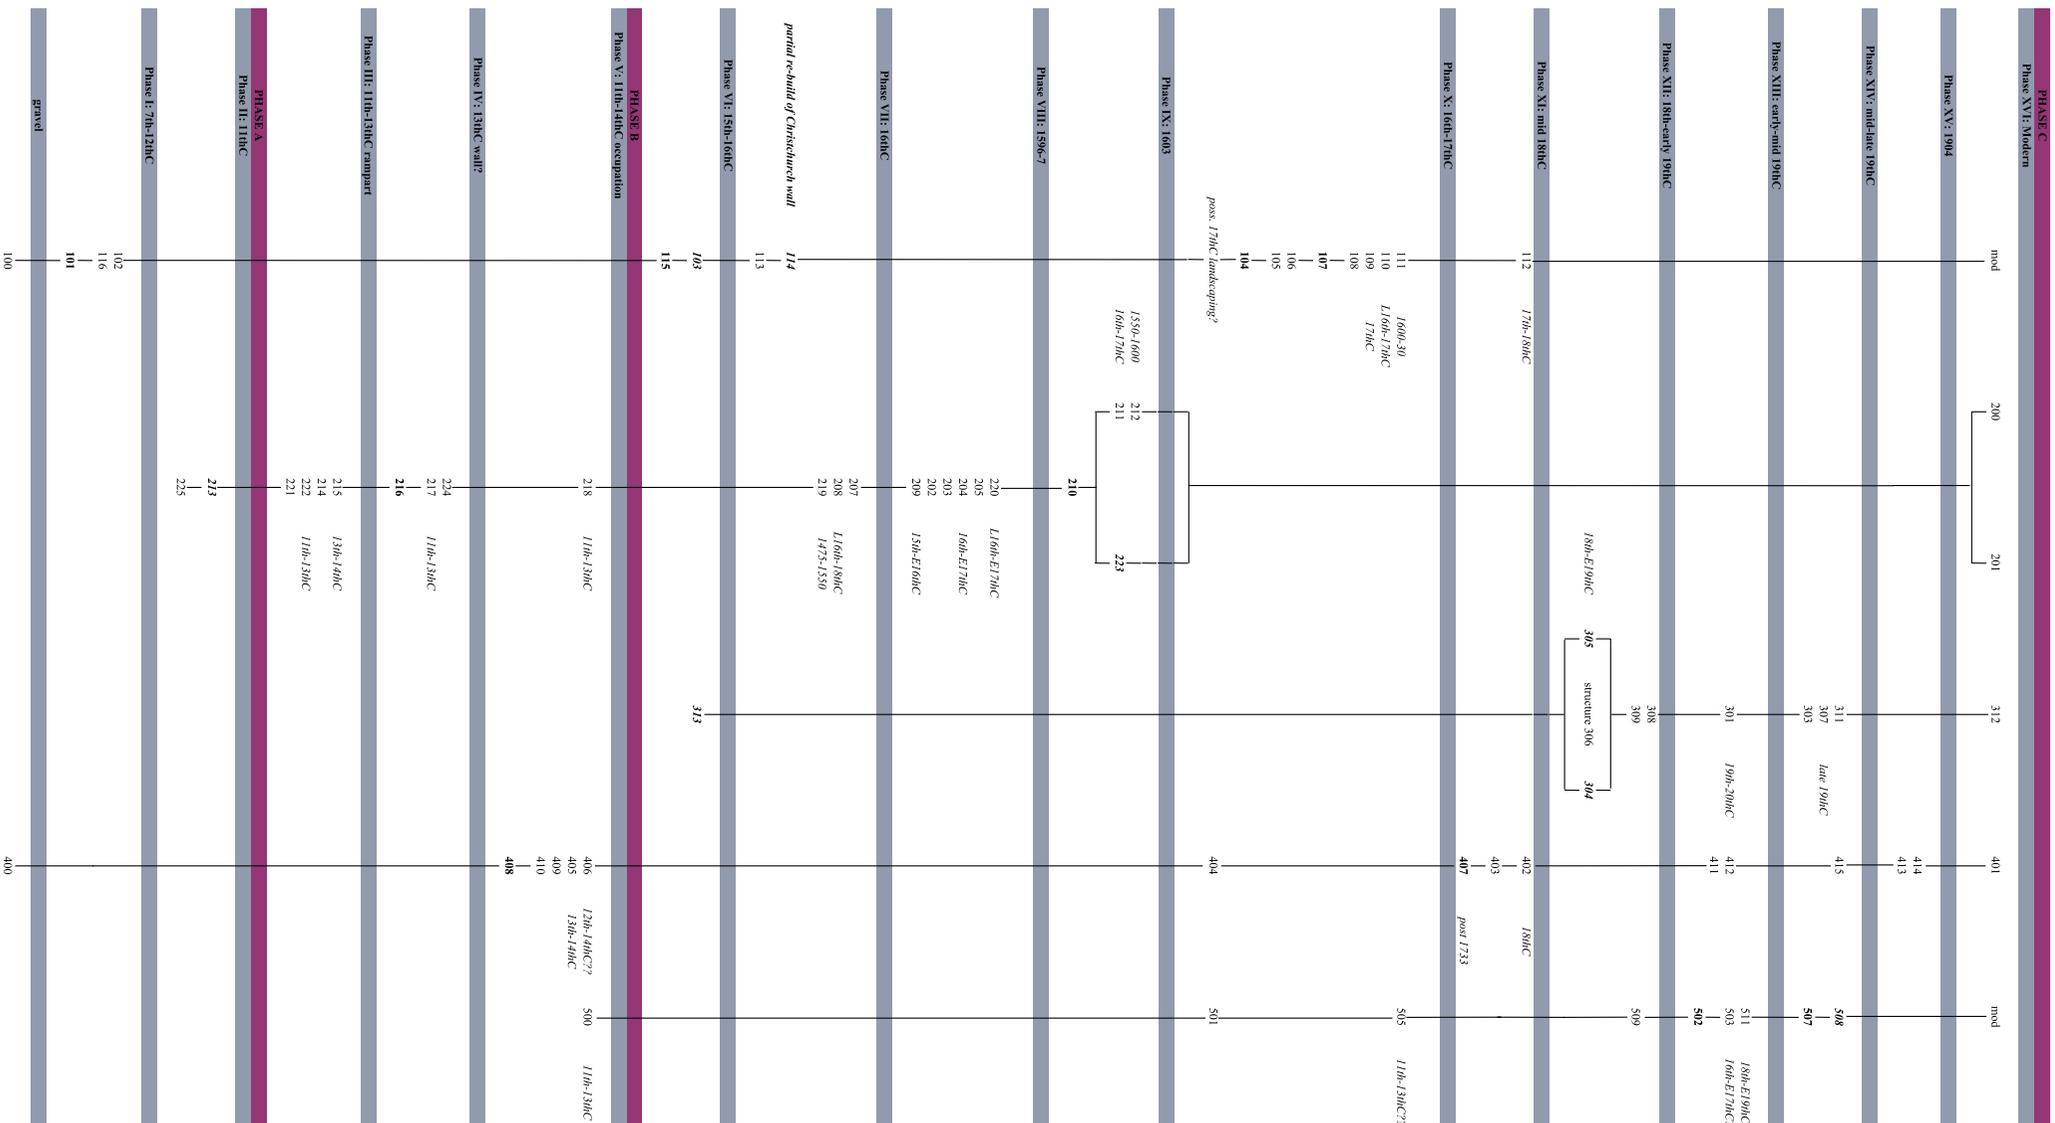
Figure 6: Stratigraphic matrix and conjectured phasing

- 8.2.1 The following interpretative discussion is broadly divided into 3 phases of activity:
- Phase A: 7th-11th century - the foundation of St Frideswides Priory to the conquest
 - Phase B: 11th-16th century - the medieval town to the foundation of the college
 - Phase C: 16th century onwards - the college garden
- 8.2.2 There are numerous sub-divisions within each of these phases as indicated on the stratigraphic matrix (Fig. 6).

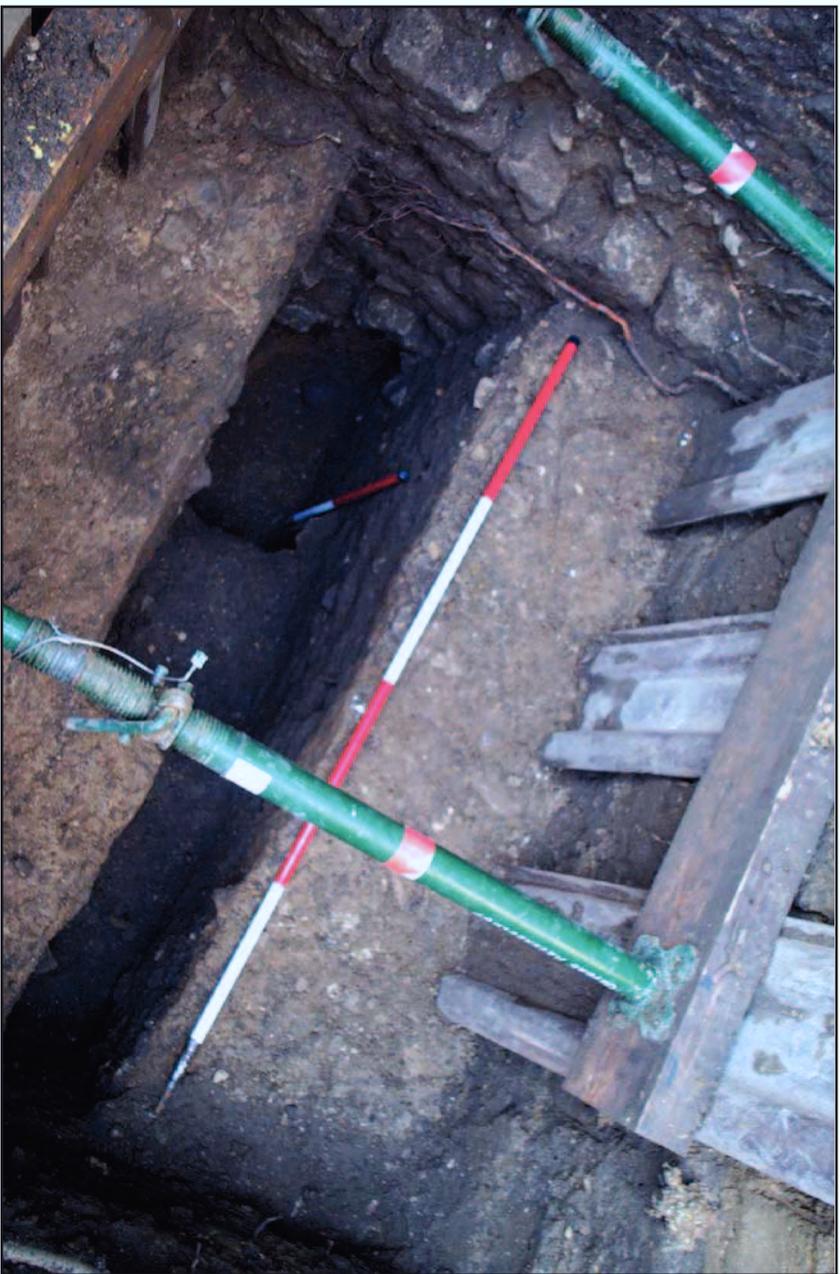
Plate 2: Trench 1A, Burial 116

- 8.2.3 Although no dating evidence was recovered from the burial within Trench 1A (101, 116, 102), the fact that it pre-dates the boundary wall between Christ Church and Corpus Christi (103) implies that at the very least it pre-dates the foundation of the college. If, as is supposed, the boundary wall lies on the course of the former Shidyerd Street, this would also imply that the burial pre-dates the medieval street grid and is therefore likely to be associated with an early phase of the cemetery of St Frideswides Minster. This would also suggest that the early cemetery extends further eastwards than its later counterpart, as the boundary wall is also thought to correspond to the eastern boundary of the cemetery (see 7.2.14).

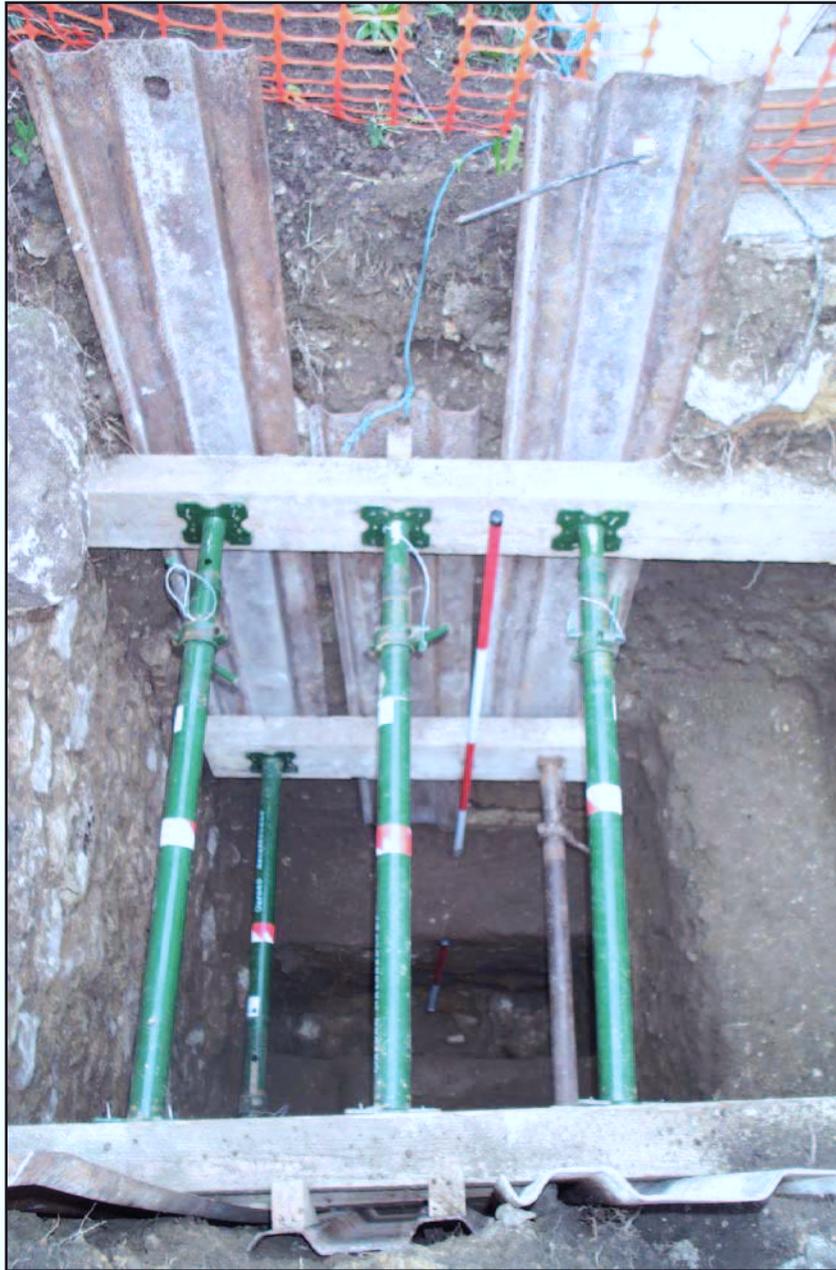
Plate 3: Trench 2

- 4.1.5 Trench 2 was a north-south aligned trench c. 1.5 m wide x 3 m long and was excavated against the northern face of the Scheduled Ancient Monument of the City Wall. The trench incorporated a hand excavated engineering test pit to test the foundations of the standing wall.

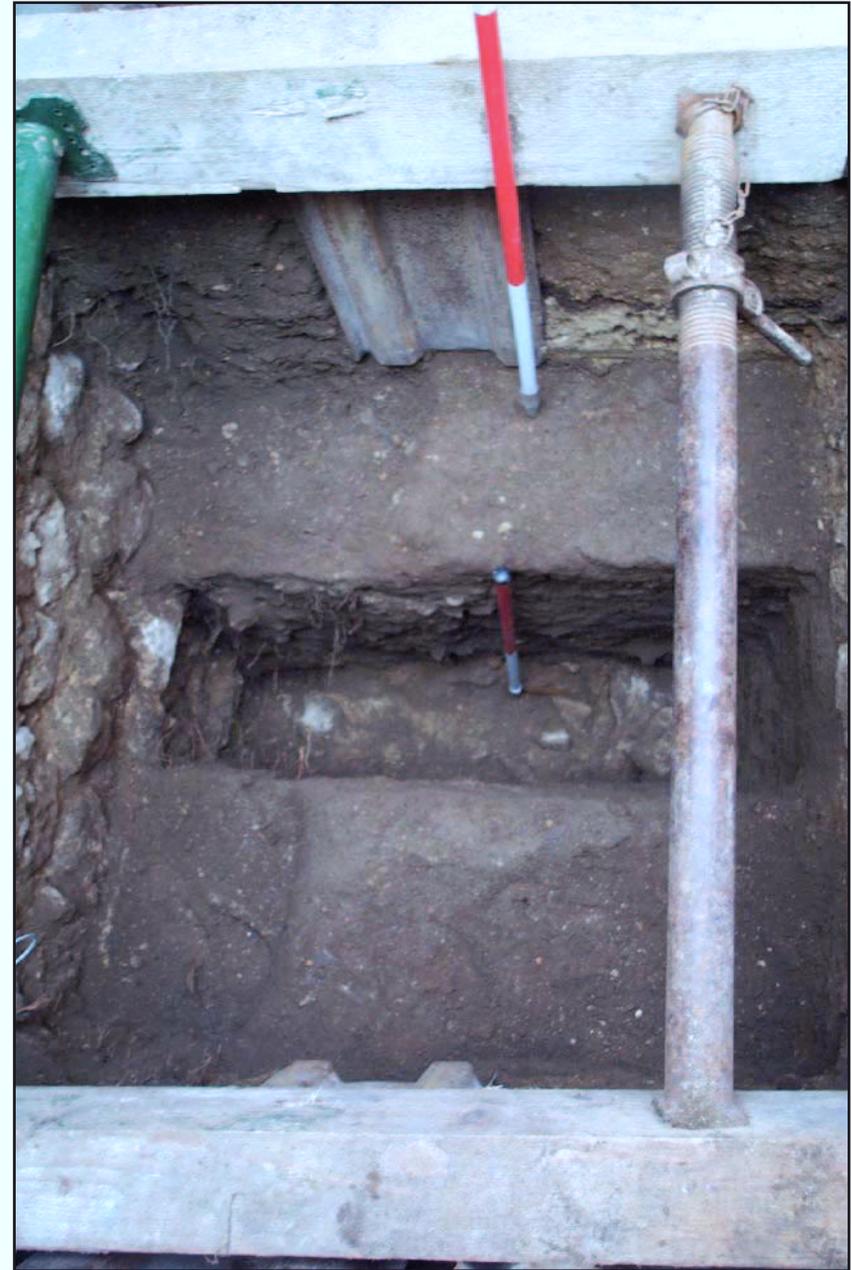
Plate 4: Trench 2, Late Saxon Revetment? 213

- 8.2.6 It is possible therefore that this structure represents a late Saxon stone revetment, similar to that observed during the recent excavations at Oxford Castle (OA, 2006(2)), and known to have fortified the burh in the 11th century. However, the augured borehole to the north of the structure was inconclusive in providing any definitive evidence for an associated rampart (the origin of deposit 225 being unclear).

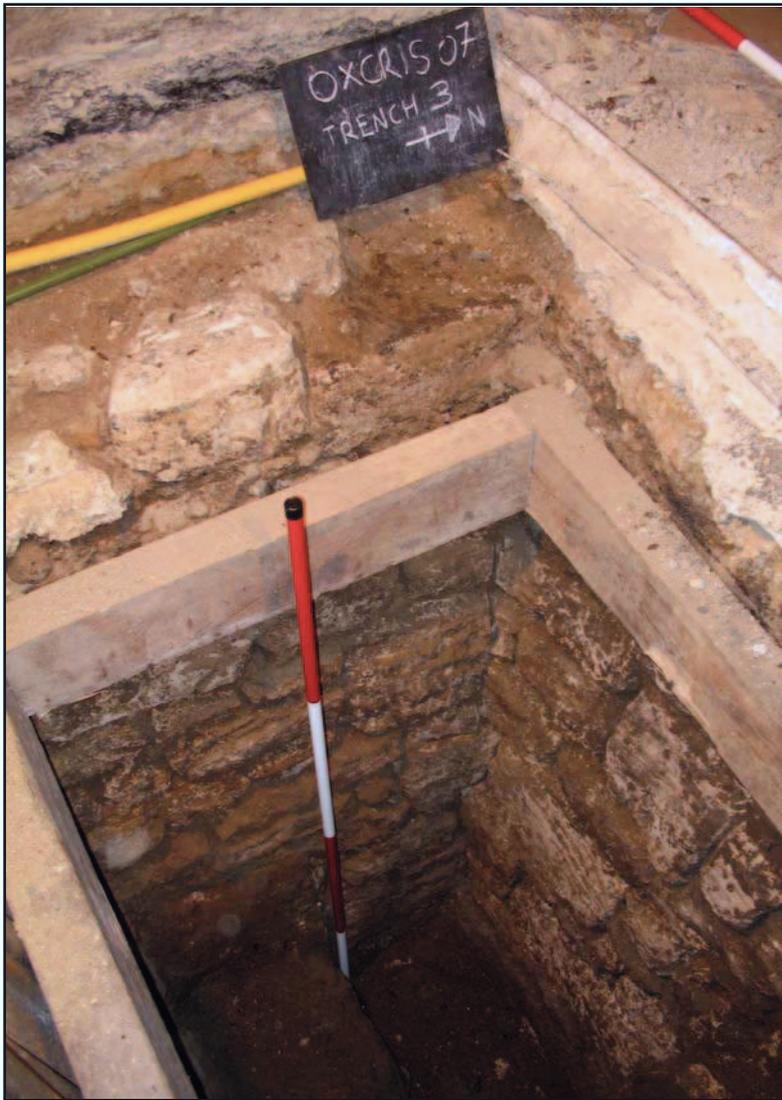
Plate 5: Trench 3 Structure 306

- 5.1.26 Trench 3 was hand excavated to 59.35 m OD. The trench lay within the north-west corner of a post-medieval stone lined cess pit (306) which had been constructed against the foundation of the boundary wall between Christ Church and Corpus Christi which now marks the western wall of the existing music room. Both the north-south (305) and east-west (304) walls of this structure had a c 20° batter from just below the existing floor deposits (60.30 m OD) to the bottom of the trench (see also 5.1.28).

- 8.2.28 It is possible that the stone-lined cess pit in Trench 3 was a direct replacement for cess pit 104. Although no dating evidence was recovered from the primary fills, the fragment of brick recovered from the fabric of wall 305 suggests an 18th-19th century date for its construction. This structure is likely to be part of the northernmost of two sub-square structures shown on the 1876 OS Map (OA, 2006, Fig. 9). This would suggest that the 'battered foundation' to the Christ Church wall observed during the 1986 watching brief is likely to be the southern continuation of wall 305, and that the N-S wall in the watching brief trench may represent the eastern limit of structure 306, c 2 m to the east of the vertical face of the Christ Church wall (ref. Dodd, 2003, p.193 and 198).

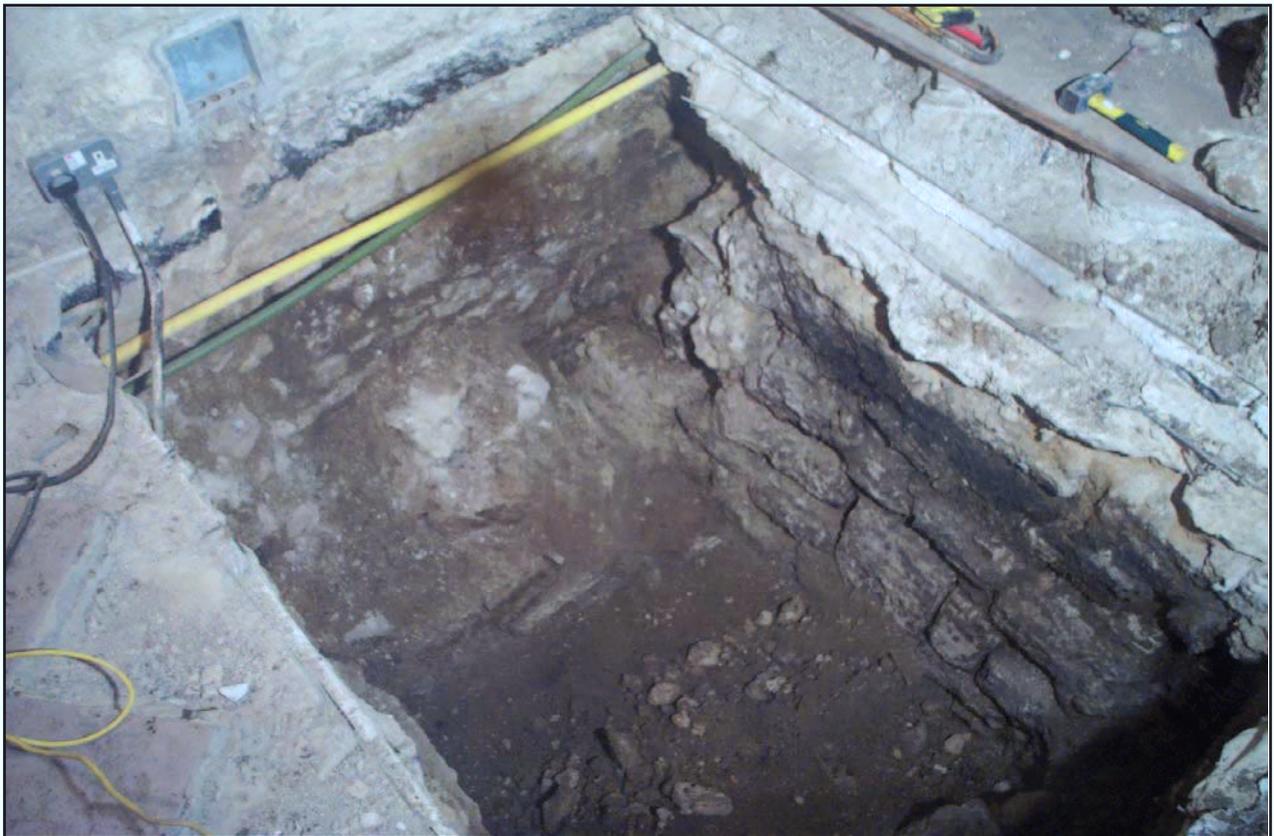
Plate 6: Trench 3 Footing 313 following partial dismantling of wall 305

- 5.1.28 In order to establish the nature of the foundation of the Christ Church wall (313) against which structure 306 had been constructed, it was agreed with Brian Durham (OCC) and Chris Welch (EH) to deconstruct part of wall 305. This revealed the near vertical footing of 313 to a depth of 1.40 m below floor level (59.33 m OD). As the top of the stepped footing in Trench 1A (103) was revealed at c 60.19 m OD and a similar step was not seen within Trench 3, it seems likely that the re-built section of wall seen in Trench 1A was localised, and does not apply to the whole of the wall. Additionally, if the stepped footing in Trench 1A equates to the standing wall in Trench 3, the base of the latter should also lie at c 59.17 m OD, approximately 0.25 m below the exposed section of the wall in Trench 3. The top of wall 305 stepped out c 0.50 m from the face of wall 313. The thickness of wall 305 at the base of the removed section (e.g. 1.40 m below ground level) was c 0.70 m, reflecting the batter on the interior faces of structure 306 (Plate VI).
