Buckingham Palace Gardens Buckingham Palace London

Archaeological Watching Brief Report

Oxford Archaeology

April 2004

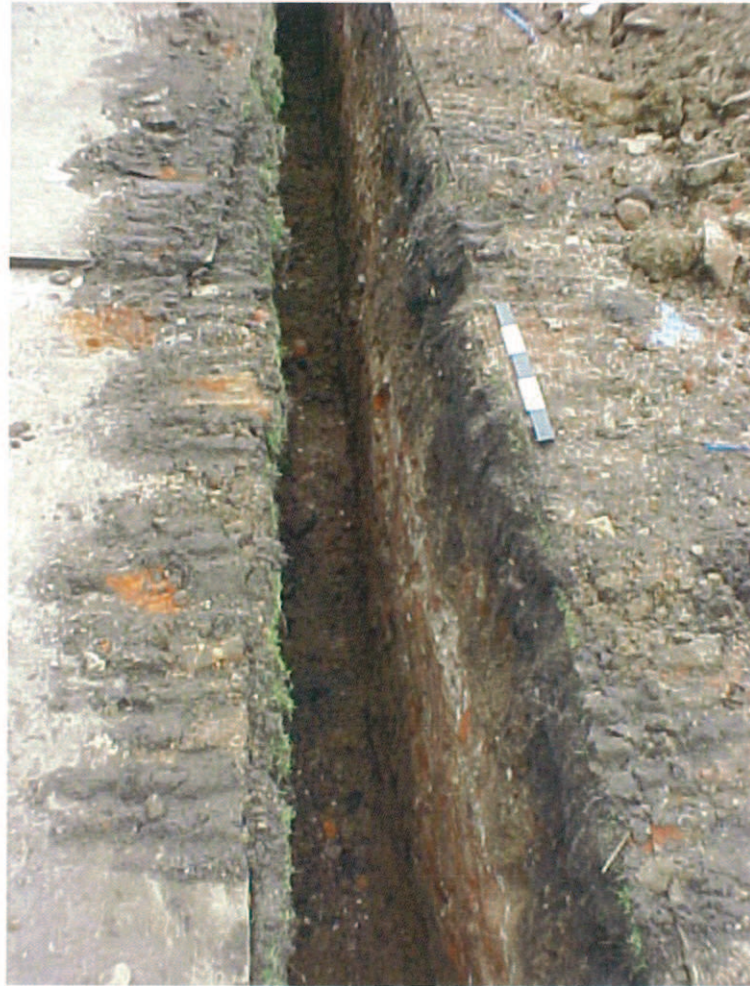
Plate 3: Trench section showing rubble deposit

Below this was a dark brown, gravelly deposit with rubble inclusions (5), which may have been re-deposited subsoil, mixed with building rubble. Below this was a distinctive layer of brick rubble (4), comprising red bricks that seem to have been dumped, some as lumps of bonded bricks with mortar, others as fragments (Fig. 3; Plates 3 and 4). The layer was identified 0.3 m to 0.4 m below the surface, and was between 0.4 m-0.7 m thick. The deposit was compact with the bricks having degraded *in-situ*. Below this deposit is a layer of re-deposited natural clay, (6), and below this, the natural orange-brown sand and gravel deposits (7).

- 4.1.1 The east end of the trench revealed evidence of the disturbance created during the recent remodelling of the south-west corner of the gardens.
- 4.1.2 The most significant find within the trench was the brick rubble layer. This appeared throughout the majority of the trench, at a constant level and thickness. This indicates that the rubble was deposited widely across this end of the main lawn.
- 4.1.3 It is possible that the layer was formed during to the installation of brick culverts, known to run from the west side of the palace to the lake. These are depicted on

historic maps and date to the Victorian era. Similar features were located during the previous watching brief (OA 2003). It is equally also possible that the layer formed part of a general levelling of the lawns in the Victorian period.
