# Old Timber Yard Historic Dockyard Chatham Kent

## Archaeological Watching Brief

**OLD TIMBER YARD  
HISTORIC DOCKYARD  
CHATHAM, KENT**

***ARCHAEOLOGICAL WATCHING BRIEF REPORT***

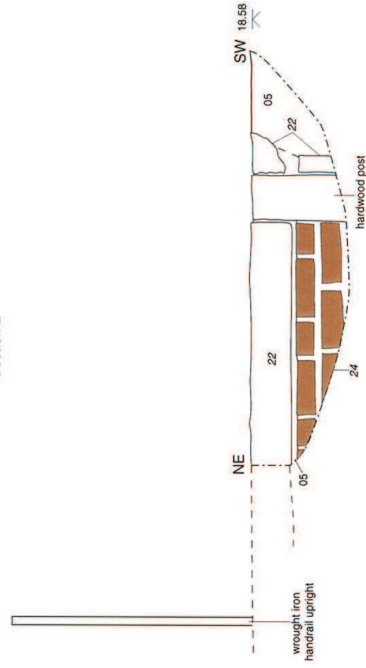
Section 2

- 3.1.5 Part of the demolished brick wall 24 was further exposed to the south (Fig. 3, section 2). Adjacent to it at this point was a hardwood post. The wall was capped with a concrete slab (22) and a hand rail made of wrought iron ran along its length.
