Hubbards Farm, West Drayton Road, Hillingdon

ARCHAEOLOGICAL EVALUATION REPORT

Planning Reference 5971AC/98/2044

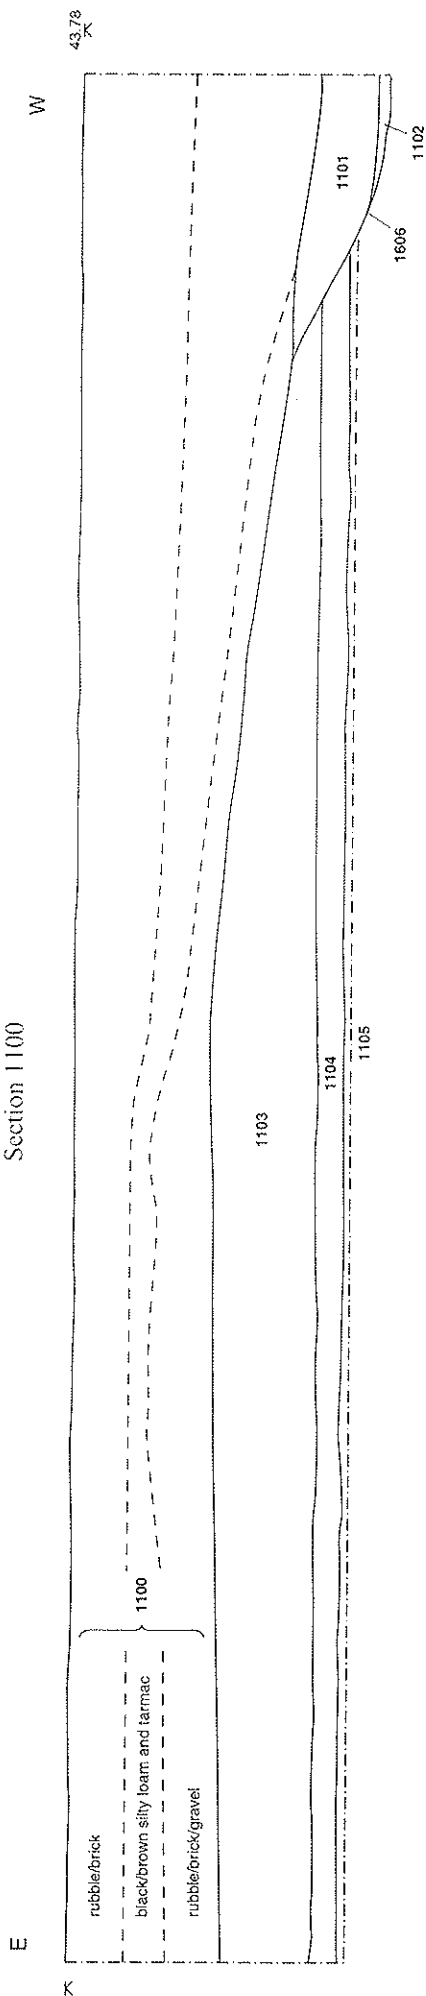
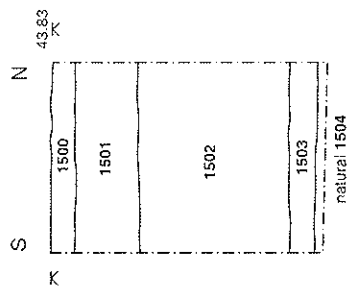
Figure 4: Sections 1100, 1500 and elevation 1601

Trench 11
Section 1100

Trench 15
Section 1500

Trench 16
Elevation 1601

- 5.1.2 The sequence in Trench 15 (Fig. 4) is typical of deposits across the site. At a depth of 1.35 m a natural deposit (1505) comprising 80% sub-angular gravel (0.01-0.06 m diameter) in a sandy matrix was revealed. This was overlain by a spread of natural brownish-yellow sandy clay (1504) followed by a 0.15 m thick greenish-brown silty clay (1503) with 5 % small gravel inclusions which could be the remains of an ancient buried soil. This was overlain by a 0.8 m thick (less in the northern area of

the site) light, buff-brown clay silt (1502) with sparse gravel inclusions broadly interpreted as brickearth. The brickearth lay below a 0.32 m thick mid-brown silty clay (1501) with sparse gravel inclusions forming a subsoil. The topsoil (1500) was largely truncated but 0.12 m of loose dark-brown silty clay remained.

- 5.1.11 Excavation of the trench revealed natural gravel (1105), overlain by a 0.18 m thick clay silt layer (1104) and in turn overlain by a 0.5 m thick layer of brickearth (1103). At the eastern end of the trench was a feature (1106) 0.45 m in depth with an edge sloping west at c 35 degrees, which was interpreted as a pond. 1106 was at least 1.5 m wide and was filled with two deposits of blue grey clay (1101, 1102), 0.35 m and 0.6 m thick respectively. A 1.20 m thick deposit comprising layers of modern dumping and makeup (1100) overlaid these primary fills.

- 5.1.12 Trench 16 measured 7 x 1.8 m and was added to investigate the foundations of the listed wall (1604) running east-west in the western area of the site. It was positioned where the part of the wall surviving above ground had been removed, but was not machined to below the made ground/subsoil deposits due to the presence of a live electric cable. A test pit was excavated by hand to investigate the wall foundation.

- 5.1.13 The wall was constructed of orange red bricks 0.25 x 0.115 x 0.06 m bonded by light-brown sandy mortar. It was 0.38 m in width and below ground seven irregularly bonded courses were seen laid on 3 courses of footings; these comprised headers set on end, the lowest two being offset from the wall face by 0.08 m. The total depth of the brickwork below ground was 0.82 m, and this rested on a hardcore foundation (1603) of which 0.08 m was seen; the deposit was not fully exposed. The lower footings have been truncated by the cut (1607) for the modern service, which has been tunnelled below the wall. The lower courses of the wall appear to have been 'trench built' but there has been truncation of the land surface and then substantial making up of the ground with modern deposits. This is greater to the south of the wall where it is abutted by at least 0.5 m of made ground.
