Barn Conversion Park House Hornton Lane Horley Oxfordshire

Archaeological Watching Brief Report

September 2010

Document Title: Barn Conversion, Park House, Hornton Lane, Horley,
Oxfordshire

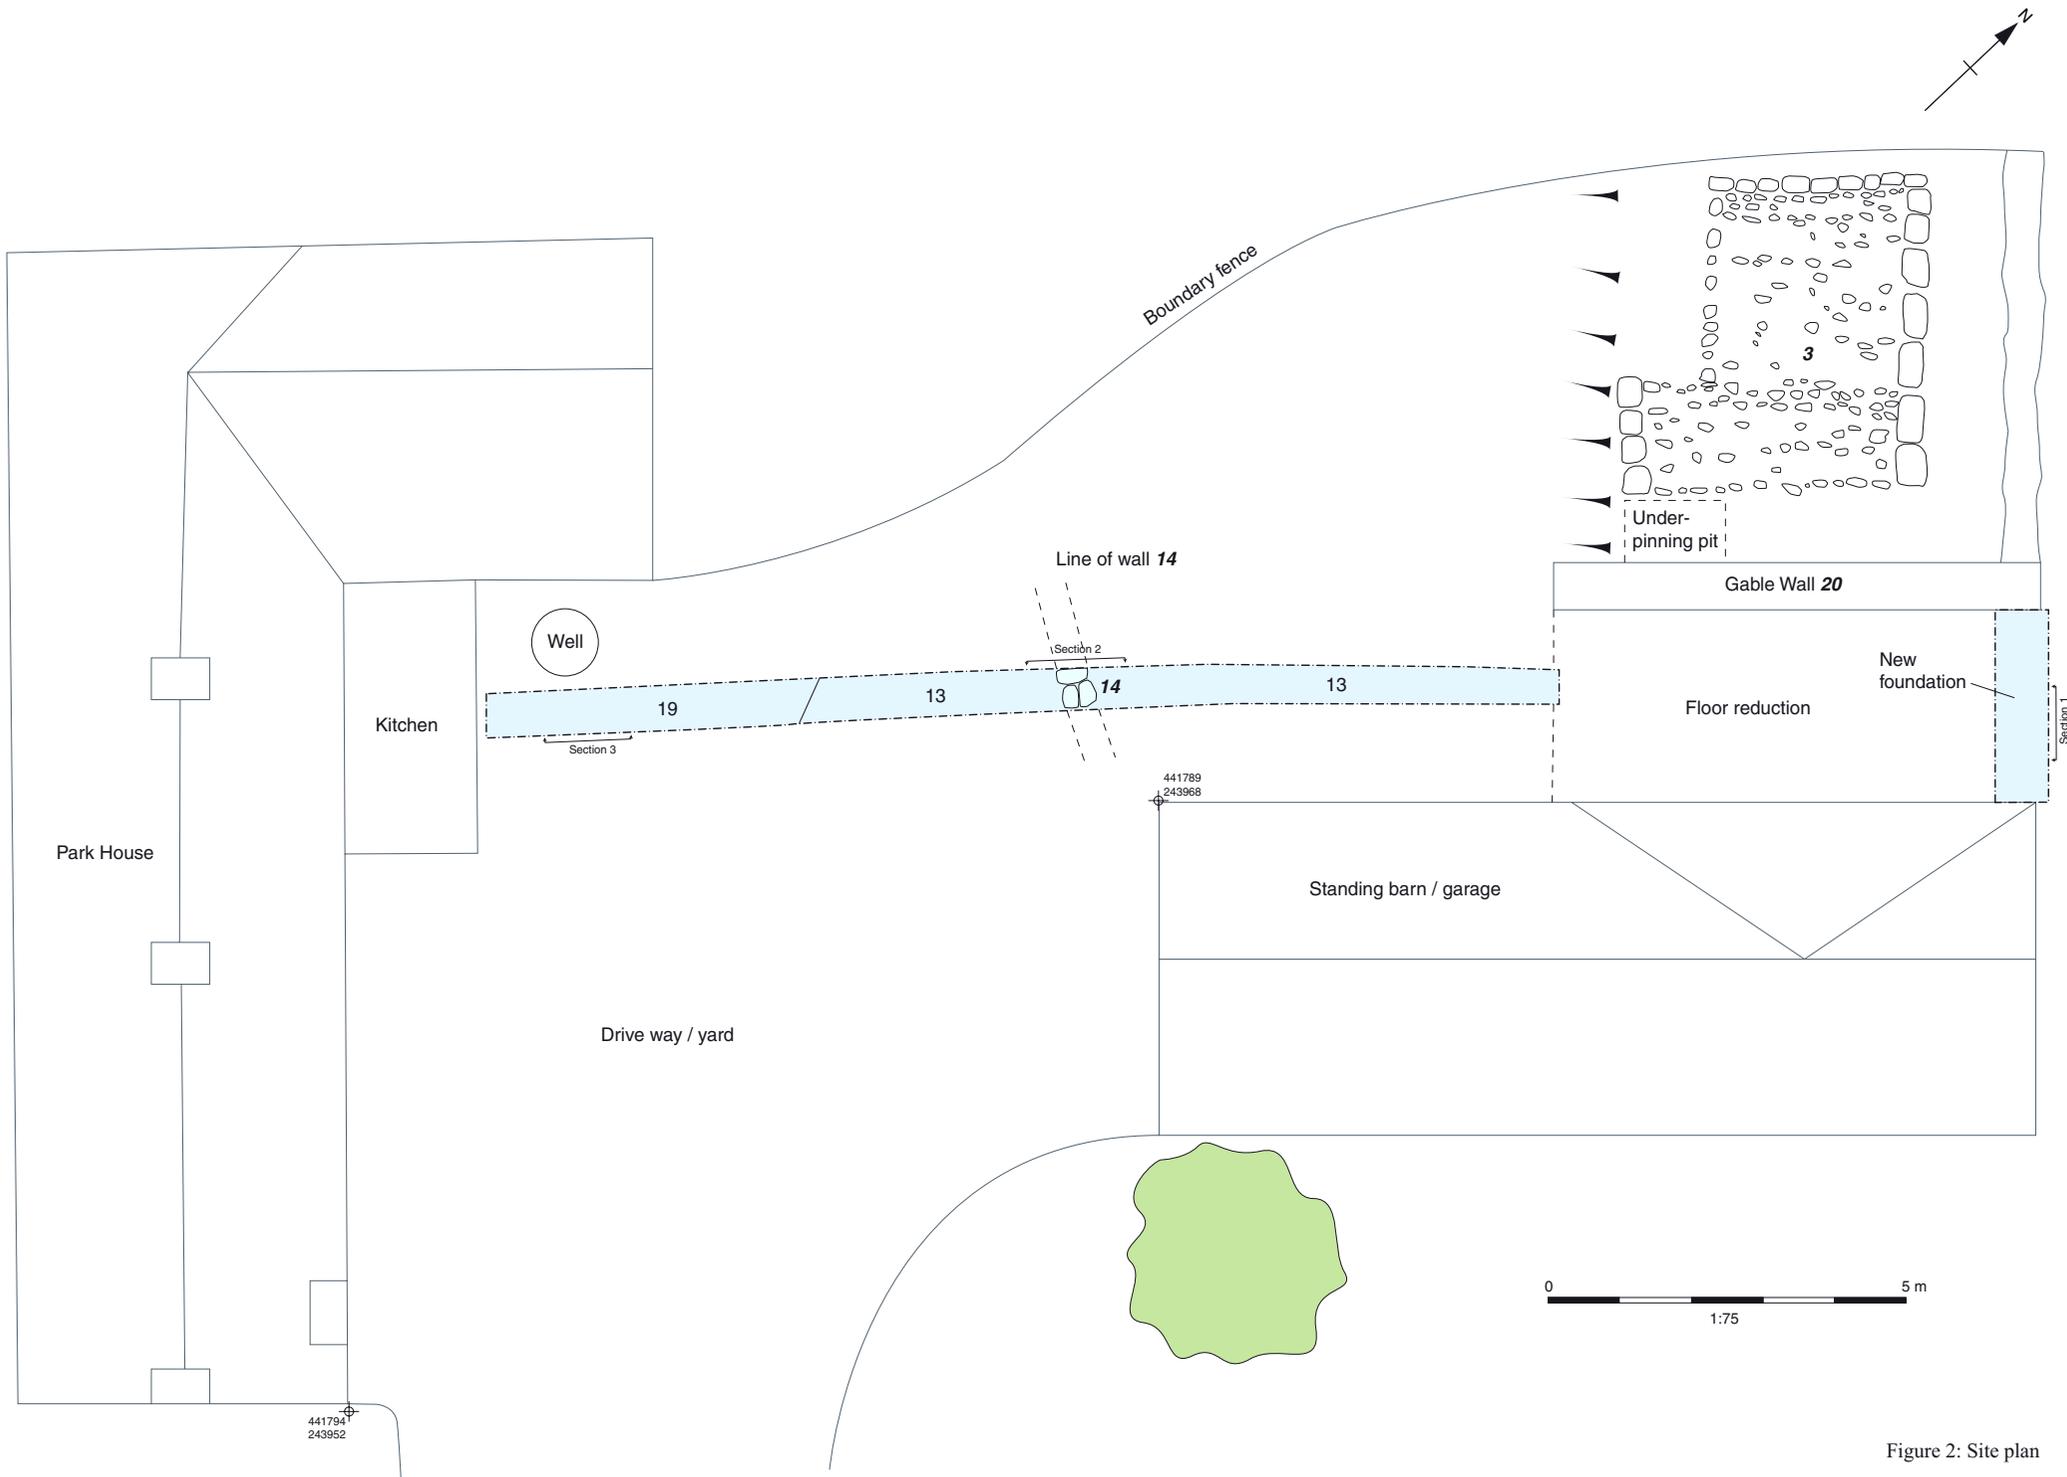
Figure 2: Site plan

- 3.1.5 As part of the work the area between the western gable wall of the barn (20) and the property boundary was cleared prior to landscaping of the area (Fig. 2). This area was raised approximately 0.5 m above the yard surface.
- 3.1.6 The area was sealed by a mixture of dark brown silt loam and charcoal and ash from a bonfire heap (6). This overlaid an area of cobbling running between the barn and the boundary fence (3). The cobbling consisted of an area measuring approximately 4.4 m x 4.4 m. The northern and southern edges were bounded by rounded ironstone blocks measuring 0.55 m by 0.4 m (depth unknown) and the western edge bounded by stones averaging 0.3 m by 0.2 m (again depth unknown). The interior was laid using south-west to north-east aligned rows of cobbles composed of ironstone measuring 0.28 m x 0.1m laid on edge. All the exposed stones had been rounded through wear.

- 3.1.9 A service trench measuring approximately 15 m in length and 0.6 m wide was excavated between the rear wall of Park House and the barn (Fig. 2). The depth of the trench measured 0.7 m at the barn increasing to 0.9 m at the rear wall of Park house.

- 3.1.10 Approximately in the centre of the trench a roughly constructed NW to SE aligned wall (14) was encountered at a level of 0.65 m below the current yard surface (Fig. 2 and Fig. 3, Section 2). This measured 0.35 m wide and 2 courses were exposed within the bottom of the trench. It had been constructed using roughly dressed local stone. No bonding agent was observed, but it is possible that this had leached out over time. No construction cut was visible at this level. Butting up to, and partially sealing the wall was a layer of grey-brown gritty silt clay (13), a probable layer of made ground. At the northern end of the trench this was overlaid by a 0.3 m deep layer of dark grey-brown clay loam (12), a probable buried soil horizon.

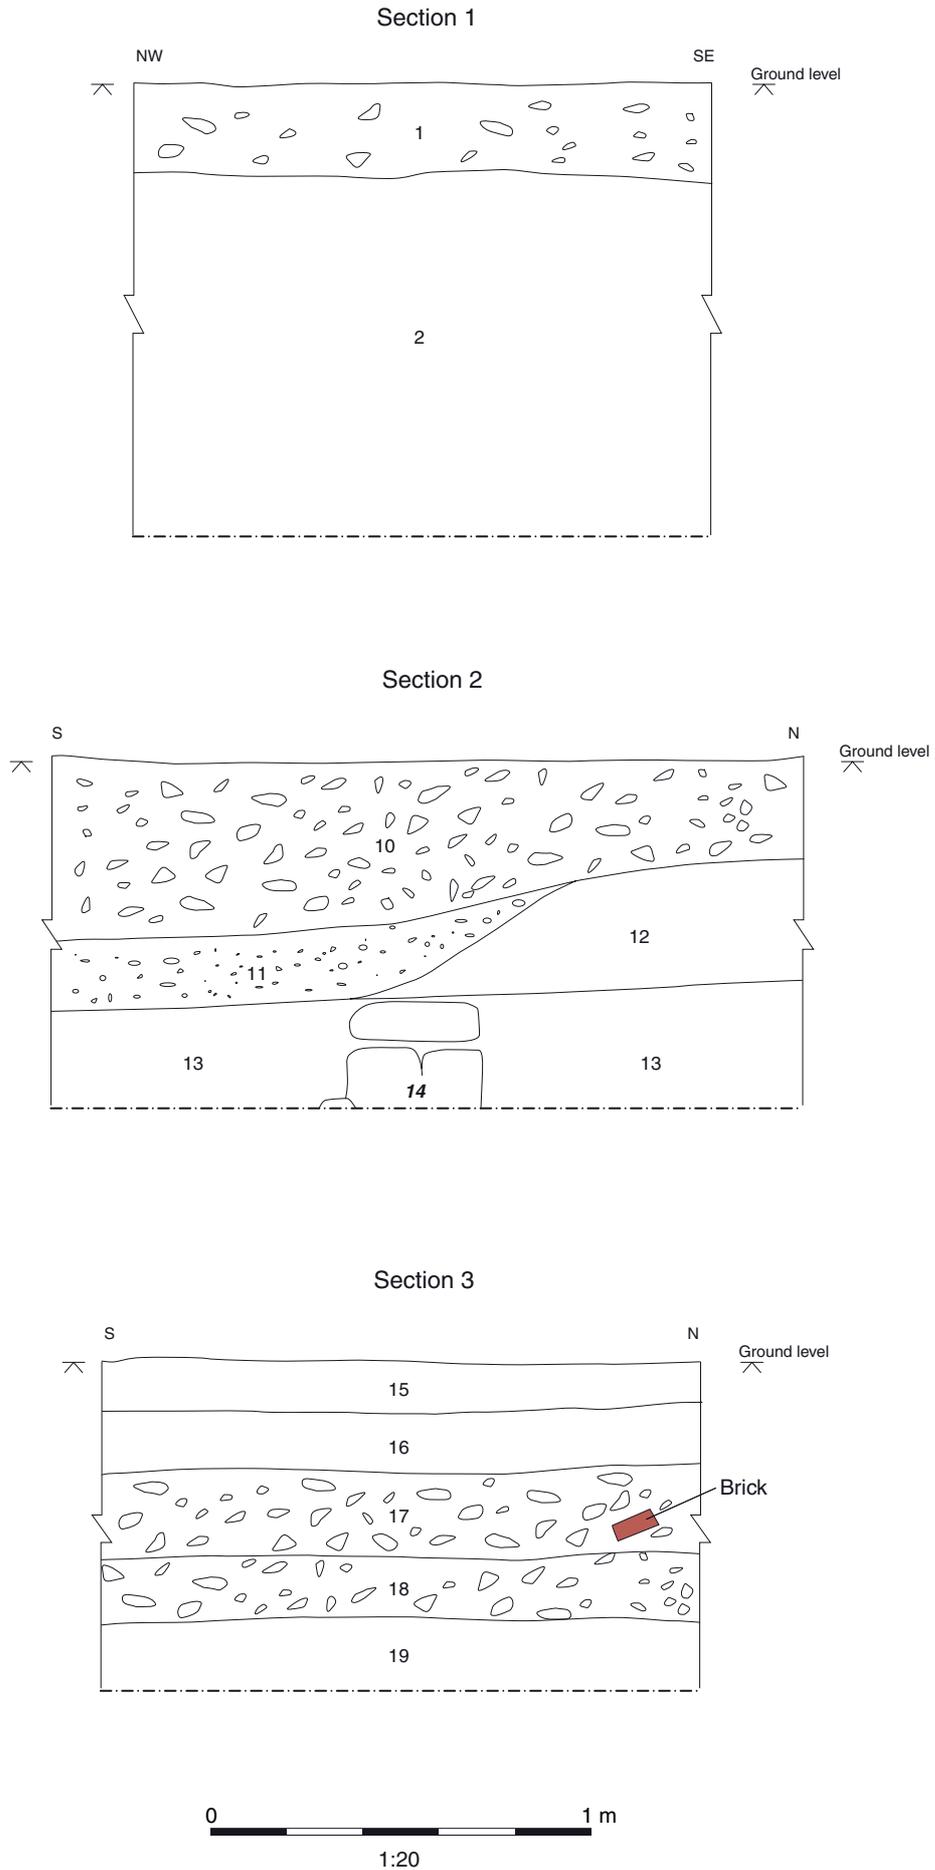
Figure 3: Sample sections

- 3.1.1 A layer of pale red-brown clay silt (2) was encountered at a depth of between 0.2 m and 0.25 m below the surrounding ground level (Fig. 3, Section 1). This was a very clean deposit and probably represents a layer of colluvium. Overlying this deposit was a 0.2 m – 0.25 m deep layer of grey-brown clay loam, the present day topsoil and turf. This deposit contained numerous small fragments of the local iron stained limestone, probably construction debris.
- 3.1.2 The observed stratigraphy was similar throughout the length of the new foundation trenching.

- 3.1.12 At the southern end of the trench close to Park House the underlying natural, a yellow-brown clay silt colluvium (19) was encountered at a depth of 0.7 m below the current yard level (Fig. 3, Section 3). This is a probable continuation of layer (9).

4.1.2 Section 3 shows that the area immediately north of the house has been reduced, truncating any topsoil and possibly reducing the level of the colluvium (19). This may have been done in order to produce a small yard to the rear of the house and also to reduce the possibility of dampness caused by soil butting up against the wall. It is probable the truncated wall (14) observed within the service trench may mark the limit of this work. Layers (17) and (18) represent two different phases of yard surface related to this activity.
