# Archaeological Evaluation of land at Goffs Oak, Waltham Cross, Hertfordshire

## Archaeological Evaluation Report

OA East Report No: 1712

**Report Number:** 1712  
**Site Name:** Land off Halstead Hill and Barrow Lane, Goffs Oak, Waltham Cross, Hertfordshire  
**Date of Works:** December 2014 – January 2015  
**Client Name:** Taylor Wimpey North Thames  
**Client Ref:** PG/xxxxx/01  
**Planning Ref:** 07/13/0631/F  
**Grid Ref:** TL 3364 0210  
**Site Code:** XHTGOF14  
**Finance Code:** XHTGOF14  
**Receiving Body:** Hertfordshire County Council Historic Environment Unit  
**Accession No:**

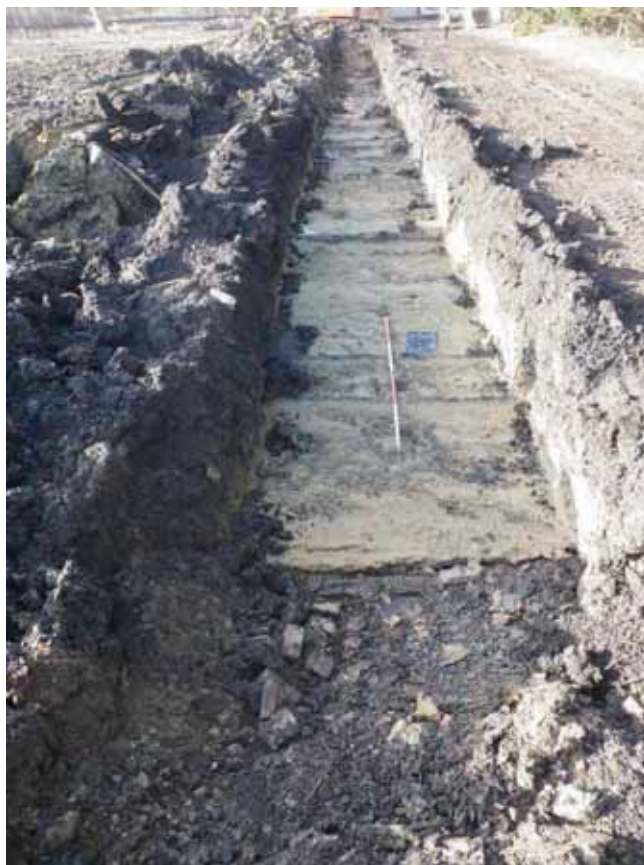
3.2.2 Trench 2 was affected by the site's previous use as a garage and had a modern pit containing brick, plastic and glass through the middle of it.

Plate 1: Trench 2. Facing west

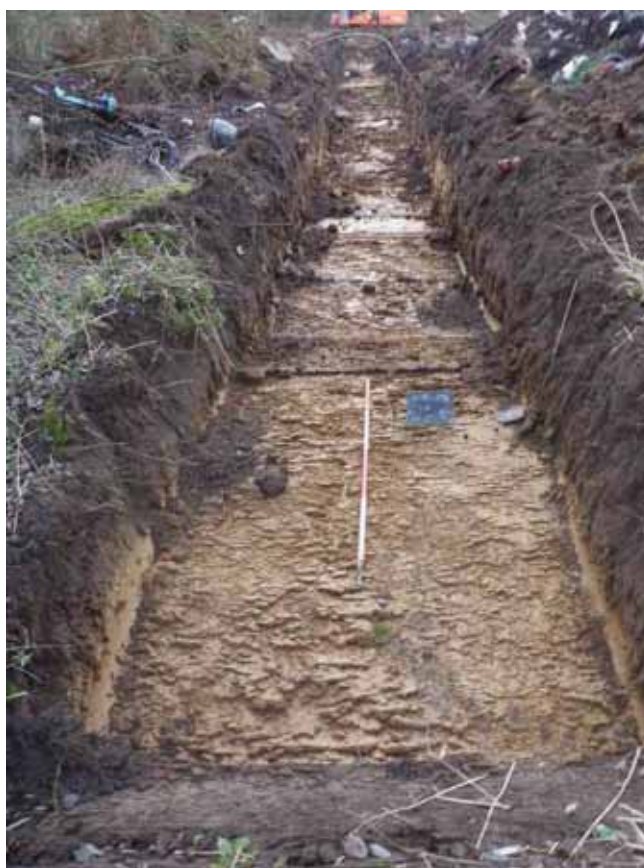
3.2.7 Trench 7 was devoid of archaeology, with modern intrusions of concrete blocks and a cast iron pipe across the middle of the trench.

Plate 2: Trench 7 with fly-tipping on the sides. Facing east

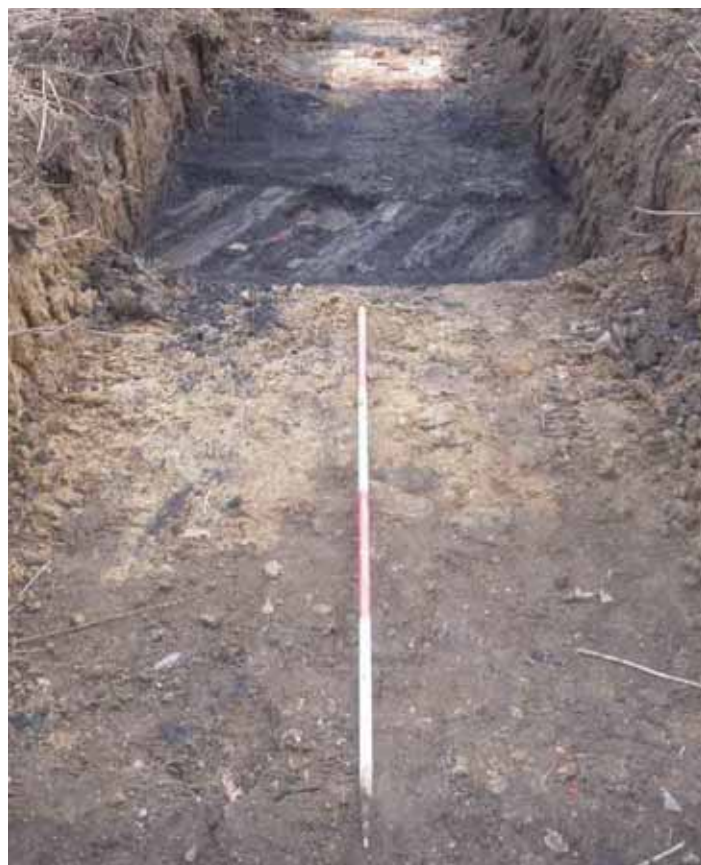
3.2.8 The north end of this trench contained a 20<sup>th</sup> century machine pit (see plate 3). The base of the pit was lined with wooden planks evenly spaced by half-bricks. Overlying the planks was a coal and coal dust deposit that had probably accumulated whilst the pit was open. The south end of the pit was 1 metre from a brick and concrete plinth, whilst the north end aligned with a square void outside the development area. Overlying

the coal deposit was a redeposited topsoil deposit that was in turn overlain by a redeposited natural and the topsoil that lay across the site.

Plate 3: Machine pit 12. Facing south

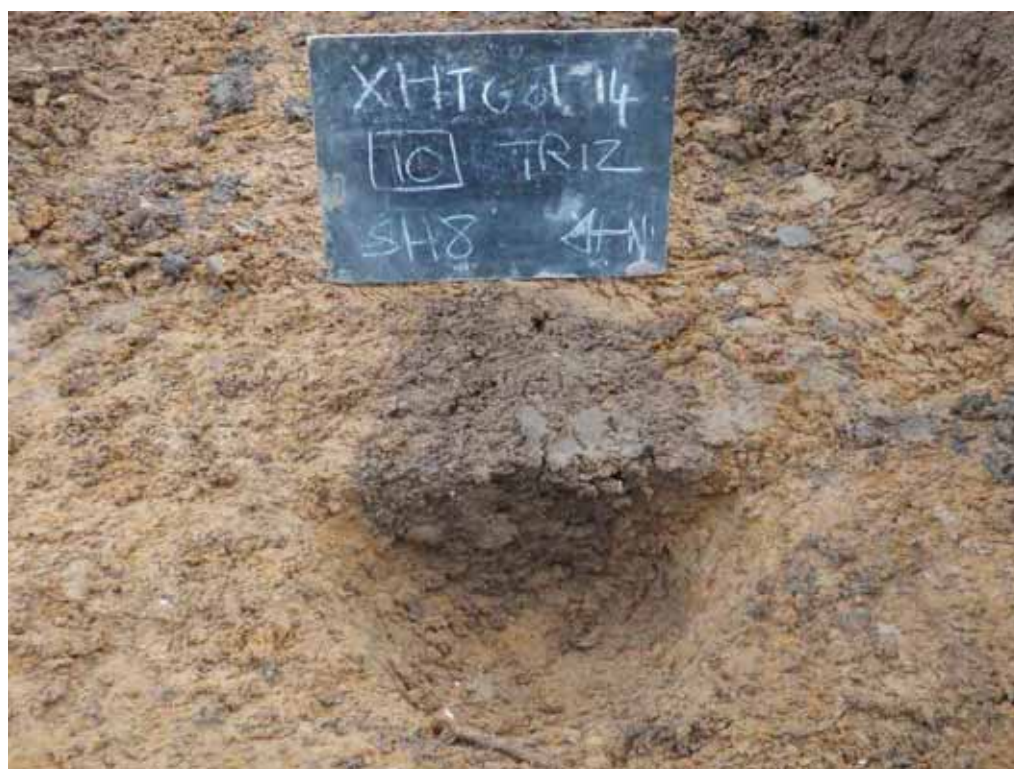
- 3.2.12 This trench contained only a modern pit and a posthole from a concrete post (see plate 4).

Plate 4: Posthole 10. Facing east
