Archaeological Watching Brief Report

January 2006

**Rye Centre,
Holywell Mead, High Wycombe, Buckinghamshire**

ARCHAEOLOGICAL WATCHING BRIEF REPORT

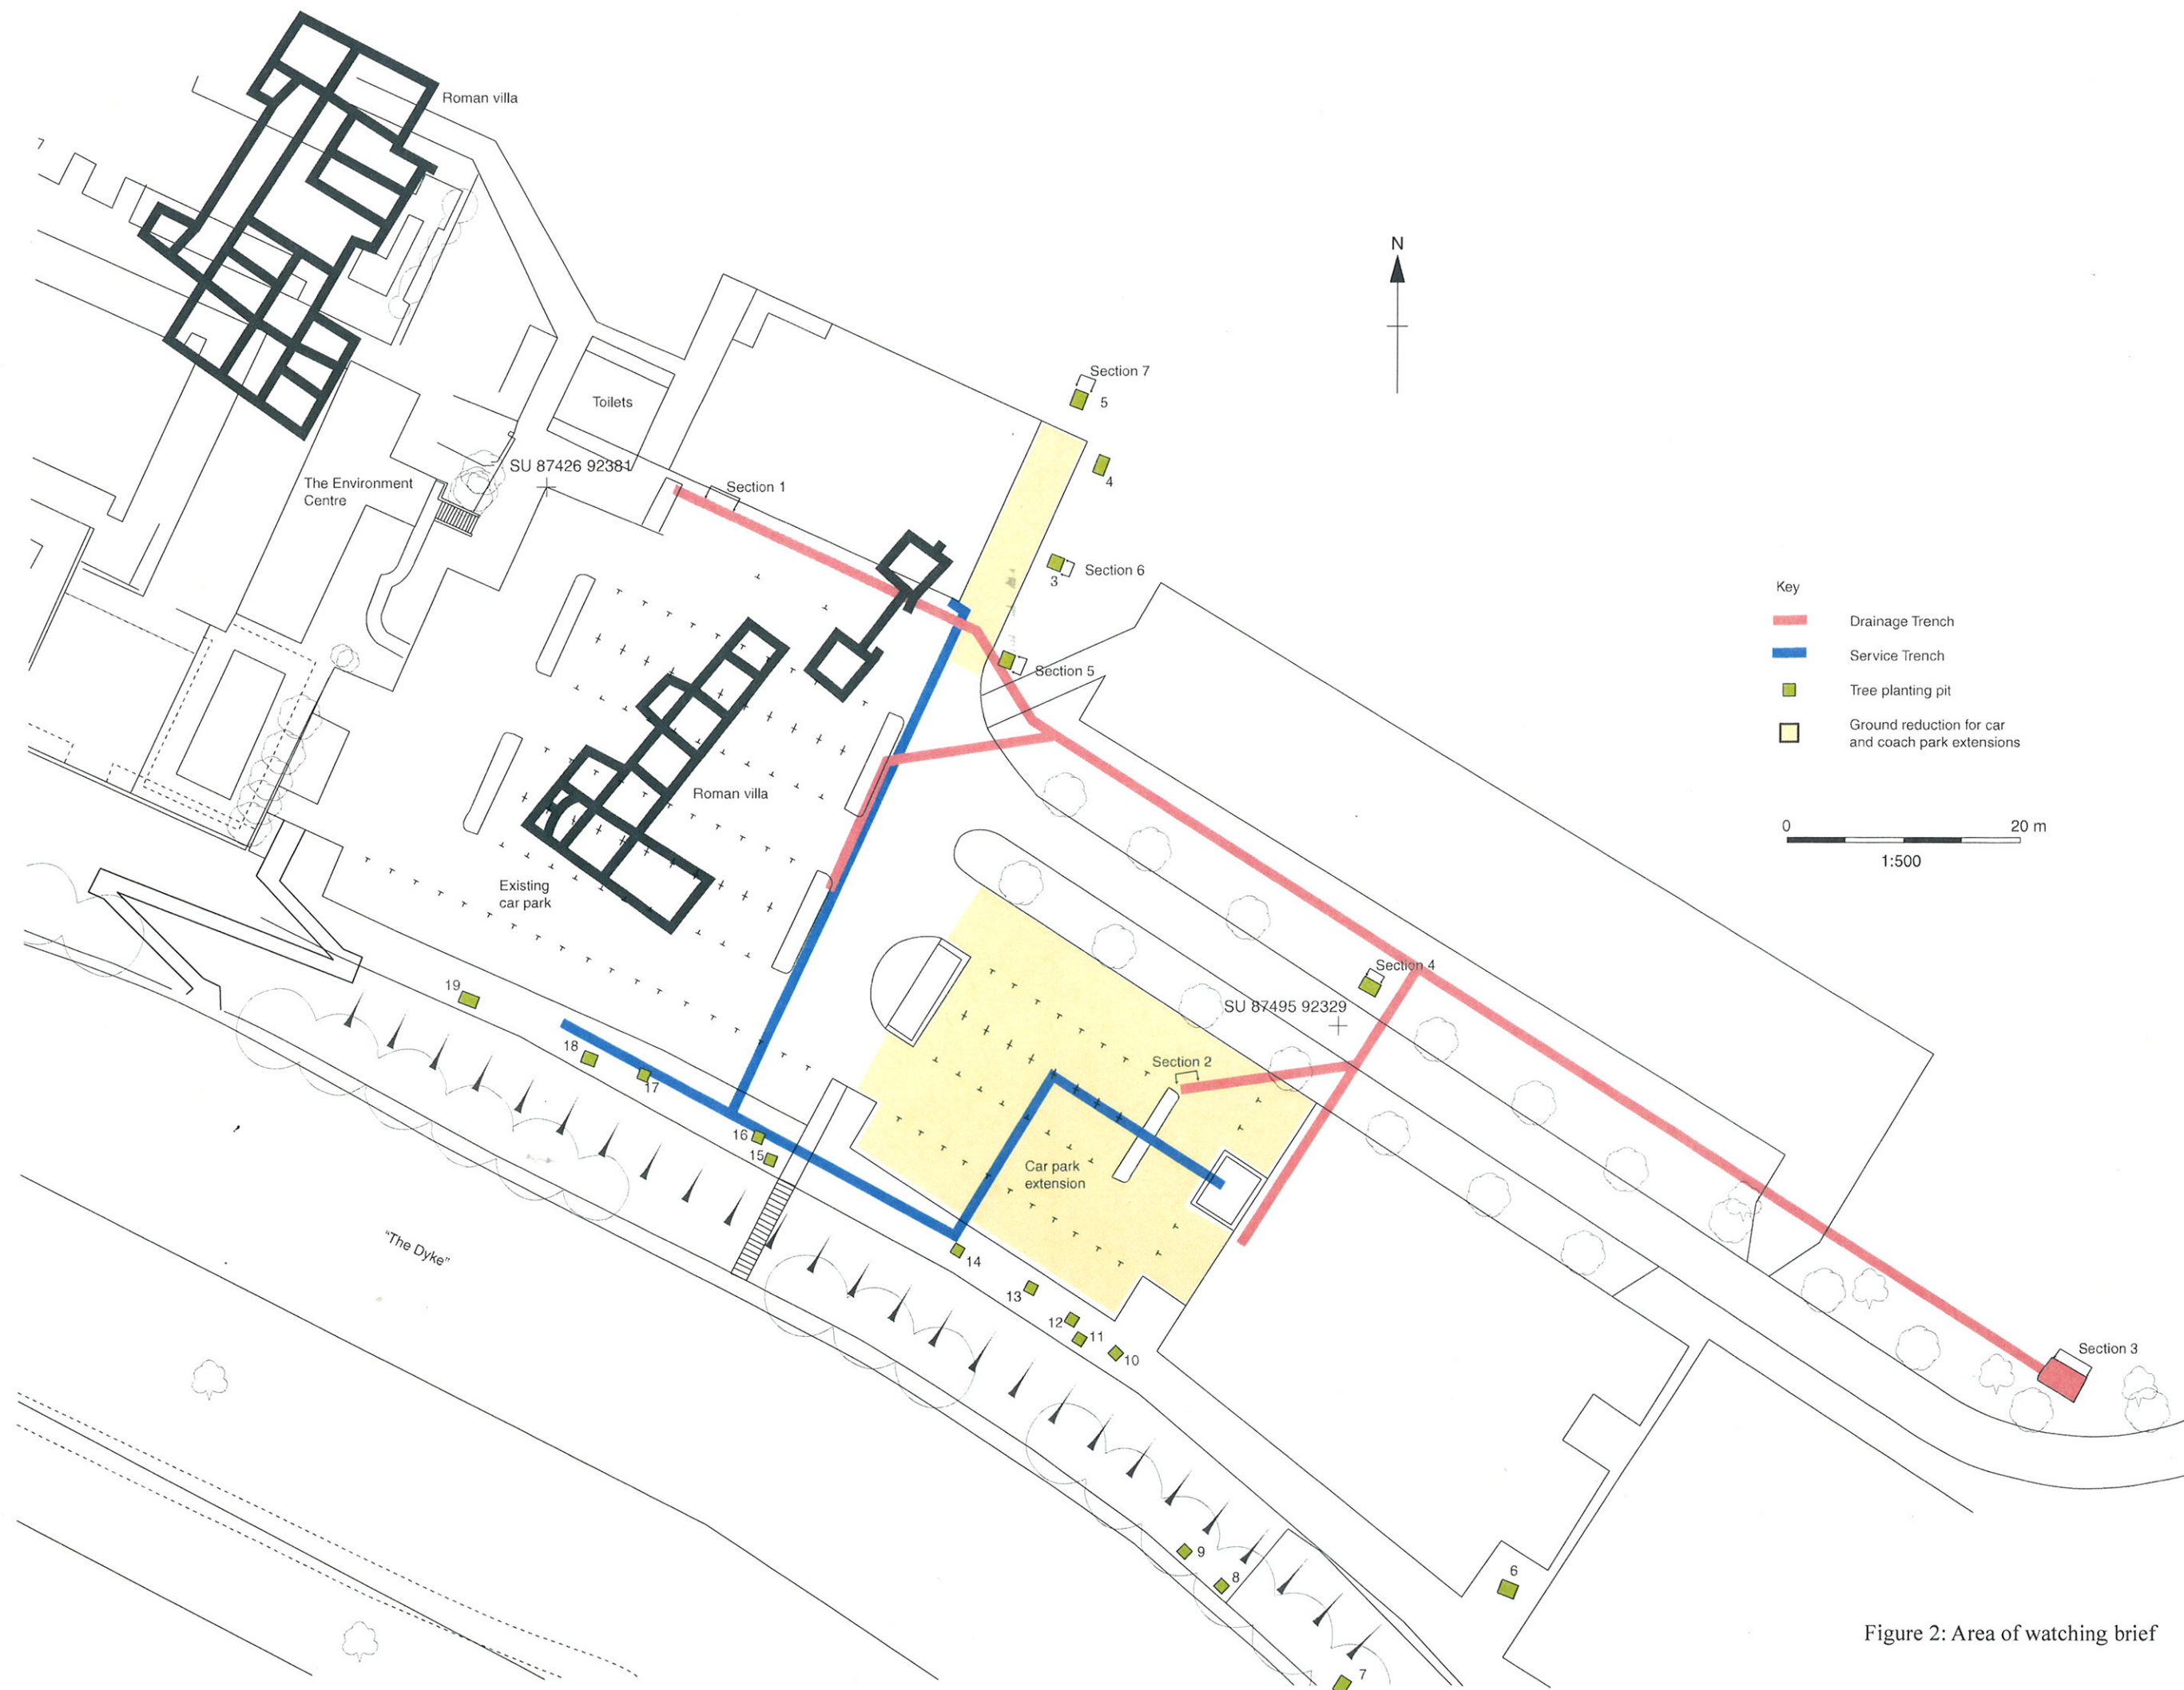
Figure 2: Area of watching brief

- 3.1.7 A total length of 80 m of trenching for cable ducting was excavated along the southern edge of the site and within the new car park extension. This trenching measured 0.5 m wide by 0.5 m deep and failed to penetrate below the modern landscaping horizon.
- 3.1.8 Six areas of dug flower beds were monitored, these also failed to penetrate below the modern landscaping horizon.
- 3.1.9 A total of 19 tree planting pits were monitored. These were all machine dug using a mini-digger fitted with a 0.6 m wide bucket. The majority of these (Pits 7 to 19) were within the footprint of the made ground forming the embankment of the "Dyke" and these exposed only post-medieval deposits.
- 3.1.10 Pits 1 to 5 were excavated along the northern edge of the access road adjacent to the changing rooms (Fig. 2) and these produced significant results.
