HEATHERSIDE COTTAGE/ROUNDBARROW HOUSE/DOONE RIDGEMOUNT ROAD, SUNNINGDALE, BERKSHIRE NGR SU 952 662 ARCHAEOLOGICAL WATCHING BRIEF REPORT

OXFORD ARCHAEOLOGICAL UNIT
JANUARY 1998

ARCHAEOLOGICAL WATCHING BRIEF REPORT

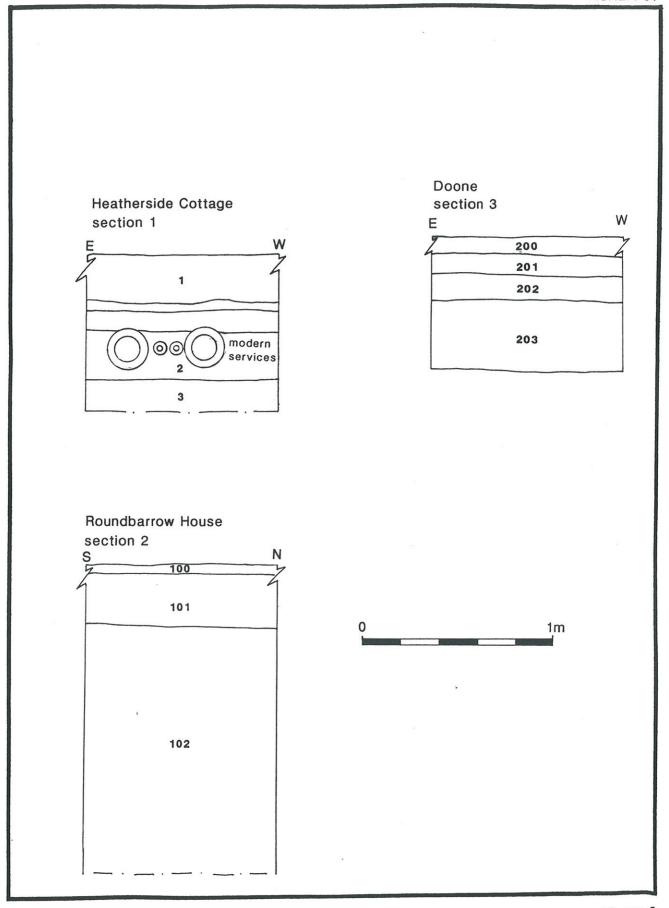
Figure 3

The deepest excavation at Heatherside Cottage comprised the soakaway pit. The earliest deposit seen here was the natural subsoil (3), a clean sand measuring 0.16 m to the base of the cut. This was sealed by (2), 0.40 m of mottled yellow/white sandy loam with 15% clay, very mixed and repeatedly cut by modern services. This was sealed by (1), 0.24 m of mid gray silty, stony clay loam with 10% silt and 20% mixed fine and medium gravels. This sequence was repeated across the site at Heatherside Cottage with very little variation.

The section of the soakaway excavation here revealed 1.30 m of olive/brown slightly sandy clay (102), sealed by 0.26 m of brown/pink pebbly gravel (101), sealed by tarmac (100), 0.06 m thick. The foundation trenches revealed (100), (101) and a thin band of (102), to the base of the cut, with no cut features seen. This sequence was repeated across the site at Roundbarrow House, with very little variation.

The foundations were inspected after excavation. The earliest deposit seen was (203), a mid brown slightly silty clay 0.34 m thick. This was sealed by (202), 0.15 m of assorted brick rubble with occasional concrete lumps. This was sealed by (201), 0.10 m of a slightly silty gravel sealed by 0.10 m of mid gray silty clay loam, (200). No cut features were revealed.
