# St Mary's Church Bampton Oxfordshire

## Archaeological Watching Brief

**Oxford Archaeology**

Document Type: Watching Brief

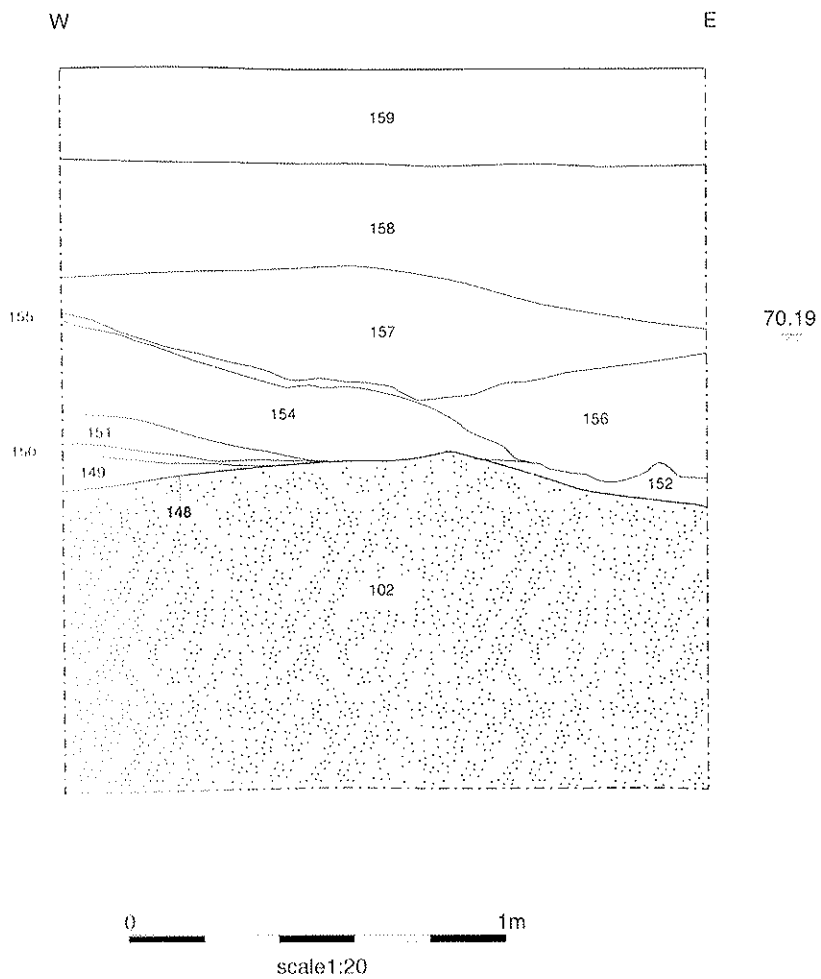
Figure 5: Sections 2 and 3

*Area of new manhole - Fig. 3 and Figs 4 & 5 - Section Drawings 1 and 2*

- 3.1.8 Natural gravel (102) was exposed in the trench sides of the new manhole and was higher here than elsewhere, suggesting that a ridge of gravel existed at this point. The gravel was cut by a grave (103) with a clear south edge cut into the higher ridge of gravel and the northern edge cutting the shallower gravel here. The feature was 0.84 m wide and 0.46 m deep where it had been truncated by the contractor's excavations. The fill (104) was a mixed dark red-brown silt with some fragments of human bone. Fill 104 was sealed by a soil layer similar to 101, as seen elsewhere in the trench.

- 3.1.9 This soil was overlain by a north-west/south-east aligned wall (126) that was 0.2 m wide and survived to a height of 0.2 m and constructed of un-bonded limestone. A length of 1.05 m was exposed in plan and section at the south-west edge of the manhole trench and the wall presumably extended to the north-west and to the south-east outside the trench limits. No dating evidence was recovered for the wall, which lay below a gravel bedding layer (128) for the present tarmac surface (127) in the churchyard.

### ***Manhole outside the churchyard - Fig. 5, Section 3***

- 3.1.19 Additional observations were made during excavations for a manhole at the south-east end of the trench. The natural gravel here was cut by a flattish-based ?ditch (148) that may be an extension to the south-east of ditch 140. The limits of the ditch were not established within the confines of the manhole trench. It was filled by brown silty gravel (149) overlain by a darker ashy deposit (150) in turn beneath a reddish-brown silty gravel (151). None of these deposits produced dating evidence.

- 3.1.20 The south-east edge of the feature proved difficult to discern, but may be represented by a noticeable peak in the gravel (about halfway along Section 3). The gravel at this point was overlain by a layer of dark brown clay silt (152), in turn overlain by a loose very dark grey deposit of charcoal and ash (153) seen during excavation of the manhole but not apparent in the trench section. This deposit is possibly evidence of a fire.

- 3.1.21 This lay below further deposits of mixed ash and silt (154 then 155, 156 and 157) that represent deliberate dumped layers. Above 157 lay a compacted layer of

limestone (158) to a depth of 0.43 m. This formed a surface that may be contemporary with surface 145 within the churchyard. Surface 158 was overlain by the topsoil and turf (159) outside the churchyard
