Croome Park Worcestershire

Archaeological excavations within The Grotto

Document Title: Croome Park, Worcestershire: Archaeological excavations within the Grotto

Document Type: Excavation Report

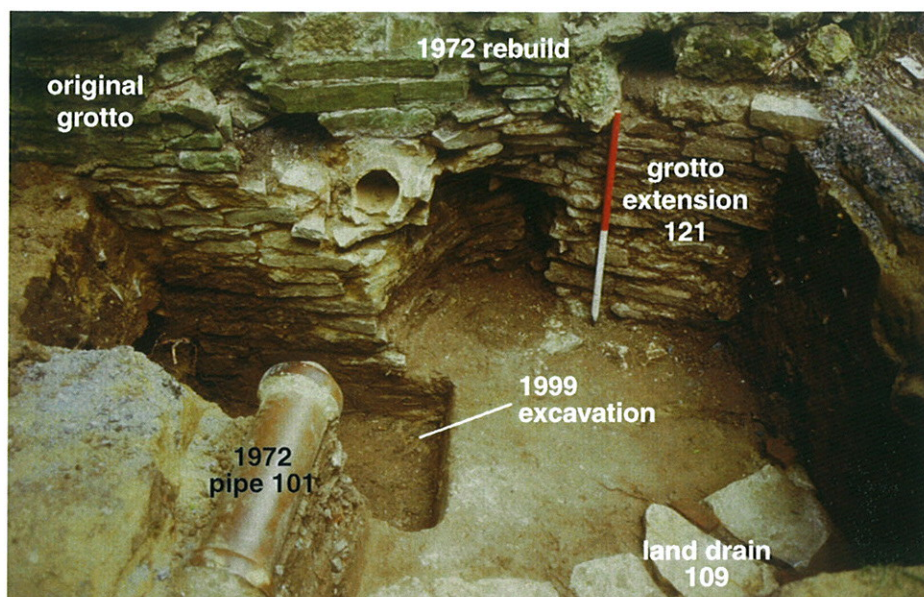
Plate 1: View of the first phase of excavations from the West.

2.2.2.1. It is unclear what phasing relationship the early Land drain (109) (see Plates 1 and 2 and Appendix A), a crudely built brick and limestone drain, has with the Grotto. No construction cut was observed for the first phase of the Grotto's construction, primarily due to previous excavation work in the northern end of the trench. This previous work (Cleary 2001a) also failed to record a primary construction cut for the foundation trench of the first phase of the Grotto. This lack of a direct relationship makes interpretation difficult. However the fact the drain respects the Grotto would lead to the conclusion that it is probably either contemporary or slightly later in date than the first phase of the Grotto.

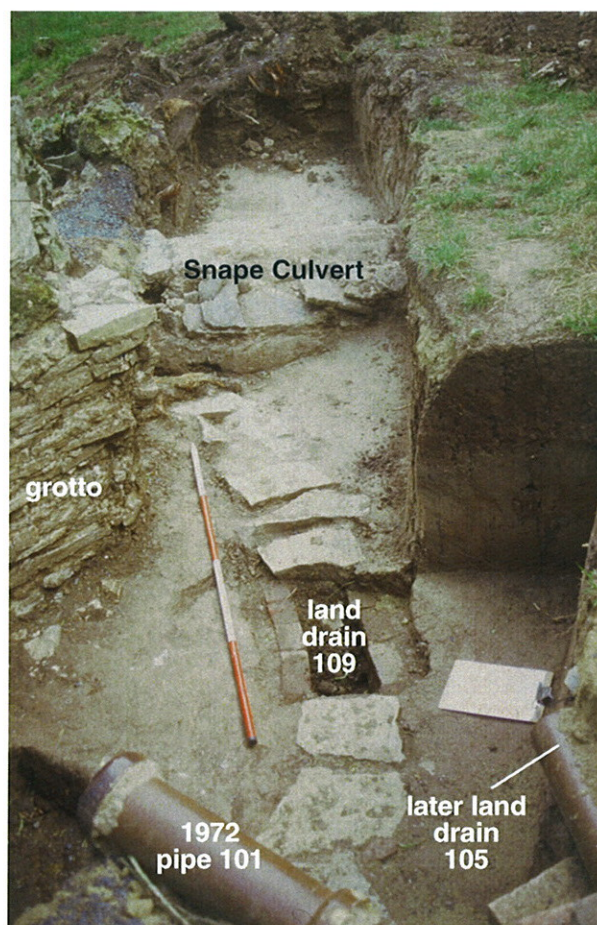
Plate 2: View of the land drain and later Snape Culvert from the North.

2.2.2.2. Its relationship with the 1780's extension to the Grotto (see below) is also unclear due to the lack of a direct relationship between the construction cuts for the two features (113 and 108). This relationship was unfortunately destroyed by the later modern land drain (105), although it is felt that the grotto extension construction trench (113) does truncate the drain. The early land drain is however truncated by the later post-1797 'Snape' Culvert (119) (see Plate 2), giving it a date range of c. 1765 to c. 1797.

2.2.5.1. The extension of the excavation works to the south revealed the 'Snape' culvert (see Plate 2). This consisted of a limestone slab covered brick culvert running roughly east-west. This culvert cut the earlier land drain (109 - see above) and avoided the southern end of the grotto. The culvert gained its name from the man responsible for its planning, John Snape, who produced a section, plan and description of the culvert in 1797 (Volume 4: Phoenix Consulting 1997).

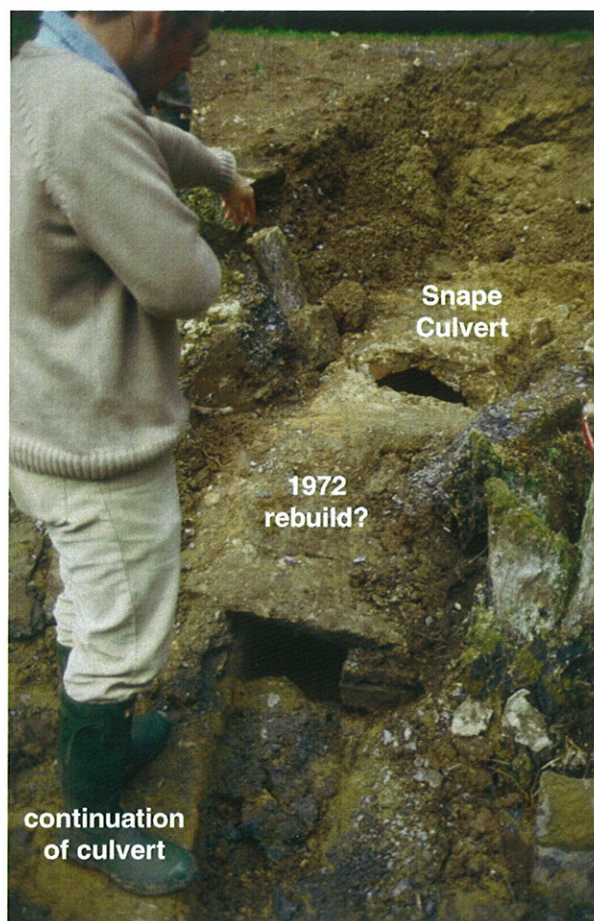
Plate 3: View of National Trust clearance at the eastern end of Culvert.

2.2.5.2. The culvert is in remarkably good condition and still supplies a significant quantity of water to the lake. Further excavations by the National Trust after the completion of the excavation works by OAU (see Plate 3), revealed that the culvert changed character just outside the eastern extent of the excavation trench where it reached the bank leading down to the path by the grotto. At the base of the slope the limestone slab layer ceased

and the brick culvert lining seems to disappear on the northern side. Tom Oliver believes that this is due to the culvert changing course and running north of the rock pool in front of the Nymph's cave. Further excavation will be required in this area to determine whether the culvert does in fact deviate from its direct course towards the lake at this point.
