Rofford Hall Chalgrove Oxfordshire

**Historic Building Investigation
and Recording**

February 2009

Client:
Berman Guedes Stretton Architects

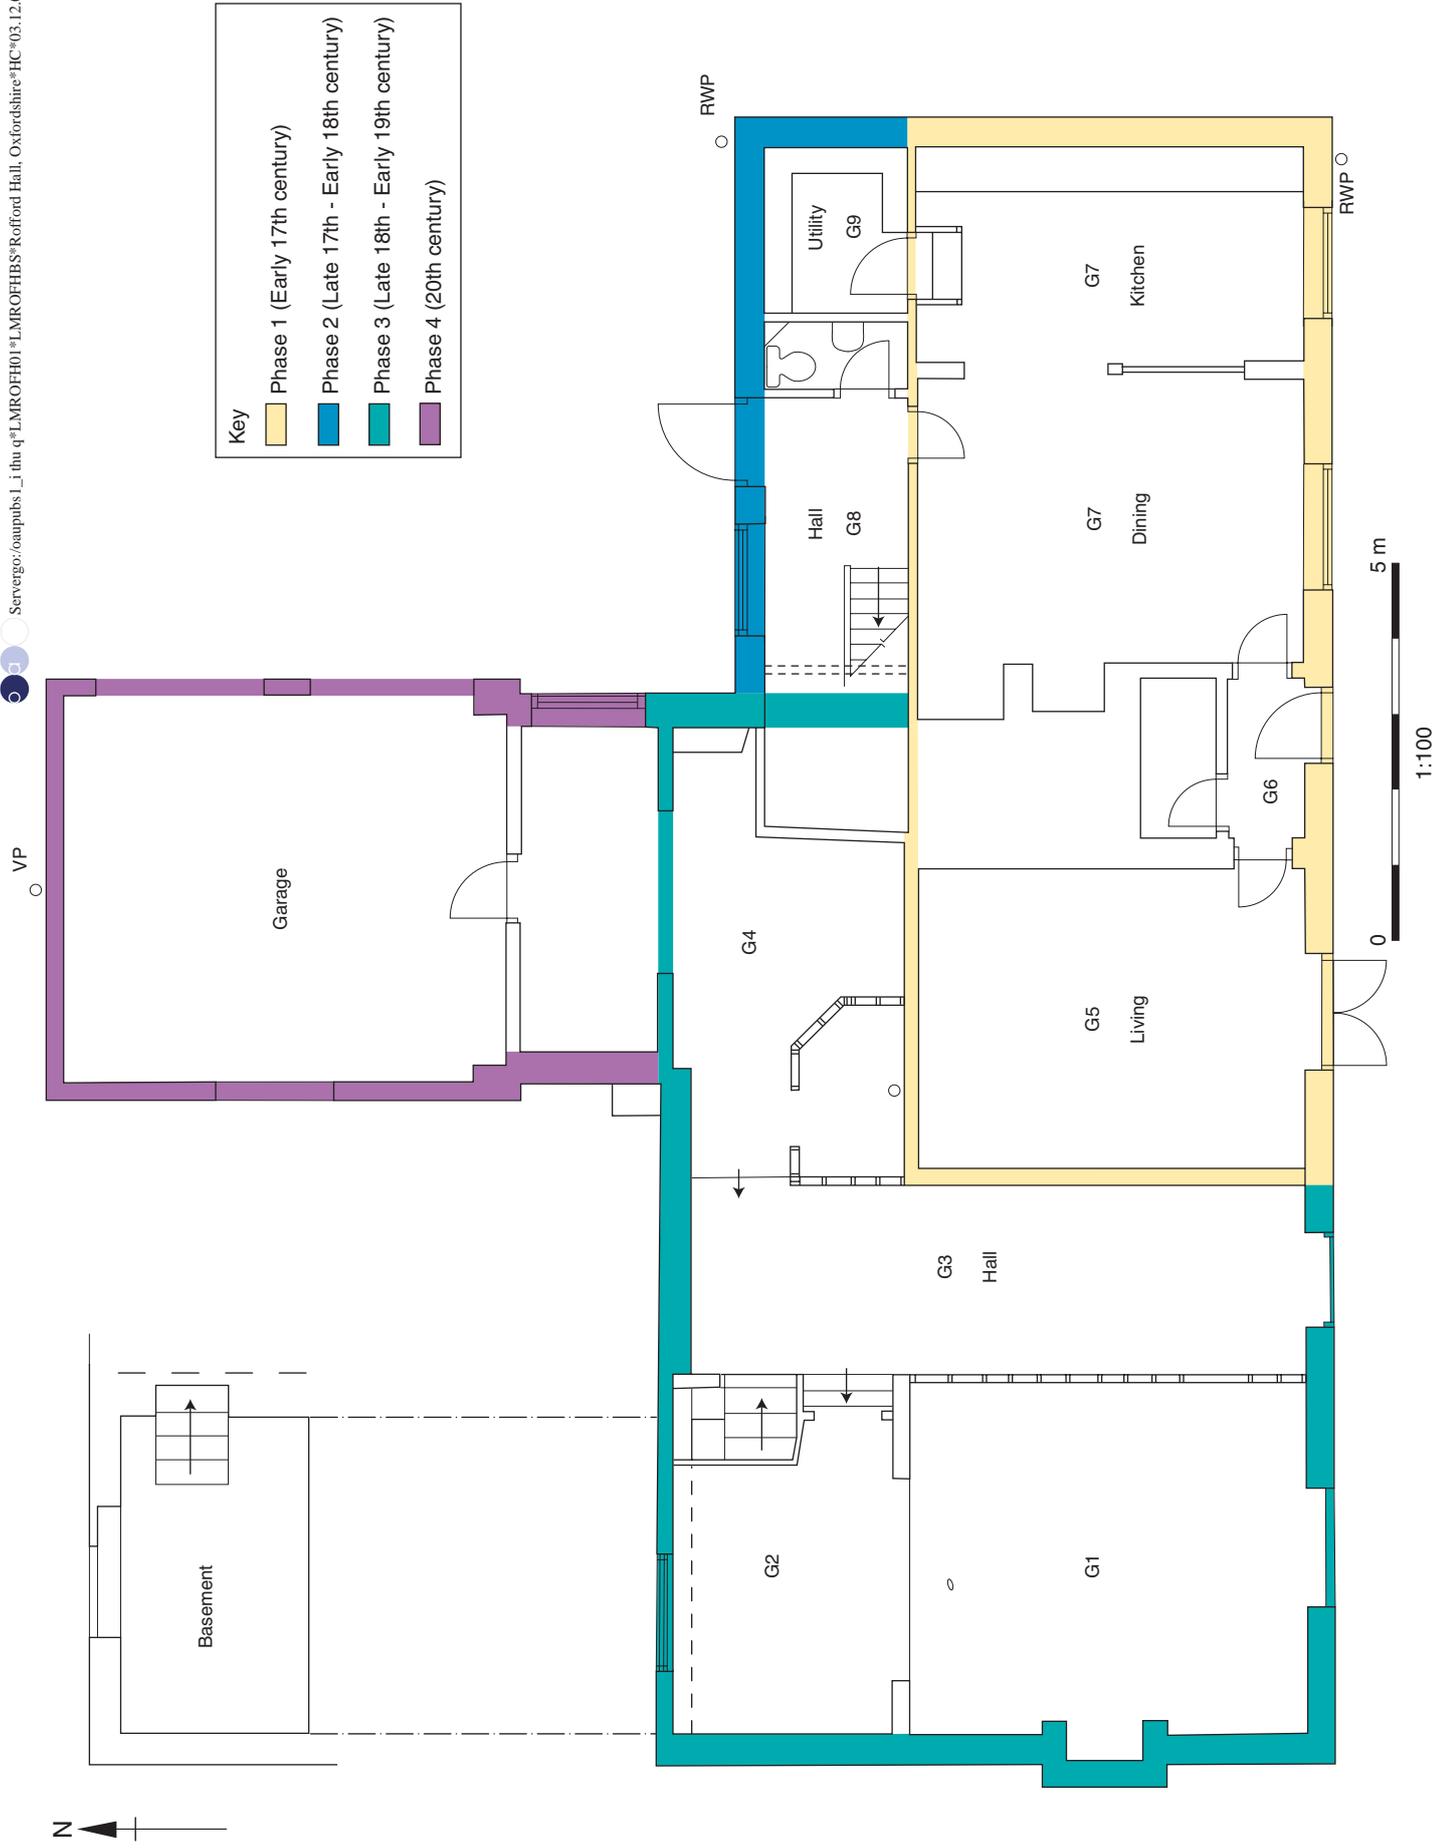
Figure 2: Phasing plan

- 3.1.1 The current building at Rofford Hall has developed in three main historical phases together with several 20th-century extensions (See Fig. 2). This section also includes a brief overall description of the structural frame of the original house.

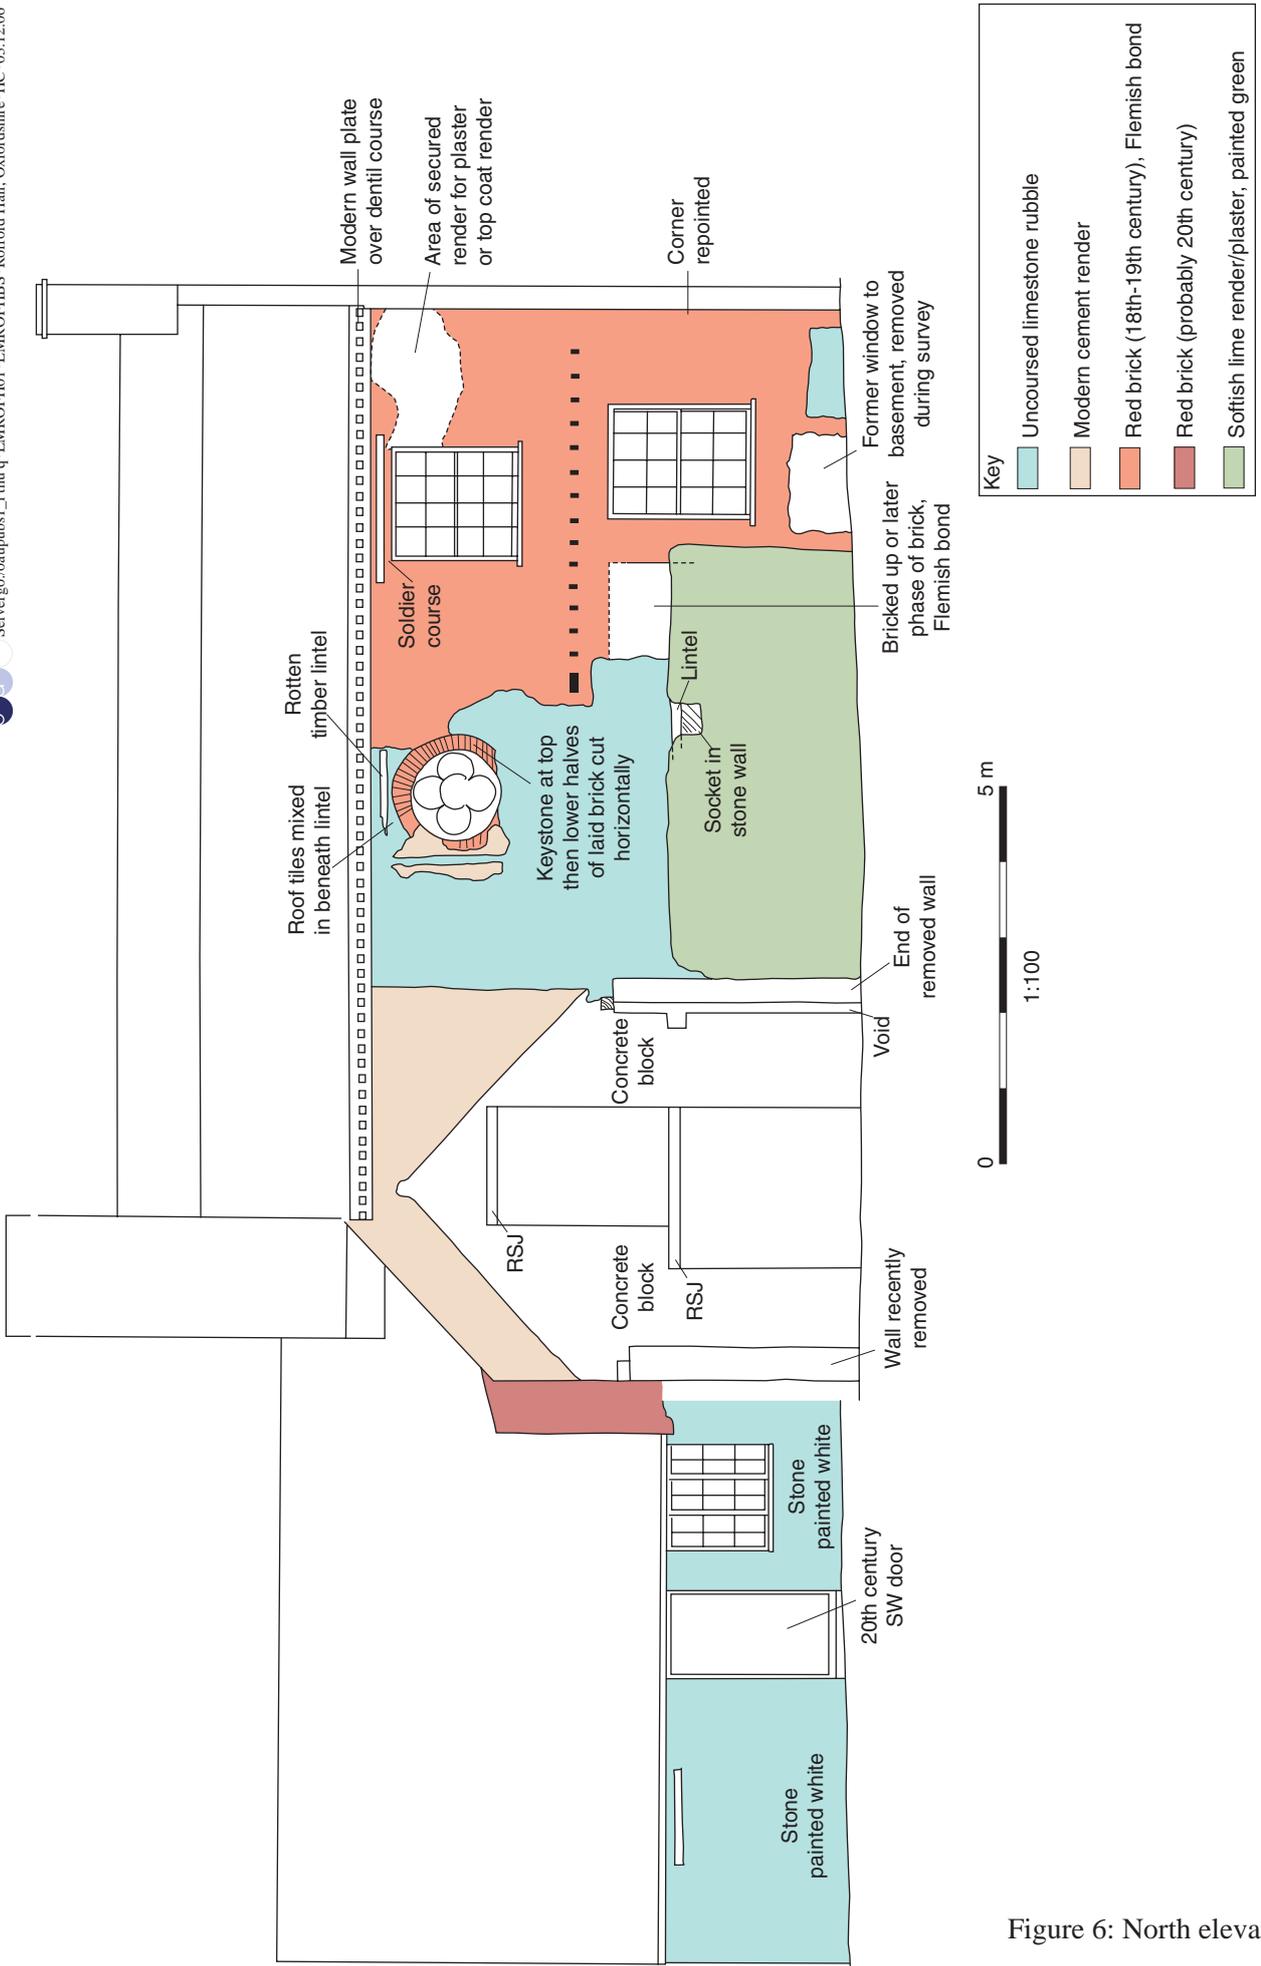
Figure 6: North elevation

- 4.2.1 The north elevation (rear) divides into three main sections: the single-storey eastern section is of uncoursed stone rubble (with partially surviving lime wash) and forms the front of the outshut (Phase II) added to the original building possibly in the early 18th century. This wall incorporates a window and door (both of later 20th-century date) but the feature of most archaeological interest is the lintel from a blocked opening to the east of the current door. It is likely that this would have been a former doorway which would have led into a small hall (G9) or ante-room off the kitchen. At its west end the front wall of the lean-to returns to the north for a short distance before being truncated by a

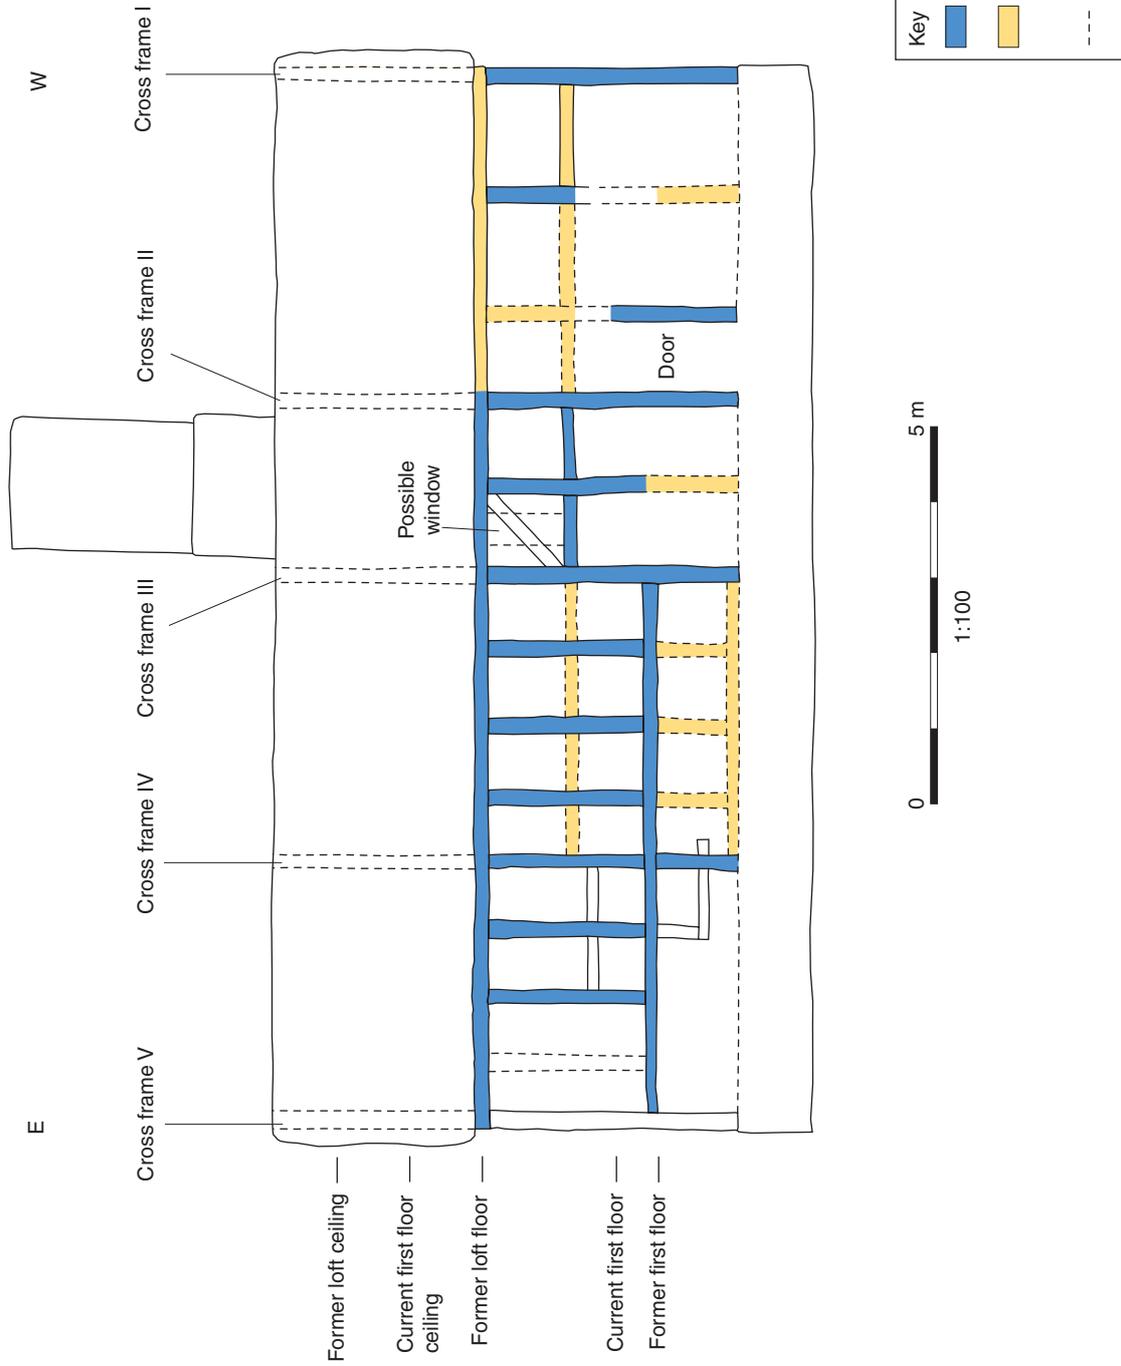
Figure 7: Framing in north wall of primary house

- 5.1.4 The north wall of G5 was also originally external but the primary frame of this wall survives less substantially than that to the east. The western two-thirds of the timber-framing have been removed and replaced by modern studs clad with plasterboard but the primary structure survives within the eastern third of the wall (visible from within the adjacent G4). The primary rubble stone plinth (similar to that in the west wall) survives in this section together with the original sole plate and a primary post. From this point the primary wall continues east adjacent to the large chimney stack.

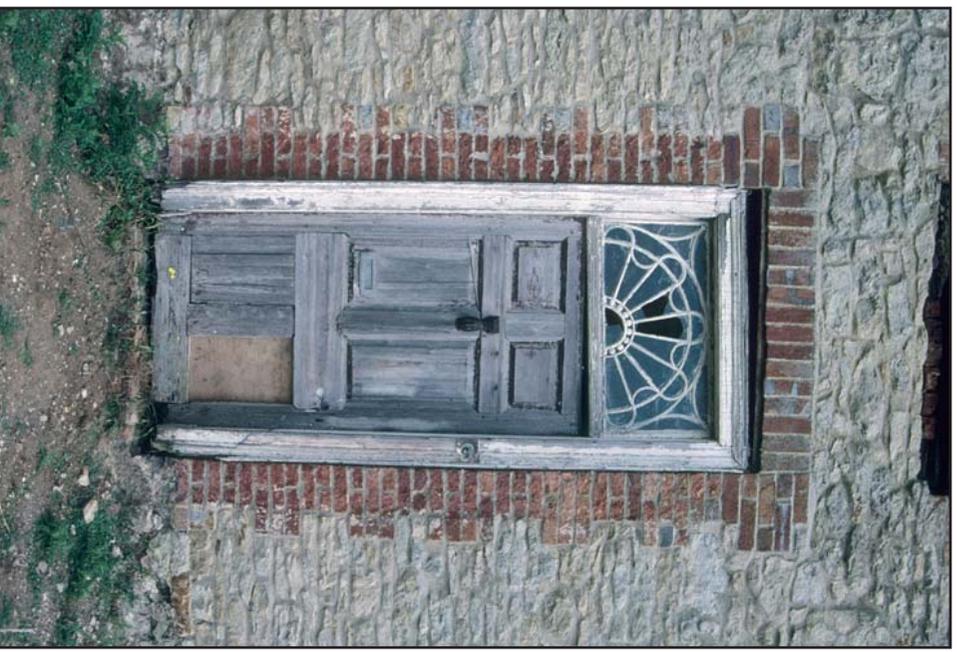
Plate 6: Front door in Georgian extension

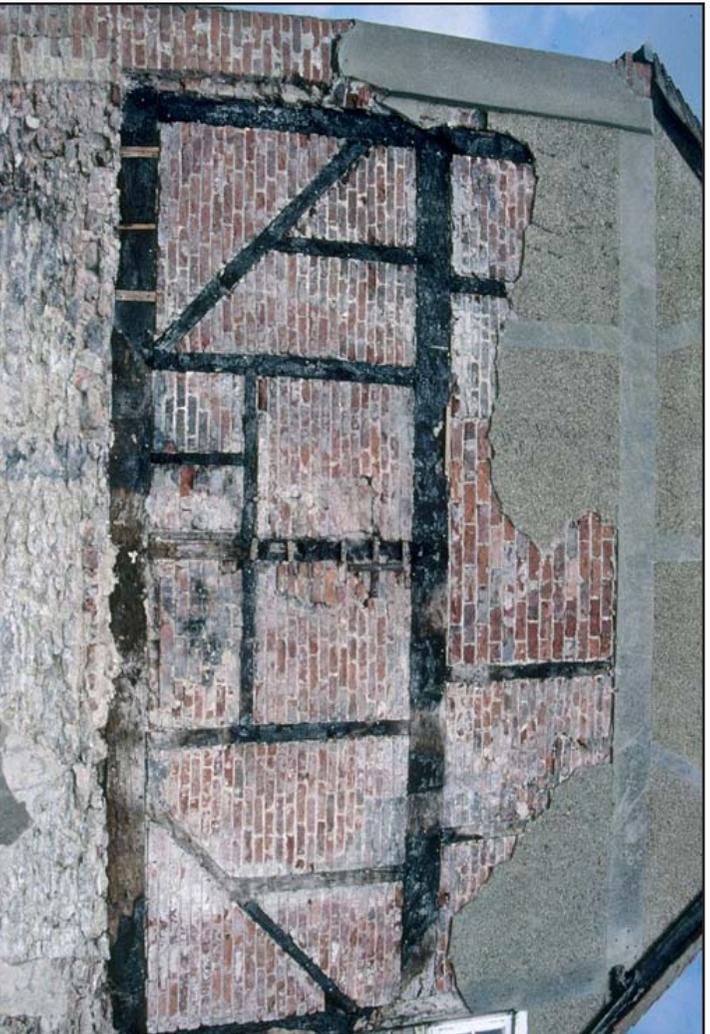
- 4.4.1 The east elevation largely consists of the gable end of the Phase I house although until recently this was partially obscured by an adjacent (although not adjoining) 20th-century brick garage (detailed above). The upper part of the wall is covered by a 20th-century render but this has largely been removed from the lower part of the wall as part of the current works to reveal the primary timber framing of the original house. The modern

Plate 7: Primary framing in east elevation

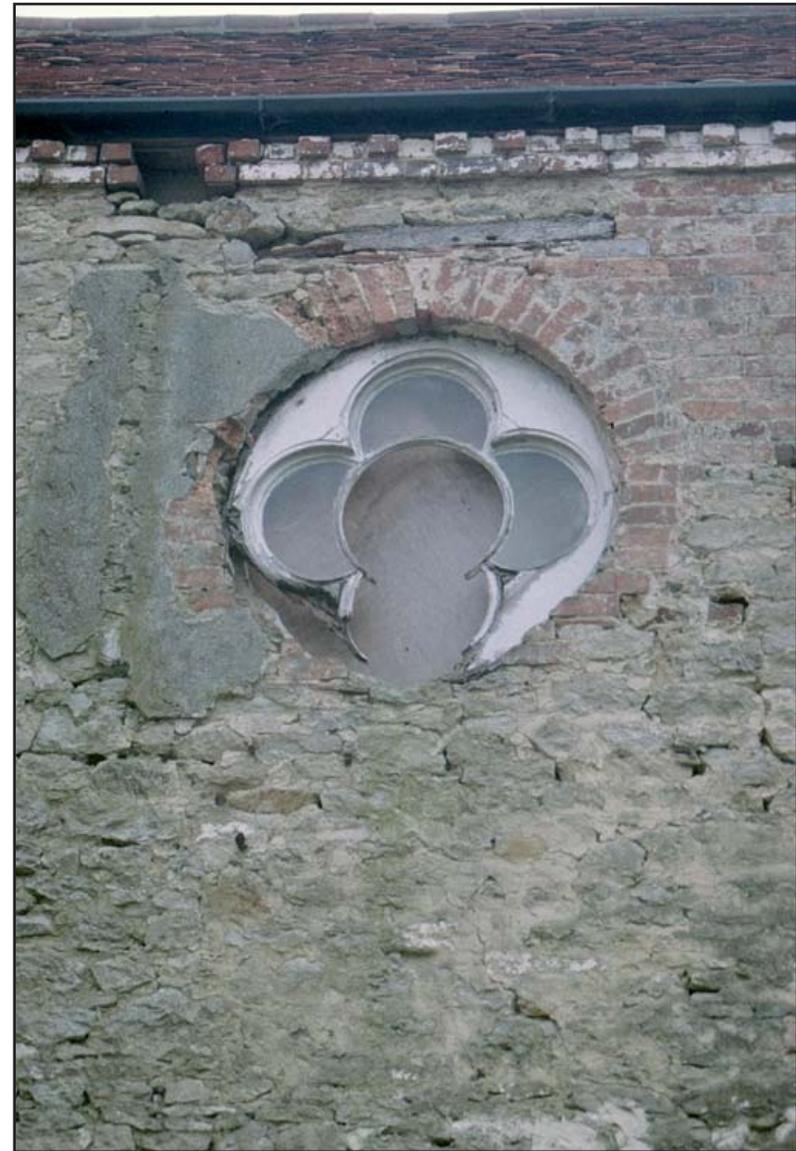
- 4.2.4 The most interesting feature within the stone part of the wall is a large brick-lined bulls-eye window with a quatrefoil design. The brickwork surrounding the window is not rubbed and is of a low quality consisting of a brick keystone, conventional bricks forming the two upper quarters of the circle, and truncated horizontally-laid bricks forming the lower two quarters of the circle. The window strongly appears to have been inserted into the pre-existing stone wall and therefore it was presumably a post-Phase III addition to provide light at the head of the internal staircase. The bulls-eye is believed to be contemporary with the rest of the brick rebuild in this elevation.

Plate 10: Bulls eye window in north elevation

- 4.2.7 The western half of the north elevation (including the bulls eye window and the secondary brick wall has had to be taken down in the current development and rebuilt in rubble stone to match the other walls. A bulls eye window to match the previous window has been reinstated.

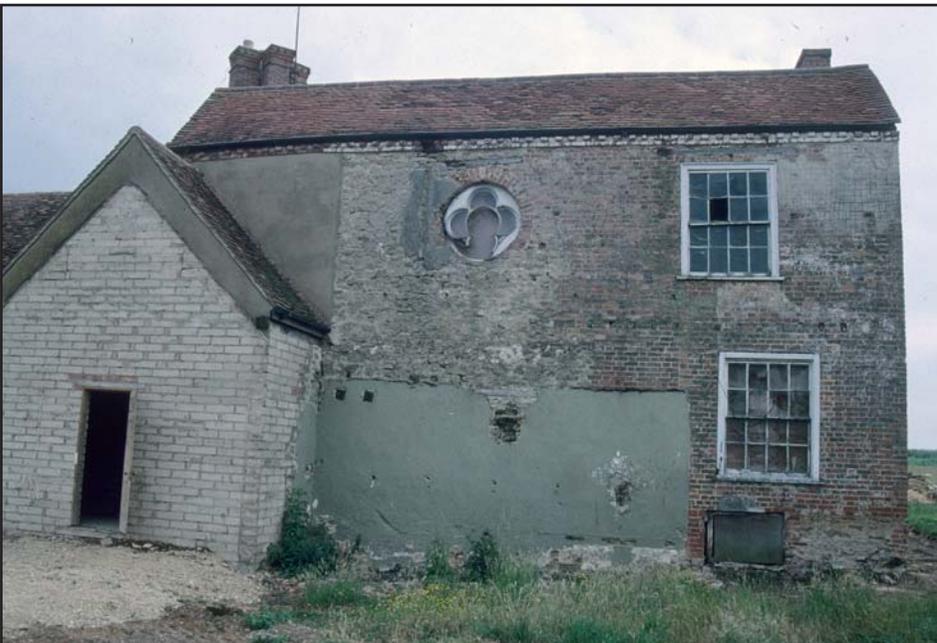
Plate 9: Rear (north) elevation

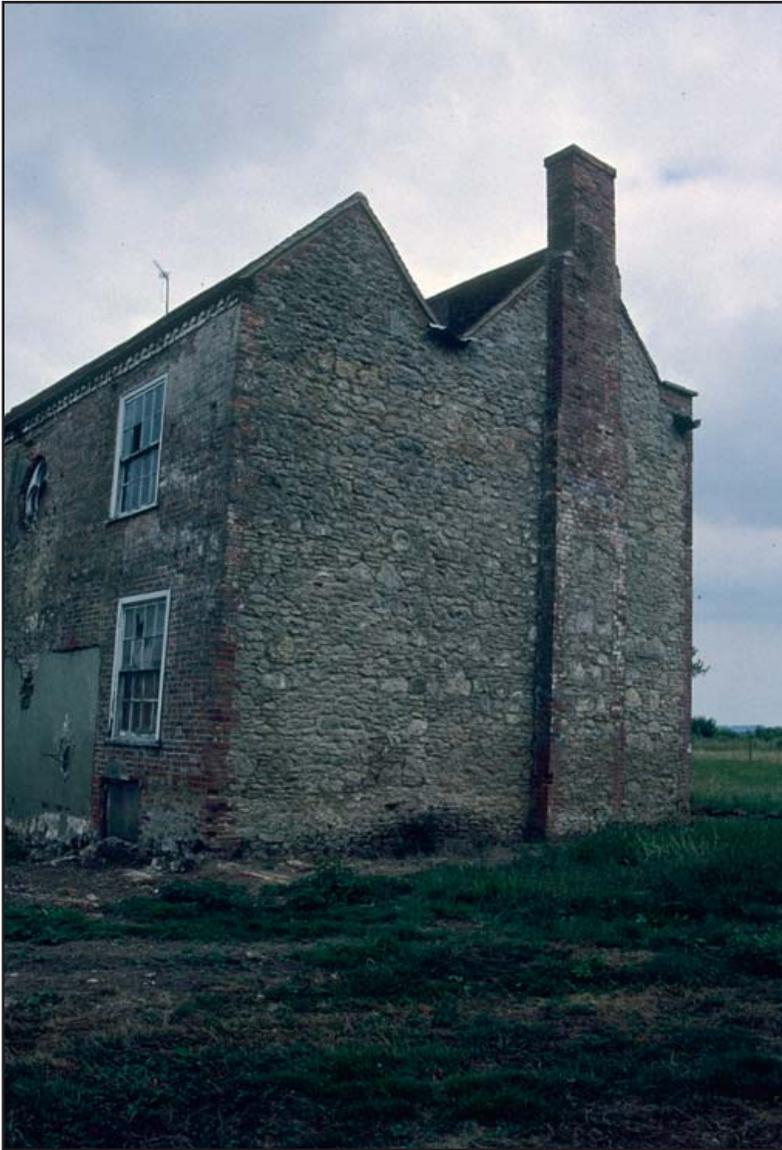
- 4.5.1 The west elevation is entirely of uncoursed rubble stone with brick quoins and there is a feature of some interest in a fossilised shell which is incorporated into the stonework. The upper part of the wall consists of two gables (the northern lower than the southern) and a plain rectangular chimney stack projects from the wall at the centre of the taller gable. The lower part of the stack is of rubble stone with brick quoins and the upper part is entirely of brick. The footings survive of a small former building immediately in front of the west elevation towards its north end. The structure would have been c.2 m by c.1.5 m and the brick suggests that it would have been of 20th-century date. Although it appears to have abutted the west elevation of the house there is no clear imprint of it against the wall.

Plate 11: West elevation

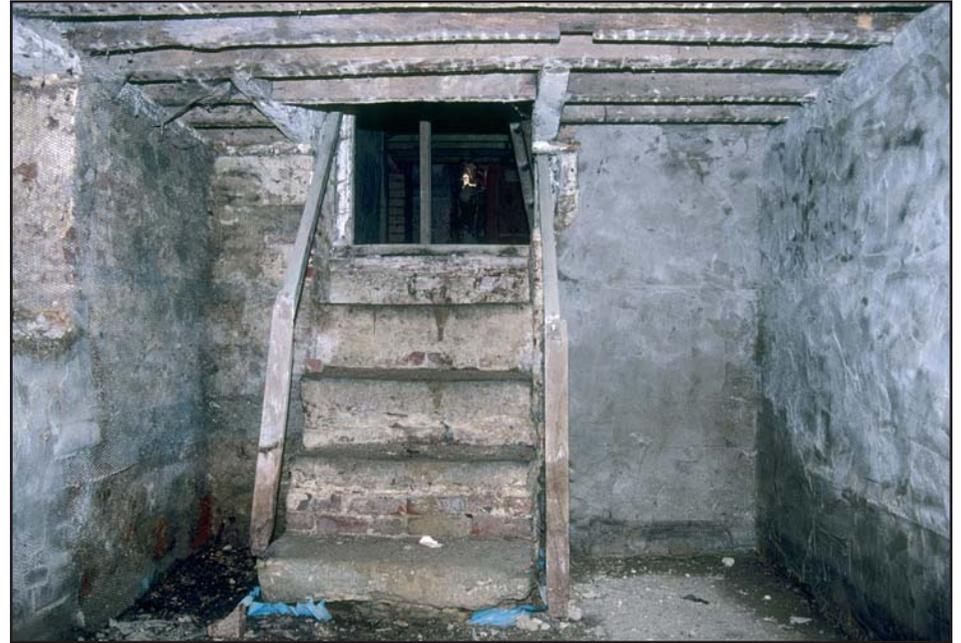
- 5.1.15 The most interesting feature of the cellar is that its walls are of uncoursed stone, including that to the north which is of brick above ground (see 4.2). This distinction corresponds to the evidence of the north elevation and suggests that the entire north wall was originally of stone (presumably all dating to the Georgian Phase III) and that the area of brickwork relates to a post-Georgian rebuilding phase. The cellar is lit by a small, softwood-framed window immediately above ground level while **G2** is lit by a large softwood sash (8 over 8) which appears to have been moved a short distance within the wall (see 4.2 above). The underside of the ground floor is visible above and consists of simple common joists which span the full width of the cellar. Although there is no ceiling above the room there are lath marks to the underside of the joists confirming that there was formerly a plastered ceiling.

Plate 12: Cellar beneath Phase III house

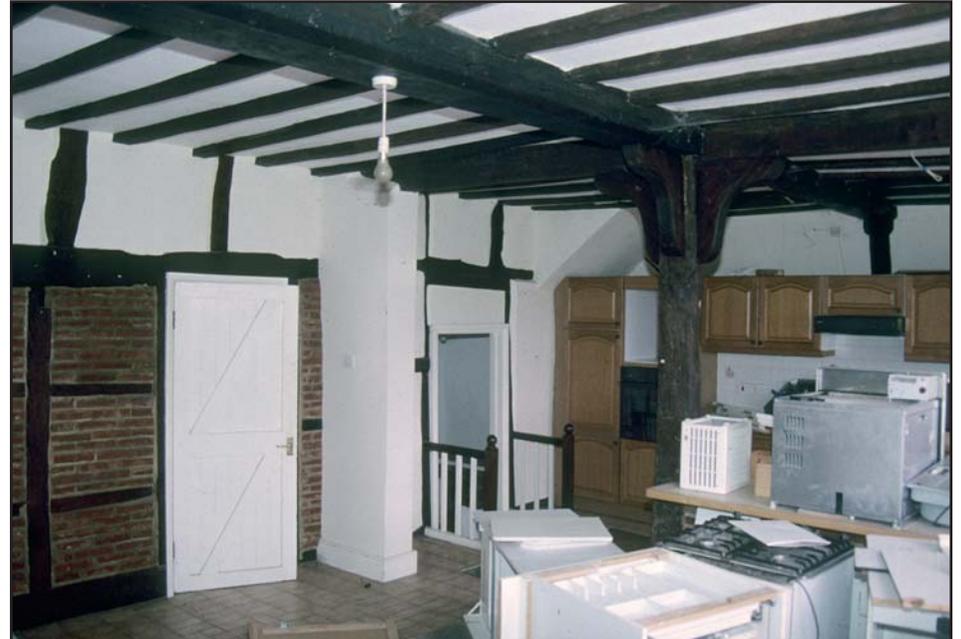
- 5.1.6 **G7** is a large kitchen occupying the two ground floor bays of the primary house to the east of the chimney stack. They would originally have been two separate rooms with a wider western room (with fireplace) and narrower eastern room without fireplace (for pantry or other unheated purpose). The floor above appears to be substantially primary and is supported by two 28 cm wide east - west axial joists (or binders) which meet close to the centre of the room at an oak Samson post (19 x 14 cm) with four load-spreading, curved brackets supporting the joists above. The Samson post must clearly be a secondary insertion dating to when the cross frame between the two original rooms was removed. The west end of the binder is supported by a pier within the chimney stack and the east end by the central post in the end frame. The binder has chamfered lower edges with stops at each end and either side of the post. The Samson post also supports a north-south principal joist across the building which is machine sawn and inserted at the same time as the Samson post (probably in the 19th century) when the cross wall was removed. Each end of the principal joist are supported by plastered masonry piers projecting slightly from north and south walls, again contemporary with the joist and Samson post. The underside of the common joists are visible; they are tenoned into the binder and project beneath the existing secondary ceiling. They appear to be largely primary and

Plate 13: Kitchen (G7) in primary house

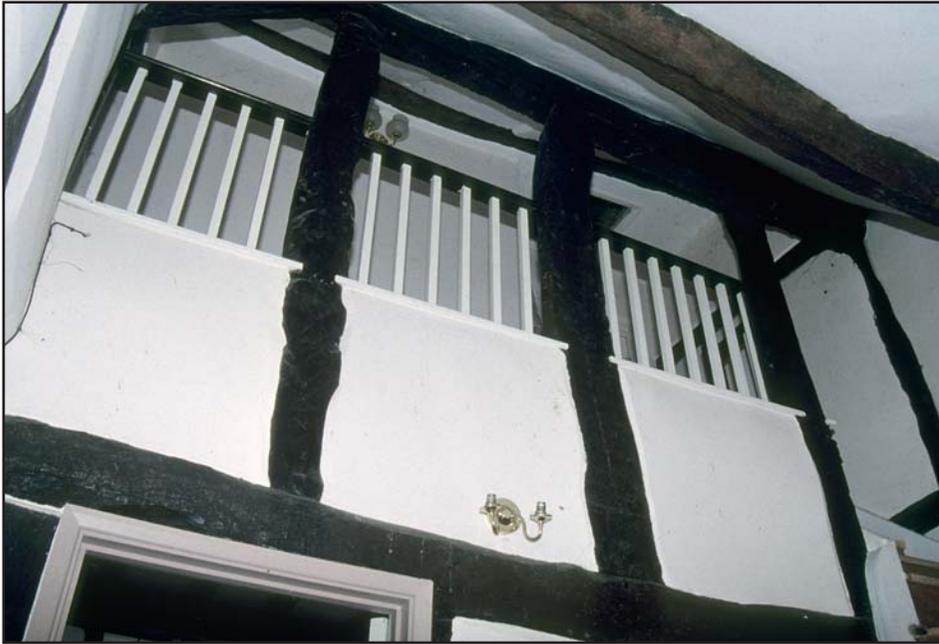
Plate 14: Primary studs in north wall of house (G8)

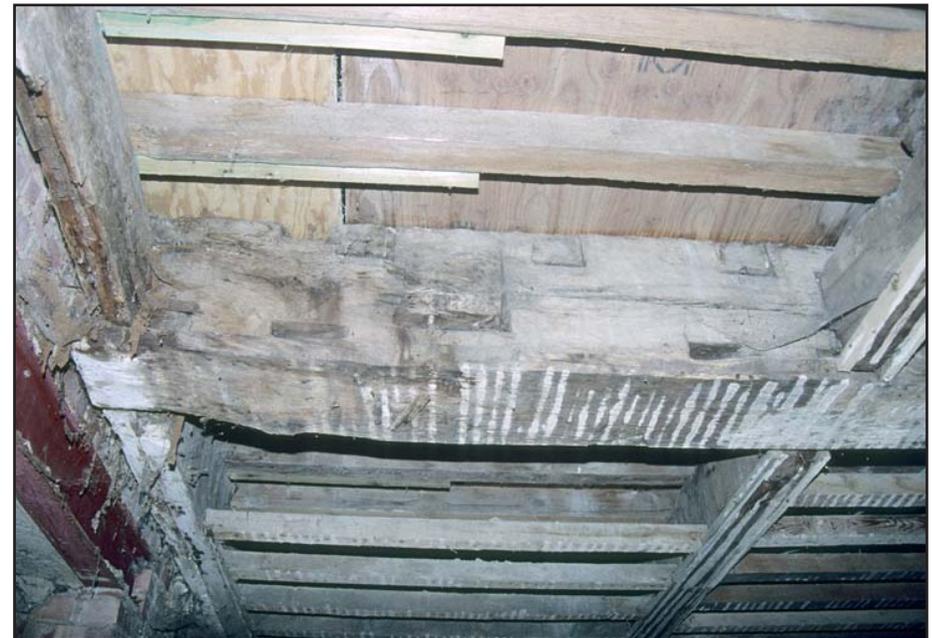
- 5.1.12 Among the most impressive features of the room is a very large (33 cm x 38 cm) north-south principal joist which has clearly been reused from a previous building and which has a variety of empty mortices from the previous and current building. There are two tiers of mortices (ie separate ceiling and floor joists) and among the mortices from the previous building are ones which would have held joists set diagonally across the room. The north end of the principal joist is supported by the two rolled steel joists referred to above and the south end is supported by a further steel I-section lintel over a window in the north wall. The north-south principal joist supports two east-west binders, north - south common joists and north - south ceiling joists.

Plate 15: Very large reused joist in G1

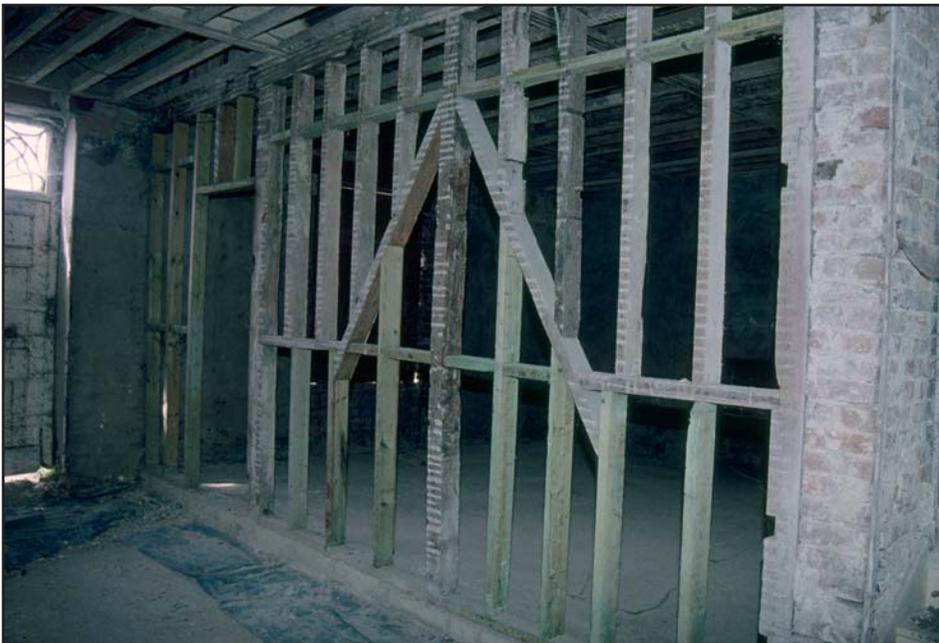
a primary doorway towards its southern end and it consists of three main posts: immediately to the north of the doorway; at the northern edge of the partition; at the mid point between the other two posts. The partition is strengthened by four horizontals (including sole-plate immediately above ground floor and upper plate immediately beneath first floor) and by two raking braces. Several members have been replaced by modern softwood (although most of the primary truss survives) and the primary members have lath marks.

Plate 16: Georgian partition between G1 and G3

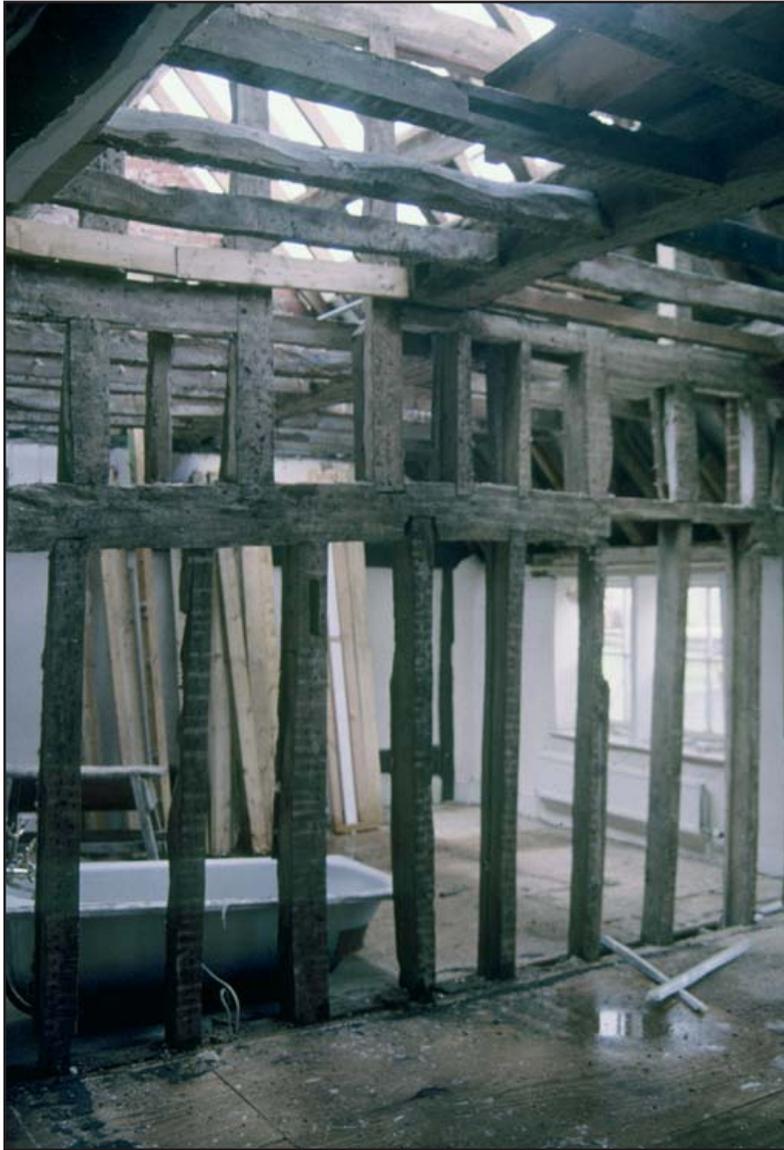
- 5.2.10 The east wall of F7 is formed by Cross Frame II but although the truss substantially survives the primary frame below this has been removed and replaced by a secondary stud frame (secured by nails). Although this frame is shown to be secondary by the fact that it is secured by nails rather than being tenoned like the primary frame it is relatively old (certainly pre-20th century) and reuses old studs. The common studs are typically 12 x 8 cm and a relatively recent doorway has been created at the north end, flanked by 20th-century posts. There is a further doorway (primary to the frame) towards its southern end which has been subsequently blocked with an infill post. A small section of the tie-beam has been removed to allow a slightly greater height to the doorway.

Plate 17: Cross Frame II at first floor looking east

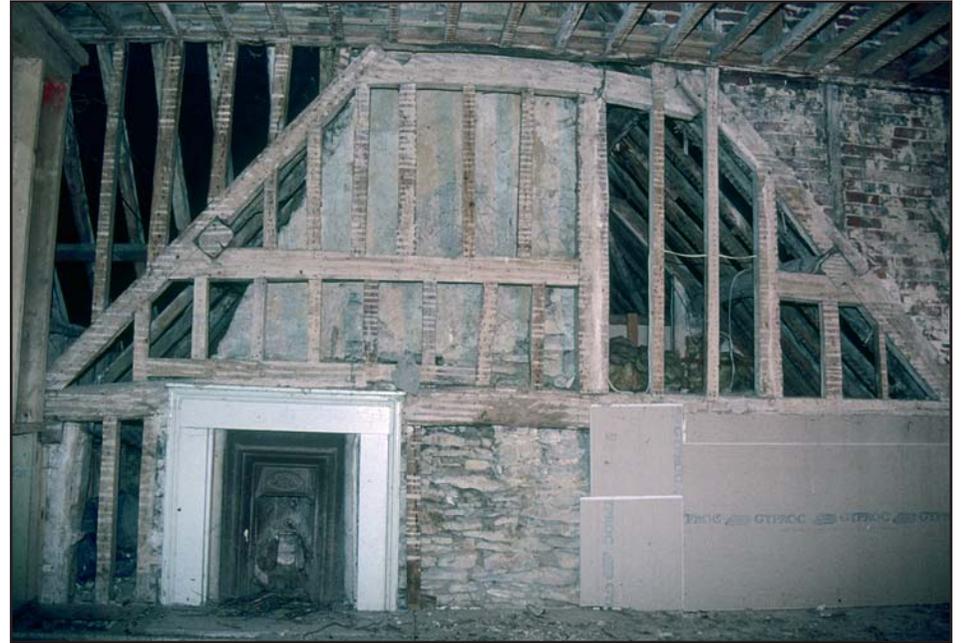
5.2.2 **F5** is of the most interest in relation to the development of the house in that although it forms part of the original building it has been enclosed by the taller Phase III roof and the original roof (purlins and rafters) within this bay has been removed. The east wall of the room consists of the large rubble chimney stack with curved northern face and the Phase I truss (in Cross Frame IV) immediately in front of it. This truss comprises a tie-beam, principal rafters and a pair of collars and there are two pairs of purlins (each clasped between collar and principal rafter) which have been truncated immediately beyond where they pass through the truss.

Plate 18: Primary truss and chimney in east wall of F5

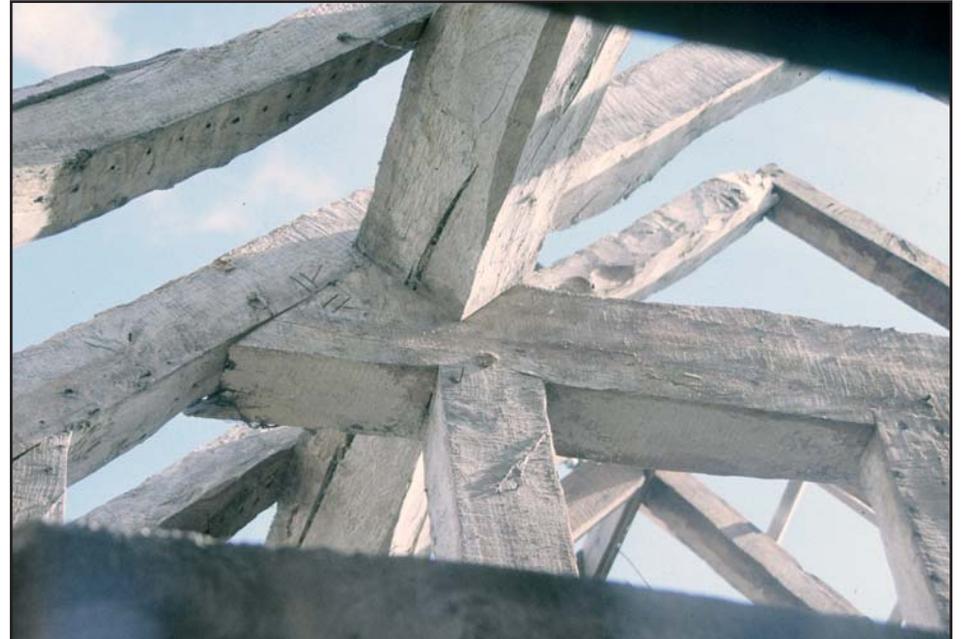
- 5.2.11 Above this studwork is the surviving primary queen post truss comprising tie-beam, principal rafters, collar, queen posts and two short spurs between the queen posts and principal rafters. The truss would have been closed (other than a central doorway between the queen posts) as beneath each of the two spurs are two small vertical struts. Unlike the studs in the frame below the truss these are tenoned and primary. The upper tier of purlins is clasped by the collar while the lower is clasped by the spurs.

Plate 19: Truss detail in Cross Frame II

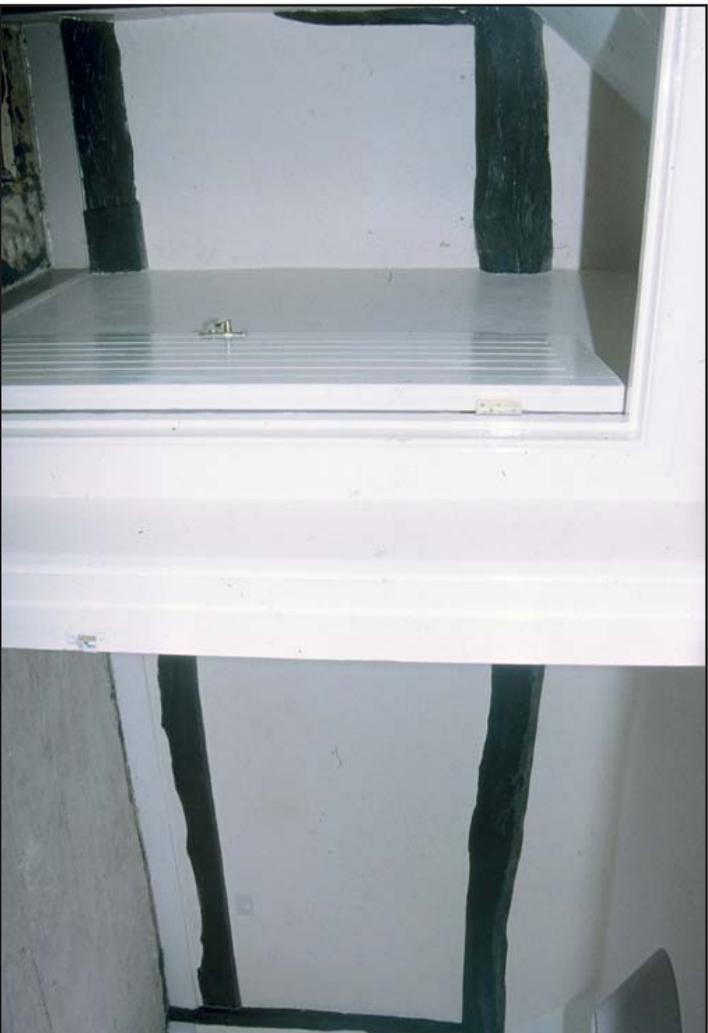
Plate 20: Tie and rail in East wall (Cross Frame I)

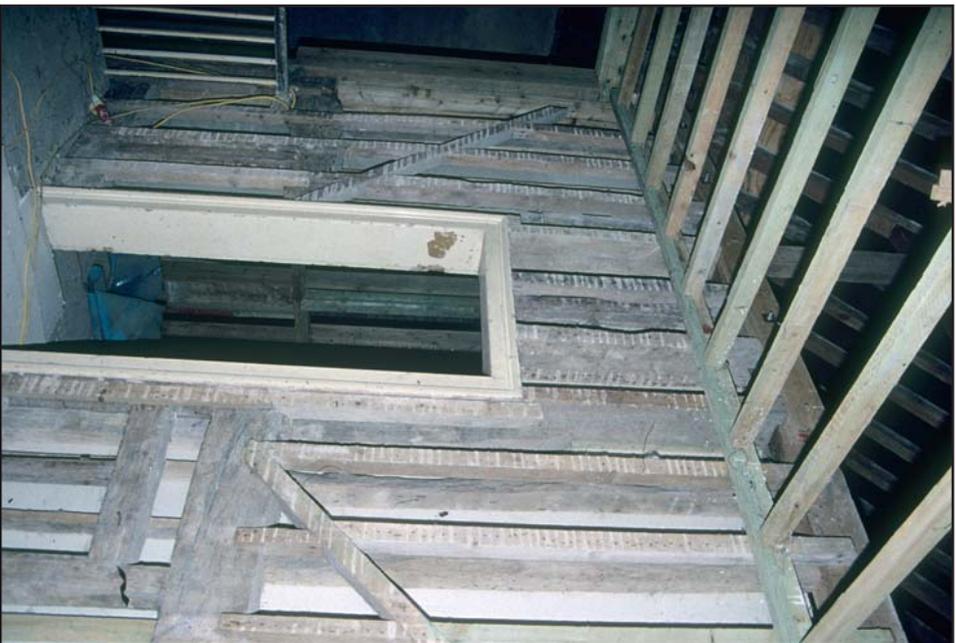
Plate 21: Secondary door between F3 and F4. Truncates primary tie-beam

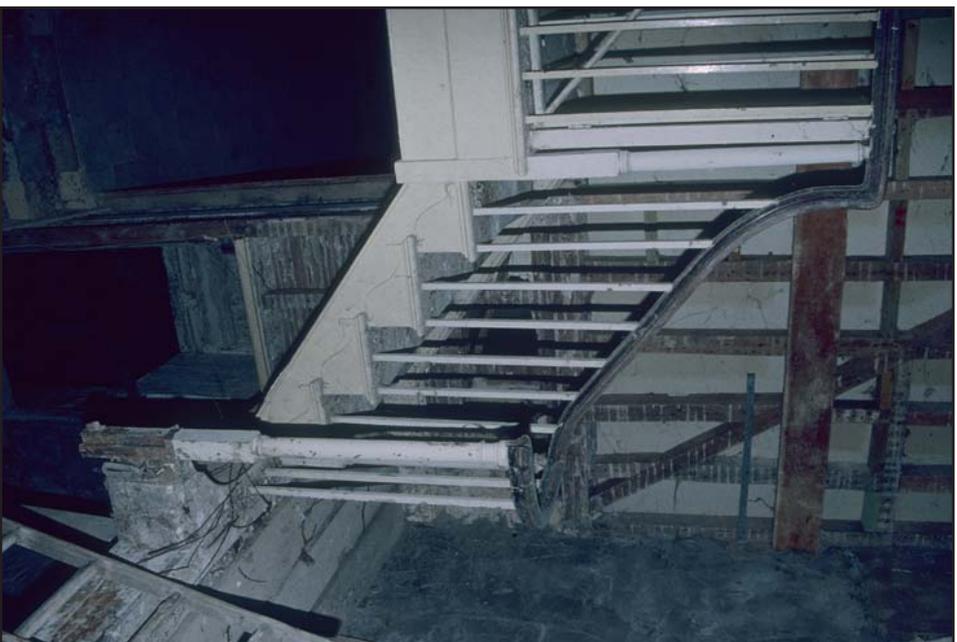
Plate 23: Staircase in Georgian extension (F4)

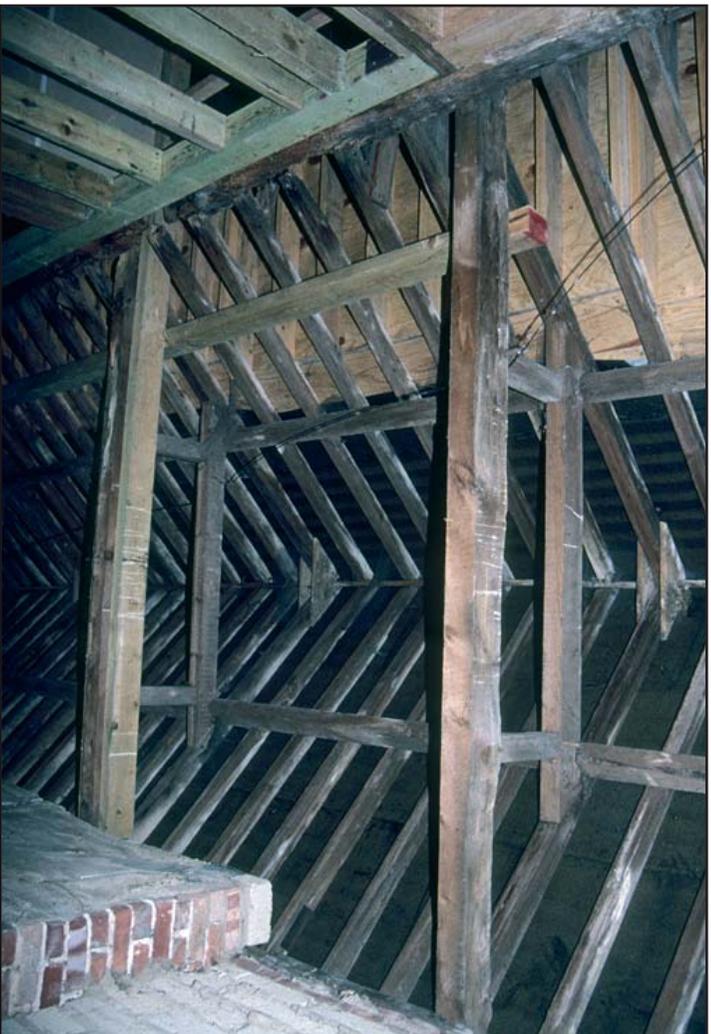
Plate 24: Queen post trusses above extension (F4)
