COTON TO LONGSTANTON PIPELINE

An Archaeological Assessment 1992

Archaeology Section Property Department Shire Hall Castle Hill Cambridge CB3 OAP Tel. (0223) 317312

Report no. 73 Cleaning the surface of 1st century features in Area 2

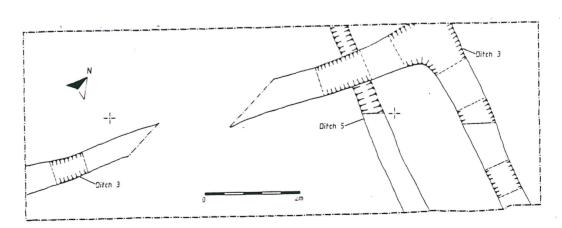
Figure 3-Area 1, plan of post-Medieval ditches 3 and 5.

A series of features were observed, cutting into the natural Gault clay (see Figure 3):

Ditch 3 (fill (002)). A steep-sided ditch, 0.60m wide and 0.35m deep, with a flat base. The ditch ran south-north with a right-angle turn to the east at its northern extent. Filled with homogeneous, pale brown, clay, it contained several large, sub-rectangular, limestone cobbles but no pottery or other finds.

Ditch 5 (fill (004)). Cut by ditch 3. A straight, parallel-sided, east-west ditch, 0.48m wide and 0.14m deep, with a slightly concave base. Filled with homogeneous, pale brown, clay. No pottery or other finds retrieved.

Shallow linear depression (fill (007) cut (006)). Cut by ditch 3. The fill was a mid brown, slightly silty, clay containing several small sherds of post-medieval pottery.

The Cambrdge Museum of Archaeaology and Anthropology could find no record of the Iron Age site, close to area 1, reported in the SMR and so its importance, or even the accuracy of the record, could not be assessed. Excavation produced no evidence of Iron Age activity and the features (ditches 3 and 5) in this area may well be a Post-Medieval agricultural building, although there is no documentary evidence to support this.

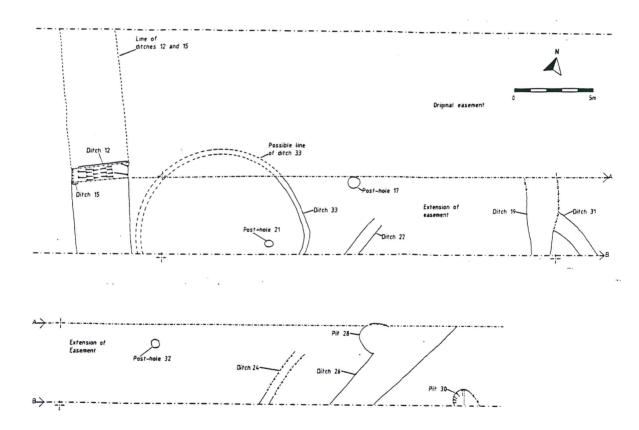
Figure 4- Area 2, plan of features.

No evidence of ridge and furrow remained, having been destroyed by ploughing. However, limited removal of remaining topsoil by hand revealed two features:

Ditch 15 (fill (014)). North-south, U-shaped ditch, 0.52m wide and 0.24m deep (see Figure 4). Filled with mid grey-brown, slightly silty clay which contained a few sherds of pottery dated to the Roman period.

When pipe-laying began, the contractors found it necessary to extend the width of the easement in area 2, initially by 4m. This was due to the depth (5-6m) of the pipe trench at this point. When the topsoil was removed, using a JCB with a toothed bucket, a series of features was observed (see Figure 4) to the east of ditches 12 and 14. These had not been visible before because of incomplete removal of topsoil over the original easement. Unfortunately, lack of time, bad weather, and the constant activity of contractor's machinery, made it only possible to record them very briefly and to excavate narrow slots across selected features:

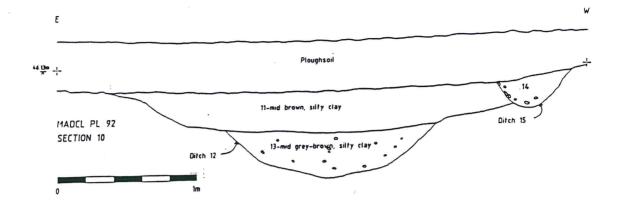
Figure 5-Section through Iron Age/Romano-British ditches 12 and 15.

Ditch 12 (fills (011), (013)). Cut by ditch 15. North-south ditch with a fairly shallow profile, the sides becoming much steeper towards the base (see Figure 5). It was 3.20m wide and 0.75m deep. This was filled with a mid greybrown, slightly silty clay (013). It contained several pottery sherds, which have been dated to the late Iron Age or to an Iron Age tradition in the early Roman period, and a considerable quantity of bone. This was sealed by an upper fill (011), a mid brown, slightly silty clay which contained occasional pottery fragments and some bone. At the base of the upper fill were found sherds from three pottery vessels, one of which was almost

In Area 2, the ditches and other features do not appear as crop marks on aerial photographs, but would have been masked by the ridge and furrow, now destroyed, which existed in this area. Ditches 12 and 15 could be a field boundary but it seems more likely that, given the number of other features recorded in the area, they form part of an enclosure for a settlement of late Iron Age or Romano-British date; ditch 26 could form part of the same enclosure as it has similar dimensions. The curved ditch 33, to the east of ditch 12 and just within the enclosure, may well be part of a circular structure of some sort; its profile certainly suggests that it was a foundation trench for posts. It is estimated that the structure would have had a diameter of about 9 or 10 metres. Several other features also contained pottery dating them to the same period, along with quantities of bone suggesting a domestic context. In aspect, the site is typical of such settlements, situated, as it is, at the brow of a hill overlooking the Callow Brook. Sherds of Roman pottery of the third century found on the stripped surface and in topsoil after removal by machine, indicate continuing, or renewed, occupation of the site in the later Roman period. However, since none of the features excavated produced any finds of this date, it is possible that the focus of the settlement had shifted, or that ploughing has destroyed the later remains. A find of Roman pottery approximately 200m to the east (SMR No 04361) may point to this having been a fairly substantial settlement.

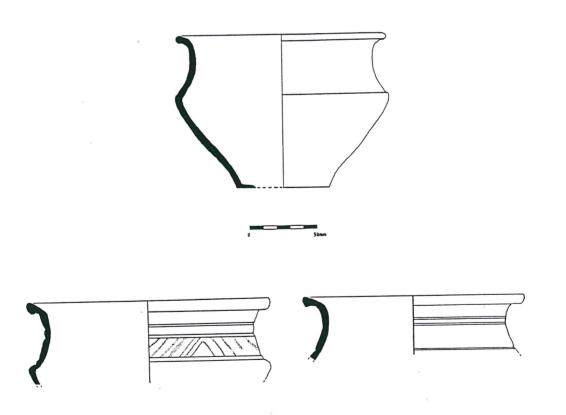
Figure 6-Late Iron Age/Romano-British pottery vessels.

complete, though broken (see Figure 6).

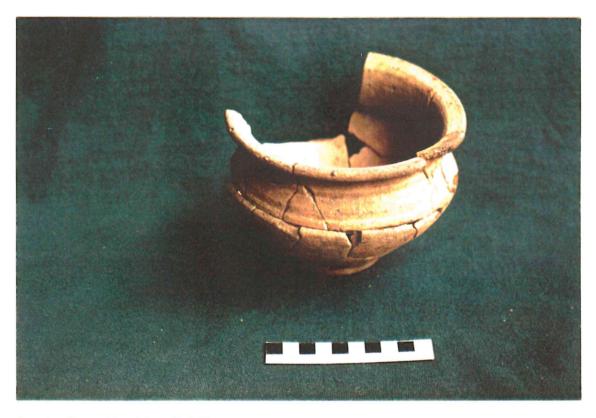
Iron Age Pottery Vessel from ditch 12
