# Old College Gateway Maidstone

## Archaeological Watching Brief Report

**Client: Maidstone Borough Council**

Document Title: Old College Southern Gateway, Maidstone

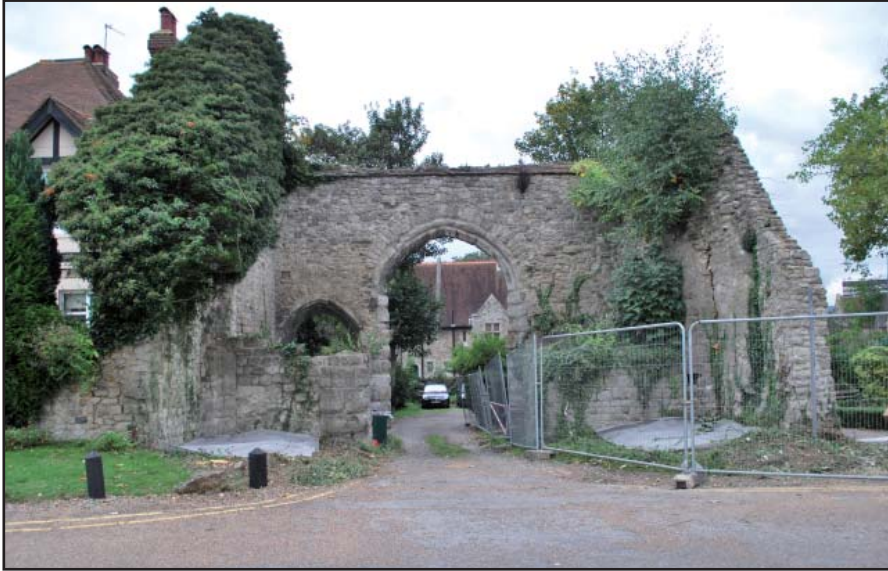
Plate 1: South facing elevation on arrival

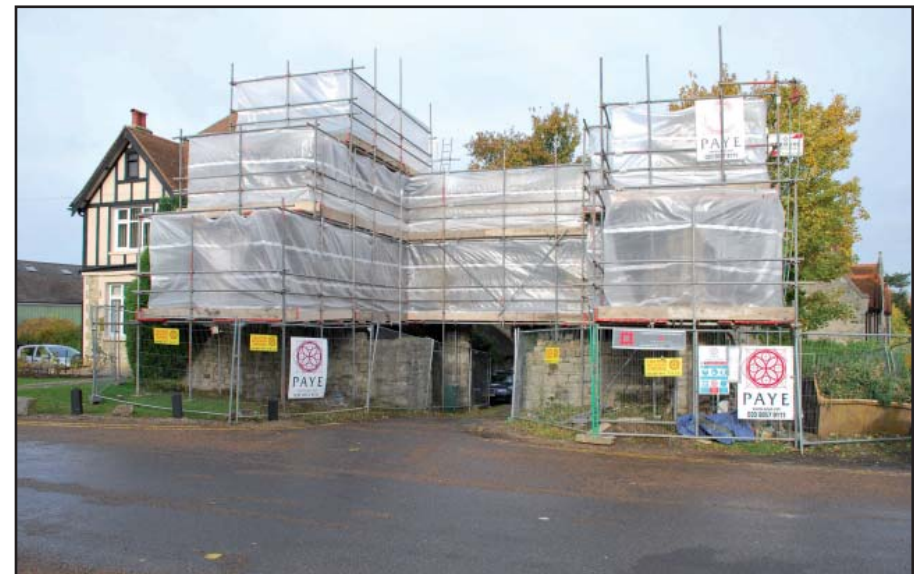
- 4.1.1 At the time OA was asked to undertake the rectified photography of the gatehouse all the vegetation had not yet been cleared. As the structure was to be enclosed by scaffolding it was decided to proceed as the scaffolding would have been more of an obstruction. This meant that several parts of the structure were obscured from clear view and as such may not be completely clear in the photographic results.

Plate 4: South-west facing elevation with scaffolding

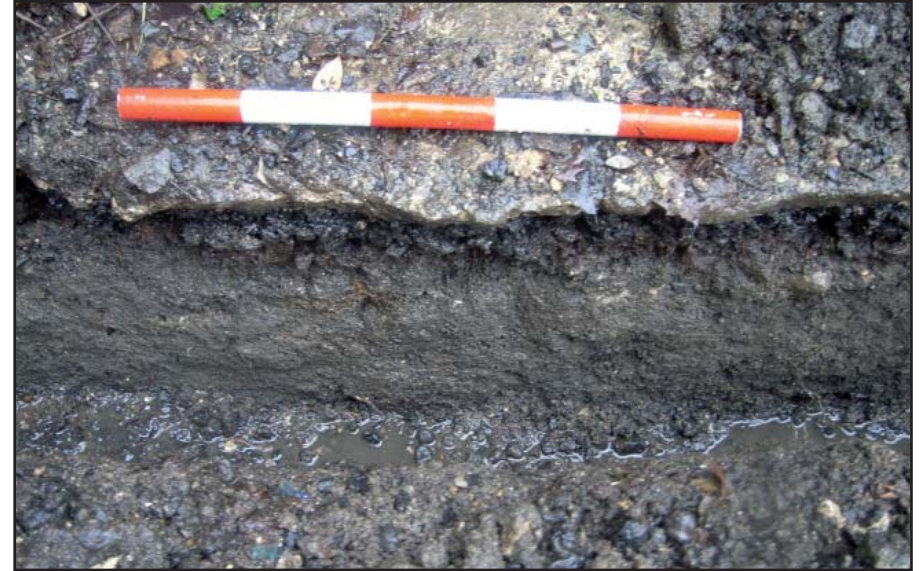
- 3.1.1 The cable trench was 8 m long and 0.3 m wide, aligned approximately N-S along the western side of the ruined gateway (Fig. 4). Modern hardcore deposit (101) was revealed 0.1 m below ground level (BGL), composed of compacted dark grey gravel. This was overlain and sealed by tarmac (100), which formed the current ground surface. No archaeological remains were observed.

Plate 6: Pipe trench section 100

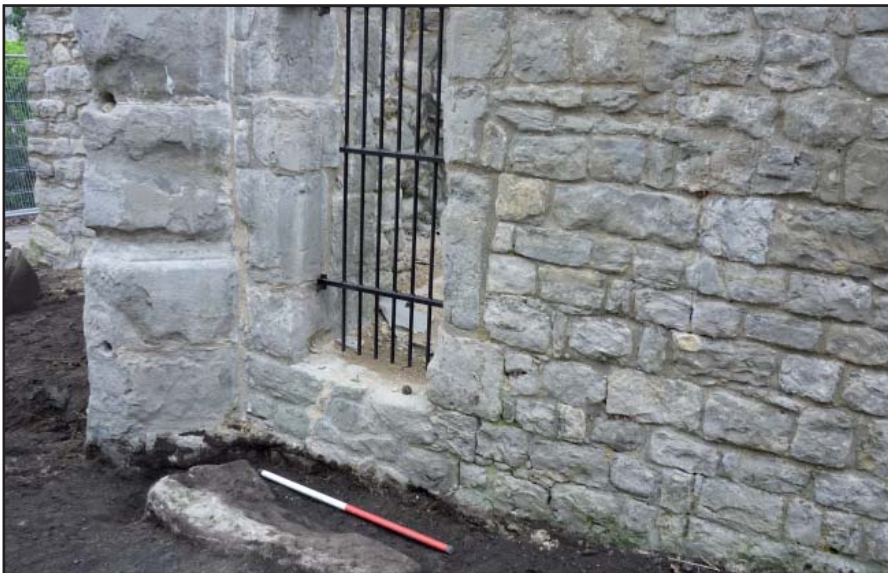
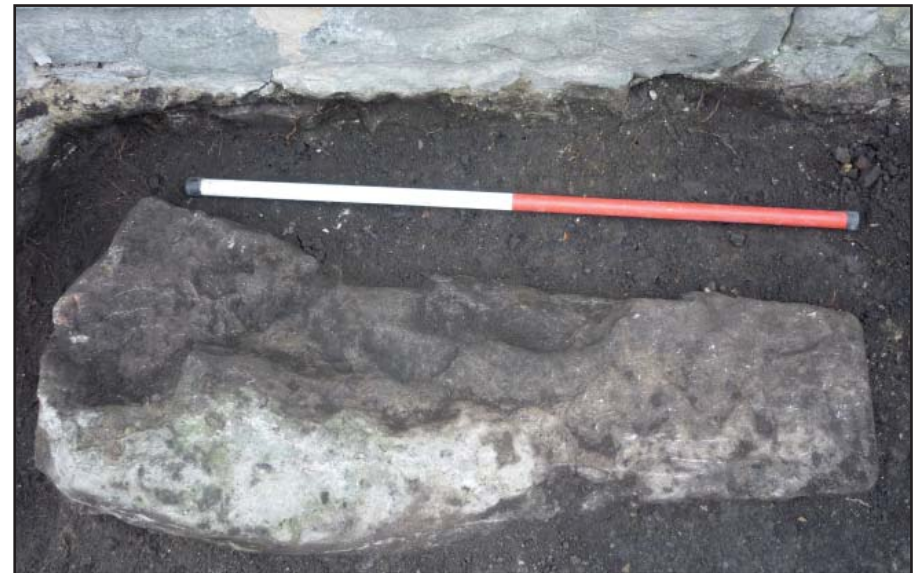
- 3.1.3 At 0.01 m BGL stone step 103 was uncovered (Plates 7 and 8), measuring 1.55 m by 0.46 m at it's widest point. A further investigation slots were excavated at either end of the stone, revealing it to be 0.26 m deep at it's northern end and 0.24 m deep at its southern (Fig. 7). The southern investigation slot further revealed that it was partially worked. The face had been square cut and included a 0.09 m square slot in the centre, measuring 0.04 m deep (plate 9).

- 4.1.3 The excavation also revealed a partially worked stone block which had been placed at the threshold of the eastern cell of the gatehouse structure to be used as a step. The southern end of the stone had been square cut and included a shallow slot which may have been used by the sawyers to move the stone.

Plate 7: Structure 103 in relation to the gateway

Plate 8: Structure 103

- 4.1.4 All archaeological deposits were left in situ. They were covered with terram and a sealing layer of sand prior to the laying of the new road surface. In order to provide adequate protection from deterioration, the gradient of the road surface was also altered to provide an increased depth of covering over the stone step beneath the pointed arch.

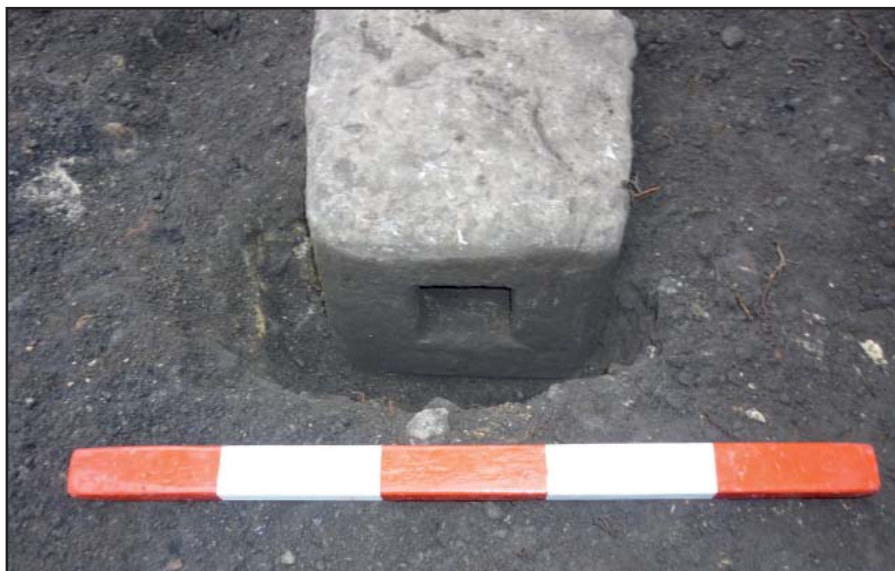
Plate 9: Detail of structure 103

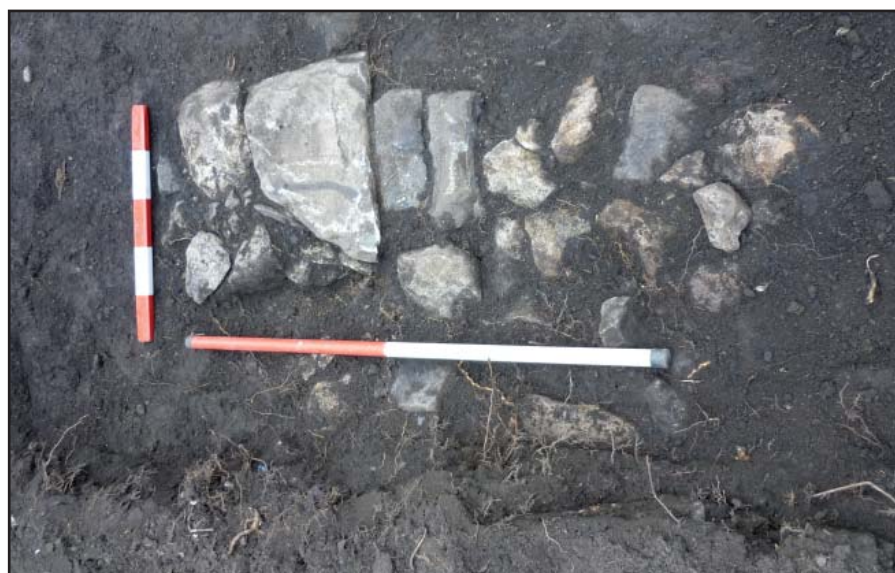
- 3.1.4 Still within the footprint of the gatehouse, north of the arch, surface 104 (Fig. 8) was revealed at a depth of 0.18 m BGL. Consisting of placed limestone blocks measuring at maximum 370x280x70 mm to a minimum of 40x50x40 mm in size (Plate 10). Some of

- 4.1.2 The carriageway running beneath the high pointed arch had been moderately impacted upon by successive layers of modern tarmac surfaces and patching in the road. The depth of excavation was intended to cause minimal impact on any existing archaeological remains beneath. The stone surface uncovered to the north of the gateway appears to form part of a stone bedding layer which continued across the width of the carriageway for a pre-20th-century road surface.

Plate 10: Surface 104

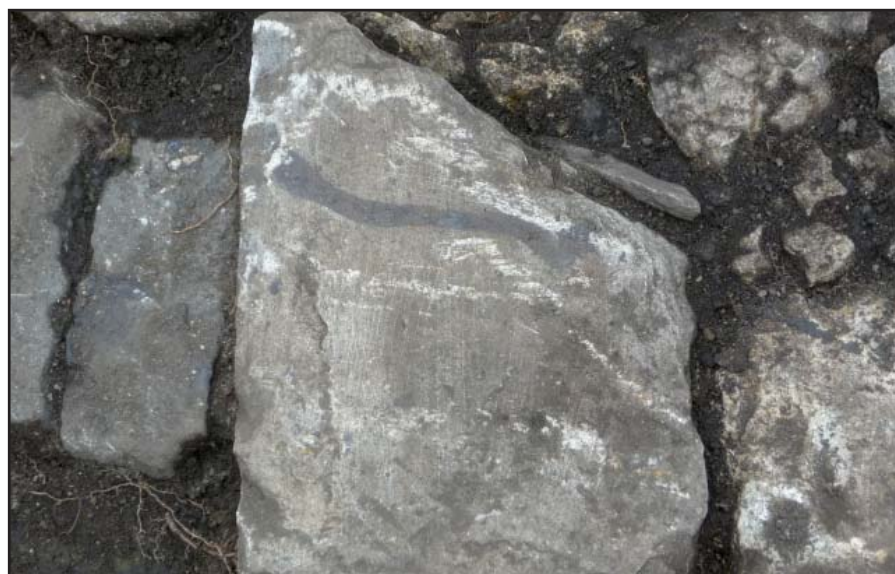
the stones appeared to have been previously worked for structural use (Plate 11) before being reused in the surface.

Plate 11: Detail of 104
