# Glencoyne Farm, Ullswater, Cumbria

## Historic Landscape Survey

**Document Type:** Historic Landscape Survey

**Client Name:** The National Trust

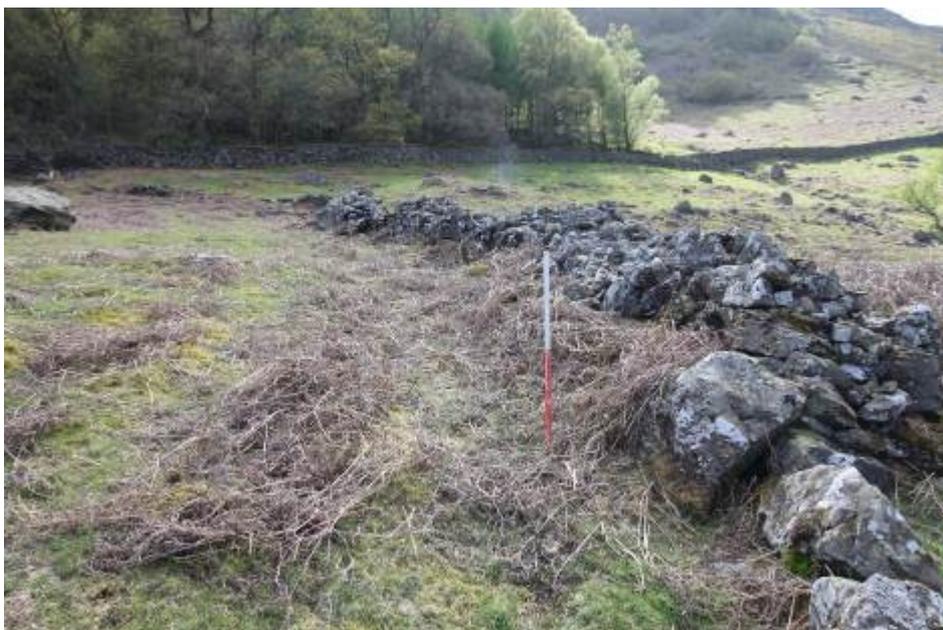
- 4.1.7 The walls making up Site **33**, a sub-circular enclosure of some 1.1ha, were particularly substantial, surviving in places to a height of 1.3m and attaining a maximum width of over 3m. Although substantially built, the enclosure (Site **33**) was poorly defined (probably having been robbed for later wall construction) and comprised two arcs of stonework suggestive of a structure *c* 70m across (Plate 12). This is marked on the first edition Ordnance Survey map of 1863 (Plate 11) as a sheep shelter, but may equally be the remains of an earlier settlement enclosure.

*Plate 12: Enclosure wall (Site 33)*

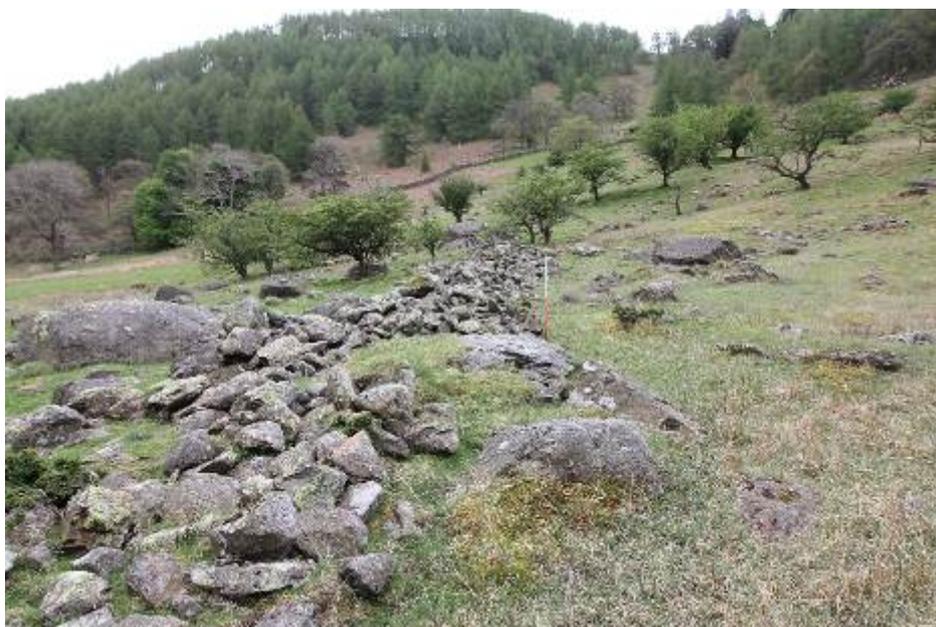
- 4.1.8 A previously unrecorded and irregular boundary (Site 36; Plate 13) was identified crossing the width of the survey area to the west of Seldom Seen. This boundary, which survived typically as a low grass-covered stone foundation, crossed the area in a series of sharp turns and may have been associated with Site 35, the boundary containing an area of ridge and furrow (Site 26), with which it appeared to share its alignment. The northern end of the wall (Site 36) terminated on the southern bank of Glencoyne Beck and appeared to continue (outside the survey area) on the north bank, from where it continues as a sinuous boundary along the edge of Glencoyne Beck and towards the farm. It seems possible that this boundary (Site 36) could relate to a former ring-garth wall.

*Plate 13: Possible former ring-garth wall (Site 36)*

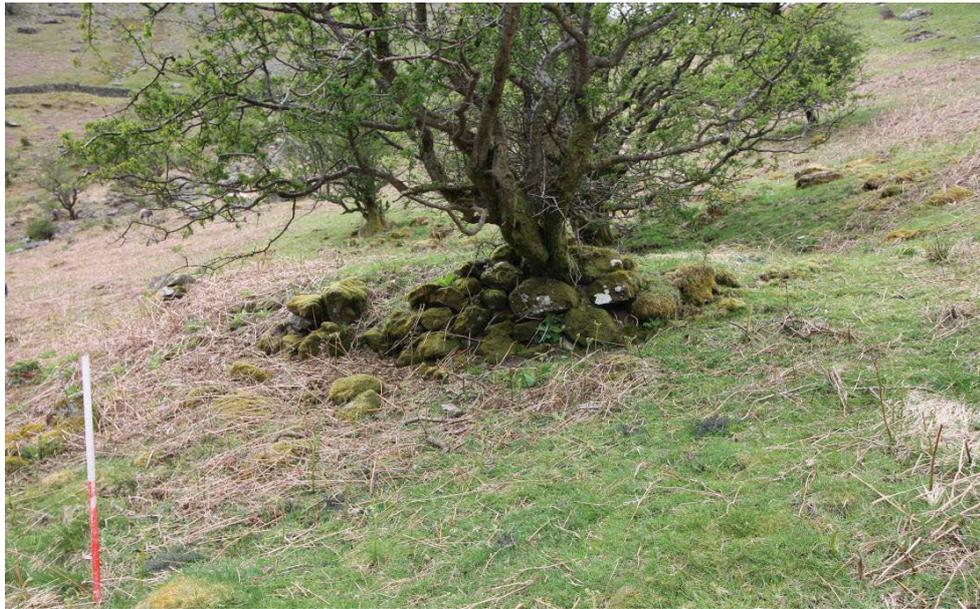
- 4.1.20 The charcoal-burning platforms were mostly ovoid in shape, typically measuring 6-9m in length and 4-7m wide. They were generally encountered on steeply sloping ground with a terrace of up to 1m on the upward slope and a revetment of 1m on the downslope. Exceptionally, Site 64 was located on a very gentle slope, making it a more subtle feature and perhaps accounting for its omission from previous surveys. Several charcoal-burning platforms showed evidence of roughly constructed revetment walls on the downward slope, with a particularly good example being Site 57 (Plate 14).

*Plate 14: Revetment wall of charcoal-burning platform, Site 57*

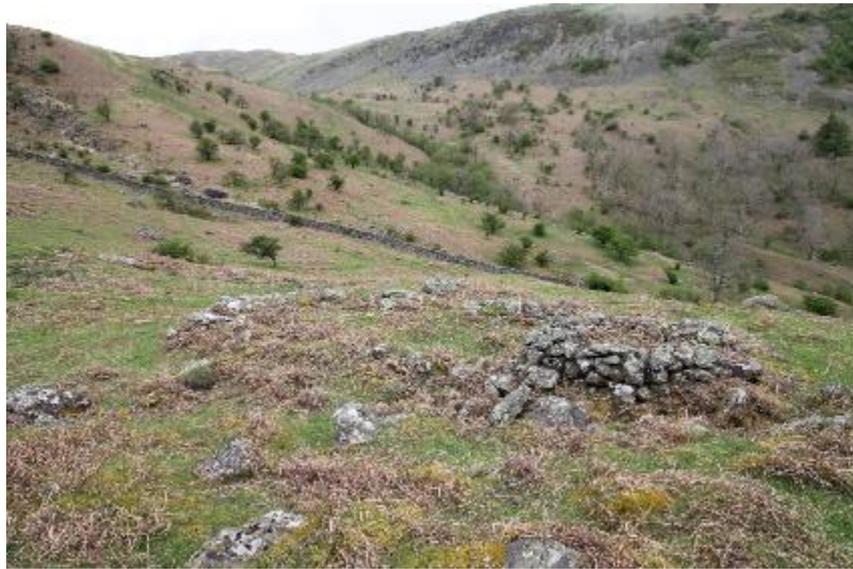
Plate 15: Shieling (Site 39)

- 4.1.25 A shieling (Site **39**) is situated close to the edge of a later intake or former head-dyke wall (Site **71**) and 37m to the north of the large stone-built enclosure (Site **33**). This seems to be related to several clearance cairns (Sites **42, 43, 44, 45**). The structure (Plate 15) is 10 x 5m and 0.5m high, and incorporates a small square extension attached to its eastern

end. There is an entrance at the centre of the northern wall and there appeared to be a narrow cross-wall to the east of the doorway, separating the main structure into two parts.

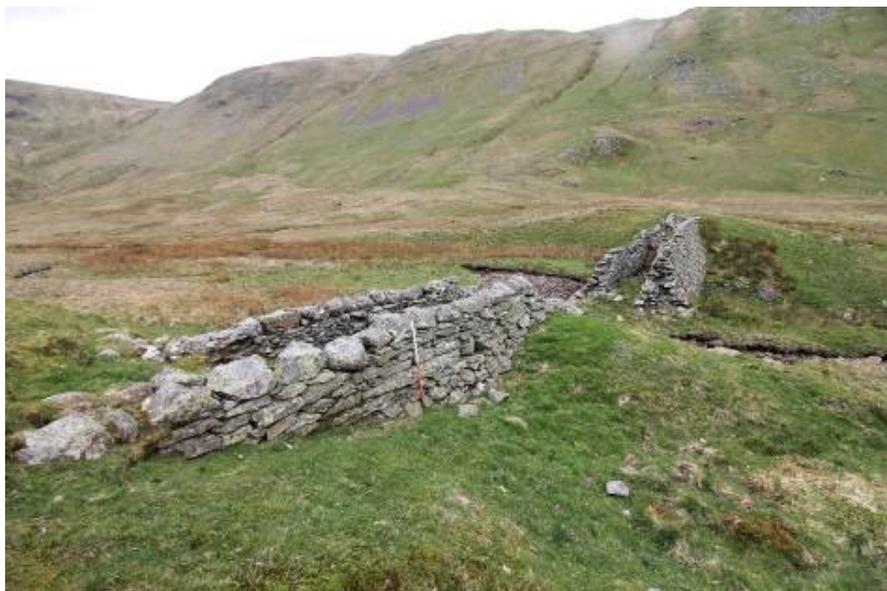
Plate 16: Dam-like structure (Site 51)

4.1.26 **Water-management Features:** the most substantial of the four features for water management identified was a dam-like structure (Site 51) some 300m to the west of the head-dyke (Site 69; Plate 16). This was formed of a pair of parallel walls separated by 1.2m, rubble-constructed with a steep batter on each side, that spanned the width of the beck. The walls survived to a height of up to 2m, but the central section of the structure had been washed away and the space between the interior face of walls was hollow, effectively leaving a channel between them. A small stone arch was preserved within the northern half of the structure, through which water still flowed. The remnants of a silted channel lay to the west of the dam.

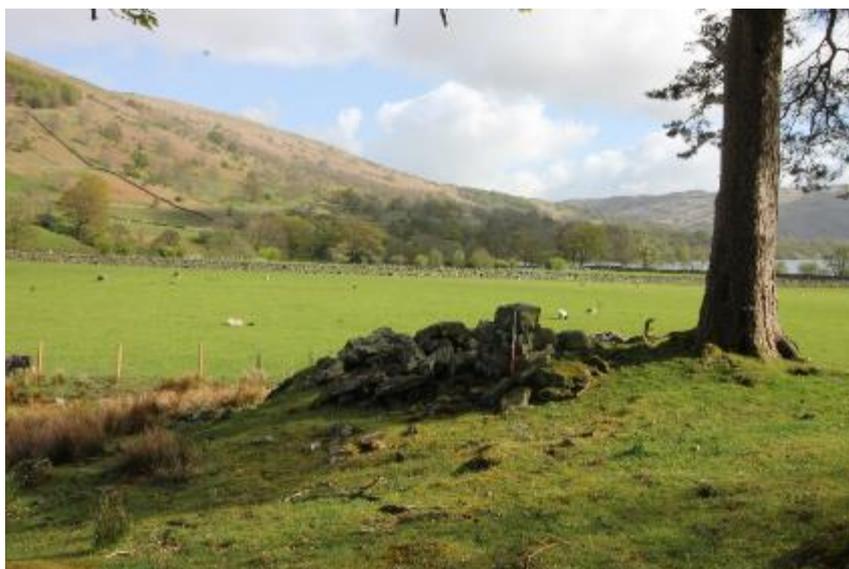
<b>Site Number</b>	1
<b>Site Name</b>	Ruined Structure, South-west of Glencoyne Farm, Patterdale
<b>NGR</b>	NY 38603 18561
<b>NTSMR No</b>	25830
<b>LDHER No</b>	39654
<b>Site Type</b>	Ruin
<b>Period</b>	Post-medieval
<b>Sources</b>	NTSMR; Walkover Survey
<b>Significance</b>	Local
<b>Condition</b>	Poor
<b>Threats</b>	Vegetation (tree rooting)
<b>Management</b>	
<b>Recommendations</b>	Regular monitoring
<b>Photo ID</b>	IMG_0064; 0066
<b>Condition</b>	Poor
<b>Description</b>	Remains of a stone building south-west of Glencoyne Farm, known locally as the 'Smithy'. The standing remains are approximately 1m high, and comprise large quoins and rubble stone-built walls. The building, measuring approximately 5 x 6m, appears to have been placed on a raised platform. The remnants of a cruck blade, recorded during a previous inspection, were not identified.

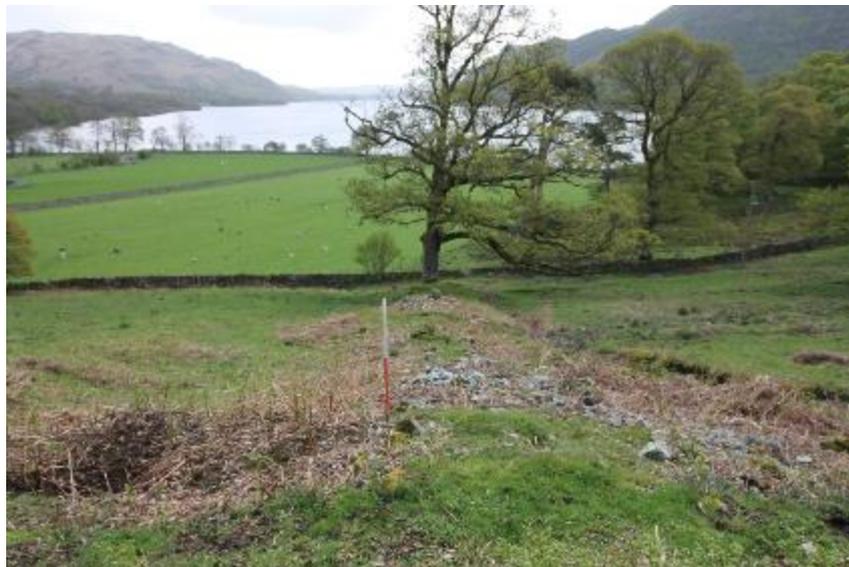
<b>Site Number</b>	2
<b>Site Name</b>	Relict Field Boundary, South-west of Glencoyne Farm, Patterdale
<b>NGR</b>	NY 38510 18564 - 38462 18548
<b>NTSMR No</b>	28401
<b>LDHER No</b>	39660
<b>Site Type</b>	Boundary Wall
<b>Period</b>	Unknown
<b>Sources</b>	NTSMR; Walkover Survey
<b>Significance</b>	Medium
<b>Condition</b>	Poor
<b>Threats</b>	Animal burrowing, vegetation
<b>Management</b>	
<b>Recommendations</b>	Regular monitoring
<b>Photo ID</b>	IMG_0071
<b>Description</b>	Remains of a stone wall extending roughly north-east/south-west for approximately 15m. The feature is 3m wide and survives to a height of 0.3m. There is a ditch or hollow on the northern

side, 0.3m deep and up to 3m wide. Animal burrowing is evident on the south-east end. This feature may be part of, or the same as, that previously identified as NTSMR 28401. The feature appears to mark out the line of part of the former inbye, and may once have joined up with a field boundary to its north-west (Site 19). The bank is large and forms a significant feature; given the presence of an associated ditch, it is possible it could have been the boundary of a former park.

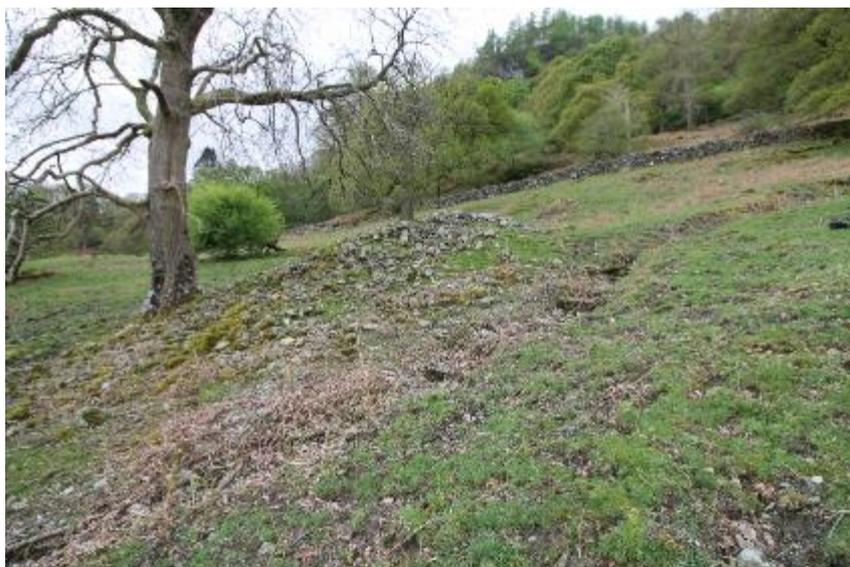
<b>Site Number</b>	3
<b>Site Name</b>	Clearance Cairn, Glencoyne Farm, Patterdale
<b>NGR</b>	NY 38461 18520
<b>NTSMR No</b>	28399
<b>LDHER No</b>	39658
<b>Site Type</b>	Clearance Cairn
<b>Period</b>	Unknown
<b>Sources</b>	NTSMR; Walkover Survey
<b>Significance</b>	Local
<b>Condition</b>	Poor
<b>Threats</b>	Vegetation
<b>Management</b>	
<b>Recommendations</b>	Regular monitoring
<b>Photo ID</b>	IMG_0074
<b>Description</b>	An oval pile of stones forms a field-clearance mound located to the south-west of a mature tree, measuring 10m long, 7.5m wide and 1.5m high.

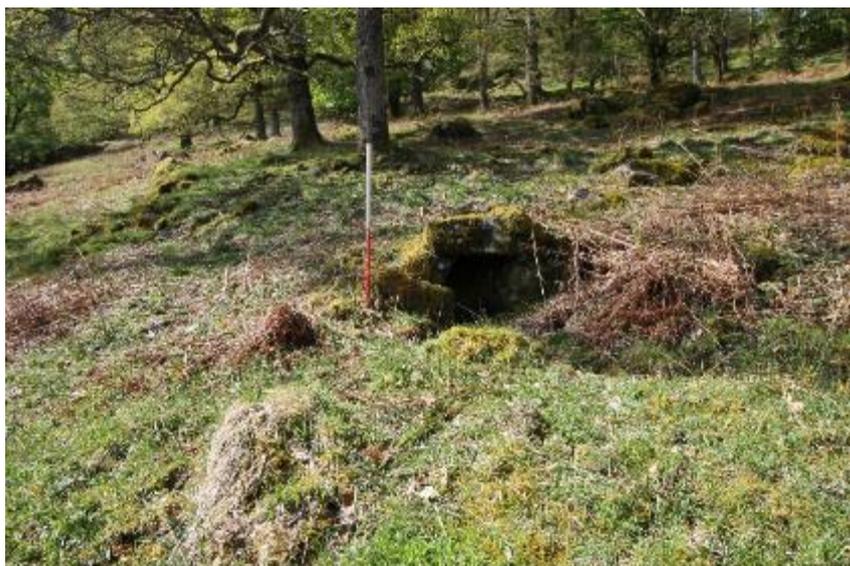
<b>Site Number</b>	4
<b>Site Name</b>	Stone Aperture, Glencoyne Farm, Patterdale
<b>NGR</b>	NY 38383 18549
<b>NTSMR No</b>	-
<b>LDHER No</b>	-
<b>Site Type</b>	Natural Spring
<b>Period</b>	Unknown
<b>Sources</b>	Walkover Survey
<b>Significance</b>	Local
<b>Condition</b>	Poor
<b>Threats</b>	Vegetation
<b>Management</b>	
<b>Recommendations</b>	Regular monitoring
<b>Photo ID</b>	IMG_0078
<b>Description</b>	A low stone-built aperture appears to have been constructed into the slope of the hill over a natural spring. The feature is 1m wide and 0.55m high and is topped by a single stone lintel.

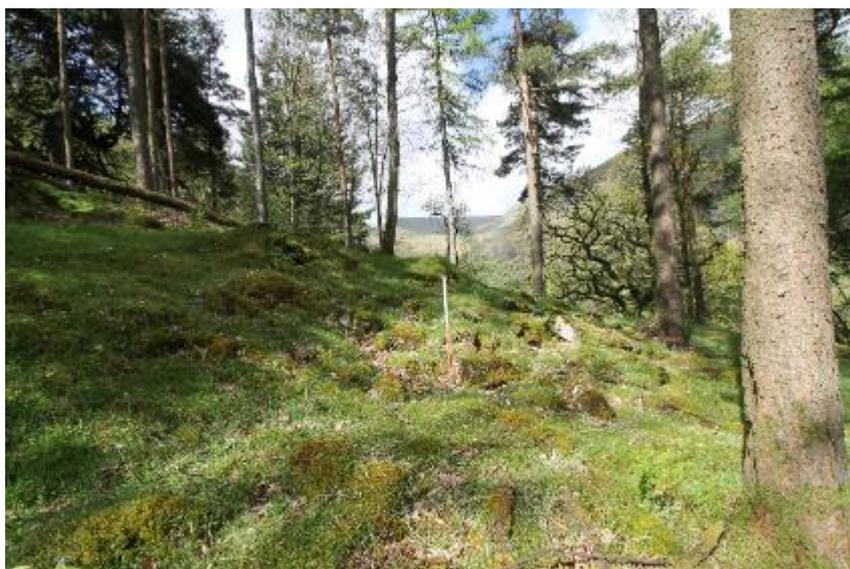
<b>Site Number</b>	5
<b>Site Name</b>	Clearance Cairn, Glencoyne Farm, Patterdale

<b>NGR</b>	NY 38315 18531
<b>NTSMR No</b>	28447
<b>LDHER No</b>	39705
<b>Site Type</b>	Clearance Cairn
<b>Period</b>	Unknown
<b>Sources</b>	NTSMR; Walkover Survey
<b>Significance</b>	Local
<b>Condition</b>	Poor
<b>Threats</b>	Vegetation
<b>Management</b>	
<b>Recommendations</b>	Regular monitoring
<b>Photo ID</b>	IMG_0081
<b>Description</b>	A large moss covered oval pile of stones 10m long, 4m wide and 1.5m high, lies on a slope on the northern edge of Glencoyne Wood, forming a field-clearance mound.

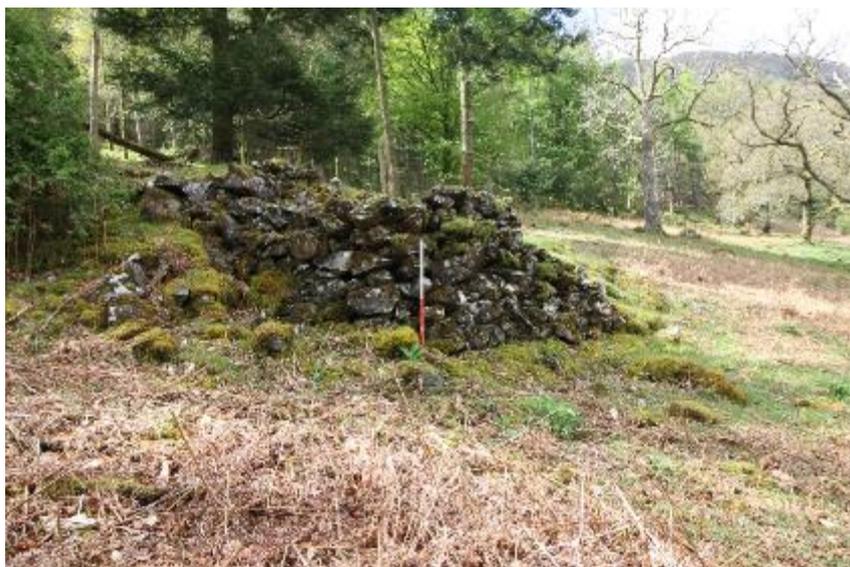
<b>Site Number</b>	6
<b>Site Name</b>	Ruined Structure, Glencoyne Farm, Patterdale
<b>NGR</b>	NY 38279 18534
<b>NTSMR No</b>	28428
<b>LDHER No</b>	39687
<b>Site Type</b>	Building
<b>Period</b>	Post-medieval
<b>Sources</b>	NTSMR; Walkover Survey
<b>Significance</b>	Local
<b>Condition</b>	Poor
<b>Threats</b>	Vegetation
<b>Management</b>	
<b>Recommendations</b>	Regular monitoring
<b>Photo ID</b>	IMG_0086
<b>Description</b>	The remains of a small rectangular, rubble stone-built structure stand on the northern edge of Glencoyne Wood. The feature measures 4 x 7m and survives on the downslope side to a maximum height of 1.3m. There appears to be a ramp on the western side, leading to the top, and previous inspections have suggested it may have been a kiln.

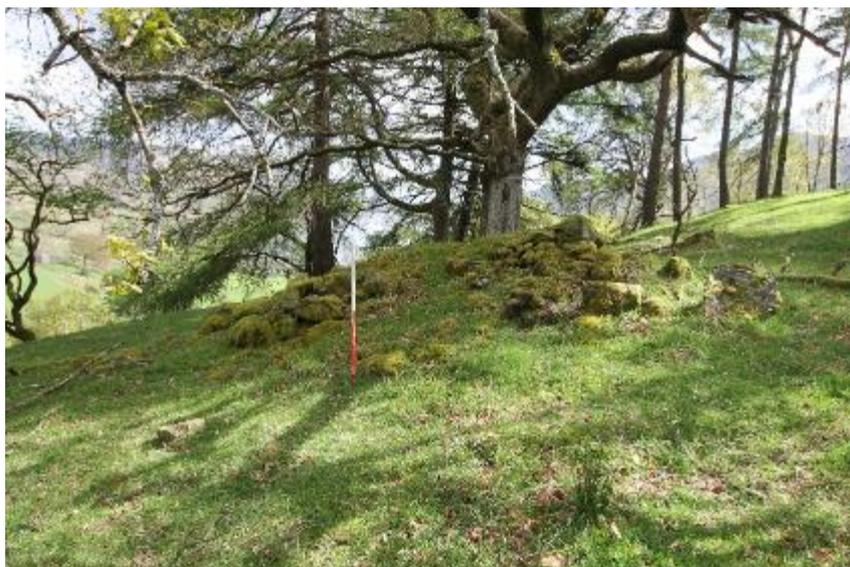
<b>Site Number</b>	7
<b>Site Name</b>	Clearance Cairn, Glencoyne Farm, Patterdale
<b>NGR</b>	NY 38287 18548
<b>NTSMR No</b>	28446
<b>LDHER No</b>	-
<b>Site Type</b>	Clearance Cairn
<b>Period</b>	Unknown
<b>Sources</b>	NTSMR; Walkover Survey
<b>Significance</b>	Local
<b>Condition</b>	Poor
<b>Threats</b>	Vegetation
<b>Management</b>	
<b>Recommendations</b>	Regular monitoring
<b>Photo ID</b>	IMG_0093
<b>Description</b>	An elongated pile of stones on the northern edge of Glencoyne Wood forms a mound, measuring 6 x 4m and reaching a height of 1m. The feature appears to be a clearance cairn, although previous surveys have suggested it was a structure.

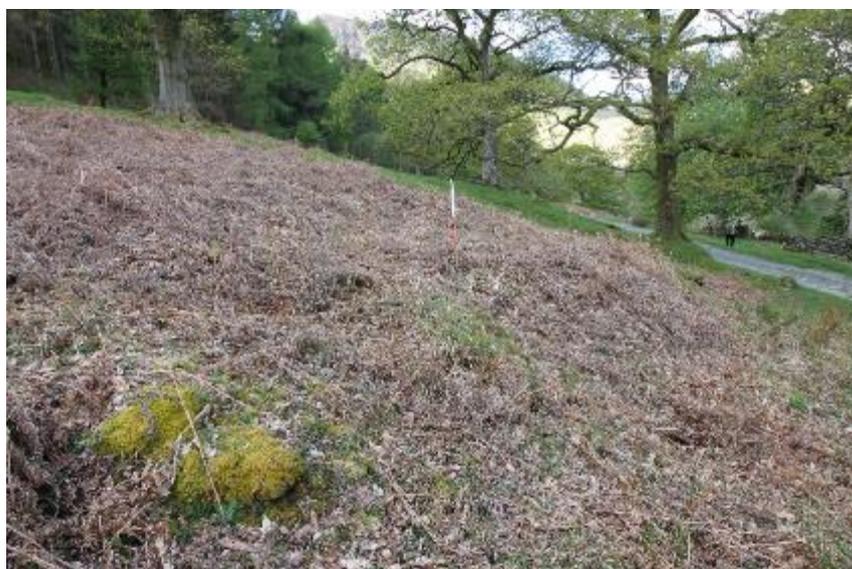
<b>Site Number</b>	9
<b>Site Name</b>	Ruined Structure, Glencoyne Farm, Patterdale
<b>NGR</b>	NY 38174 18559
<b>NTSMR No</b>	25831
<b>LDHER No</b>	39655
<b>Site Type</b>	Building
<b>Period</b>	Post-medieval
<b>Sources</b>	NTSMR; Walkover Survey
<b>Significance</b>	Local
<b>Condition</b>	Poor
<b>Threats</b>	Lies near a large tree with possible root disturbance. The interior is heavily vegetated
<b>Management</b>	
<b>Recommendations</b>	Regular monitoring, possible consolidation
<b>Description</b>	The remnants of a small rectangular barn are constructed predominantly of field stones with large irregular corner quoins. The western lateral wall and northern gable wall survive to nearly full height and form part of the present field-boundary wall. The southern and eastern walls survive only as foundations. The structure measures 7 x 4m and survives to a maximum height of 2.8m. It may previously have served as a Hogg House, although it was reportedly taken down to build another barn at the farmstead (NTSMR).

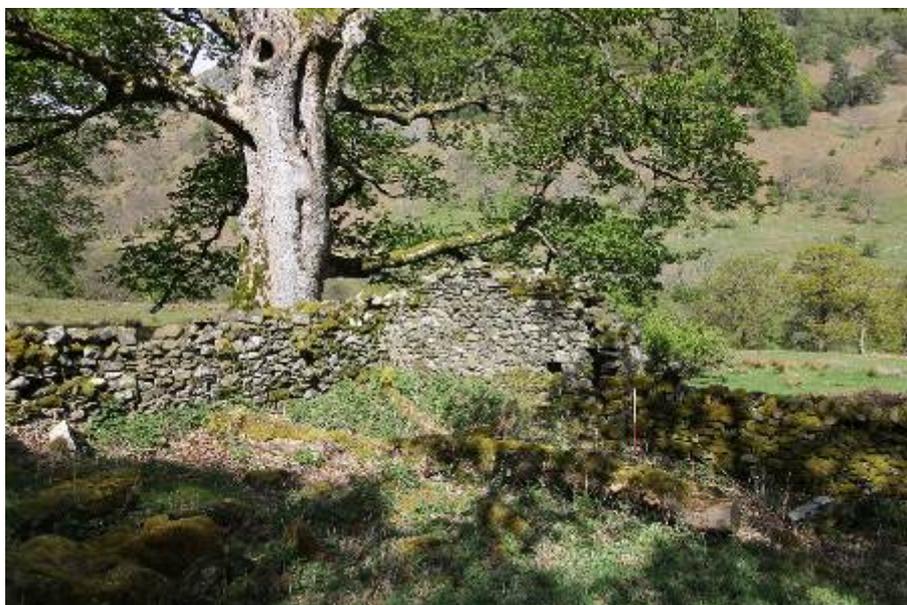
<b>Site Number</b>	10
<b>Site Name</b>	Relict Field Boundary, Glencoyne Farm, Patterdale
<b>NGR</b>	NY 38198 18576 - 38204 18621
<b>NTSMR No</b>	-
<b>LDHER No</b>	-
<b>Site Type</b>	Boundary Wall
<b>Period</b>	Post-medieval
<b>Sources</b>	Walkover Survey
<b>Significance</b>	Local
<b>Condition</b>	Poor
<b>Threats</b>	Vegetation
<b>Management</b>	
<b>Recommendations</b>	Regular monitoring
<b>Photo ID</b>	IMG_0105, 0107
<b>Description</b>	The remains of a stone wall foundation extend up a rise from the north to the south for approximately 45m, with an opening of approximately 2m near the centre, allowing for through access, with a cobbled surface track. The wall was composed of field stones and measured 2.3m wide and 0.5m high. It forms part of a previously unrecorded relict field system.

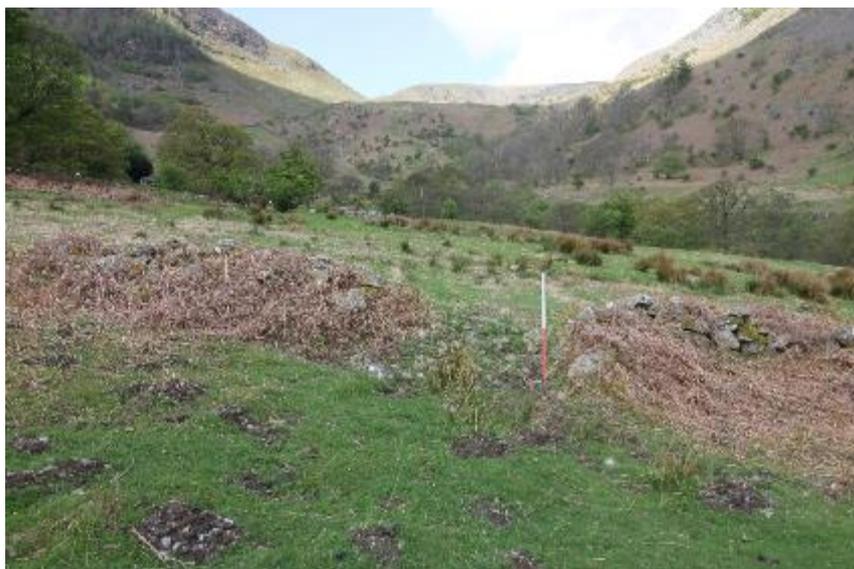
<b>Site Number</b>	11
<b>Site Name</b>	Ruined Structure, Glencoyne Farm, Patterdale
<b>NGR</b>	NY 38205 18631
<b>NTSMR No</b>	28397
<b>LDHER No</b>	39656
<b>Site Type</b>	Building
<b>Period</b>	Post-medieval
<b>Sources</b>	NTSMR; Walkover Survey
<b>Significance</b>	Local
<b>Condition</b>	Poor
<b>Threats</b>	Vegetation
<b>Management</b>	
<b>Recommendations</b>	Regular monitoring
<b>Photo ID</b>	IMG_0012
<b>Description</b>	A pile of rubble, 9.7m long, 6.8m wide and just 0.5m high, has a possible right-angle at the south-western corner. The feature occupies a position at the southern end of a relict boundary wall (Site <b>10</b> ) and a previous survey suggested it may have been a field barn, although it is not marked on historical maps.

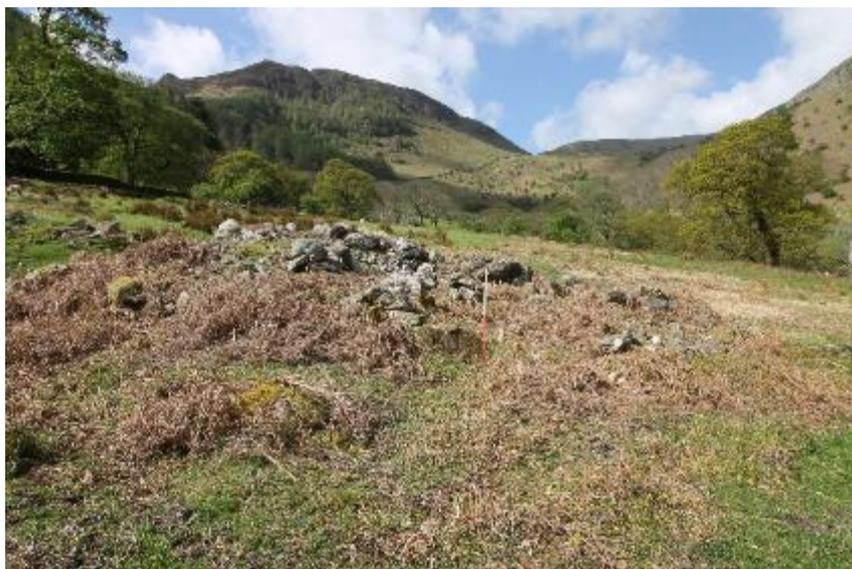
<b>Site Number</b>	12
<b>Site Name</b>	Clearance Cairn, Glencoyne Farm, Patterdale
<b>NGR</b>	NY 38216 18638
<b>NTSMR No</b>	-
<b>LDHER No</b>	-
<b>Site Type</b>	Clearance Cairn
<b>Period</b>	Unknown
<b>Sources</b>	Walkover Survey
<b>Significance</b>	Local
<b>Condition</b>	Poor
<b>Threats</b>	Vegetation
<b>Management</b>	
<b>Recommendations</b>	Regular monitoring
<b>Photo ID</b>	IMG_0115
<b>Description</b>	An ovoid pile of stones is close to Sites <i>10</i> and <i>11</i> . It is a field-clearance cairn, approximately 9 x 7m and 0.75m high.

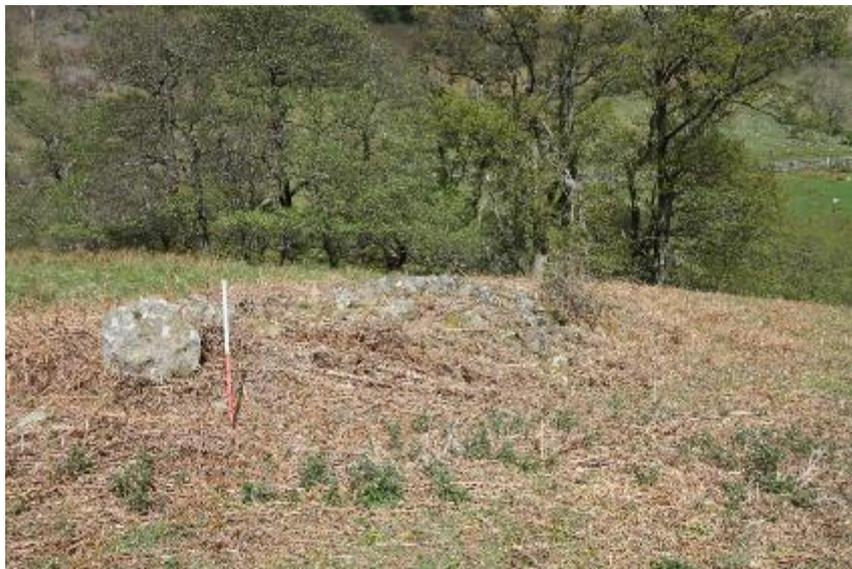
<b>Site Number</b>	13
<b>Site Name</b>	Clearance Cairn, Glencoyne Farm, Patterdale
<b>NGR</b>	NY 38231 18596
<b>NTSMR No</b>	28403
<b>LDHER No</b>	39662
<b>Site Type</b>	Clearance Cairn
<b>Period</b>	Unknown
<b>Sources</b>	NTSMR; Walkover Survey
<b>Significance</b>	Local
<b>Condition</b>	Poor
<b>Threats</b>	Vegetation
<b>Management</b>	
<b>Recommendations</b>	Regular monitoring
<b>Photo ID</b>	IMG_0117
<b>Description</b>	An oval pile of stones forms a field-clearance cairn, measuring approximately 7 x 5m and surviving to a height of 0.5m.

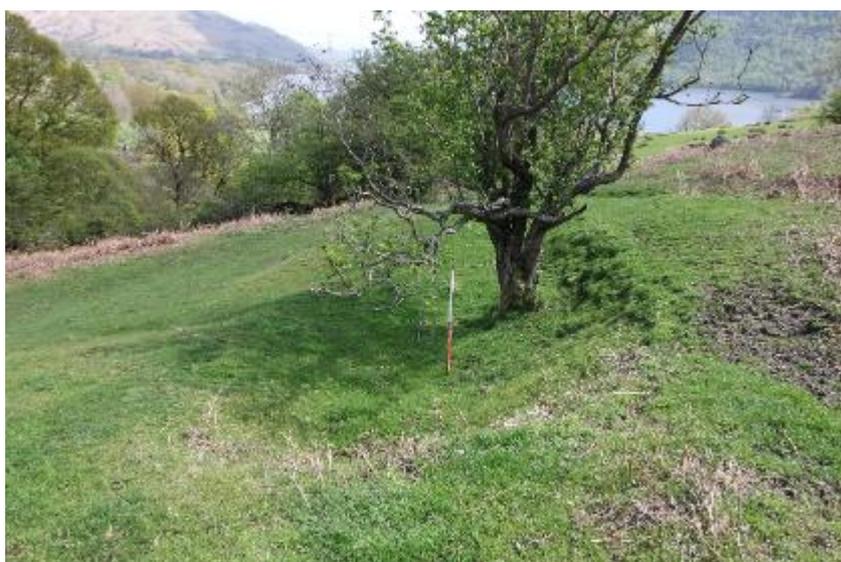
<b>Site Number</b>	14
<b>Site Name</b>	Quarry Hollow, Glencoyne Farm, Patterdale
<b>NGR</b>	NY 38239 18620
<b>NTSMR No</b>	-
<b>LDHER No</b>	-
<b>Site Type</b>	Quarry
<b>Period</b>	Unknown
<b>Sources</b>	Walkover Survey
<b>Significance</b>	Local
<b>Condition</b>	Moderate
<b>Threats</b>	Tree rooting
<b>Management</b>	
<b>Recommendations</b>	Regular monitoring
<b>Photo ID</b>	IMG_0119
<b>Description</b>	An oval-shaped hollow/scoop, on an east/west alignment, has been excavated into the natural slope, with an entrance to the north. It is probably the result of small-scale quarrying. The feature measures approximately 10 x 3m and is 1m deep.

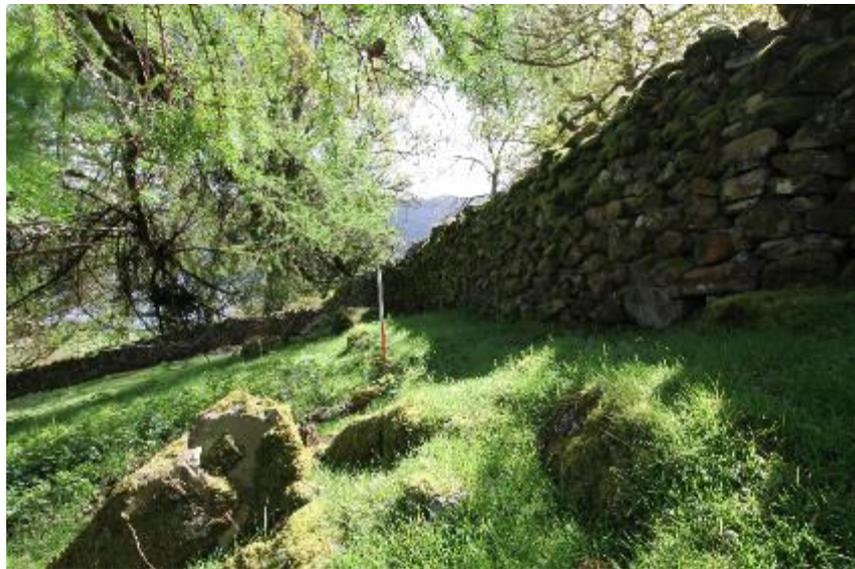
<b>Site Number</b>	15
<b>Site Name</b>	Relict Field Boundary, Glencoyne Farm, Patterdale
<b>NGR</b>	NY 38344 18576
<b>NTSMR No</b>	28433
<b>LDHER No</b>	39692
<b>Site Type</b>	Boundary Wall
<b>Period</b>	Unknown
<b>Sources</b>	NTSMR; Walkover Survey
<b>Significance</b>	Local
<b>Condition</b>	Poor
<b>Threats</b>	Tree Rooting, vegetation
<b>Management</b>	
<b>Recommendations</b>	Regular monitoring
<b>Photo ID</b>	IMG_0127
<b>Description</b>	The remains of a linear stone wall foundation, 13m long and 1m wide, survive to a maximum height of 0.3m. The feature is roughly aligned east-west and possibly turns to the north at its eastern end. It is made up of large stones and is to the north of the present-day field boundary, although on a slightly different alignment.

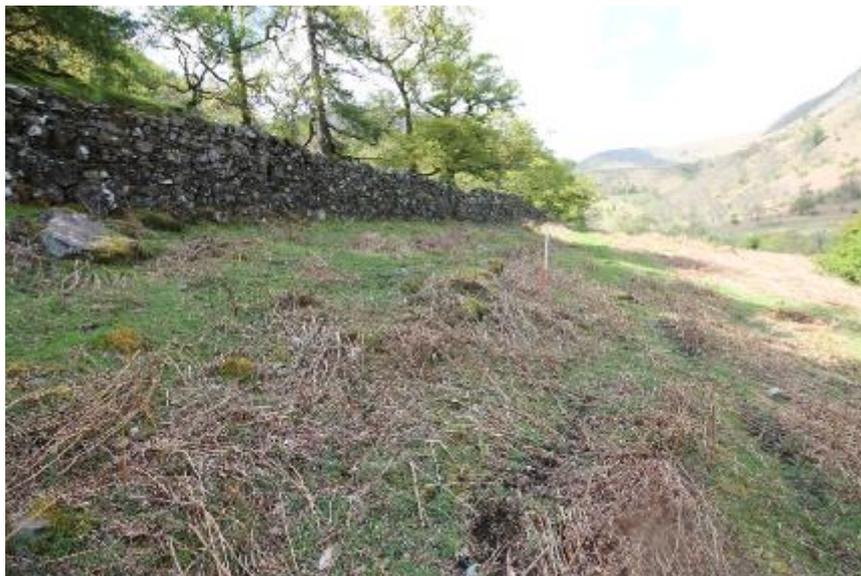
<b>Site Number</b>	16
<b>Site Name</b>	Relict Field Boundary, Glencoyne Farm, Patterdale
<b>NGR</b>	NY 38307 18579 - 38277 18577
<b>NTSMR No</b>	28433
<b>LDHER No</b>	39692
<b>Site Type</b>	Field Boundary
<b>Period</b>	Unknown
<b>Sources</b>	Walkover Survey
<b>Significance</b>	Local
<b>Condition</b>	Poor
<b>Threats</b>	Vegetation
<b>Management</b>	
<b>Recommendations</b>	Regular monitoring
<b>Photo ID</b>	IMG_0130
<b>Description</b>	The remains of a linear stone wall foundation are roughly on an east-west alignment. This may be a continuation of Site <b>15</b> , as it appears to be on the same alignment and they are in close proximity. The NTSMR records Sites <b>15</b> and <b>16</b> under the same number, but no physical connection was observed.

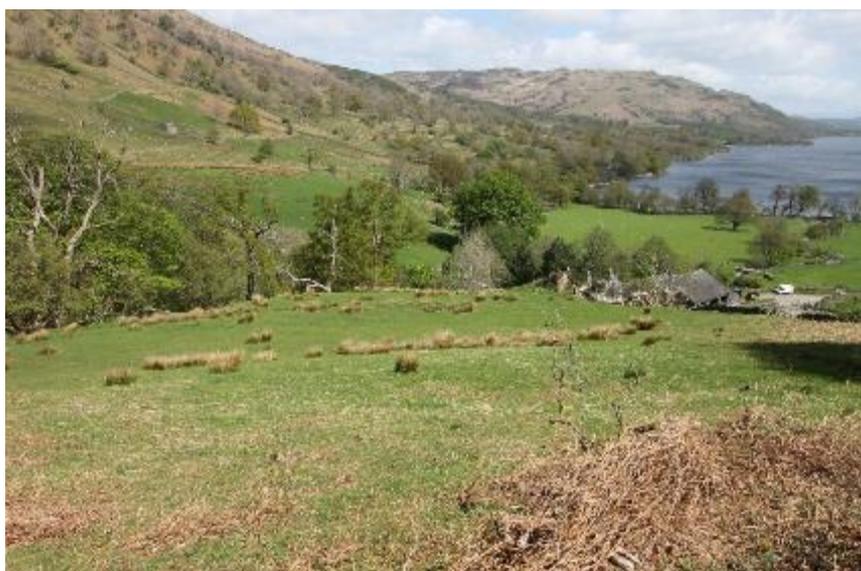
<b>Site Number</b>	17
<b>Site Name</b>	Ridge and Furrow, Glencoyne Farm, Patterdale
<b>NGR</b>	NY 38330 18609
<b>NTSMR No</b>	28421
<b>LDHER No</b>	39680
<b>Site Type</b>	Ridge and Furrow
<b>Period</b>	Medieval - Post-medieval
<b>Sources</b>	NTSMR; Walkover survey
<b>Significance</b>	Local
<b>Condition</b>	Moderate
<b>Threats</b>	None observed
<b>Management</b>	
<b>Recommendations</b>	Regular monitoring
<b>Photo ID</b>	IMG_0134
<b>Description</b>	An area of ridge and furrow is visible on a broadly flat area of rough pasture, 50-60m in length and covering an area up to 30m wide. The furrows were oriented north-west/south-east and were a maximum of 0.2m deep. The measurement from ridge to ridge was 2-2.5m. A second smaller area of ridge and furrow lay immediately to the north (Site <b>18</b> ).

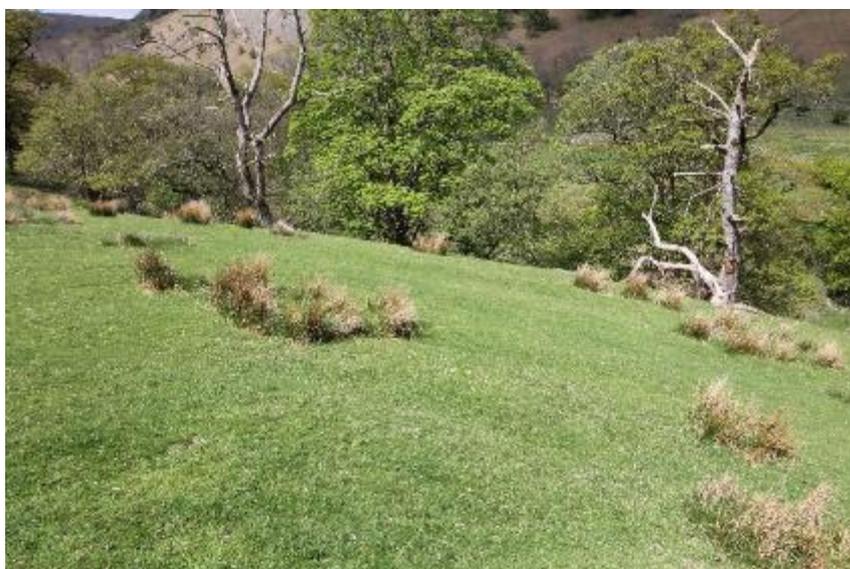
<b>Site Number</b>	18
<b>Site Name</b>	Ridge and Furrow, Glencoyne Farm, Patterdale
<b>NGR</b>	NY 38349 18628
<b>NTSMR No</b>	28601
<b>LDHER No</b>	39859
<b>Site Type</b>	Ridge and Furrow
<b>Period</b>	Medieval - Post-medieval
<b>Sources</b>	NTSMR; Walkover Survey
<b>Significance</b>	Local
<b>Condition</b>	Moderate
<b>Threats</b>	None observed
<b>Management</b>	
<b>Recommendations</b>	Regular monitoring
<b>Photo ID</b>	IMG_0136
<b>Description</b>	An area of ridge and furrow was located to the north of Site <i>17</i> , to which it is identical in general character but varies in alignment, being orientated north-east/south-west. Site <i>18</i> also covers a smaller area of perhaps 12 x 30m and has been ploughed into a gentle north-facing slope.

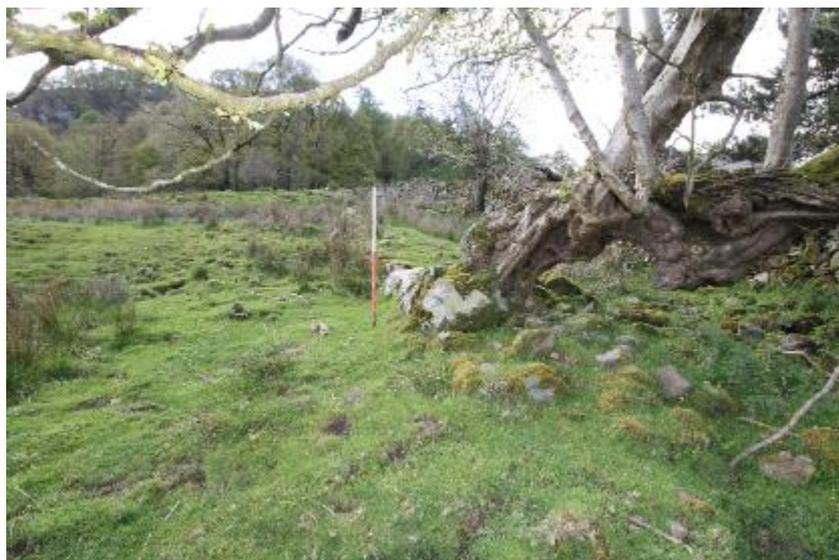
<b>Site Number</b>	19
<b>Site Name</b>	Relict Field Boundary, Glencoyne Farm, Patterdale
<b>NGR</b>	NY 38383 18563 - 38399 18653
<b>NTSMR No</b>	-
<b>LDHER No</b>	-
<b>Site Type</b>	Field Boundary
<b>Period</b>	Unknown
<b>Sources</b>	Walkover Survey, OS 1863; OS 1899
<b>Significance</b>	Local
<b>Condition</b>	Poor
<b>Threats</b>	Vegetation (tree rooting)
<b>Management</b>	
<b>Recommendations</b>	Regular monitoring
<b>Photo ID</b>	IMG_0148, 0153
<b>Description</b>	The remains of an old field boundary extend north/south, parallel to an existing boundary but curving to the east at the southern end. The wall is a low linear rubble mound, 2.6m wide, 0.4m high and c 100m long. It is likely to pre-date the present wall, which follows a straighter line, and probably marks the extent of the medieval inbye wall. Its presence on historical mapping suggests it may once have also joined with Site <i>2</i> .

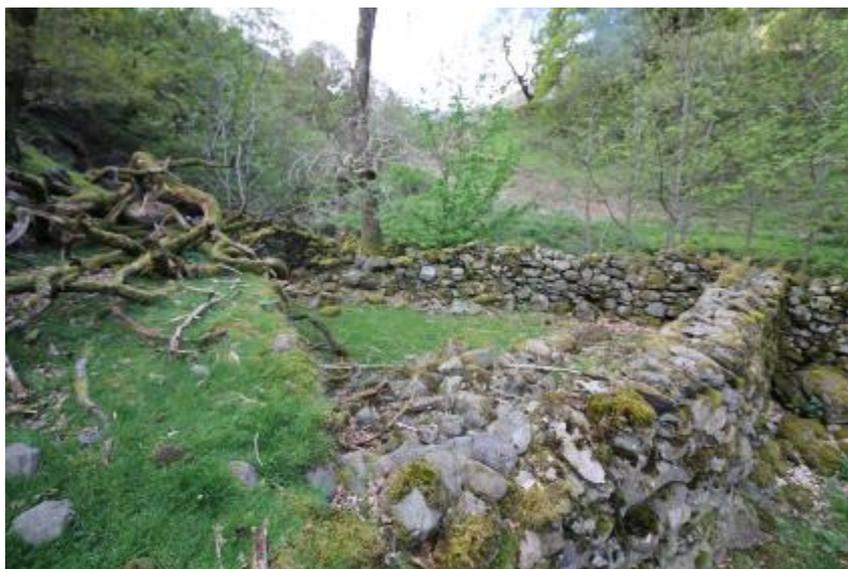
<b>Site Number</b>	20
<b>Site Name</b>	Washfold west of Glencoyne Farm, Patterdale
<b>NGR</b>	NY 38369 18690
<b>NTSMR No</b>	27661
<b>LDHER No</b>	39440, 34429
<b>Site Type</b>	Washfold
<b>Period</b>	Post-medieval
<b>Sources</b>	NTSMR; Walkover Survey
<b>Significance</b>	Local
<b>Condition</b>	Moderate
<b>Threats</b>	Vegetation, river-bank erosion
<b>Management</b>	
<b>Recommendations</b>	Regular monitoring
<b>Photo ID</b>	IMG_0157
<b>Description</b>	A double-celled washfold was located on the side of Glencoyne Beck <i>c</i> 50m to the west of Glencoyne Farm (Site <b>66</b> ). The structure is built of field stones and is roughly triangular in plan tapering to the west, with a cross wall dividing the two cells near the centre, which incorporates a connecting doorway. The eastern cell measures 7m in width and 10m in length and the western cell is 7m in length and a maximum of 7m in width, but tapering to just 1m to the west, where it is open to the river bank. The structure would have been used as a holding pen during sheep washing in the beck but is no longer in use. It may originally have had an additional cell to the east, which is now used as a yard. This record also includes NTSMR 21360 and NTSMR 28443, which are almost certainly duplicate numbers identifying the same feature during different surveys.

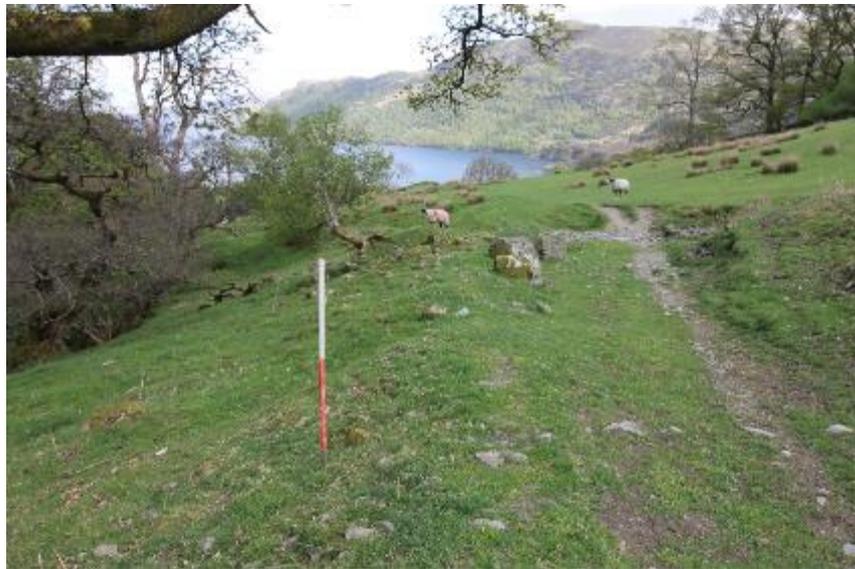
<b>Site Number</b>	23
<b>Site Name</b>	Earthwork, west of Glencoyne Farm, Patterdale
<b>NGR</b>	NY 38278 18626 - 38325 18636
<b>NTSMR No</b>	-
<b>LDHER No</b>	-
<b>Site Type</b>	Earthwork
<b>Period</b>	Unknown
<b>Sources</b>	Walkover Survey
<b>Significance</b>	Local
<b>Condition</b>	Moderate
<b>Threats</b>	Footfall, some limited erosion on the southern side of the bank
<b>Management</b>	
<b>Recommendations</b>	Regular Monitoring
<b>Photo ID</b>	IMG_0172
<b>Description</b>	A curving stone and earth, grass-covered bank forms the northern edge of a track that is part of the present public access to the higher fells. The bank measured 2m across, 0.4m high and extended for a length of 50m, curving from north-east to west. It is adjacent to two areas of ridge and furrow (Sites <i>17</i> and <i>18</i> ) and may have been formed of field-clearance stones.

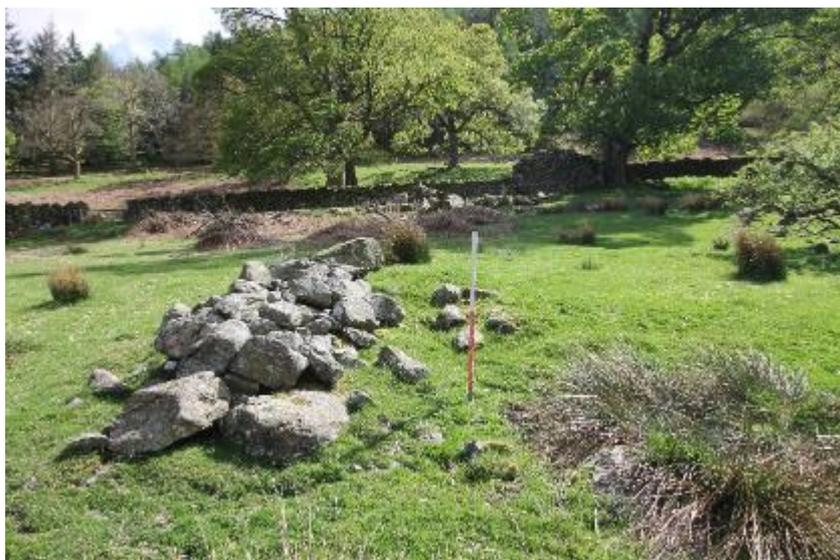
<b>Site Number</b>	24
<b>Site Name</b>	Clearance Cairn, Glencoyne Farm, Patterdale
<b>NGR</b>	NY 38176 18598
<b>NTSMR No</b>	-
<b>LDHER No</b>	-
<b>Site Type</b>	Clearance Cairn
<b>Period</b>	Post-medieval
<b>Sources</b>	Walkover Survey
<b>Significance</b>	Local
<b>Condition</b>	Moderate
<b>Threats</b>	None observed
<b>Management</b>	
<b>Recommendations</b>	Regular Monitoring
<b>Photo ID</b>	IMG_0174
<b>Description</b>	An oval stone-clearance cairn was located within enclosed rough pasture, in close proximity to a boundary (Site <i>10</i> ). The cairn measures approximately 4 x 2.5m and is 0.5m high. The relative sparsity of vegetation may indicate a post-medieval origin.

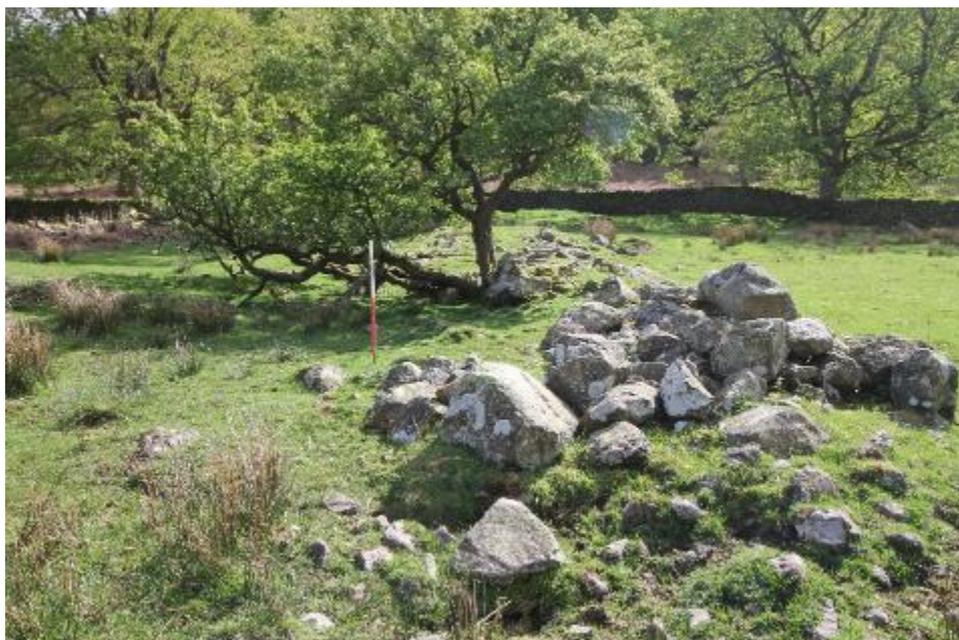
<b>Site Number</b>	25
<b>Site Name</b>	Relict Boundary, Glencoyne Farm, Patterdale
<b>NGR</b>	NY 38166 18581 - 38160 18601
<b>NTSMR No</b>	-
<b>LDHER No</b>	-
<b>Site Type</b>	Boundary/Clearance Wall
<b>Period</b>	Post-medieval
<b>Sources</b>	Walkover Survey
<b>Significance</b>	Local
<b>Condition</b>	Poor
<b>Threats</b>	Vegetation, tree rooting
<b>Management</b>	
<b>Recommendations</b>	Regular Monitoring
<b>Photo ID</b>	IMG_0176
<b>Description</b>	A ruined boundary wall was located to the west of Site <b>24</b> , measuring approximately 20 x 2.2m and 0.75m high. The feature, which incorporates mounds of clearance stone, is roughly north/south-aligned, with a possible turn to the east at the northern end, and a larger concentration of stones at the southern end.

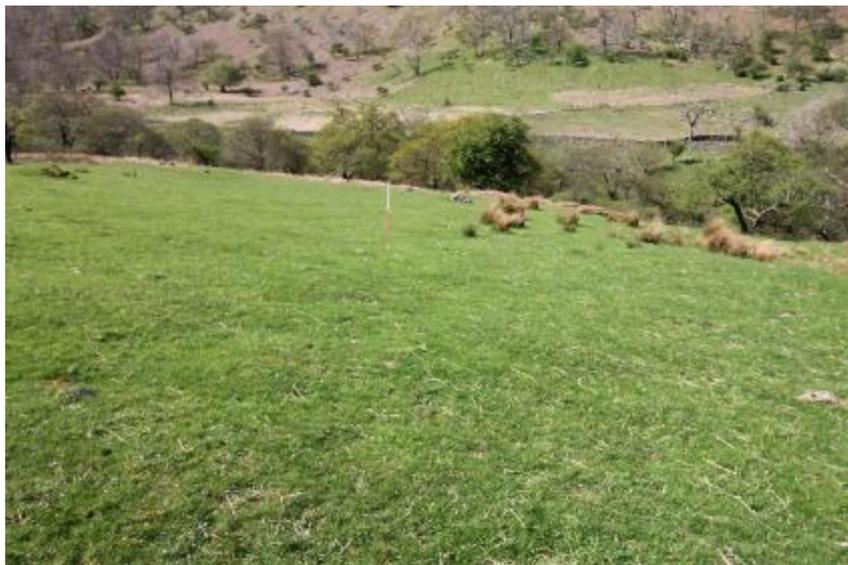
<b>Site Number</b>	26
<b>Site Name</b>	Ridge and Furrow, Glencoyne Farm, Patterdale
<b>NGR</b>	NY 37872 18517 (centred)
<b>NTSMR No</b>	-
<b>LDHER No</b>	-
<b>Site Type</b>	Ridge and Furrow
<b>Period</b>	Medieval/Post-medieval
<b>Sources</b>	Walkover Survey
<b>Significance</b>	Local
<b>Condition</b>	Moderate
<b>Threats</b>	None observed
<b>Management</b>	
<b>Recommendations</b>	Regular Monitoring
<b>Photo ID</b>	IMG_0177
<b>Description</b>	An area of ridge and furrow, aligned north-east/south-west, is approximately 80m long and 70m wide, bisected at its centre by a small stream. The furrows survived to a depth of 0.2m and measured 2-2.5m from ridge to ridge. It is identical in general character to Sites <i>17</i> and <i>18</i> .

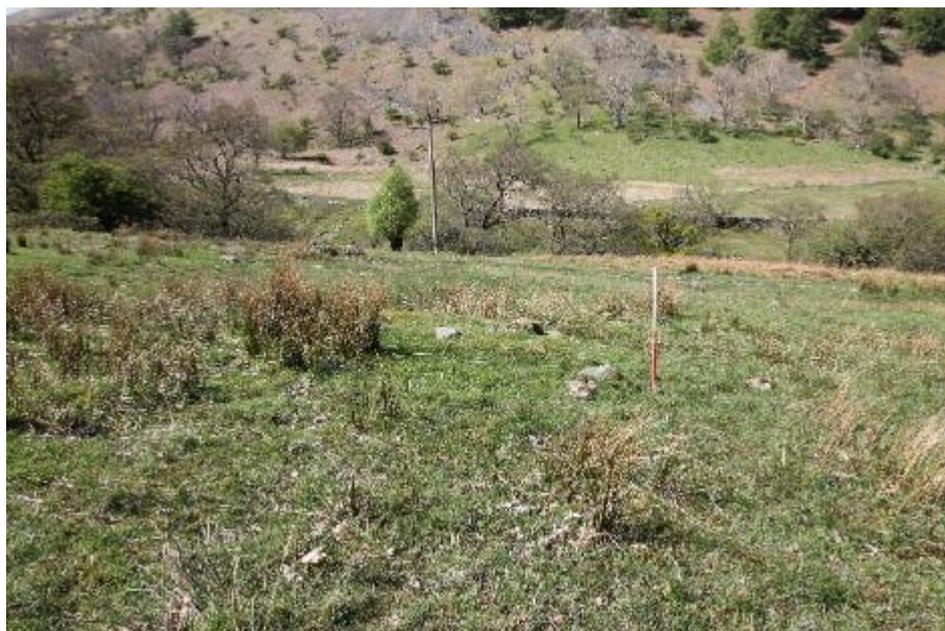
<b>Site Number</b>	27
<b>Site Name</b>	Clearance Cairn, Glencoyne Farm, Patterdale
<b>NGR</b>	NY 38085 18580
<b>NTSMR No</b>	-
<b>LDHER No</b>	-
<b>Site Type</b>	Clearance Cairn
<b>Period</b>	Unknown
<b>Sources</b>	Walkover Survey
<b>Significance</b>	Local
<b>Condition</b>	Poor
<b>Threats</b>	Vegetation
<b>Management</b>	
<b>Recommendations</b>	Regular Monitoring
<b>Photo ID</b>	IMG_0183
<b>Description</b>	A circular clearance cairn was located north-east of Seldom Seen Cottages (Site 65), measuring approximately 3.5 x 3.5m, with a height of 0.25m. It is in close proximity to other cairns (Sites 28 and 29).

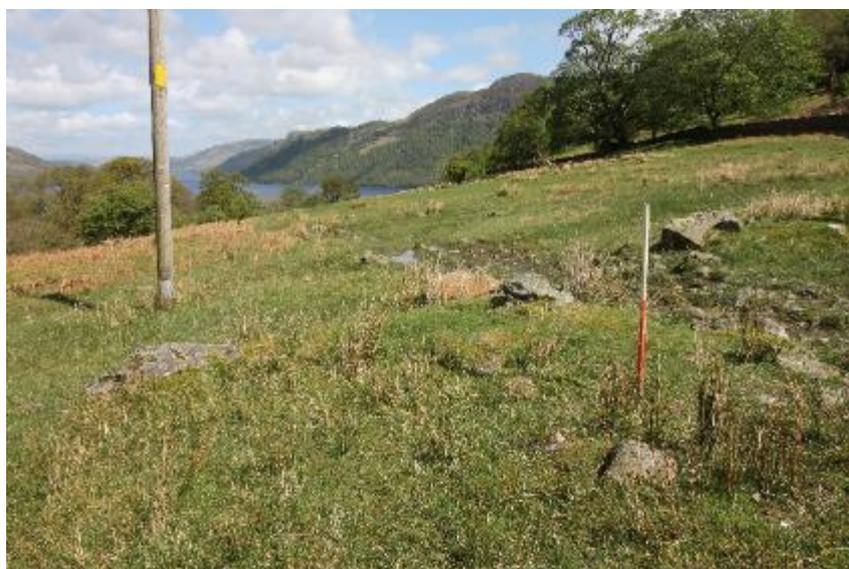
<b>Site Number</b>	28
<b>Site Name</b>	Clearance Cairn, Glencoyne Farm, Patterdale
<b>NGR</b>	NY 38068 18591
<b>NTSMR No</b>	-
<b>LDHER No</b>	-
<b>Site Type</b>	Clearance Cairn
<b>Period</b>	Unknown
<b>Sources</b>	Walkover Survey
<b>Significance</b>	Local
<b>Condition</b>	Poor
<b>Threats</b>	Vegetation, footpath/vehicle erosion
<b>Management</b>	
<b>Recommendations</b>	Regular Monitoring
<b>Photo ID</b>	IMG_0187
<b>Description</b>	A circular clearance cairn was located north-east of Seldom Seen Cottages (Site 65), measuring approximately 3.5 x 3.5m and standing to a height of 0.25m. It is possibly the same as Site 29 but is cut through by a footpath/trackway.

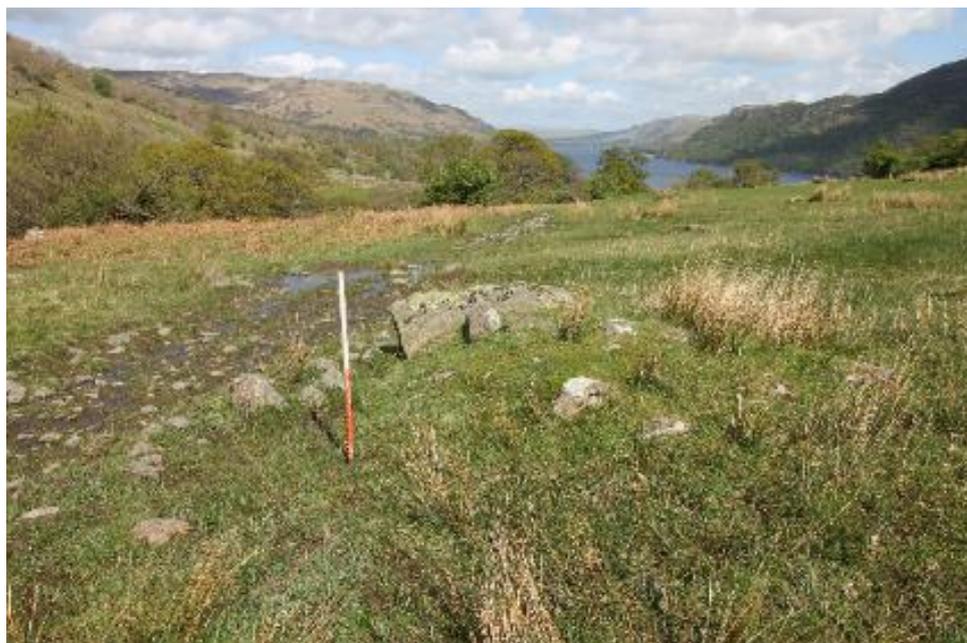
<b>Site Number</b>	29
<b>Site Name</b>	Clearance Cairn, Glencoyne Farm, Patterdale
<b>NGR</b>	NY 38068 18591
<b>NTSMR No</b>	-
<b>LDHER No</b>	-
<b>Site Type</b>	Clearance Cairn
<b>Period</b>	Unknown
<b>Sources</b>	Walkover Survey
<b>Significance</b>	Local
<b>Condition</b>	Poor
<b>Threats</b>	Vegetation, footpath/vehicle erosion
<b>Management</b>	
<b>Recommendations</b>	Regular Monitoring
<b>Photo ID</b>	IMG_0185
<b>Description</b>	A circular clearance cairn was located north-east of Seldom Seen Cottages (Site 65), measuring approximately 3.5 x 3.5m and 0.25m high. A footpath/trackway passes immediately to the north and other cairns (Sites 27 and 28) lie in close proximity.
