# Glencoyne Farm, Ullswater, Cumbria

## Historic Landscape Survey

**Document Type:** Historic Landscape Survey

**Client Name:** The National Trust

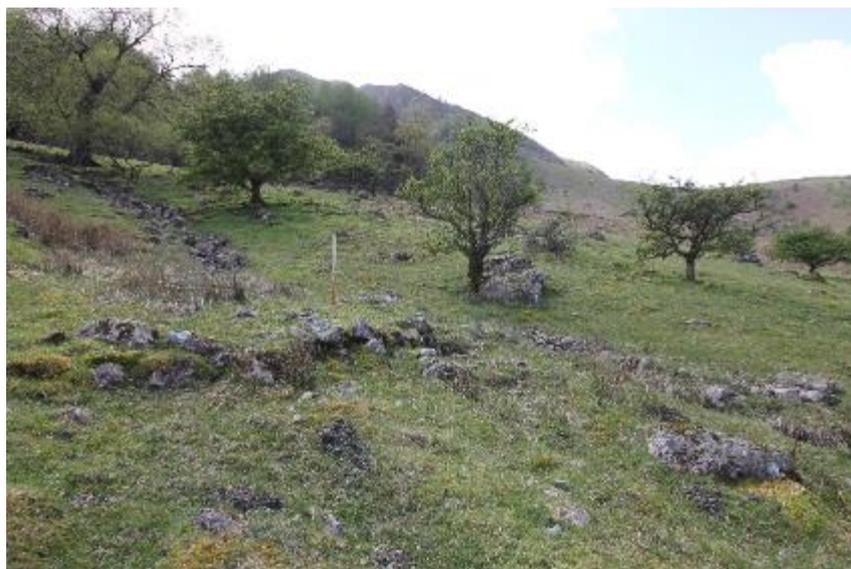
<b>Site Number</b>	30
<b>Site Name</b>	Charcoal-burning Platform, Glencoyne Farm, Patterdale
<b>NGR</b>	NY 37843 18426
<b>NTSMR No</b>	28419
<b>LDHER No</b>	39678
<b>Site Type</b>	Charcoal-burning Platform
<b>Period</b>	Post-medieval
<b>Sources</b>	NTSMR
<b>Significance</b>	Local
<b>Condition</b>	Moderate
<b>Threats</b>	Vegetation
<b>Management</b>	
<b>Recommendations</b>	Regular Monitoring
<b>Photo ID</b>	IMG_0192
<b>Description</b>	An oval charcoal-burning platform, measuring 8 x 6m, was located next to a small stream. It is slightly cut into the slope on the south side to a depth of 0.5m and is built up on the north side, with a man-made revetment of stones, to a height of approximately 0.5m on the downward slope.

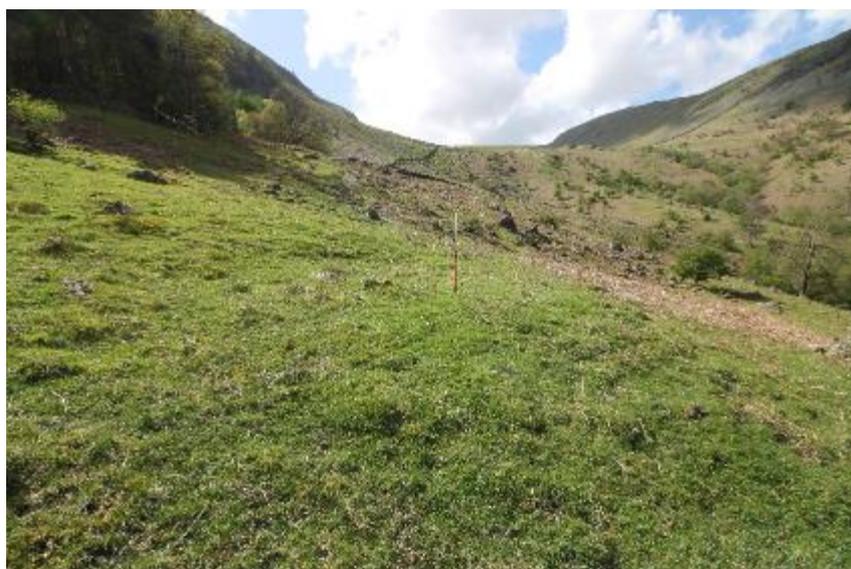
<b>Site Number</b>	32
<b>Site Name</b>	Pair of Smoots/ Hogg Holes, Glencoyne Farm, Patterdale
<b>NGR</b>	NY 37777 18377
<b>NTSMR No</b>	-
<b>LDHER No</b>	-
<b>Site Type</b>	Smoot
<b>Period</b>	Post-medieval
<b>Sources</b>	Walkover Survey
<b>Significance</b>	Local
<b>Condition</b>	Good
<b>Threats</b>	Vegetation
<b>Management</b>	
<b>Recommendations</b>	Regular Monitoring
<b>Photo ID</b>	IMG_0199
<b>Description</b>	Two adjacent stone-built smoots are incorporated into the southern boundary wall (Site 70). They are each approximately 0.5 x 0.5m, and blocked on the southern side, being found to the south of Site 31.

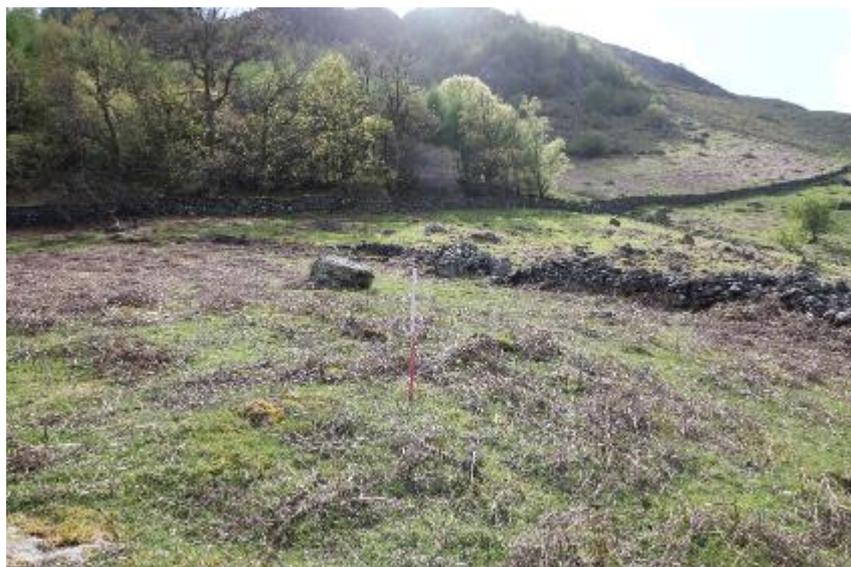
<b>Site Number</b>	33
<b>Site Name</b>	Enclosure/Settlement, Glencoyne Farm, Patterdale
<b>NGR</b>	NY 37690 18420 (centred)
<b>NTSMR No</b>	28405
<b>LDHER No</b>	39664
<b>Site Type</b>	Enclosure
<b>Period</b>	Unknown
<b>Sources</b>	NTSMR; Walkover Survey; OS 1863
<b>Significance</b>	Moderate
<b>Condition</b>	Poor
<b>Threats</b>	Vegetation, footpath erosion
<b>Management</b>	
<b>Recommendations</b>	Regular Monitoring
<b>Photo ID</b>	IMG_0212, 0214, 0215
<b>Description</b>	Fragmentary curvilinear stone walls form a roughly circular enclosure surrounding an area of raised ground measuring 1.1ha. The walls were constructed in drystone and survive to a maximum height of 1.3m. No structures were encountered internally, but the area appears to have been purposefully cleared of stones. A footpath/trackway runs through the southern end of the enclosure. It could be an Iron Age/Romano-British settlement enclosure, as it is of comparable dimensions and height AOD to excavated/surveyed examples in Glencoyne Park (Loney and Hoan 2000; Hoan and Loney 2003). Alternatively, it could be a corral associated

with the nearby shieling (Site 39). It is shown on the first edition OS map (1863) as a sheep shelter.

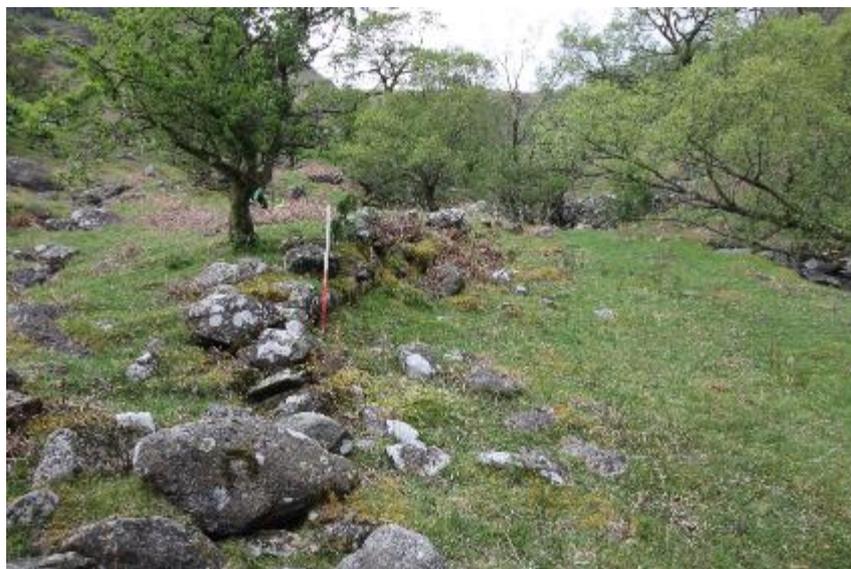
<b>Site Number</b>	34
<b>Site Name</b>	Revetment Wall, Glencoyne Farm, Patterdale
<b>NGR</b>	NY 37909 18624 - 37931 18622
<b>NTSMR No</b>	-
<b>LDHER No</b>	-
<b>Site Type</b>	Relict Boundary Wall
<b>Period</b>	Unknown
<b>Sources</b>	NTSMR: Walkover Survey
<b>Significance</b>	Local
<b>Condition</b>	Poor
<b>Threats</b>	Vegetation
<b>Management</b>	
<b>Recommendations</b>	Regular Monitoring
<b>Photo ID</b>	IMG_0218
<b>Description</b>	A possible revetment wall, 0.5m high, 21m long and 1.2m wide, was located on the low ground to the south of Glencoyne Beck, with the revetment to the north. Large field boulders/stones have been used as revetment material.

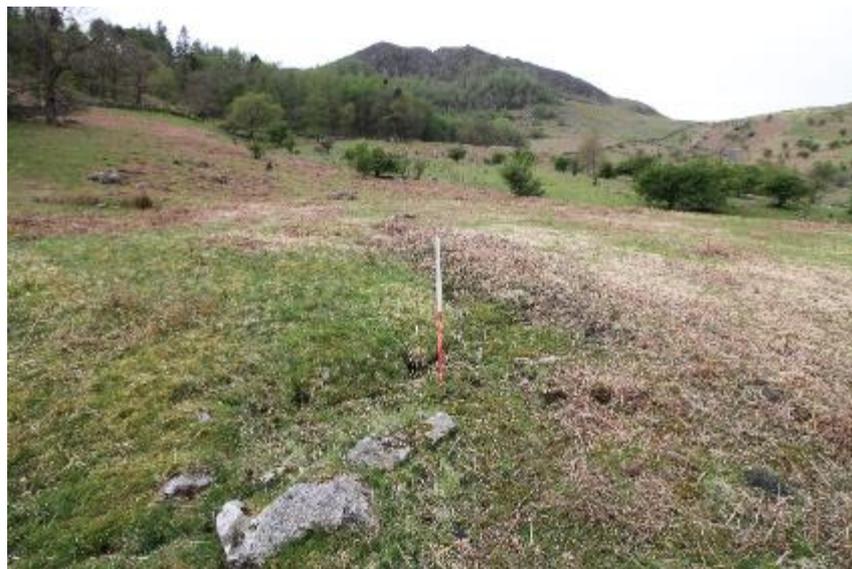
<b>Site Number</b>	35
<b>Site Name</b>	Earthwork, Glencoyne Farm, Patterdale
<b>NGR</b>	NY 37904 18509
<b>NTSMR No</b>	-
<b>LDHER No</b>	-
<b>Site Type</b>	Earthwork
<b>Period</b>	Pre-1860s
<b>Sources</b>	Walkover Survey
<b>Significance</b>	Moderate
<b>Condition</b>	Poor
<b>Threats</b>	Vegetation, footfall
<b>Management</b>	
<b>Recommendations</b>	Regular Monitoring
<b>Photo ID</b>	IMG_0228; IMG_0235
<b>Description</b>	An earthwork is visible to the west of Seldom Seen Cottages (Site 65). It is linear, aligned north-east/south-west, and measures approximately 30 x 2 x 0.25m, with a second linear earthwork extending from the first in a north-west direction, measuring approximately 15 x 2 x 0.25m. The feature appears to have a three-way subdivision, with two raised platforms in the south-western angle, the largest measuring approximately 10 x 7.5 x 0.5m, and the smaller 3.5 x 2.5 x 0.5m. A shallow gully is visible around the north-western corner of the larger mound. A trackway/footpath passes close to the southern edge of the feature. The platforms could represent buildings; if so, this site may be the remains of a former tenement, possibly superseded by Seldom Seen Cottages (Site 65).

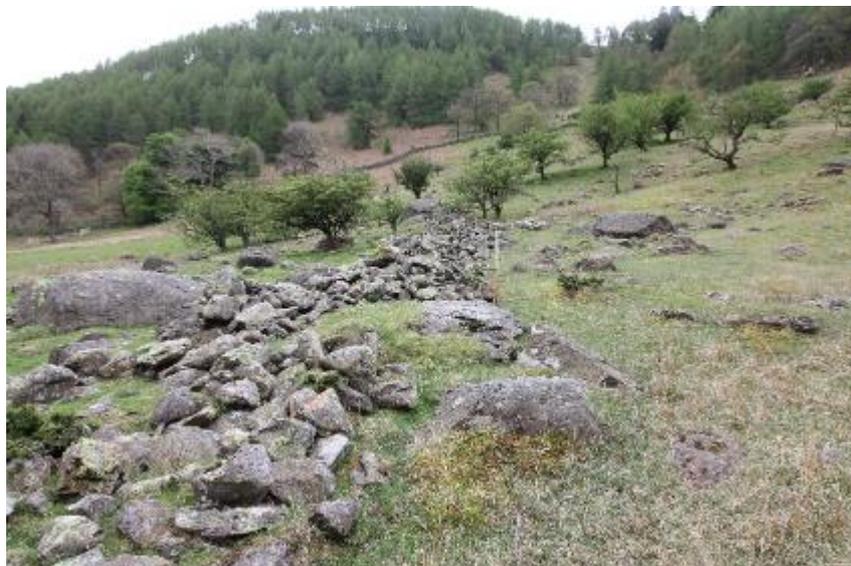
<b>Site Number</b>	36
<b>Site Name</b>	Relict Field Boundary, Glencoyne Farm, Patterdale
<b>NGR</b>	NY 37779 18617 - 37814 18530
<b>NTSMR No</b>	-
<b>LDHER No</b>	-
<b>Site Type</b>	Relict Field Boundary
<b>Period</b>	Pre-1860s
<b>Sources</b>	Walkover Survey
<b>Significance</b>	District
<b>Condition</b>	Poor
<b>Threats</b>	Vegetation
<b>Management</b>	
<b>Recommendations</b>	Regular Monitoring
<b>Photo ID</b>	IMG_0239; IMG_0242
<b>Description</b>	The remnants of a field boundary wall crosses the survey area from north to south for a length of 90m. The feature survives best at the northern end, close to Glencoyne Beck, with a height

of 1.5m and width of 0.75m at the base, where it forms a dog-leg before continuing to the river's edge. The remainder of the wall is in poor condition and of variable width and height. At the southern end, it branches off to the south-east, where it appears to join with the earthwork element of Site 35. It is not illustrated on historical mapping. The feature could be a former ring-garth wall, as it seems to mark the former extent of enclosed land in the valley, superseded by walls forming a later intake (Site 71) and the present head-dyke (Site 69).

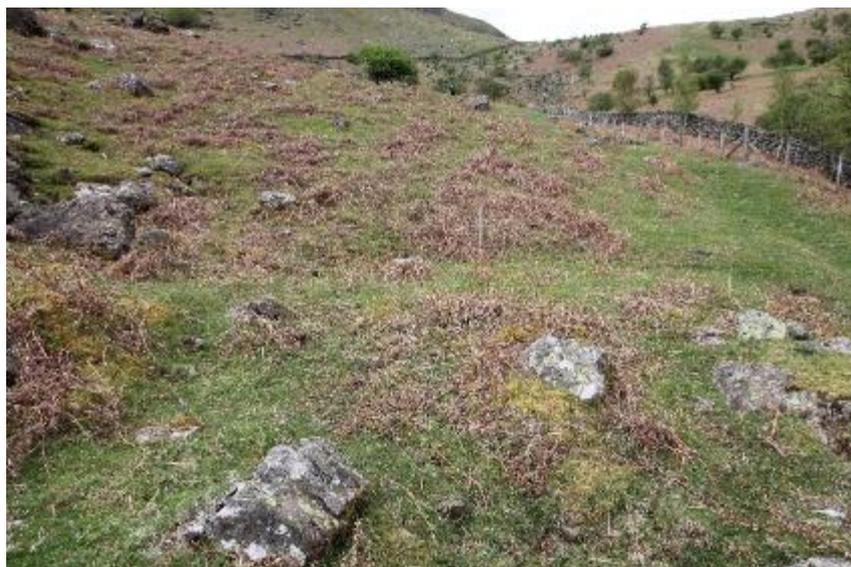
<b>Site Number</b>	37
<b>Site Name</b>	Charcoal-burning Platform, Glencoyne Farm, Patterdale
<b>NGR</b>	NY 37677 18539
<b>NTSMR No</b>	28414
<b>LDHER No</b>	39673
<b>Site Type</b>	Charcoal-burning Platform
<b>Period</b>	Post-medieval
<b>Sources</b>	NTSMR; Walkover Survey
<b>Significance</b>	District
<b>Condition</b>	Moderate
<b>Threats</b>	Vegetation
<b>Management</b>	
<b>Recommendations</b>	Regular Monitoring
<b>Photo ID</b>	IMG_0246
<b>Description</b>	An oval charcoal-burning platform, 7 x 5 x 0.5m, has been cut into the slope on the south-west side to create a platform. There was no visible sign of a formal stone revetment on the north-eastern slope.

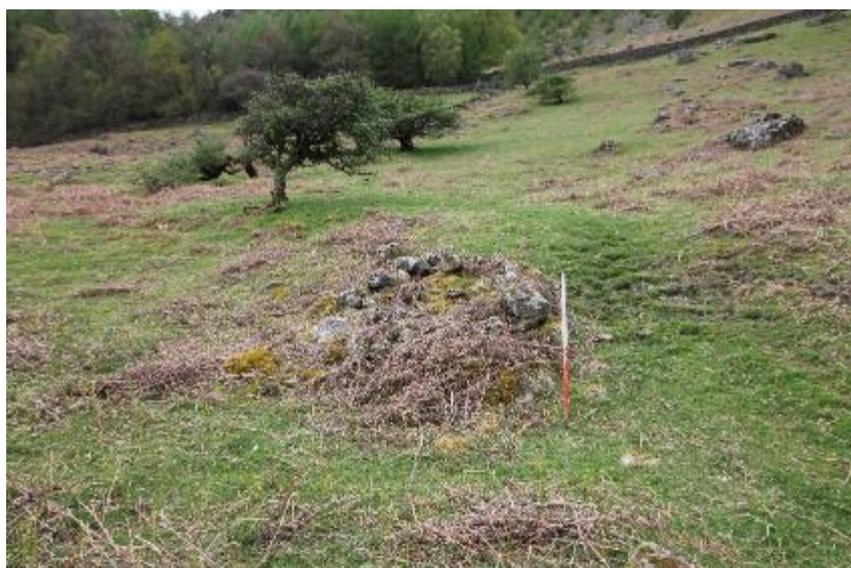
<b>Site Number</b>	38
<b>Site Name</b>	Clearance Cairn, Glencoyne Farm, Patterdale
<b>NGR</b>	NY 37616 18504
<b>NTSMR No</b>	-
<b>LDHER No</b>	39663
<b>Site Type</b>	Clearance Cairn
<b>Period</b>	Unknown
<b>Sources</b>	Walkover Survey
<b>Significance</b>	Local
<b>Condition</b>	Poor
<b>Threats</b>	Vegetation
<b>Management</b>	
<b>Recommendations</b>	Regular Monitoring
<b>Photo ID</b>	IMG_0248
<b>Description</b>	A circular clearance cairn, measuring approximately 3.5 x 3.5m, with a height of 0.50m, was located within an area of rough pasture to the north-west of the enclosure (Site 33) and in close proximity to several other cairns (eg Sites 42, 43, 44, 45).

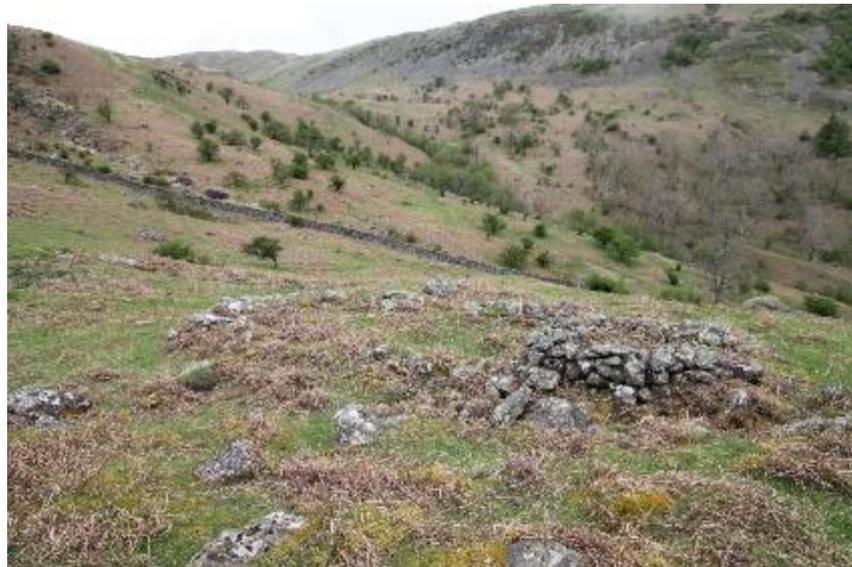
<b>Site Number</b>	40
<b>Site Name</b>	Relict Field Boundary, Glencoyne Farm, Patterdale
<b>NGR</b>	NY 37657 18511 - 37672 18486
<b>NTSMR No</b>	-
<b>LDHER No</b>	-
<b>Site Type</b>	Relict Field Boundary
<b>Period</b>	Unknown
<b>Sources</b>	Walkover Survey
<b>Significance</b>	Local
<b>Condition</b>	Poor
<b>Threats</b>	Vegetation
<b>Management</b>	
<b>Recommendations</b>	Regular monitoring
<b>Photo ID</b>	IMG_0257
<b>Description</b>	The possible remains of a relict field system were located a short distance downslope of the shieling (Site 39), on a north-west/south-east alignment. The wall measures 30 x 1.5m and survives to a maximum height of 0.75m. A group of clearance cairns is close by (Sites 42, 43, 44, 45).

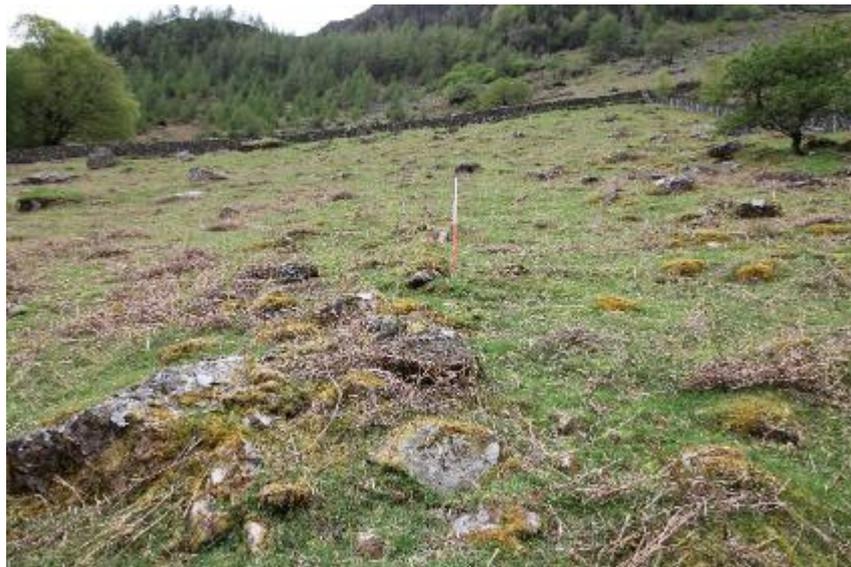
<b>Site Number</b>	41
<b>Site Name</b>	Relict Field Boundary, Glencoyne Farm, Patterdale
<b>NGR</b>	NY 37549 18482
<b>NTSMR No</b>	28402
<b>LDHER No</b>	39661
<b>Site Type</b>	Relict Field Boundary
<b>Period</b>	Unknown
<b>Sources</b>	Walkover Survey; Aerial Survey
<b>Significance</b>	Local
<b>Condition</b>	Poor
<b>Damage Agents</b>	Vegetation
<b>Management</b>	
<b>Recommendations</b>	Regular monitoring
<b>Photo ID</b>	IMG_0260 and aerial survey
<b>Description</b>	The possible remains of a relict field system were located north-west of the enclosure (Site 33), on a north-east/south-west alignment. The wall is visible as an earthwork, 9m long, 1m wide and 0.25m high, but is clearly constructed at least partially of field stone. The drone survey revealed the feature to be far more extensive, continuing a further 27m to the north-east and turning at its southern end in a south-easterly direction for a further 52m. A group of clearance cairns is close by (Sites 42, 43, 44, 45).

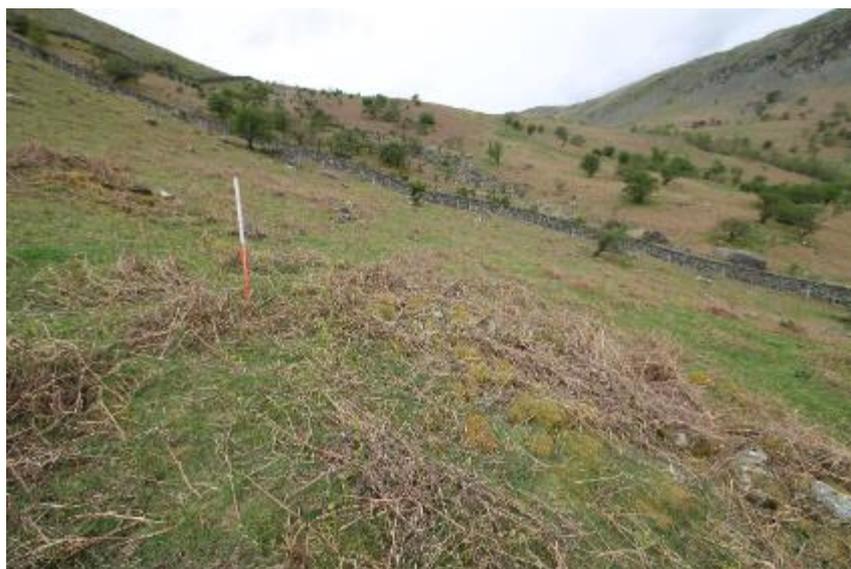
<b>Site Number</b>	42
<b>Site Name</b>	Clearance Cairn, Glencoyne Farm, Patterdale
<b>NGR</b>	NY 37578 18475
<b>NTSMR No</b>	-
<b>LDHER No</b>	39663
<b>Site Type</b>	Clearance Cairn
<b>Period</b>	Unknown
<b>Sources</b>	Walkover Survey
<b>Significance</b>	Local
<b>Condition</b>	Poor
<b>Threats</b>	Vegetation
<b>Management</b>	
<b>Recommendations</b>	Regular monitoring
<b>Photo ID</b>	IMG_0265
<b>Description</b>	An oval clearance cairn measures approximately 5.5 x 4 x 0.5m. It is one of several clearance cairns (eg Sites 43, 44, 45) located to the west of Site 33, and was constructed by piling stone to clear land for improved grazing.

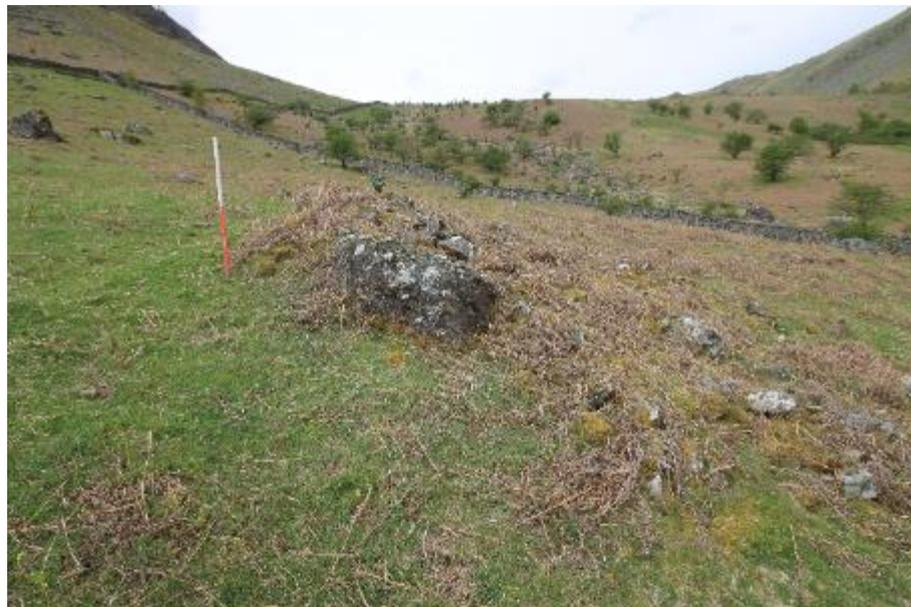
<b>Site Number</b>	43
<b>Site Name</b>	Clearance Cairn, Glencoyne Farm, Patterdale
<b>NGR</b>	NY 37597 18479
<b>NTSMR No</b>	28404
<b>LDHER No</b>	39663
<b>Site Type</b>	Clearance Cairn
<b>Period</b>	Unknown
<b>Sources</b>	Walkover Survey
<b>Significance</b>	Local
<b>Condition</b>	Moderate
<b>Threats</b>	Vegetation
<b>Management</b>	
<b>Recommendations</b>	Regular monitoring
<b>Photo ID</b>	IMG_0269
<b>Description</b>	A circular clearance cairn measures approximately 6 x 6m and 0.5m in height. It is one of several clearance cairns (eg Sites 42, 44, 45) located to the west of Site 33. This one was constructed by piling stone against an earthfast boulder.

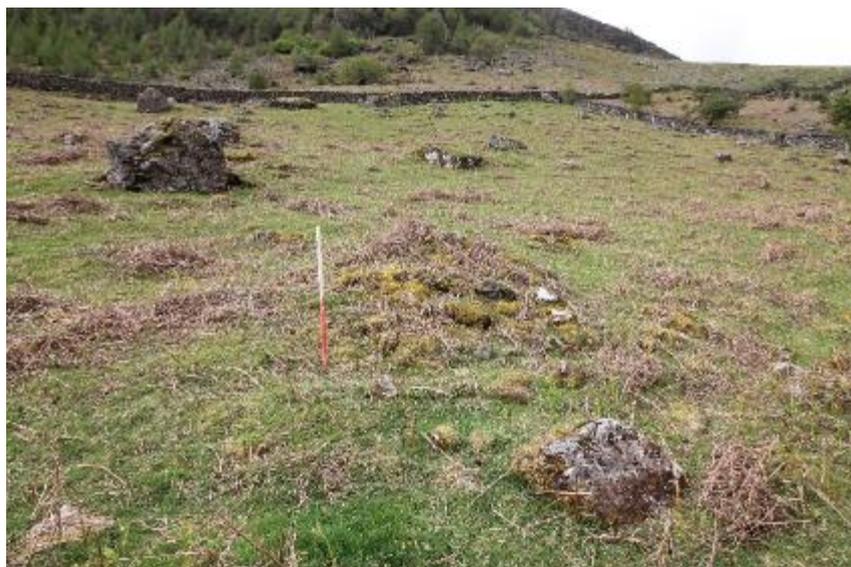
<b>Site Number</b>	44
<b>Site Name</b>	Clearance Cairn, Glencoyne Farm, Patterdale
<b>NGR</b>	NY 37572 18470
<b>NTSMR No</b>	28404
<b>LDHER No</b>	39663
<b>Site Type</b>	Clearance Cairn
<b>Period</b>	Unknown
<b>Sources</b>	NTSMR; Walkover Survey
<b>Significance</b>	Local
<b>Condition</b>	Moderate
<b>Threats</b>	Vegetation
<b>Management</b>	
<b>Recommendations</b>	Regular monitoring
<b>Photo ID</b>	IMG_0272
<b>Description</b>	An oval clearance cairn measures approximately 3 x 3 x 0.5m. It is one of several clearance cairns (eg Sites 42, 43, 45) located to the west of the enclosure (Site 33).

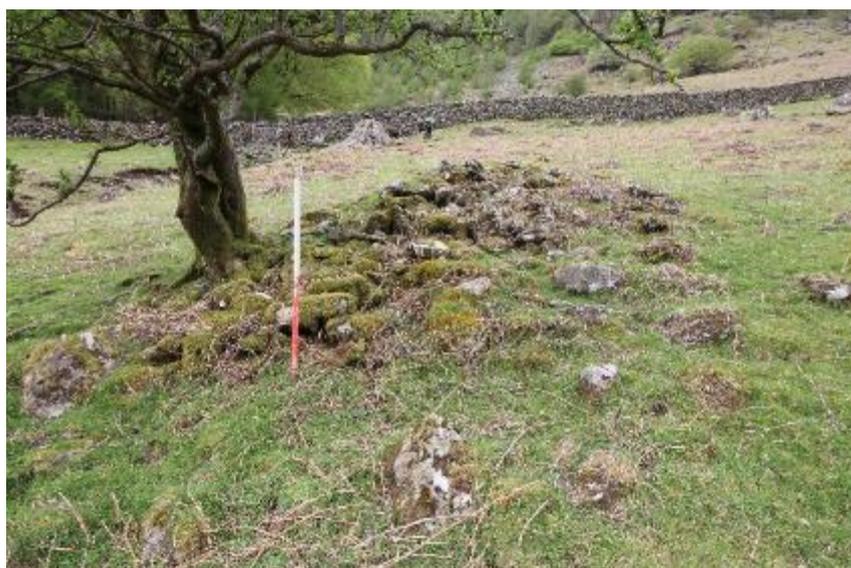
<b>Site Number</b>	45
<b>Site Name</b>	Clearance Cairn, Glencoyne Farm, Patterdale
<b>NGR</b>	NY 37582 18434
<b>NTSMR No</b>	28404
<b>LDHER No</b>	39663
<b>Site Type</b>	Clearance Cairn
<b>Period</b>	Unknown
<b>Sources</b>	Walkover Survey
<b>Significance</b>	Local
<b>Condition</b>	Moderate
<b>Threats</b>	Vegetation (tree rooting)
<b>Management</b>	
<b>Recommendations</b>	Regular monitoring
<b>Photo ID</b>	IMG_0275
<b>Description</b>	An oval clearance cairn measures approximately 8 x 5 x 0.5m. It is one of several clearance cairns (eg Sites <b>42</b> , <b>43</b> , <b>44</b> ) located to the west of the enclosure (Site <b>33</b> ), presumably to clear land for improved grazing.

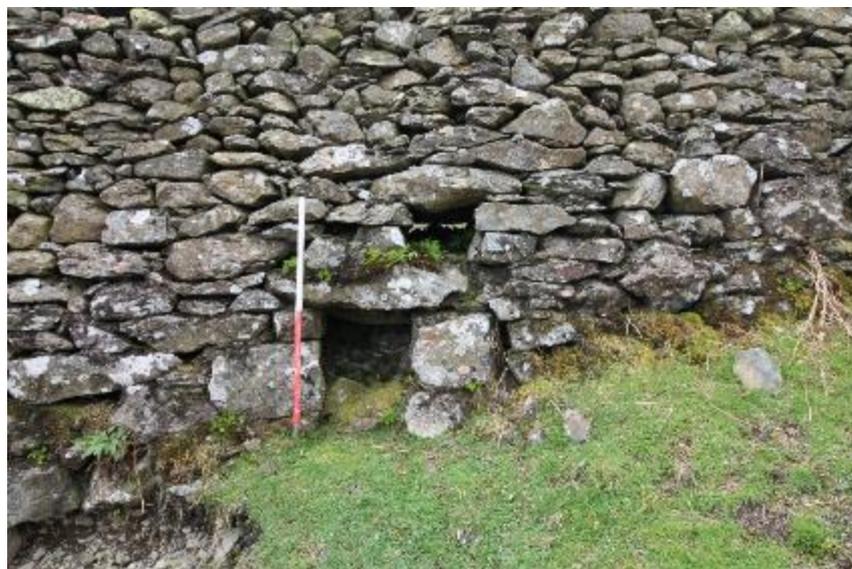
<b>Site Number</b>	46
<b>Site Name</b>	Smoot/ Hogg Hole, Glencoyne Farm, Patterdale
<b>NGR</b>	NY 37569 18401
<b>NTSMR No</b>	-
<b>LDHER No</b>	-
<b>Site Type</b>	Smoot
<b>Period</b>	Post-medieval
<b>Sources</b>	Walkover Survey
<b>Significance</b>	Local
<b>Condition</b>	Good
<b>Threats</b>	Vegetation
<b>Management</b>	
<b>Recommendations</b>	Regular monitoring
<b>Photo ID</b>	IMG_0278
<b>Description</b>	A smoot or hogg hole was located within the main southern boundary wall, to the east of Site 47. It consists of two openings, the lower measuring 0.5 x 0.5m and the upper 0.3 x 0.3m. The openings have been blocked from the southern side.

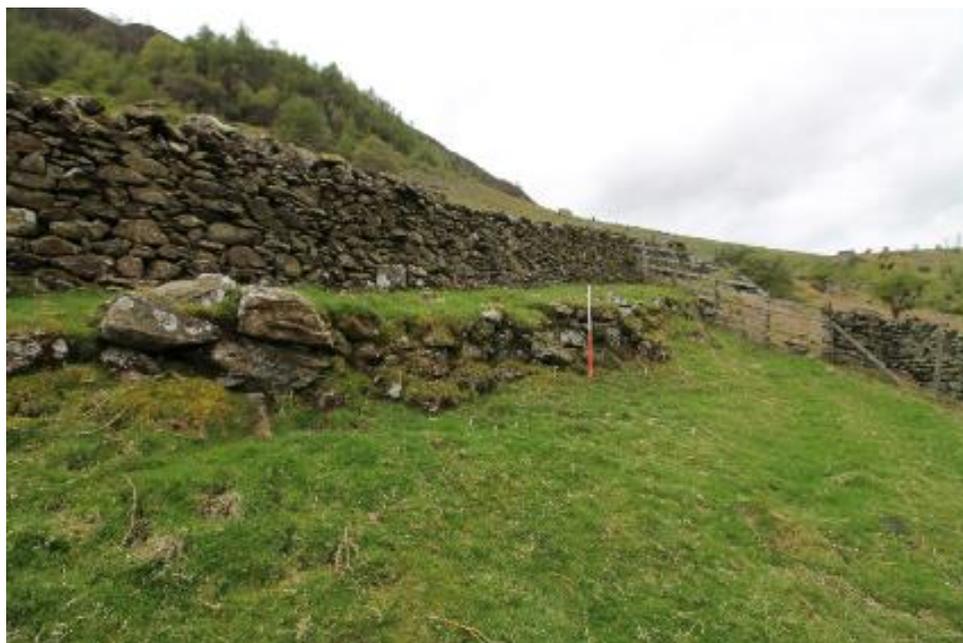
<b>Site Number</b>	47
<b>Site Name</b>	Relict Field Boundary, Glencoyne Farm, Patterdale
<b>NGR</b>	NY 37517 18427 - 37481 18439
<b>NTSMR No</b>	28646
<b>LDHER No</b>	39904
<b>Site Type</b>	Relict Field Boundary
<b>Period</b>	Unknown
<b>Sources</b>	NTSMR; Walkover Survey
<b>Significance</b>	Local
<b>Condition</b>	Moderate
<b>Threats</b>	Vegetation
<b>Management</b>	
<b>Recommendations</b>	Regular monitoring
<b>Photo ID</b>	IMG_0282
<b>Description</b>	A platform, measuring 38m in length, on a north-west/south-east alignment, steps out approximately 2.5m north of the main southern boundary wall (Site 70). A revetment wall, constructed in field stone, is visible on the downslope, standing approximately 0.75m high. The absence of a continuation to the south of the boundary suggests the feature may have been built to stabilise the foundation for the boundary wall on sloping ground. It is similar in character to Sites 15 and 16 to the east.

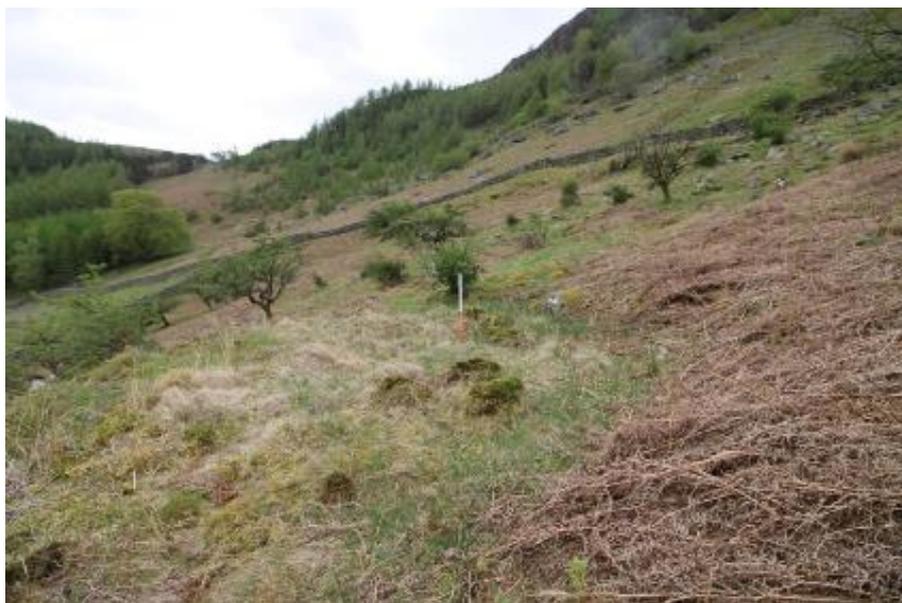
<b>Site Number</b>	48
<b>Site Name</b>	Charcoal-burning Platform, Glencoyne Farm, Patterdale
<b>NGR</b>	NY 37455 18499
<b>NTSMR No</b>	28647
<b>LDHER No</b>	39905
<b>Site Type</b>	Charcoal-burning Platform
<b>Period</b>	Post-medieval
<b>Sources</b>	NTSMR, Walkover Survey
<b>Significance</b>	District
<b>Condition</b>	Moderate
<b>Threats</b>	Vegetation
<b>Management</b>	
<b>Recommendations</b>	Regular monitoring
<b>Photo ID</b>	IMG_0287
<b>Description</b>	An oval charcoal-burning platform, 9 x 7m, is cut into the slope on the south-west side to a depth of 1.2m and built up on the north-eastern side to a height of 1m, creating a level platform in an area presently used for rough grazing. There was no visible sign of a formal stone revetment on the north-eastern slope.

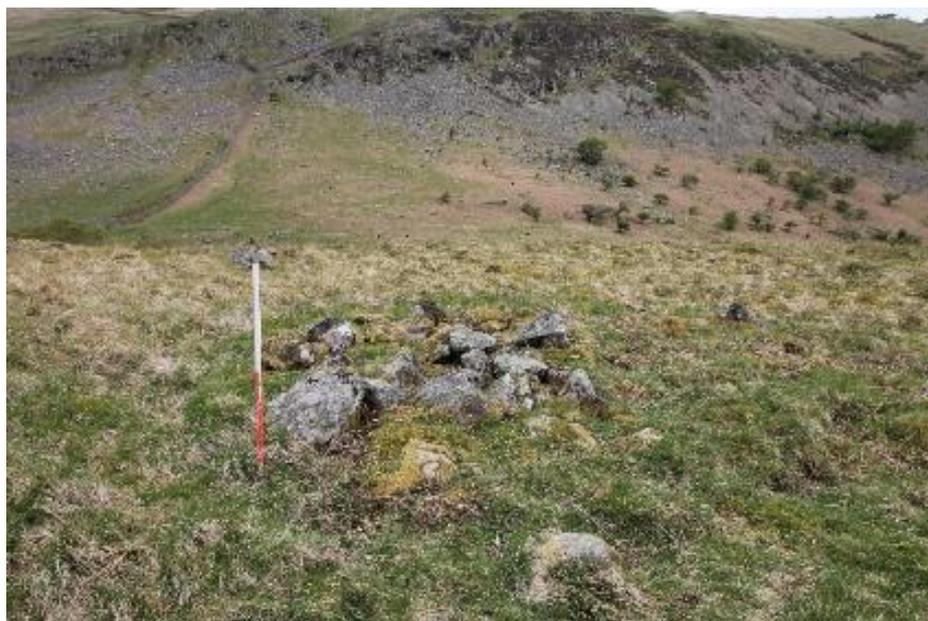
<b>Site Number</b>	49
<b>Site Name</b>	Clearance Cairn, Glencoyne Farm, Patterdale
<b>NGR</b>	NY 37327 18645
<b>NTSMR No</b>	28649
<b>LDHER No</b>	39703
<b>Site Type</b>	Clearance Cairn
<b>Period</b>	Unknown
<b>Sources</b>	NTSMR; Walkover Survey
<b>Significance</b>	Local
<b>Condition</b>	Moderate
<b>Damage Agents</b>	Vegetation
<b>Management</b>	
<b>Recommendations</b>	Regular monitoring
<b>Photo ID</b>	IMG_0292
<b>Description</b>	A small sub-circular clearance cairn, measuring 3 x 2m and surviving to a height of 0.4m, was located within an area currently in use for rough pasture. It is in close proximity to another cairn (Site 50), with which it shares its NTSMR number. A nearly identical site record exists for two cairns a short distance to the south of these (NTSMR 28445) and it is highly likely that these represent duplicates from separate surveys.

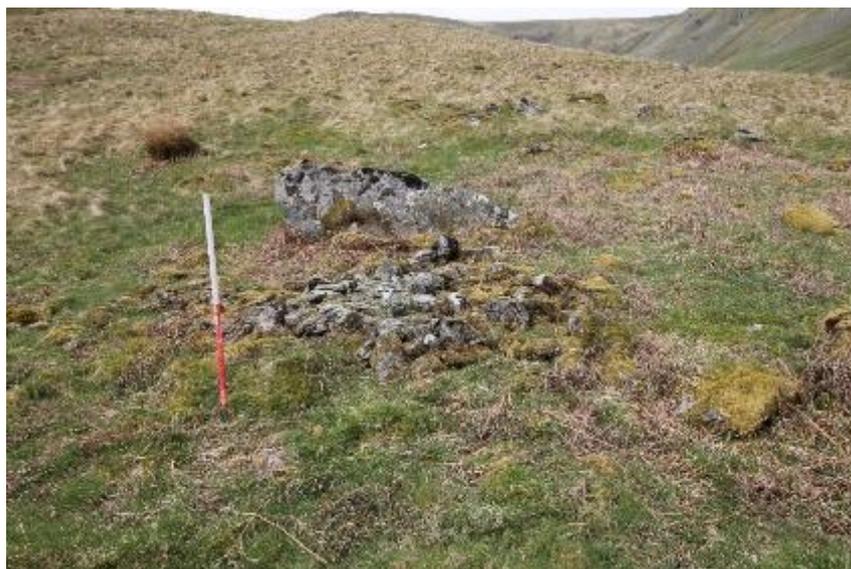
<b>Site Number</b>	50
<b>Site Name</b>	Clearance Cairn, Glencoyne Farm, Patterdale
<b>NGR</b>	NY 37313 18657
<b>NTSMR No</b>	28649
<b>LDHER No</b>	39703
<b>Site Type</b>	Clearance Cairn
<b>Period</b>	Unknown
<b>Sources</b>	NTSMR; Walkover Survey
<b>Significance</b>	Local
<b>Condition</b>	Moderate
<b>Damage Agents</b>	Vegetation
<b>Management</b>	
<b>Recommendations</b>	Regular monitoring
<b>Photo ID</b>	IMG_0293
<b>Description</b>	A small sub-circular clearance cairn, measuring 3 x 2m and surviving to a height of 0.3m, was located within an area currently in use as rough pasture. The cairn has been built beside a medium-sized boulder and is in close proximity to another cairn (Site <b>49</b> ), with which it shares an NTSMR number. A nearly identical site record exists for two cairns a short distance to the south of these (NTSMR 28445) and it is highly likely that these represent duplicates from separate surveys.

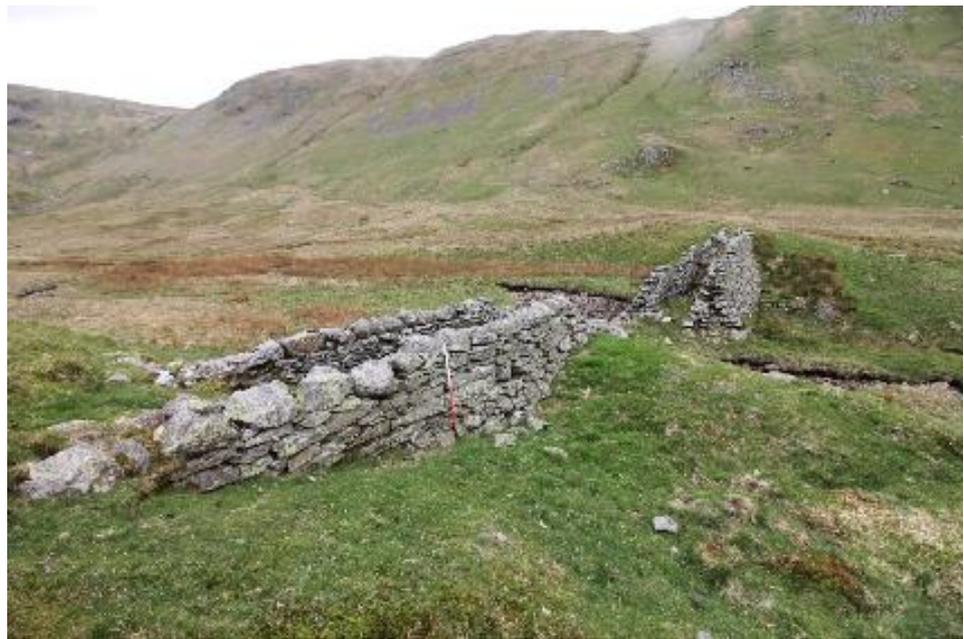
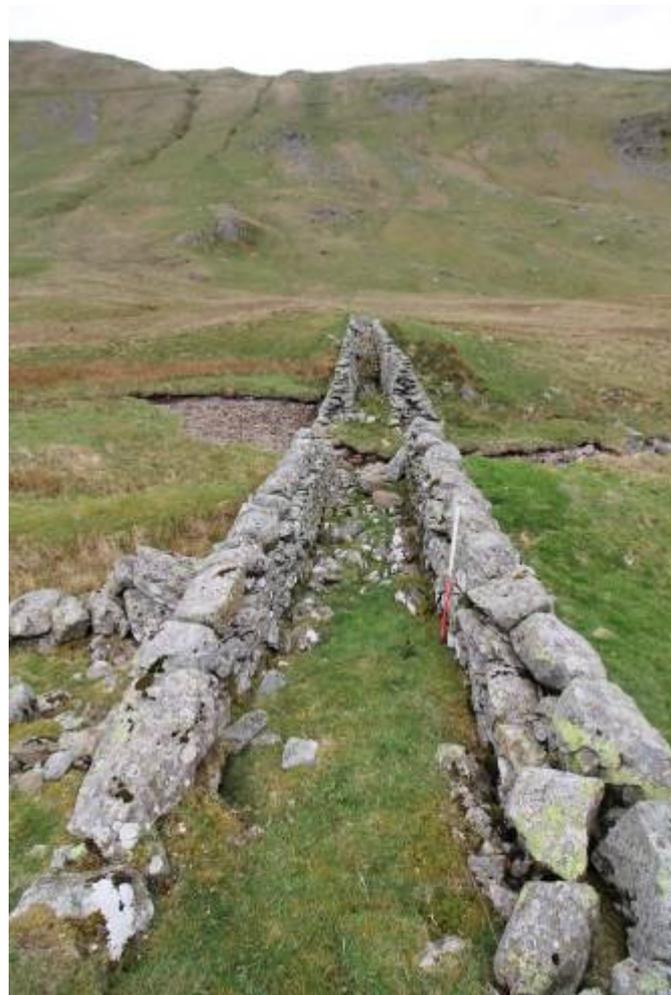
<b>Site Number</b>	51
<b>Site Name</b>	Dam, Glencoyne Farm, Patterdale
<b>NGR</b>	NY 36954 18738
<b>NTSMR No</b>	28448
<b>LDHER No</b>	-
<b>Site Type</b>	Dam
<b>Period</b>	Late Nineteenth Century
<b>Sources</b>	NTSMR; Walkover Survey
<b>Significance</b>	Local
<b>Condition</b>	Moderate
<b>Threats</b>	Flooding
<b>Management</b>	
<b>Recommendations</b>	Regular monitoring, assessment for consolidation
<b>Photo ID</b>	IMG_0296; IMG_0308
<b>Description</b>	A pair of rubble-built parallel linear walls, set 1.2m apart, extend to a length of 32m across the width of the Glencoyne Beck and stand to a maximum height of 2m. The walls have been erected with a significant batter, giving them a triangular cross-section, and a small stone-arched aperture was noted at the northern end, through which water still flowed. The centre of the structure has collapsed and to the west, a channel cut into the ground has largely silted up. The feature may have been used to wash sheep prior to the widespread introduction of sheep dipping.

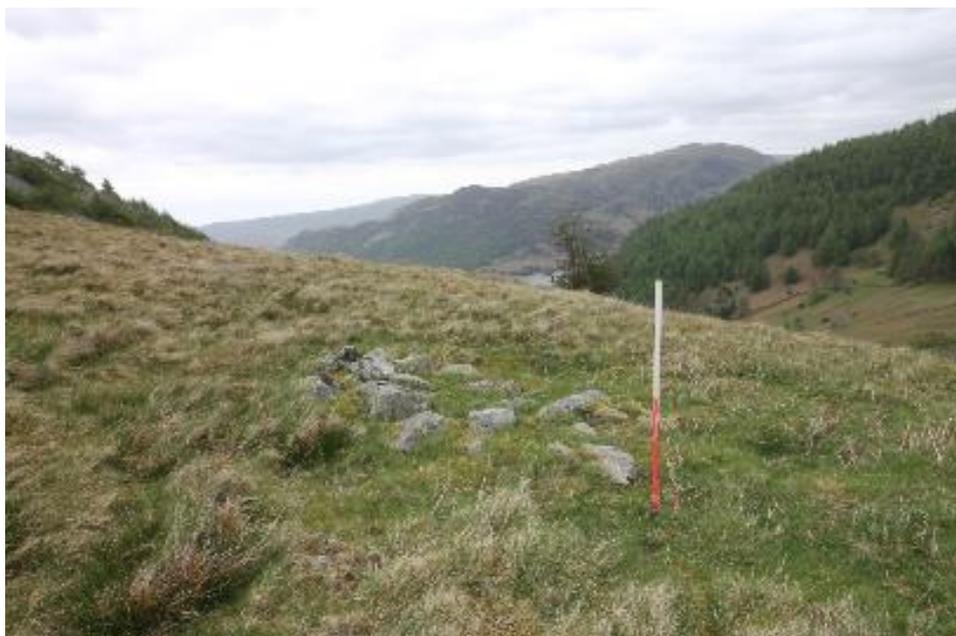
<b>Site Number</b>	55
<b>Site Name</b>	Clearance Cairn, Glencoyne Farm, Patterdale
<b>NGR</b>	NY 37323 18823
<b>NTSMR No</b>	28651
<b>LDHER No</b>	39909
<b>Site Type</b>	Clearance Carin
<b>Period</b>	Unknown
<b>Sources</b>	NTSMR; Walkover Survey
<b>Significance</b>	Local
<b>Condition</b>	Poor
<b>Threats</b>	Vegetation
<b>Management</b>	
<b>Recommendations</b>	Regular monitoring
<b>Photo ID</b>	IMG_0323
<b>Description</b>	A small clearance cairn is 3m in diameter and 0.25m in height. The site lies outside the head-dyke (Site 69) at the northern end of a boundary (Site 54) and was previously recorded as being within the survey area. However, the present survey demonstrated that it clearly lies beyond this boundary.

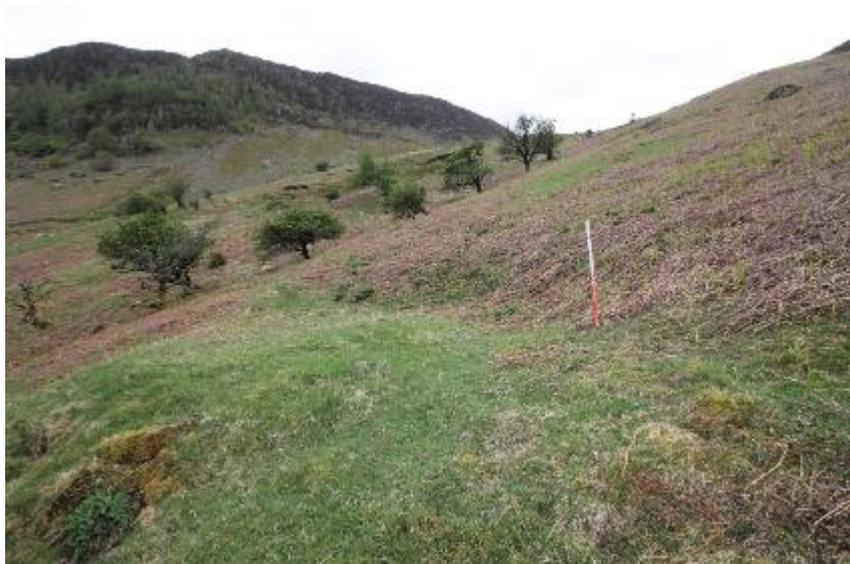
<b>Site Number</b>	56
<b>Site Name</b>	Charcoal-burning Platform, Glencoyne Farm, Patterdale
<b>NGR</b>	NY 37460 186470
<b>NTSMR No</b>	28648
<b>LDHER No</b>	39906
<b>Site Type</b>	Charcoal-burning Platform
<b>Period</b>	Post-medieval
<b>Sources</b>	NTSMR; Walkover Survey
<b>Significance</b>	District
<b>Condition</b>	Fair
<b>Threats</b>	Vegetation (root damage)
<b>Management</b>	
<b>Recommendations</b>	Regular monitoring
<b>Photo ID</b>	IMG_0325
<b>Description</b>	An oval charcoal-burning platform, 11 x 6m, is cut into the slope on the western side to a depth of 0.6m and built up on the eastern side to a height of 1m, creating a level platform. There was no visible sign of a formal stone revetment, although the area was covered in grass and a hawthorn bush was growing out of the bank, which may have obscured this.

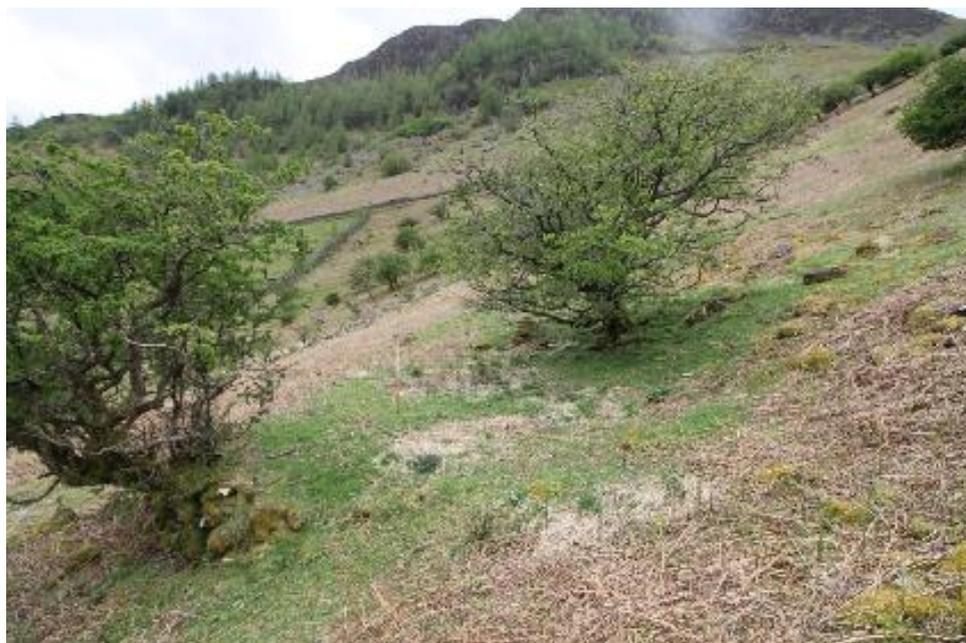
<b>Site Number</b>	57
<b>Site Name</b>	Charcoal-burning Platform, Glencoyne Farm, Patterdale
<b>NGR</b>	NY 37519 18573
<b>NTSMR No</b>	28412
<b>LDHER No</b>	39671
<b>Site Type</b>	Charcoal-burning Platform
<b>Period</b>	Post-medieval
<b>Sources</b>	NTSMR; Walkover Survey
<b>Significance</b>	District
<b>Condition</b>	Fair
<b>Threats</b>	Vegetation (tree rooting)
<b>Management</b>	
<b>Recommendations</b>	Regular monitoring
<b>Photo ID</b>	IMG_0328
<b>Description</b>	An oval charcoal-burning platform, 9 x 7m, is cut into the slope on the western side to a depth of 1m and built up on the eastern side to a height of 1m, creating a level platform. Evidence survived to the east of a stone revetment wall constructed from field stone. A pair of hawthorn bushes were growing within the feature, one of which was growing out of the retaining wall.

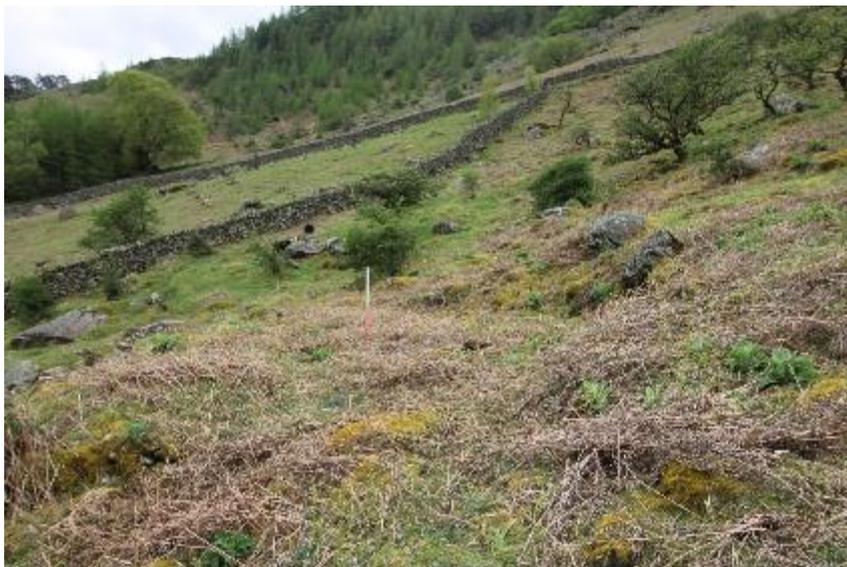
<b>Site Number</b>	58
<b>Site Name</b>	Charcoal-burning Platform, Glencoyne Farm, Patterdale
<b>NGR</b>	NY 37523 18506
<b>NTSMR No</b>	28411
<b>LDHER No</b>	39670
<b>Site Type</b>	Charcoal-burning Platform
<b>Period</b>	Post-medieval
<b>Sources</b>	NTSMR; Walkover Survey
<b>Significance</b>	District
<b>Condition</b>	Fair
<b>Threats</b>	Vegetation (tree and bracken rooting)
<b>Management</b>	
<b>Recommendations</b>	Regular monitoring
<b>Photo ID</b>	IMG_0331
<b>Description</b>	An oval charcoal-burning platform, 7 x 6m, is cut into the slope on the western side to a depth of 1m and built up on the eastern side to a height of 1m, creating a level platform. The feature was partly obscured by dead bracken, but preserved evidence, to the east, of a stone revetment wall.

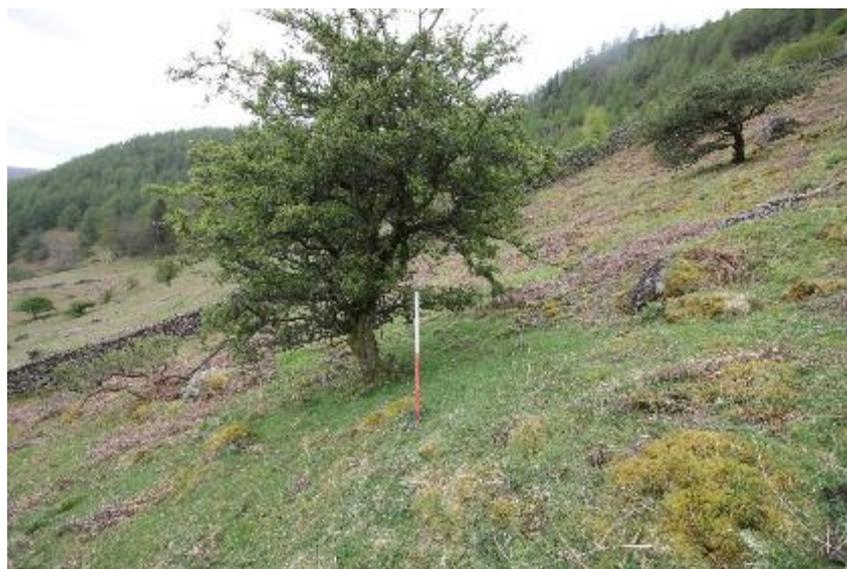
<b>Site Number</b>	60
<b>Site Name</b>	Charcoal-burning Platform, Glencoyne Farm, Patterdale
<b>NGR</b>	NY 37567 18572
<b>NTSMR No</b>	28407
<b>LDHER No</b>	39666
<b>Site Type</b>	Charcoal-burning Platform
<b>Period</b>	Post-medieval
<b>Sources</b>	NTSMR; Walkover Survey
<b>Significance</b>	District
<b>Condition</b>	Fair
<b>Threats</b>	Vegetation (bracken)
<b>Management</b>	
<b>Recommendations</b>	Regular monitoring
<b>Photo ID</b>	IMG_0334
<b>Description</b>	An oval charcoal-burning platform, 9 x 6m, is cut into the slope on the western side to a depth of 0.9m and built up on the eastern side to a height of 1m, creating a level platform. No revetment wall was observed, although the feature was partly obscured by dead bracken cover.

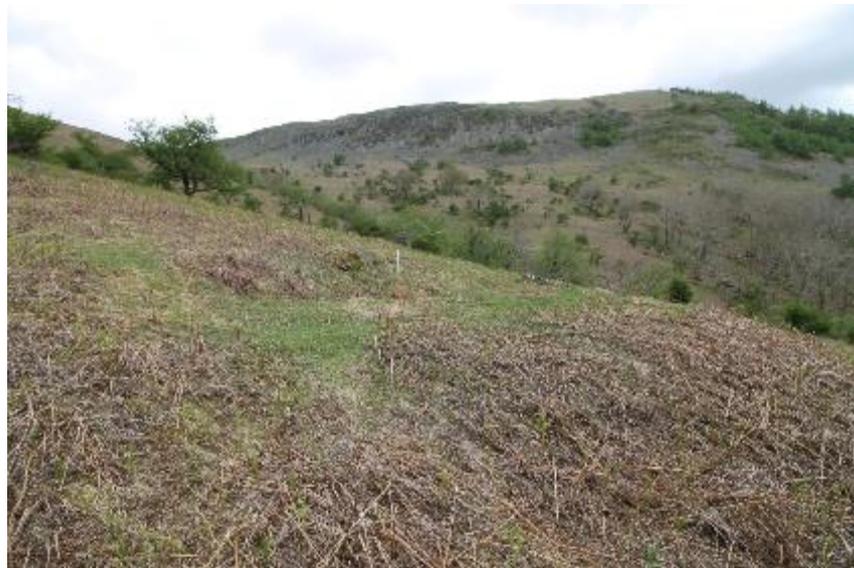
<b>Site Number</b>	61
<b>Site Name</b>	Charcoal-burning Platform, Glencoyne Farm, Patterdale
<b>NGR</b>	NY 37640 18589
<b>NTSMR No</b>	28409
<b>LDHER No</b>	39668
<b>Site Type</b>	Charcoal-burning Platform
<b>Period</b>	Post-medieval
<b>Sources</b>	NTSMR; Walkover Survey
<b>Significance</b>	District
<b>Condition</b>	Fair
<b>Threats</b>	Vegetation (bracken rooting)
<b>Management</b>	
<b>Recommendations</b>	Regular monitoring
<b>Photo ID</b>	IMG_0336
<b>Description</b>	An oval charcoal-burning platform, 9 x 7m, is cut into the slope on the western side to a depth of 0.8m and built up on the eastern side to a height of 1m, creating a level platform. No revetment wall was observed, although the feature was partly obscured by dead bracken. A hawthorn bush is growing out of the western bank.

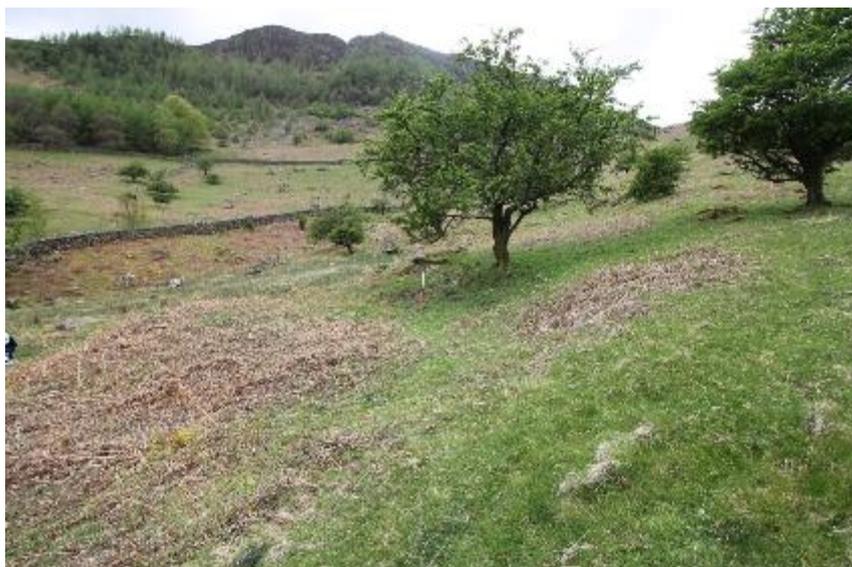
<b>Site Number</b>	62
<b>Site Name</b>	Charcoal-burning Platform, Glencoyne Farm, Patterdale
<b>NGR</b>	NY 37711 18597
<b>NTSMR No</b>	28413
<b>LDHER No</b>	39672
<b>Site Type</b>	Charcoal-burning Platform
<b>Period</b>	Post-medieval
<b>Sources</b>	NTSMR; Walkover survey
<b>Significance</b>	District
<b>Condition</b>	Fair
<b>Threats</b>	Vegetation (tree and bracken rooting)
<b>Management</b>	
<b>Recommendations</b>	Regular monitoring
<b>Photo ID</b>	IMG_0338
<b>Description</b>	A circular charcoal-burning platform, 7 x 7m, is cut into the slope on the western side to a depth of 0.5m and built up on the eastern side to a height of 0.75m, creating a level platform. Although overgrown, there appeared to be the remnants of a revetment wall to the east. The trunk of a dead tree stands within the western bank.

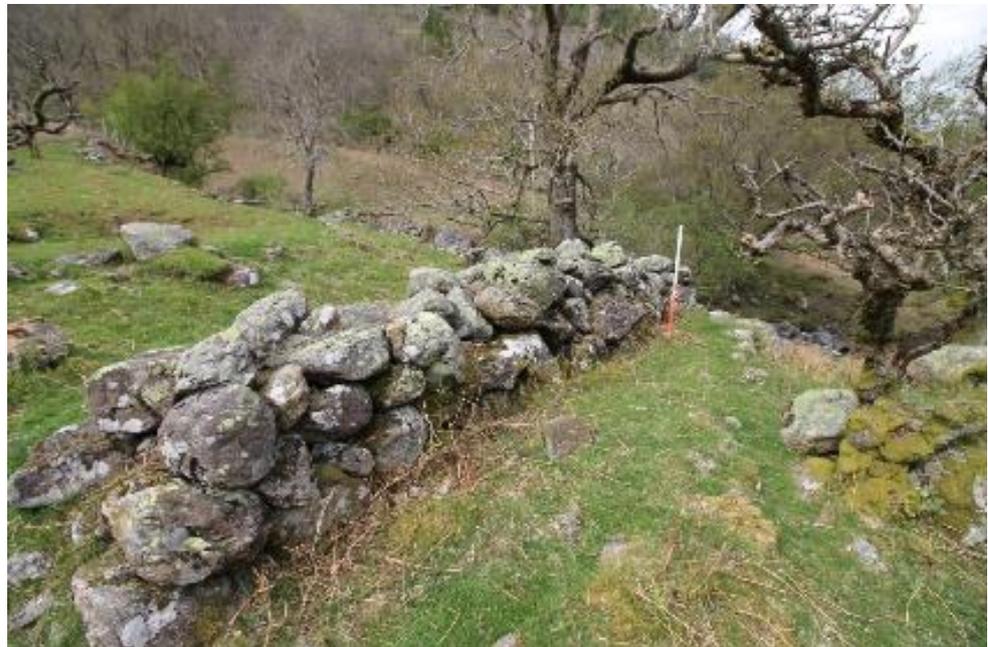
<b>Site Number</b>	63
<b>Site Name</b>	Relict Field Boundary, Glencoyne Farm, Patterdale
<b>NGR</b>	NY 37713 18594 - 37721 18603
<b>NTSMR No</b>	-
<b>LDHER No</b>	-
<b>Site Type</b>	Relict Field Boundary
<b>Period</b>	Unknown
<b>Sources</b>	Walkover Survey
<b>Significance</b>	Local
<b>Condition</b>	Poor
<b>Threats</b>	Vegetation
<b>Management</b>	
<b>Recommendations</b>	Regular monitoring
<b>Photo ID</b>	IMG_0340
<b>Description</b>	A fragment of a north/south-aligned boundary wall, close to Glencoyne Beck, probably originally related to the extant boundary wall to the south, which crosses the width of the survey area (Site 71). It survives to a height of 0.75m, with a width of 1m and extends for a length of 12m to the edge of the beck.

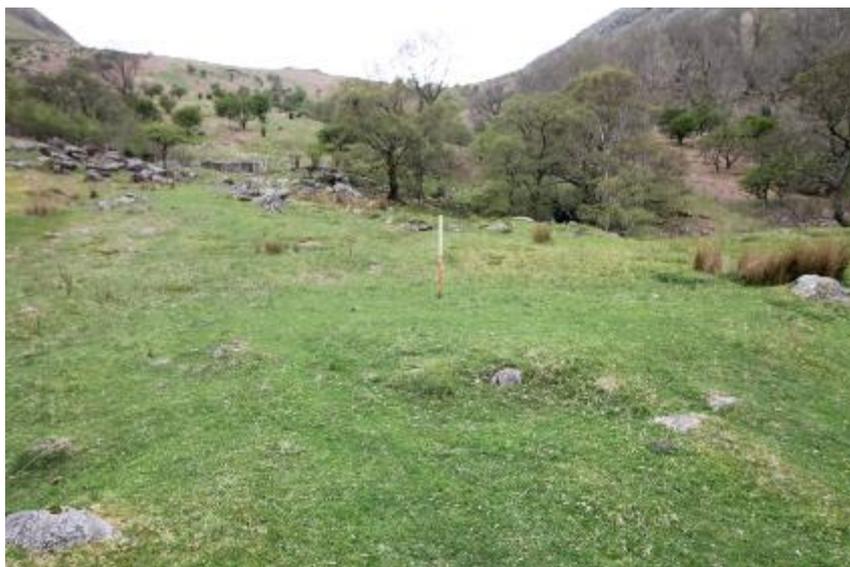
<b>Site Number</b>	64
<b>Site Name</b>	Charcoal-burning Platform, Glencoyne Farm, Patterdale
<b>NGR</b>	NY 37770 18590
<b>NTSMR No</b>	-
<b>LDHER No</b>	-
<b>Site Type</b>	Charcoal-burning Platform
<b>Period</b>	Post-medieval
<b>Sources</b>	Walkover Survey
<b>Significance</b>	District
<b>Condition</b>	Fair
<b>Threats</b>	Vegetation
<b>Management</b>	
<b>Recommendations</b>	Regular monitoring
<b>Photo ID</b>	IMG_0342
<b>Description</b>	An oval charcoal-burning platform, 6 x 7m, is cut into the slope slightly, on the western side, to a depth of 0.25m and built up on the eastern side to a height of about the same, creating a level platform in an area presently used for rough grazing.
