# Glencoyne Farm, Ullswater, Cumbria

## Historic Landscape Survey

**Document Type:** Historic Landscape Survey

**Client Name:** The National Trust

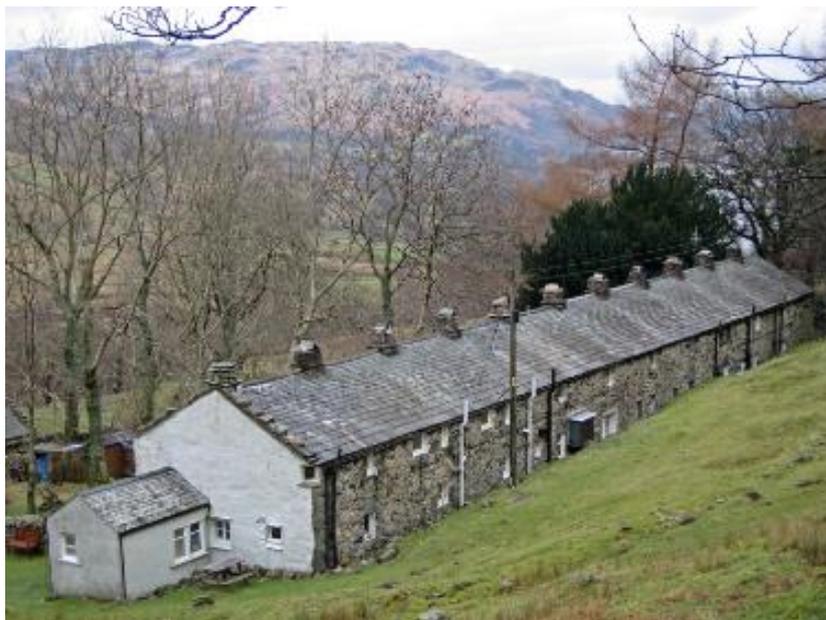
<b>Site Number</b>	65
<b>Site Name</b>	Seldom Seen Cottages, Glencoyne Farm, Patterdale
<b>NGR</b>	NY 37987 18509
<b>NTSMR No</b>	-
<b>LDHER No</b>	-
<b>Site Type</b>	Domestic Housing
<b>Period</b>	Nineteenth Century
<b>Sources</b>	Walkover Survey; OS 1863; OS 1899
<b>Significance</b>	District
<b>Condition</b>	Good
<b>Threats</b>	None observed
<b>Management</b>	
<b>Recommendations</b>	Regular monitoring
<b>Photo ID</b>	IMG_0345
<b>Description</b>	A row of two storey stone-built workers' cottages is first marked on the first edition OS (1863), which are likely to have previously been associated with the lead mine at Greenside. Land at Glencoyne was owned by the Howard family, who also had an interest in the mine, 3km to the west. The cottages are not under the ownership of the National Trust, but the buildings fall within the survey area.

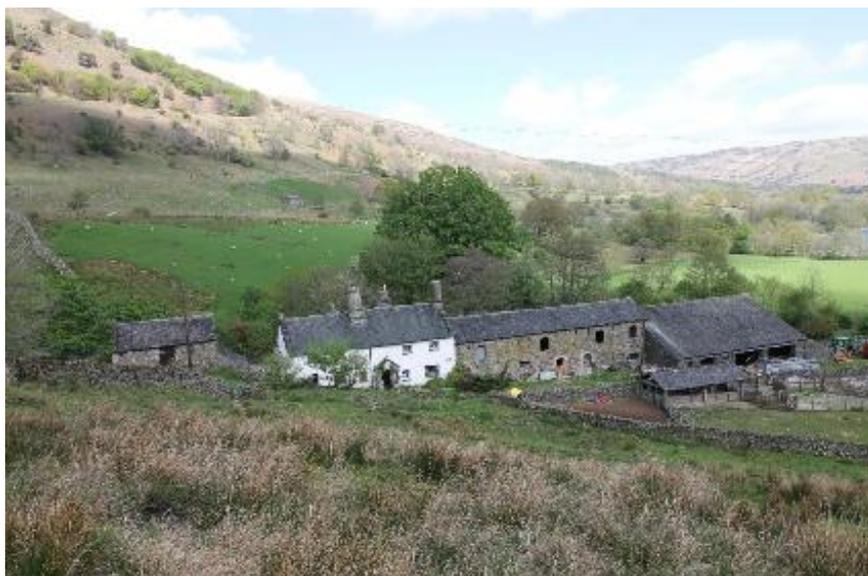
<b>Site Number</b>	66
<b>Site Name</b>	Glencoyne Farmstead, Glencoyne Farm, Patterdale
<b>NGR</b>	NY 38439 18691
<b>NTSMR No</b>	20235 (overall number)
<b>LDHER No</b>	33651, 37895, 37897, 37898, 37899, 37900, 37906
<b>Site Type</b>	Farmstead
<b>Period</b>	Post-medieval - Present
<b>Sources</b>	NTSMR; Walkover Survey
<b>Significance</b>	National (Grade II* listed; NHLE 1245329)
<b>Condition</b>	Good
<b>Threats</b>	None observed
<b>Management</b>	
<b>Recommendations</b>	Regular Monitoring
<b>Photo ID</b>	IMG_0151
<b>Description</b>	The farmstead includes a two-storey rubble-built seventeenth-century house, with extensions, adjoining a barn and byre to the east, built in the earlier nineteenth century. There is a detached hogg house to the west and kennels and equipment shed to the north. The house, which is dated to at least 1629 by a plasterwork panel in an upper room, was constructed by the Howard family and was originally thought to be an example of a cross-passage house, but investigations have revealed this arrangement to be a secondary development (VAG 2015). This NTSMR number incorporates NTSMR 25824, NTSMR 25826, NTSMR 25827, NTSMR 25828, NTSMR 25829.

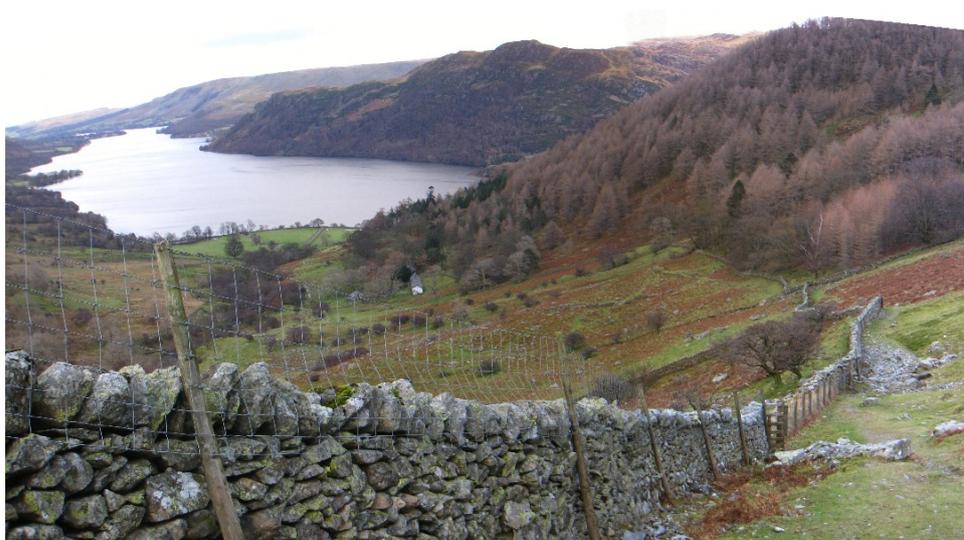
<b>Site Number</b>	70
<b>Site Name</b>	Southern Boundary of landholding, Glencoyne Farm, Patterdale
<b>NGR</b>	NY 33719 51854 - 33874 51842
<b>NTSMR No</b>	-
<b>LDHER No</b>	-
<b>Site Type</b>	Field Boundary
<b>Period</b>	Medieval - Post-medieval
<b>Sources</b>	Greenwood and Greenwood 1824; OS 1863; OS 1899; modern mapping
<b>Significance</b>	Local
<b>Threats</b>	Vegetation
<b>Management</b>	
<b>Recommendations</b>	Regular Monitoring
<b>Photo ID</b>	IMG_0346, 0347
<b>Description</b>	The southern boundary of the farm's enclosed area extends from the A592 to the head-dyke wall (Site <b>69</b> ), and probably incorporates a series of builds and extensions from the original ring-garth. Where observed, the wall was typically 0.8-0.6m wide, 1.4m high and constructed of field-stone rubble. It is shown on Greenwood and Greenwood's map of 1824 and, in its entirety, is likely to be of eighteenth- or early nineteenth-century date.

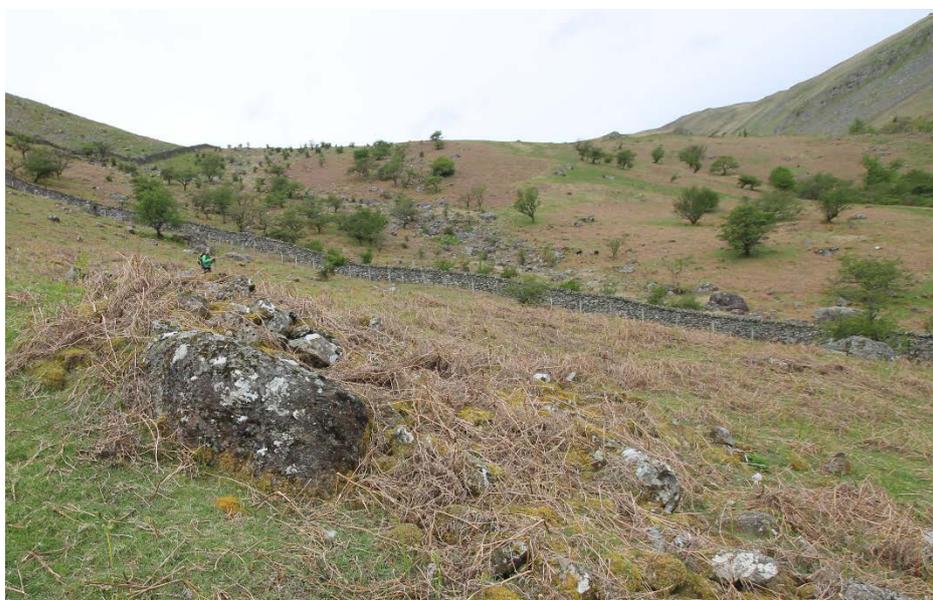
<b>Site Number</b>	71
<b>Site Name</b>	Field Boundary, Glencoyne Farm, Patterdale
<b>NGR</b>	NY 37725 18610 - 37496 18436
<b>NTSMR No</b>	-
<b>LDHER No</b>	-
<b>Site Type</b>	Field Boundary
<b>Period</b>	Post-medieval
<b>Sources</b>	OS 1863; OS 1899; modern OS mapping
<b>Significance</b>	District
<b>Condition</b>	Good
<b>Threats</b>	Vegetation
<b>Management</b>	
<b>Recommendations</b>	Regular Monitoring
<b>Photo ID</b>	IMG_0269
<b>Description</b>	A field boundary crosses the width of the study area at the base of a steep slope, running along the line of a tributary beck. The wall is marked on the 1863 OS map and is approximately 300m long and, at its northern extent close to Glencoyne Beck, related to Site <b>63</b> . The boundary marks the line of a former intake and, prior to the construction of the present head-dyke (Site <b>69</b> ), may have demarcated the line between enclosed and common land. Like Site <b>69</b> , it is closely associated with a sheepfold adjacent to the beck (Site <b>81</b> ).

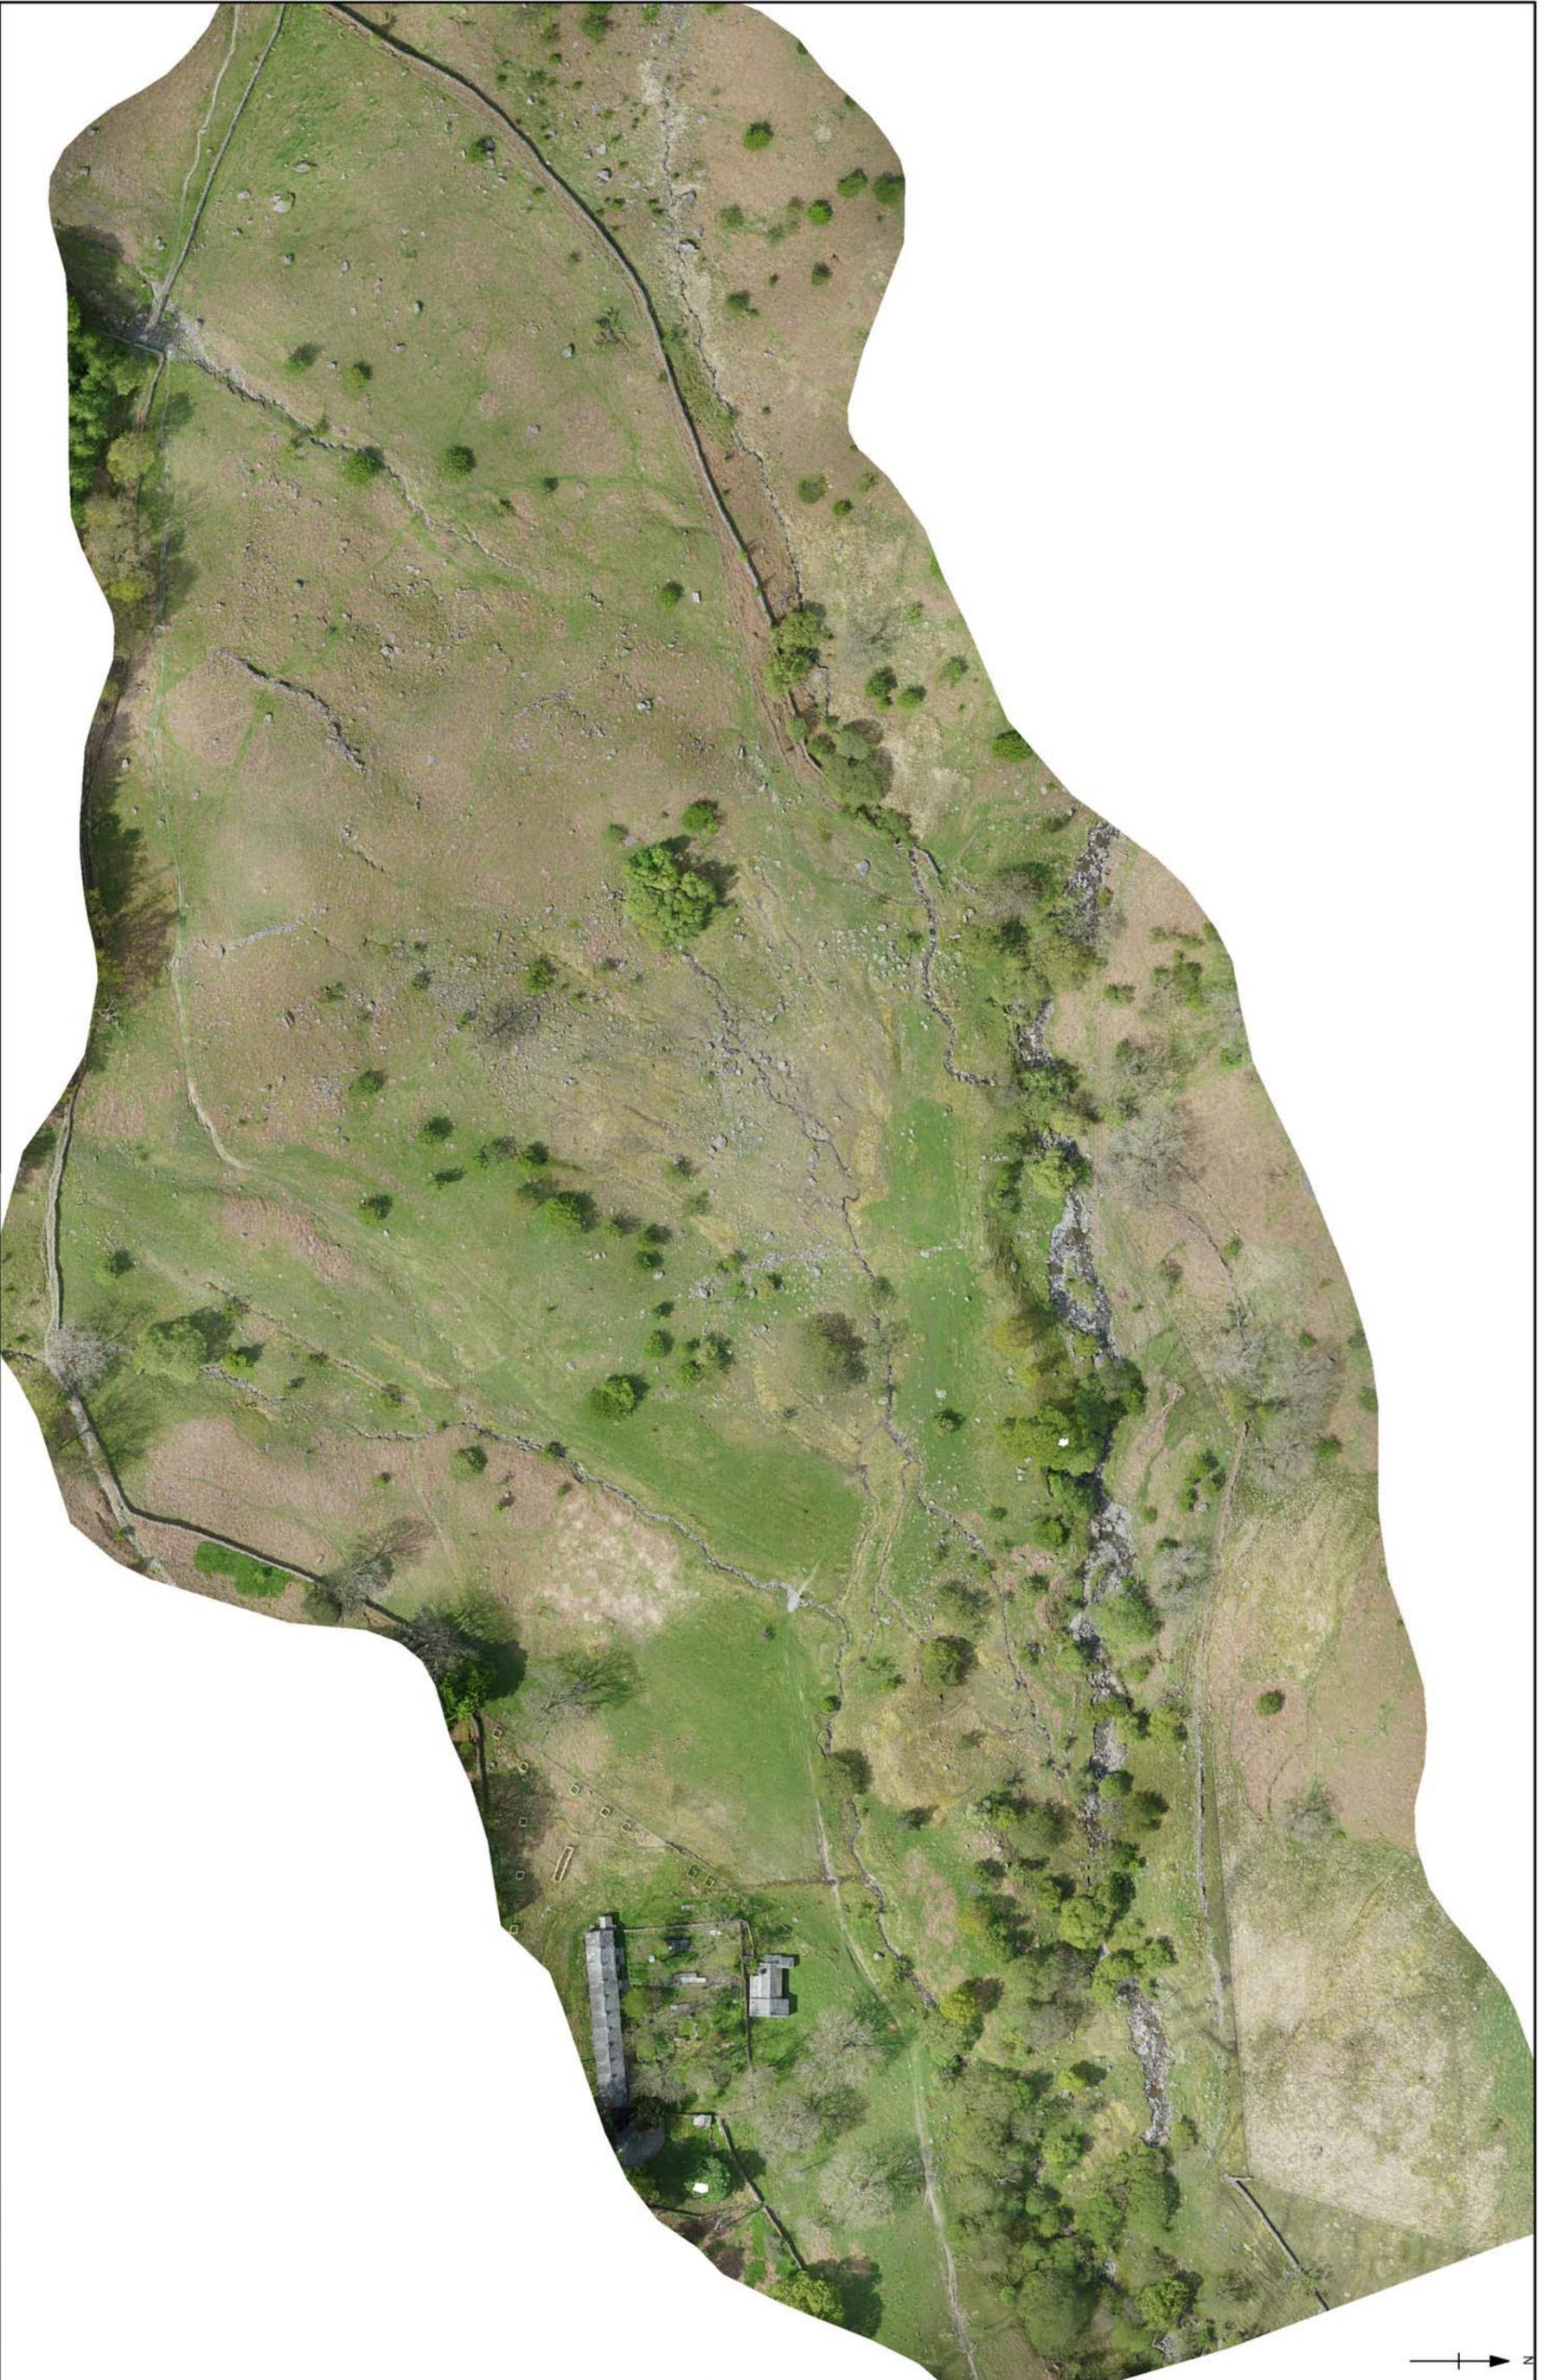
Figure 2: Glencoyne Photogrammetric Survey

2.2.4 **Photogrammetric Survey:** a photogrammetric survey was completed for the central portion of the site using a UAV, a small multi-engined model helicopter that provides photography from altitudes up to approximately 200m above the ground (Fig 2). Survey control was introduced to the photographs by the placement of survey control targets across the site, which were located by means of survey-grade GPS.
