Shepperdine Farm, Shepperdine

South Gloucestershire

Historic Buildings Investigation and Recording

February 2018

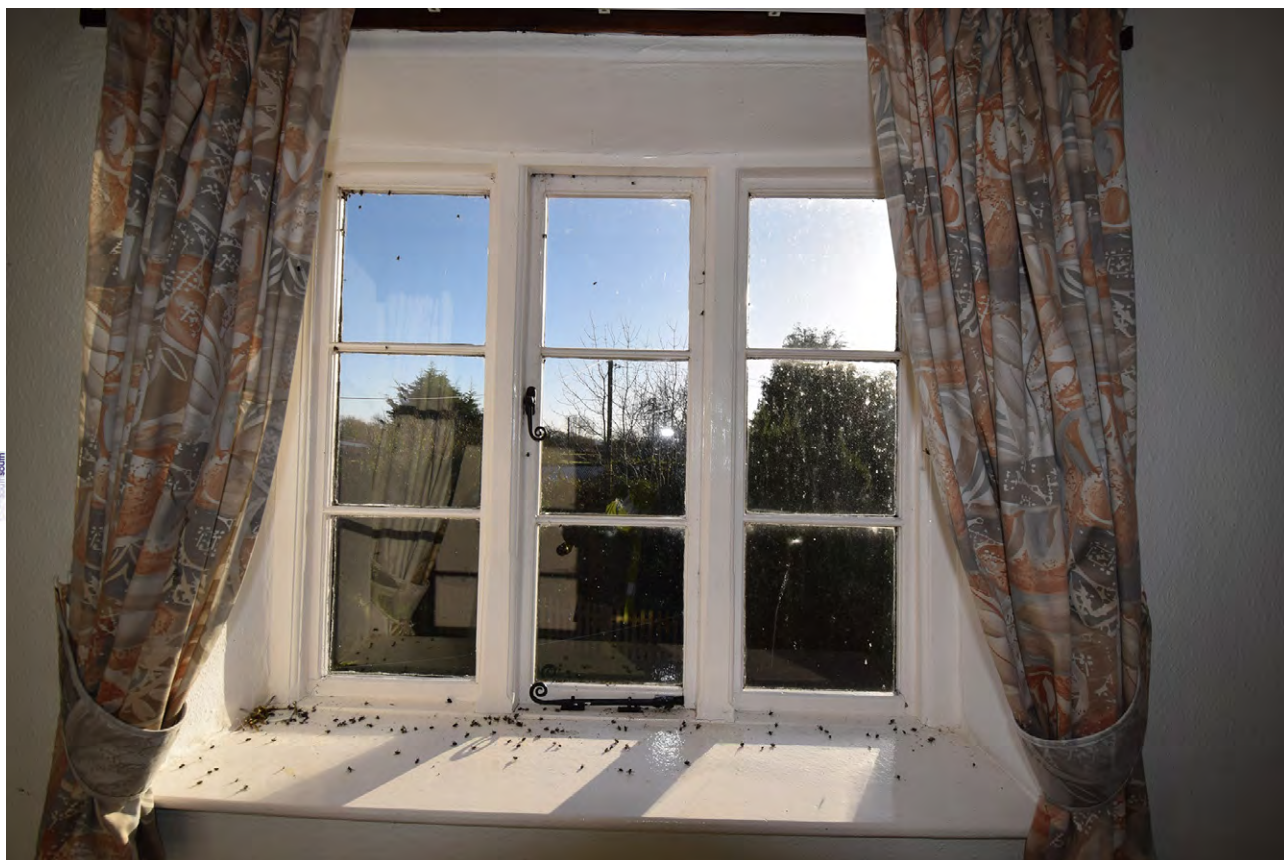
- 3.2.23 The first floor hallway has a low beaded skirting board and a window in each bay of the east wall (Plate 43). These are nine-pane casement windows, like those in the ground floor hallway and corridor. Many of their catches and stays have been replaced in modern times. They have simple timber sills, but like that in the east wall of the ground floor corridor, they appear to have had their window seats filled in. The carpet was lifted to inspect the floor boards and it was observed that the orientation of the boards changed from the north bay to the central bay (Plate 44). Those to the north are orientated east to west, and those in the central bay are orientated north to south. This corridor is arguably a later addition to the original arrangement of the house, and so the boards may be reused and reoriented in part. Two ceiling beams are visible in the ceiling of the hallway, orientated east to west and crossing roughly the centre of the north and central bays. They are chamfered but only that in the central bay has chamfered stops on its east end where it meets the east exterior wall (Plate 45). There is a lintel in the hallway between the north and central bays and this is likely to conceal another beam, that crosses and is supported by the north side of the large chimney stack.

Plate 43: The window in the east wall of the first floor hallway of Sheppardine farmhouse, looking east

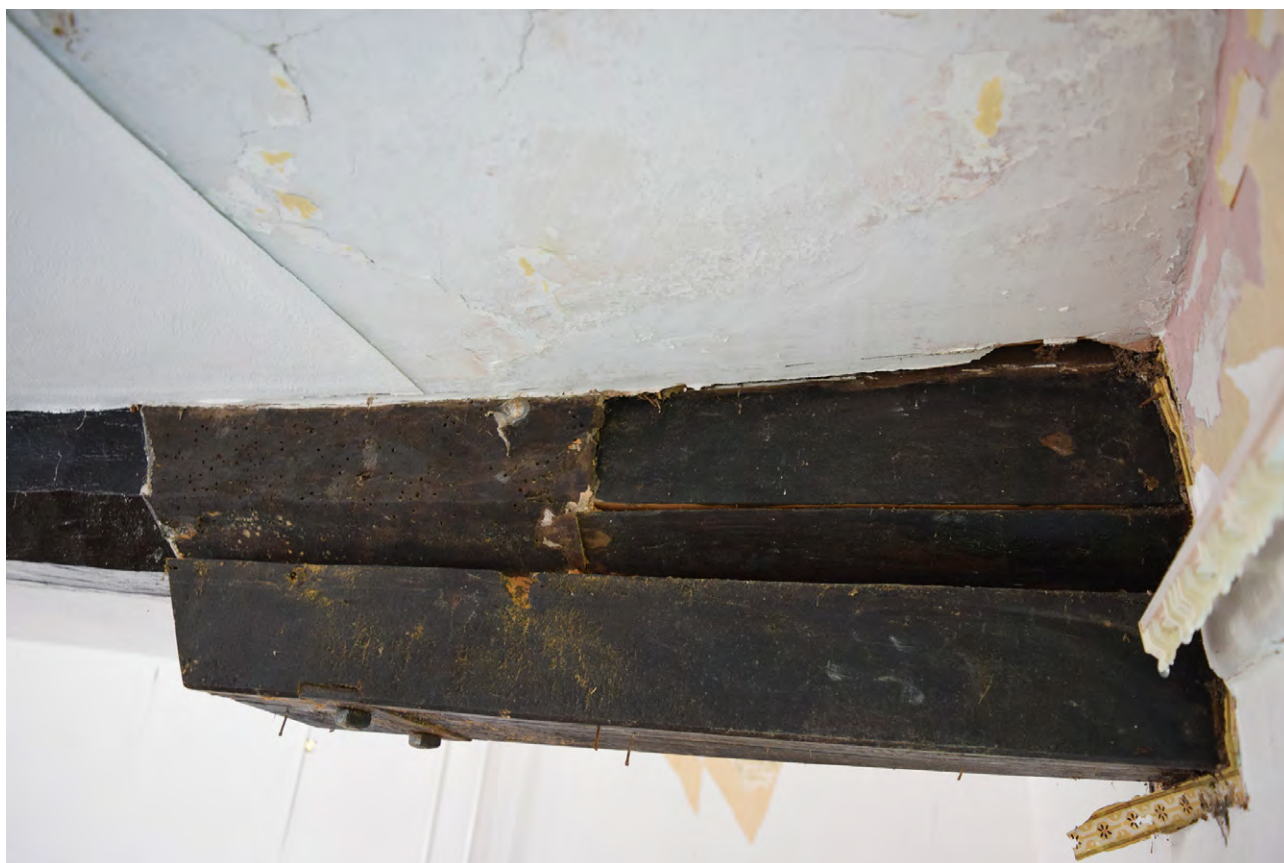
- 3.2.30 A large, chamfered ceiling beam runs east to west across the south bedroom in the same position as that in the south reception room below. A repair that has been boxed in with modern panels was investigated further. Here, the west end of the beam has been cut and a false chamfered piece inserted that reaches the west wall. Below this, a timber, that seems to act as an extended corbel, holds up the false piece and is bolted to the end of the original beam from underneath (Plate 60). The ceiling around the beam is papered and there is a modern light fitting.

Plate 60: The west end of the ceiling beam in the south bedroom of Shepperdine farmhouse, looking south (What appears to be a break in the beam on the far left is in fact an impression left by the removed paneling)

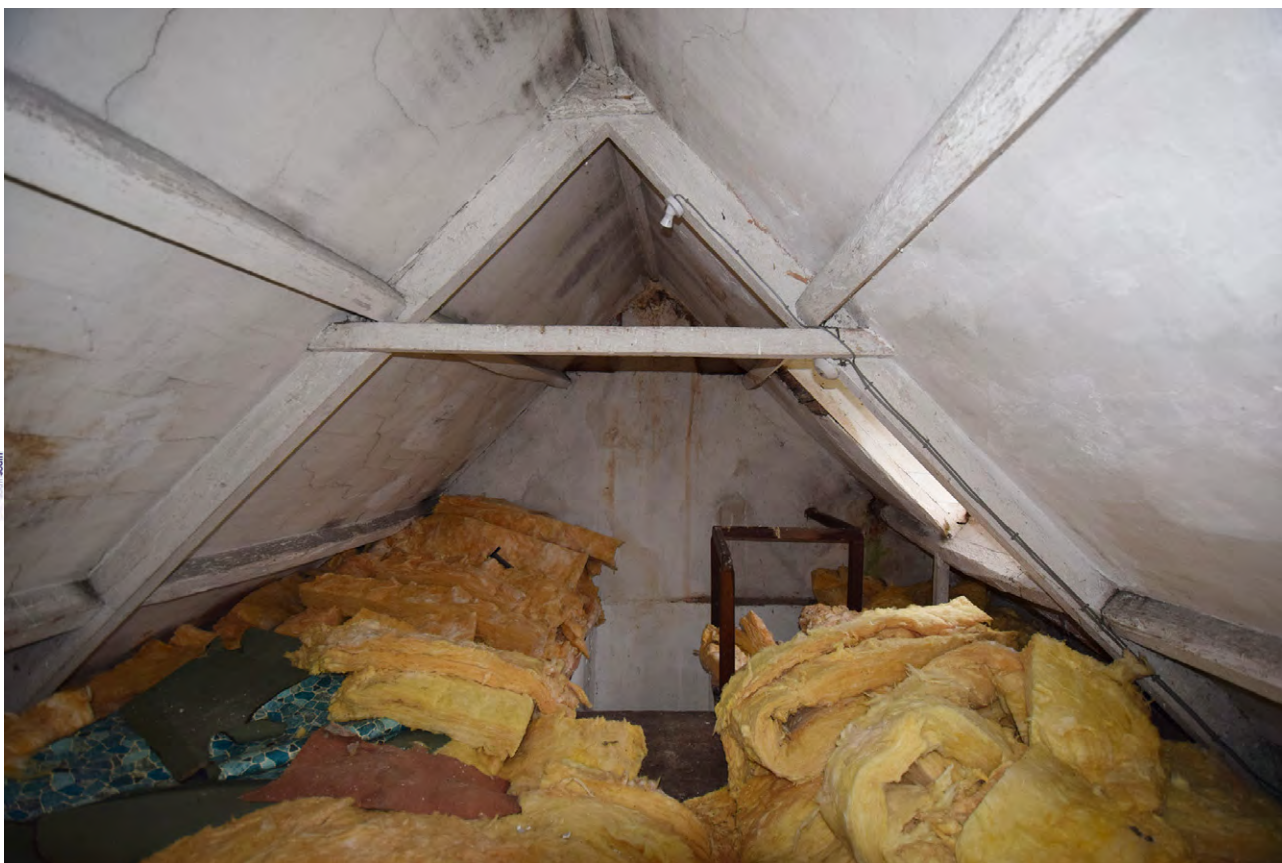
- 3.2.32 *The north attic room* (Fig. 11) The north room features a wooden handrail at its north end where the stairs rise and a dormer window in the east side of the pitched roof, to the north of the central truss (Plate 61). There are two rows of purlins and the dormer extends outwards between them, its sill resting on the lower purlin. The sides of the dormer are horizontal boards and the window is a four-pane casement with an original catch and stay on the north side (Plate 62). The flue that can be seen on the exterior of the north gable can be observed on the interior high in the gable where it emerges from the roof.

Plate 61: The north attic room in Sheppardine farmhouse, looking north

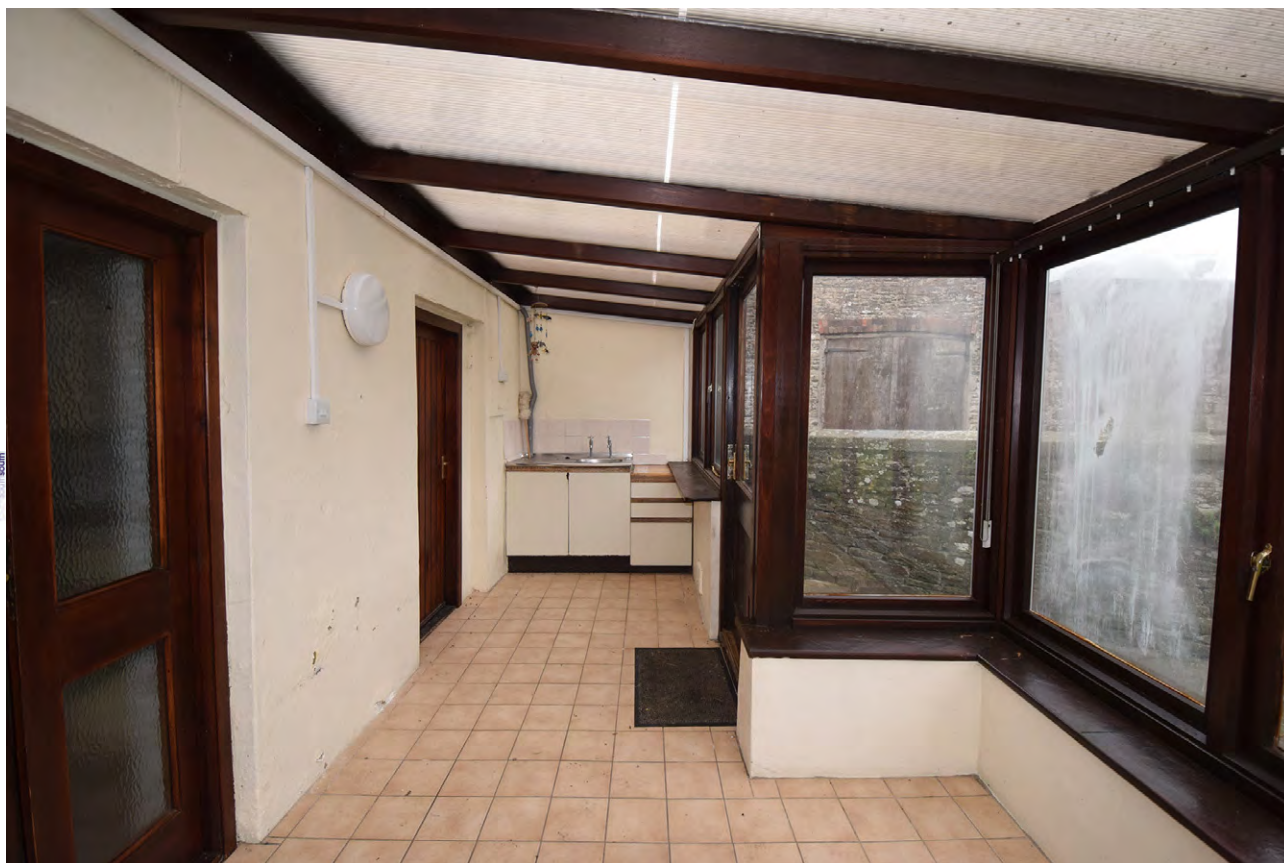
- 3.2.40 *The lean-to* (Fig. 9) The north extension is entered through the glazed lean-to on its east side. This is a modern timber frame structure built on a solid plinth and is floored with modern tiles on the interior (Plate 67). It extends further east at its south end and a ledge under the windows forms a shelf or a seat. At the north end is a kitchen area with a sink over two modern cupboards and three drawers on the east side. In the west wall are two doorways. The one on the south side has a modern timber double door, with two frosted glass panels on each side, which leads to the kitchen. The doorway to its north has a modern door of vertical timbers and leads to the scullery.

Plate 67: The modern lean-to on the east side of the north extension to Sheppardine farmhouse, looking north

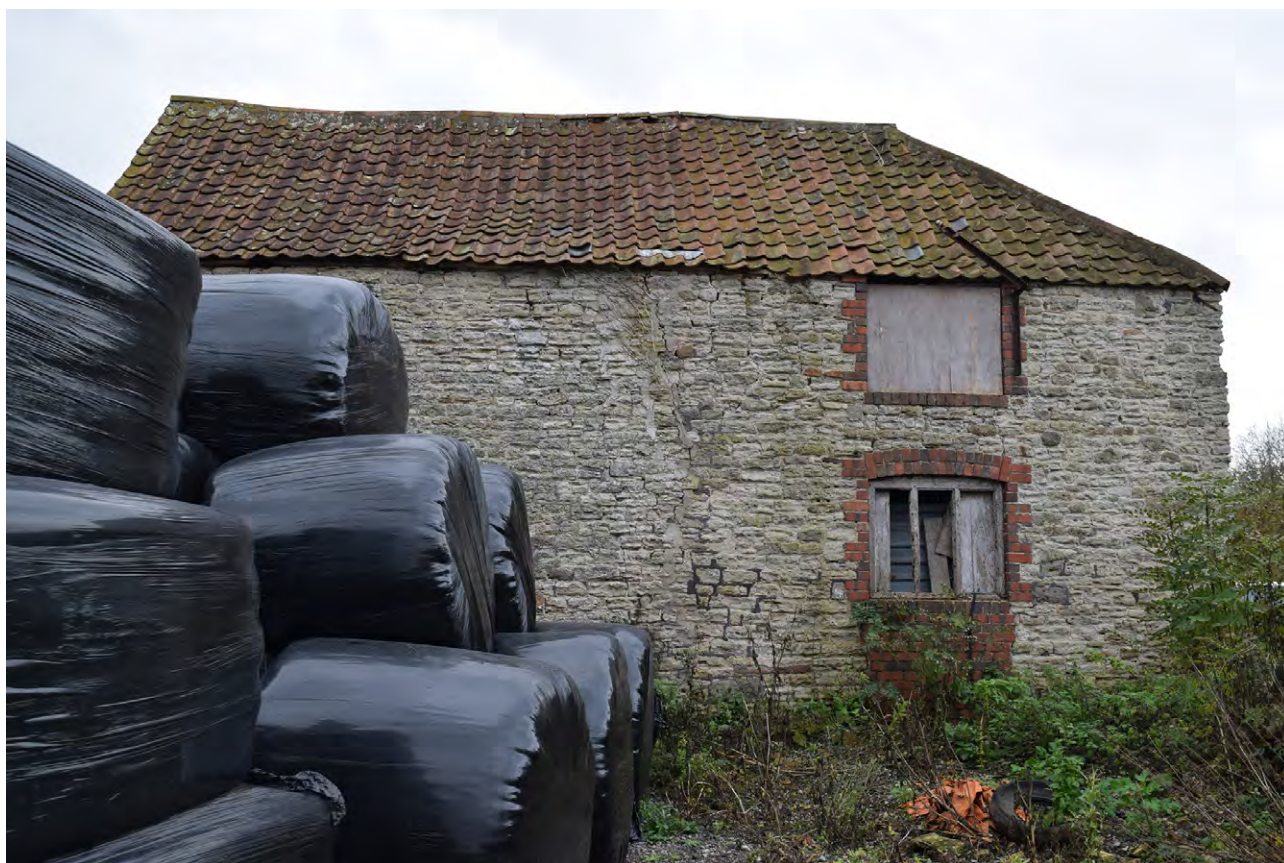
- 3.3.3 The north elevation of the shed has two windows, one over the other, on the west side (Plate 76). The ground floor window has a red brick segmental arch and red brick quoining. Below the sill is red brick but it appears to be a part of the construction of the window rather than a blocking. In the opening is a three-light, timber frame casement that has broken shuttering on its interior. The window over it at loft level has red brick quoining and a red brick sill. It is boarded over. The elevation is otherwise featureless except for a corresponding cement-filled large crack in the masonry, which is may mark where the later west bay was added or indicate some subsidence of the west end. The west elevation of the shed is featureless.

Plate 76: The north elevation of the shed, looking south

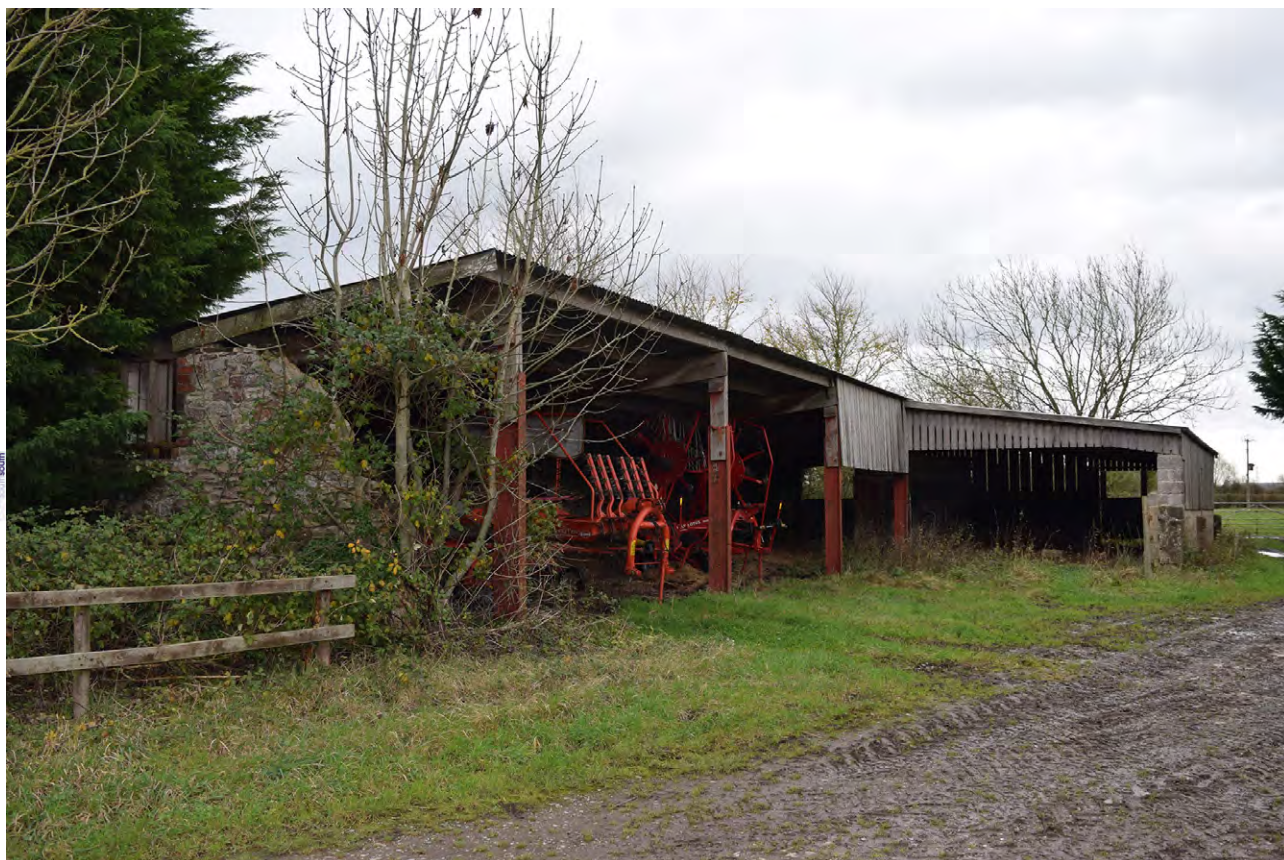
3.4.3 *The equipment shed and animal shelters* These outbuildings, on the north-east side of the farmyard currently house tractor equipment in the west end, and the adjoining shelters to the east have straw floor covering in them (Plate 92). The whole structure has roughly the same footprint as that which appears on the 1880 OS map, but it is clear much of its fabric has been replaced over time. The equipment shed now has a flat roof, slightly inclined towards the south, but the stone-built west end is a partially demolished gable, the window of which is crossed by the current roof (Plate 93). This is clearly part of a previous, gabled structure and may be that which appears on the historic maps. Along the north side, the stone wall partially exists but gaps have been blocked with breeze blocks and sheets of corrugated metal. The animal sheds are at the east end and, where the structure extends towards the south, there is a dividing wall built of stone (Plate 94). The roof is a simple structure of cross beams, sitting on posts, many of which have been replaced with rolled steel joists, which support east to west running joists. Much of the rest of the building is built with breeze blocks and other modern materials. It has the appearance of a structure that was allowed to fall into ruin before being restored for its current purposes in the later 20th century.

Plate 92: Exterior of the equipment shed, looking north-east
