Chorlton Fold, Monton, Eccles, Greater Manchester

Final Excavation Report

July 2011

Stewart Milne Homes Ltd

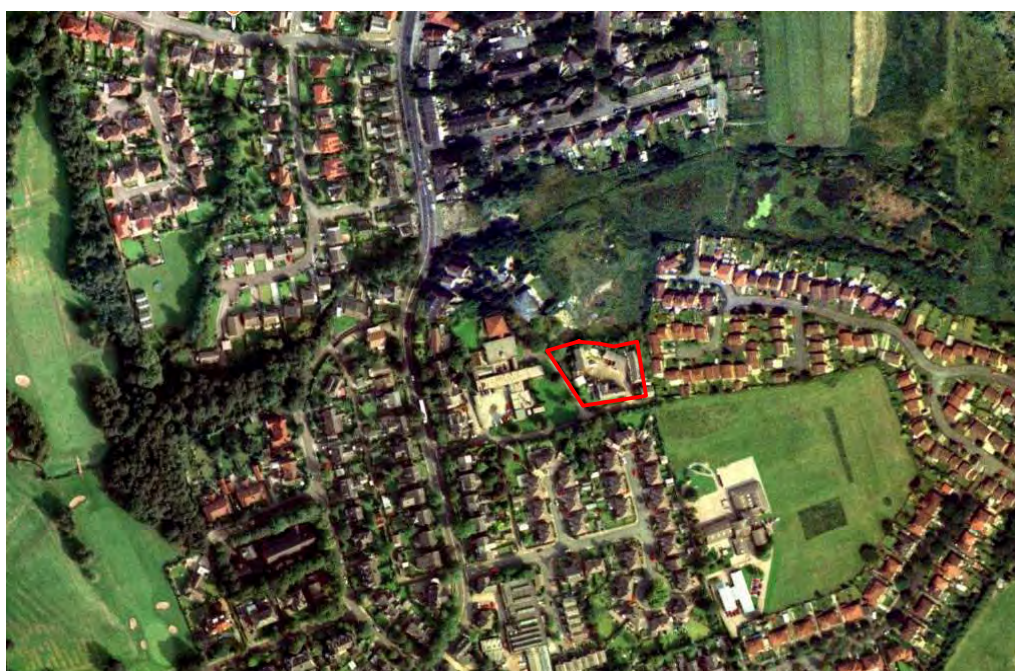
Plate 1: Aerial view of the study area before the demolition of Chorlton Fold Farm

- 1.1.1 Chorlton Fold Farm is a former eighteenth-century farmstead situated some 8km to the west-north-west of Manchester, in the municipal borough of Eccles, which forms part of the metropolitan district of Salford (Fig 1). This site now resides unobtrusively within the residential area of Monton, which is characterised by swathes of modern housing that skirt the southern, eastern and western sides of the former farmstead (Plate 1).

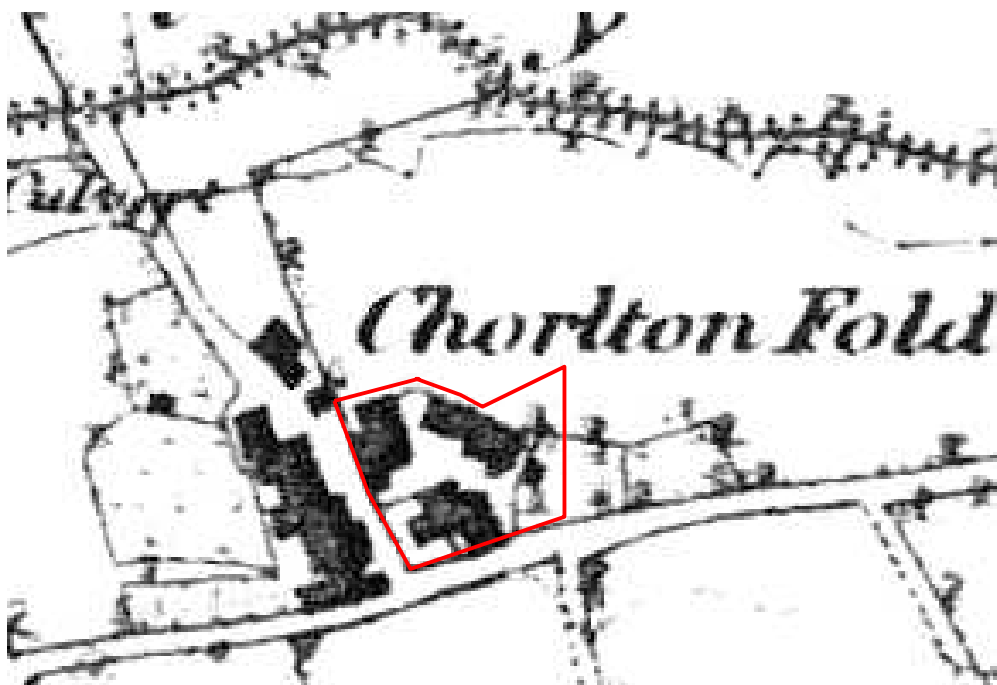
Plate 3: Extract from the 1848 Ordnance Survey map, with Chorlton Fold outlined in red

- 2.3.3 Significantly more detail of the farm is provided by the Ordnance Survey 6": 1 mile map, published in 1848, which shows the farm to have comprised a developed farmstead with four buildings (Plate 3). This map indicates that the farmhouse at the southern extent of the farmstead had a main east/west-aligned axis, and an extended rear wing on its northern elevation. In addition, a further 'wing' appears to lie on the front of the building at its eastern end. To the north-west of the farmhouse, a building is depicted which appears to be the barn that was demolished in 2007, although the Ordnance Survey mapping also plots the position of an elongated outshut, or extension, on its western elevation. To the east of this barn is a rectangular structure, again occupying a similar alignment and position to an outbuilding which was recorded prior to its demolition in 2007. The Ordnance Survey map also plots the position of a small, square pen, or animal shelter, situated immediately to the east of this outbuilding.

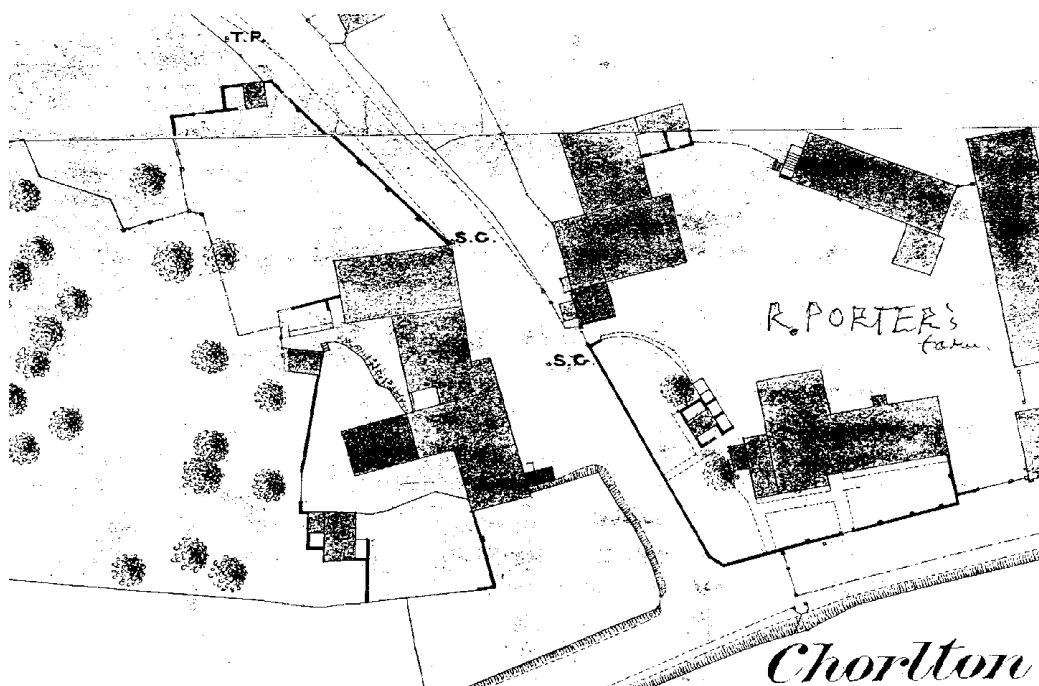
Plate 4: Extract from the 1894 Ordnance Survey map, showing the position of the Chorlton Fold farm buildings

- 2.3.4 By the time of the publication of the 1894 Ordnance Survey 1:2500 map, the farm appears to have undergone some marked changes and alterations (Plate 4). Whilst the farmhouse is again present, the front 'wing' is less pronounced than that depicted on earlier Ordnance Survey mapping. Similarly, the barn to the north-west of the farmhouse appears to have been altered. The elongated outshut on the western elevation had clearly been removed, whilst a further outshut may have been appended to the southern elevation. The added outbuilding to the east of the barn was still standing, although it appears as a narrower building on this map, compared with that depicted on the earlier survey. To the immediate east, the small pen or animal shelter had been removed and replaced by another rectangular outbuilding, which was aligned north/south. A fifth building is also illustrated to the east of the farmhouse, which may represent the open hay barn, or Dutch barn, which was demolished in 2007.

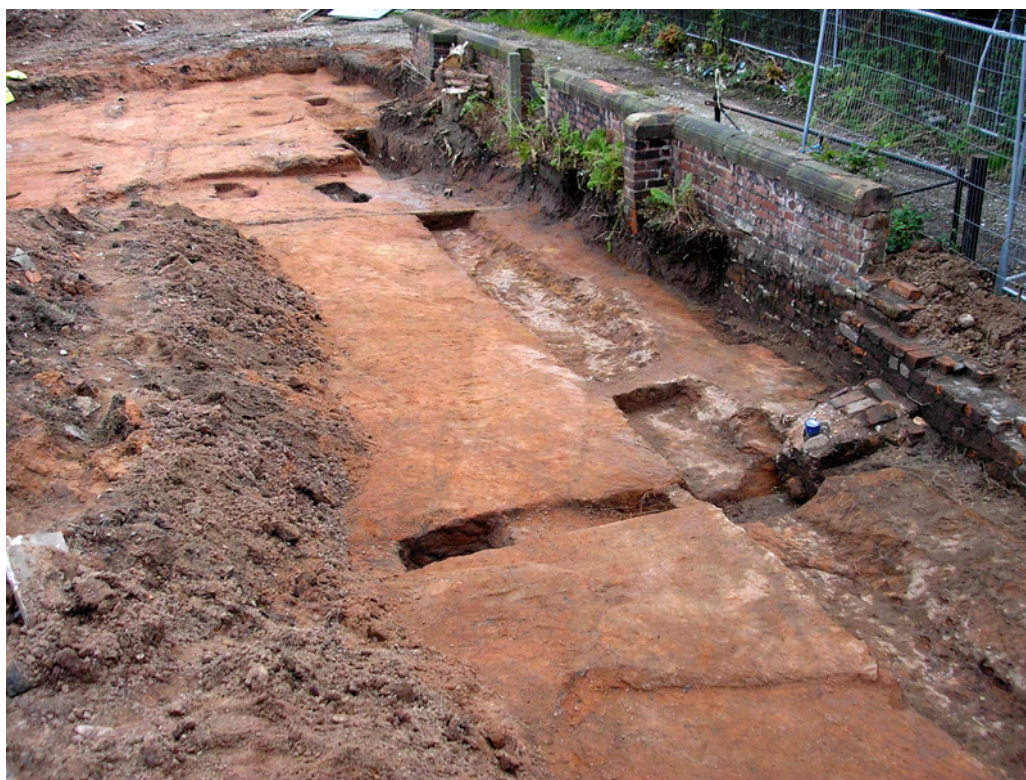
Plate 6: Area 2, general view of ditch **25/58**, looking south-east

- 3.3.2 **Late medieval ditch:** a shallow ditch (25/58) was exposed within Area 2, following its initial discovery in evaluation Trenches 3 and 5. In total, a c 23m-long section of this ditch was discovered, which extended across the complete length of the open-area trench (Plate 6). This ditch was aligned east/west, though at its western end it curved to the north-west for a distance of 1.6m, close to the modern boundary wall (Fig 3). This appeared to indicate that after this point the ditch changed course and ran in a north/south direction. The ditch had been cut into the bedrock (196), was 0.55m-1m wide, and had a shallow U-shaped base. It also varied in depth, with a very gradual slope from west to east, and had a maximum depth of 0.68m at its western end, rising to a

depth of only 0.05m at its eastern end. The ditch had been filled with a homogeneous reddish-brown clay (**26**), which contained small lumps of iron slag and several sherds of late medieval pottery, along with Cistercian-type ware, which may date to the sixteenth or, perhaps, very early seventeenth century. Significantly, the earlier artefacts indicate that the area witnessed some form of late medieval activity, whilst those later sherds provide a *terminus ante quem* for the cutting of the ditch, suggesting that it was probably established prior to the late sixteenth, or very early part of the seventeenth, century (see *Section 4*).

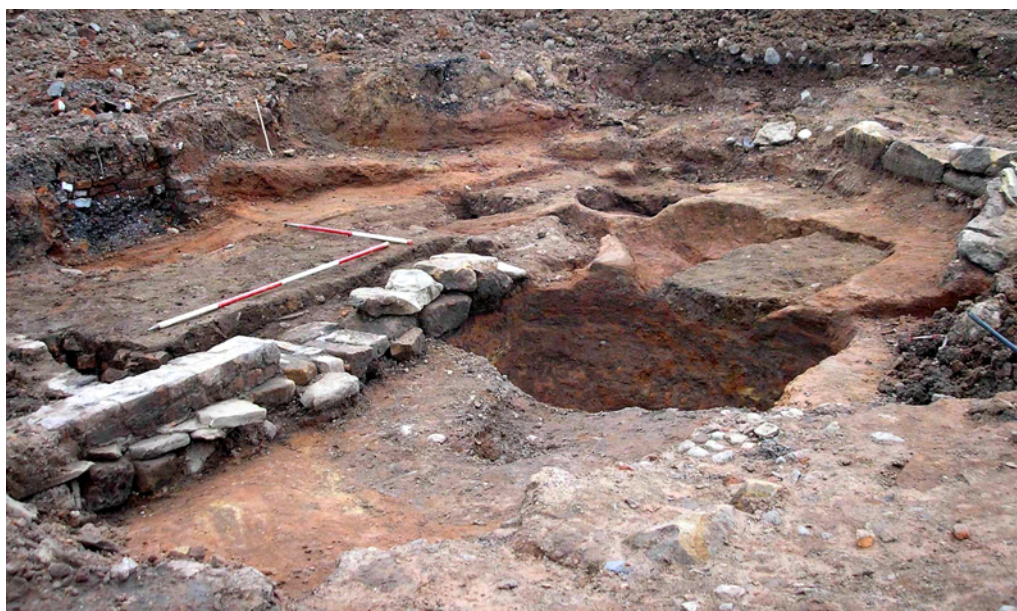
Plate 7: View of pit 45 (foreground) following half-sectioning

- 3.4.9 In Area 3, two pits (**45** and **159**) were discovered (Plate 7), each containing pottery dating to between the sixteenth and eighteenth centuries. Pit **45** was sub-rectangular in plan, measuring 2.8m long by 1.8m wide, and had been excavated into the bedrock (**200**). The pit was 0.98m deep and had been filled

with a 0.20m-0.30m-thick dump of degraded sandstone (**201**), spread across the base, which was probably laid to aid drainage within this feature. The stones were sealed by a spread of dense organic matter, some 0.15m thick, and comprising decayed tree roots. This layer was, in turn, sealed by a 0.5m-thick deposit of grey sticky clay (**46**), which contained numerous fragments of pottery, and lesser amounts of coal, clay tobacco pipe and fragments of leather shoes. The composition of the materials filling the pit suggested that it functioned as a rubbish pit, though it is possible that it was originally dug as means of extracting clay from this part of the site. The second pit (**159**) in Area 3 was located 2m south-east of pit **45**, and was also cut into the bedrock (**200**). This pit was sub-circular in plan, and measured 1m by 0.65m. Excavation demonstrated that it extended to a depth of 0.2m, had a flat base, and was filled with mid-grey brown clay-silt (**160**), which contained sherds of Blackware-type pottery dating to the seventeenth or eighteenth century.

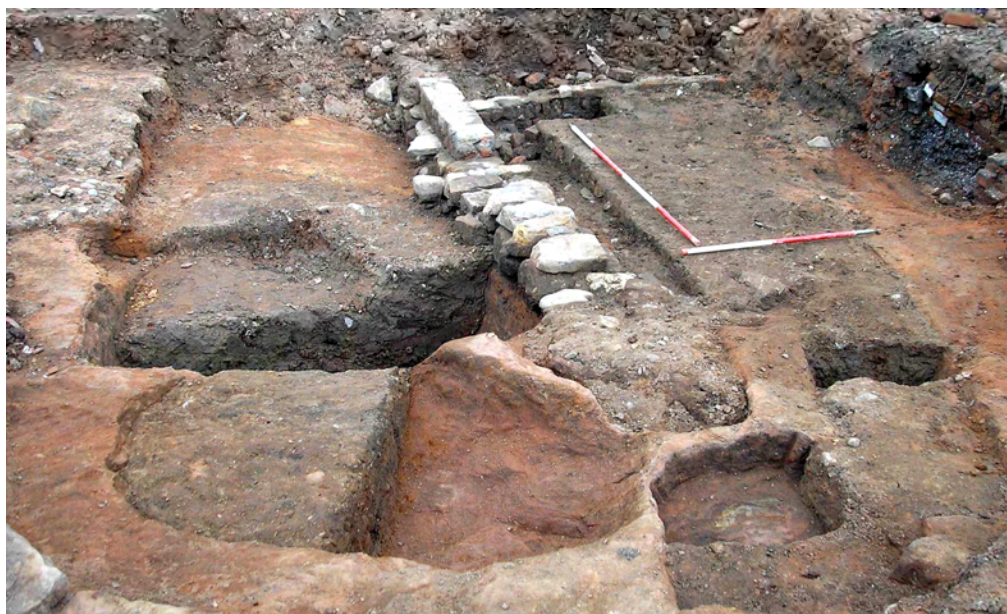
Plate 8: The remains of the Phase 2 building, looking north

- 3.4.11 **Building foundations:** several structural features were exposed in Area 3, which appeared to indicate that a building, with an attached enclosure, had occupied this part of the site during Phase 2 (Plate 8). The remains associated with these potential structures included two dry-stone walls (**144** and **147**), and a small area of cobbles (**139**) that represented the remains of a yard.

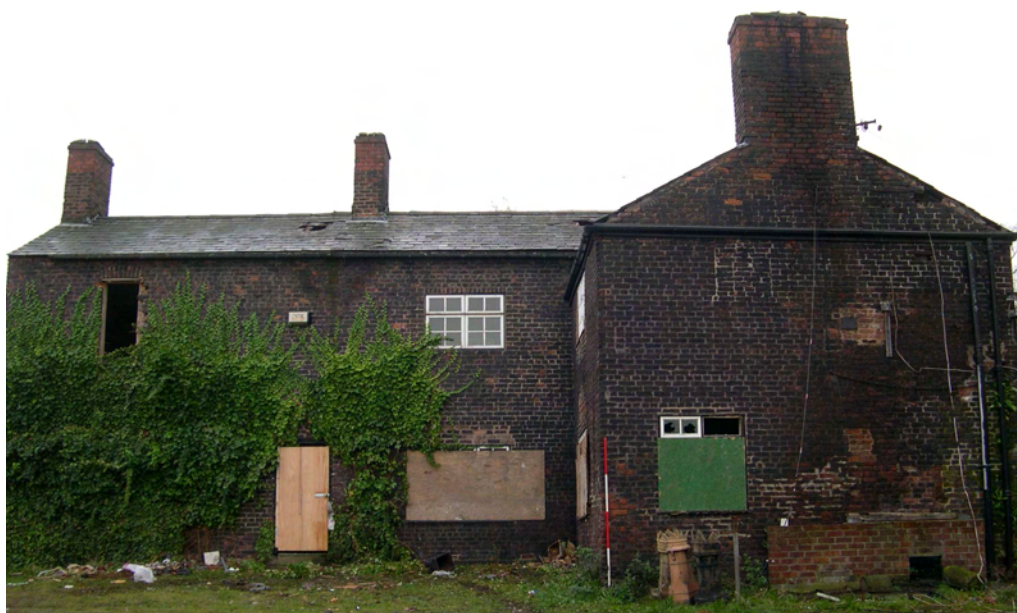
Plate 10: The rear (south) elevation of the farmhouse, with the rear wing to the right

3.5.2 *The farmstead:* the building survey concluded that the farmhouse was built during the eighteenth century. This building was expanded subsequently, when a further bay was added to the west elevation, followed by the addition of a rear wing during the late eighteenth, or early nineteenth, century (Plate 10). The barn to the north of the farmhouse and the more westerly of the outbuildings were also constructed during this original phase of construction.

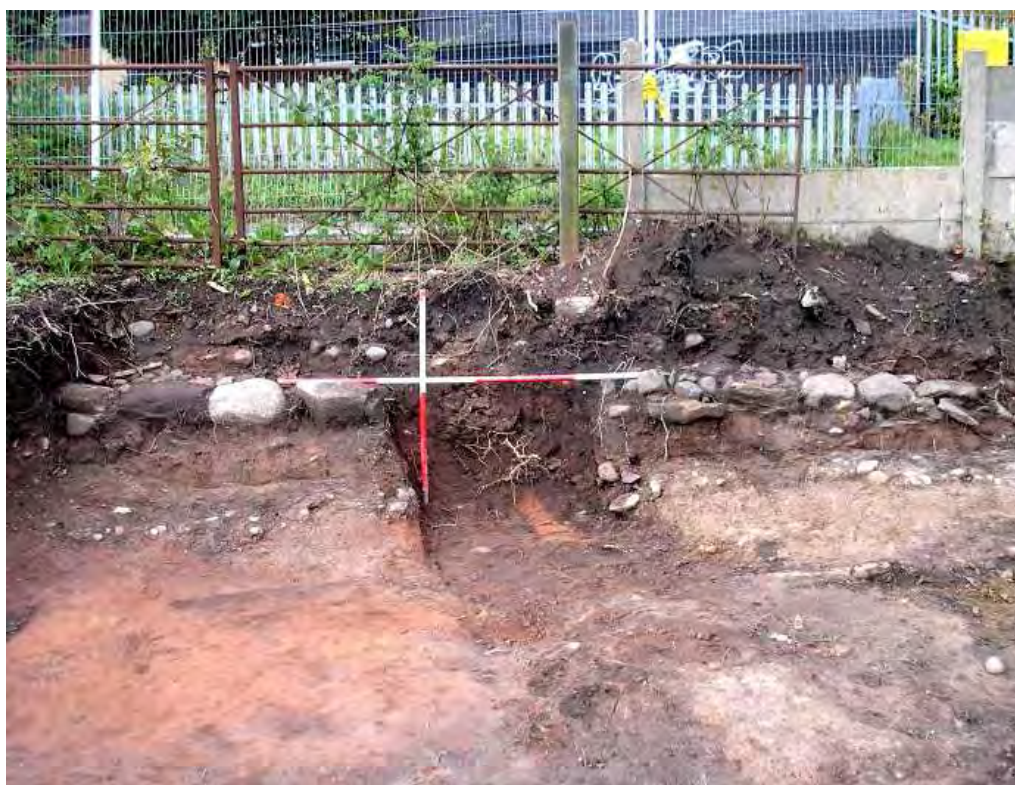
Plate 11: Boundary wall 2, looking west

- 3.5.14 In Area 1, a 4m length of this wall (**2**) was exposed (Plate 11). This was aligned north/south, and respected the course of Chorlton Fold Lane, being

constructed of water-worn sandstone blocks of various sizes. The blocks were not bonded, although several small cobbles were used as packing within a mixture of sand and loose soil (4). For part of its course, the wall was contained within a construction cut (3) excavated along the western side of the wall, which was also found to contain several sherds of pottery dating to the seventeenth to nineteenth centuries. In other areas, the wall overlaid a pale brown sand bedding layer.

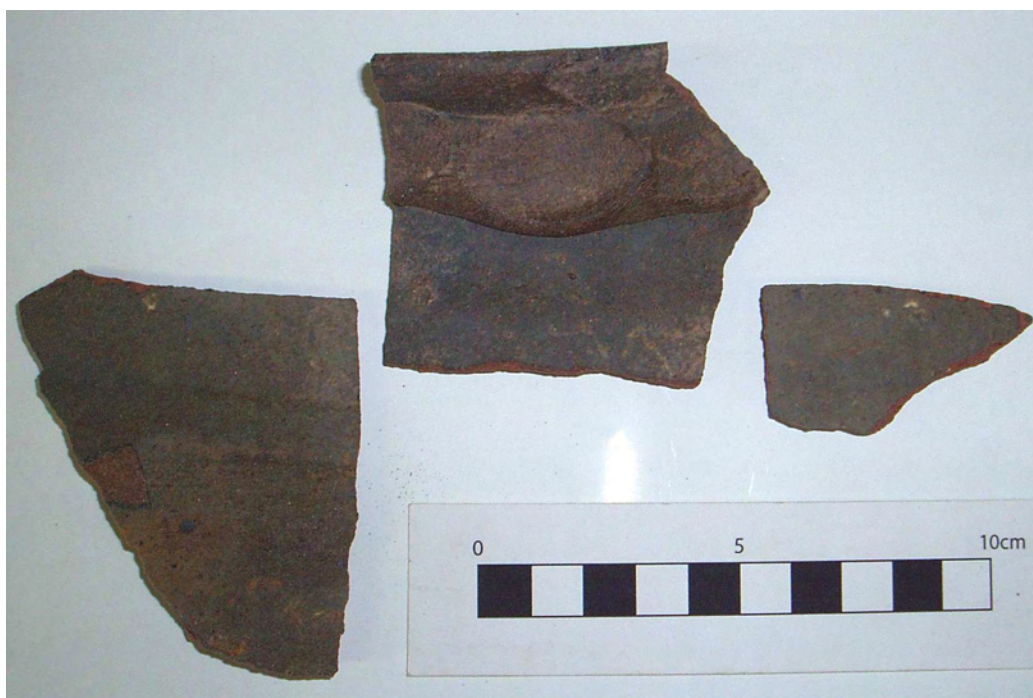
Plate 12: Late-medieval pottery recovered from ditch fill **26** (**26/1023**)

- 3.7.2 **Late medieval pottery:** in total, eight sherds of late medieval pottery were recovered from three contexts scattered across the site, including ditch fill **26** (Phase 1, Area 2), the fill of a tree bole (**89**) in Trench 5, and layer **132** (Phase 2, Area 1). In general terms, the pottery was in a good condition, with most of the sherds measuring over 50mm in size. The sherds were all of a hard-fired, red, gritty fabric, and may have derived from a single vessel. None were glazed, although several had a thumbled decoration under the rim (Plate 12). The precise form of the vessel could not be established from the surviving fragments, although it is likely to have been a jar of rounded proportions, with an everted rim. The source of the pottery is unknown, although it is likely to have been produced locally. Its style and appearance is consistent with a broad fourteenth- or fifteenth-century date, and is reminiscent of early Midlands Purple-type wares.

- 3.7.3 The dearth of medieval pottery from archaeological excavations in the North West has been highlighted in a review of medieval ceramic studies by English Heritage (Mellor 1994). Moreover, where significant groups of pottery have been discovered in the region, such as in Wigan (OA North 2011), research into its supply is severely restricted by a lack of knowledge of production sites. However, recent excavations in Wigan contained similar hard-fired pottery to the Chorlton Fold examples, which were recovered from late medieval contexts. These comprised Midlands Purple-type ware with applied thumb strip decoration. Other examples of later Midlands Purple-type wares were present in a pinkish-orange to orange fabric with a purplish glaze or slip.

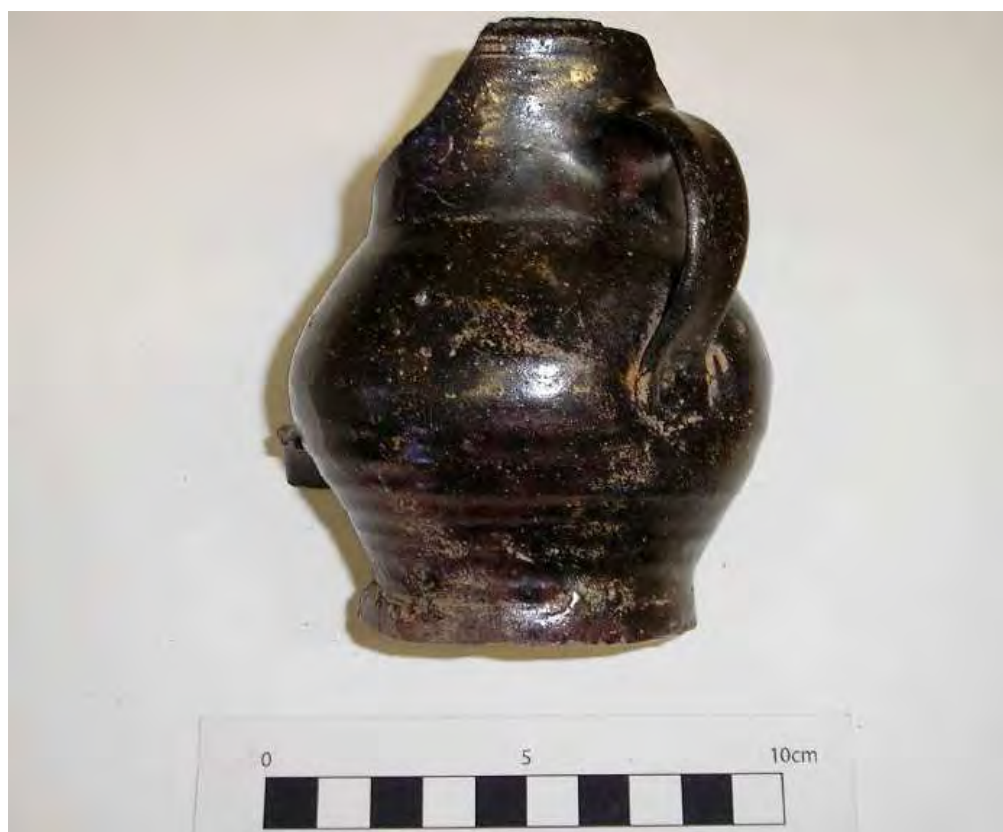
Plate 13: Developed Blackware cup recovered from ditch fill **26** (**26/1023**)

- 3.7.5 **Sixteenth-seventeenth-century pottery:** the earliest material within the assemblage includes several fragments of Cistercian-type ware. A later Cistercian/early developed Blackware cup of globular style, of sixteenth- or perhaps very early seventeenth-century date, recovered from ditch fill **26**, is of note (Plate 13). Interestingly, the form type is not usually found in either the Cistercian or Blackware series (Ford 1995). Instead, it reflects influence, perhaps, from both Raeren stoneware-type vessels (Gaimster 1997), which follow a similar form (apart from a thumbbed base), and some Tudor Greenware vessels of similar date and style. The origins of this cup are uncertain, but it may have been made locally.

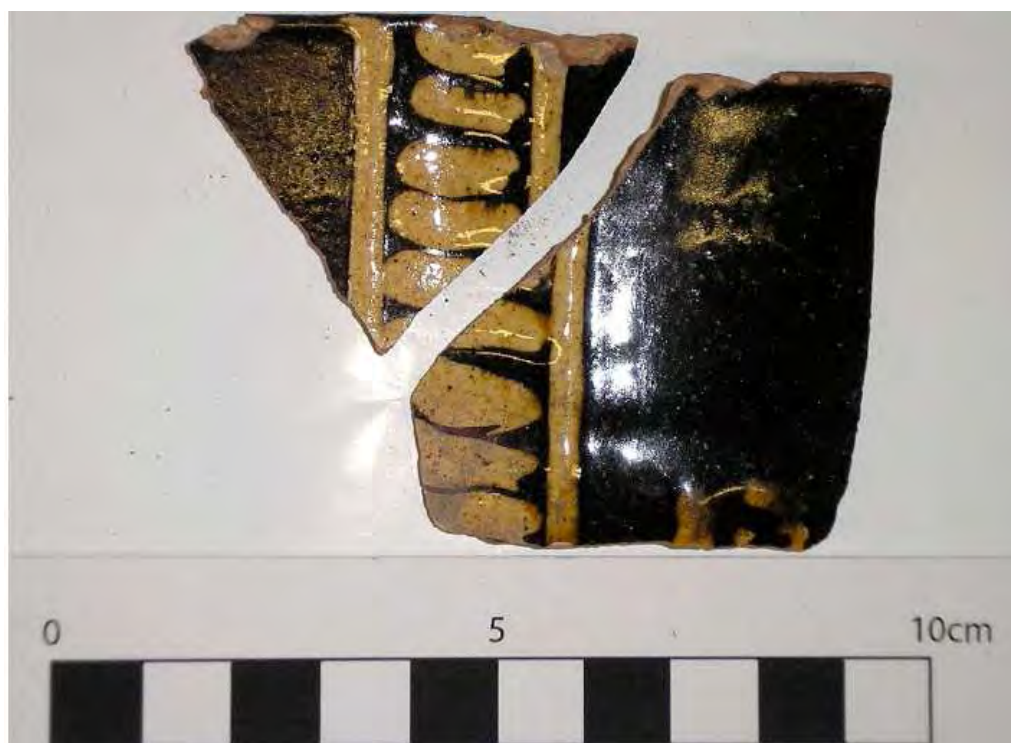
Plate 14: Fragments of a Cistercian-ware vessel recovered from ditch fill 22 (22/1038)

- 3.7.6 Two further sherds of Cistercian-type ware from ditch fill **22** (Phase 1, Area 2), with a pink/buff fabric and slip-trailed decoration, may derive from Ticknall, Derbyshire (Barker and Halfpenny 1990). These sherds belong to the same vessel which probably dates to the sixteenth century (Plate 14). Another possible Cistercian/developed Blackware fragment was also noted in the same context, but, being a body sherd, it is difficult to date with precision. Two sherds of a Midlands Yellow-ware cup base were also retrieved from the excavation. Local post-medieval coarsewares in the North West have been

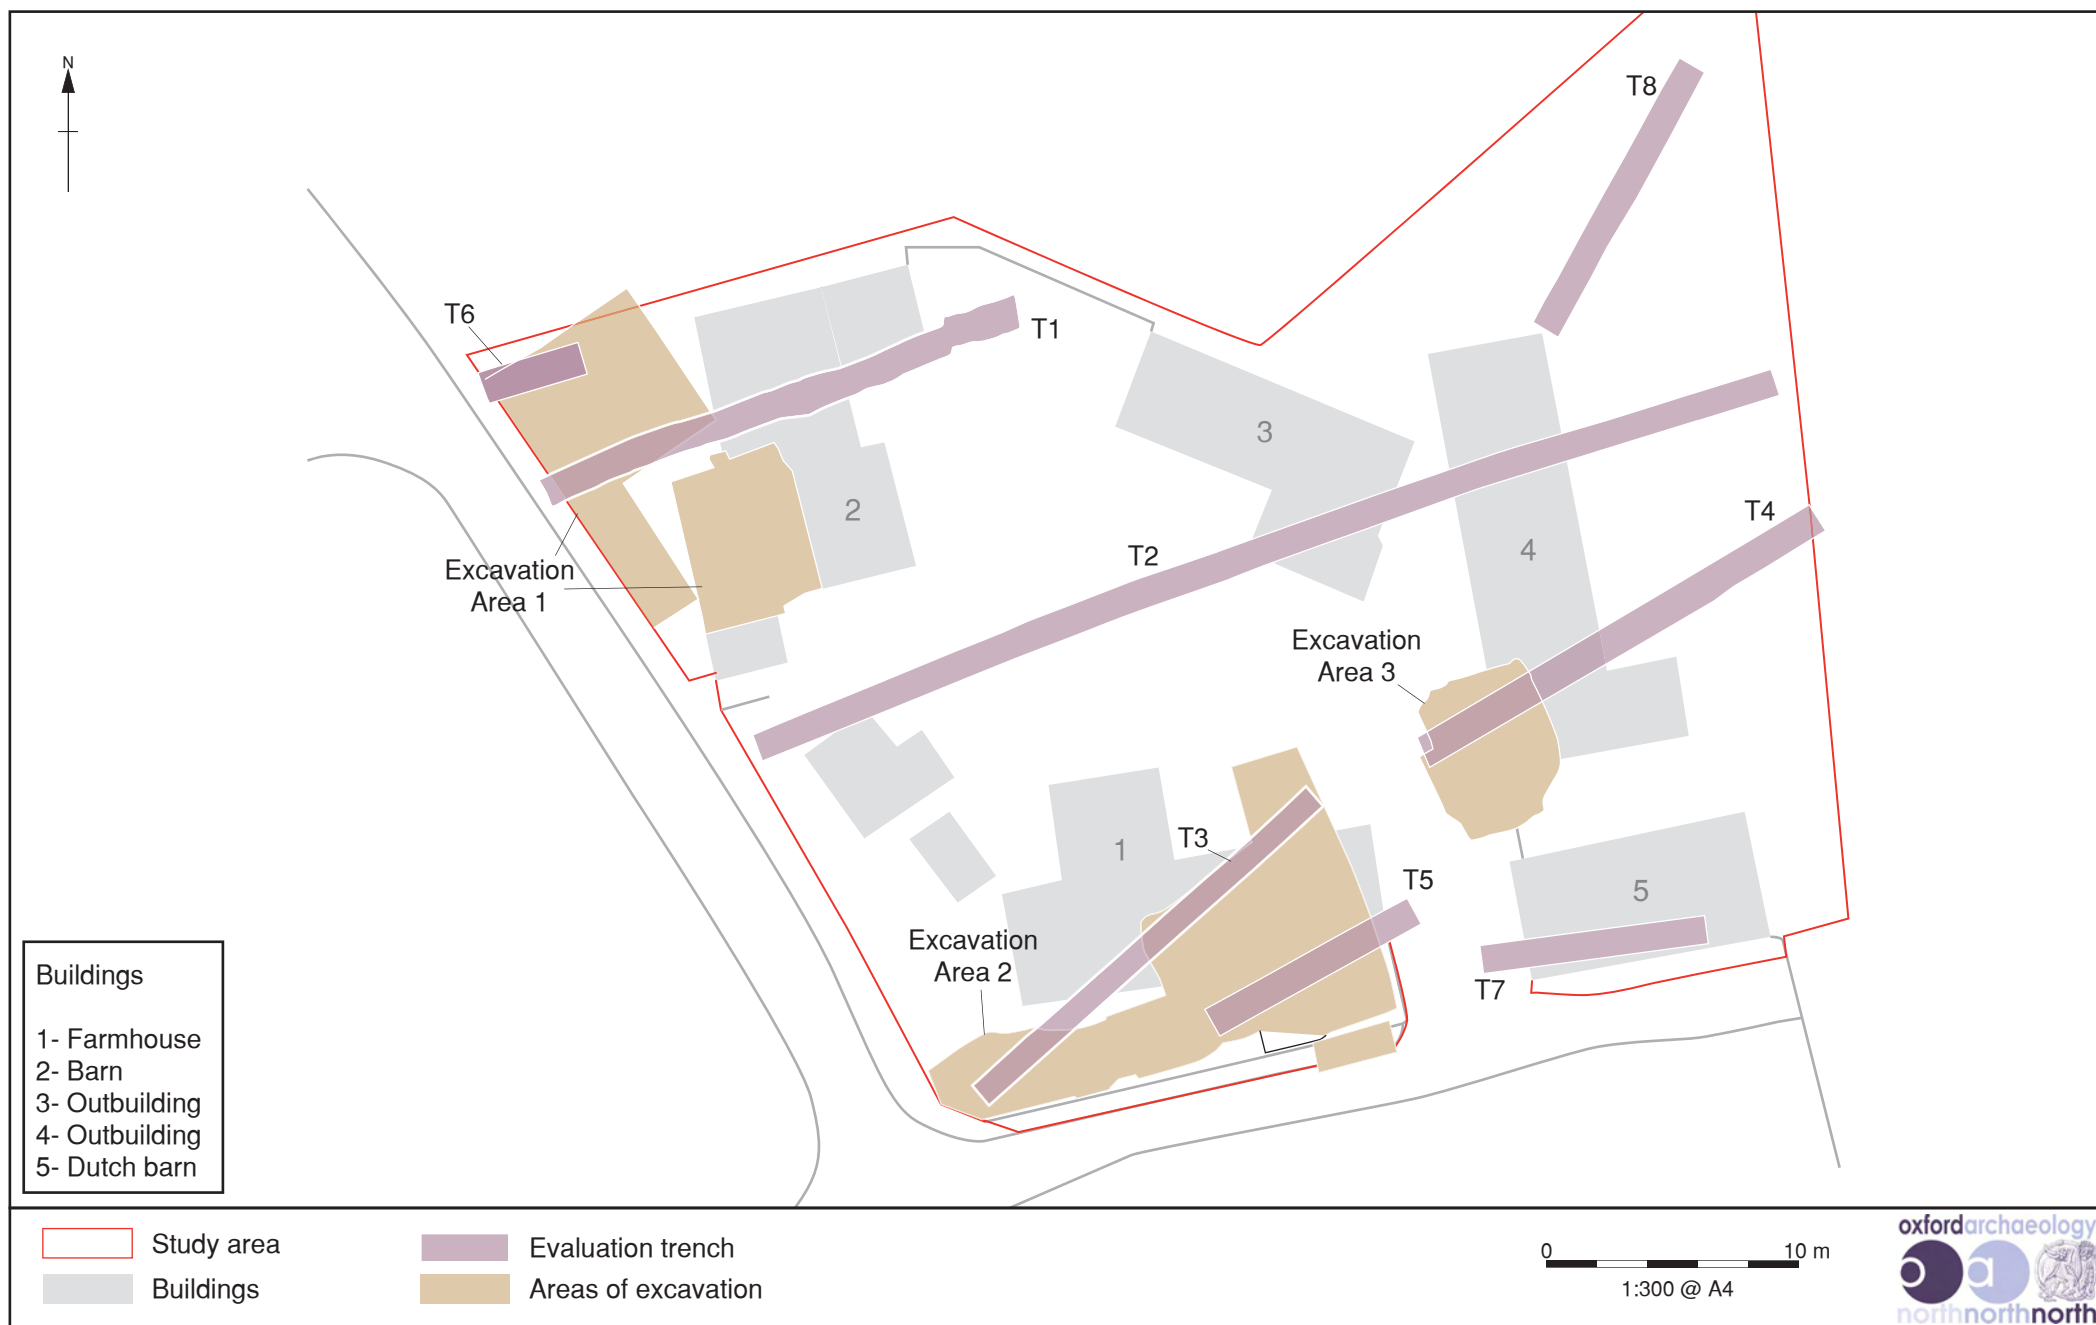
Figure 2: Plan showing the position of the evaluation trenches and excavated areas superimposed on the footprint of the former farm buildings

- 1.2.3 Once the buildings at Chorlton Fold had been demolished, a further programme of archaeological investigation was then recommended by GMAU. OA North was commissioned by Nuttall Construction Ltd to undertake this work, which comprised an intrusive archaeological evaluation that aimed to assess the nature, extent, and significance of any buried archaeological remains found within the boundary of the proposed development. This scheme of investigation was undertaken in August 2007, and involved the excavation of seven evaluation trenches (Fig 2: Trenches 1-7).

- 1.2.4 During the course of the evaluation, it became clear that significant archaeological remains survived *in-situ* across the site. Following on-site discussions with the Greater Manchester County Archaeologist, it was recommended that these features merited further investigation, and detailed recording, in advance of their destruction. This additional phase of investigation comprised the excavation of three open-area trenches, in order to expose those areas of the site that appeared to contain significant archaeological remains (Fig 2). In addition, a further evaluation trench (Trench 8) was excavated in the north-eastern corner of the site (Fig 2). This phase of work was carried out by OA North in September 2007.
