Bourn Hall, Bourn – An Archaeological Watching Brief

Report No B005

Bourn Hall, Bourn – An Archaeological Watching Brief (TL 3219 5624)

**BOURN HALL, TL32195624,
BOURN,
CAMBRIDGESHIRE:
AERIAL PHOTOGRAPHIC ASSESSMENT**

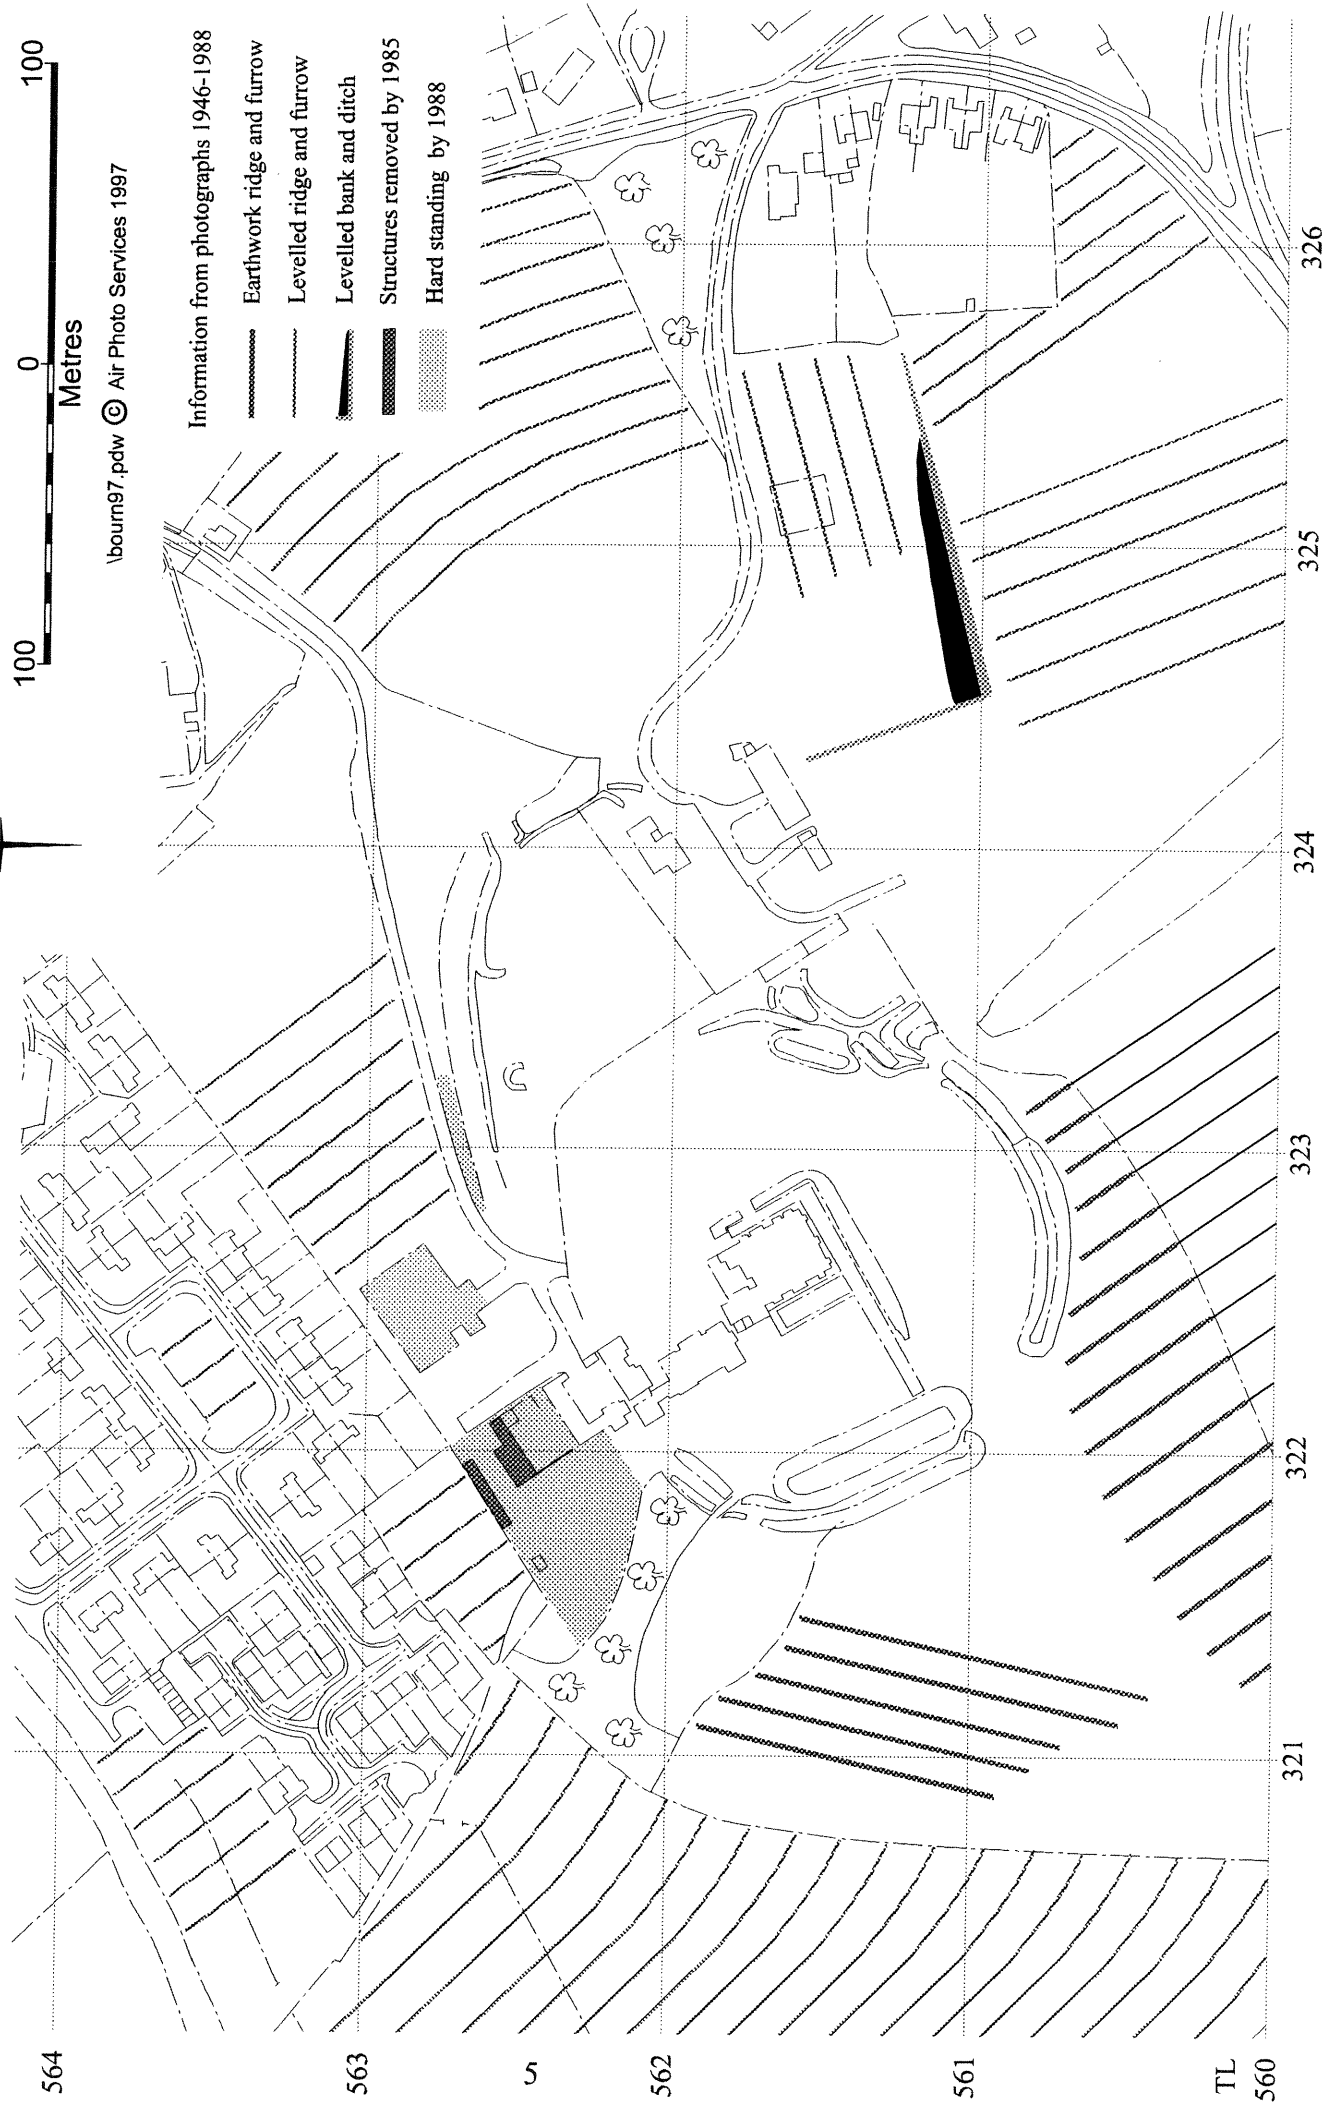
Figure 1. Bourn Hall: features identified from aerial photographs

Other than ridge and furrow and associated remains of medieval agriculture, this assessment has identified no archaeological features in the vicinity of Bourn Hall. Some of the medieval furlongs remained as slight earthworks at the last date of photography (1988) but even those will probably have been smoothed by parkland mowing.

Of relevance to the present assessment is the identification of former structures in the area to be developed. These comprised two buildings: one, clear of the assessment area, which abutted the present hedge line between Bourn Hall and houses to the north; the other adjoining buildings which remain standing. This latter structure formed one side (north) of a probable yard which was 'closed' by a wall (west) which contained an entrance. The remaining two sides (east and south) are still standing. Both former buildings were recorded on photographs from the 1930s until 1972. By 1983 that forming the north side of the yard, together with the west wall, had been demolished and the area converted to what is presumably a hard-standing car park. The structure against the northern hedge line was standing in 1983 but was not identified on 1985 photographs.

One other point of note, although not of relevance to this present assessment, is a recently (by 1985) added hard standing parking area between the access road to Bourn Hall and the bailey of the former earthwork (at TL32305627). It is possible that this may impinge on the remaining earthwork ditch and cause erosion to its edge.
