# MID CHESHIRE PHASE 2 PIPELINE, EATON BOREHOLE TO NANNEY'S BRIDGE, Cheshire

Walkover,  
Topographic Surveys  
and Evaluation -  
Supplementary  
Report

December 2009

**United Utilities**

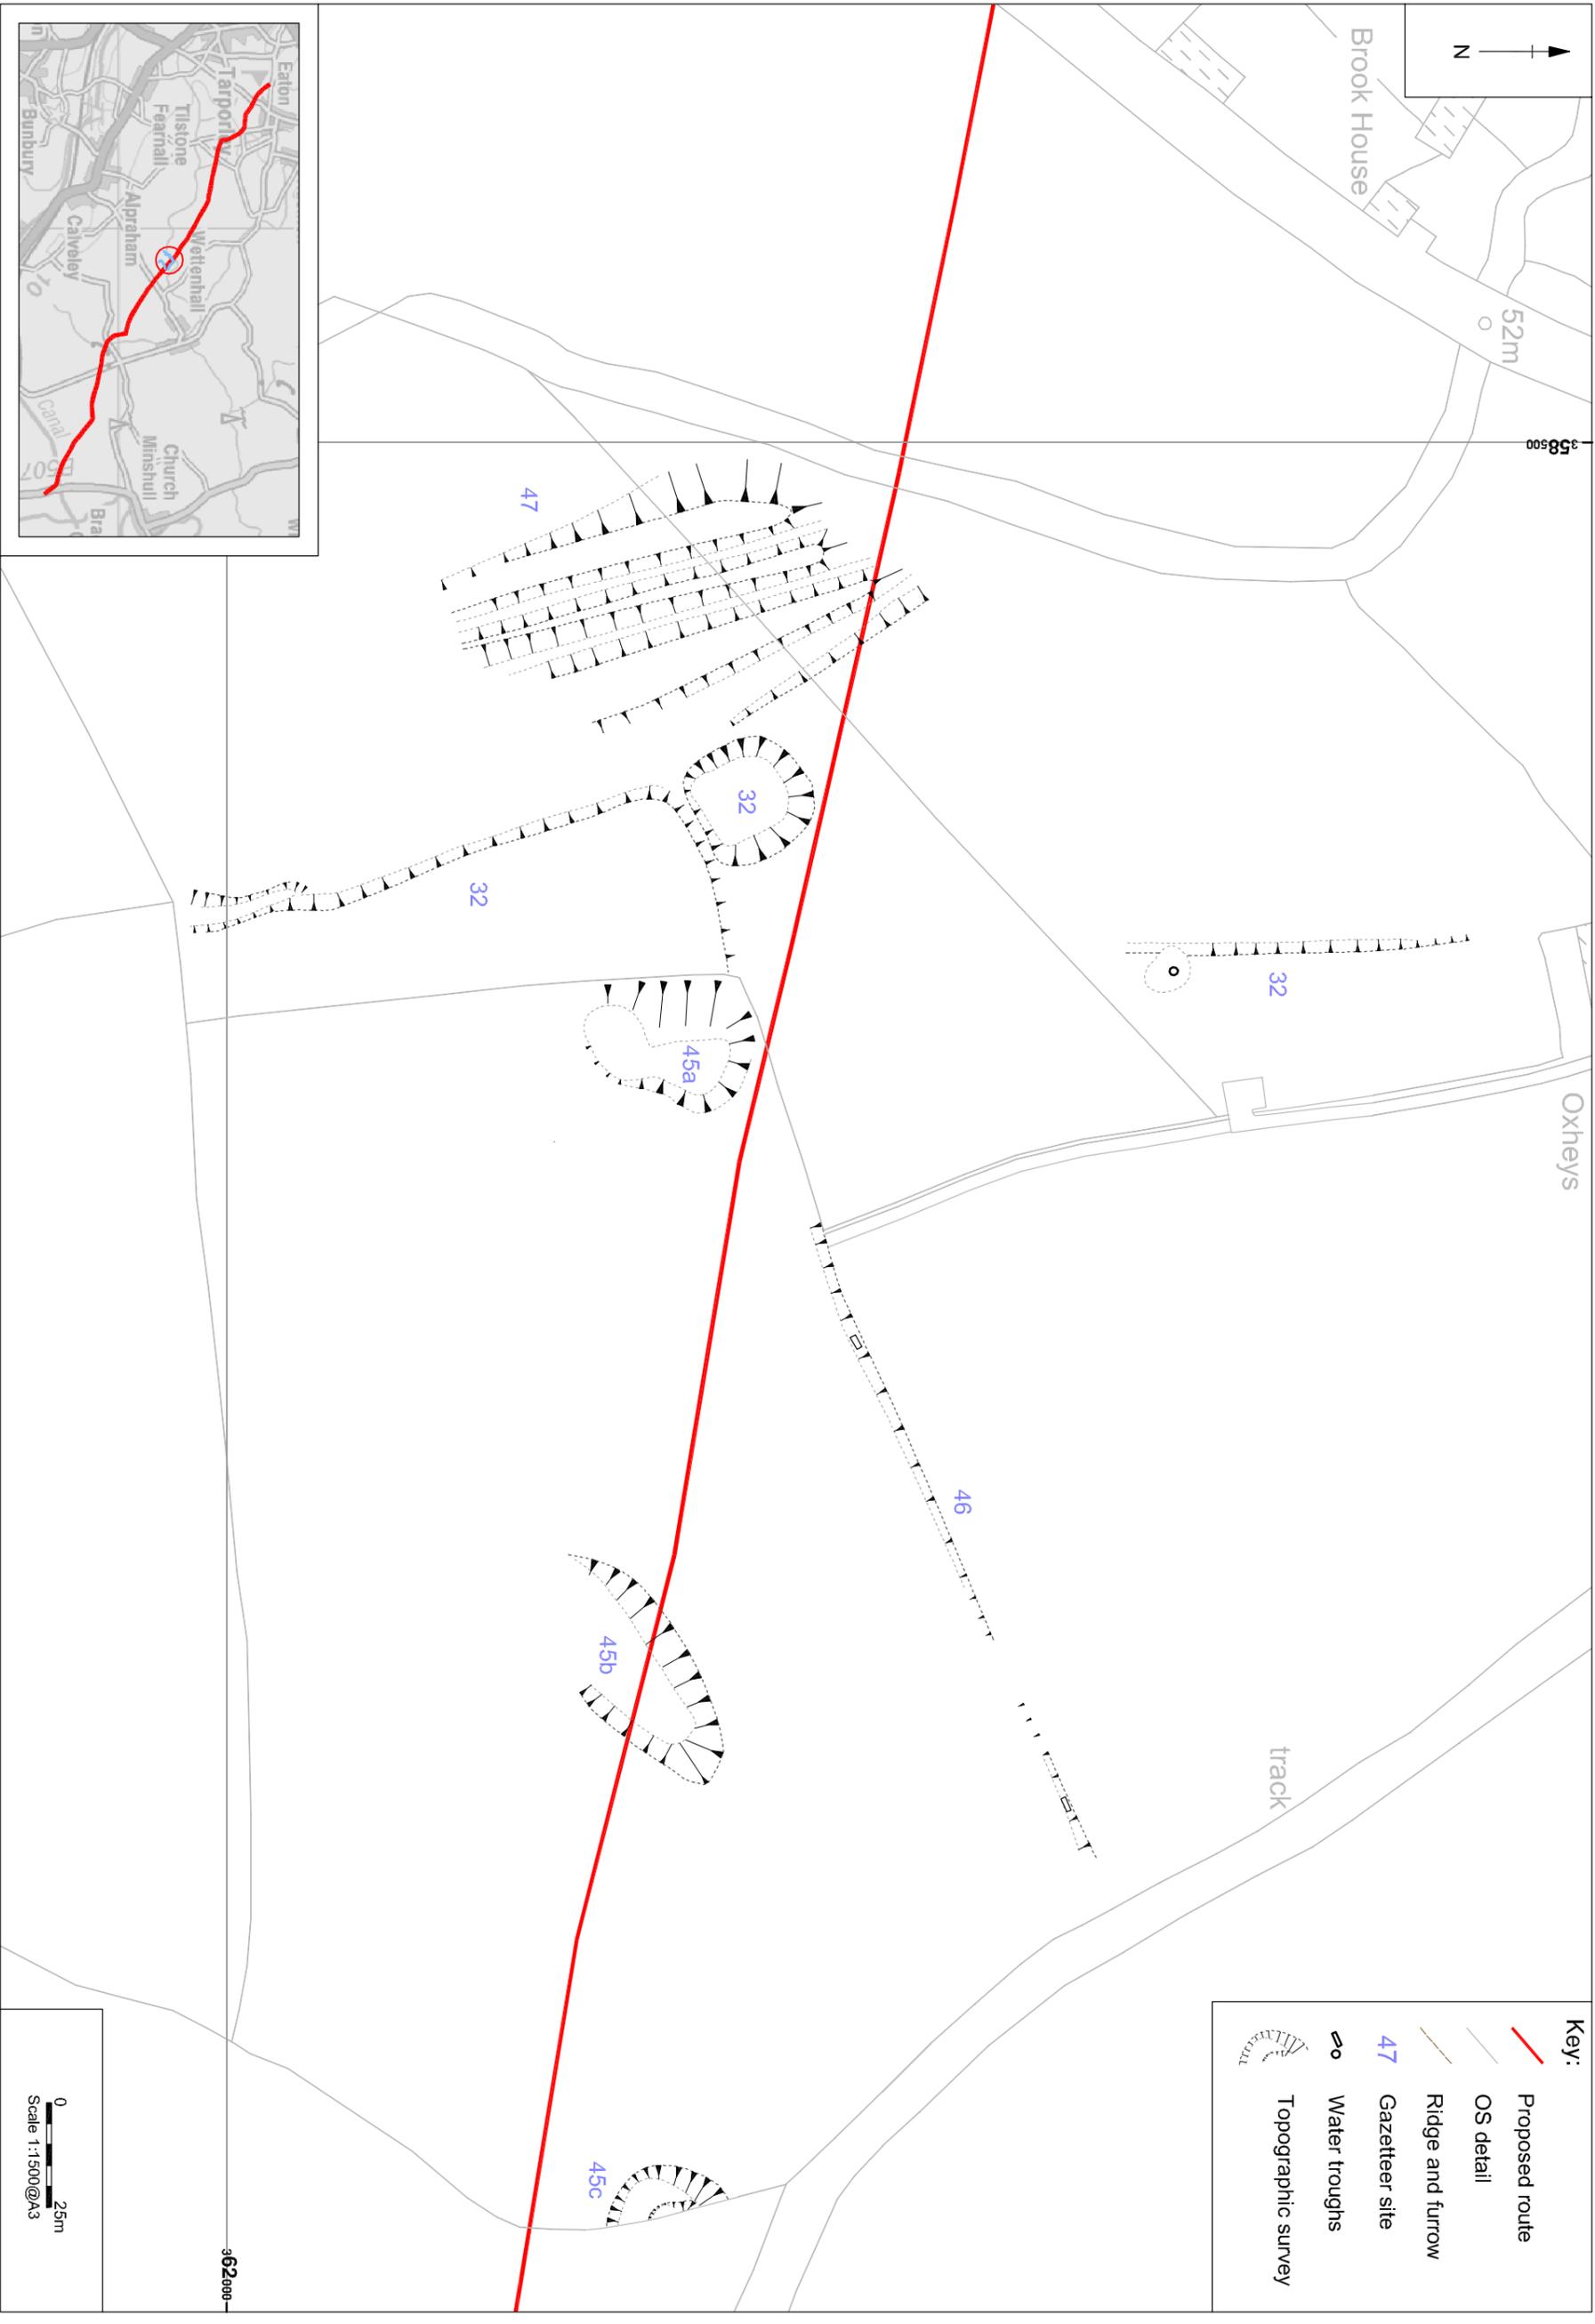
Figure 3: Topographic detail of Sites 32, and 45 to 47

6.2.3 **Site 45:** (Fig 3; Plates 3 and 4) was first interpreted as an irregular bank running across Field 43. On closer inspection during the topographic survey, it was concluded that the earthworks was actually three marl pits, each being in a different condition. The marl pit to the east, Site **45a**, had been truncated by a modern field boundary, and measured roughly 40m in diameter. The central pit, Site **45b**, was approximately 65m by 25m, and denuded to the south-west, while the western pit, Site **45c**, was roughly figure-of-eight in shape, and measured 70m by 30m. It appeared to respect the field boundary to the north and west (Site **46**). Again, all the pits were filled with water.

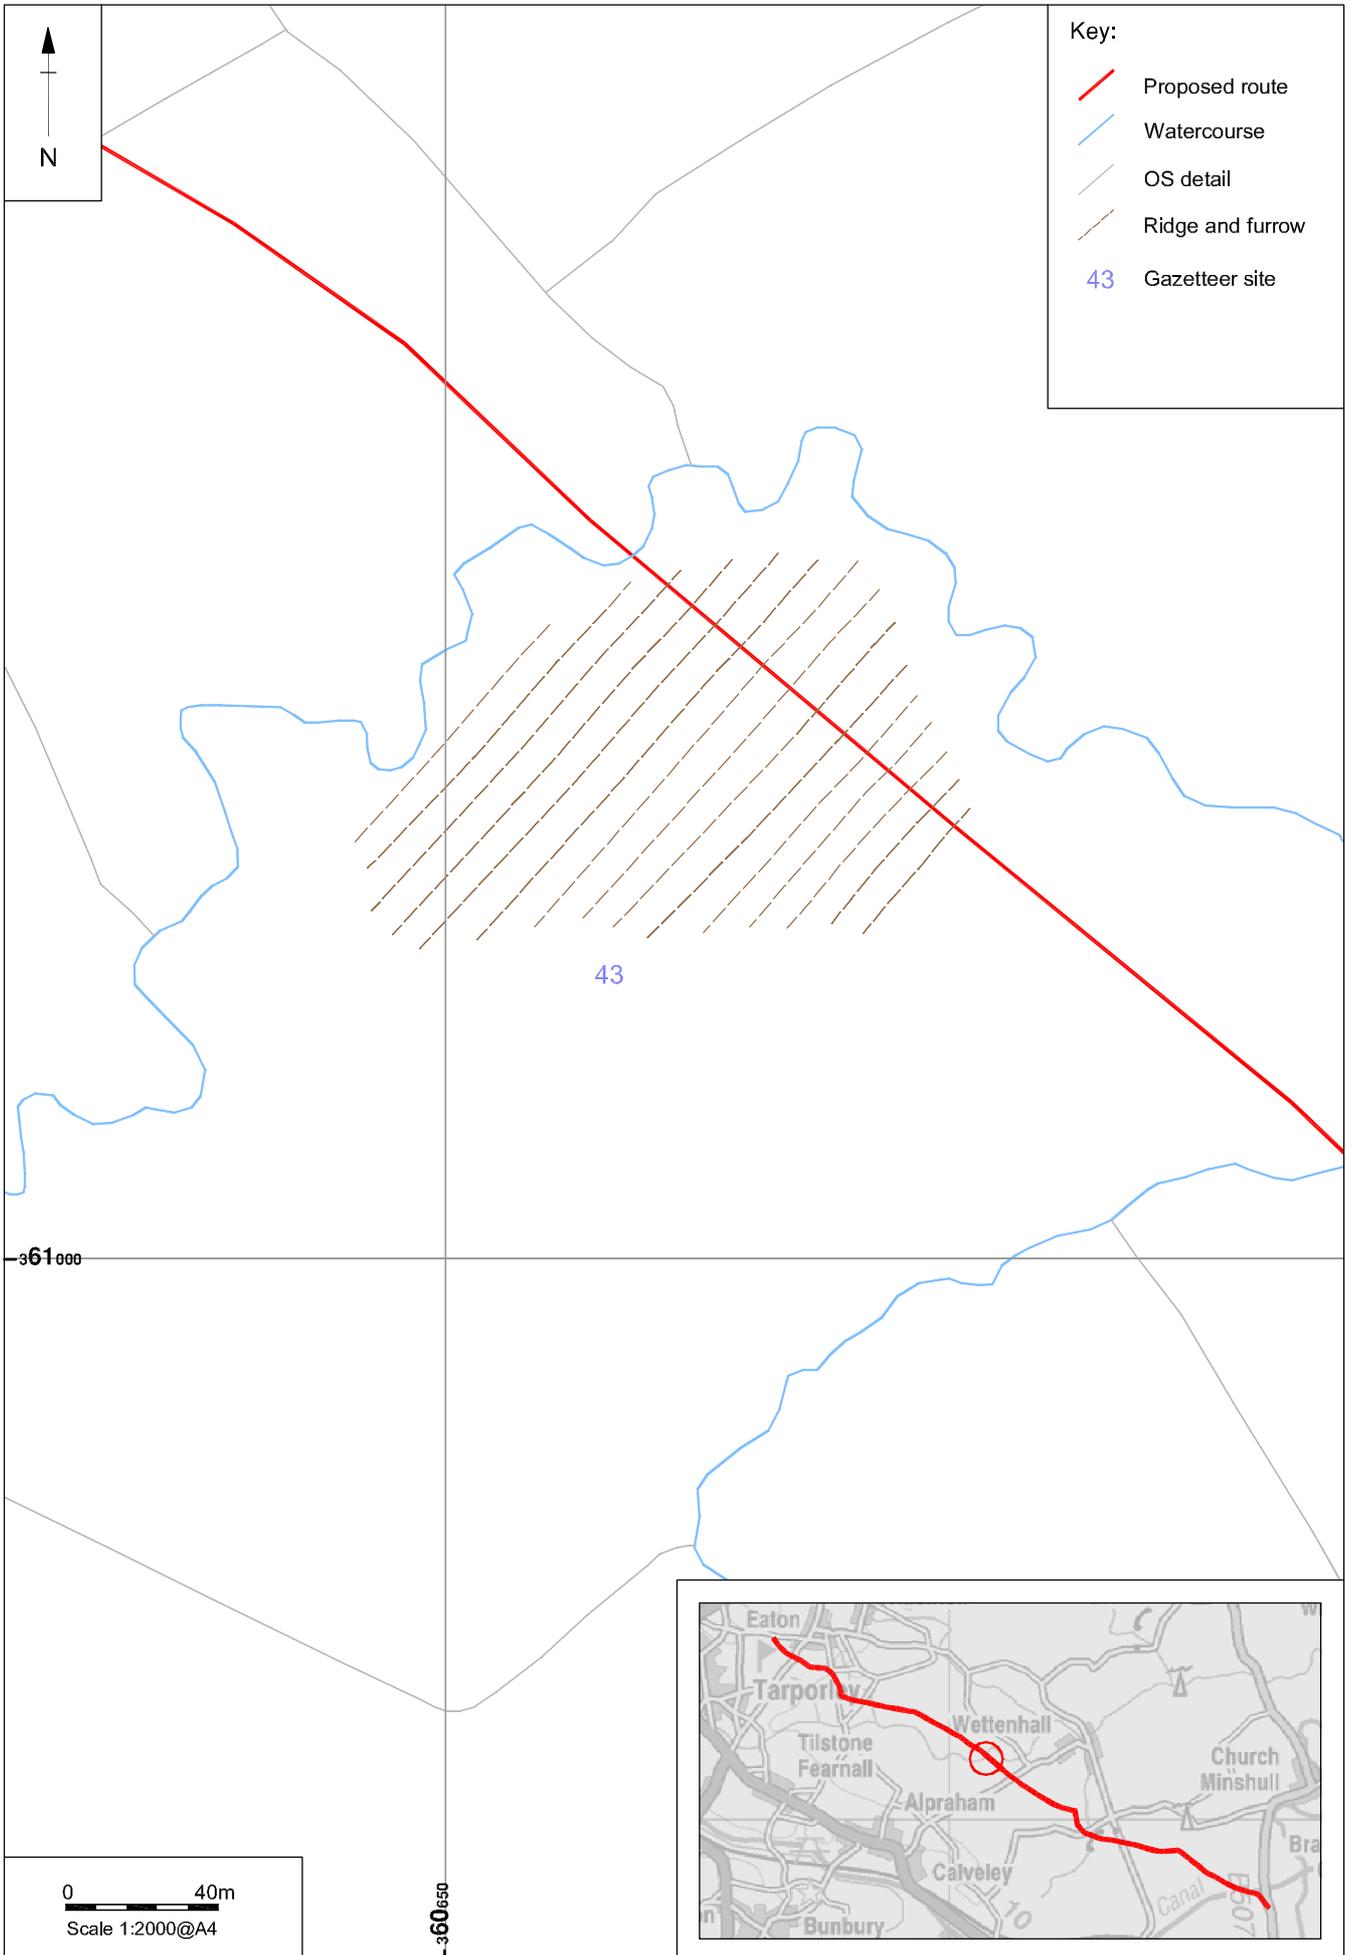
Figure 4: Topographic detail of Site 43

6.2.2 **Site 43:** (Fig 4) was an area of ridge and furrow initially identified in Field 30, but during the topographic survey was found to extend into Field 43 to the north-east. It comprises heavily denuded but regular, post-medieval ridge and furrow, with the crests measuring approximately 7m apart. It has been truncated by later marl pits, Site **45**.

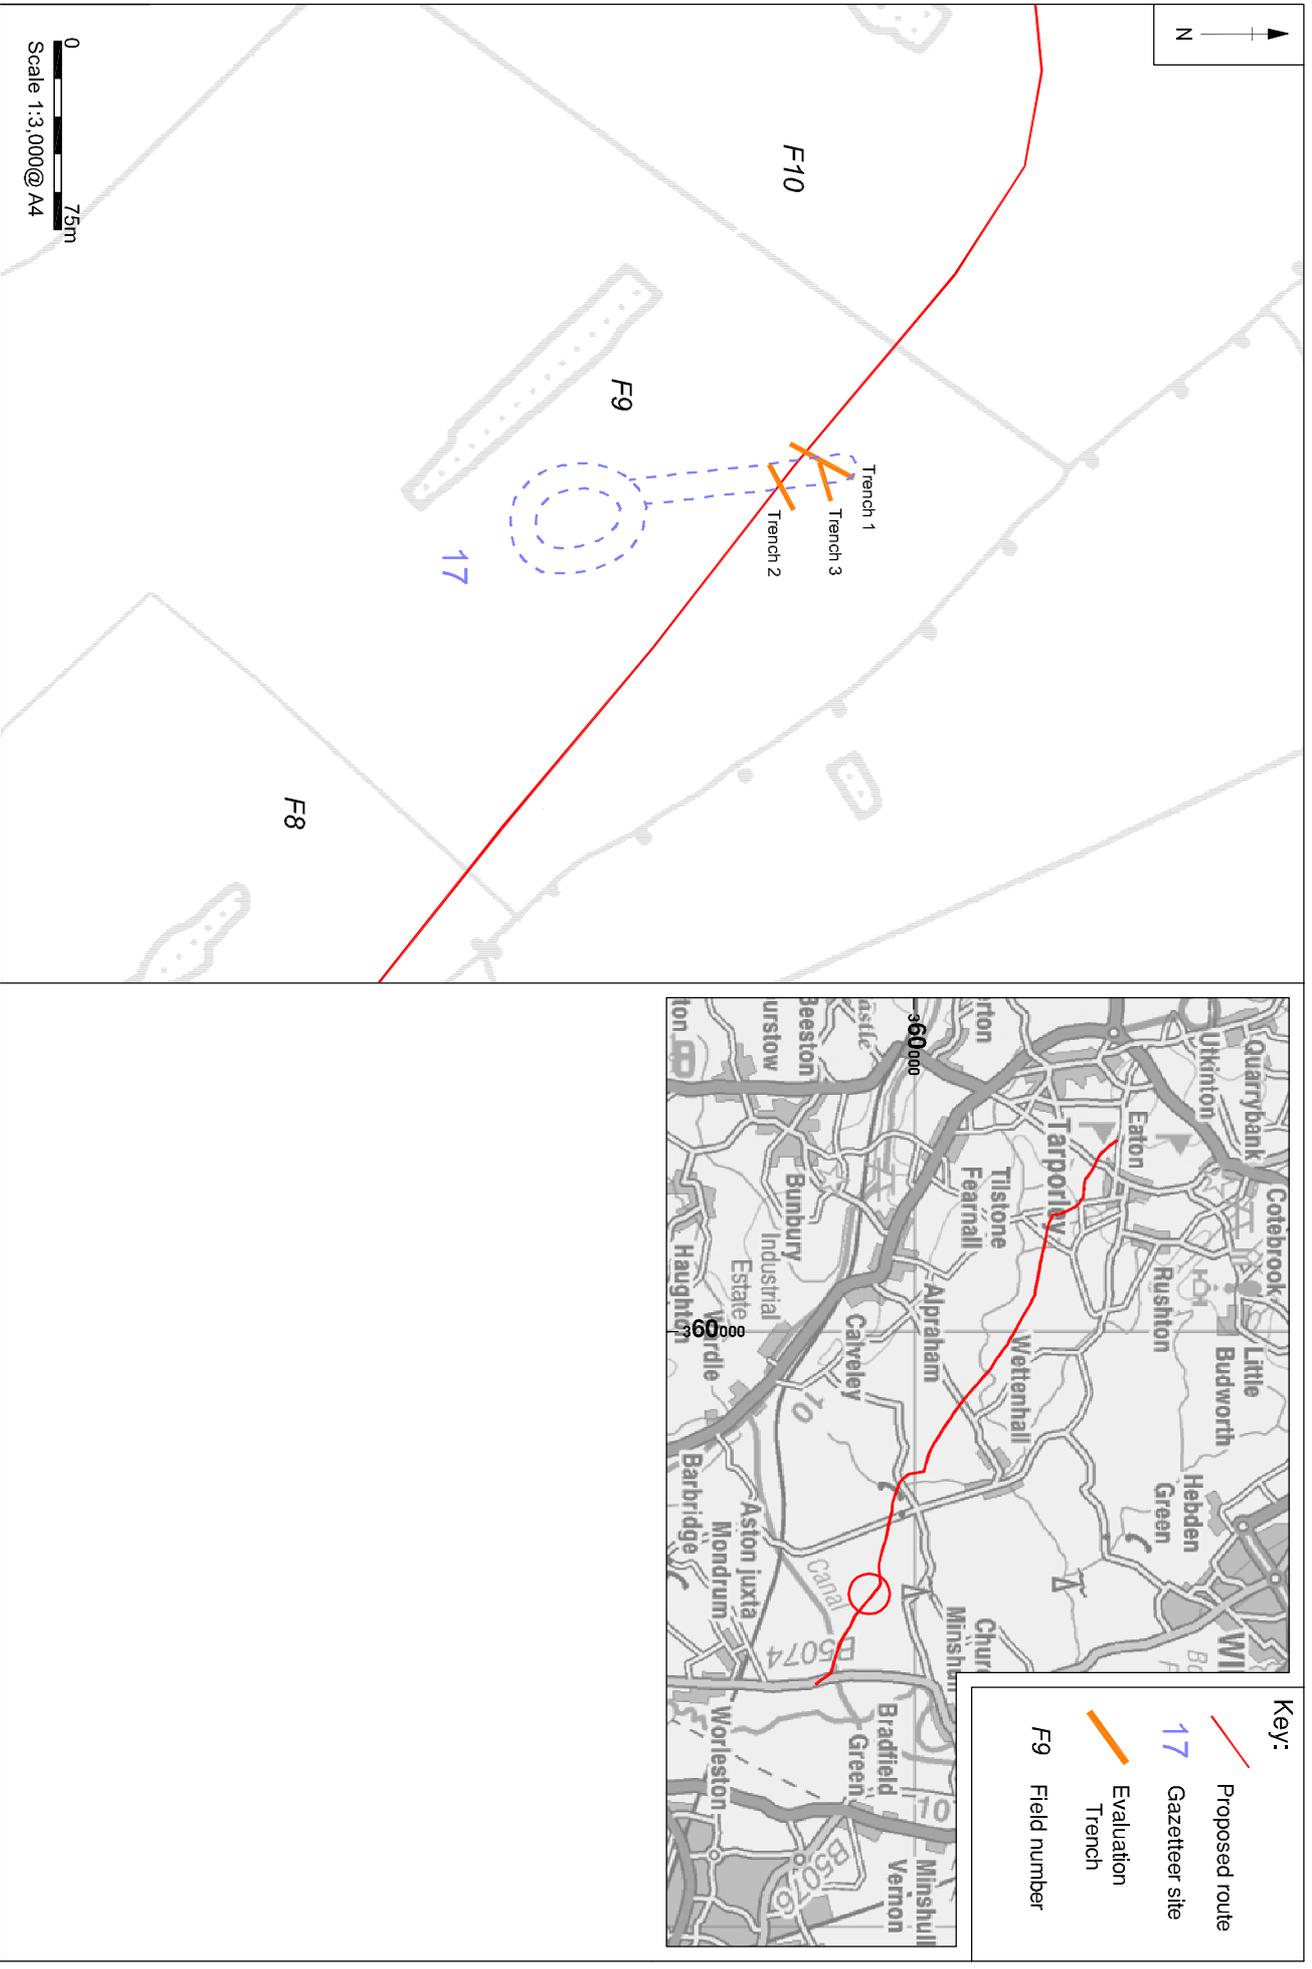
Figure 5: Site 17 evaluation trenches

- 7.1.5 Trench 1 was aligned north-east/south-west for a length of 28.50m. It was excavated to an average depth of 0.30m with a deeper slot at the north-east end to 0.55m. This was inserted to ensure that natural deposits had been reached. No archaeological features were observed.

- 7.1.6 Trench 2 was aligned almost east/west 10.00m from the south-west end of Trench 1. It had a length of 20.50m and depth of 0.30m. A possible linear feature was observed running north/south towards the centre of the trench but after a slot was inserted by machine at the north-east to a depth of 0.40m it was deemed to be a variation in the colour of the natural. No archaeological features were observed.

- 7.1.7 Trench 3 ran parallel to the north-east of Trench 2 and truncated the south-east section of Trench 1. It was 16.00m in length and 0.32m in depth. A slightly more frequent collection of rounded pebbles was present at the western end within the natural. No archaeological features were observed.

7.2.1 The earthwork enclosures (Site **17** and **34**) as identified from aerial photographs (OA North 2007) were not detected during the walkover survey, and the subsequent evaluation failed to find any physical evidence. It is possible that the remains of the enclosures have been removed by agricultural activities such as ploughing.

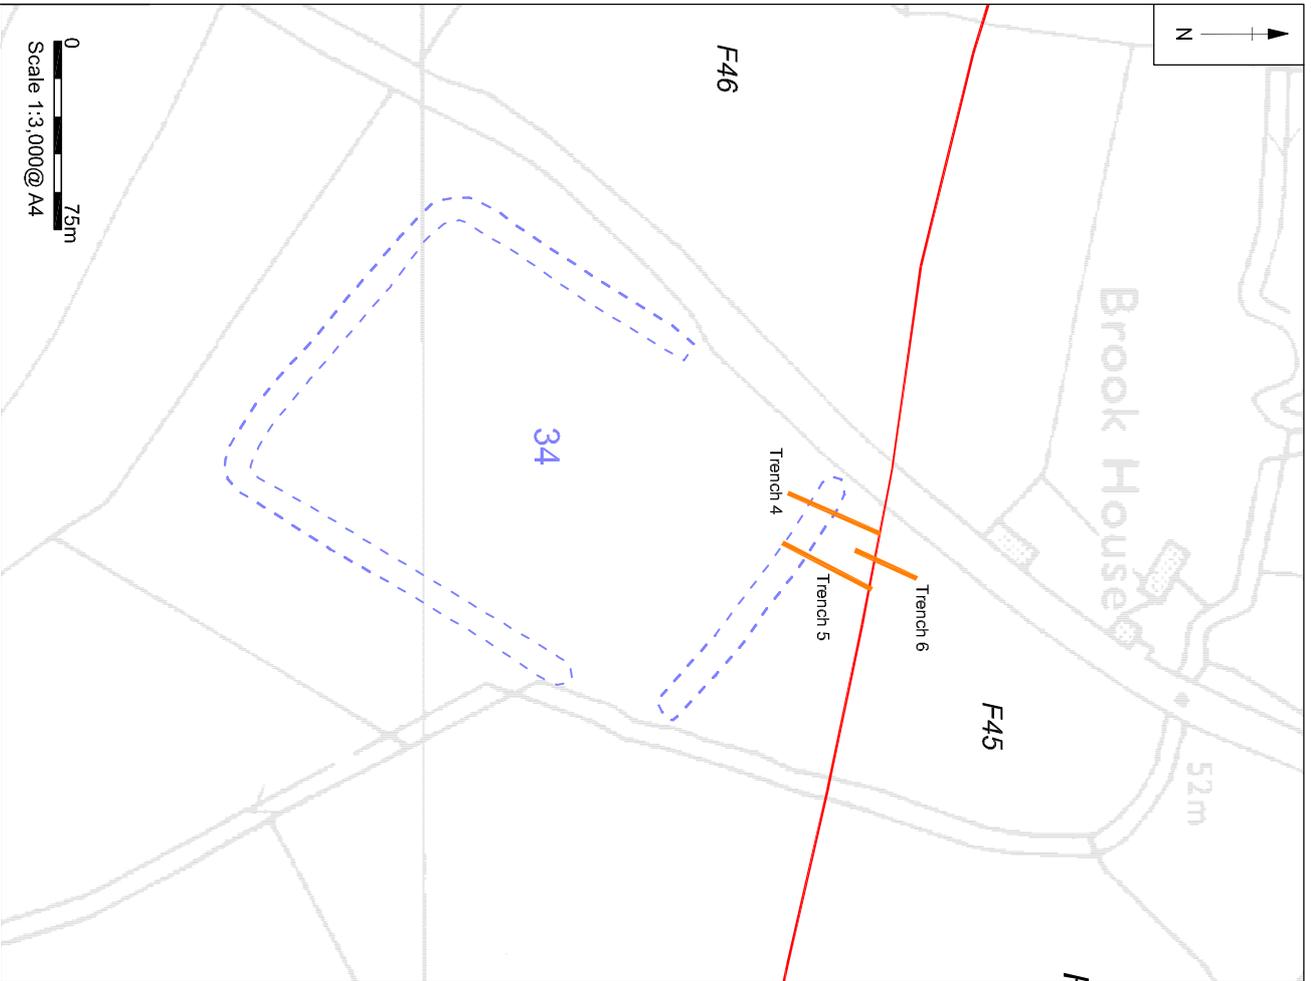
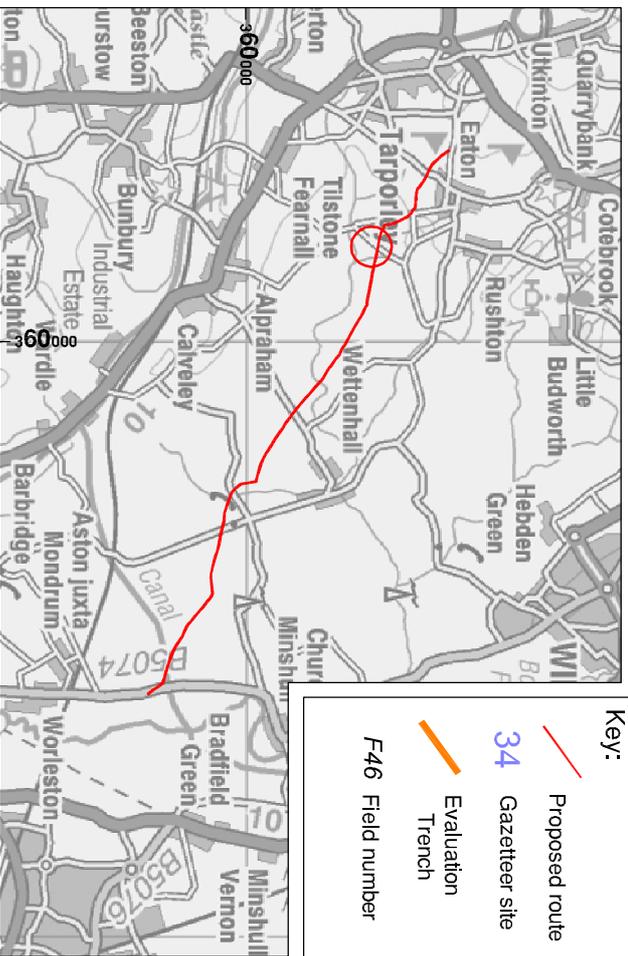
Figure 6: Site 34 evaluation trenches

- 7.1.11 Trench 4 was aligned north-east/south-west, had a length of 40.00m and a depth of 0.40m. Two field drain trenches, aligned east/west and north/south were exposed. Both were 0.25m wide and infilled with a mixture of topsoil and clay. As the actual drain was not reached and the cut was so uniform it was presumed that the drains were inserted by machine and were not of archaeological interest. Nothing of archaeological significance was observed.

7.1.14 Trench 6 was aligned the same as Trench 4 and Trench 5 and was between the two but was shorter at 27.00m and was placed further to the north. Like the other trenches in Field 45 it was excavated to 0.40m but a deeper slot was put in to the south-west extent to 0.60m. This determined that the clay revealed was indeed natural and it was not necessary to excavate further. One field drain was exposed and may have been the continuation to the north-east of that seen in Trench 5 due to its position and alignment. Nothing of archaeological significance was observed.

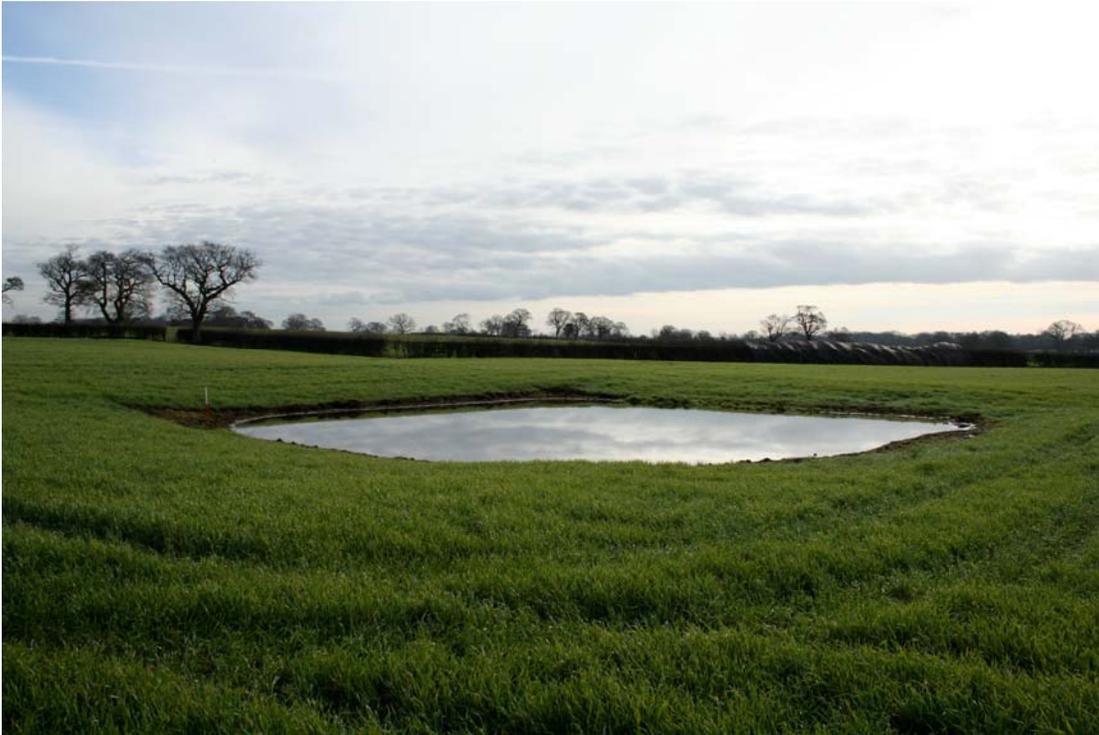
Plate 1: Flooded marl pit (Site **32**), facing east

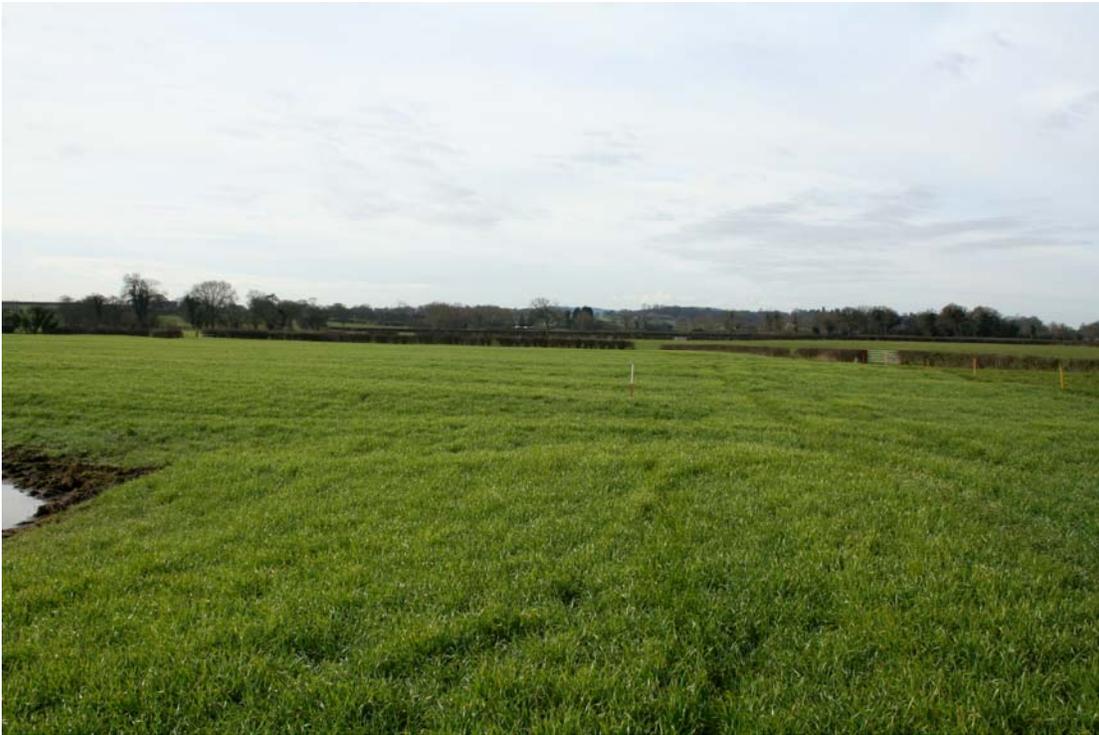
Plate 2: Ridge and furrow (Site **47**), facing south-west

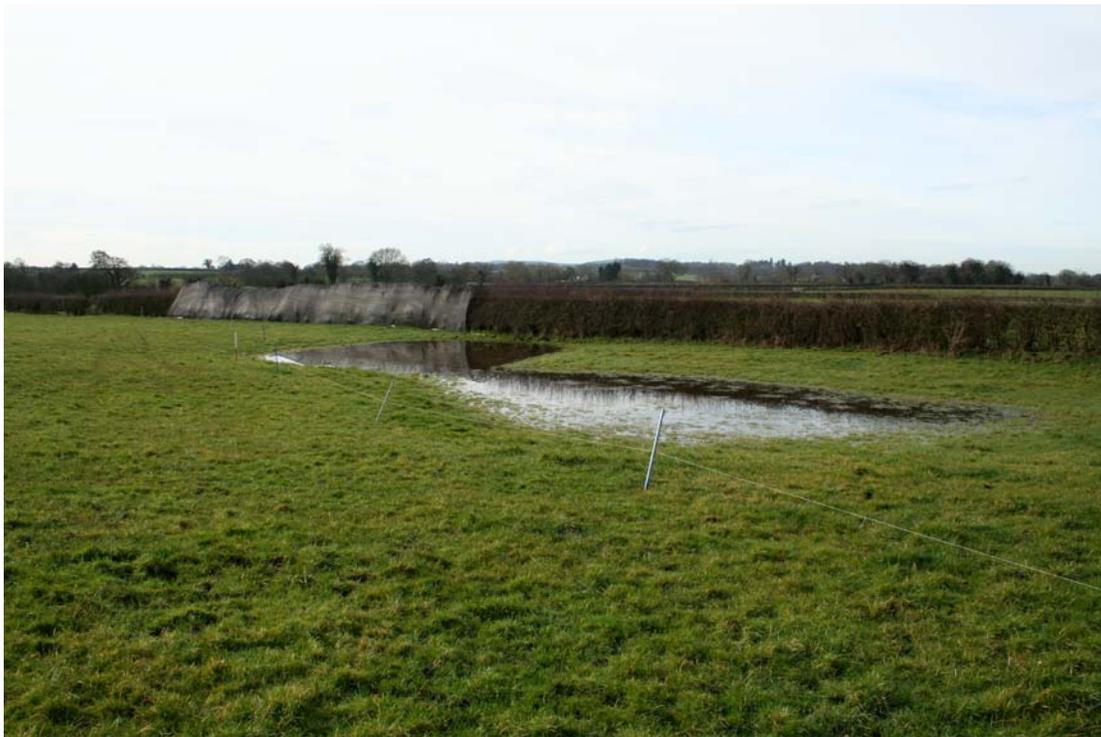
Plate 3: Flooded marl pit (Site **45**), figure- of - eight shaped, facing west

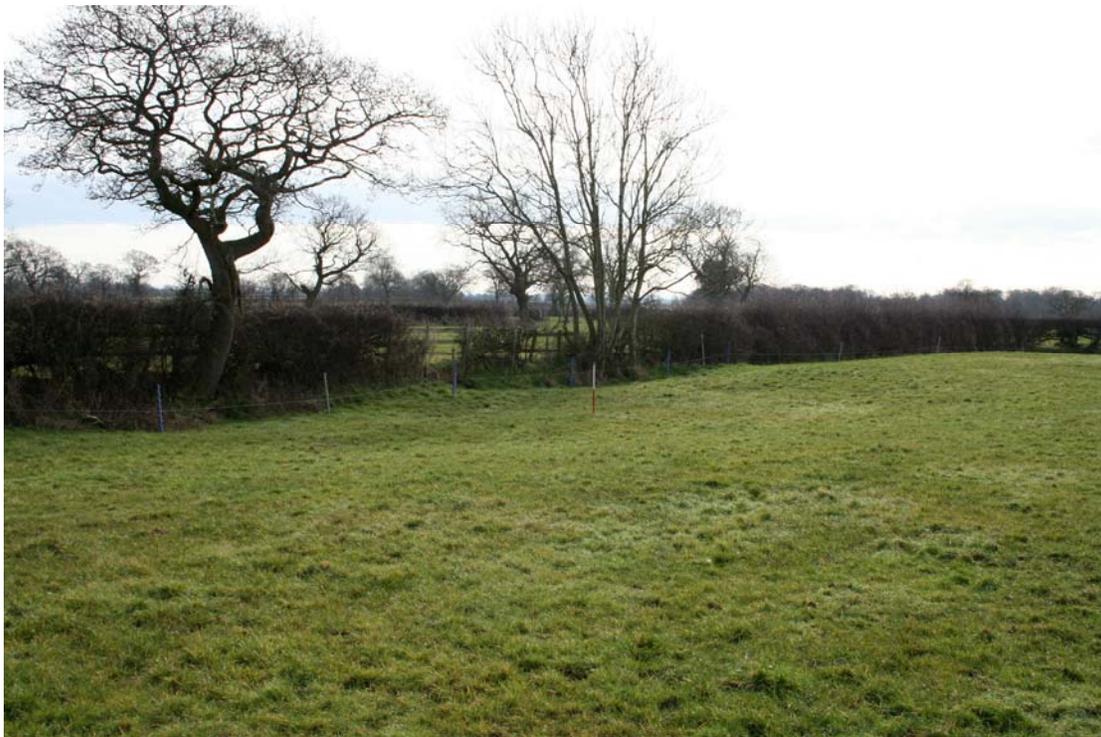
Plate 4: Part of marl pit (Site **45**), facing east
