No 18 York St, Clitheroe, Lancashire

Archaeological Building Investigation

Oxford Archaeology North

August 2007

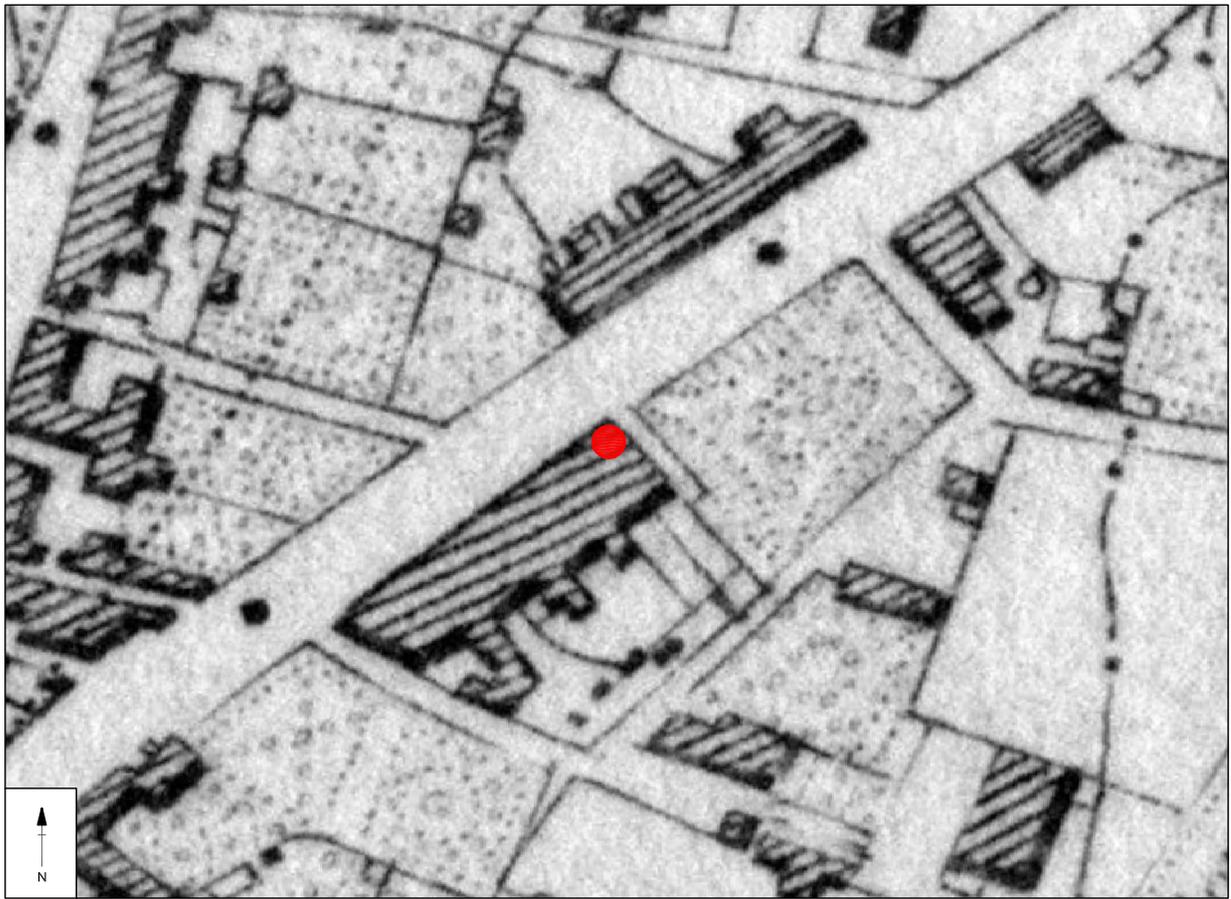
Figure 2: Extract from Ordnance Survey First Edition Map, 1847, 6": 1 Mile series

3.2.1 *Ordnance Survey first edition 6" map 1847 (Fig 2)*: this is the earliest map of Clitheroe, and it clearly illustrates the building in question. It is situated at the end of a terrace of buildings and appears to have a long garden plot (in common with No 16). Some of the properties in the terrace extend further back into these plots.

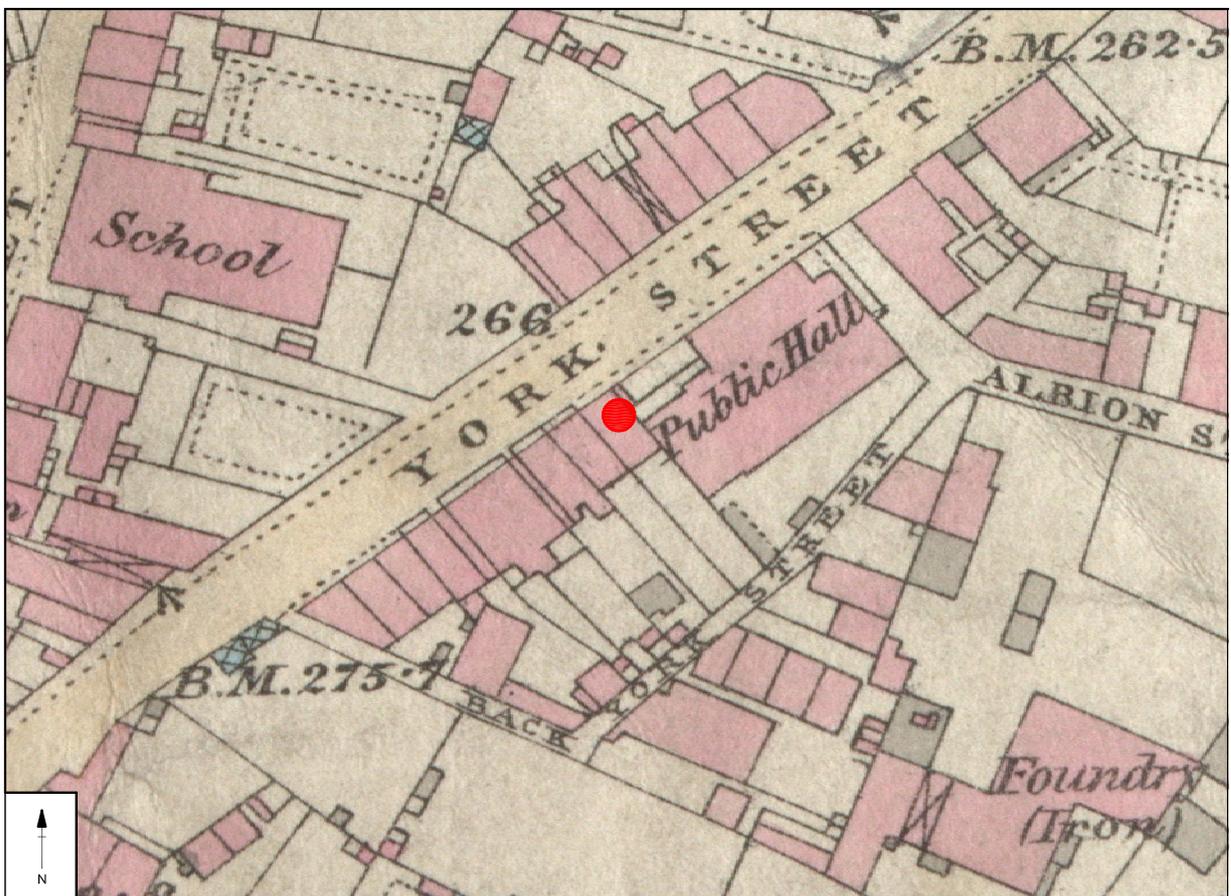
Figure 3: Extract from Ordnance Survey First Edition Map, 1886, 1:2500 series

3.2.2 *Ordnance Survey first edition 25" map 1886 (Fig 3)*: by this date a plot of empty land, situated to the east of the terrace, has been developed and a building labelled 'Public Hall' now stands on the site. This building has a similar footprint to the current structure, the former Grand Cinema, which is undergoing development as part of The Grand at Clitheroe project. Additional buildings illustrated include Albion Mill and Brooks Mill. Number 18 York Street remains unaltered and is shown as having a long garden plot to the rear.

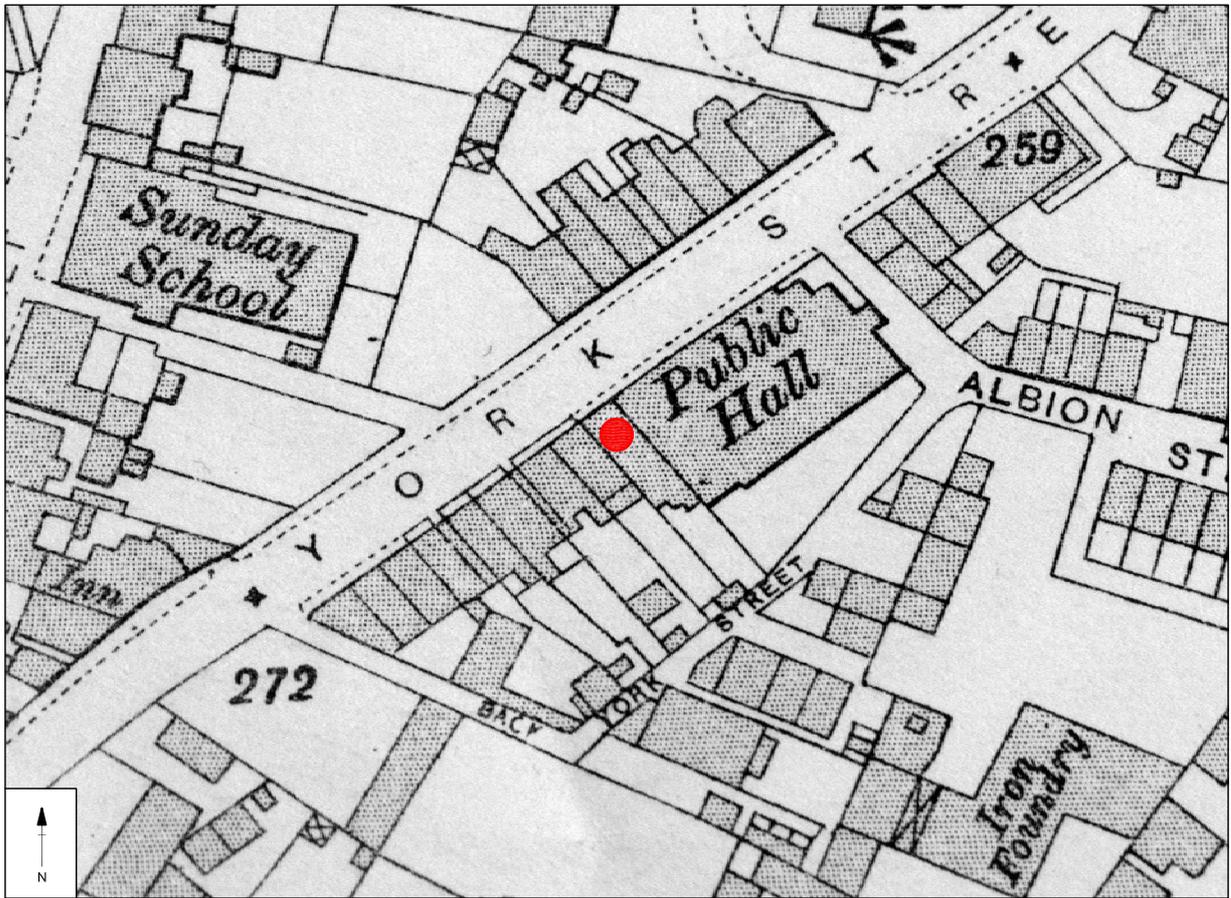
Figure 4: Extract from Ordnance Survey Second Edition Map, 1912, 1:2500 series

3.2.3 *Ordnance Survey second edition 25" map 1912 (Fig 4)*: this map shows Number 18 as having an extended footprint at this time, which almost certainly relates to the building having been extended at some prior to this date but since 1886. The backyard is smaller and the rear of building is now almost level with the adjacent public hall. Number 17 also appears to have been extended rearward. Other development in the area is fairly small-scale, with the notable addition of a row of terraced properties on Albion Street. Interestingly, the footprint of the public hall has changed slightly, which is at odds with its current layout.

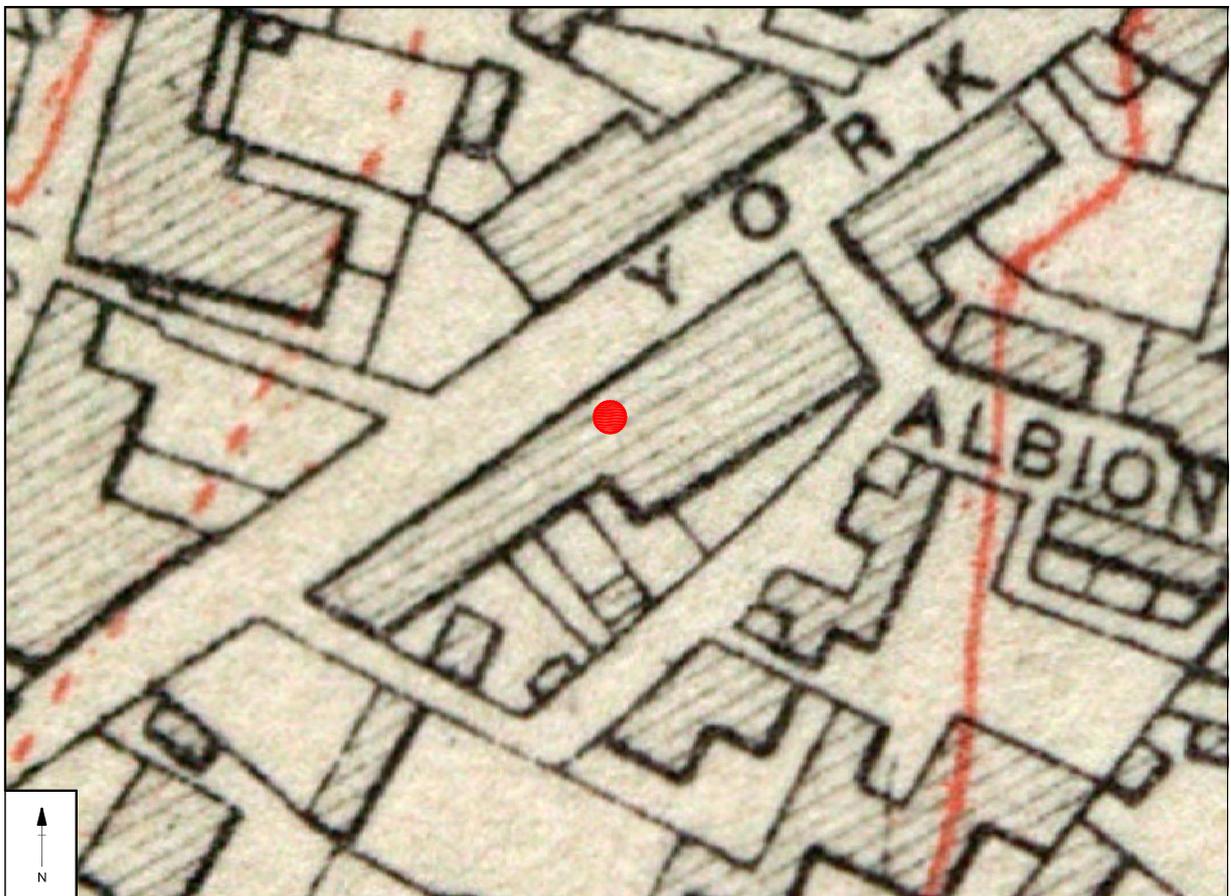
Figure 5: Extract from Ordnance Survey Second Edition Map, 1914, 1:2500 series

3.2.4 *Ordnance Survey 1914 (Fig 5)*: this map is not as detailed as the 1912 map but it does illustrate the rear of the public hall (not labelled) and Number 18 as being on the same alignment. The eastern boundary of the backyard of Number 18 is illustrated.

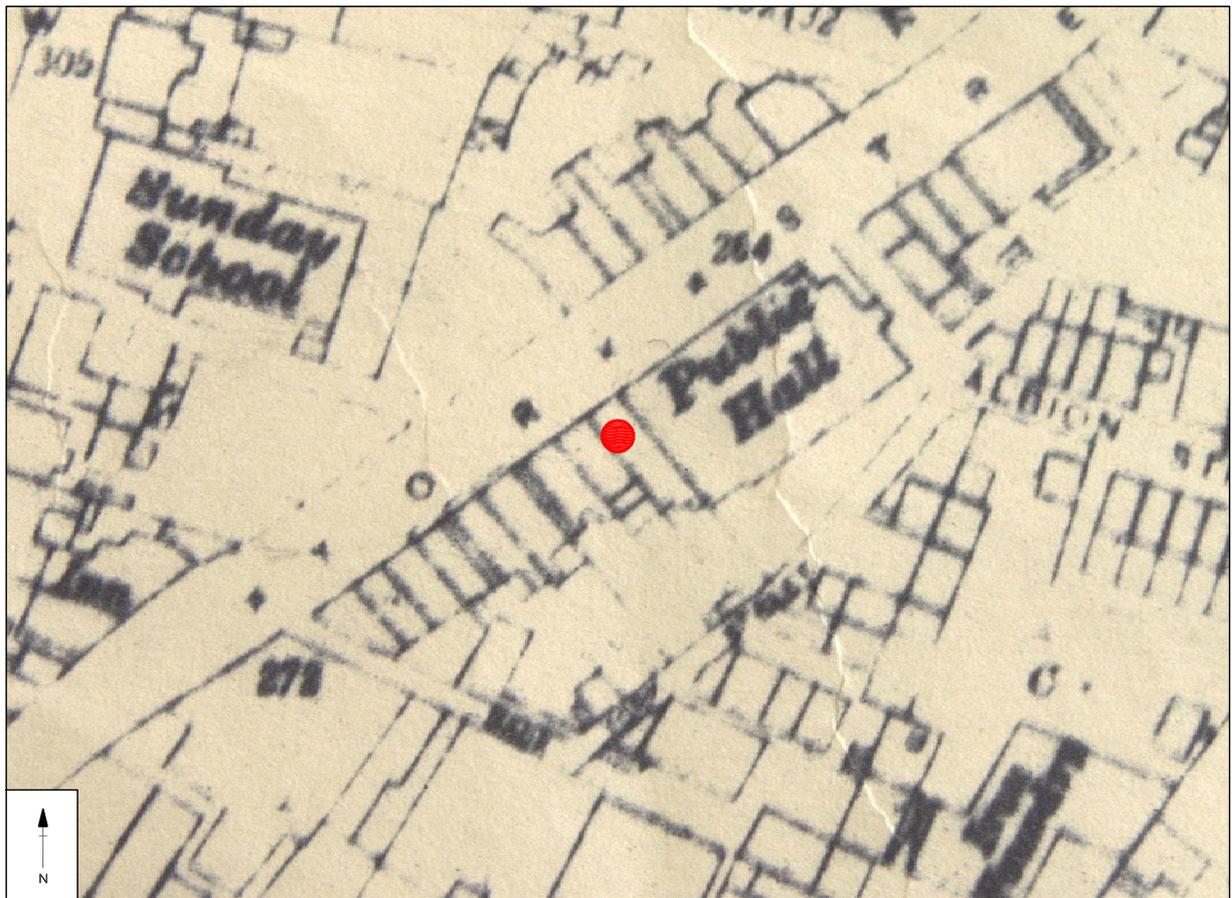
Figure 6: Extract from Ordnance Survey Third Edition Map, 1932, 1:2500 series

3.2.5 *Ordnance Survey 1932 (Fig 6)*: this is a poor quality map and the detail is almost identical to that on the 1912 map (Fig 4). This suggests that no major changes occurred in the intervening period.

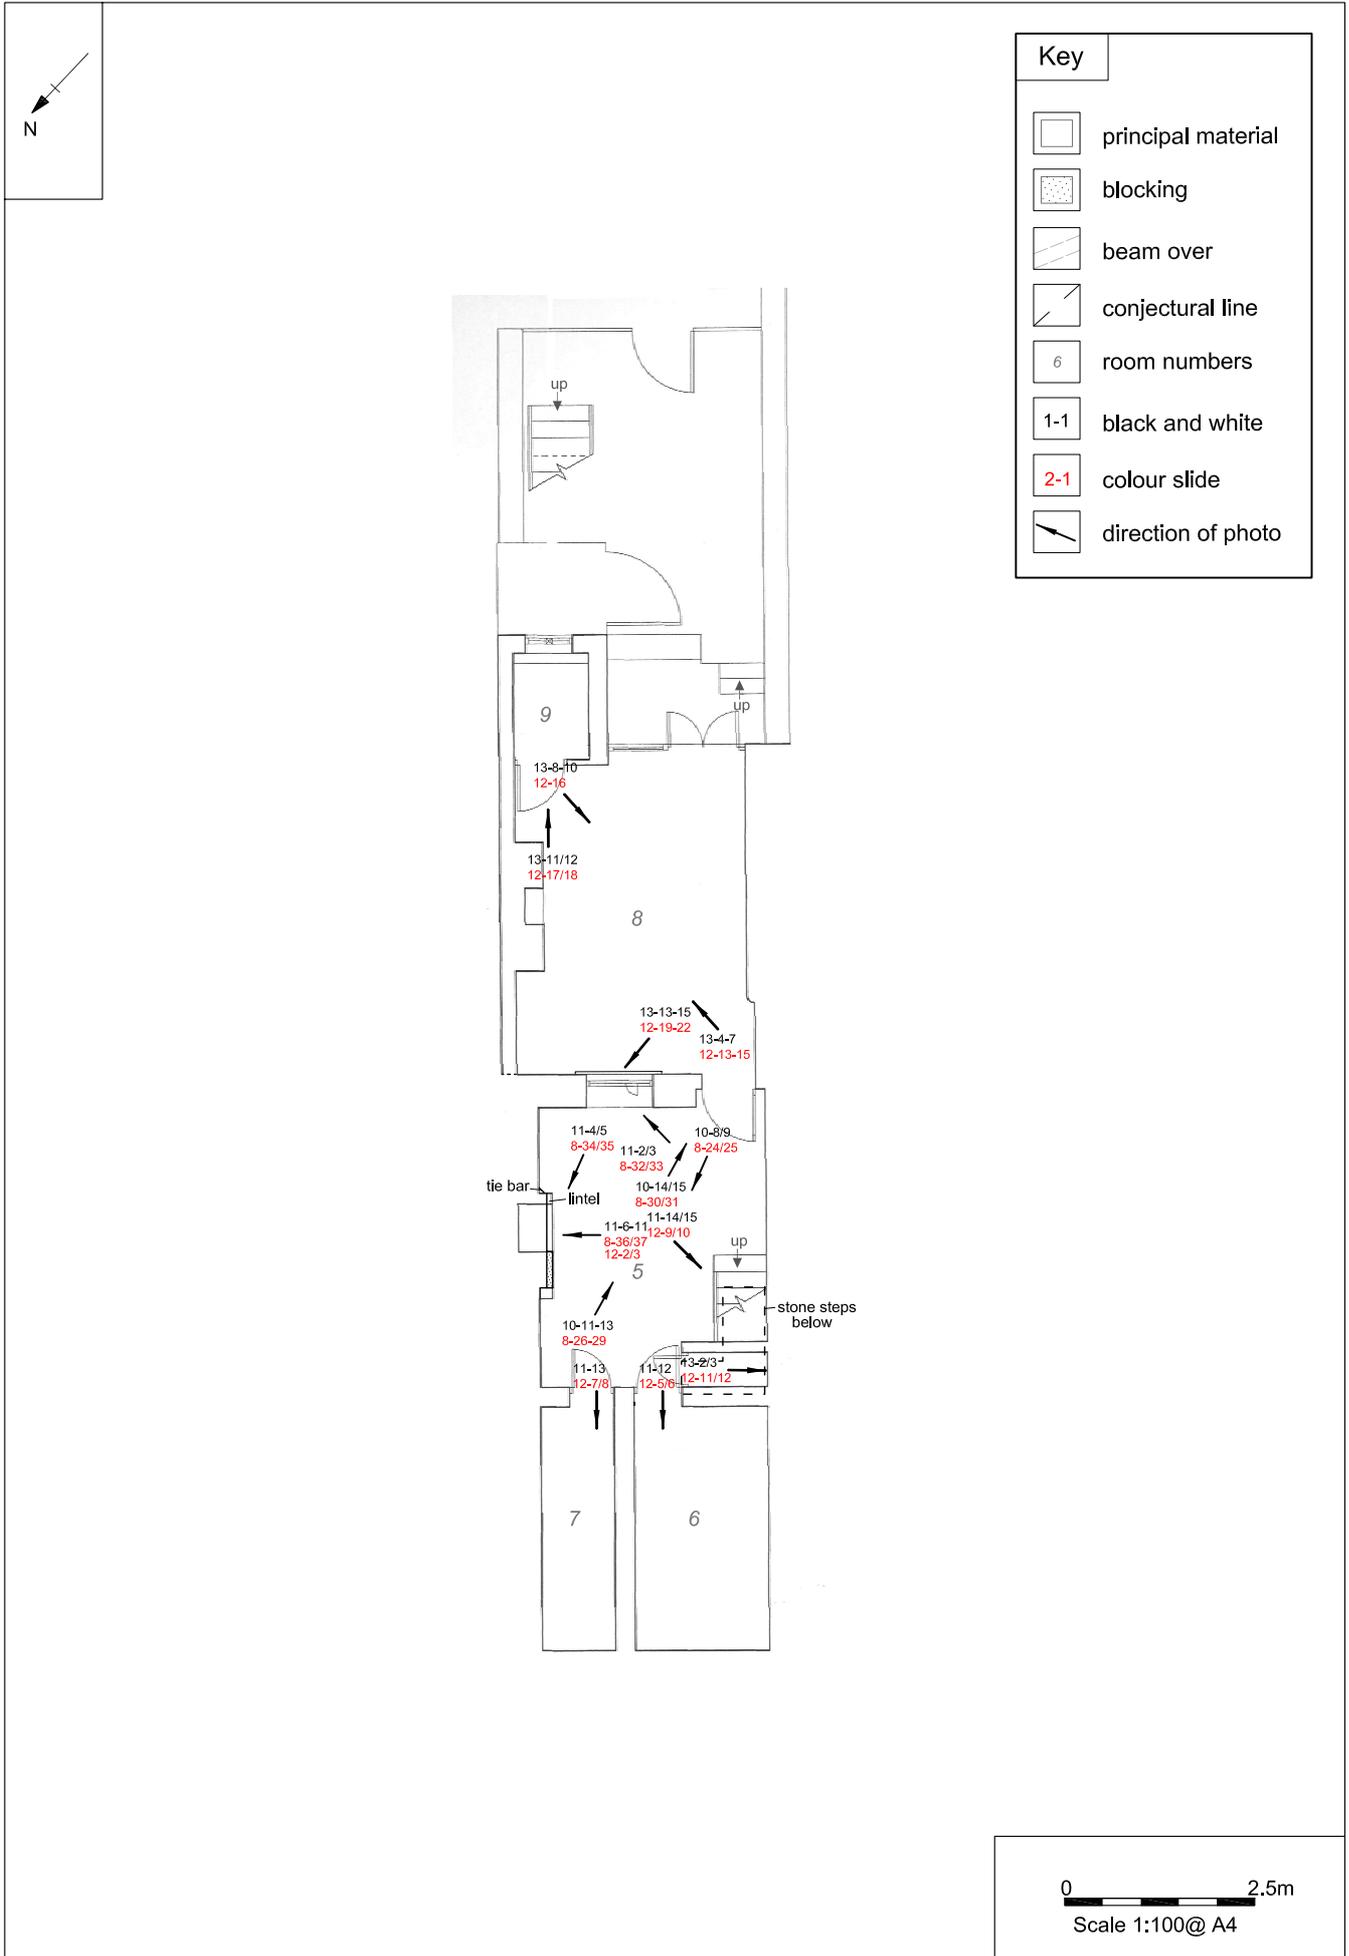
Figure 7: Basement Plan

- 4.2.2 The house is a single room wide (approximately 4.5m or 14 ft) and is three rooms deep (excluding the staircase and landings) on the basement (Fig 7), ground (Fig 8) and first floors (Fig 9). The second floor is two rooms deep (Fig 10). Partition walls divide some of the rooms into smaller units. The staircase is located behind the front rooms, and allows access to all of the floors. It is clear that the house has been extended to the rear at some time, and that the original structure was only two rooms deep (10m or 33 ft) on all floors (see *Section 3.2* and *5.2*). Access to the house is via the front door on York Street or via a back door, which leads directly into the basement.

- 4.5.21 **Room 6 Store:** this room is located in the north-west corner of the basement and is only able to be accessed via Room 5 (Fig 7). It is, for the most part, a plain windowless rectangular room with few distinguishing features. It is plain plastered and exhibits areas of plaster repair with cement. The ceiling is lath and plaster and is the same height as the ceiling in Room 5. The floor is concrete.

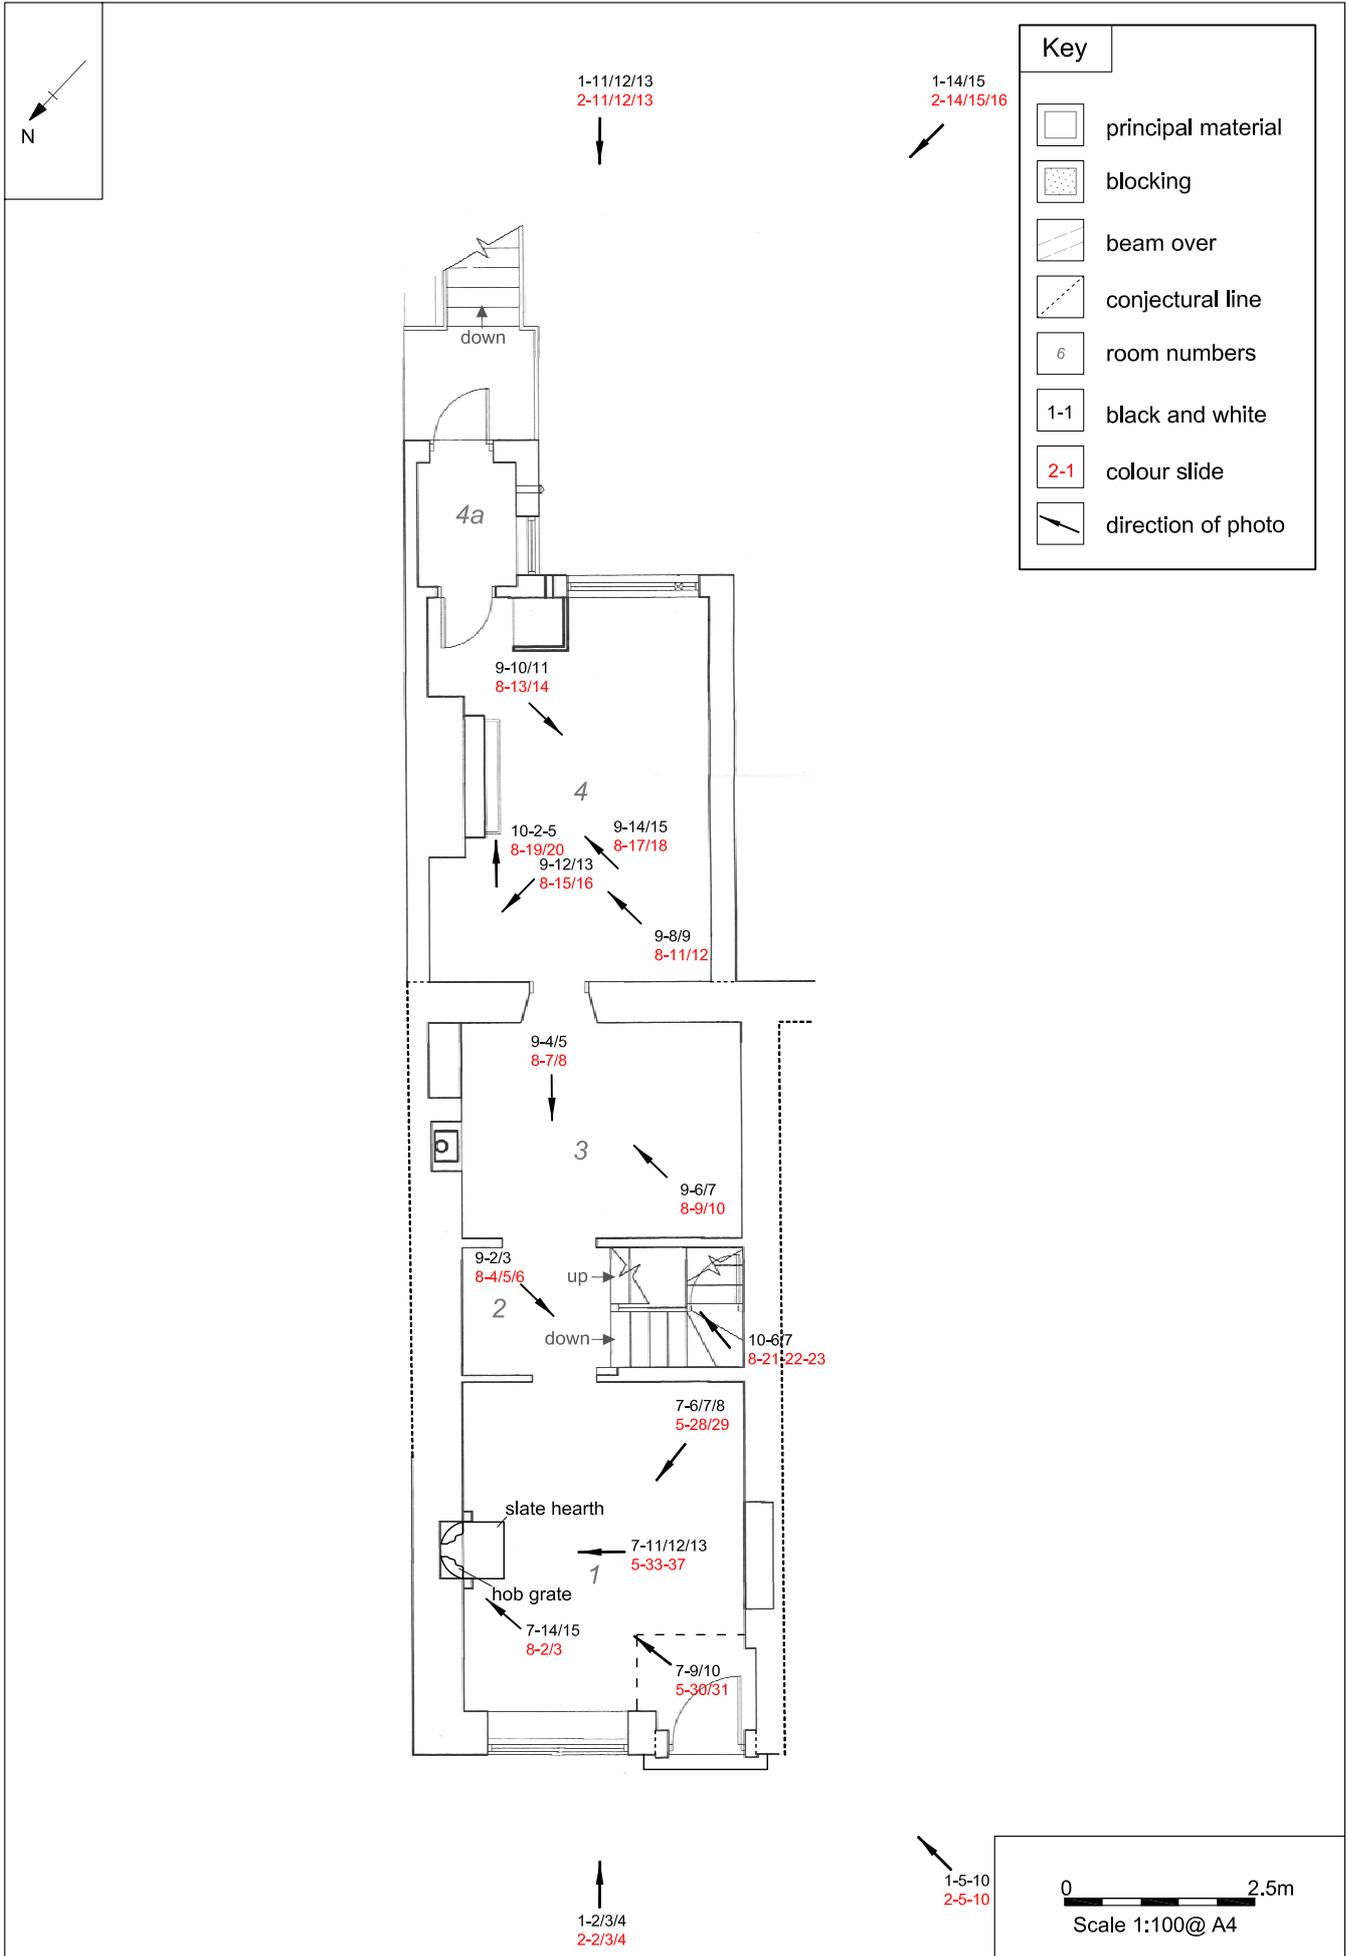
Figure 8: Ground Floor Plan

- 4.5.12 **Room 4 Kitchen:** this room is situated within the extension at the rear of the building and is slightly narrower than the other rooms on this floor (Fig 8). It is rectangular and has a high ceiling (3.15m) with a picture rail (Plate 13). The floor is laid down to patterned vinyl flooring over hardboard and has a simple 6in skirting of nineteenth century appearance. It is plain plastered and painted. There is a large window at the south end, which overlooks the backyard and is a twentieth century casement (*See also Section 4.4.6*). The general appearance of this room is consistent with a late nineteenth century date for the extension.

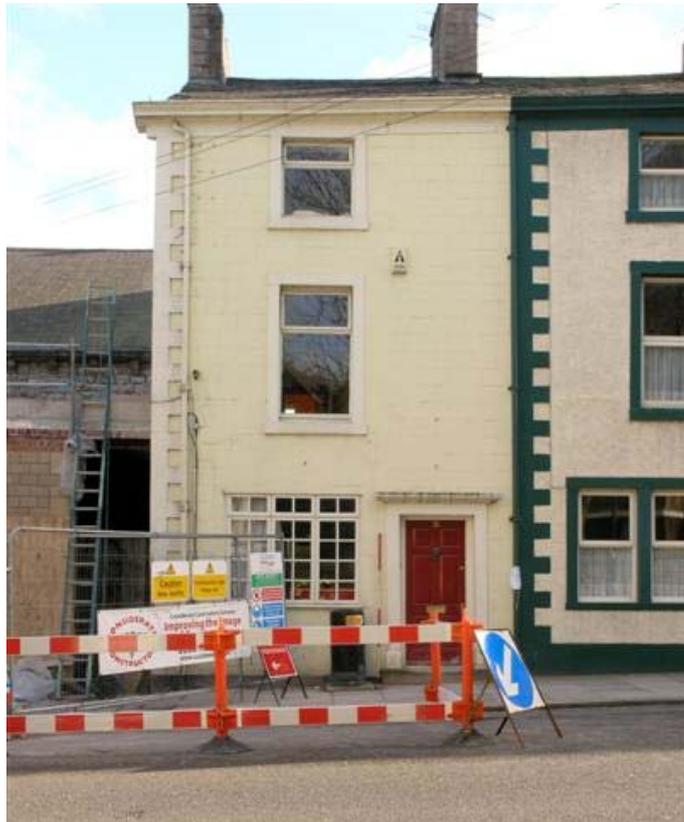
- 4.4.1 ***The Front (North Elevation):*** this houses the main entrance and is three storeys high with a single window on each (Plate 1). It has painted stucco decoration, with projecting alternate quoins, and a band-course at the top of the wall just below the eaves. The timber gutter is lead-lined and is supported upon the projecting eaves cornice. A single cast iron down pipe exits the cornice at the east side.

- 4.4.2 The window apertures on the upper floors have slightly projecting architraves with further projecting sills. The window on the ground floor does not exhibit this feature but it is reasonable to assume that it was similar to that on Number 16 (Plates 1 and 2), as the upper windows are of a similar pattern (although other houses in the terrace have slightly different ground floor windows). The casement window frame on the ground floor is twentieth century in appearance and replaces an earlier construction. The window frames on the upper floors are also twentieth century casements. Other houses in the row retain sliding sash windows and it probable that Number 18 had similar at sometime.

- 4.4.3 The front doorway has the same architrave as the upper windows and exhibits plinth blocks. There is a simple hood mould above the door, and the substantial threshold step is heavily worn. The door itself is a late twentieth century replacement.

Plate 2: Front (North) Elevation

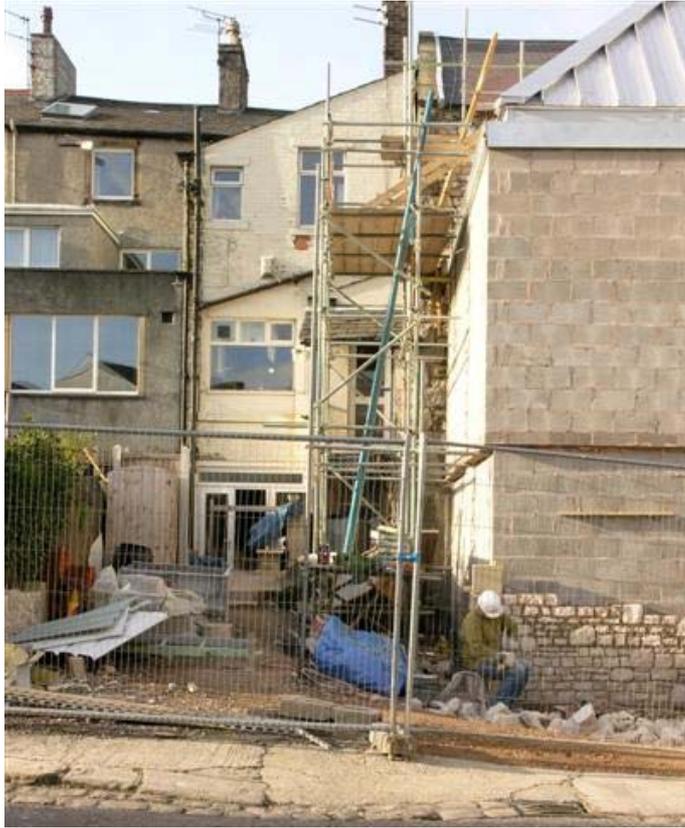
- 4.4.5 ***The Rear (South) Elevation:*** the rear of the house comprises a two-storey (plus basement) brick extension, which obscures most of the original rear elevation (Plates 3 and 4). Part of the original rear elevation of the house is visible on the second storey and this is roughcast rendered and plain in appearance. There is a small, twentieth century casement window visible on the second floor, and a two-over-two sliding sash window with architrave, similar to those on the front elevation, on the first floor. The rainwater goods are plastic and cast-iron.

Plate 3: Rear (South) Elevation

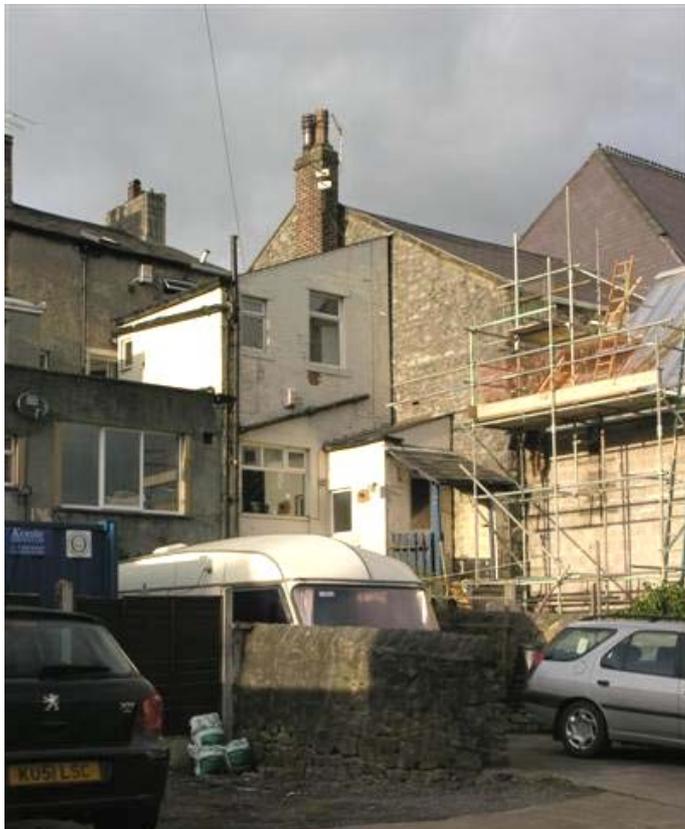
- 4.3.1 The front part of the house is of solid construction, probably of stone (some evidence of this was visible in fireplaces and cupboards). The rear extension (Plate 4) is constructed from brick, and this is laid in stretcher bond. All of the windows have timber frames. Most of the internal walls are of solid construction, although a number are stud partitions. The roof is covered with grey slate, which appears to have been replaced fairly recently (there was no access to the roof space internally) and has clay ridge tiles. A 'Velux' rooflight is present on the north slope, within Room 17. The chimney-stack, which straddles the ridge, is of worked stone and has a single terracotta pot. A second chimney-stack on the rear extension is of brick. The rainwater goods are cast iron and timber. Internally, all the rooms are plain plastered (mostly wallpapered), with concrete or timber floors.

- 4.4.6 The two elevations of the extension are plain and painted. The elevation facing west, which is partly obscured by the extension at the rear of Number 16, is canted in order to accommodate the sash window mentioned above, and contains two PVCu windows. There is a cast iron gutter, which has an ogee profile, and the remainder of the rainwater goods and waste pipes are also cast iron. The elevation facing south contains three window apertures, all of which contain twentieth century casement frames. The openings have slightly projecting sills and lintels, and the large window on the ground floor in the kitchen appears to have been reduced in size (Plate 3). At basement level there is a wide PVCu patio door arrangement. A second, smaller extension (Plate 4),

creates an entrance lobby to the ground floor kitchen. This contains a PCVu window and door.

- 4.4.7 The roofs of both extensions are mono-pitched and slope to the west. The coverings are identical to that on the main roof. A tall brick chimney-stack projects above the ridge of the neighbouring building and has two chimney pots (Plate 4).
- 4.4.8 **The Rear Yard:** at the time of survey, this was full of scaffolding and general building rubble (Plate 3). Traces of sandstone flags are visible and the walls appear to have been of random rubblestone construction, with pointed copings similar to the neighbouring houses (Plate 4).

Plate 4: View of rear extension

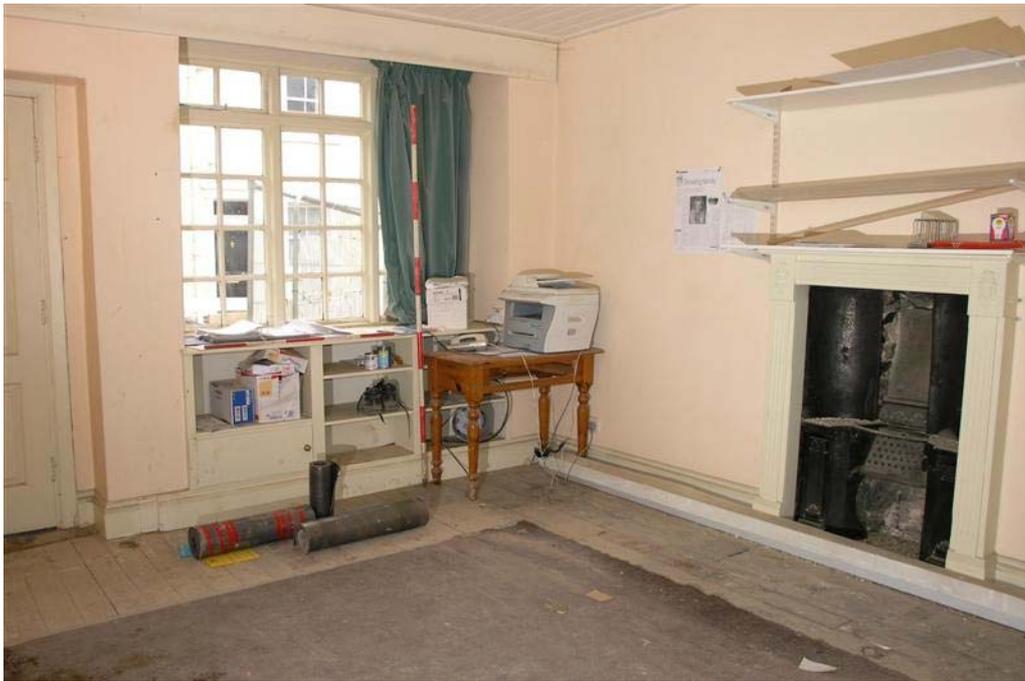
- 4.5.3 The main window is set within a square reveal, with a built-in cupboard of twentieth century appearance (Plate 5). There is a second cupboard and shelves recessed into the west wall of the room (Plate 6), which is late twentieth century. This may have replaced an earlier example.

Plate 5: Room 1 facing north-east

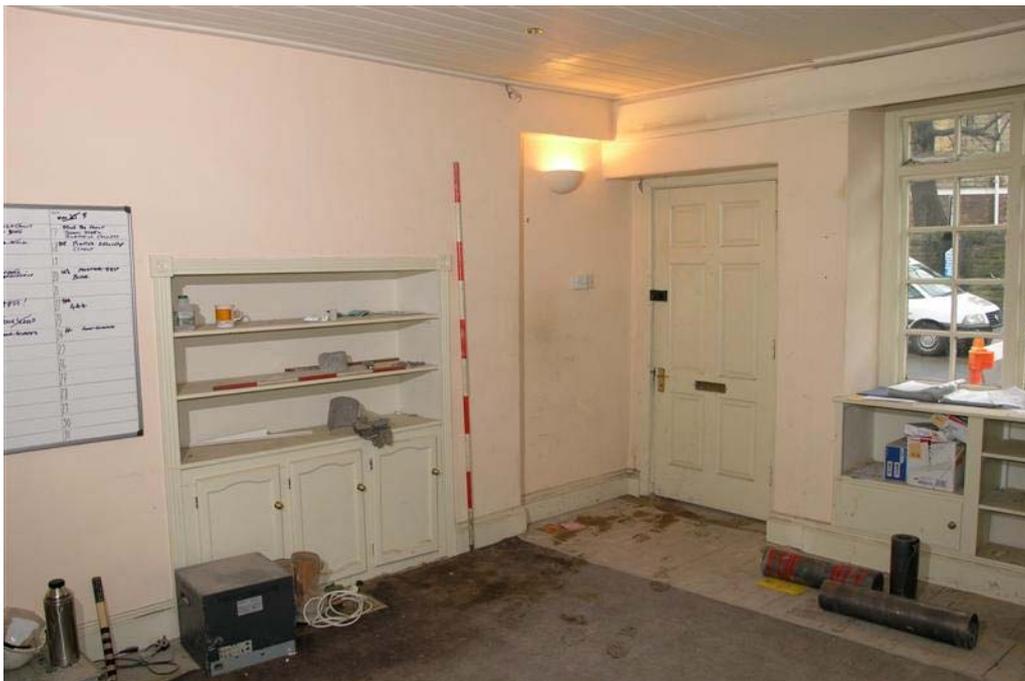
Plate 6: Room 1 facing north-west

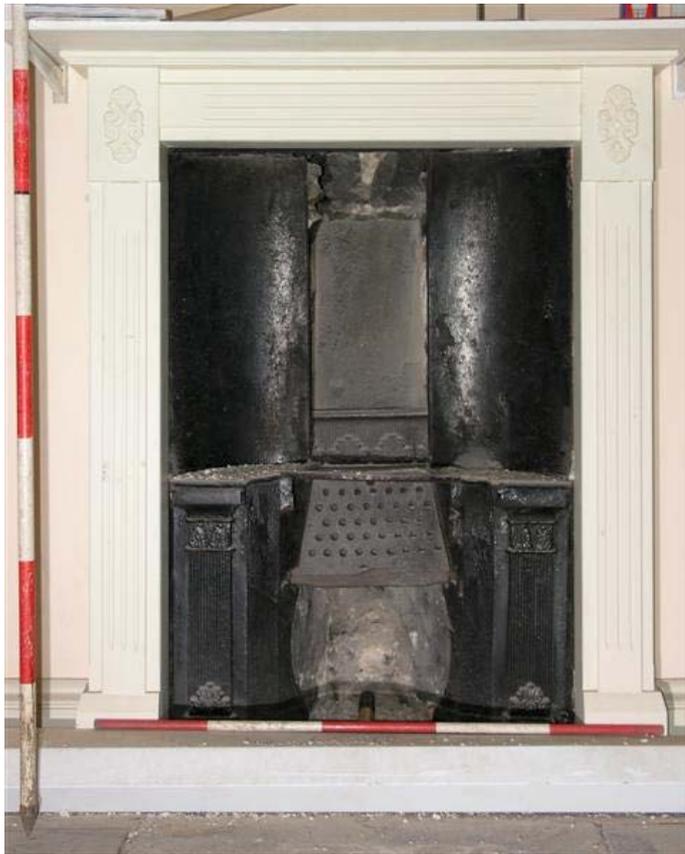
- 4.5.4 The main feature in this room is the fireplace (Plates 5 and 7). This contains a hob grate, which probably dates to the early nineteenth century. It measures 1.18m high by 0.75m wide, has curved cheeks and probably had a curved firebasket. Each side of the grate exhibits reeded vertical decoration embellished with leaf motifs. The hearth is slate and there is no chimney-breast. Unfortunately, the surround is a modern replacement, and modern shelving is present above this.

Plate 7: Hob grate in Room 1

- 5.3.1 During the building investigation, no archaeological features or historical evidence was discovered which warrant further investigation in the form of more detailed building investigation. It is, however, recommended that certain features remain *in situ* including the hob grate in Room **1**, the range in Room **4** (if practical), the window, door and oven in Room **5** and the window architrave and below sill cupboard in Room **11**.

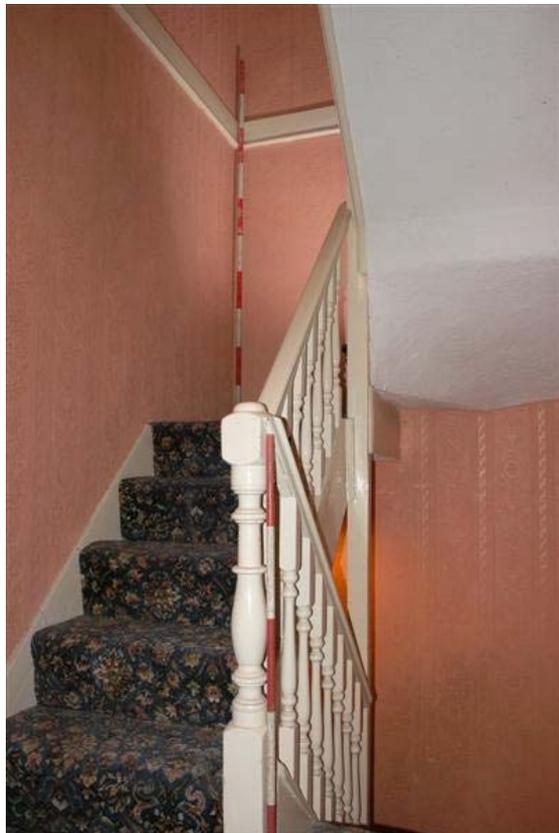
- 4.5.6 **Rooms 2, 10 and 15 (Staircase):** this allows access to all the floors including the basement, and is situated behind the front rooms (Plate 8). The staircase is a half-turn with winders, and has simple turned balusters and newels with plain handrails and strings. The soffits are plastered. There are landings on each floor to allow access into the rooms. The stairwell is wallpapered.

Plate 8: The staircase

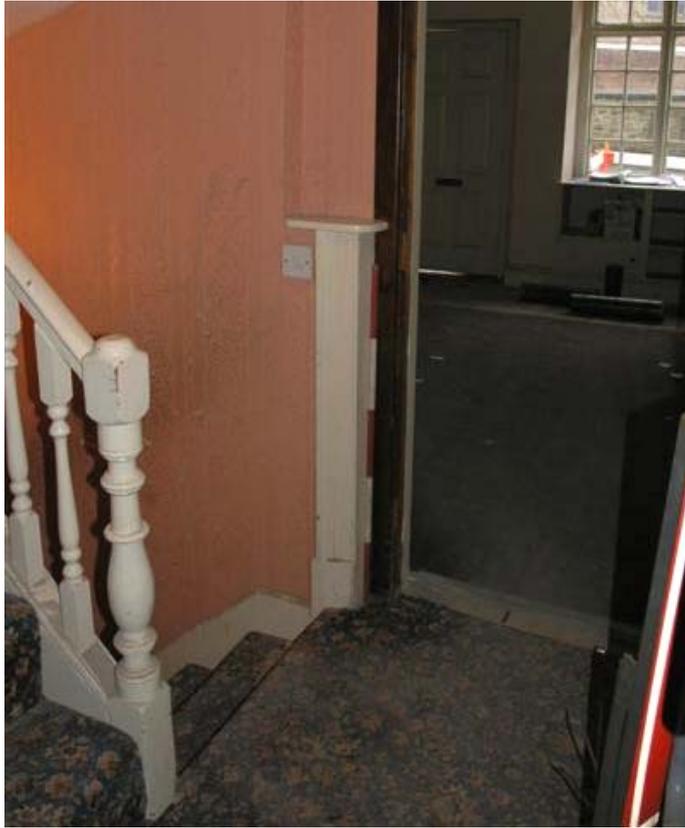
- 4.5.7 On the ground floor within **Room 2**, and located adjacent to the doorway leading into **Room 1**, is an upright wooden architrave topped by a small shelf

(Plate 9). It has a plinth block and is a remnant of the original access arrangement between these two rooms. A small cupboard is present below the stairs and is visible as one descends down to the basement.

Plate 9: Feature between Rooms 1 and 2

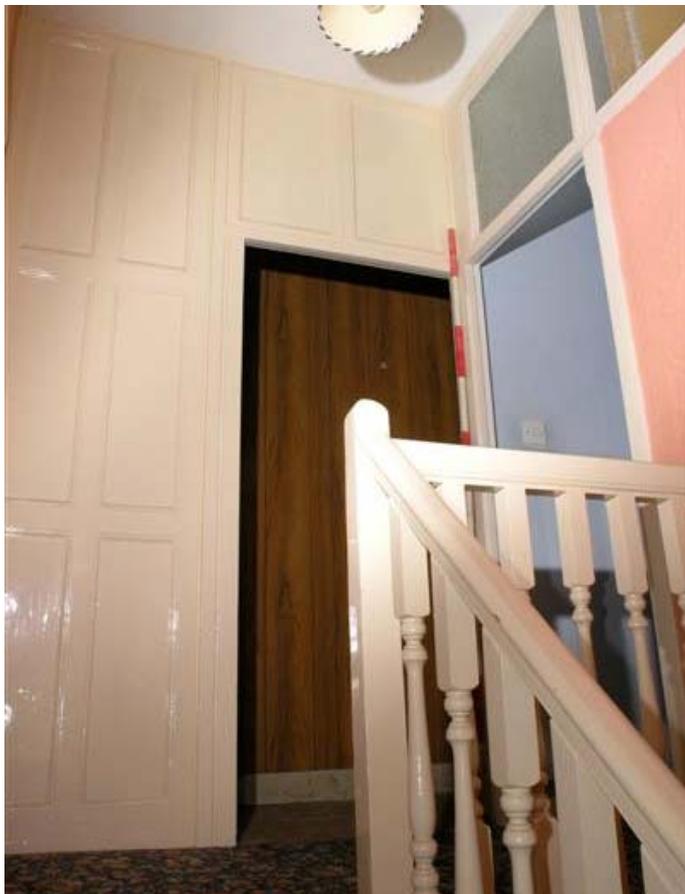
- 4.5.8 At the top of the staircase, in Room **15**, the upper part of the south dividing wall is glazed (Plates 10). The glass is patterned glass but the glazing bars are plain. This was obviously present before the current arrangement of rooms (Room **17**) was inserted (Plate 10). The east end of Room **15** is panelled and this conceals a small cupboard (Plate 10). There is a small landing providing access into Rooms **17** and **18**.

Plate 10: Room 15

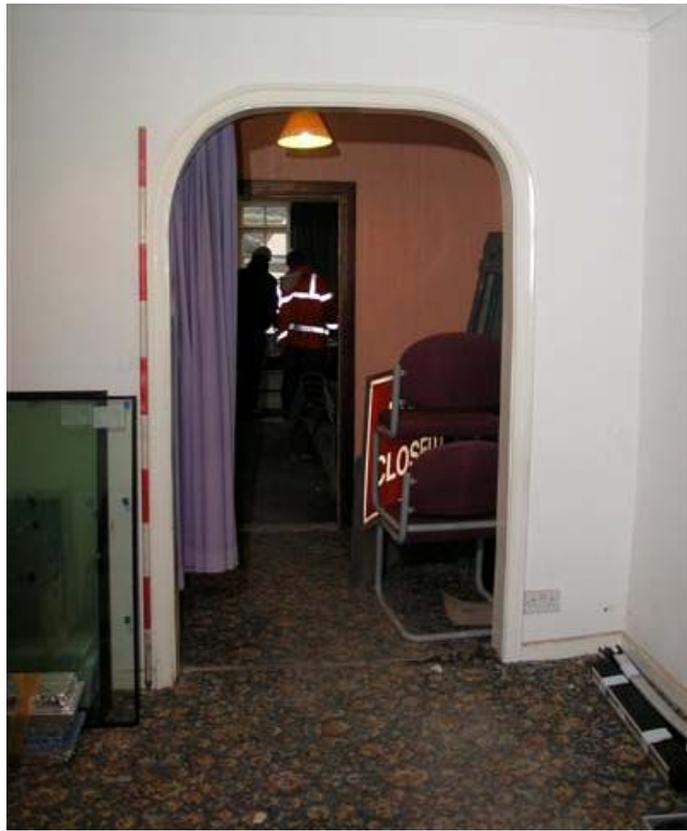
- 4.5.10 The doorless access from Room **2** is wide and has a flat arch with rounded shoulders (Plate 11). The architrave is plain and simply moulded. The access into Room **4** has a transom and is similarly plain in appearance, and is set within a canted reveal.

Plate 11: Access between Rooms 2 and 3

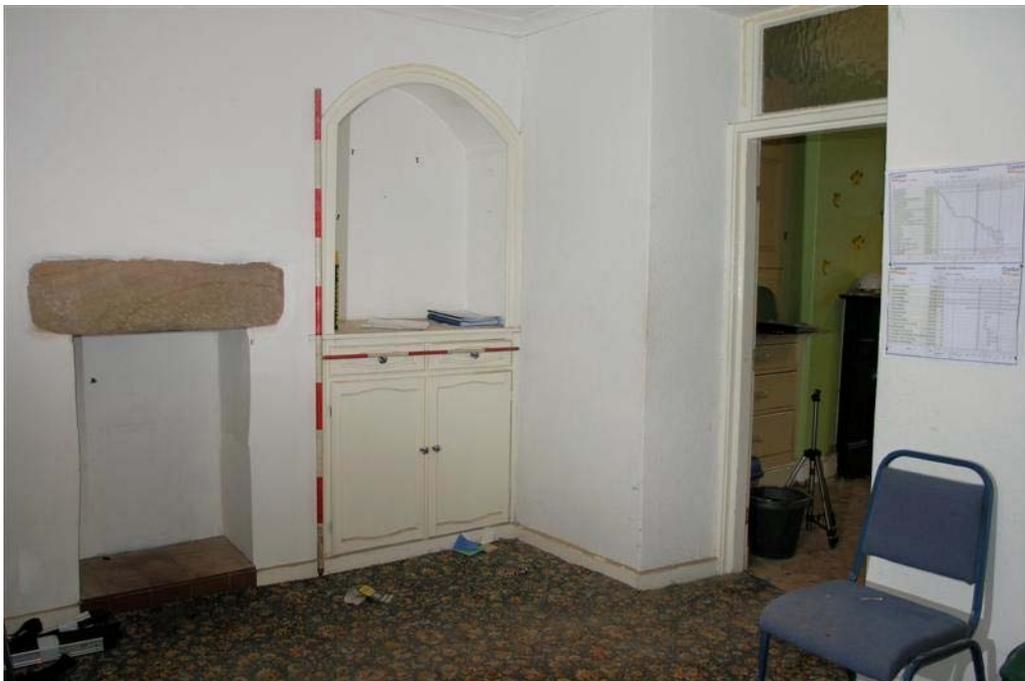
- 4.5.11 There is a fireplace located on the east wall, which probably last housed a stove (Plate 12). A large sandstone lintel is visible and the hearth is laid down to modern quarry tiles. A cupboard is built into an alcove to the right of the fireplace, which although exhibiting twentieth century features, may be earlier (Plate 12)

Plate 12: Fireplace and cupboard in Room 3

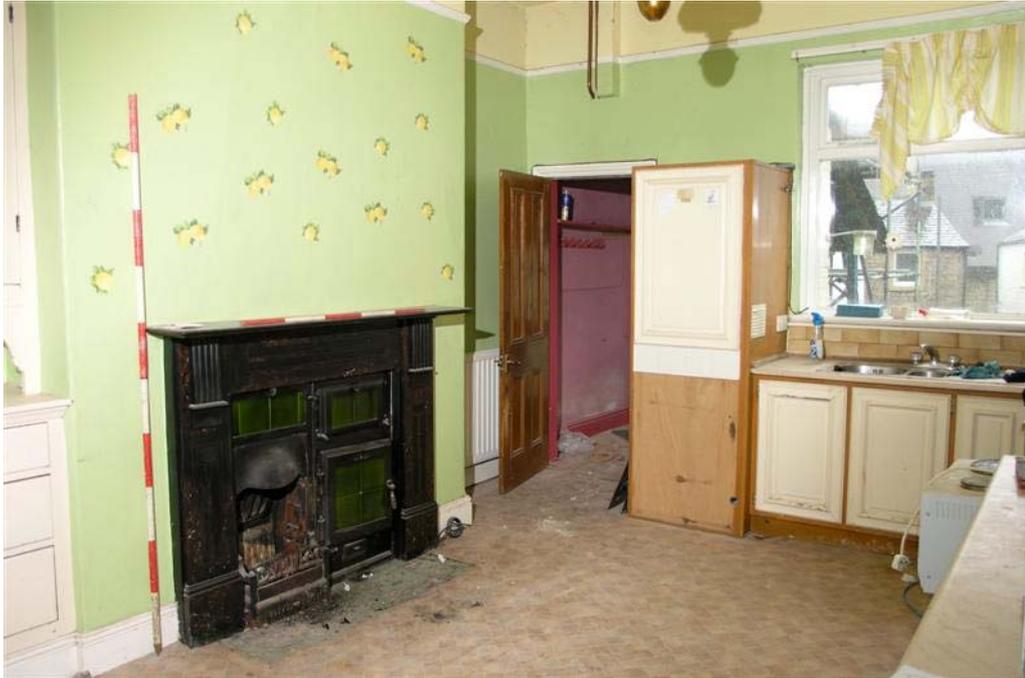
- 4.5.13 The most notable feature of the kitchen is the impressive range located on the east wall (Plate 13). It is 1.74m wide by 1.45m high and is set within a wide chimney-breast and has a substantial marble surround (Plate 15). It has two oven doors with glazed green inset tiles and a single grate. The hearth, which measures 1.39m by 0.38m, is constructed from 6in square tiles, exhibiting an art nouveau knotwork design. To the right of the range is a built-in dresser of nineteenth century appearance (Plate 16). The remainder of the kitchen fixtures and fittings are of late twentieth century appearance.

Plate 13: Room 4 The kitchen
