NATIONAL TRUST HOLDINGS ON THE NORTH YORKSHIRE COAST

Historic Landscape Survey

Oxford Archaeology North

August 2007

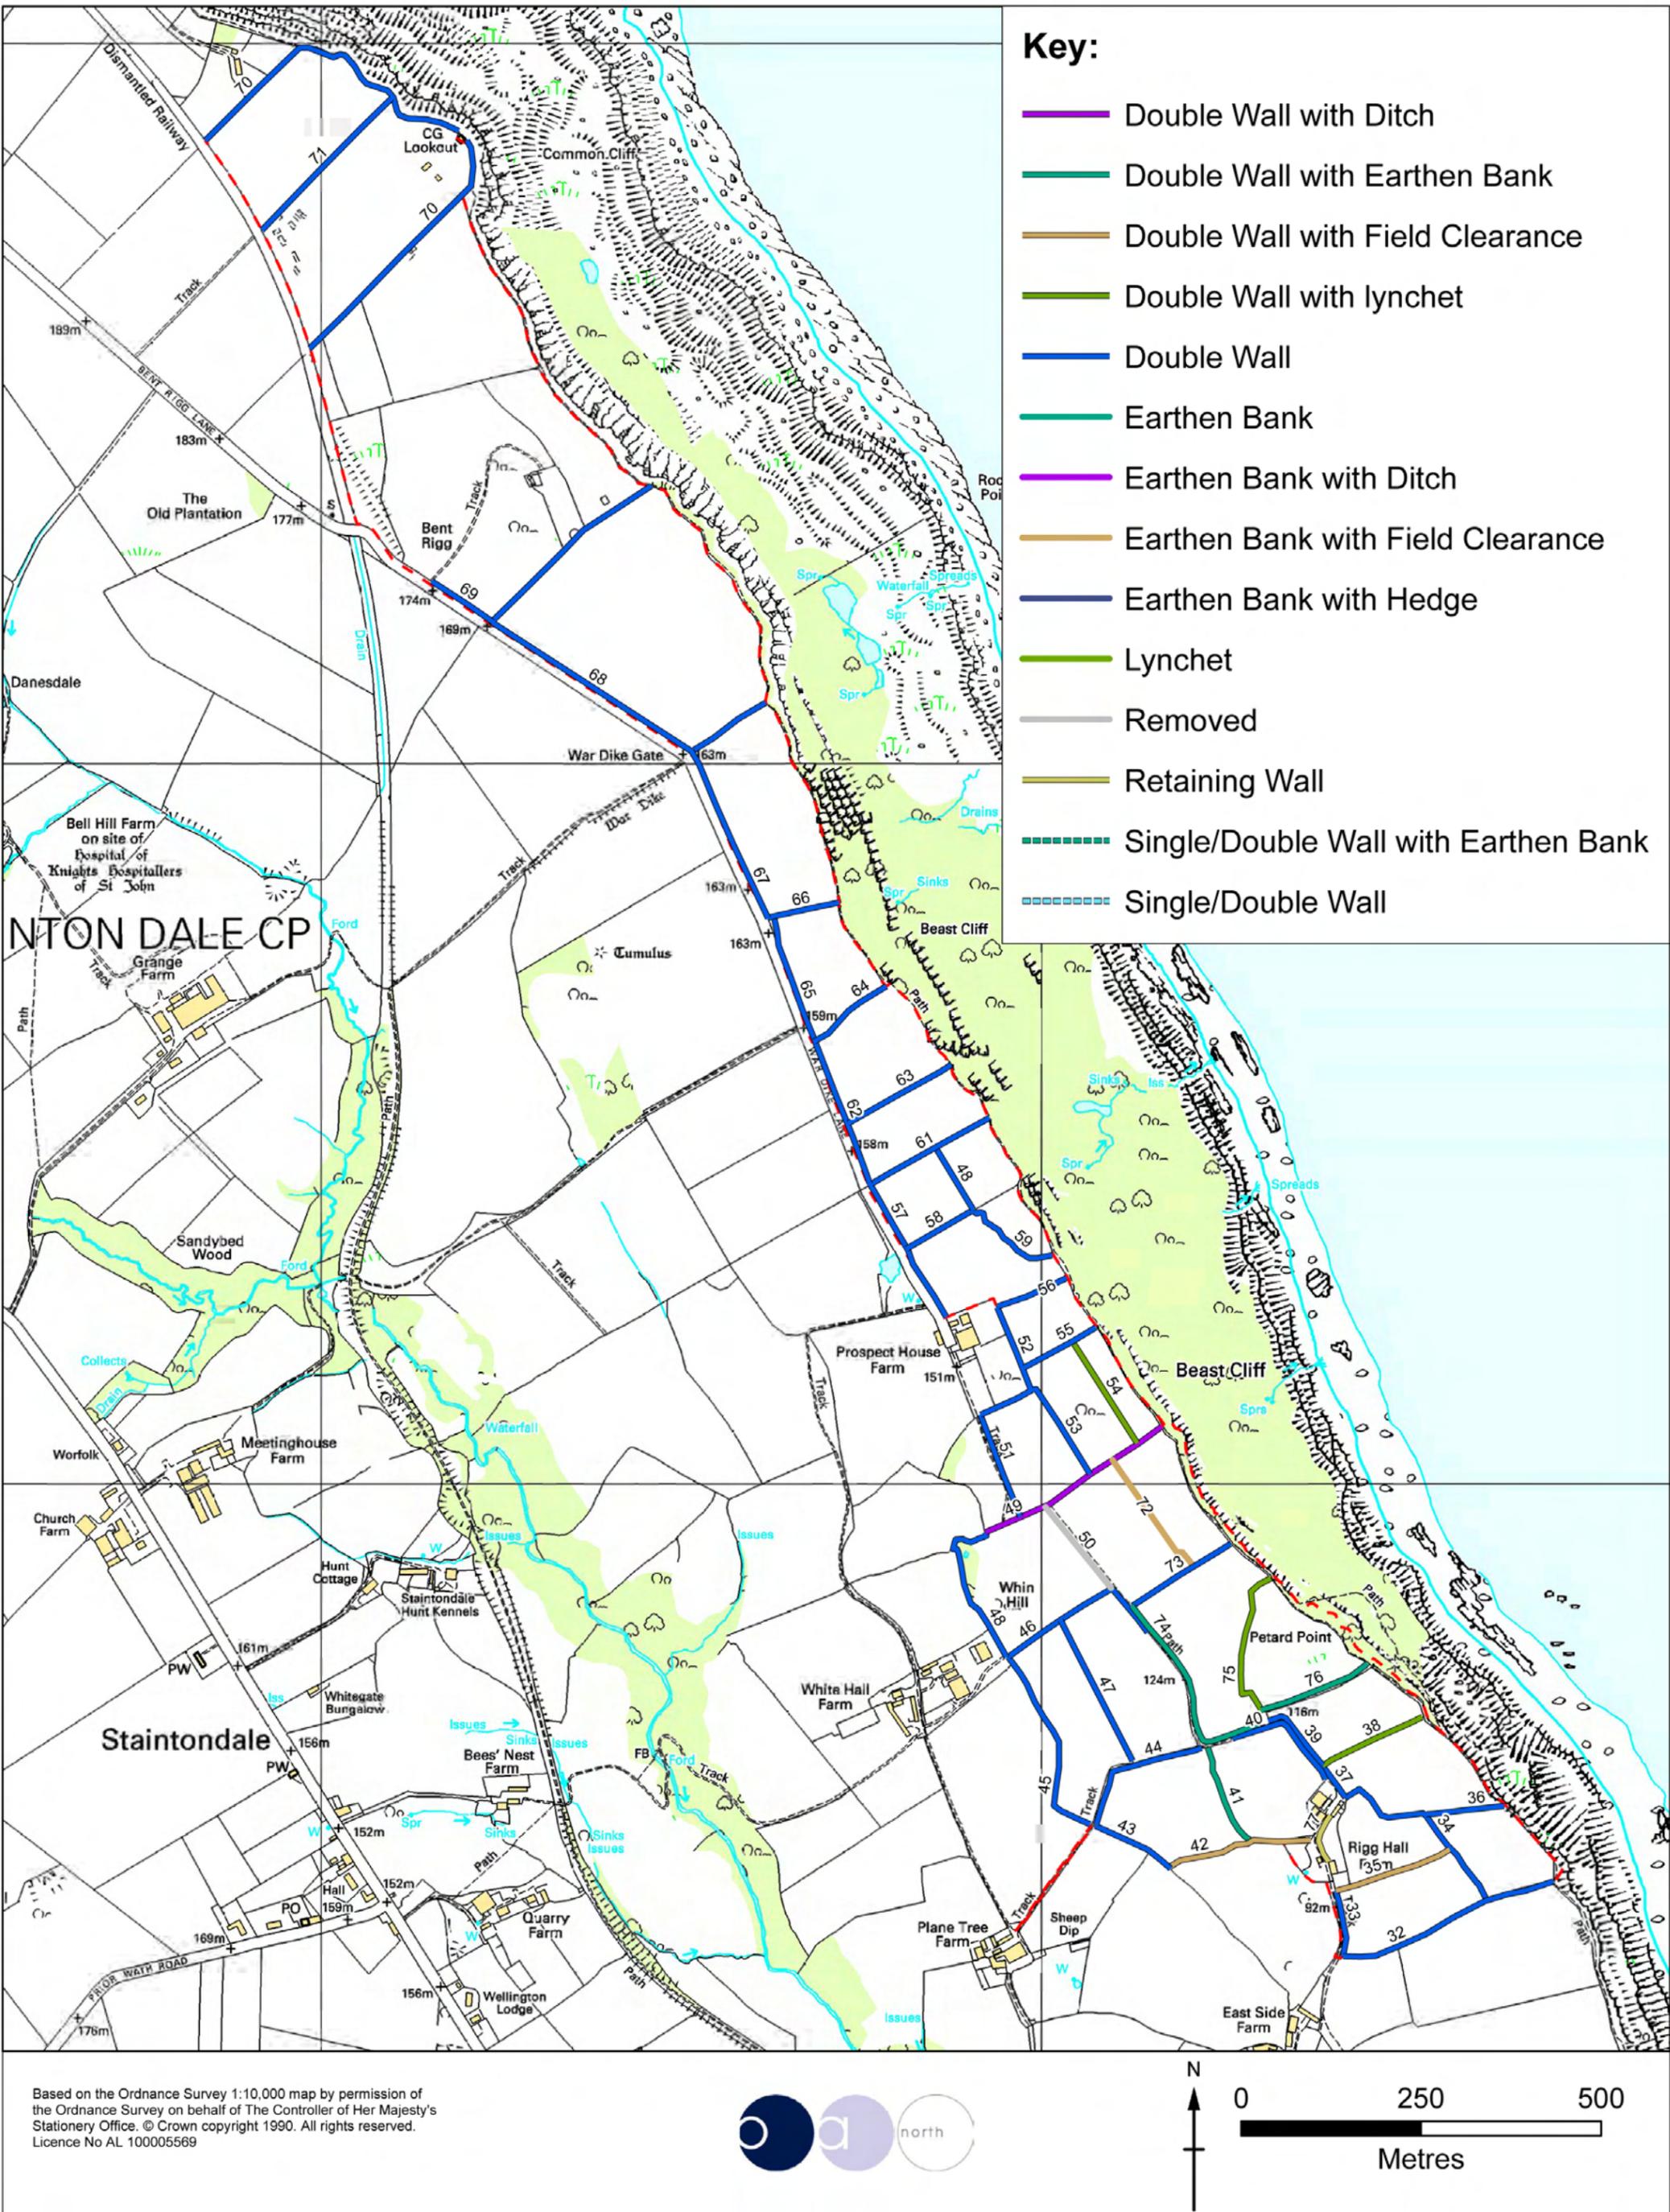
Figure 18: Boundary Survey at Staintondale

- Key:**
- Double Wall with Ditch
 - Double Wall with Earthen Bank
 - Double Wall with Field Clearance
 - Double Wall with lynchet
 - Double Wall
 - Earthen Bank
 - Earthen Bank with Ditch
 - Earthen Bank with Field Clearance
 - Earthen Bank with Hedge
 - Lynchet
 - Removed
 - Retaining Wall
 - - - Single/Double Wall with Earthen Bank
 - - - Single/Double Wall

- 5.1.2 The field boundary recording phase of the project was useful as a record of the surviving extent and types of field boundaries within the study areas (Figs 18 and 19). The evidence of extant field boundaries aids the regression analysis of the farmsteads, as the key relationships at boundary junctions have the potential to indicate which were earlier or later constructions. The field survey found that, whilst a large proportion of walled field boundaries survived, only a small proportion of them had boundary relationships surviving. Often the relationships were masked by wall modifications or re-builds, or farm gates were placed on the ends of field walls, or when walls became disused the junctions were often removed or had tumbled.

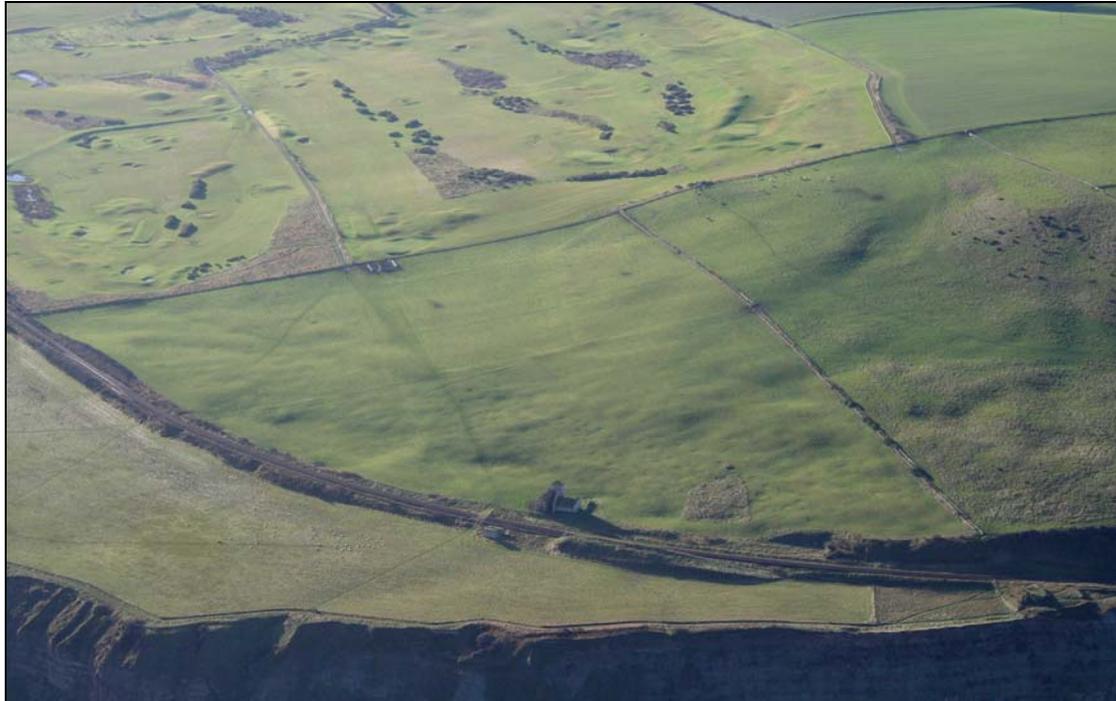
Plate 4: View of the Surface Ironstone Pitting and the Later Huntcliff Mine on Warsett Hill (OAN 54 and 225)

- 4.3.8 Evidence of the earliest ironstone extraction survives as obvious earthwork depressions across much of the foot of Warsett Hill, towards the railway line (Plate 4, OAN Sites 225 and 287). The shafts, engine bases, and railway siding comprising the remnants of the Cliff Mine, all survive as earthworks or brick-built footings (OAN Sites 227-230 and 289). The later Huntcliff mine has numerous surviving features, including the reservoir to the south of the mine (OAN Site 219), and the foundation base and superstructure of the scheduled Guibal Fanhouse (OAN Site 152). The Fanhouse itself has fared well since scheduling (SM RC43), and appears to be little changed from descriptions within the scheduling notes (1985), and the Vernacular Building Survey (Anon, 1992). The present survey did reveal, however, that there is a crack in the tower, and that the security gates have been breached, leading to internal vandalism. The vaulting for the ventilation adit, running into the side of the hill from beneath the fanhouse, has been also been breached, and is eroding from the edge of the mound (Plate 10). Other structures that survive at the mine include the steam engine base and the loading ramp, although all trace of the mineworker's buildings have been removed.

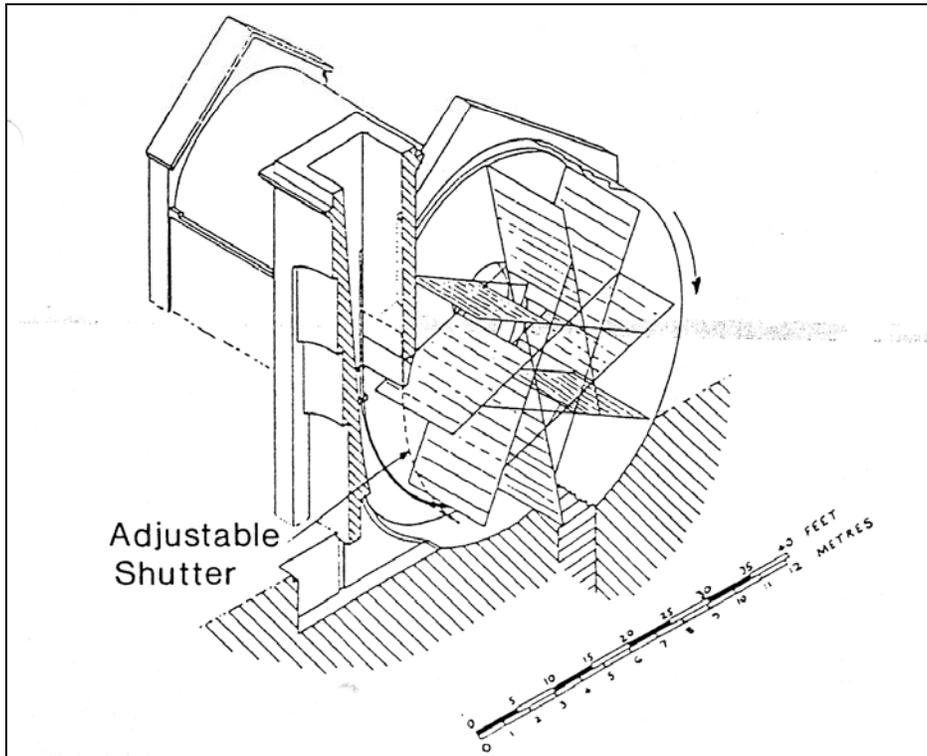
Plate 7: Cutaway Drawing of the Guibal Ventilation Fan at Huntcliff Mine, Warsett Hill (Chapman 1992)

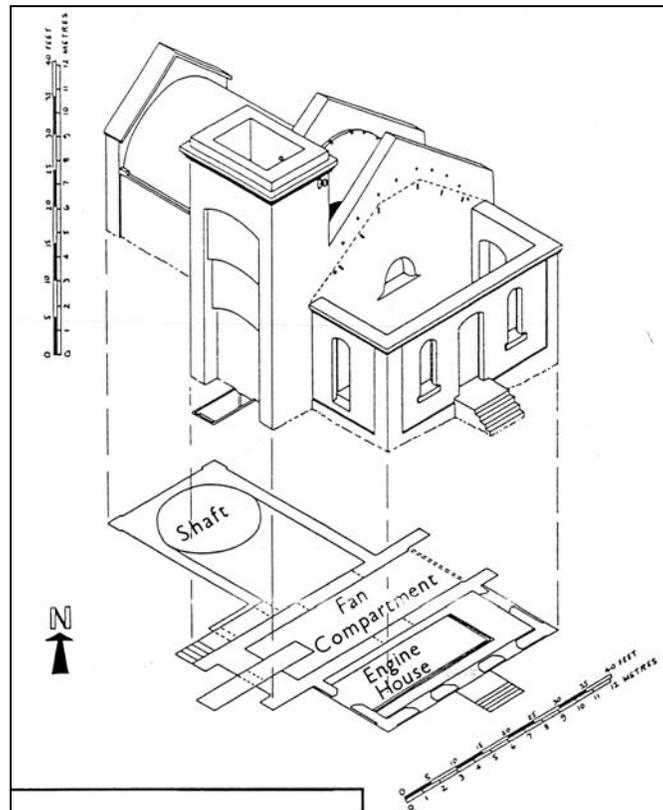
Plate 8: Isometric View of the Guibal Fanhouse at Huntcliff Mine, Warsett Hill (Chapman 1992)

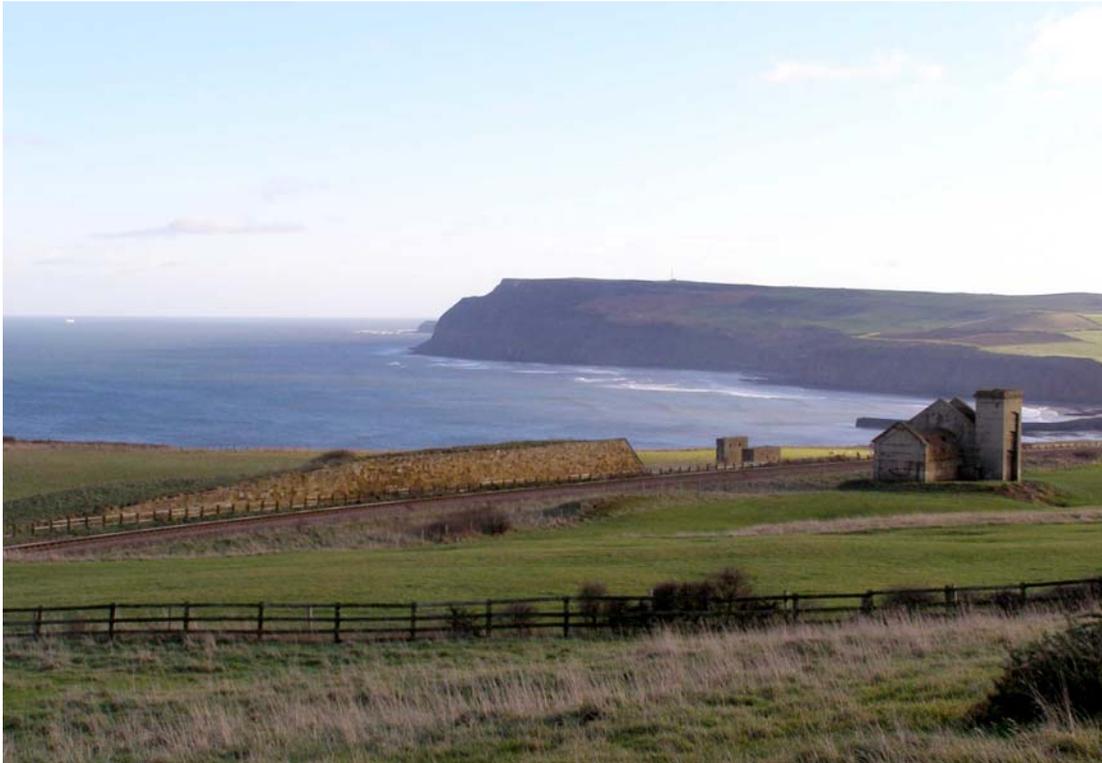
Plate 9: View of the Surviving Surface Remains at Huntcliff Ironstone Mine, Warsett Hill (OAN 54)

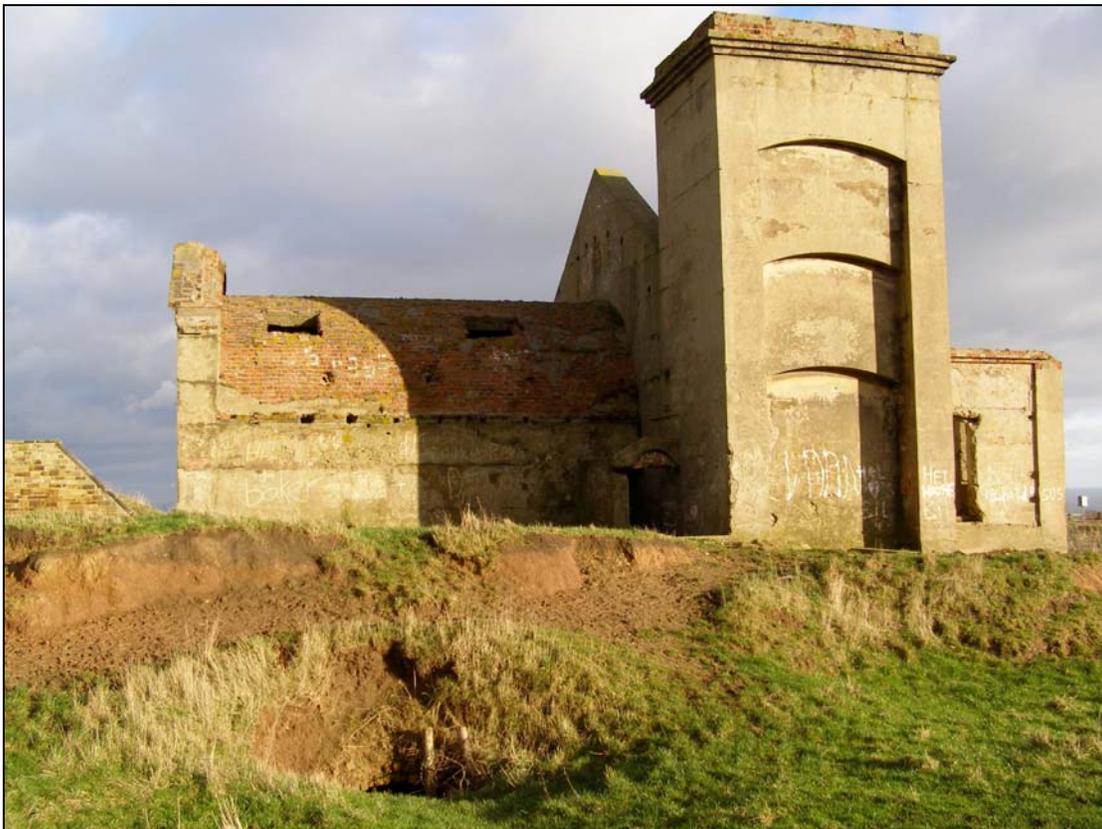
Plate 10: Erosion to the Tunnel Vaulting and General Survival of the Guibal Fanhouse at Huntcliff Ironstone Mine, Warsett Hill (OAN 152)

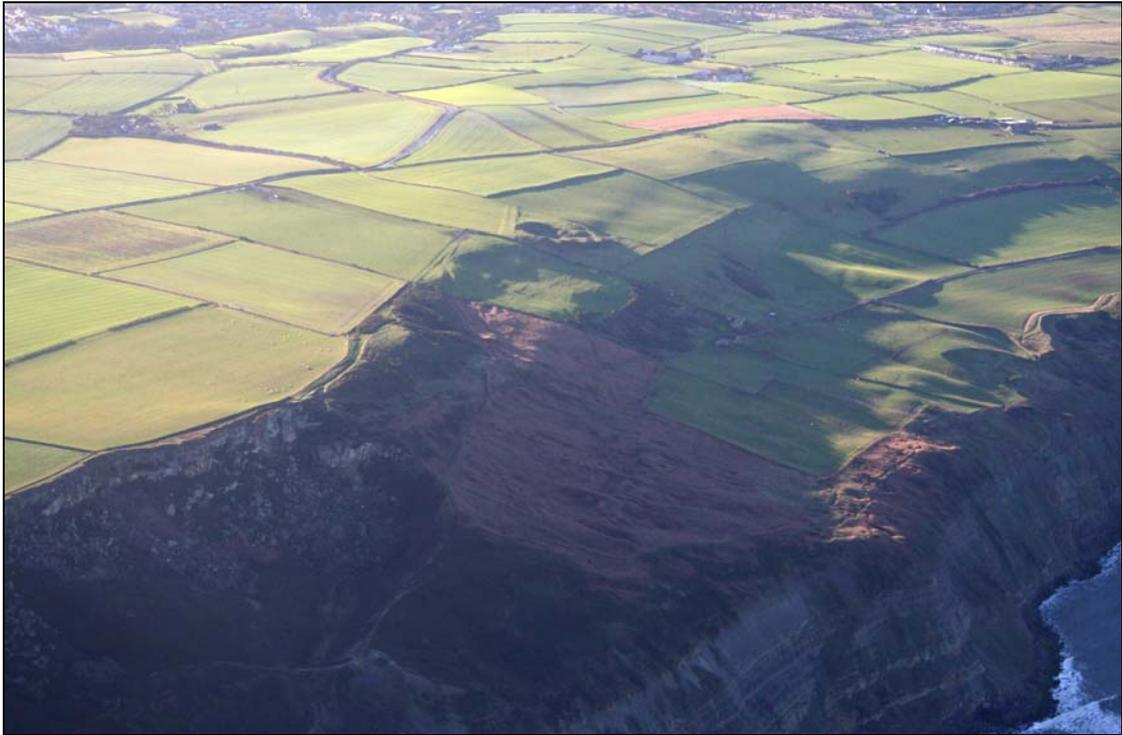
Plate 13: Aerial view of the Rough Ground at 'The Warren', Loftus Alum Works

- 4.4.11 The ancillary features associated with the alum works at The Warren were investigated during the present survey. The ground conditions were particularly restrictive, with gorse, bracken and brambles covering the whole area (Plate 13), which had also prevented English Heritage from surveying features within this area (Hunt 2004). The central portion of The Warren still contains two large possible reservoirs, formerly used to store water for alum processing (OAN Site 203). The ground surrounding this was undulating in nature, and seems to have either been quarried, investigated for trial pits, or contains alum processing features masked by the vegetation and topsoil (OAN Site 333). On the edge of the clifftop there were undulating pits, which may have related to jet quarrying (OAN

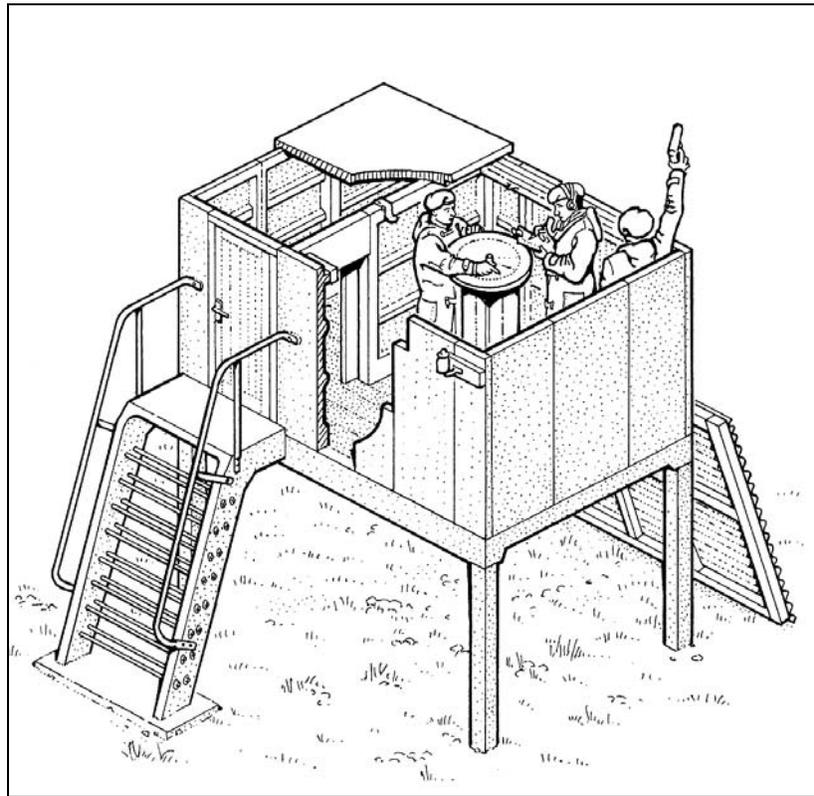
Plate 14: Cutaway view of a 1950s Orlit Royal Observation Corps Observation Post, similar to the dismantled site at Loftus (OAN 347), but without the legs (Cocroft *et al* 2004)

- 4.4.9 At some point before 1962, the observation post (OAN Site 347) was rebuilt as an Orlit-A observation post (Plate 14), as part of the latest advance in visual warning against enemy aircraft. These were, however, found to be inadequate and too slow at identifying threats from jet aircraft (Cocroft and Thomas 2004). The observation post was subsequently rebuilt, reflecting the change of operational emphasis after the Royal Observer Corps was reorganised into the United Kingdom Warning and Monitoring Organisation (UKWMO). Its role was to warn of air attack, confirm nuclear strikes, to set off public warnings, and to provide an emergency meteorological service to help predict fallout paths (*ibid*). An underground reinforced concrete monitoring post for the measurement of nuclear fallout (OAN Site 213, Plate 15) was constructed on Warsett Hill, and formed part of a web of such sites across the entire United Kingdom. The site on Warsett Hill was short lived as it opened in June 1962, but closed in October 1968 (Catford 2001). Many of the other sites, and the program itself, was not decommissioned until after the end of the Cold War in the early 1990s (Cocroft and Thomas 2004). The site was said to have been in-filled with rubble by the time of the 2000 field visit (Catford 2001).

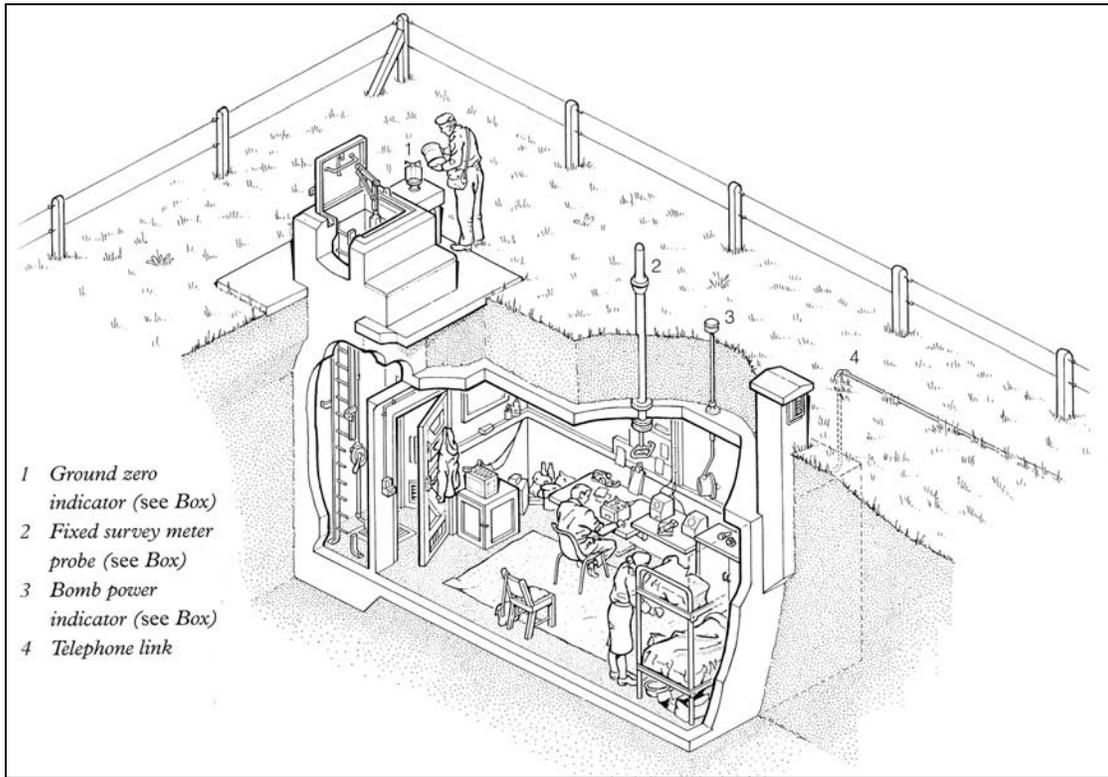
Plate 15: Cutaway view of a 1960s Royal Observation Corps Nuclear Monitoring Post (Cocroft *et al* 2004), of which the Site at Loftus (OAN 213) is an example

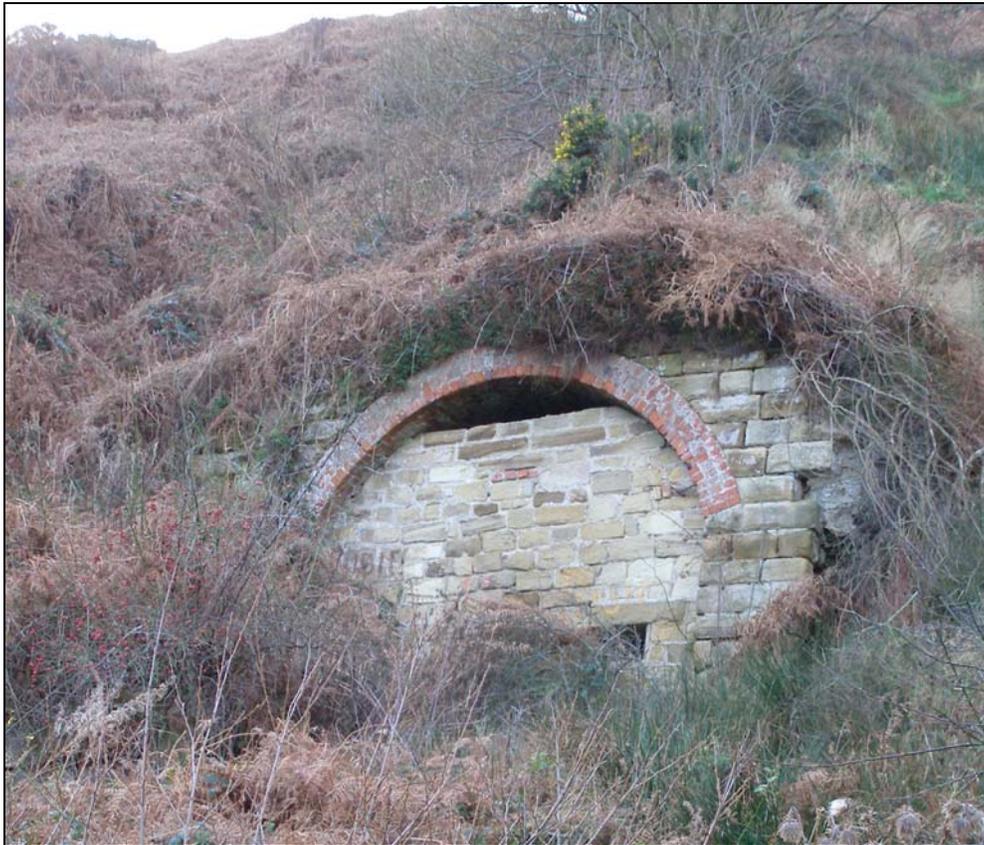
Plate 20: The Surviving Remains of the Tunnel Mouth at Port Mulgrave (OAN 194)

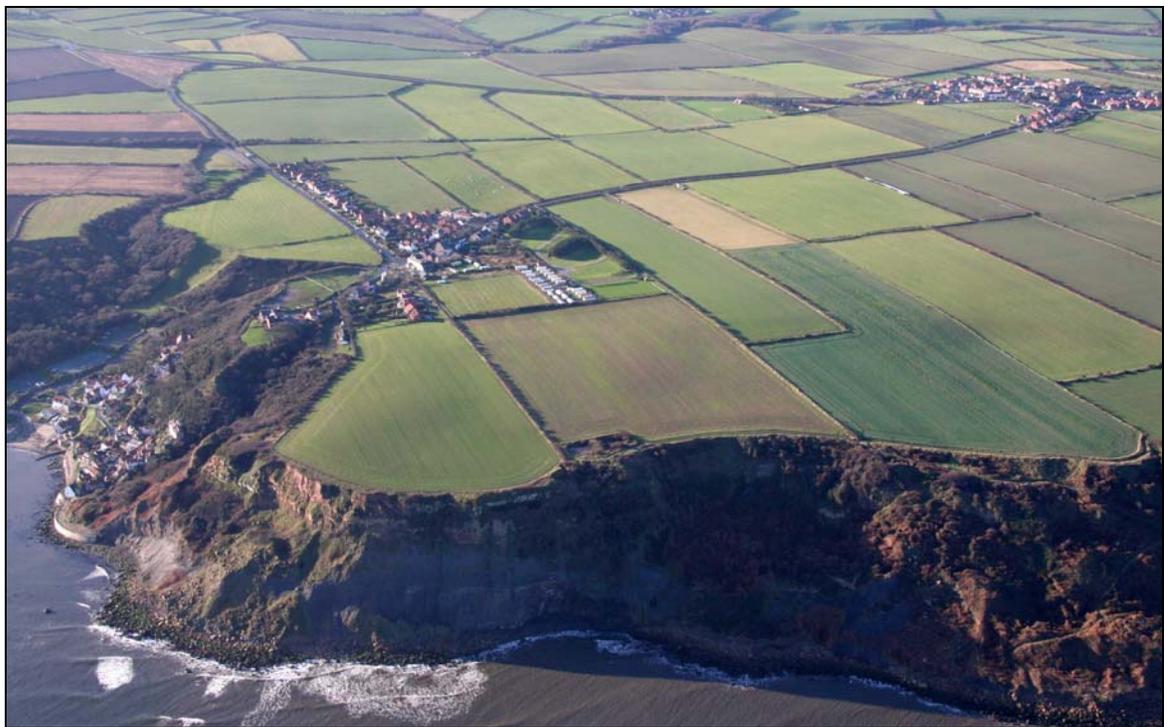
Plate 22: View of the Post-Landslip Ground Conditions at Victoria Ironstone Mine, Runswick Bay (OAN 78)

- 4.7.3 **Survey Results:** several elements of the ironworks had previously been recorded in the area, including the top level adit (OAN Site 192), the calcining kiln (OAN Site 150), two shafts (OAN Sites 190 and 191), and the two cliff-top reservoirs (OAN Sites 50 and 79). Previous long term archaeological observation at the site through the 1980s, by the Cleveland Industrial Archaeology Society, had identified surviving evidence of several significant archaeological structures associated with the later workings of the site. They also acknowledged the precarious ground conditions, and subsequent land slippage on the site (Owen 1988). The most obvious surviving sites at the time are the mostly buried calcining kilns (which have probably slumped up to 21m over the top of the site of the furnace), part of the harbour (out of the study area) and the cliff-top reservoirs (*ibid*). Of these sites, the present survey was only able to locate the cliff-top reservoirs with any confidence, and access to the rest of the site was confined to an area adjacent to an access footpath through the uneven slumped cliffside, which was also heavily overgrown with bracken and brambles (Plate 22).

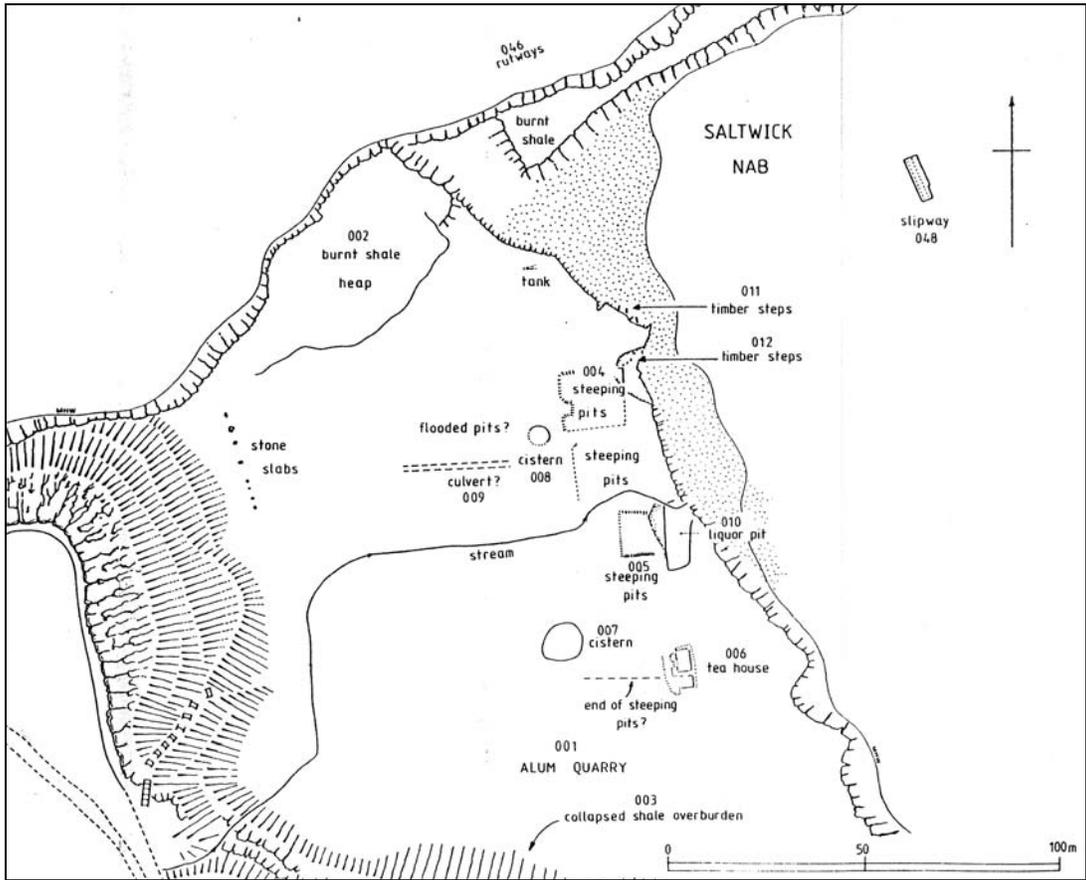
Plate 23: The part of the Alum Works under National Trust ownership at Saltwick Nab (Marshall 1994)

- 4.8.3 **Survey Results:** the present field survey revealed earthwork evidence for all of the features of the alum processing complex that had previously been identified at the quarry (Plate 23). The condition of the earthworks was predominantly unchanged from the earlier survey (Marshall 1994; 1995a), although the alum shale spoil heap (OAN Site 353) is being continually eroded by the sea. Furthermore, the liquor tank, described as having surviving floor elements (OAN Site 5), was now found to have eroded down to the rock-cut base and is empty. Several new sites had been identified by the desk-based assessment, and located within or adjacent to the study area. These included an area of jet quarrying on the foreshore on the north side of the nab (OAN Site 353), a common example of this type of mining so near the centre for jet goods production at Whitby. In addition, there was a stone slipway, located on the foreshore on the east side of the nab (OAN Site 340), and an area described by Marshall (1994) as containing two areas of 'ladder steps' (OAN Site 339; Plate 23). This latter site was found to be the eroded remains of a further alum liquor pit (not a steeping pit). The pit had been eroded on the north, east and south sides, leaving only a thin section intact. The pit had obvious tip-lines of later spoil and debris within it, and had areas of surviving wooden framing (what was described as the 'ladder steps'), and a puddled clay floor sealing its base, in a similar fashion to the other liquor pit (Plate 25).

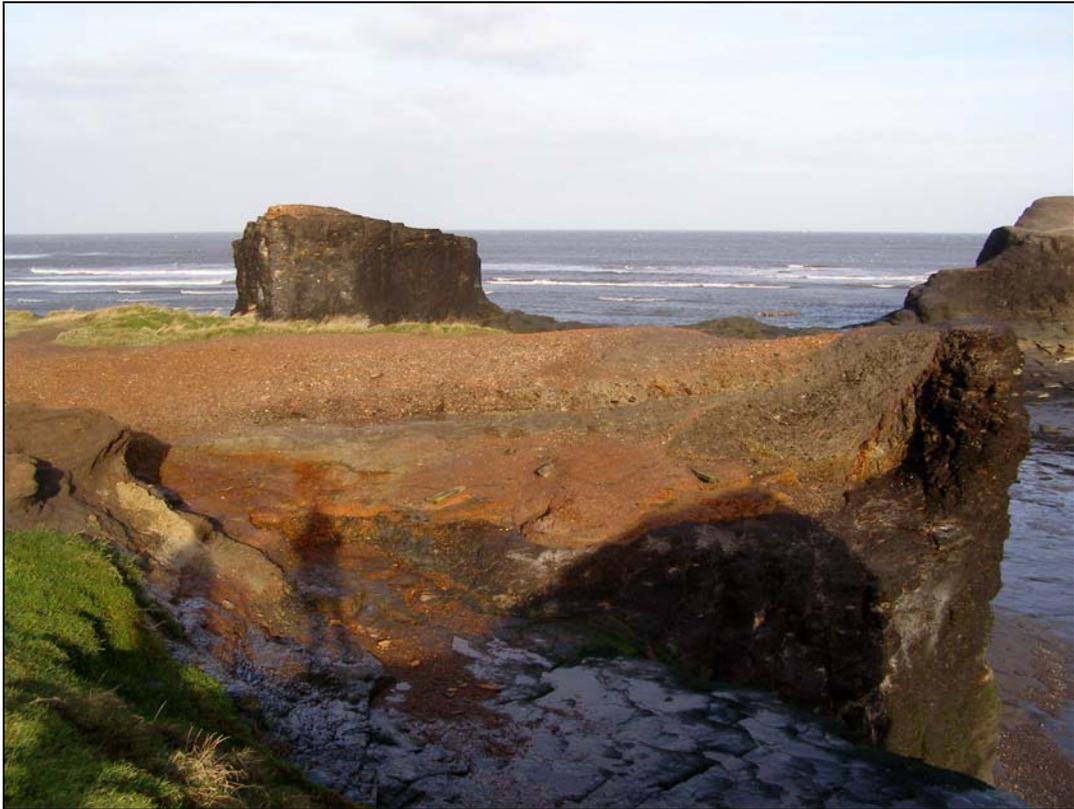
Plate 25: An eroded Section through the Northern Liquor Pit, Saltwick Nab (OAN 339)

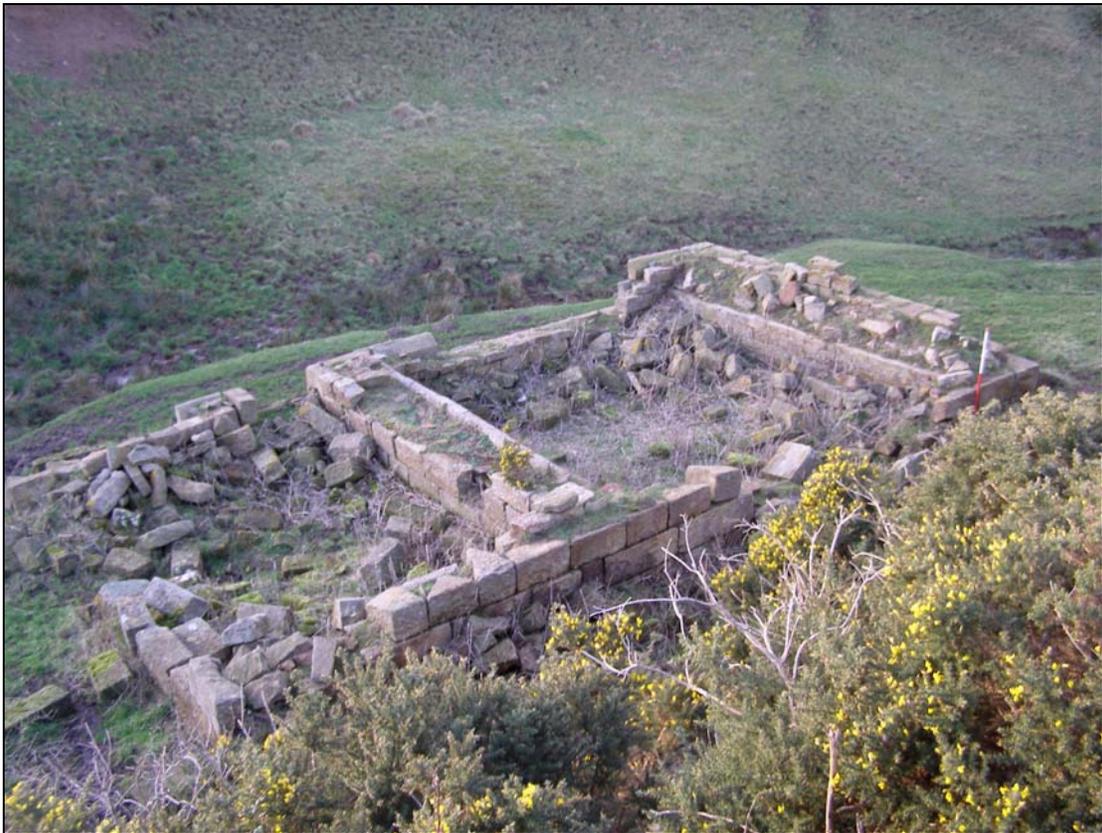
Plate 26: The ruinous structure at Limekiln Slack, Robin Hood's Bay (OAN 45)

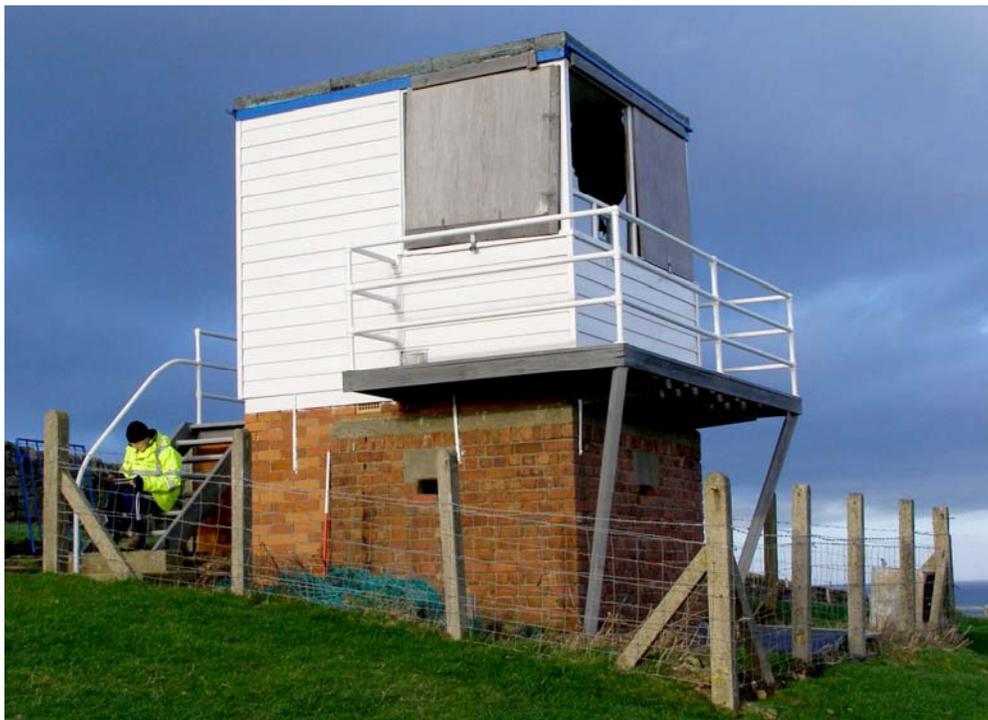
Plate 28: View of the Coastguard Lookout Point at Robin Hood's Bay (OAN 185)

- 4.9.7 The coast guard station was found to be extant, and comprises a red brick built pillbox, with an original, flat reinforced concrete roof. The pillbox had latterly been extended to the rear, and this provided the base for a wooden coastguard hut which sat on top.

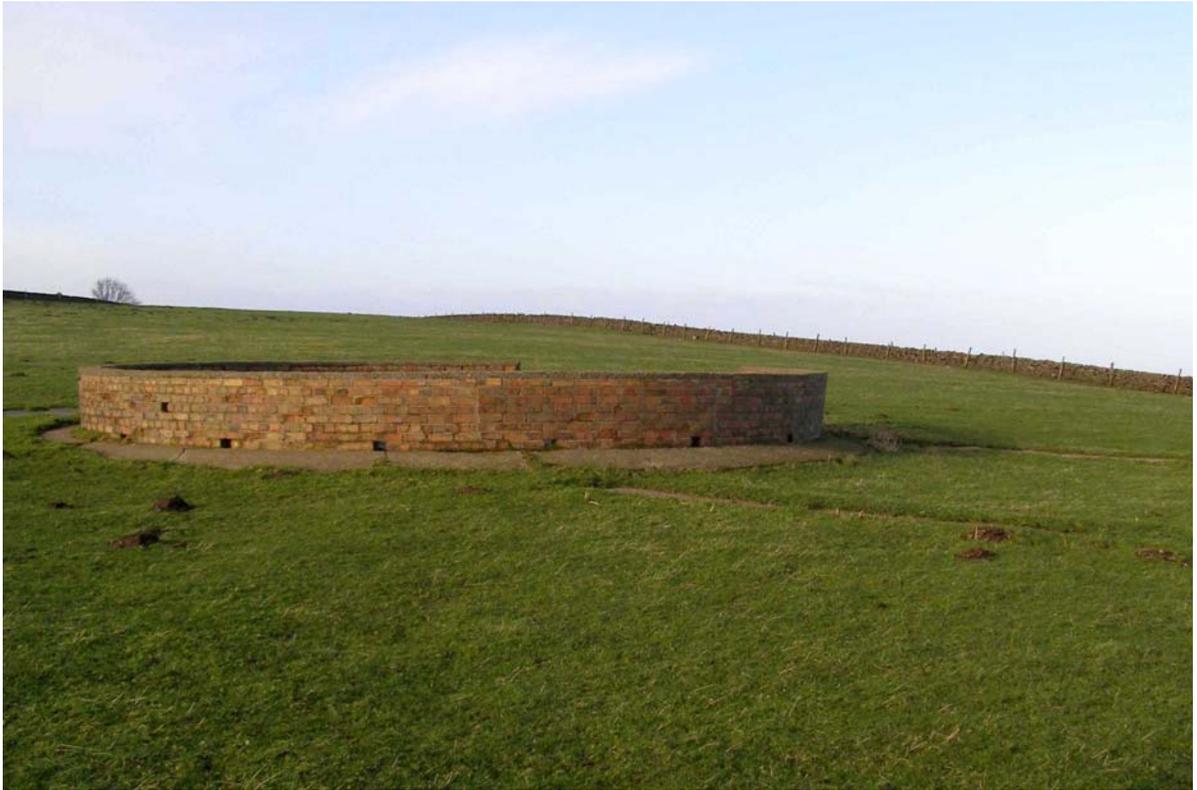
Plate 36: The putative acoustic listening device (OAN 134) at Ravenscar

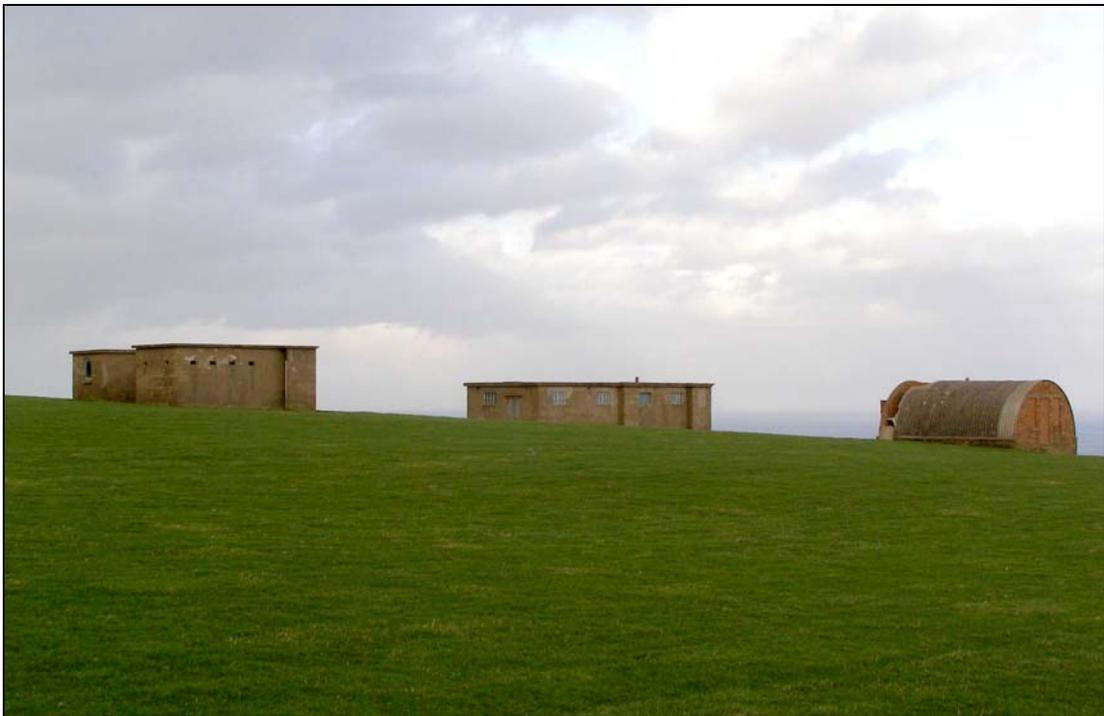
Plate 37: Part of the surviving remains of Bent Rigg Radar Station, Staintondale (OAN 6)

housing the electric generator and the fuel store. South-east of the TX/RX building is a Nissen hut, containing a number of original fittings. North-east of the TX/RX building is a small concrete platform, which represents the footings of a structure of unknown function. Adjacent to the railway track, a little distance to the west, lie the foundations of five barrack buildings and a further five buildings including a mess hut, the station commander's accommodation, offices, and stores. The latrine blocks lay 40m north of the administrative buildings, and survive as the footings of two small structures (Pritchard 2001a - Scheduling Notes for SM 34842).

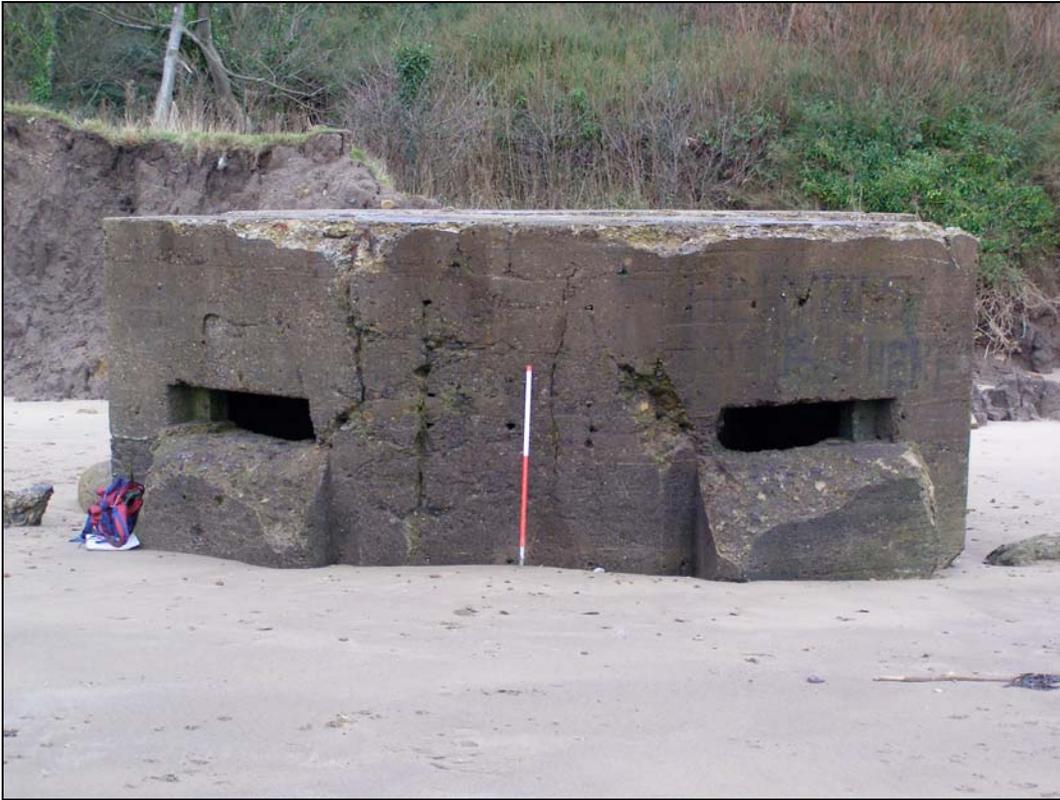
Plate 40: Example of a surviving variant Pillbox on Cayton Bay Beach (OAN 271)

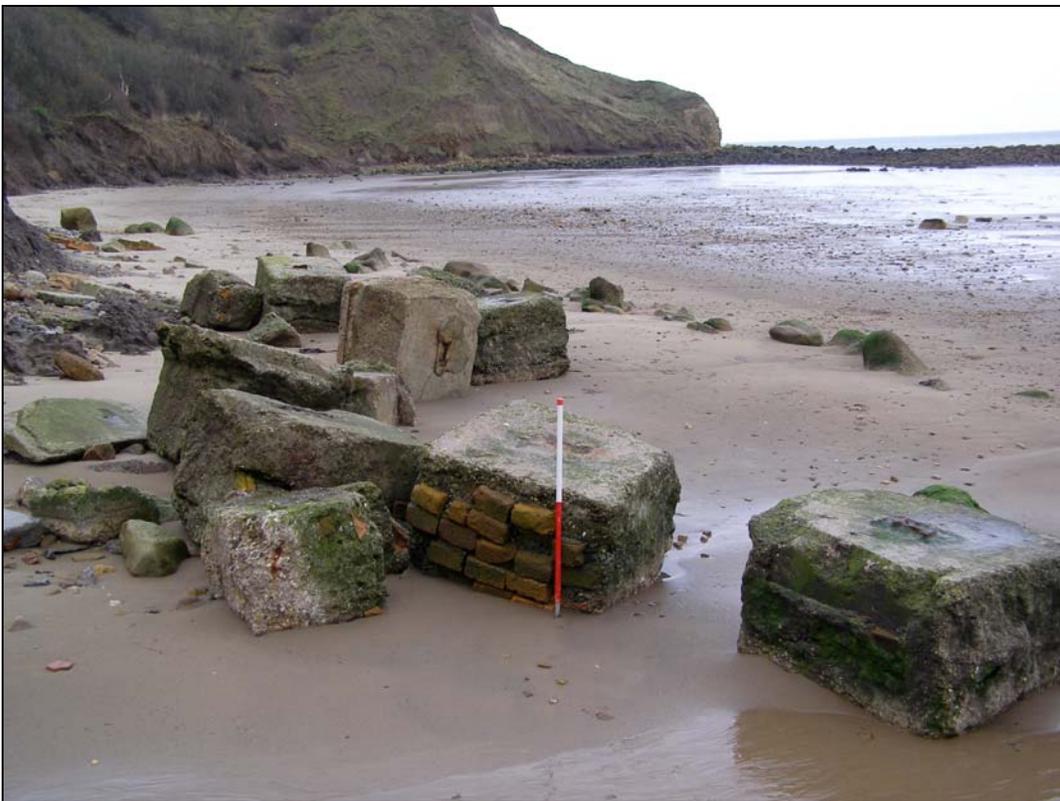
Plate 41: The surviving Second World War defensive concrete blocks on Cayton Bay Beach (OAN 160/266)
