# **New Sedgwick Gunpowder Works, Sedgwick, Cumbria**

## **Archaeological Watching Brief**

Issue No:	2007/8-774
OA North Job No:	L9755
NGR:	SD 5098 8814

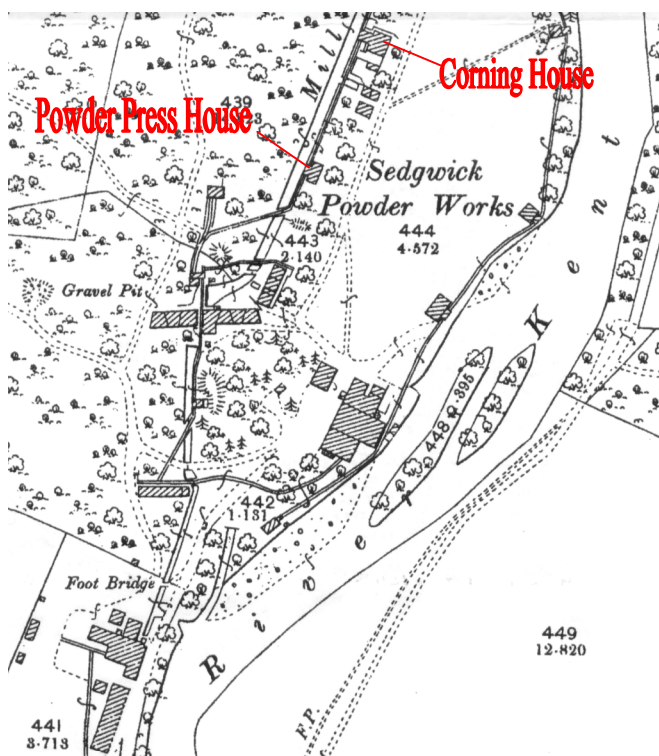
- 3.4.6 The corning house also had to be rebuilt several times after disastrous explosions, but it was always located on the same site. The original corning house is shown on the Ordnance Survey map of 1857, which shows a rectangular building, measuring some 11m by 5m, situated on the eastern side of the main leat and separated from the first powder press house by a blast wall. The rebuilt corning house depicted on the Ordnance Survey map of 1898 comprised a 'T'-shaped building, with the stem part extending over the tramway (Fig 3). The building was destroyed by an explosion in 1903, although it is shown on the Ordnance Survey map of 1914 to have been rebuilt on the same footprint.

Extract from the Ordnance Survey map of 1914

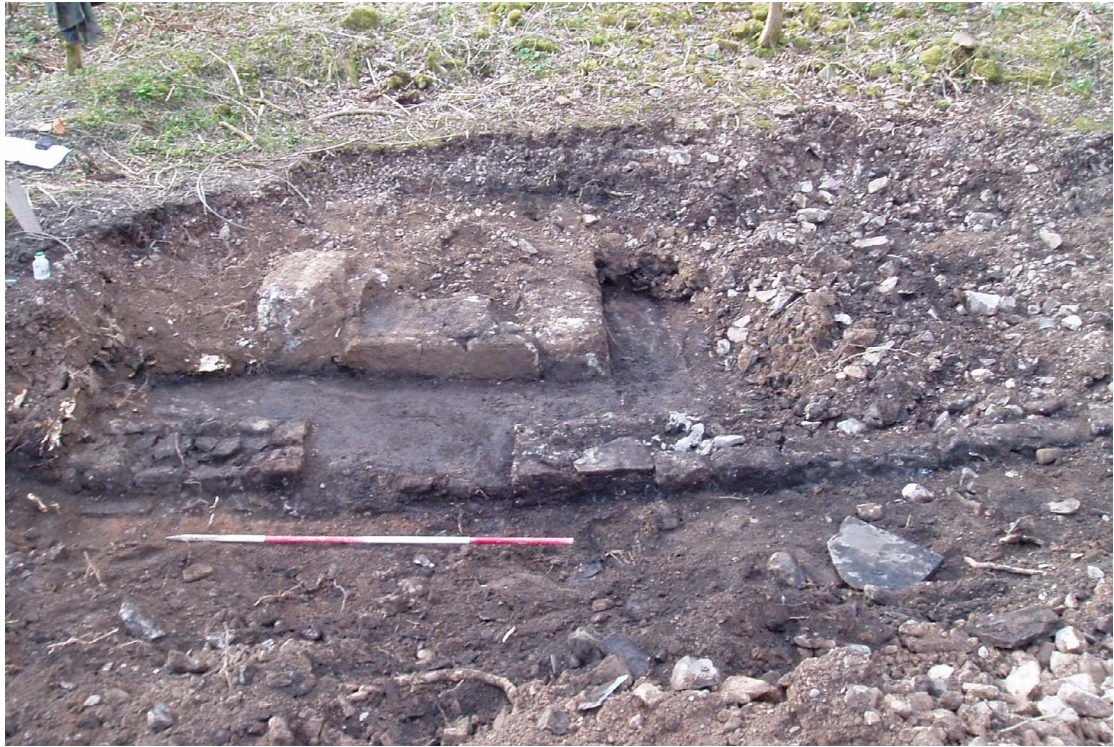
- 4.5.3 Removal of rubble layer **410** revealed the foundations of a stone building (Plate 1), situated 5.6m south of the leat and 27m east of the footbridge that crosses the leat. The building was aligned east/west, parallel with the leat, and was 5.95m long; the full width of the building was not established.

Plate 1: The exposed remains of the new powder press house, looking west (2m scale)

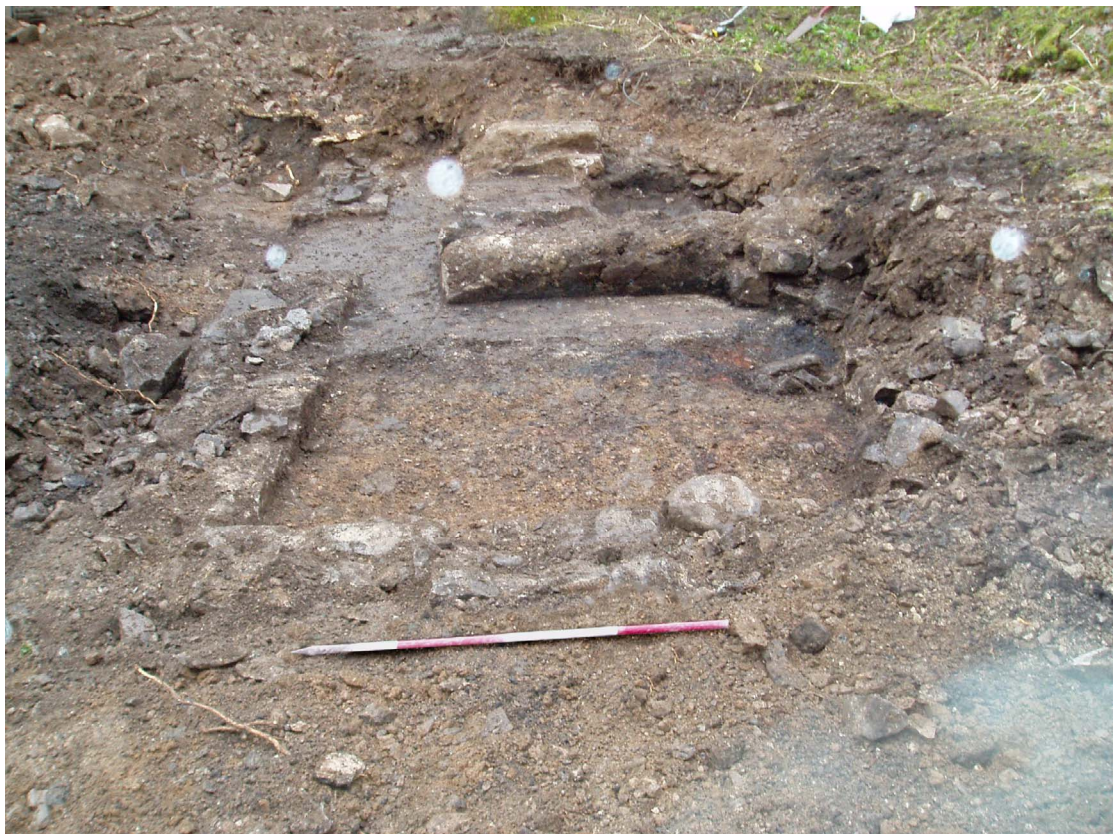
- 4.5.4 The exposed elements of the building comprised the eastern wall (**402**), part of the northern wall (**403**), and several internal features (Fig 4). The eastern wall was exposed for a distance of 5.95m, and measured 0.5m wide. The wall incorporated an aperture, some 1.2m wide, which almost certainly represented the position of a doorway (Plate 1). The internal and external elevations comprised worked stone blocks, with a limestone rubble core and mortar bonding. The wall survived to an average height of 0.15m, although the southern part incorporated an offset foundation course, which extended 0.12m from the overlying masonry; the northern part of wall **402** is also likely to have incorporated an offset foundation course, although this was not exposed. The northern wall (**403**) was exposed for a distance of 1.8m, and whilst of similar construction to the east wall, it was slightly narrower, measuring 0.4m wide (Plate 2).

Plate 2: The exposed remains of the new powder press house, looking south  
(2m scale)

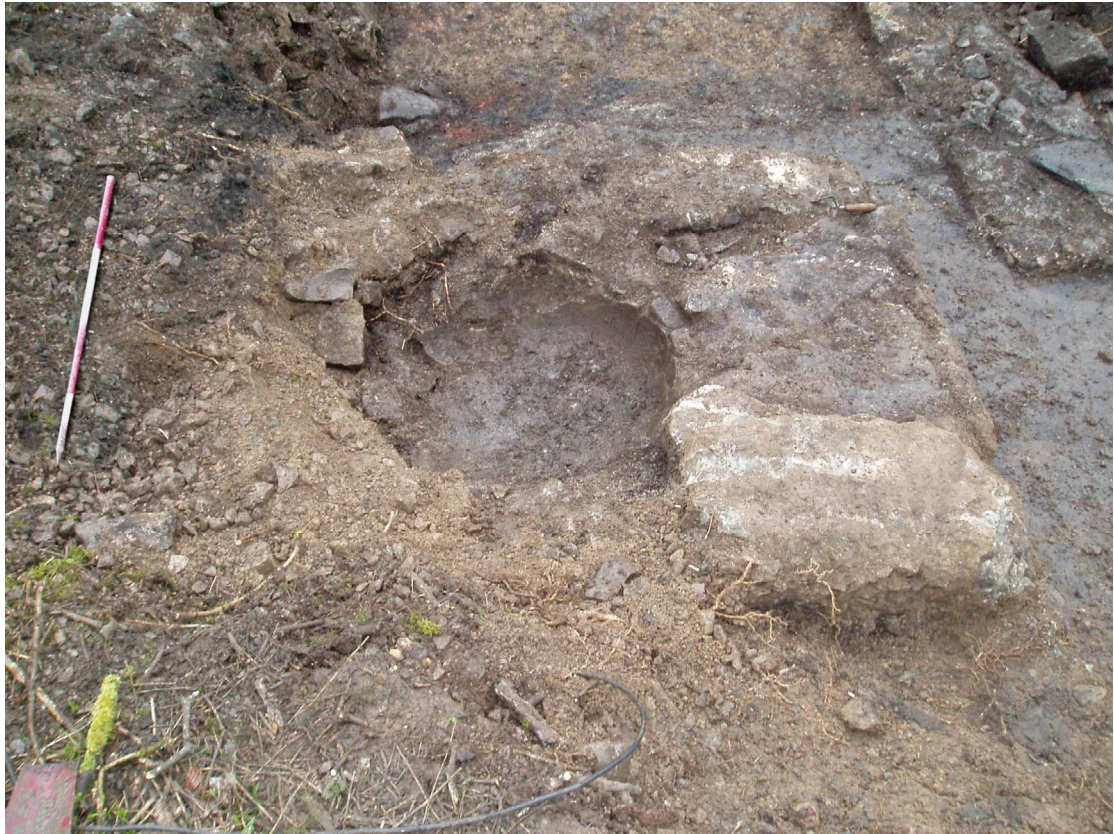
- 4.5.8 Structural components **405** and **406** seemingly bounded a large circular feature, which had been cut into the natural geology (Plate 3). This feature had a diameter of 0.92m, and a maximum depth of 0.22m. The western edge of this feature was lined with medium-sized, sub-angular stones (Fig 4), although it is uncertain whether these had been laid deliberately, or derived from the demolition of the building.

Plate 3: Circular feature exposed within the new powder press house, looking north  
(2m scale)

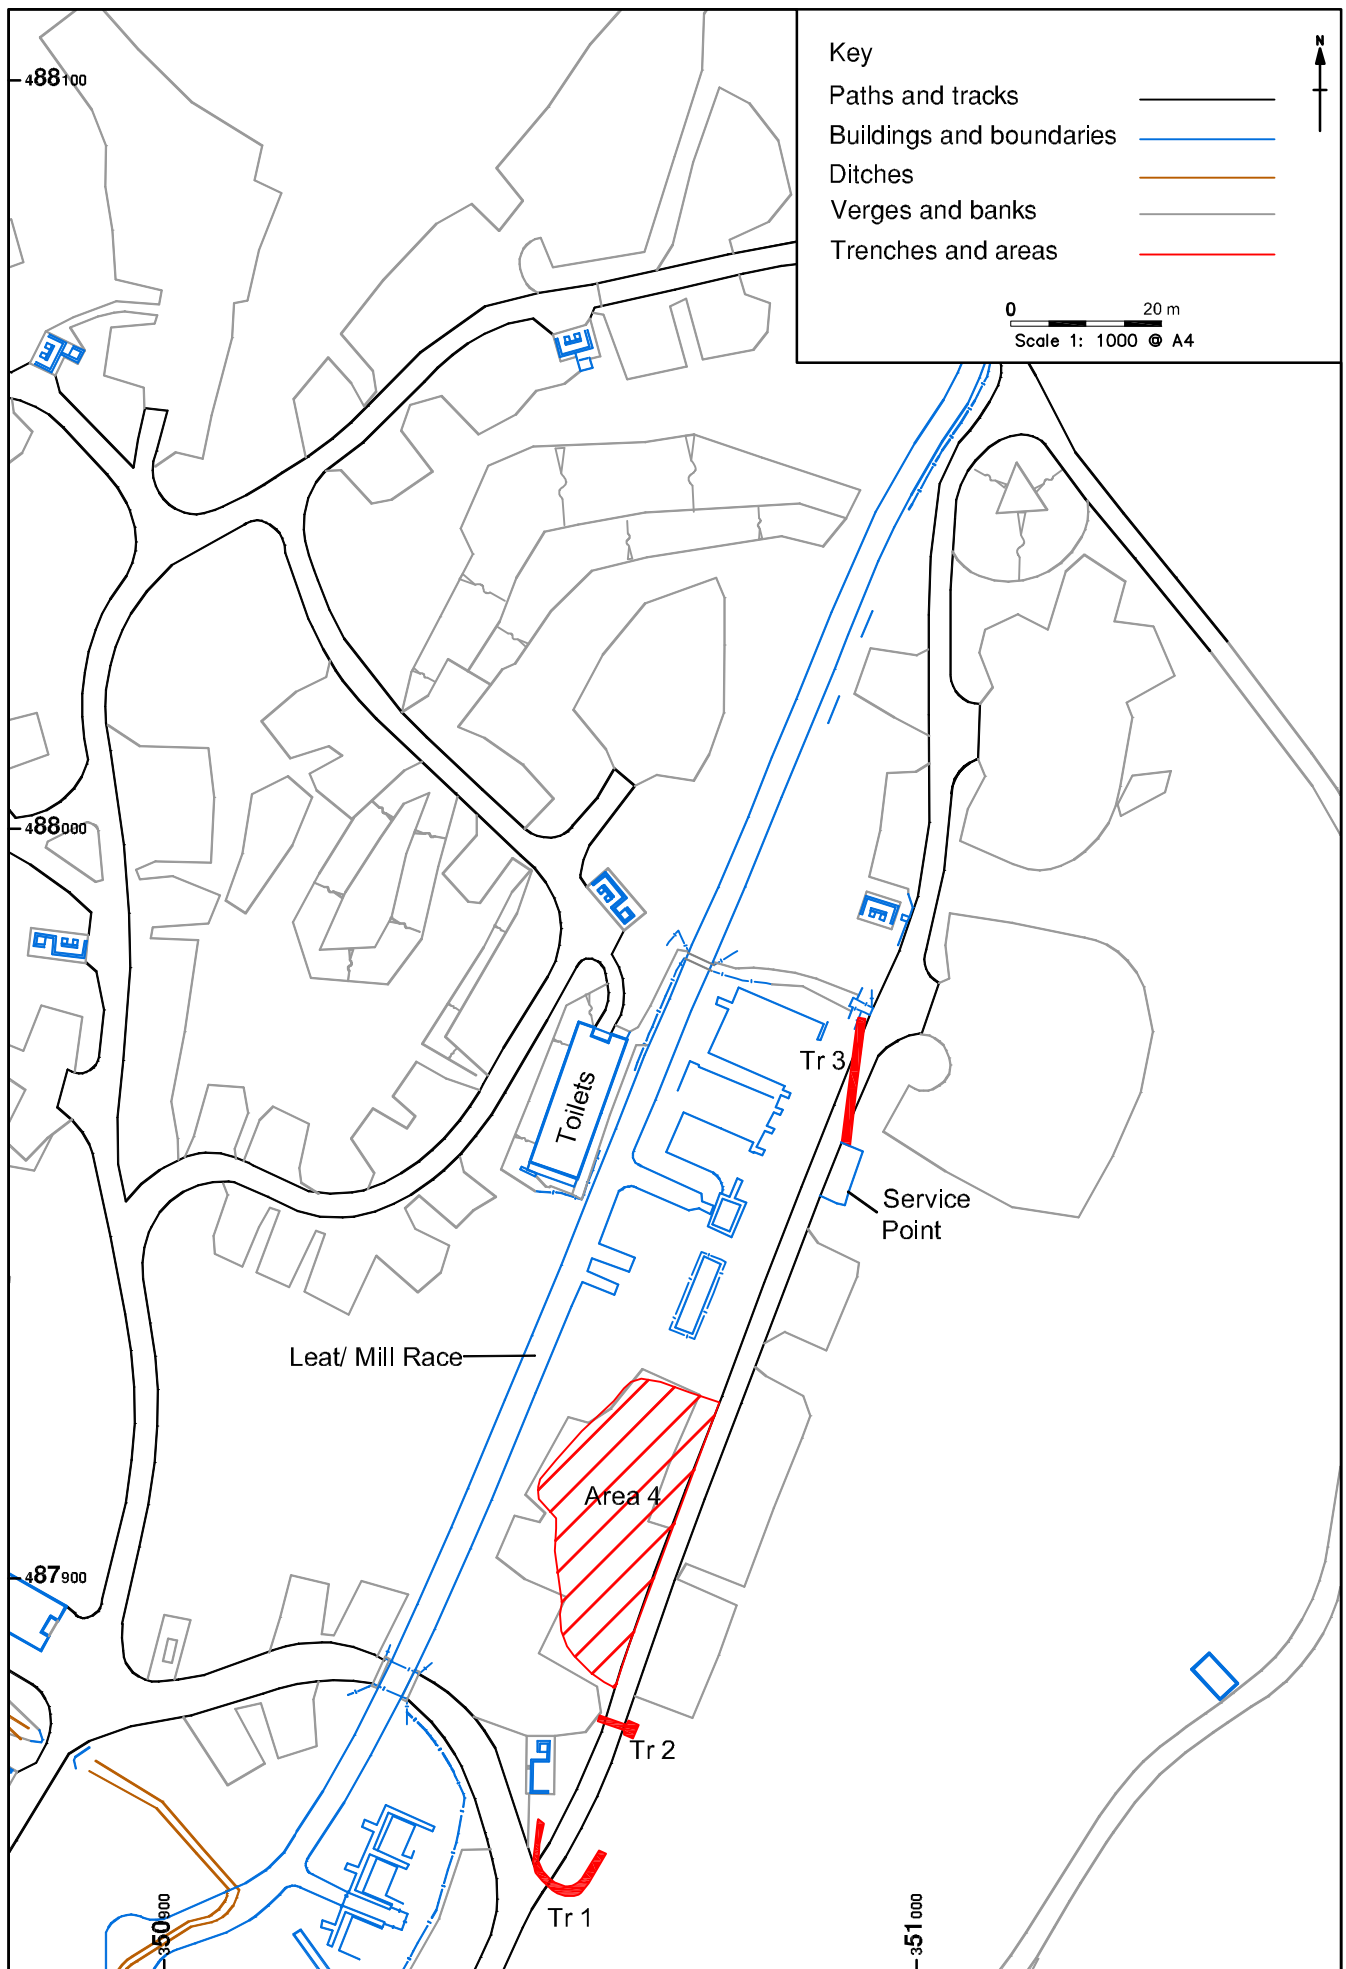
Figure 2: Plan showing Trenches 1, 2, and 3, and Area 4

- 4.1.1 The proposed scheme of development allowed for the refurbishment of the toilet blocks, the refurbishment of the reception area, the opening of a new interpretation and information centre, repair work to the access roads, and repairs to several caravan pitches. Of these works, only the proposed repairs to the access roads and caravan pitches were considered to have archaeological implications, and it was these works that were targeted for archaeological monitoring.
- 4.1.2 An archaeological watching brief was maintained during the excavation three service trenches, and the mechanical removal of a gravel surface along the main road running north/south between the main buildings of the gunpowder works and the river Kent.

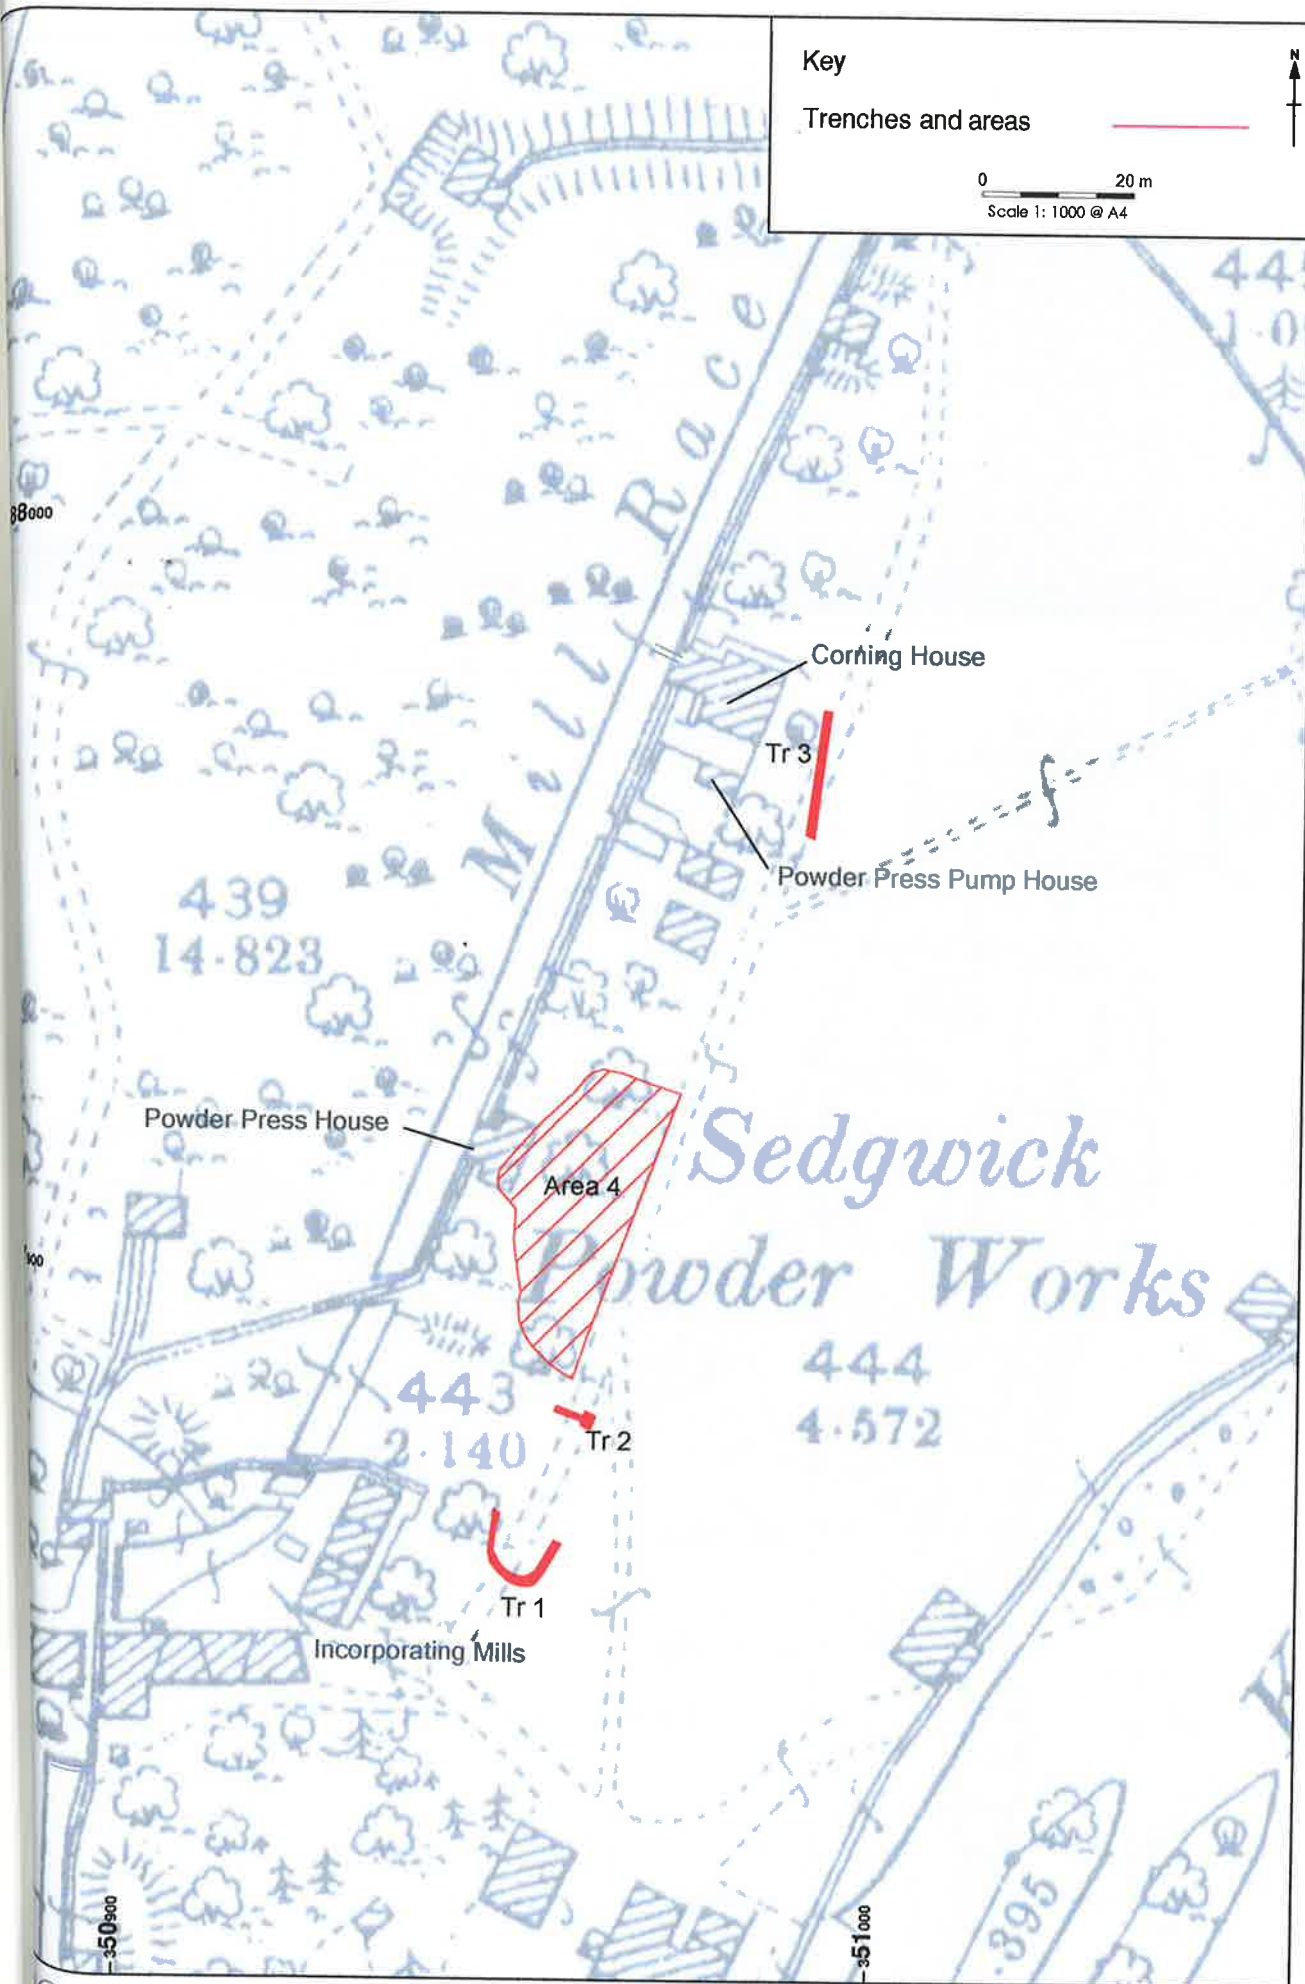
Figure 3: Plan showing Trenches 1, 2, and 3, and Area 4 superimposed onto the Ordnance Survey map of 1898

- 4.2.1 This trench was excavated across the access road, and was situated a short distance to the east of the site of the Incorporating Mills (Fig 3). The trench measured 5.2m long by 0.5m wide, and was excavated to a maximum depth of 0.4m.
- 4.2.2 The natural geology (**103**) was exposed along the base of the trench. This was overlain by levelling deposits (**101** and **102**), seemingly of modern origin. No features or deposits of archaeological interest were exposed in the trench, and no artefacts were recovered.

- 4.4.1 This trench was excavated broadly north/south across the access road to the rear of the Powder Press Pump House and the Corning House (Fig 3). The trench measured 15.2m long and 0.5m wide, and excavated to a maximum depth of 0.8m.
- 4.4.2 The natural geology (**305**) was exposed at a depth of 0.4m below the modern ground surface. This deposit was overlain in the eastern part of the trench by the topsoil, **302**, which had a maximum depth of 0.4m. Where the trench cut across the access road, the section revealed a make-up layer of ash, soil and large sub-rounded stones and deposits of limestone chippings. This was overlain by a tarmac surface. No features or deposits of archaeological interest were exposed in the trench, and no artefacts were recovered.

- 5.2 The position of the buried structures encountered in Area 4 correspond to the location of a building shown on the Ordnance Survey map of 1898, and almost certainly represent the vestiges of the powder press house. This component of the works was erected in this position in *c*1875, following the destruction of the original powder press house, which had been sited adjacent to the corning house to the north. The new powder press house was built on the site of an expense magazine, which itself may not have dated to the initial construction phase of the works as it does not appear on the first edition of the Ordnance Survey 25" map (surveyed in 1857), or on the 1859/1860 sketch maps of the site. A building screened by trees is visible at this location on an historic photograph, dated 1873-5 (Dunn *et al* 2003), which shows a single-storey rectangular building on top of a raised stone base. It is considered likely, however, that this building was the expense magazine rather than the powder press house, as the latter was still under construction in 1875 (*ibid*).

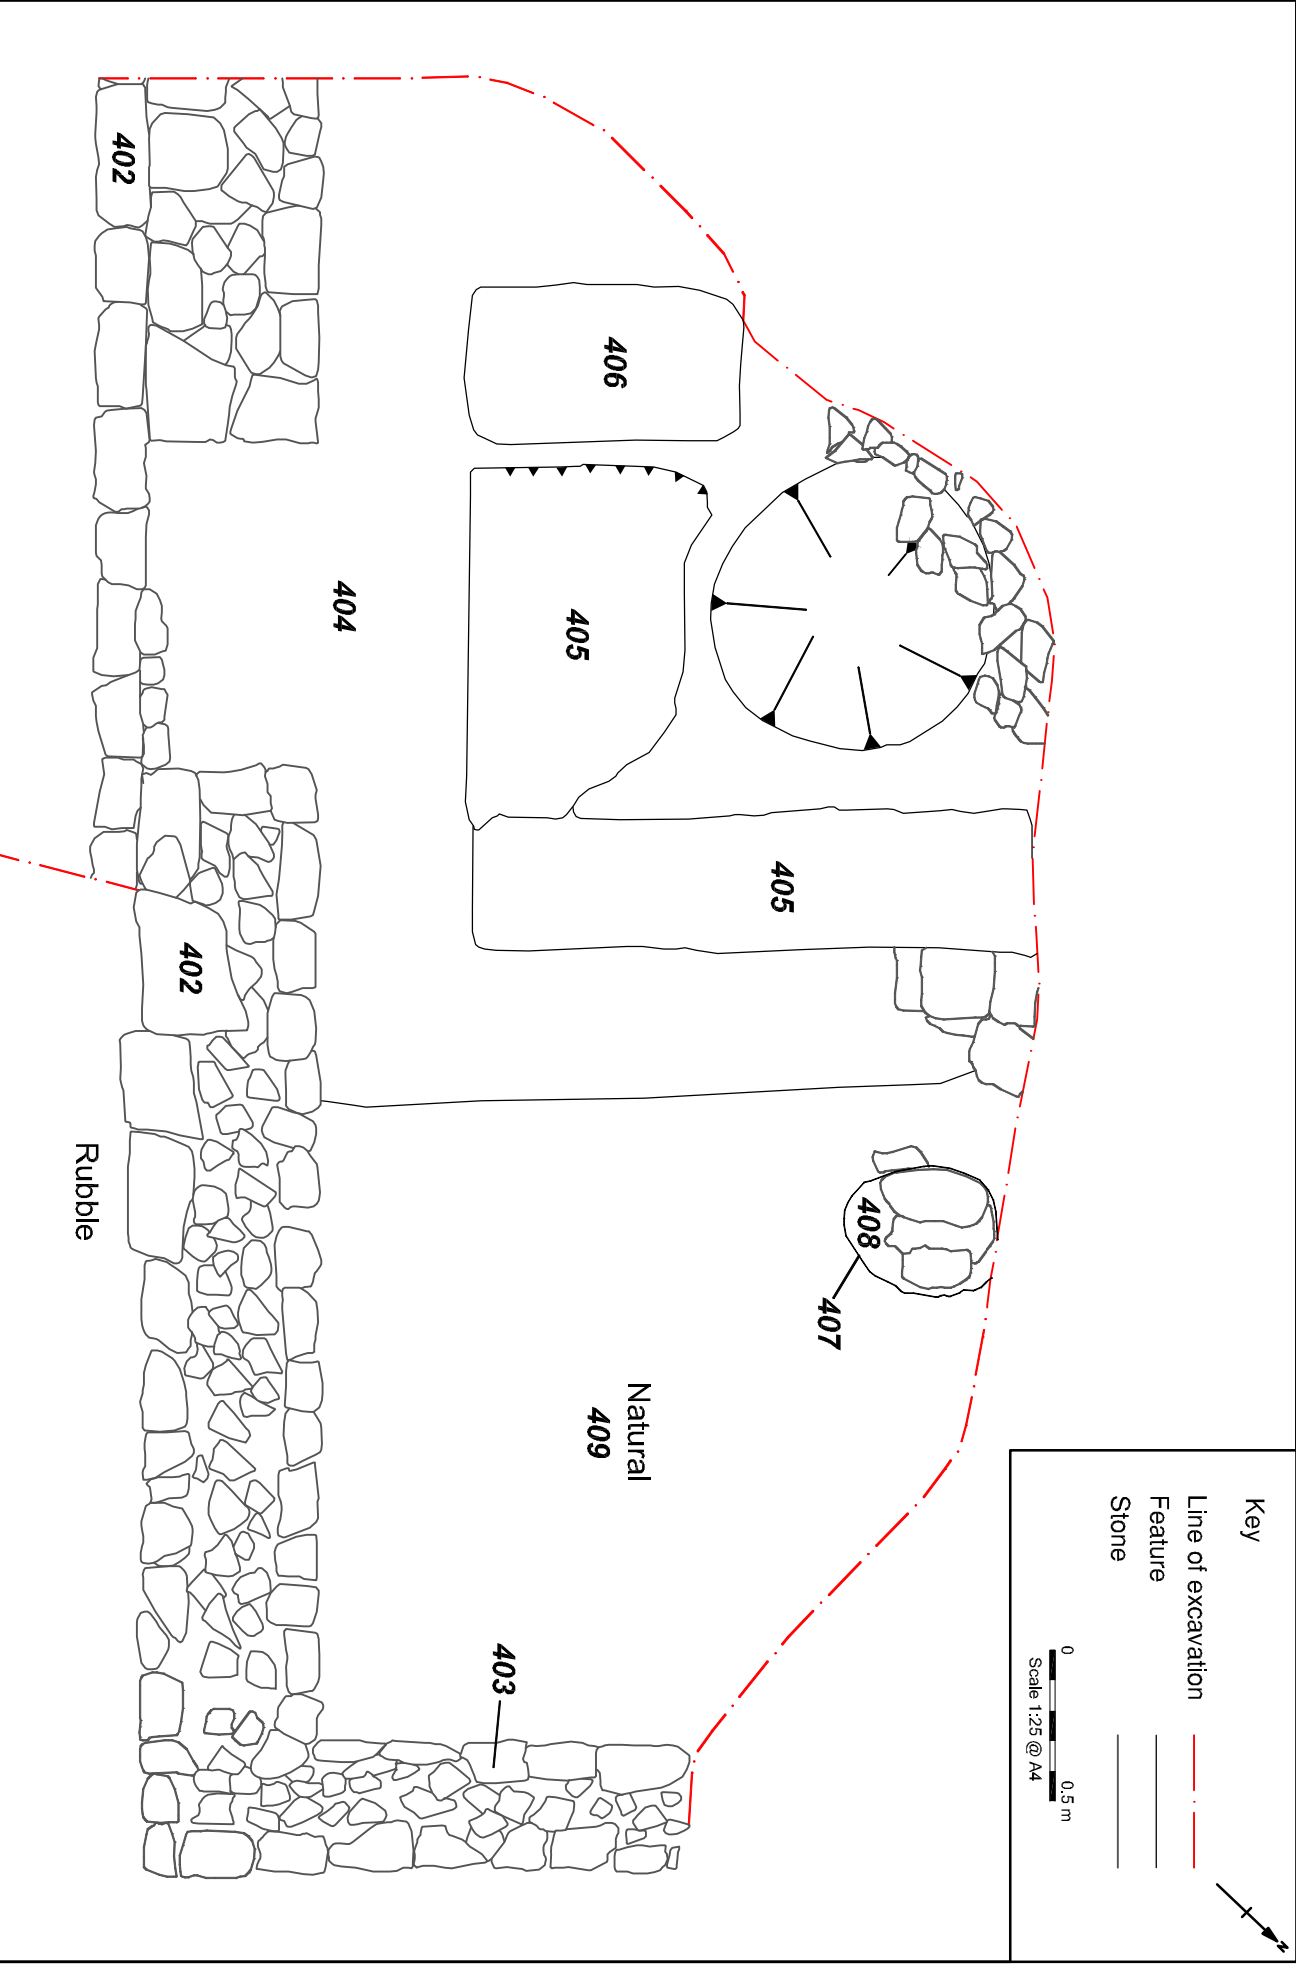
Figure 4: Detail of Area 4

- 4.5.5 Internally, the building retained an *in-situ* floor (**404**) across its southern part. This floor was composed of concrete, and covered an area measuring some 3.2m by 2.9m. No internal surfacing survived to the north, where the compacted, sandy-clay natural geology (**409**) was exposed (Fig 4).

- 4.5.6 A small, sub-circular pit or posthole (**407**), cut into the natural geology, was revealed in the north-western corner of the exposed area. The feature measured 0.51 by 0.4m, and was 0.38m deep. It contained three large sub-rounded stones, possibly representing post-packing material, set in a sandy-clay matrix (**408**) that contained frequent inclusions of charcoal and burnt clay.

- 4.5.7 Within the southern part of the building, set on concrete floor **404**, were the remains of a concrete plinth, **405**, which survived to a height of 0.26m. This was seemingly associated with a large concrete block, **406**, which lay immediately to the south of plinth **405**. Concrete block **406** measured 0.9m by 0.5m, and survived to a height of 0.52m.
