Middlemoor Windfarm, North of Alnwick, Northumberland

Archaeological Evaluation

Oxford Archaeology North

November 2006

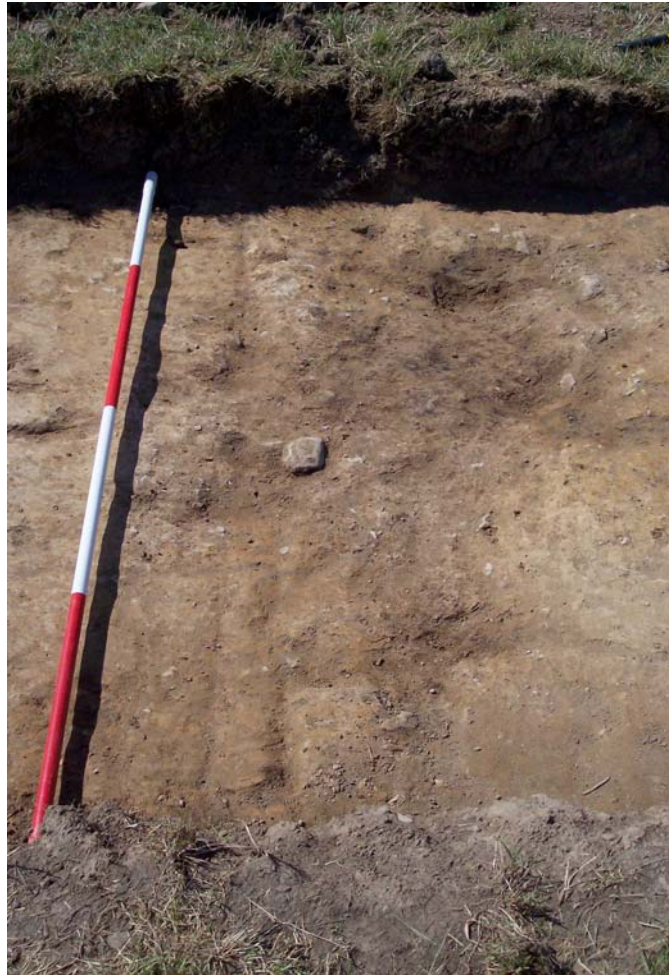
- 4.2.3 A small post-hole, **1016**, and a burnt spread representing the upper fill, **1017**, of a probable pit, **1018**, were located adjacent to the edge of a plough-mark (Plate 1). The post-hole, **1016**, survived to a depth of 0.04m and was filled with a loose dark-brown silt, **1015**. Burnt spread **1017**, comprised a dark-brown sandy-silt that contained a deposit of charred remains, which was 0.08m thick; this sealed a compacted orange-grey burnt clay, **1019**, representing the primary fill. The fills were contained within a sub-circular shaped feature, **1018**, that measured 1.12m by 0.66m, and suggested the remains of a small bonfire. No dating evidence was recovered from either of these features.

- 5.5.2 **Trench 9:** post-hole **1016** and burnt spread **1017** are not particularly diagnostic but could represent a central tent post and a small bonfire. Although no dating evidence was recovered from these features, a prehistoric origin cannot be excluded.

Plate 1: Trench 9; east/west aligned plough-mark and upper fill (**1017**) of pit **1018**, looking west

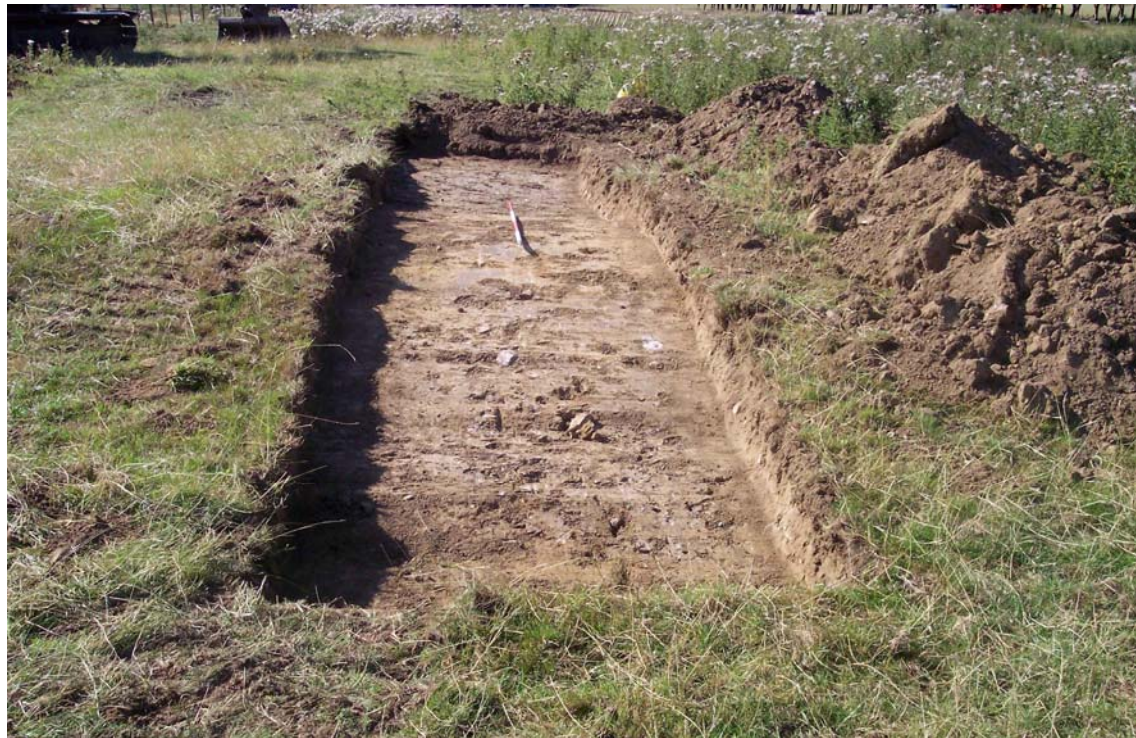
- 4.3.3 All the identifiable ridges were aligned north/south and were visible along the eastern edge of the field. A distance of 10m was recorded between each visible ridge crown, which is relatively broad and normally a product of oxen ploughing and therefore probably of medieval date; however, no evidence of headland was observed to confirm the use of oxen ploughing.

Plate 3: Trench 27; view of ridge and furrow, looking west

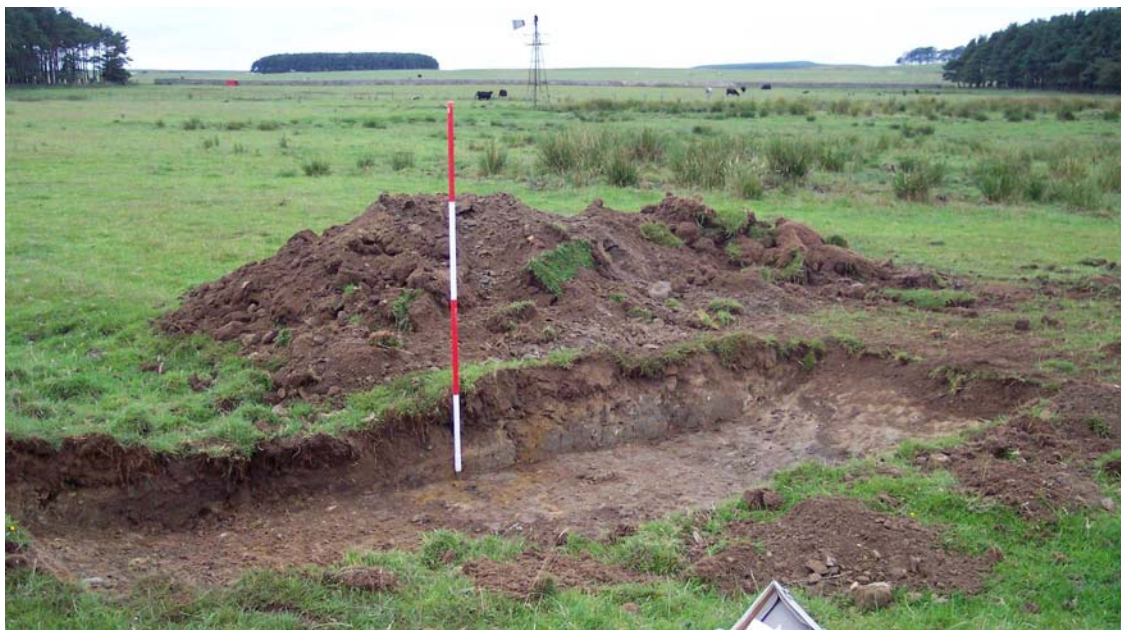
- 4.4.14 **Trench 66:** (Figs 15 and 16; Plate 8) was aligned north/south and was excavated across the width of a possible old field boundary ditch, which was located along the southern limit of the trench. (Fig 15). The deposits encountered reflected the damp environment and included humified topsoil and manganese-rich subsoils. The subsoils were rich in composition varying between a grey to pale-red-brown sandy clay that was diffused with a water-worn gravel along the southern part of the trench in the base of the ditch. No finds were recovered.

Plate 8: Trench 66; looking north-west

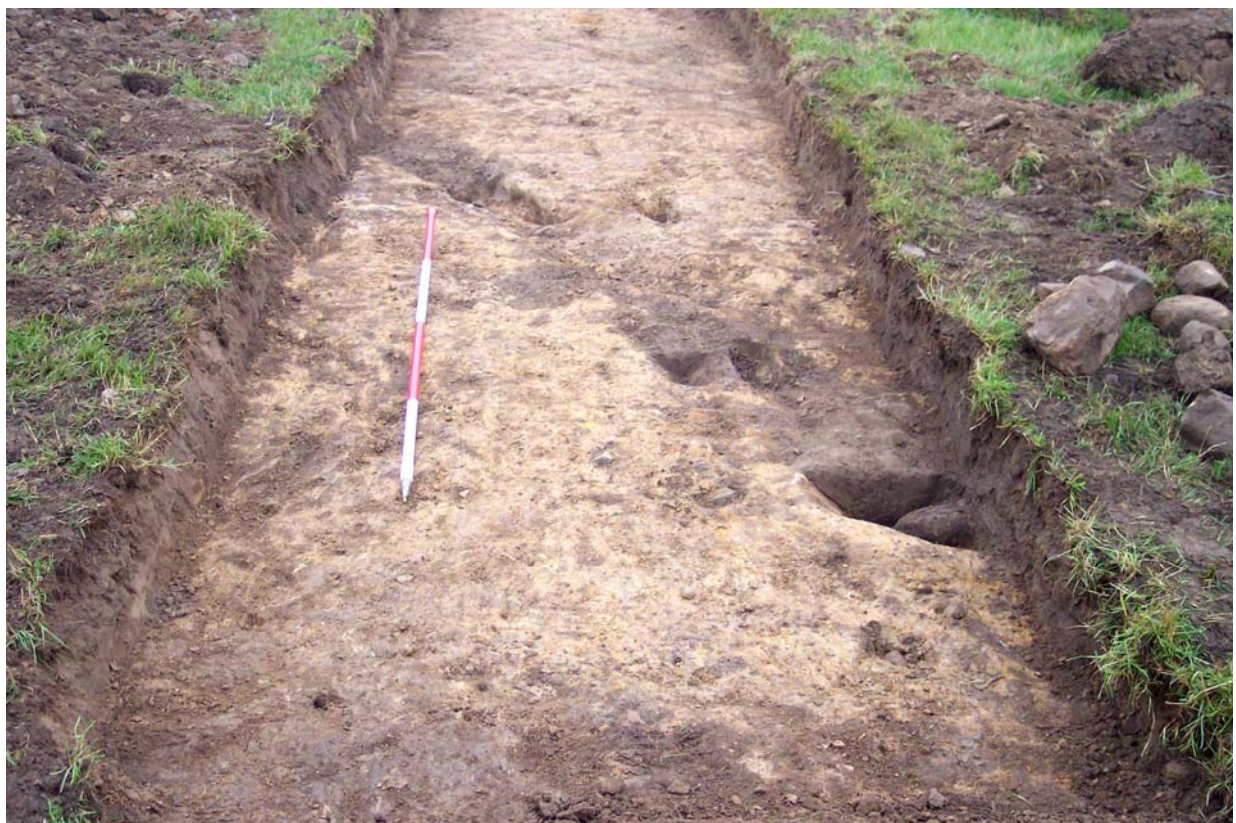
- 4.4.21 Ditch **1065** was at least 2.50m long and 0.33m wide, and had a 'U'-shaped profile. It survived to a depth of 0.10m; however, the feature became gradually deeper at the north-east end, and shallower at the south-west end, perhaps suggesting a terminus. Its base was lined with loose stone that was in turn overlain by a dark-grey-brown sandy-silt, **1066**. Pit **1057** was sub-rounded in plan and measured

Plate 10: Trench 91; ditch *1065*, looking north-east

- 6.1.1 The construction of the crane stand adjacent to Turbine **18** (Trench 91), in its present proposed position, will damage the archaeology in that specific location. No remains were encountered in the other two trenches and there is no evidence of any archaeological features on the site of Turbine **18**.

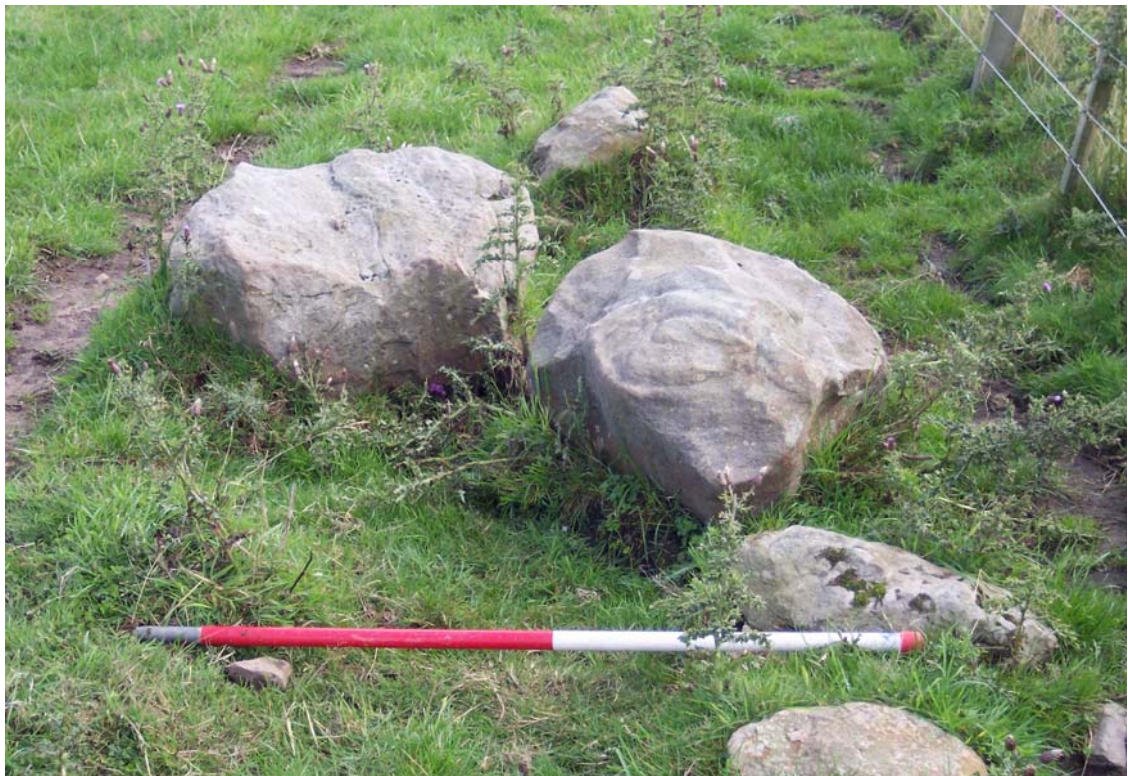
- 4.5.1 A single example of a possible element of rock art was located within a field close to Middlemoor Road centred on NU 413851 623123. The stone (Plates 11 and 12) was observed amongst boulders that had been dragged to the edge of the field as part of field clearance operations. The carving comprises a deep grooved sub-circular panel, measuring 0.25m by 0.15m, which enclosed a faint design (Fig 19). The design bears a faint resemblance to an oculus-style motif, within a sub-circular shaped panel, that was carved along the upper surface of a roughly 1m long by 0.50m high sandstone block. It would appear that the carving was not ‘finished’ or had been broken off at one edge. There is a vaguely similar design found at Hangingstones Rock on Ilkley Moor (Boughey and Vickerman 2003, Plate **83**), although the latter was a much more elaborate example. This is not a conventional rock art pattern and there is the possibility that the form reflects a natural process of surface layer separation, which has resulted in irregular patterns on the rock. Consequently, it cannot be confirmed that this it was of anthropogenic origin.

Plate 11: Possible carved stone amongst boulders along the southern edge of the field containing Trenches 60 to 62

- 7.4.2 The location of the putative rock art near Turbine **6** highlights the potential for further remains that could be extant under the ground surface. Therefore, it is recommended that a watching brief be maintained during all ground disturbances in the western part of the study area, north of Middlemoor Road. Elsewhere it is recommended that a watching brief be undertaken on the sites of the proposed crane and turbine bases.

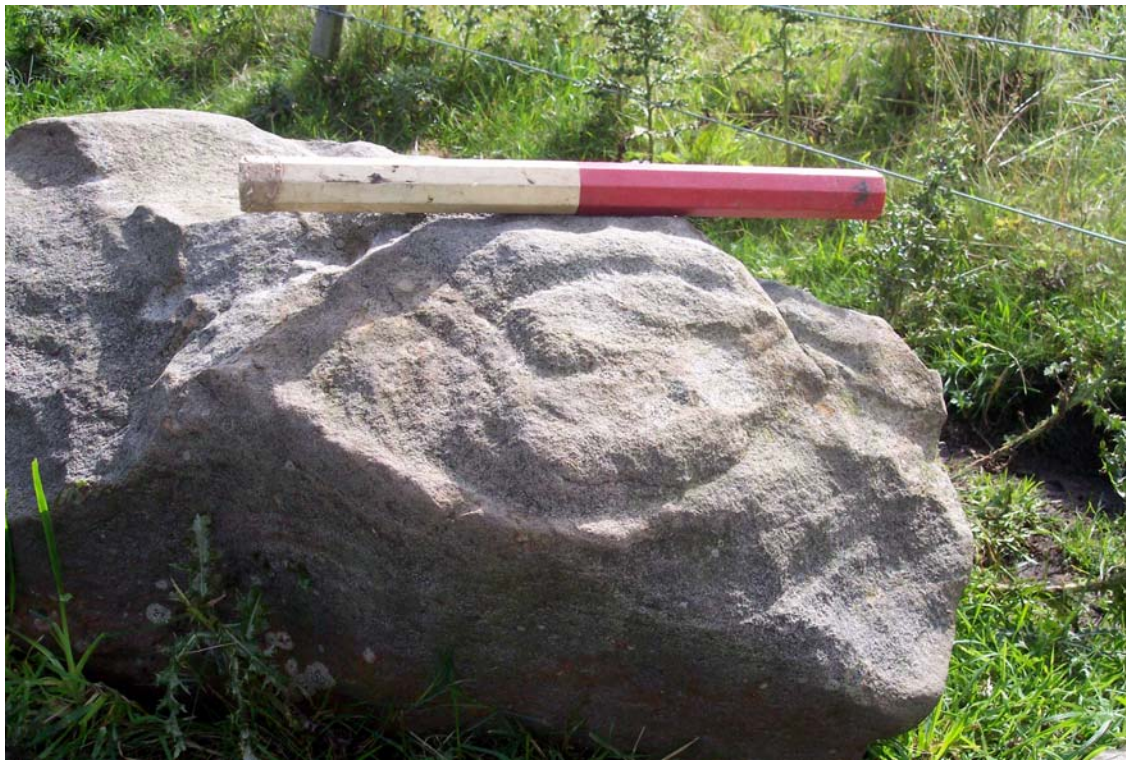
Plate 12: Detail of putative 'rock art'
