Chapel Court

East Facing Elevation

Hampton Court Palace

**Historic Building Recording
and Investigation**

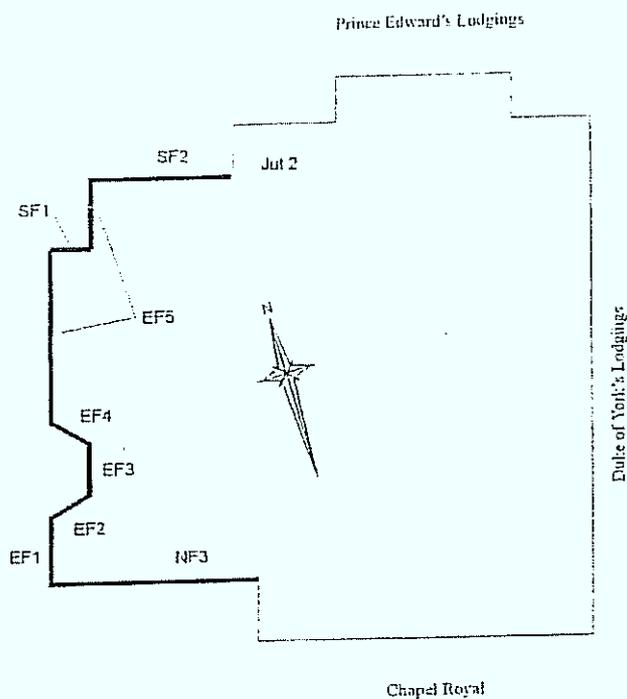
Fig. 1 Sketch Plan of Chapel Court.

Area surveyed during April-May 2007 shown by thick outline, and elevation identifiers indicated.

The area surveyed is marked with a thick outline in Fig.1., and the details are marked on the photogrammetric plots listed below.

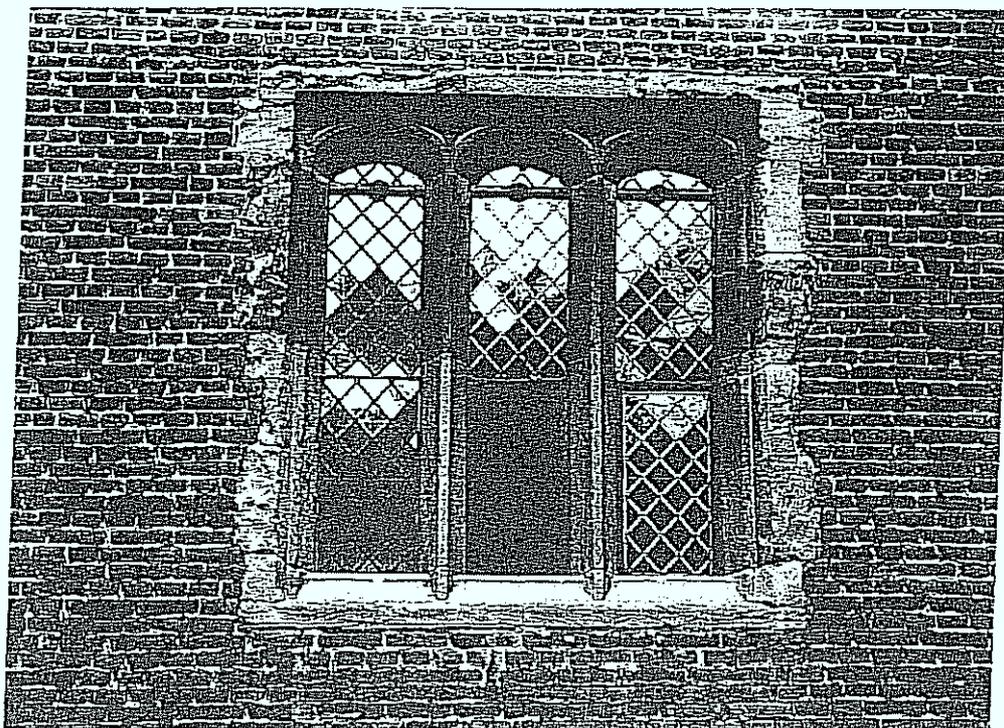
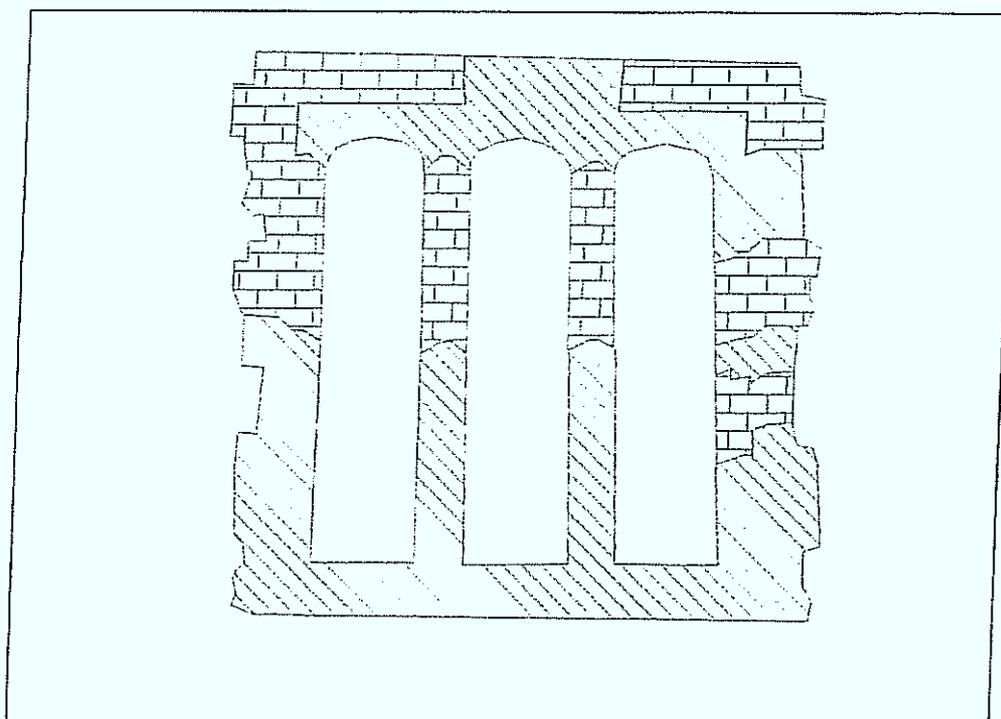
Fig. 1. South Face 2. 1st floor window.

Brick pattern = Taynton Stone.
Diagonal hatching = Artificial cast stone.

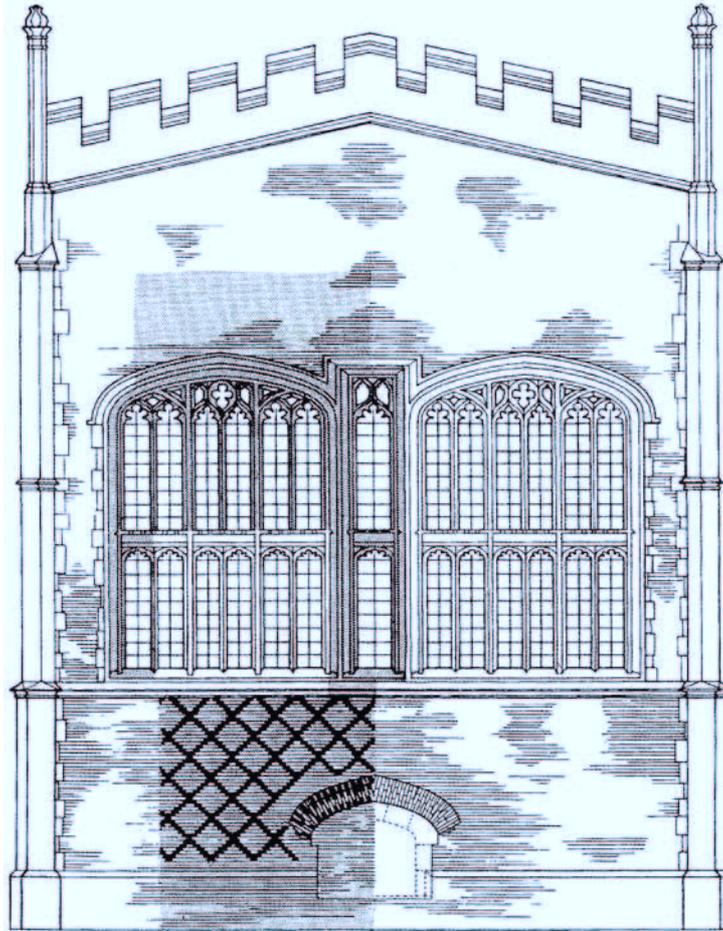
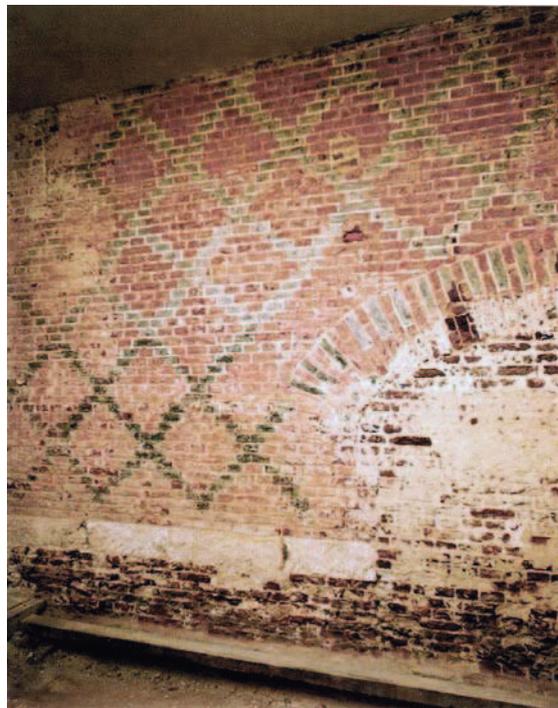
Figure 5: Hampton Court Palace, Chapel Court, East Facing Elevation - The probable Tudor diaperwork design as seen beside the Chapel east wall window (drawing: Daphne Ford)

- 4.2.3 This surviving material can be compared with the paintwork scheme that was found after the uncovering of the Chapel east wall in 1981 (fig 5). This wall was originally an external wall but it had been covered during Wren’s works to the Palace in the 18th century, thus protecting the earlier decoration. The uncovered wall has a red wash applied with a black regular diamond grid pattern painted over both bricks and mortar to ensure the fictitious diaperwork pattern is uniform. The

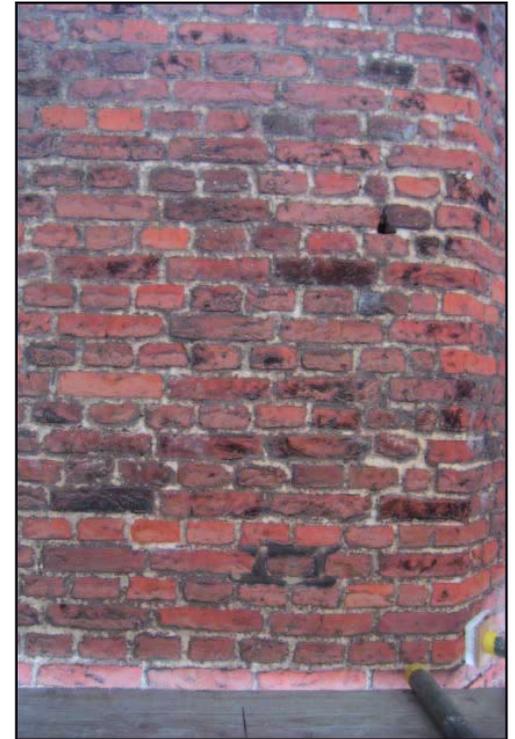
Plate 2: Type B brickwork on face 4

3.2.1 The earliest part of this elevation (faces 1 - 4) consist of Wolsey stock brick, dated to between 1522-1528 (plate 2) and defined as Type B by Daphne Ford in the English Heritage brick typology (Ford 1991, AS2/113). This brick type is consistent with the probable date for construction of the Chapel during the final part of Wolsey's occupation of Hampton Court. The Type B bricks are a red/brown/orange in colour with some small to medium sized stone inclusions. The bricks have no frog and the brickwork is laid in English bond. Some bricks have large inclusions, pebbles and pebble fragments, and there are holes where inclusions have fallen out. Bricks may also have fractures caused by weathering and the adhesion of the black ash mortar or have natural fractures formed during the forming and firing process. There are overfired and vitrified bricks present but they do not form part of a diaperwork pattern.

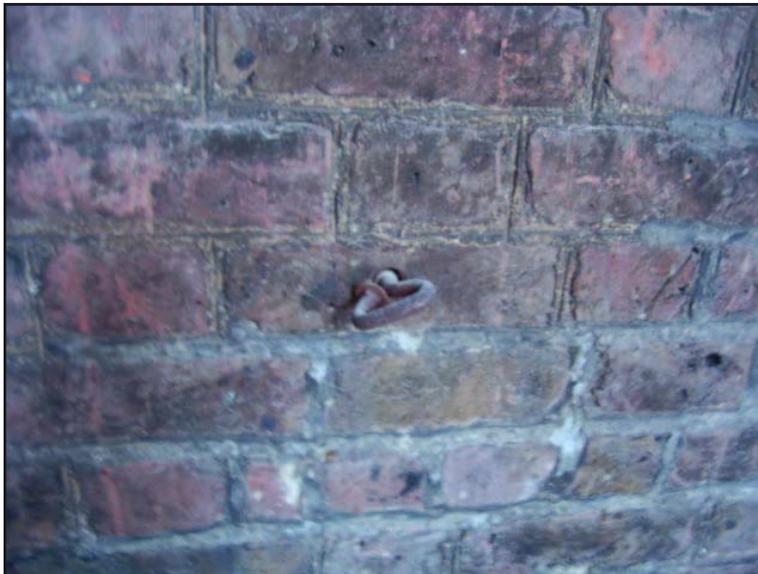
Plate 3: Type I Wren brickwork on face 1

3.2.3 On east face 1 there is a section of bricks identified as Type I Wren stock bricks (dated late 17th/early 18th century) by Daphne Ford (plate 3). These Type I bricks have a dark plum/brown colour and are laid in a Flemish bond which contrasts to the English bond on the Wolsey brickwork below. It is likely that this brickwork section forms part of the 18th century heightening of the range. Pictorial evidence suggests this to have occurred post 1710, and pre 1775 (Ford 1991, AS2/113). The use of Wren Type I bricks for this work would suggest an early 18th century date.

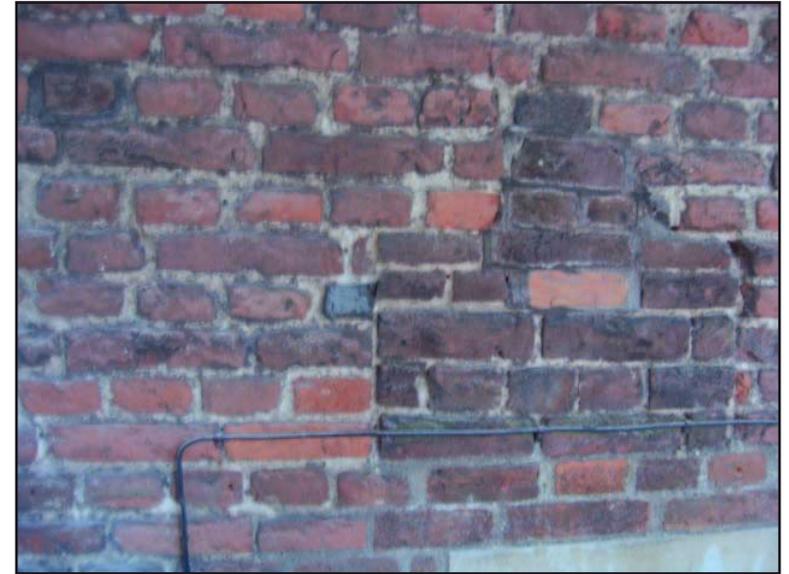
Plate 4: Type I Wren bricks used on infill patch face 1

3.2.4 There is also a patch of Type I bricks above the ground floor window of face 1 and there are straight joints suggesting it is infilling a removed fixture or feature (plate 4). Type I bricks have also been used on face 3 of the north facing elevation where refenestration of an antechapel ground floor window replaced a Tudor twelve-light window with an eight-light window, with Type I bricks used in the blocking of the void (plate 5). This is likely to have been during the 1710/1711 works to the chapel where the Tudor windows were replaced with casements (Rawlinson, 2005).

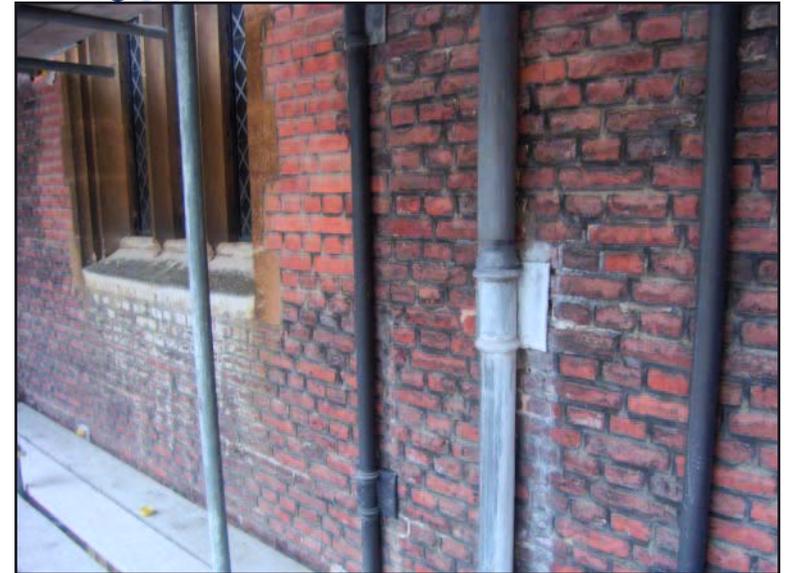
Plate 6: Type C brickwork on face 5

3.2.2 The council chamber built by Henry VIII in 1529 (face 5) was constructed with Type C Henrician stock bricks, dated to between 1529-1566 (plate 6). This brick type is also used on the south and west facing elevations as well. These bricks are brown/orange/rose in colour with occasional stone inclusions. They have no frog and the brickwork is laid in an English bond. There is a small area of diaperwork pattern using vitrified bricks and this is discussed further in §4.1 but otherwise vitrified bricks are used randomly within the elevation.

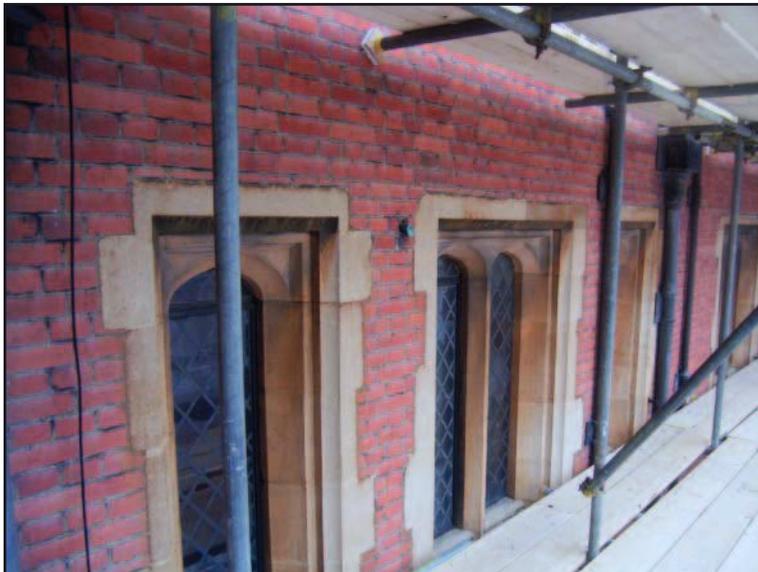
Plate 7: Type T brickwork on face 5

3.2.5 The upper storey of the west range consists of 19th century stock bricks (Type T) laid in an English bond (plate 7). The crenellations above are also 19th century stock bricks (Type T) but these are laid out in a Flemish bond which is the usual brick bond for this date. It is possible that the 18th century brickwork beneath the

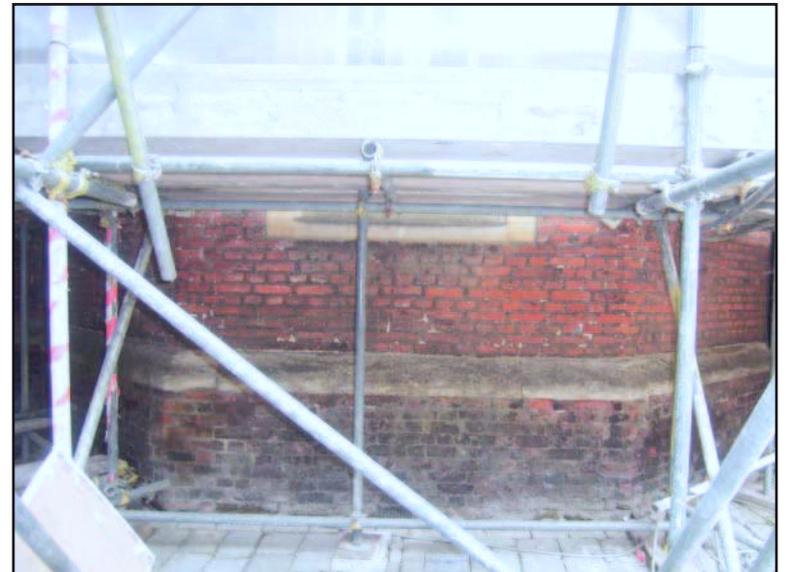
Plate 8: Type T brickwork on plinth

3.2.6 There is a brickwork plinth at the base of the elevation that is topped by a stone weathering course (plate 8). There is calcification upon the brickwork and a large quantity of organic growth, mostly a mossy substance. The bricks are 19th century Type T stock bricks in various shades of orangey-red; the mortar is flat and a light grey in colour. There are large areas of friable soft bricks, probably due to weathering.

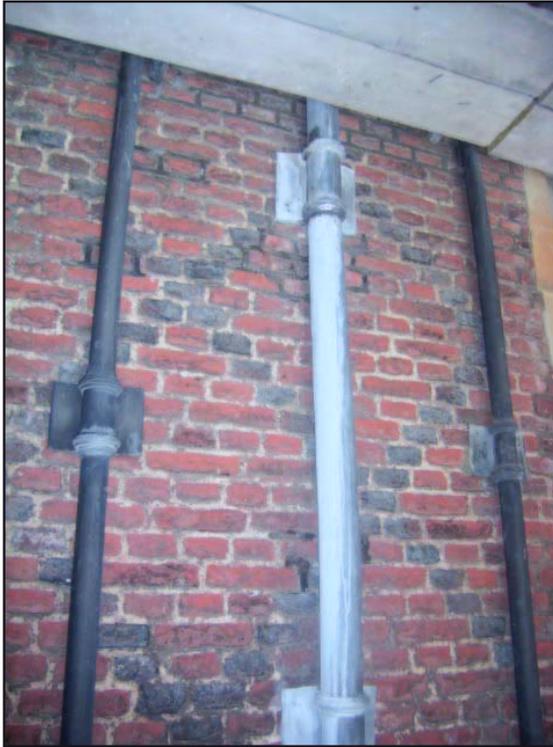
Plate 9: Henrician vitrified diaperwork

- 4.1.1 Small patches of vitrified diaperwork can be seen on east elevation face 5 as part of the Henrician build. The diaperwork is completely formed using vitrified headers, with variations in the English brick bond to accommodate this. This section is the only occurrence of vitrified diaperwork within this courtyard.

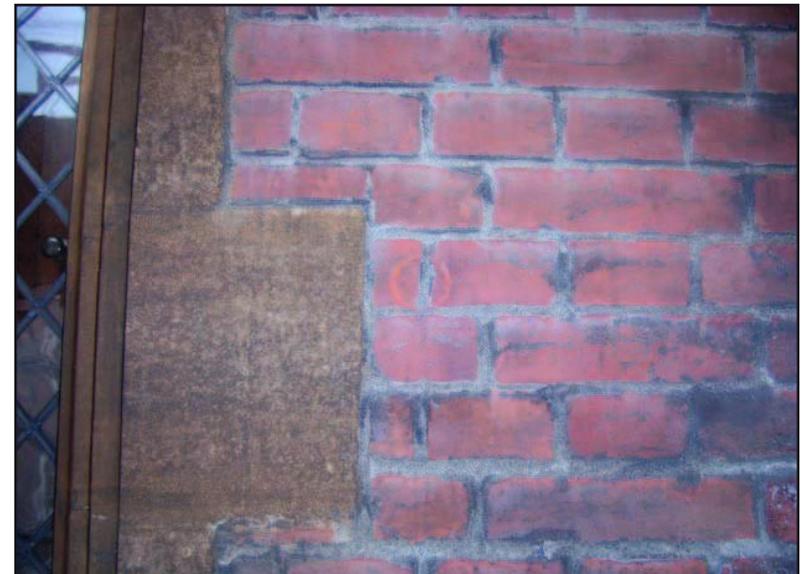
Plate 16: 20th century scaffolding mark

4.5.1 As with the north facing elevation surveyed in September 2006, there were several scaffolding marks found on the elevation (fig 4). The marks are approximately 50mm in diameter and formed by a hollow scaffolding tube rubbing against the brickwork creating a slightly oval shape (plate 16).

4.5.2 Due to the popularity of metal scaffolding from the 1920s onwards it can be assumed that these marks therefore relate to works from the 20th century, and are most likely from the replacement of the crenellation stonework and two windows on face 1.

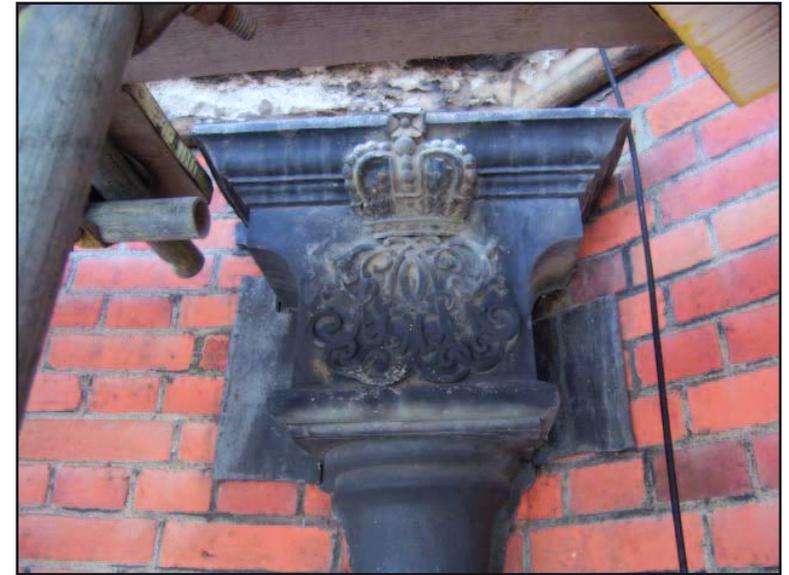
Plate 18: George IV lead hodder and 19th century brickwork

4.3.3 The east elevation has three lead downpipes (one of unknown date, one George IV and one Victorian) that collect rainwater from the roof behind the parapet crenellations. These have some repairs and replacements to sections of the piping and fixings.
