KENDAL FELL, KENDAL, Cumbria

Archaeological Watching Brief Report

June 2016

United Utilities

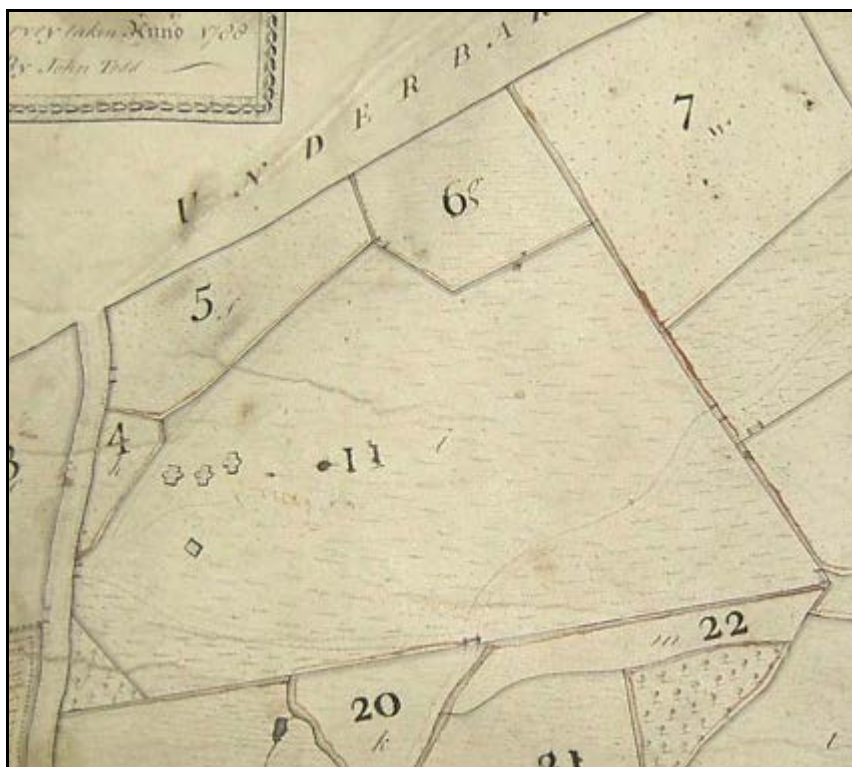
Plate 1: Extract from John Todd's plan of 1788 (CRO(K) WDX/29/1)

- 3.2.1 The 1788 plan of Kendal Fell by John Todd (CRO(K) WDX/29/1; Plate 1) shows three kilns off Greenside. They are depicted as broadly cruciform in plan, with opposed apsidal ends (perhaps denoting the position of the draw-holes of the kiln (Williams 1989)), and are arranged in a line, as described in the Kendal Fell Trust Minute Books of 1787. A close match between John Todd's plan and more modern mapping is not possible, but the present site lies

in the approximate position of the rectangular building shown to the south of the lime kilns.

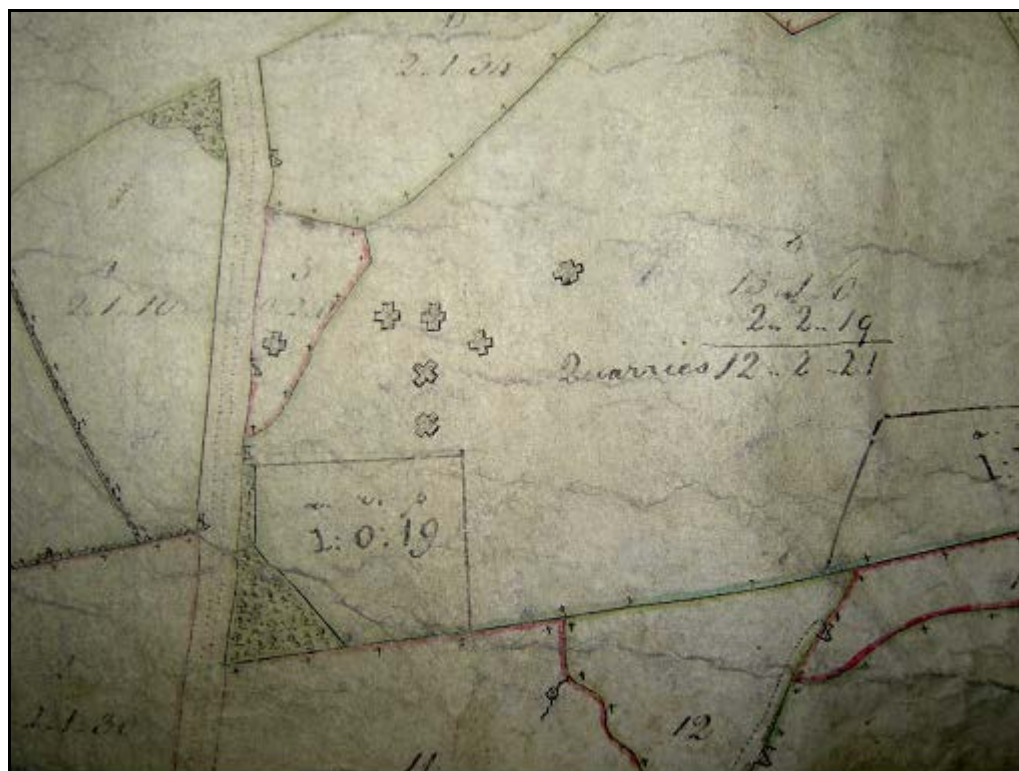
Plate 2: Extract from John Todd's plan of 1812 (CRO(K) WDX/29/2)

- 3.2.2 Two of the three lime kilns shown on the 1788 plan are also shown on Todd's 1812 plan (CRO(K) WDX/29/2; Plate 2), along with the addition of four more kilns. The position of the rectangular structure shown in 1788 appears, at this date, to be occupied by another kiln. The site under investigation by this project lies in the vicinity of the more southerly kilns, possibly close to the site of the rectangular building shown on the 1788 plan or the kiln directly to the north seen on the 1812 plan.

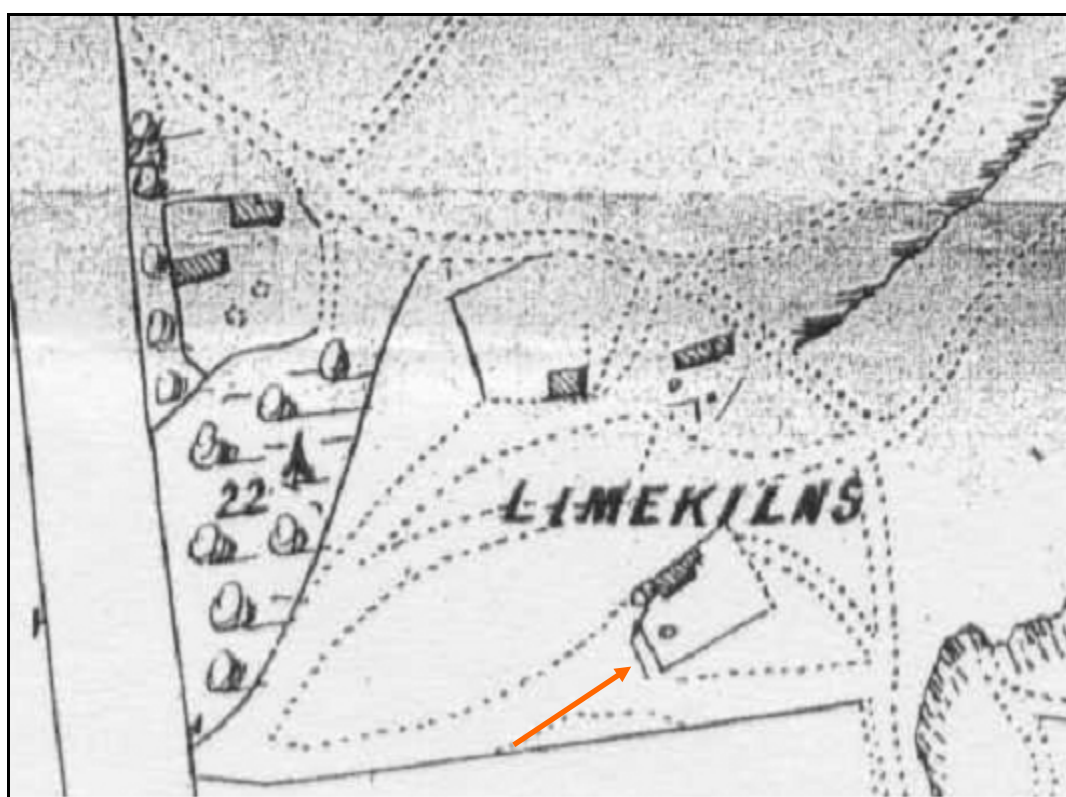
Plate 3: Extract from John Watson's plan of 1847 (CRO(K) WDX/29/2), with north to the right and a red arrow indicating the position of the site

- 3.2.3 The schematic depiction of the kilns on John Todd's plans provides no fine detail as to their form or that of any associated buildings. John Watson's plan of 1847 (CRO(K) WDSO 10/Z3), however, provides greater detail, with the three lime kilns indicated by the depiction of twin circular kiln pots. It has again proved difficult to align this plan with modern mapping, but in comparison to later Ordnance Survey maps it is clear that the kiln under investigation is in the lower part of Plate 3.

- 3.2.4 The present site is shown, with a sub-rectangular walled area which would have provided a substantial revetment wall which serves to raise the ground level, in order to provide an upper platform above the kiln hearths. The kilns would have been loaded with lime and coal, filling the kiln pot, from an upper charging platform, fired, and then unloaded from the draw eye at the base of the structure. An examples of this type of kiln can be seen in the surviving lime kiln at Kendal Fell (Plates 4 and 5).
- 3.2.5 A long building, aligned north-west/south-east, is depicted along the south-western boundary of the walled area, with a smaller annex attached to its north-western end; presumably this housed offices or accommodation. One

kiln pot is depicted, as a circular feature within the southern part of the walled area. A second circular feature is shown at the south-eastern end of the building, but it remains uncertain as to whether this is a kiln, as it would be normal for a kiln pot to be shown within the walled structure, not free-standing.

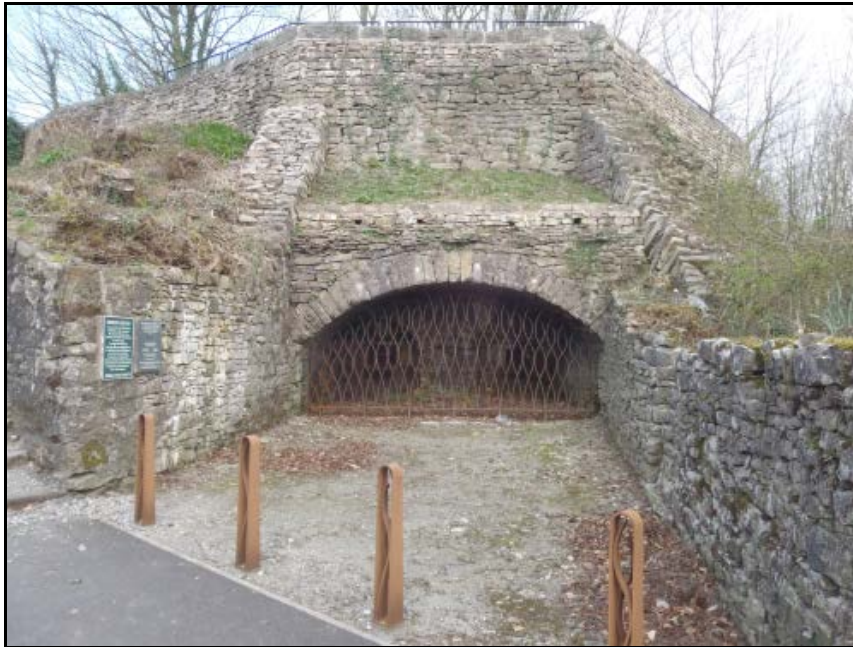
Plate 4: View of the lower part of the surviving lime kiln at Kendal Fell

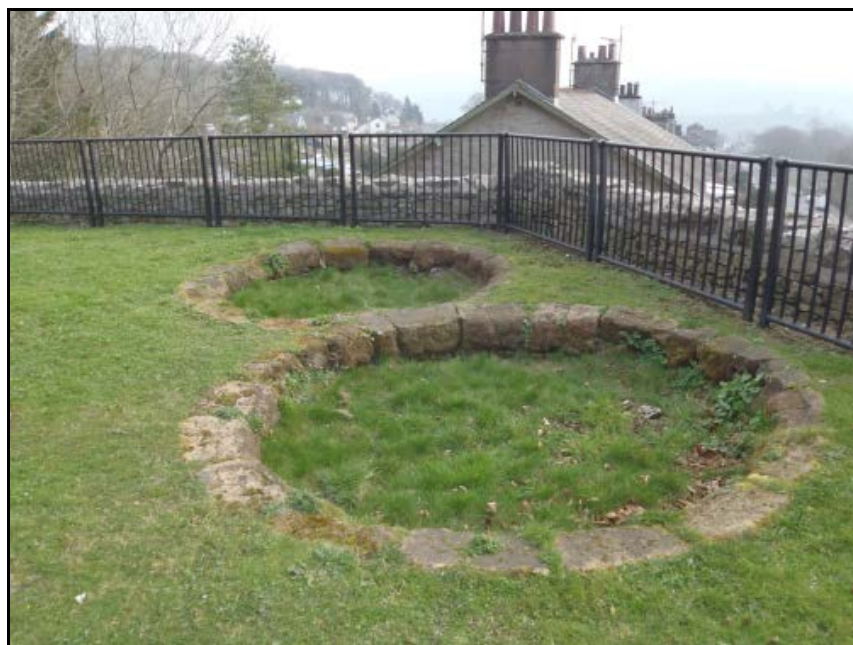
Plate 5: View of the upper part of the kiln pots from the charging platform of the surviving lime kiln at Kendal Fell

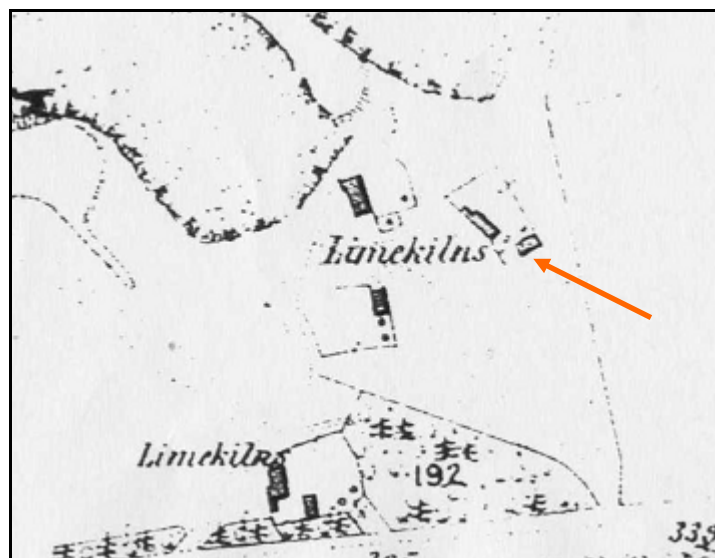
Plate 6: Extract from the 1859 6'' : 1-mile Ordnance Survey map, with a red arrow marking the position of the site

3.2.6 The 1859 Ordnance Survey map of Kendal Fell (Plate 6) depicts the kiln located by the watching brief, but with a number of changes. Its enclosure is more rectangular in shape, and two twin circular kiln pots are clearly marked inside it, close to the south-eastern wall. The annex depicted to the south-west of the walled area on Watson's map appears to have been roofed or replaced by a building. An additional wall also projects from the southern-most corner of the walled area.

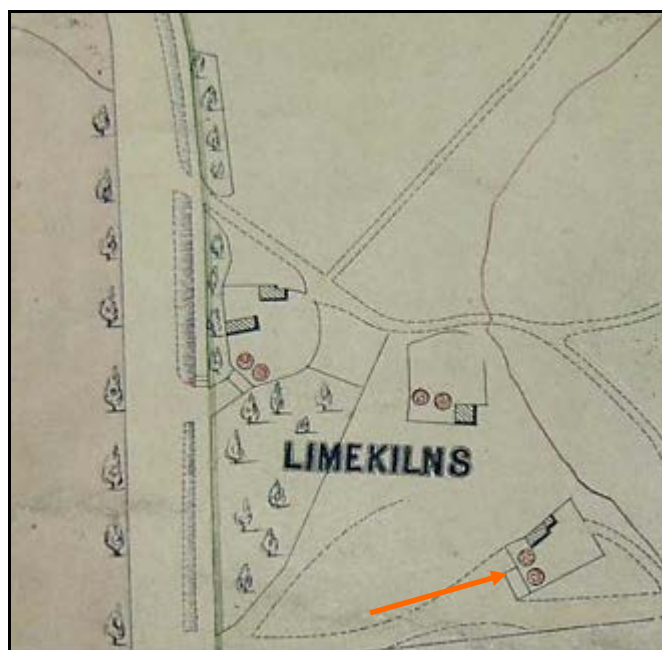
Plate 7: Extract from the 1870 Town Plan of Kendal, with north to the right and a red arrow indicating the position of the site

3.2.7 The 1870 Town Plan of Kendal Fell (Plate 7) shows little change in comparison to the previous map. The kiln pots are clearly marked in red. The smaller structure to the south-east is again marked as an unroofed walled area.

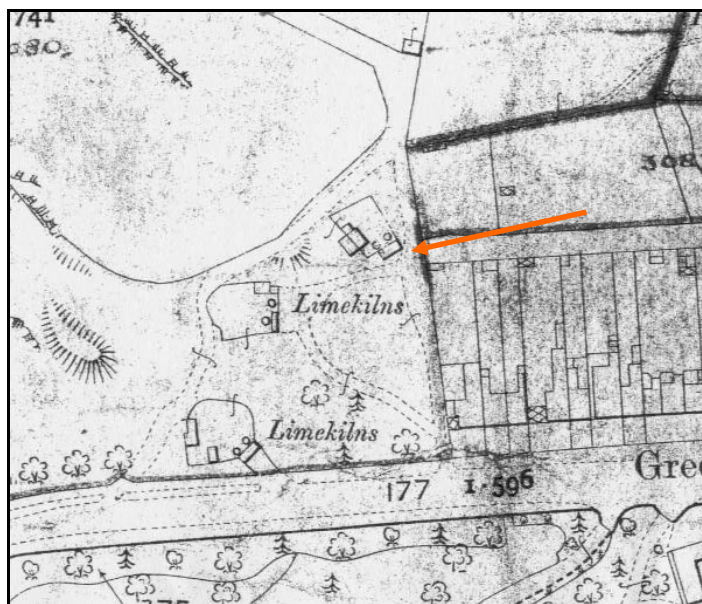
Plate 8: Extract from the 1898 6":1-mile Ordnance Survey map, with a red arrow marking the position of the site

- 3.2.8 The 1898 Ordnance Survey map of the area (Plate 8) depicts a new building, constructed along the south-western wall of the earlier building of the site and doubling the size. The smaller building to the south-east is once again shown as a roofed structure.

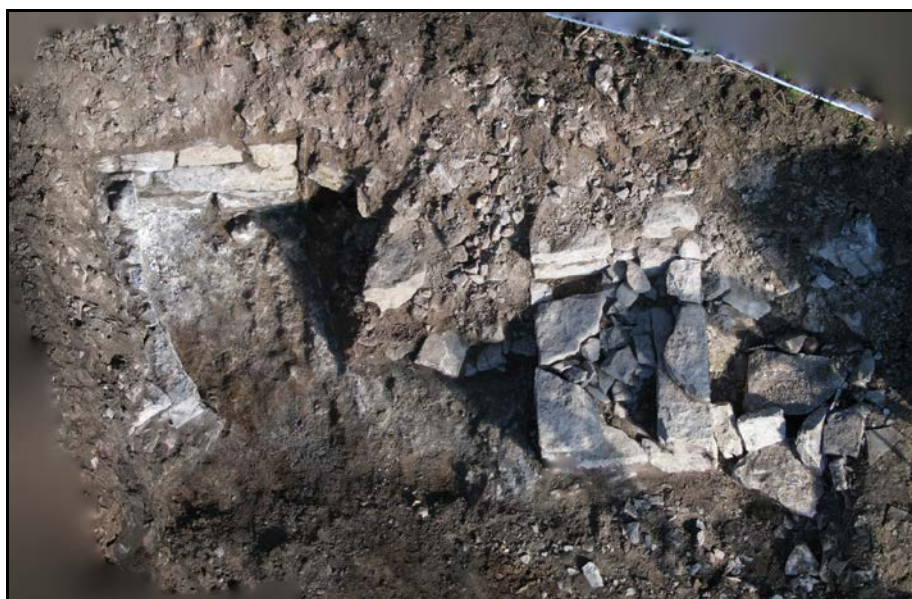
4.2.1 Excavation using the mechanical excavator removed a substantial quantity of building rubble (deposit *I*) measuring up to 2.66m deep. This layer contained large quantities of building rubble, including large dressed limestone blocks and fragments of refractory brick. Most of the excavated area was machined down to the level of the natural limestone bedrock, but the substantial remains of the south-eastern side of a lime kiln were located, projecting from the northern limit of excavation (Fig 2; Plates 9 and 10).

Plate 9: Overhead view of the northern end of the watching brief area produced from rectified photographs, with north to the top

- 4.2.3 Wall **8** is the remains of a substantial north-west/south-east wall fragment, some 1.6m wide (Fig 2; Plate 9 and 11). It is highly likely that this wall continued in a north-easterly direction, forming the north-eastern revetment wall of the kiln. The portion of this wall located by the watching brief also matches the position of the north-easterly wall of the smaller rectangular building depicted on the 1859 OS map (Plate 6). The remains of a less substantial wall, **4**, formed the south-western wall of the same structure (Plate 9 and 12). The gap between the walls **8** and wall **3**, filled with rubble **1**, is most likely to be a recessed area, within which the draw eyes of both, or possibly just the north-easterly, kiln pots were situated.

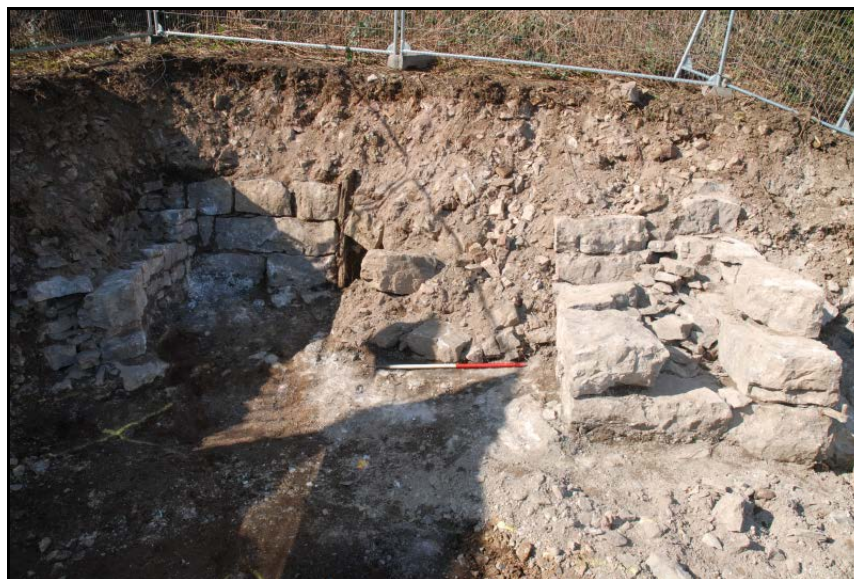
Plate 10: General shot of northern end of site, looking north

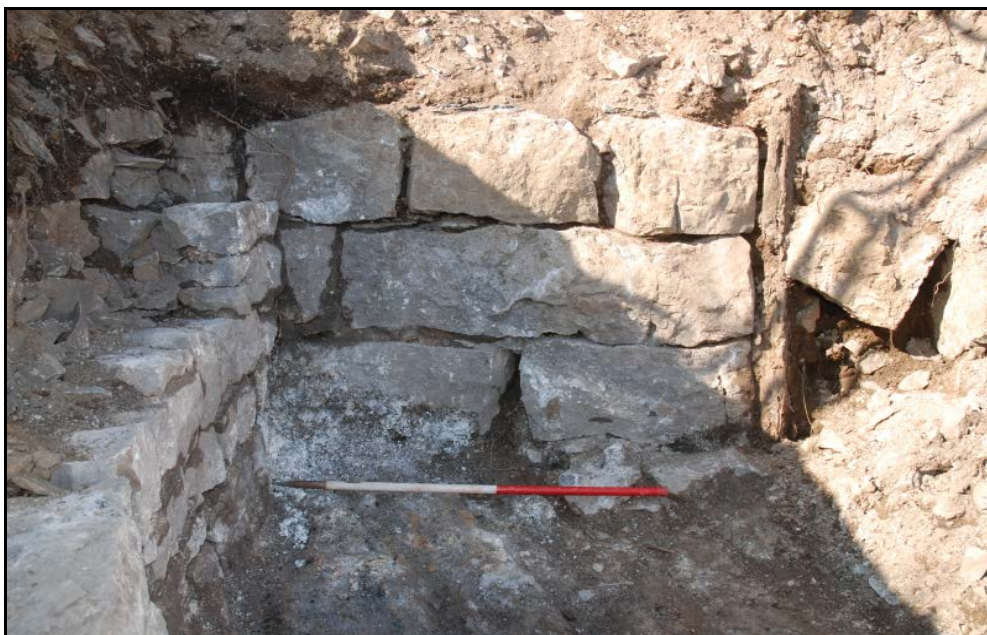
- 4.2.2 **Stone structural elements:** three structural elements of the lime kiln were located by the watching brief. The elevation of a substantial north-east/south-west aligned revetment wall, masonry **3** (Fig 2; Plate 9 and 10), was encountered along the northern edge of the excavation. It is undoubtedly the revetment wall for most of the kiln's raised platform, above which the kiln pots' charging platform would have been situated.

Plate 11: Elevation of wall 3, looking north

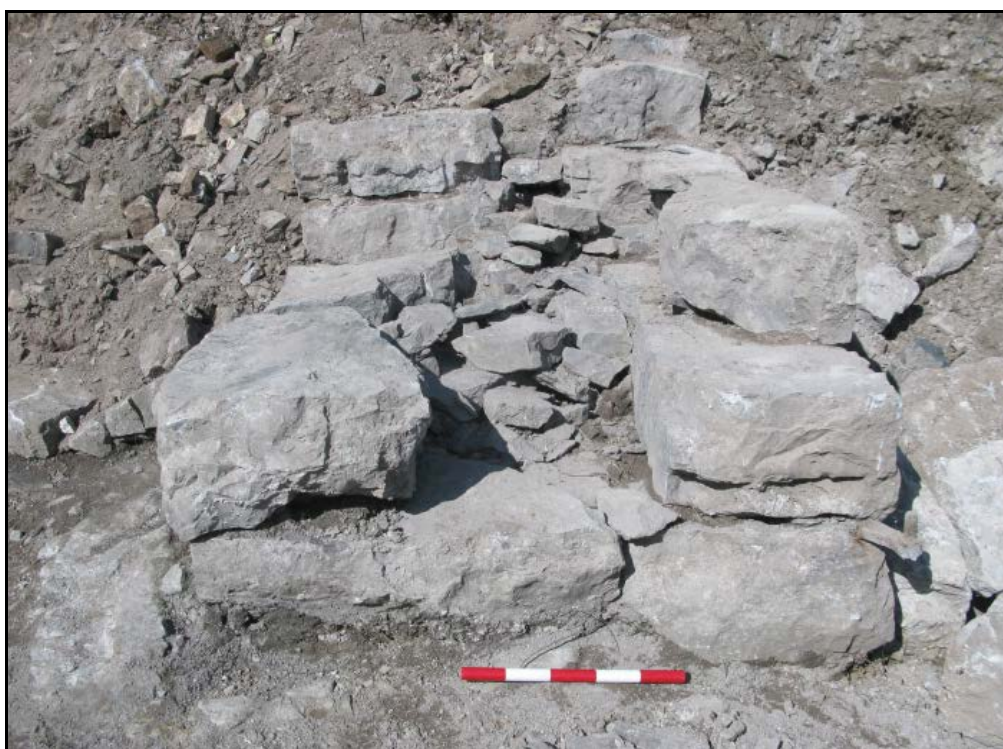
Plate 12: Wall 8, looking north

presumably residue of the material drawn from the kiln whilst unloading the lime. A patch of lime, deposit 5, was also located in the corner of walls 3 and 4 (Fig 2; Plate 12).

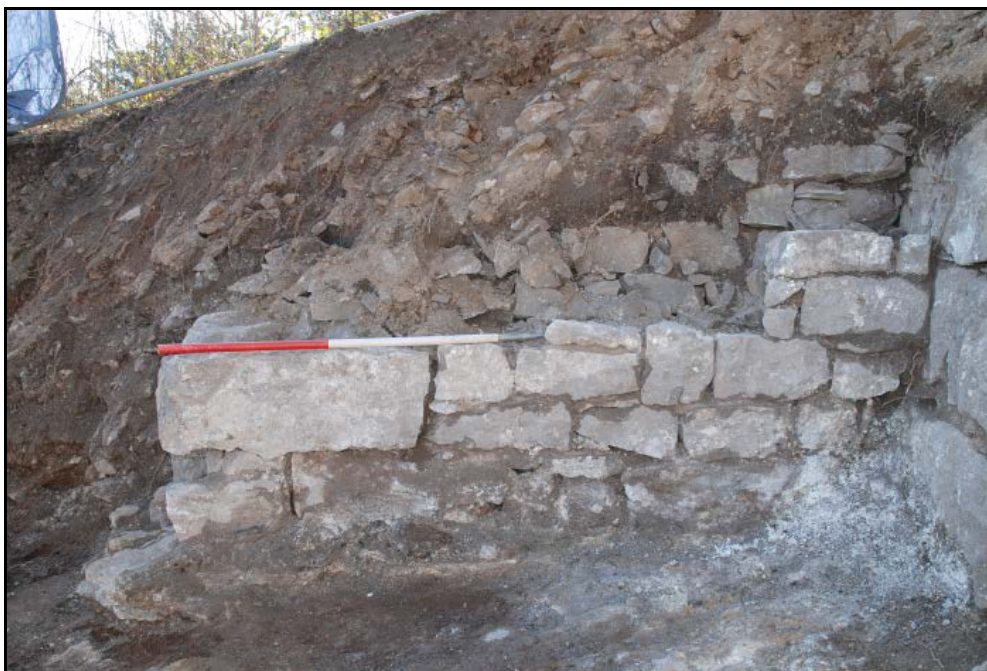
Plate 13: North-eastern elevations of wall 4, butting up to wall 3, looking west

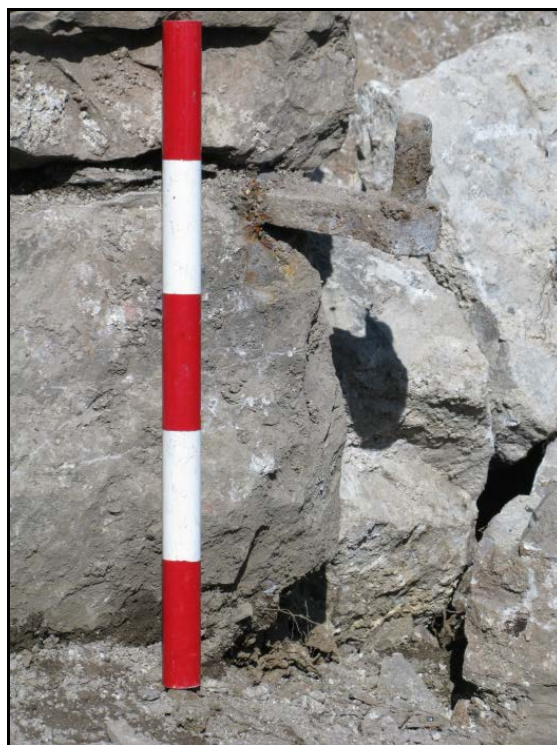
- 4.2.4 **Other elements:** a hinge or pintle, probably late nineteenth-century in date (Chris Wild pers comm), was located protruding from the eastern-most corner of wall 8, 0.25m above the base of the wall at a 135° angle to the wall (Plate 13). This would have allowed a door to swing up to the south-eastern and north-eastern elevations of wall 8.

Plate 14: Hinge or lintel in wall 8, looking north-east

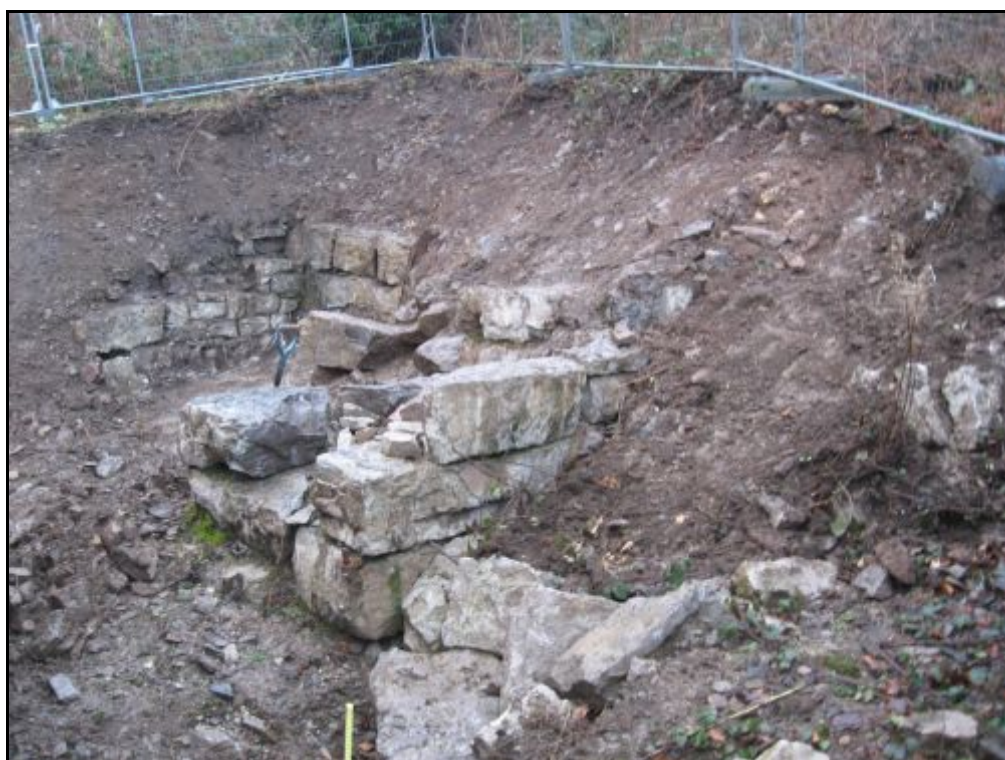
- 4.2.7 **Secondary landscaping works:** the bank forming the boundary of the development site was subsequently landscaped to form a 45° slope above, and adjacent to, the kiln remains. This exercise comprised the careful scraping of material from the slopes, and its manipulation with a toothed ditching bucket to form stable sides (Plate 15). The material excavated was a mid-brown sandy-silt with significant quantities of demolition rubble, including limestone blocks, refractory bricks and lime mortar. The *in situ* kiln was not disturbed, and was subsequently cleaned by hand. No further remains of archaeological interest were observed during this phase of groundworks.

Plate 15: post-excitation shot of the landscaping works around the kiln, looking north-west
