Stove House Five, Lion Salt Works, Marston, Northwich, Cheshire West

Archaeological Excavation

Oxford Archaeology North

May 2013

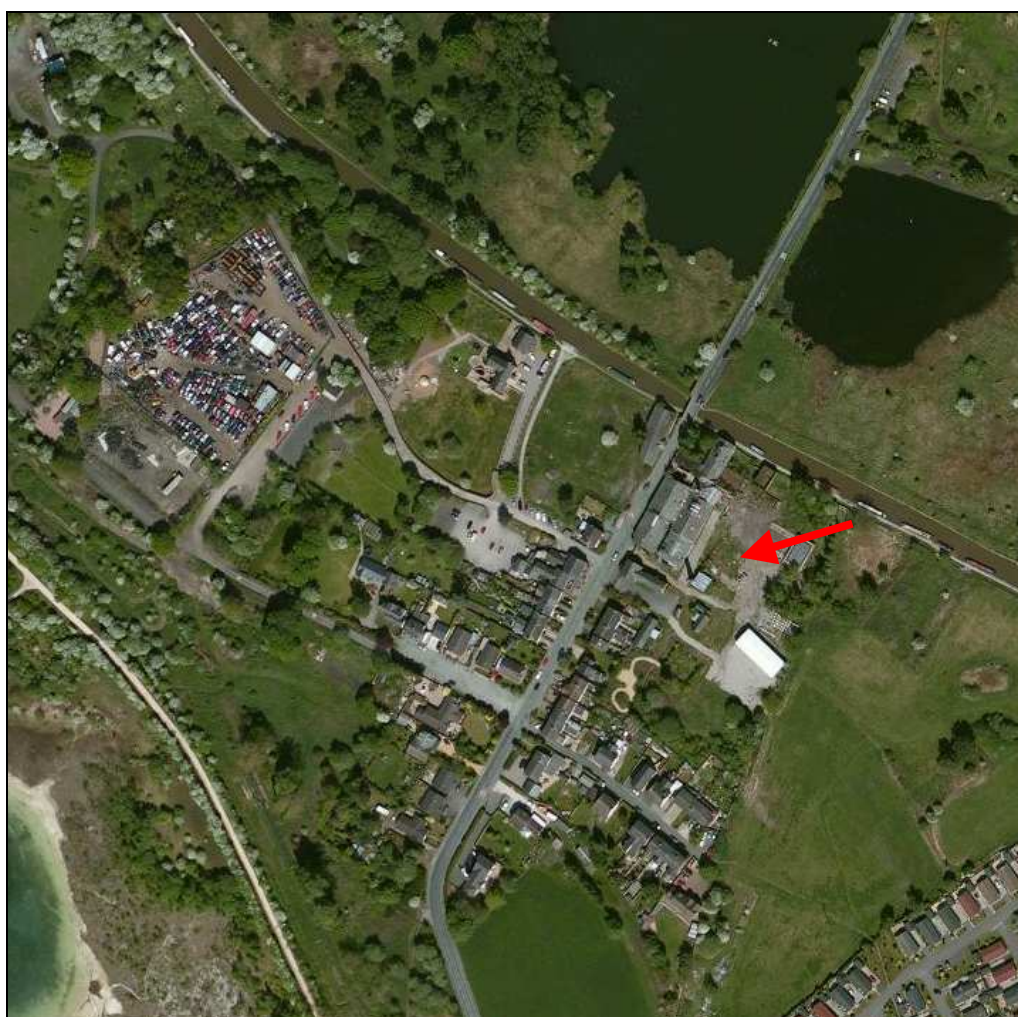
Plate 1: Aerial view of Marston and the Lion Salt Works prior to the repair works, with arrow marking the position of Stove House Five

- 1.2.1 The Lion Salt Works lies on the east side of Ollershaw Lane (the B5075) and immediately to the south of the Trench and Mersey Canal in the village of Marston (Plate 1), which is situated some 2km to the north-east of Northwich, Cheshire (centred on NGR 367109 375470). The works occupies a level site at a height of approximately 25m above Ordnance Datum (aOD), from where ground level falls gently in a south-westerly direction towards the valley of the River Weaver. The site forms an important historic component of the Marston Conservation Area, within which it lies.

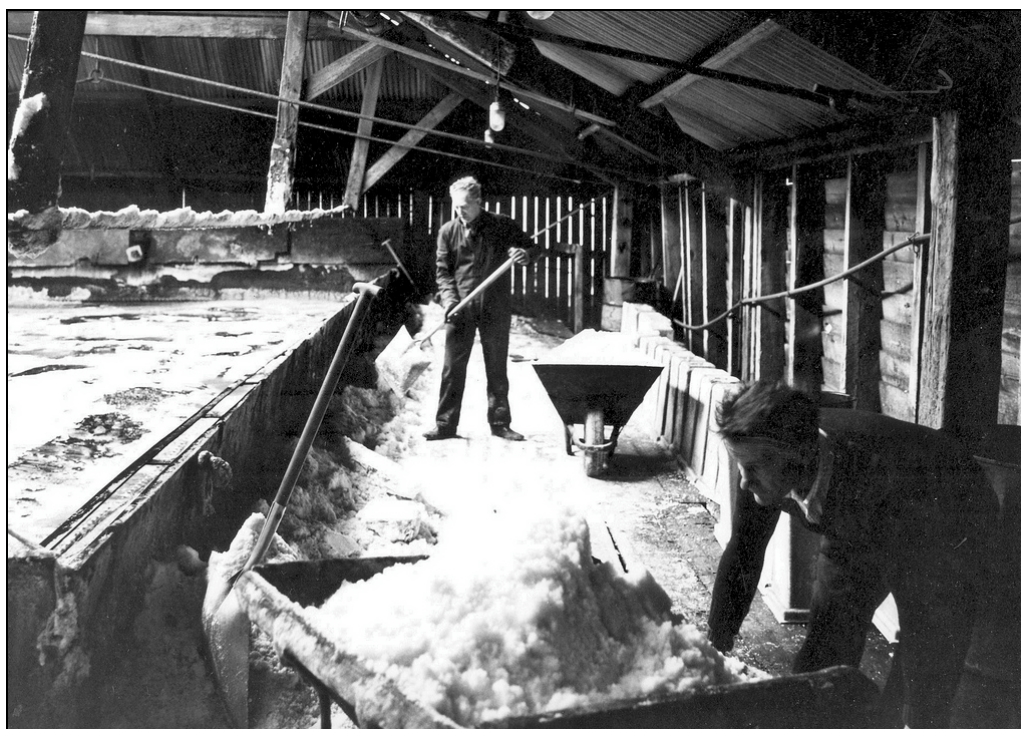
Plate 2: Removing salt crystals from the evaporating pan at Lion Salt Works

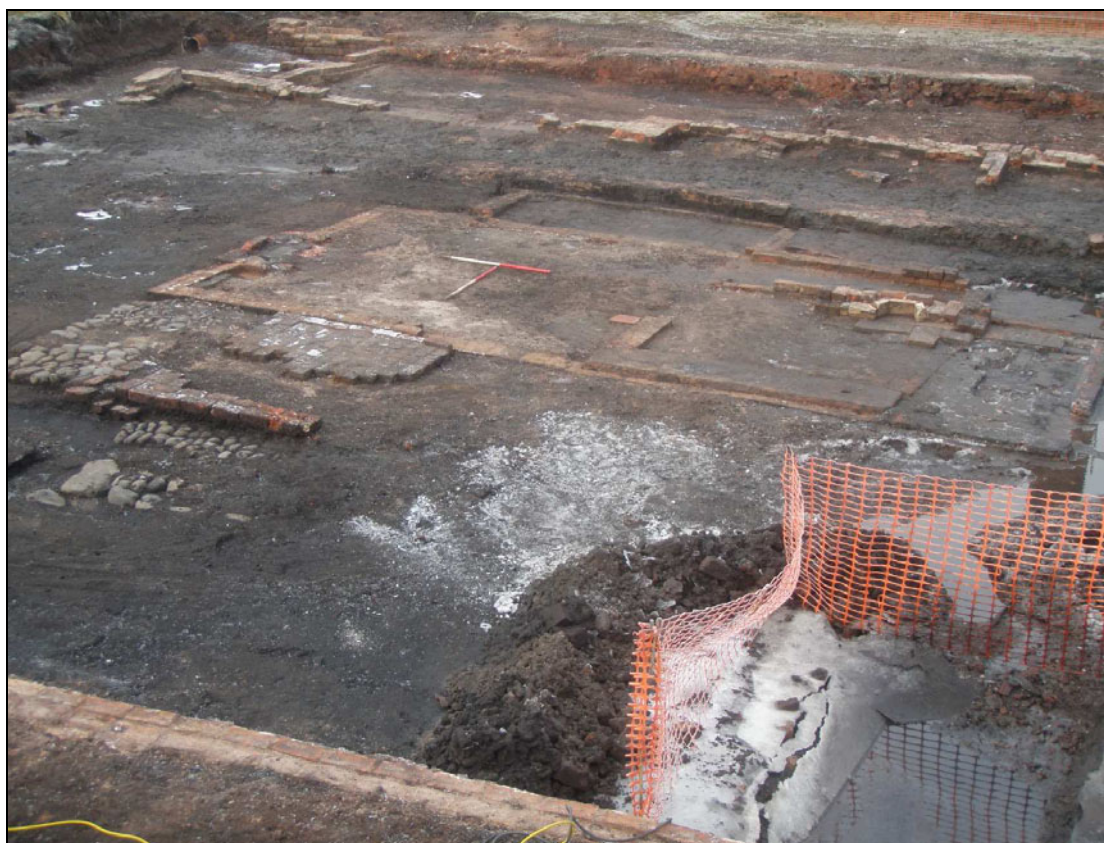
Plate 3: General view of the smithy (Building 1), looking west

- 3.2.3 The south-western building (Building 1) comprised two main rooms, measuring 7.8 x 4.0m, with smaller additional rooms to the south-east and north-west (Plate 3). All of the component walls comprised hand-made bricks bonded with crumbly, lime-based mortar. The large main room to the south-west measured 4.3 x 4.0m, and was bounded by walls **2047** and **2060**, which were both two courses wide. The building retained the remnants of a tiled floor (**2058**), laid on a bedding of ash and crushed brick (**2059**). Set into the south-west wall of the room was a brick-built fireplace (**2062**), which was 1.15m wide and 0.65m deep. An area of tiles in front of the fireplace may have been a later addition.

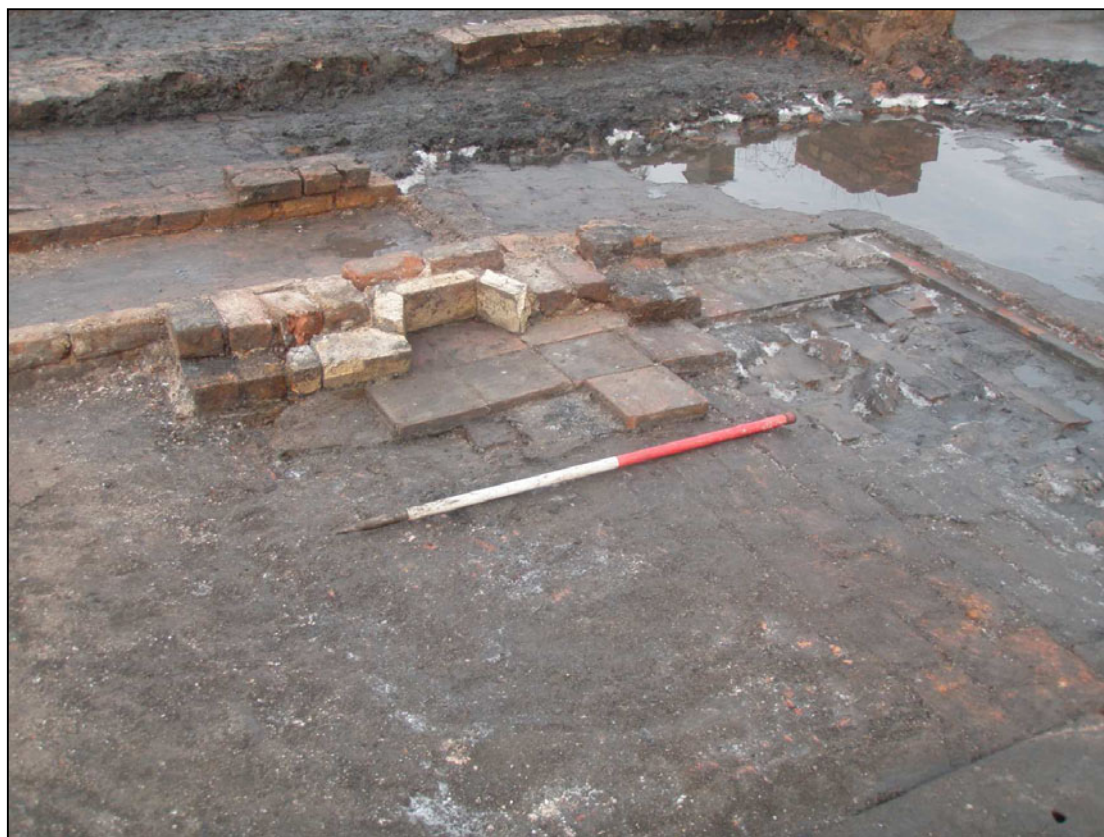
Plate 4: Firebrick-lined hearth, looking north-west

- 3.2.4 The main room in the north-eastern part of the building was bounded by walls **2060**, **2061**, **2051** and **2047**. It measured 3.5 x 2.75m, and had an entrance through wall **2051** at its north-eastern corner. The south-western two thirds of the room had a brick floor (**2054**), with the remaining third showing evidence of a tiled surface (**2055**), both of which had been laid on a bedding layer of ash and crushed brick (**2080**). A fireplace (**2056**) had been built against the north-western wall, constructed from brick with a cladding of refractory bricks (Plate 4), suggesting that the fireplace was operating at a much higher temperature than that of a normal domestic hearth.

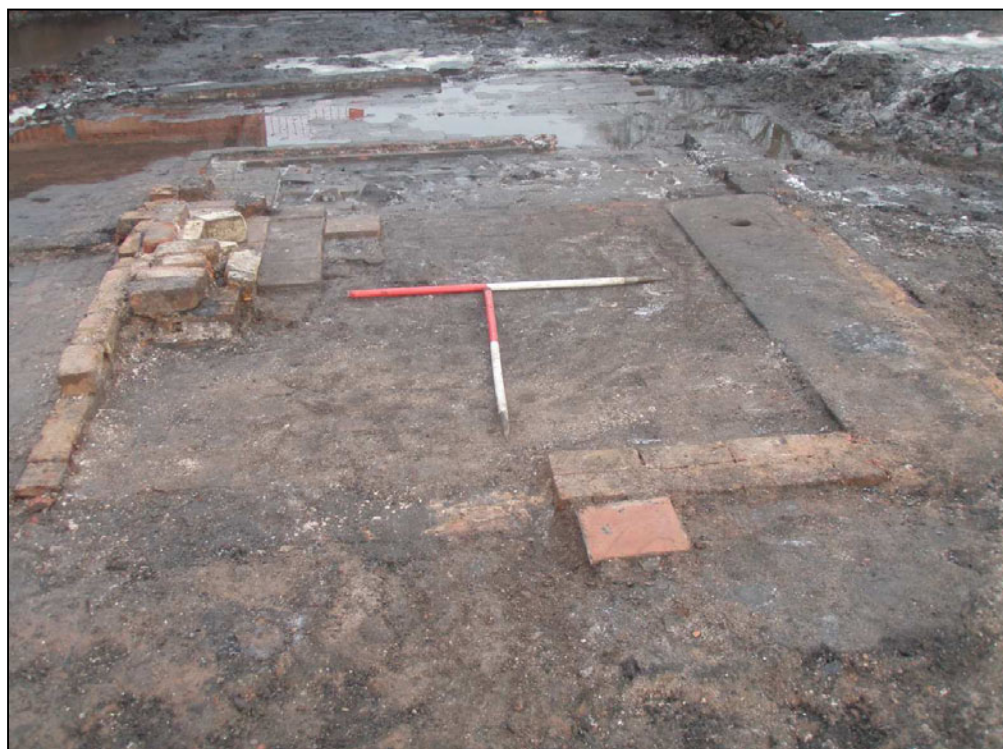
Plate 5: Building 1 south-east room looking north-east, showing the hearth on left and machine bed on right

- 3.2.5 Set into the south-eastern wall at floor level was a 2.35 x 0.5m sandstone block (Plate 5), which incorporated a rectangular recess carved into it for a machine setting. At its south-western end were four small holding down bolts, and at the north-eastern end it had two holes drilled into of 100mm and 30mm diameter respectively.

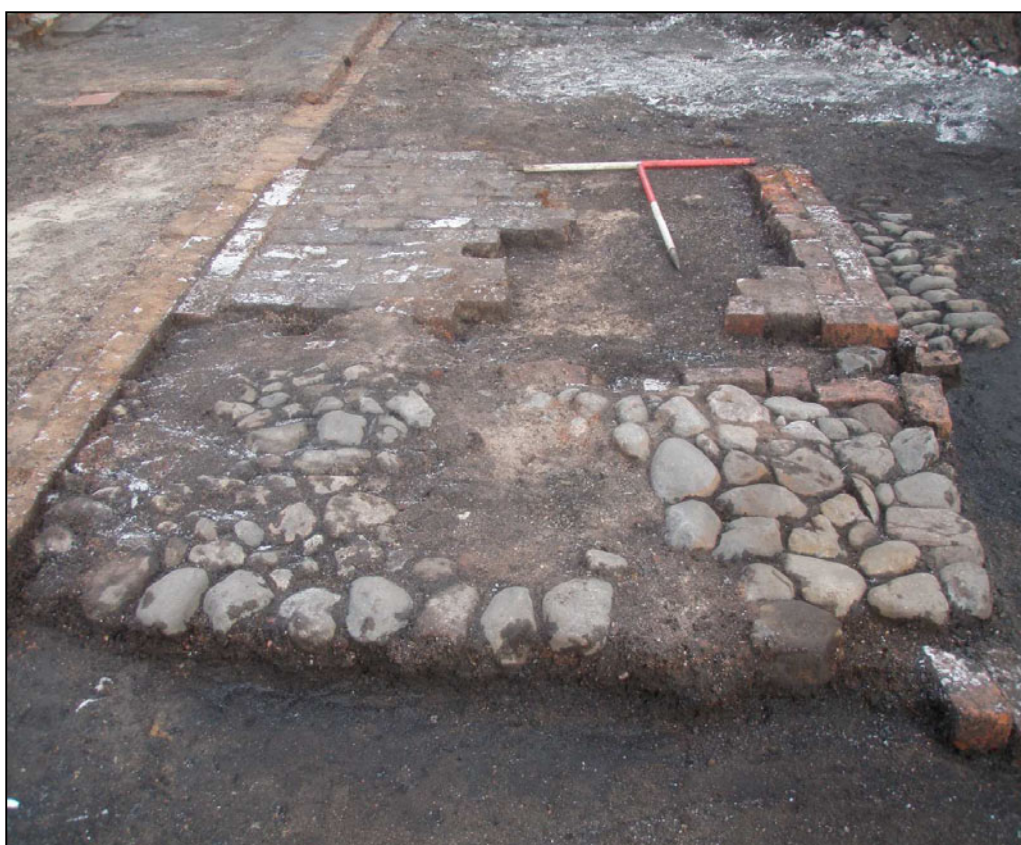
Plate 6: Brick outshut and cobbled next to Building 1 looking north-east

- 3.2.9 The remains of a small cobbled yard (**2072**), and a brick-built outshut comprising walls **2068**, **2070** and **2071**, was exposed to the south-east of Building 1 (Plate 6). The yard only survived in the southern corner of the building complex, but may have continued originally to the south-west, where disturbed cobbles were excavated. The brick outshut measured 2.2m square, contained a brick floor (**2069**), and was open to the north-east.

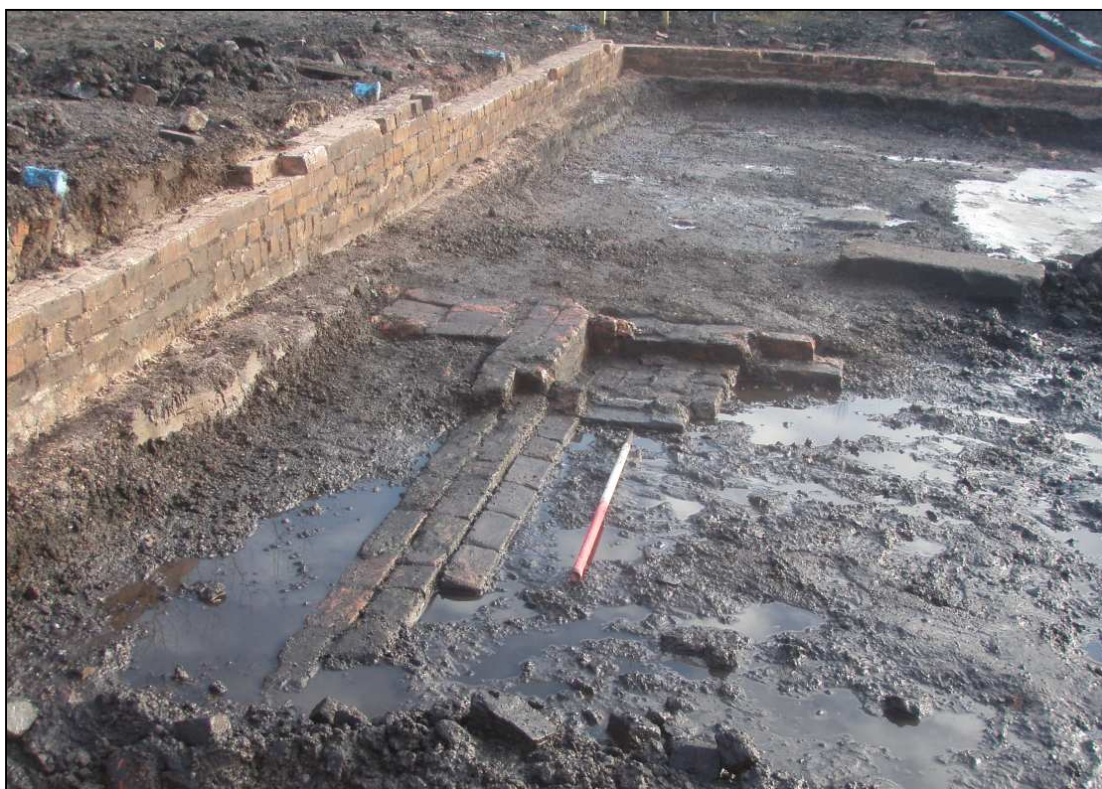
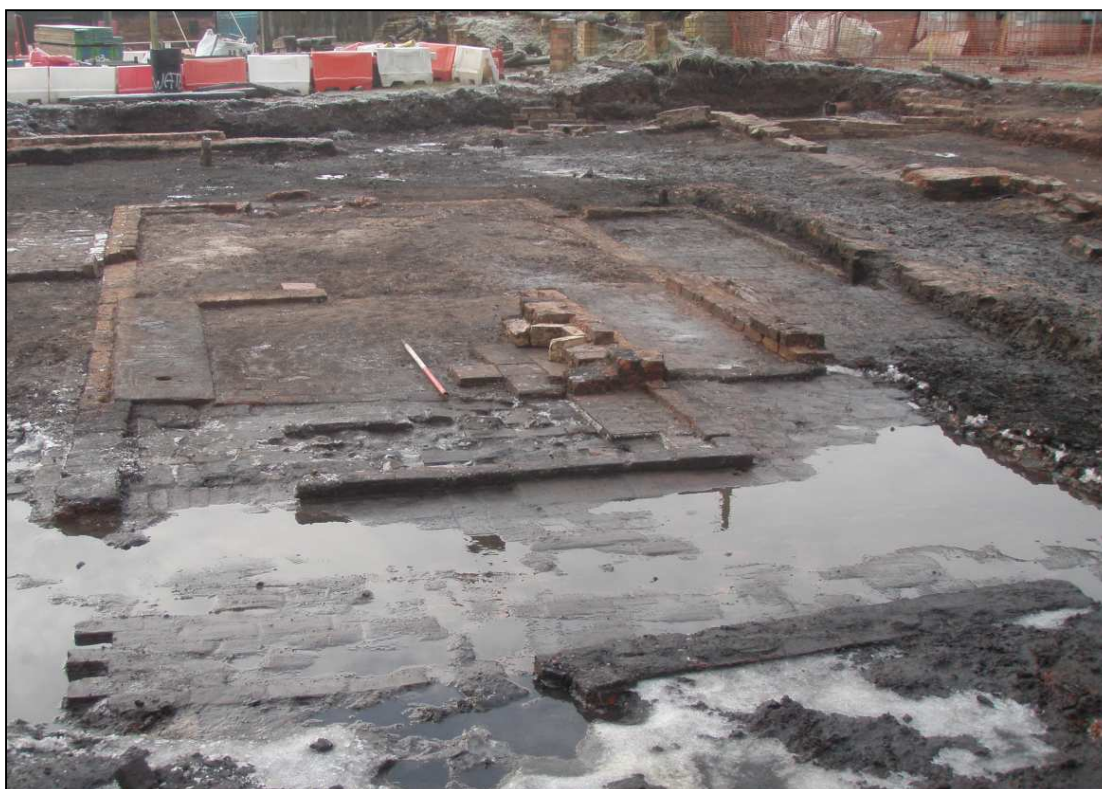
Plate 7: The brick-built foundations of Building 2 looking east

Plate 8: North-western wall of Building 2, with Building 1 in background, looking south-west

- 3.2.11 An L-shaped section of brick walling, which represented the remains of a smaller building (Building 2), lay to the north-east of the Building 1 (Plates 7 and 8). This section of wall ran 1.8m was aligned south-west/north-east, in line with the wall **2047** of Building 1, and then returned to the north-west for a distance of 3.1m. It had been truncated at its north-western and south-eastern ends. The south-western wall of Building 2 was probably represented by wall **2052**, although only fragmentary remains survived. Building 2 would have measured at least *c* 4.9 x 2.9m.

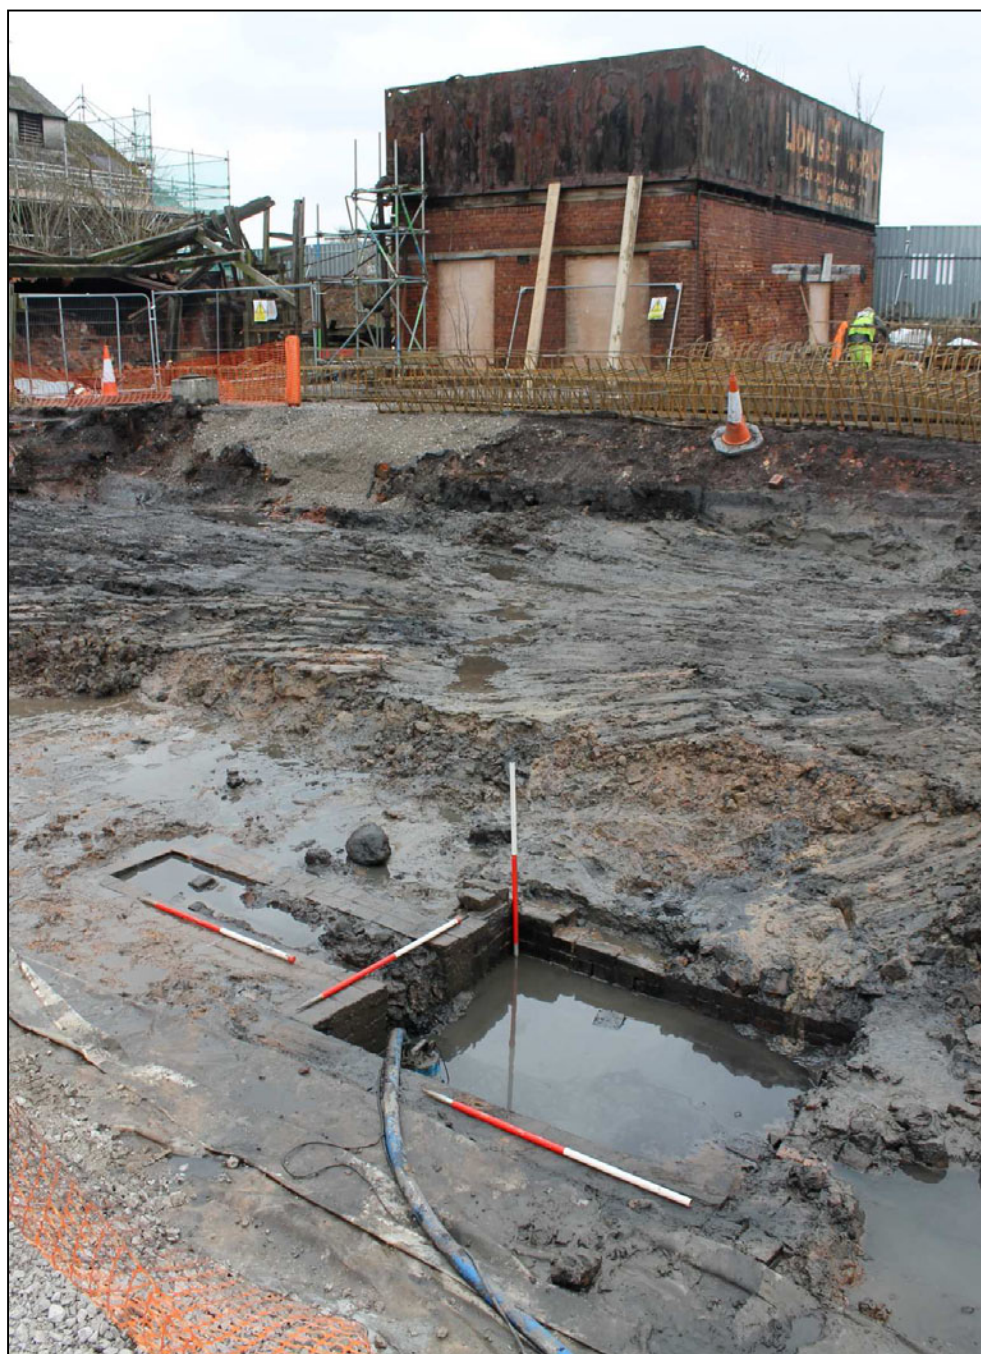
Plate 9: Brick flywheel pit uncovered during groundworks, looking north

- 3.2.14 Further excavation of this part of the site revealed the remains of a brick structure beneath Building 2. This comprised a brick-built chamber, measuring 2.1 x 2.4m and 0.4m deep, with a 0.98m wide channel extending 2.1m to the north-west (Plate 9). This structure resembled a flywheel pit associated with a small steam engine located within the outshut on the side of Building 2.

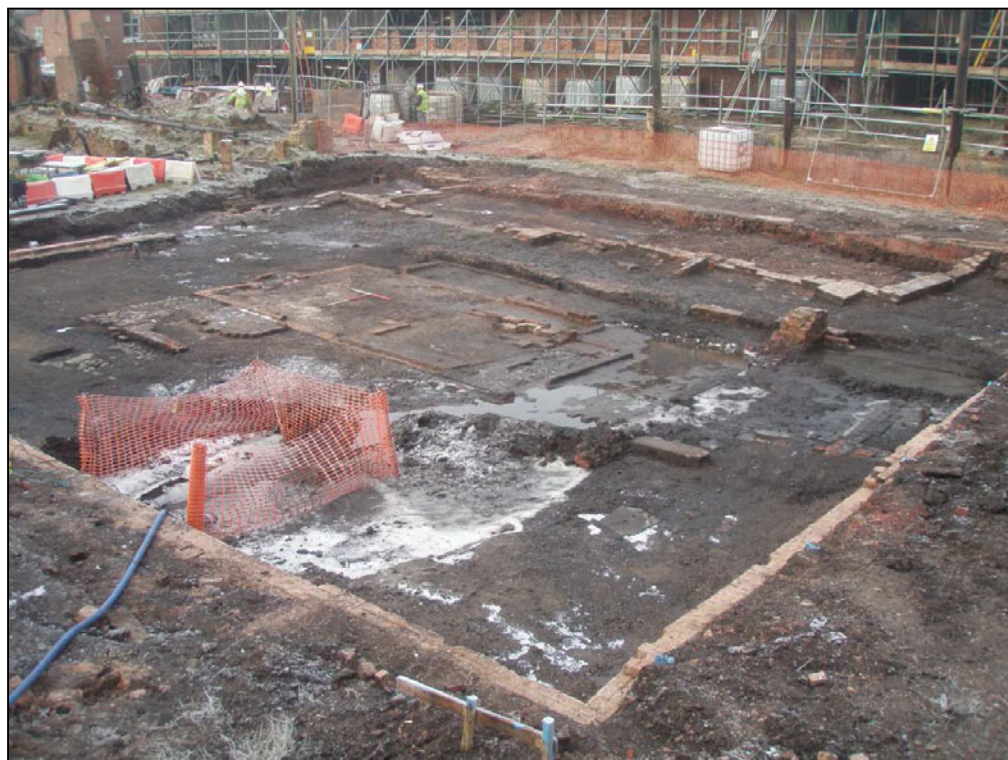
Plate 10: Outer walls are Stove House Five, with Buildings 1 and 2 in the centre and the Fisheries Pans in the background, looking west

3.2.18 The excavation area was largely enclosed by a two-course wide wall of machine-made bricks (**2001**), which formed a square structure measuring 18.8 x 18.5m, although excavation extended slightly beyond this footprint to the north-west and south-west (Plate 10). The position of wall **2001** corresponded with the footprint of Stove House Five depicted on historical mapping. Wall **2001** had been built on a concrete foundation (**2002**) that splayed out a further 100mm from the wall.

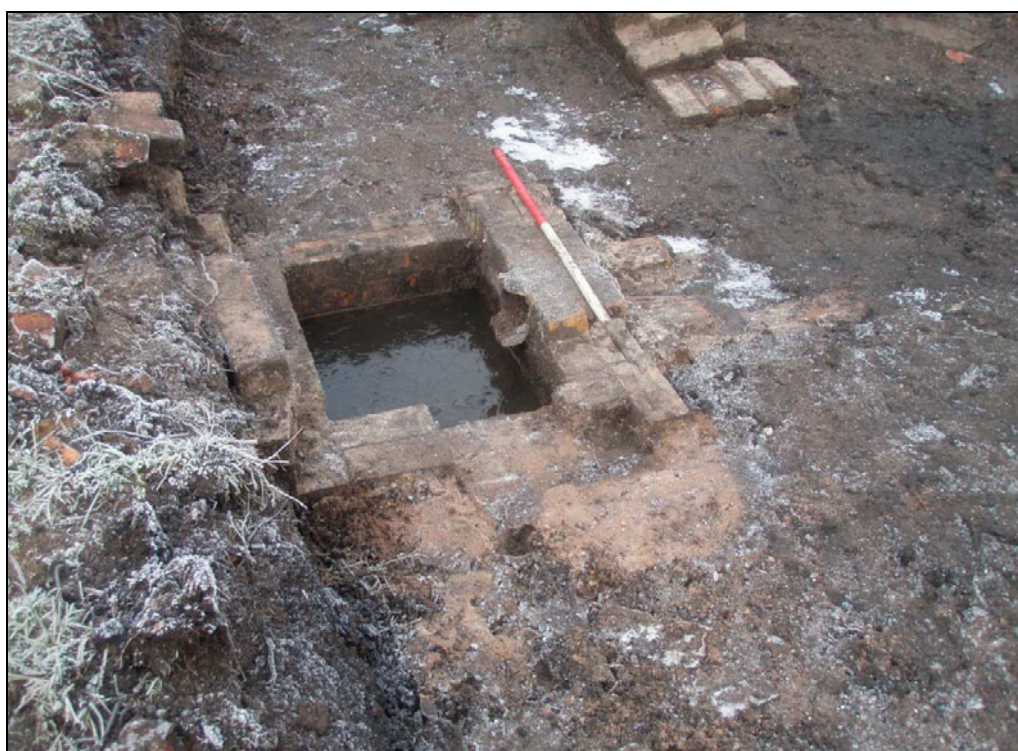
Plate 11: Manhole 2004, looking north-west

3.2.19 A brick-built manhole (**2111**) measuring 0.83 x 0.63m had been inserted through the wall on its south-eastern side, affording access to a ceramic drainage pipe that ran beneath the wall. Another manhole (**2004**) was exposed in the south-western part of the excavation area, immediately beyond wall **2001**. Manhole **2004** measured 1.2 x 1.1m and comprised machine-made bricks (Plate 11). It acted as a junction for three ceramic drainpipes (**2007**, **2009** and **2011**). Drain **2007** approached from the north-west, drain **2009** from the south-east, and drain **2011**, which showed some evidence of brick lining, from the north-east.

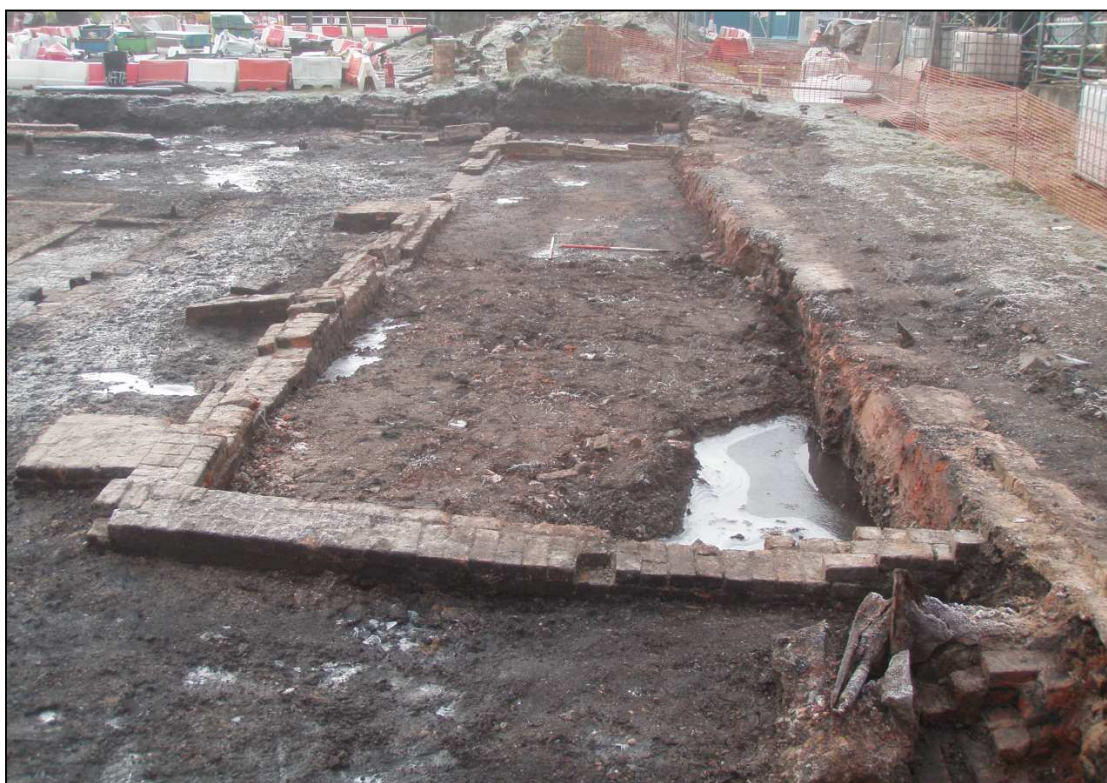
Plate 12: Fisheries salt pan, showing wall 2024 extending along the centre of the excavated area, with the remains of the furnaces on the left, looking south-west

- 3.2.21 A series of brick walls exposed along the north-western side of the excavation area formed a rectangular structure that almost certainly represented the remains of the south-western fisheries salt pan depicted on historic mapping. The main wall (**2024**) of this salt pan ran north-east/south-west for 16.2m, and was three courses wide (Plate 12). At the south-western end wall **2022** continued to the north-west for a distance of 3.8m, where brick wall **2021** extended to the south-west. A short stub of internal walling (**2023**) ran south-west from wall **2022** (Plate 13). These walls formed a 3.8m wide chamber at the south-western end of the structure. The south-western end of this chamber had been destroyed by the insertion of drain **2007**, and thus its original length could not be determined accurately. The north-eastern end of wall **2024** extended beneath later wall **2001**, where it was truncated; the entire north-western part of the structure had evidently been removed. Nevertheless, it is likely that the 3.8m width of the north-west chamber represented the full original width of the fisheries pans.

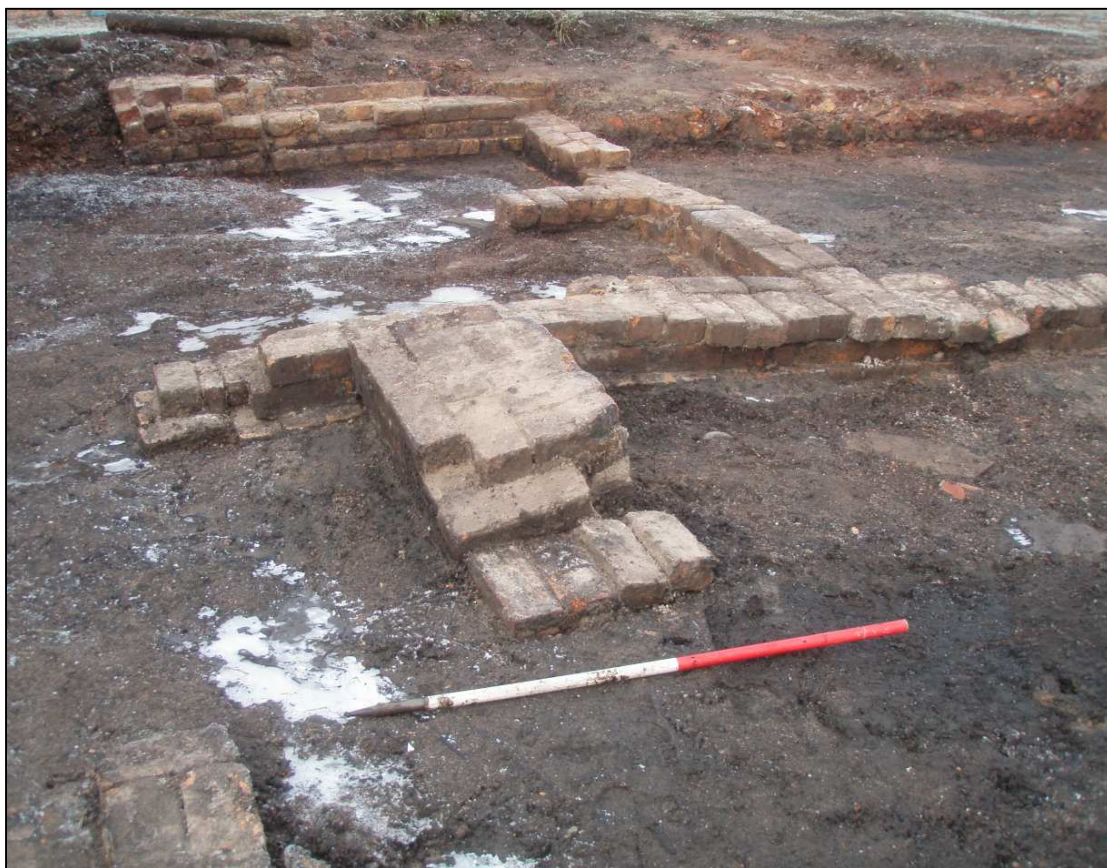
Plate 13: The north-western end of the fisheries pan, looking north-west

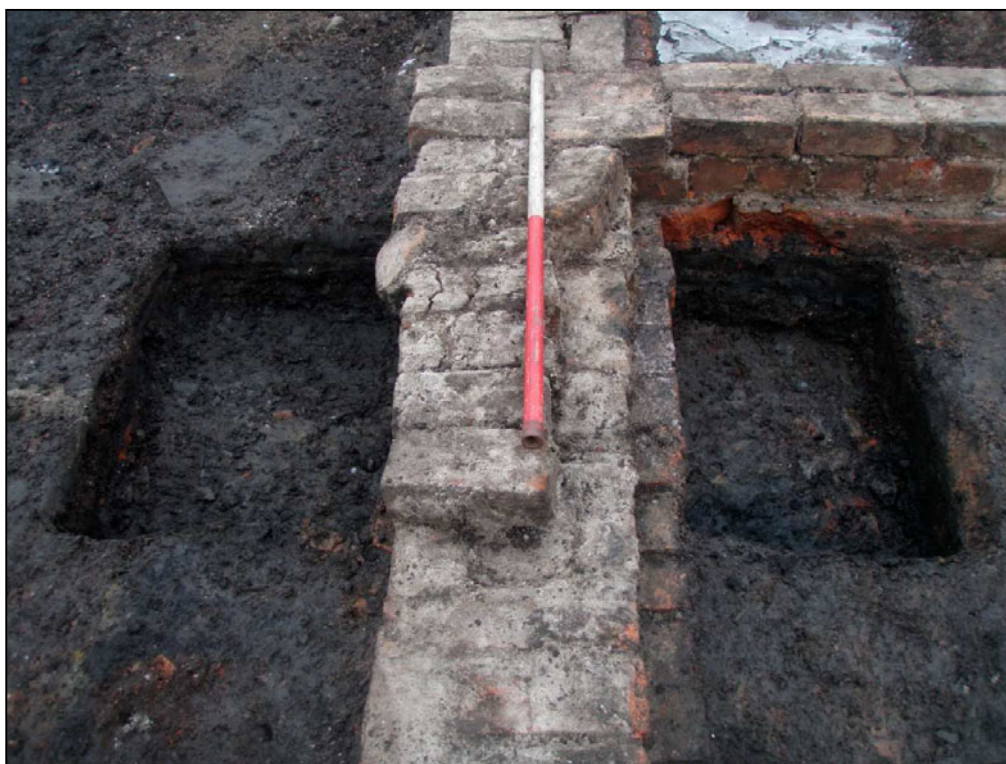
Plate 14: Limited excavation across wall 2024, looking south-west

- 3.2.22 Limited manual excavation across wall **2024** provided a vertical section of the sequence of deposits within the fisheries pans (Plate 14). Inside the main structure was a 30mm thick lens of compacted mixed clay and sand with abundant stone and brick fragments (**2018**). Outside the main structure, and in the area of the pan furnaces, was a 35mm thick band of mixed clay with brick fragments (**2019**), which retained some evidence of heating. Below this on both sides was a 150mm thick layer of smooth, black ashy clay (**2082**), into which wall **2024** had been cut, with an 80mm thick layer of compact cinders and crushed brick (**2081**) below. Below this was a layer of compact grey clay with abundant fragments of brick, stone and slate (**2083**), which was also observed across the south-western part of the excavated area immediately above the natural clay.

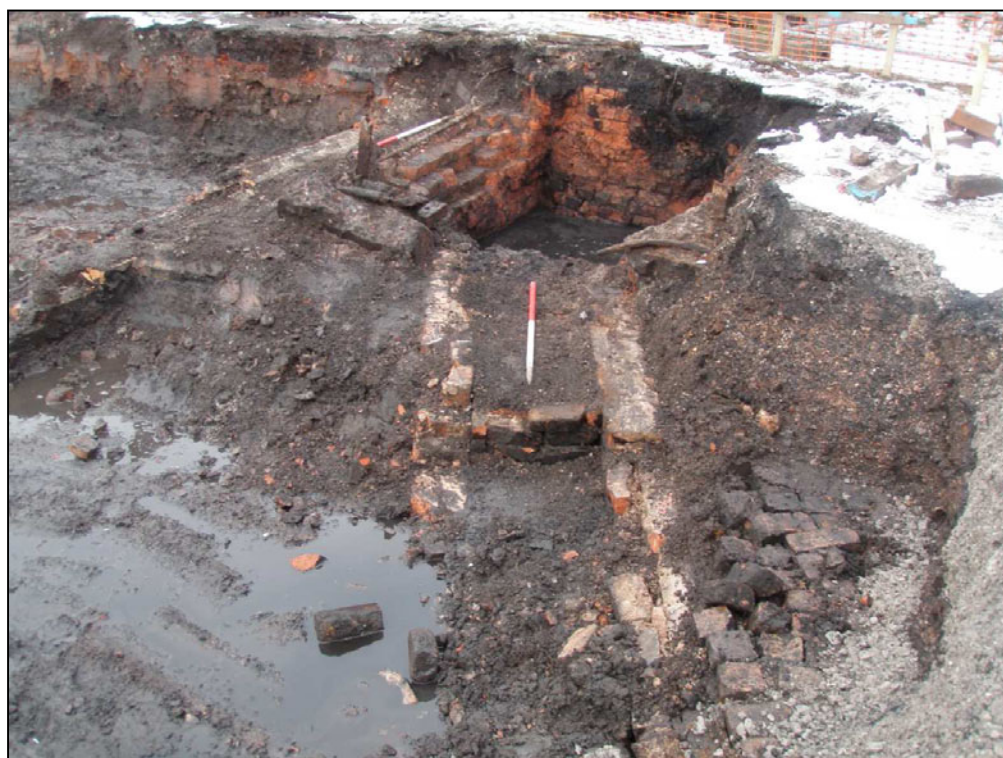
Plate 15: Chimney 2033 and blocked flue 2034, looking west

3.2.24 The remains of a rectangular chimney (**2033**) fitted apertures for two flues were revealed immediately to the north-east of the fisheries pans (Plate 15). The chimney comprised a 2.0 x 1.8m brick inner structure surrounded by an outer shell of concrete, into which a cast-iron pipe was set around the internal brick structure. A 0.95m wide brick flue (**2034**) extended into the chimney from the east, probably from the boiler below the brine tank. This flue had been blocked subsequently with brick (**2112**), probably when the 'nodding donkey' was installed in 1938. The second flue (**2114**) was 1m wide and entered the chimney from the north-west, probably from the furnaces associated with a second fisheries pan. This flue was not blocked, indicating that it remained in use until the fisheries pans were demolished between 1947 and 1954. Neither the chimney nor the flues were excavated entirely during the excavation. Immediately to the north of flue **2034** was a rough brick surface (**2086**), which may have formed part of a surface surrounding the brine shaft and the associated pipes.

5.4.1 In 1938, the original steam pump for the brine shafts was replaced with the 'nodding donkey' to the south-west. This rendered the boiler and engine below the brine tank redundant, and resulted in the blocking of flue 2034. The flues from the pan furnaces were still in use at this time, and thus flue 2114 would have remained open.

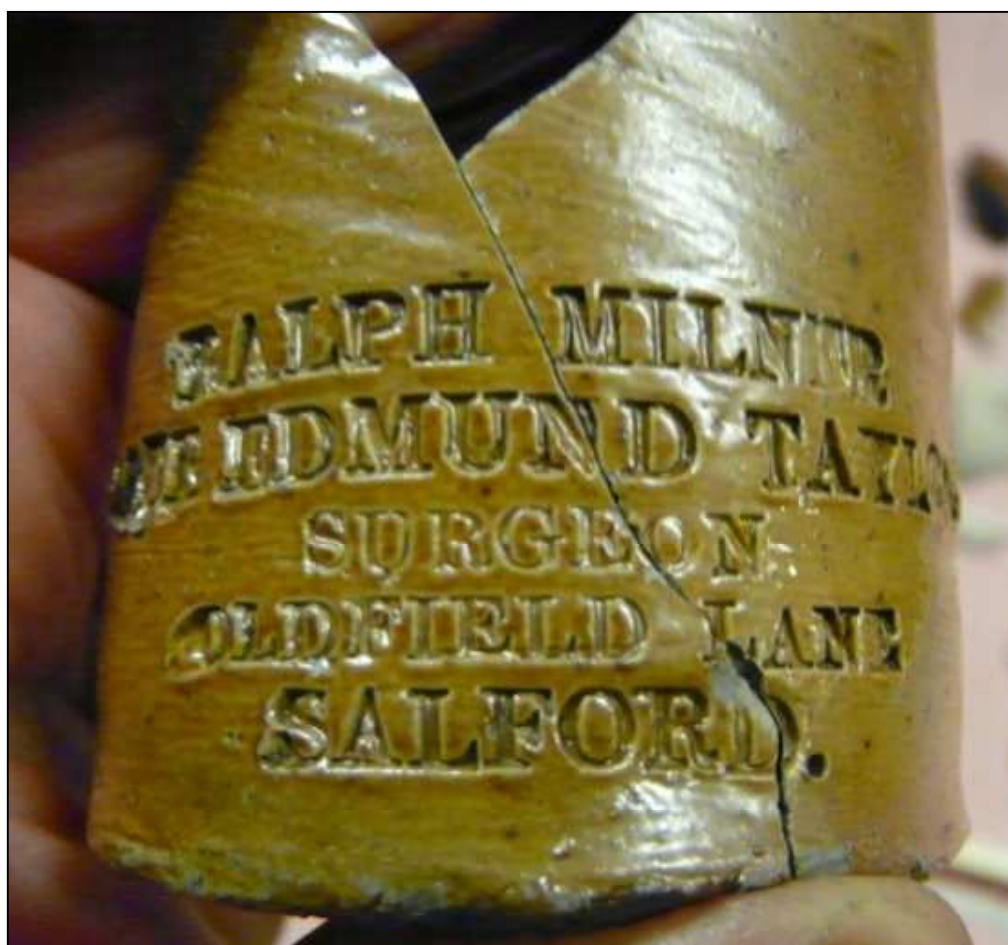
Plate 16: Stamped stoneware bottle

- 4.1.3 Kitchen wares and stoneware storage vessels form a relatively small part of the pottery assemblage, with only a few fragments of the former, most from black-glazed redware pancheons. A single rather thinner, hard-fired fragment of black-glazed redware, from **2018**, could be marginally earlier than the majority of the pottery, perhaps being of eighteenth-century date, but there is nothing else in the assemblage to suggest a date any earlier than the second half of the nineteenth century. Two joining fragments of a brown stoneware bottle are stamped 'Ralph Milner: late Edmund Taylor: Oldfield Lane: Salford' (Plate 16). Ralph Taylor, a surgeon, qualified in 1840, teaming up with Edmund Taylor shortly afterwards, and continuing the practice after Taylor's death until his own in 1882 (weastcemeteryheritagetrail.co.uk), and this bottle clearly dates to after the death of Taylor.

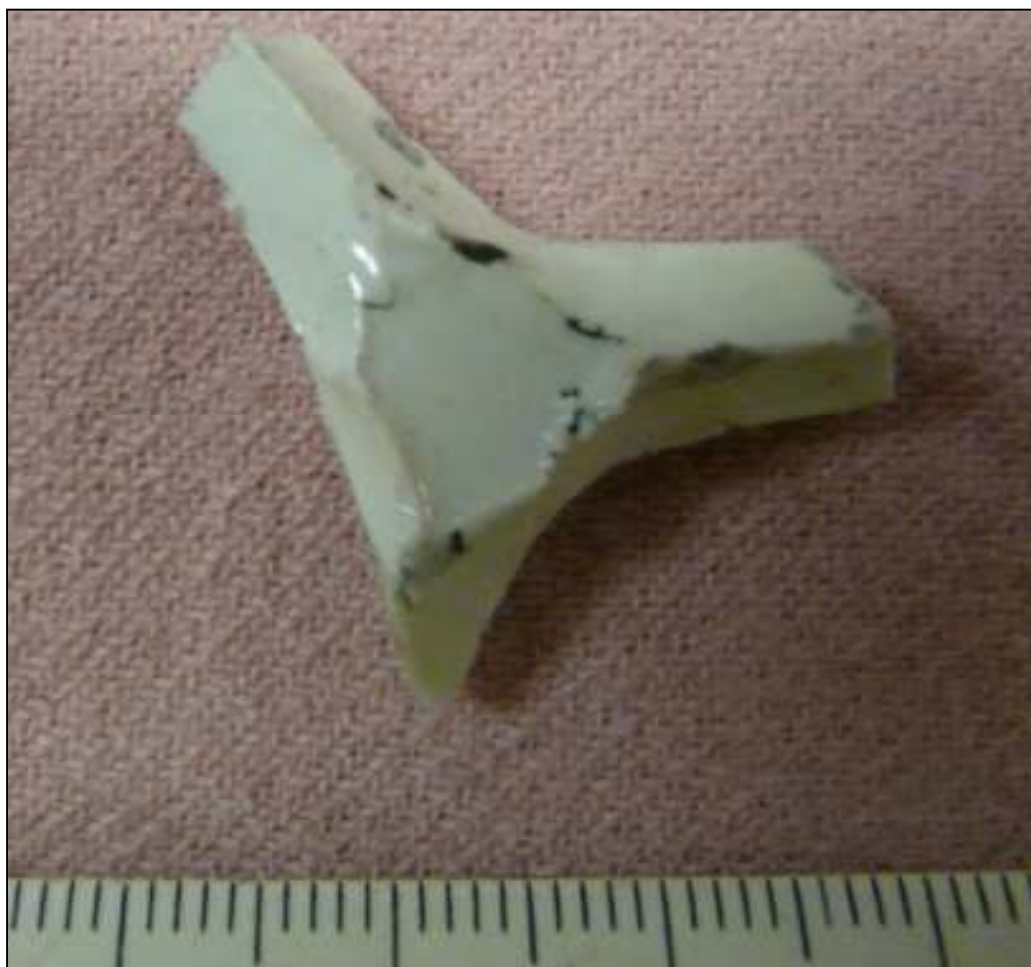
Plate 17: Porcelain stilt

- 4.1.5 There is single industrial object of interest (Plate 17). A glazed porcelain spur, used in the production of glazed earthenware (Hamer and Hamer 2004) came from **2019**. It is clearly a machine-made example, and may be unused. Machine production of these objects began in 1846 (Goodwin and Barker 2009, 55) and continues to the present day. The presence of such a specialised object does, presumably, suggest some connection with the pottery industry, although its nature must remain obscure.
