Hopes Carr, Stockport

Archaeological Investigation

Oxford Archaeology North

September 2011

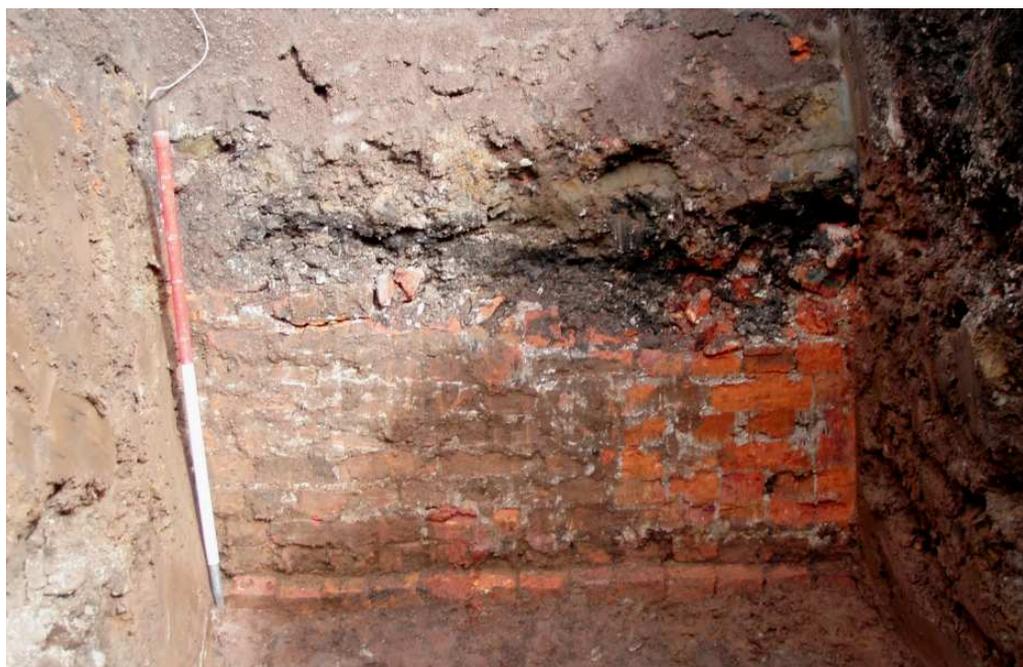
4.2.2 The natural geology was cut by a wall (10), which was aligned north-north-west/south-south-east across the central part of the trench. Wall 10 was two brick-courses wide, and survived to a height of 1.3m, with the upper course being exposed at a depth of *c* 1.5m below the modern ground surface. The base of the wall comprised a single offset foundation course (Plate 6). The wall was composed of hand-made bricks, which were laid in stretcher bond and set in a lime-based mortar, indicative of an eighteenth- or early nineteenth-century construction date. The wall appeared to have been terraced into the natural slope, as excavation revealed the natural ground level to be at a lower level on the northern side of the wall.

Plate 6: The south-west-facing elevation of wall 10

- 5.1.2 It seems possible that the vestiges of this building were represented by wall **10**, which was exposed across the central part of the excavated trench at a depth of *c* 1.5m below the modern ground surface. The position and alignment of this wall corresponded broadly with the western wall of the building shown on Thornton's map and the Ordnance Survey map of 1851, whilst its fabric was indicative of a late eighteenth- or early nineteenth-century construction date. No other internal features, such as floor surfacing, which could be firmly associated with wall **10** or the earliest phase of the building survived. However, at the south-western end of the excavated trench at a depth of *c* 1m below the modern ground surface were the remains of a circular structure (**8**) that may have represented the foundations for a chimney. The location of this structure corresponds broadly with a detached feature situated close to the north-western corner of the warehouse shown on the Ordnance Survey map of 1851. Conversely, structure **8** cannot be identified with any of the detail shown on subsequent editions of Ordnance Survey mapping, further suggesting that it was of an earlier date.

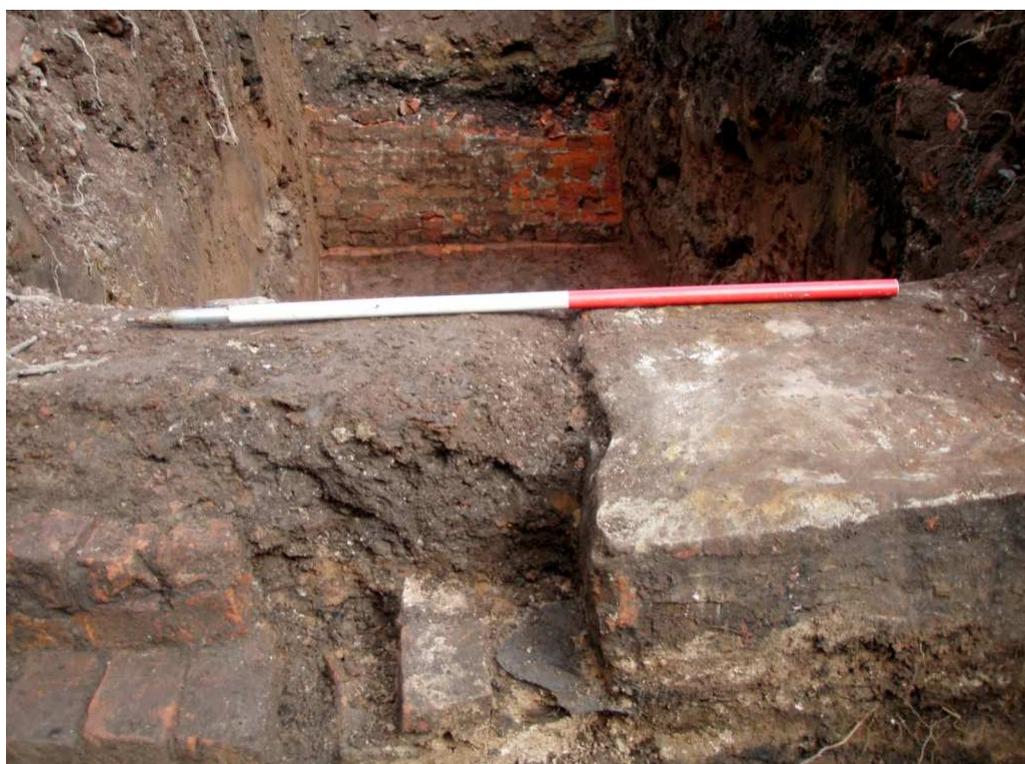
- 4.2.4 Situated 2.77m to the south-west of wall 10, and 2.2m to the north-east of the putative chimney, were the remains of a 1.07m wide, brick-built structure (9). The fabric of structure 9 comprised two courses of hand-made bricks, bonded with dark grey mortar, and a single flagstone (Plate 7). It seems likely that structure 9 represented the remodelling of the site in the 1860-70s, and had formed an internal partition within the hat works, with the flagstone forming a solid foundation for a column.

Plate 7: Structure 9, with wall 10 visible to the rear

- 5.1.3 Physical evidence for the remodelling of the building in the later nineteenth century was provided by the fragmentary remains of a wall (**9**) and associated stone block that is likely to have been a base for a cast-iron column within the hat factory that occupied the site by 1872. However, no other structural remains that could be firmly associated with this phase of the site's development were identified in the excavated trench.

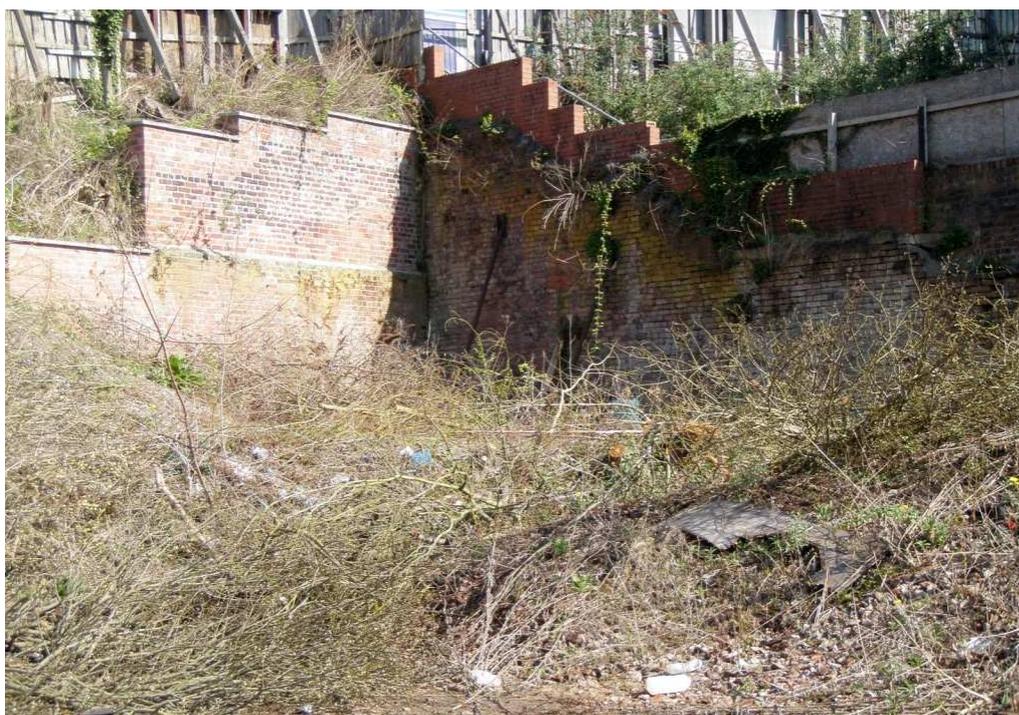
- 4.3.2 The fabric of wall **101** comprised hand-made bricks with stone capping on top of the north-west/south-east-aligned section (Plate 8). The lower 3m of the northern return were also of hand-made bricks, with machine-pressed bricks forming the upper section. A modern brick wall had been added at the top of the north-west/south-east-aligned section, set back slightly from the original wall, along the edge of an alleyway to the north-east which ascended from the top of ramp **102**. At the south-eastern end of the wall was a slight indent and the stubs of two walls composed of hand-made bricks, one running south-west and the second aligned north-west, forming a room that measured 8.7 x 3.5m. This room was plastered internally, and retained a roof scar that sloped downwards from south-east to north-west on the north-eastern elevation.

- 4.3.3 The earliest elements of wall **101**, represented by the hand-made bricks, were the remains of the engineering works built between 1872 and 1893. It seems likely that these bricks had probably been re-used from elsewhere, possibly the demolition of the original mill complex to the south-west. The roof scar visible on the north-east elevation suggests that at some point part of this area was an open yard containing one or more single-storey ancillary buildings.

Plate 8: Wall **101**, looking north

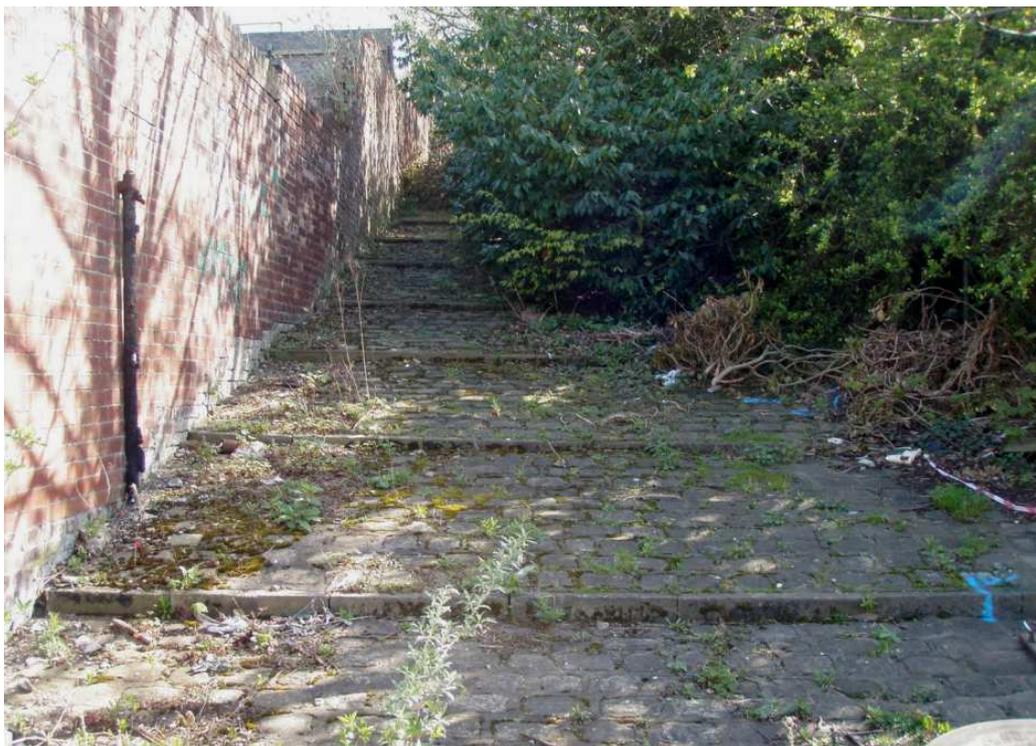
- 4.3.4 **Ramp 102:** a 17.7m long and 8.2m wide ramp rising from the south-west to the north-east between the engineering works (represented by wall **101**) and the site of the Lavender Brow houses (building **103**). It comprises 3.6m wide steps made of concrete and stone with concrete kerbs (Plate 9), and is probably contemporary with the partially demolished twentieth-century structure situated immediately to the south-east. It is likely that this is a replacement for steps or a ramp affording access from Wellington Street to the nineteenth-century engineering works.

Plate 9: Ramp 102, looking east

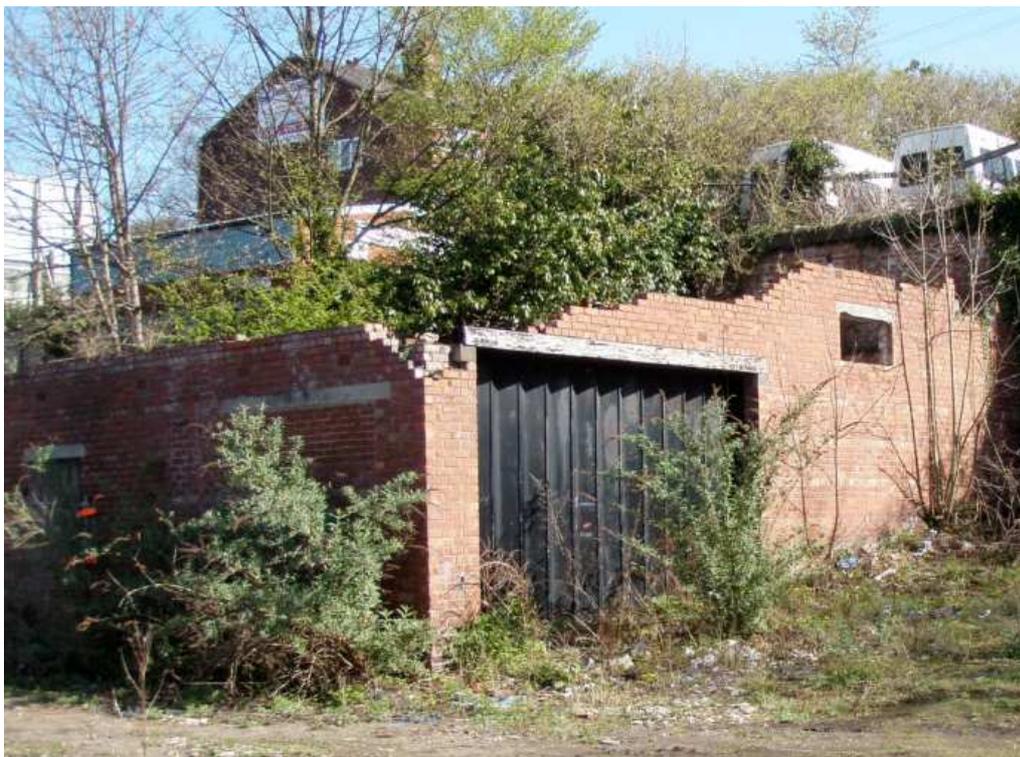
- 4.3.5 **Building 103:** the remains of a rectangular building that was erected between 1934 and 1960, and replaced the demolished Lavender Brow houses. The extant elements of the building measure 14 x 7.6m, and survive to a maximum height of *c* 4.5m (Plate 10). The fabric of the building comprised modern machine-pressed bricks with concrete lintels above the door and window apertures.
- 4.3.6 Only the external walls of this building survive, with the roof and all of the internal features having been removed. A 1.16m wide window aperture and a blocked 2.1m wide window aperture exist in the south-western elevation of the building, whilst the south-eastern elevation contains a small 1.36m wide window aperture at the top of the wall and a 3m wide main entrance with a sliding door.

Plate 10: Building 102, looking north-east

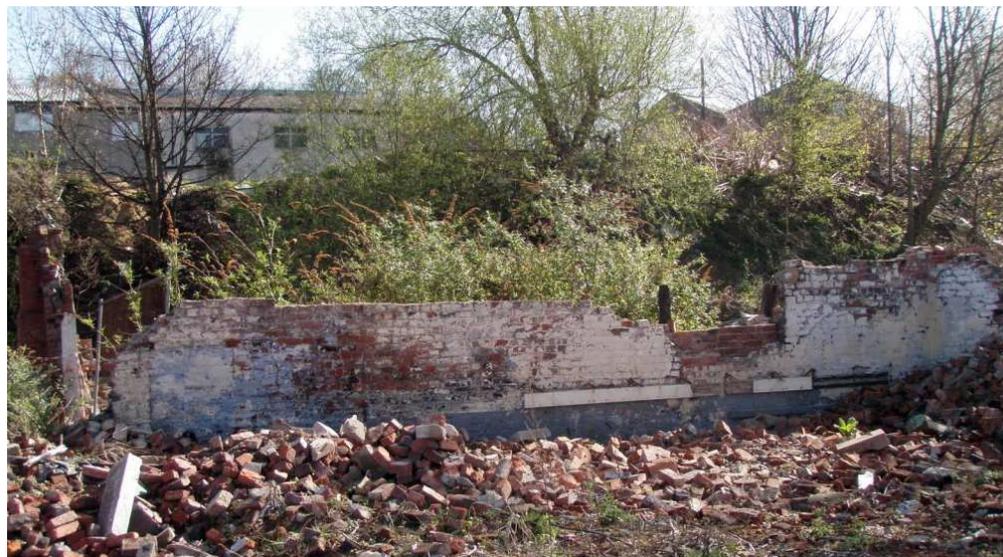
- 4.3.9 **Building 105:** the remains of a rectangular building measuring 13.3 x 6m in the south-eastern part of the study area. The south-eastern and south-western walls of the building survive to a maximum height of 1.7m (Plate 11), whilst the north-eastern and north-western walls have been demolished to foundation level. All of the walls are 0.28m thick, and their fabric comprises machine-pressed bricks

- 4.3.10 A modern, square brick column, standing to a height of 2.5m, had been added to the northern corner of the building. This is probably the remains of the smaller building added to the machine shop between 1872 and 1893, and demolished between 2004 and 2009; the main building, was demolished between 2009 and 2011 in order to accommodate the demolition contractor's compound.

Plate 11: Building 105, looking east

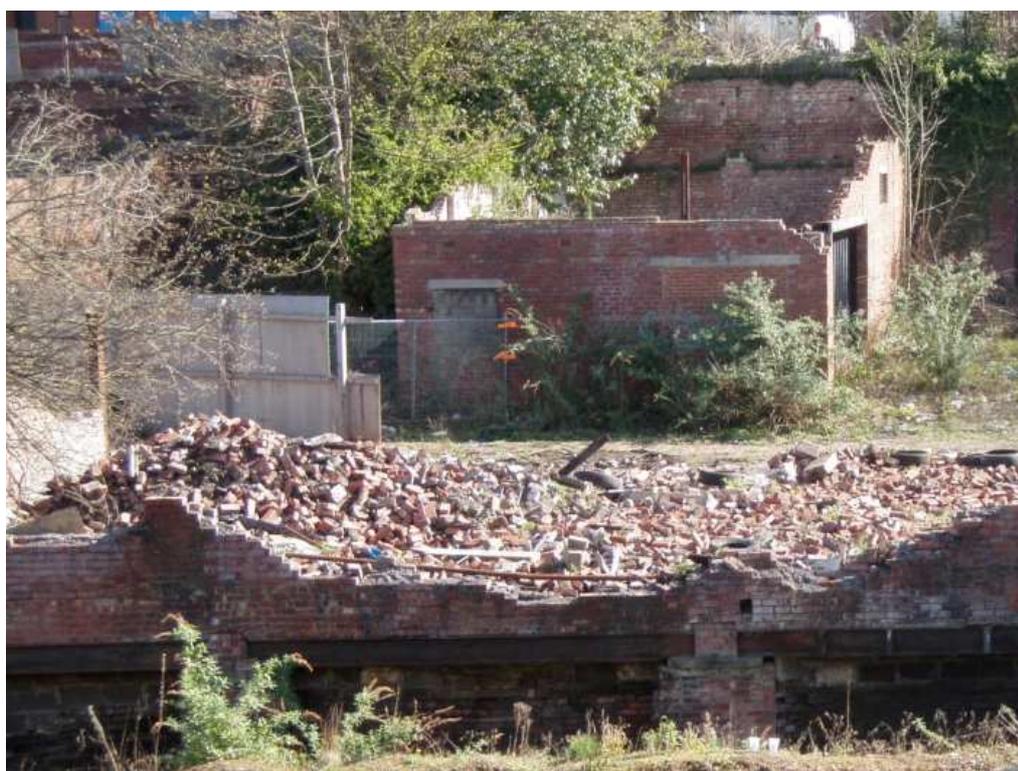
4.3.11 **Building 106:** the remains of an irregularly shaped structure, measuring 17.6m long and 7.6m wide at the north-western end and 3.6m wide at the south-eastern end, situated on the eastern boundary of the study area. Building 106 lies on top of the original brook culvert walling, which it overhangs by *c* 0.5m with four square brick columns inserted through the culvert walling for support. A smaller room, measuring 5.8 x 2.5m and surviving to a height of *c* 3m, is attached to the north-western end of the building (Plate 12). The fabric of all the walls comprise machine-pressed bricks. The building incorporates a lintel that bears a date of 1922.

Plate 12: Building 106, looking east

- 5.2.7 Survey element **106**, comprising the remains of a small engineering works, lay on the eastern side of the Hempshaw Brook. This triangular-shaped building incorporated a stone above a lintel on the main southern entrance that bore the lettering 'H.D. 1922', which almost certainly refers to the date of construction.

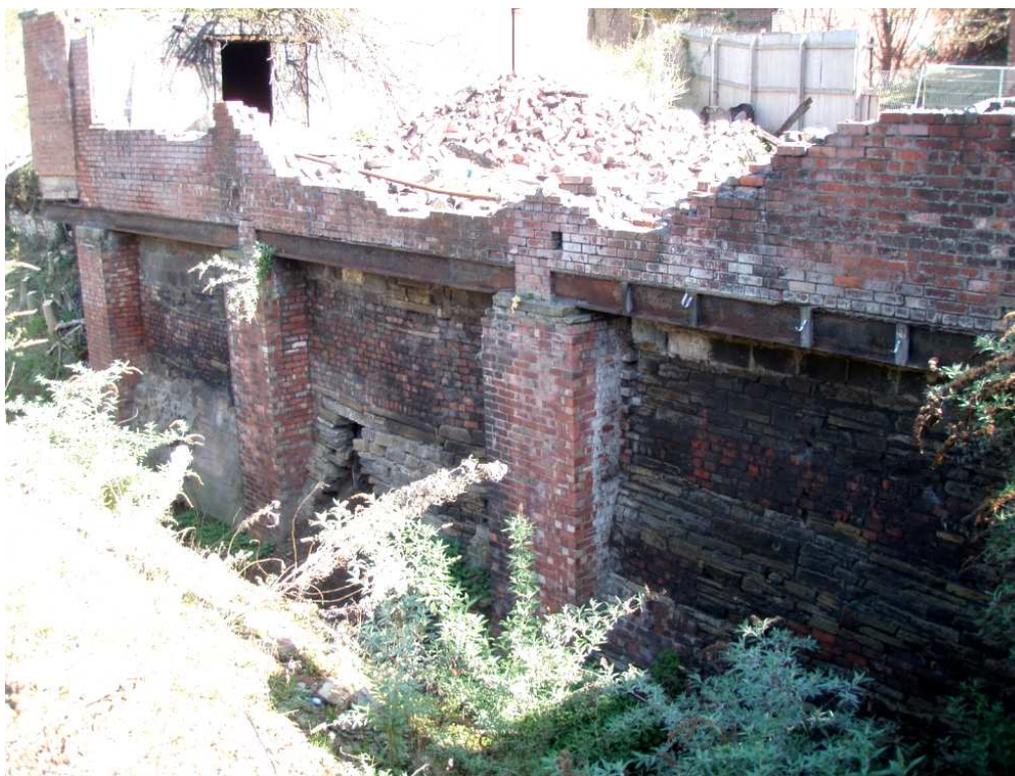
- 4.3.13 **Culvert 108:** an open culvert containing the Hempshaw Brook as it flows north-west/south-east across the study area (Plate 14). The walls of the culvert are up to *c* 2.5m high in places, and are composed largely of stone blocks with some small sections of hand-made brick and concrete representing various phases of repair. The repair work is especially visible below building **106**, and was probably necessitated as a result of the insertion of the brick columns associated with that building. At both ends of the culvert is an arched tunnel through which the brook flows.

- 4.3.14 A wall surviving to a height of 2.5m sits above the arch at the south-eastern end of the culvert, with a small barred window and a drainage/ventilation grate, both looking along the brook to the north-west. This wall extends across the brook from the southern corner of building **106**, and continues south-west for a distance of 6.6m, beyond which it has been demolished. The fabric of the wall comprises hand-made bricks, and is likely to have formed part of the south-east wall of the former hat works.

- 4.3.15 At the north-west end of the open culvert, where it continues into the arched tunnel, there are small rectangular openings in the wall with stone lintels that flank the sides of the tunnel. These are too low to be windows, and their intended function remains uncertain. The brook is first shown as culverted on the Ordnance Survey map of 1893, although the construction of the culvert walls suggests an earlier date and it seems possible that the culvert was contemporary with the silk mill described in the list of 1785.

Plate 14: Culvert 108, looking north-east

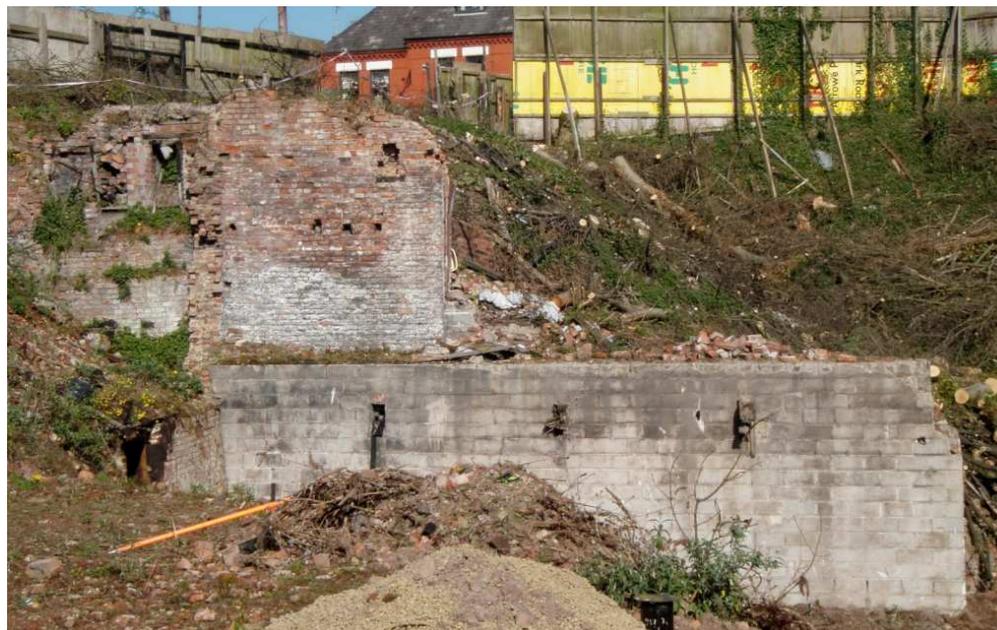
- 4.3.16 **Wall 109:** a north-east/south-west-aligned wall extending 26.2m from the north-western end of culvert **108** to the north-west end of wall **111** (Plate 15). The wall survives to a maximum height of 6.5m at its south-western end, reducing to a height of 0.3m at its north-eastern end, where it adjoins culvert **108**. The fabric of the wall comprises hand-made bricks bonded in a lime-based mortar, suggesting a late eighteenth- or early nineteenth-century construction date, although there is a possibility that the bricks were re-used from an earlier demolished structure.

- 4.3.17 The central section of wall **109** was supported by a 3.4m high retaining wall of cinder-block construction (Fig 6). The stub of the upper level of wall **112** is visible in its elevation. Three rectangular apertures survive to the south-west of this wall stub (Fig 6). The western opening aperture is 1.68m high, 0.8m wide at the top and 0.73m wide at the base, and has been blocked with brick. The central aperture is 1.9m high and 0.5m wide, with a wooden beam situated 0.35m above the base. This aperture has not been purposefully blocked, but infilled with rubble. The eastern aperture is 1.05m high and 0.53m wide, blocked with brick and had a 0.8m wide wooden beam above it. To the north-east of the wall stub the elevation retains a 0.11m diameter hole, probably a drain, and three rectangular voids which appeared to be slots for wooden beams. Above these, and offset slightly to the north-east, is a 0.47m wide wooden beam set into the wall. This wall was most likely the remains of walling from the hat factory, which had replaced the original warehouse/factory by 1872. Wall **111** is keyed into, and probably contemporary with, wall **109**.

Plate 15: Wall 109, looking north-east

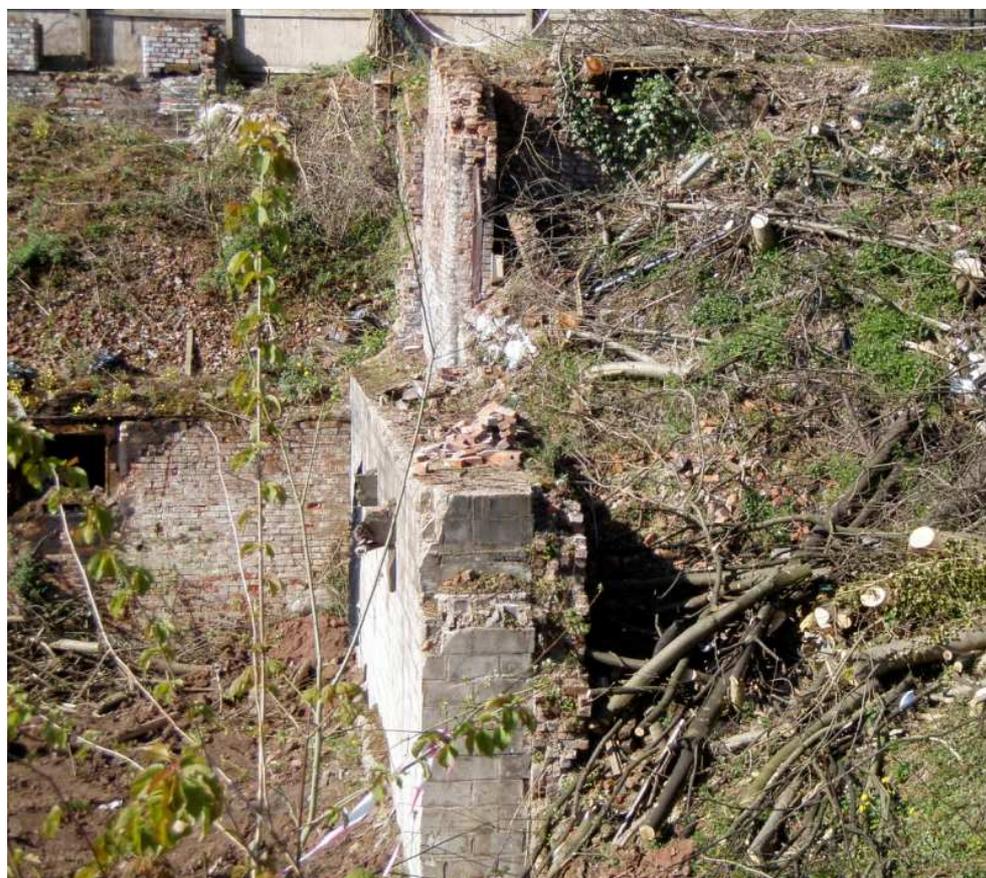
4.3.18 **Wall 110:** a north-west/south-east-aligned wall extending 3.7m from wall 109, with which it was contemporary. It survives to a maximum height of 3.1m (Plate 16), and was probably part of the walling from the hat factory that had replaced the original warehouse/factory by 1872.

Plate 16: Wall 110, looking south-east

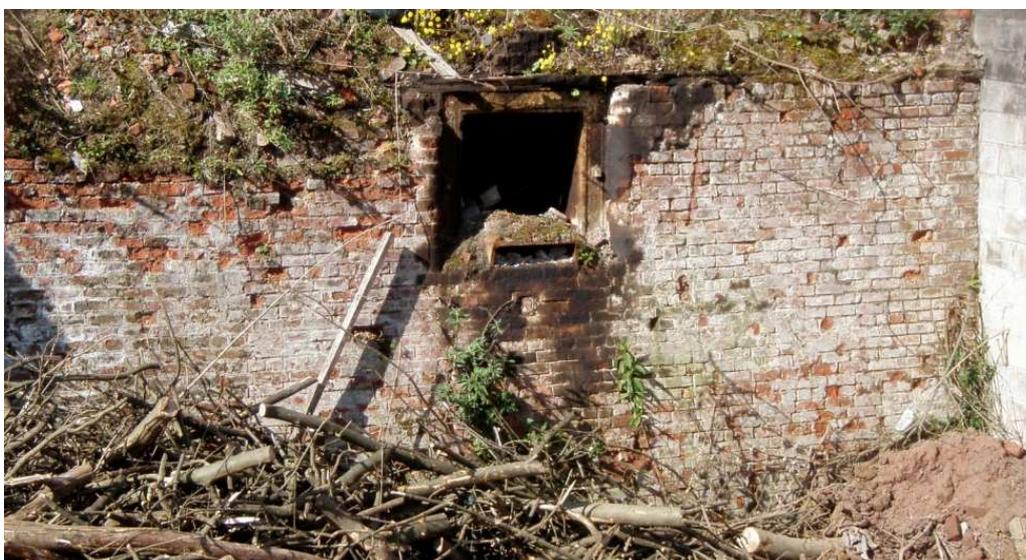
4.3.20 **Wall 112:** a wall extending south-eastwards for a distance of 8.5m from the cinder-block component wall **109**, and surviving to a maximum height of 2.7m. A wall scar visible in the elevation of wall **109** suggests that the two walls were originally of the same height. At its southern end, wall **112** steps out by 0.75m and then continues south-east for a further 2.25m. This section of the wall retained evidence for at least two phases of construction. The earliest fabric, forming the lower section of the wall to a height of 0.81m, is of random rubble construction, suggesting a late eighteenth-century construction date. The upper portion of the wall comprises hand-made bricks bonded in a lime-based mortar. A cast-iron bearing box, measuring 1.25 x 1.2m (Fig 7), is set within the north-western section of the wall (Plate 18).

Plate 18: Wall 112, looking north-west

- 5.2.4 Wall **112** formed the western wall of a basement for the hat factory, which had evidently been terraced into the natural slope below Hopes Carr. This wall retained the only firm evidence for the mill's power transmission system, represented by a cast-iron bearing box. It is likely that this housed the end bearing for a line shaft that powered machinery in the basement.

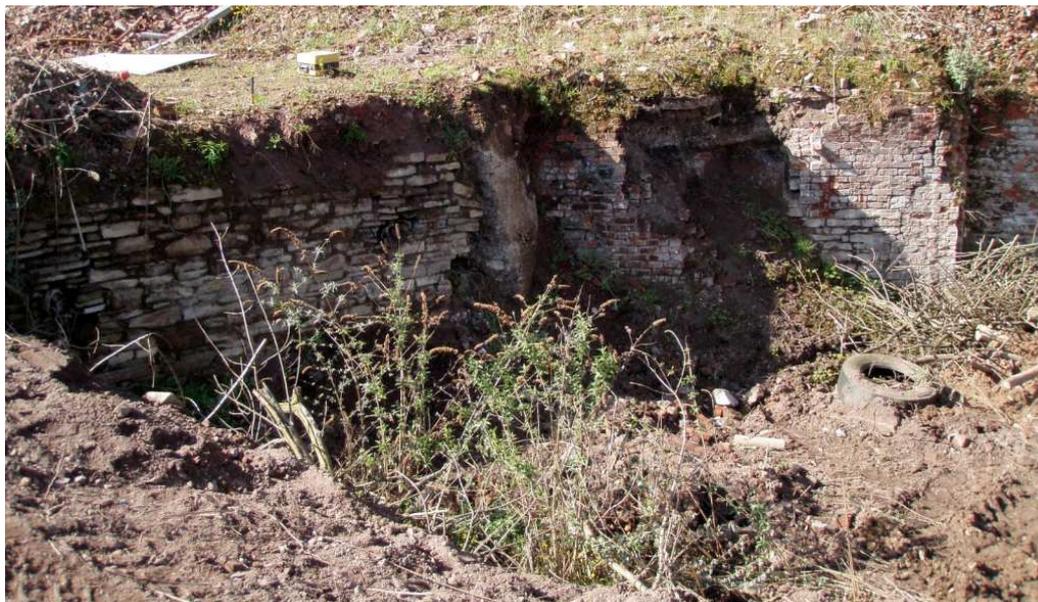
- 4.3.21 **Wall 113:** a north-west/south-east aligned wall situated in the central part of the study area, and broadly parallel to wall **112**. The gap between the brick-built section of wall **113** and the south-east end of wall **112** was filled with rubble in an ash matrix, and may possibly represent the heavily truncated remains of a flue that had been inserted through the original stone wall.
- 4.3.22 Wall **113** survived to a maximum height of 2.2m. The fabric of wall **113** also comprised a mixture of random stone rubble and hand-made bricks, which occurred in separate sections (Plate 19).

Plate 19: Wall **113**, looking south-west

- 5.2.2 The earliest remains recorded during the survey were almost certainly the stone-built elements of walls **112** and **113**. These could possibly represent the remains of a basement for the eighteenth-century warehouse and factory referred to in historical documents, which were incorporated into later phases of remodelling.

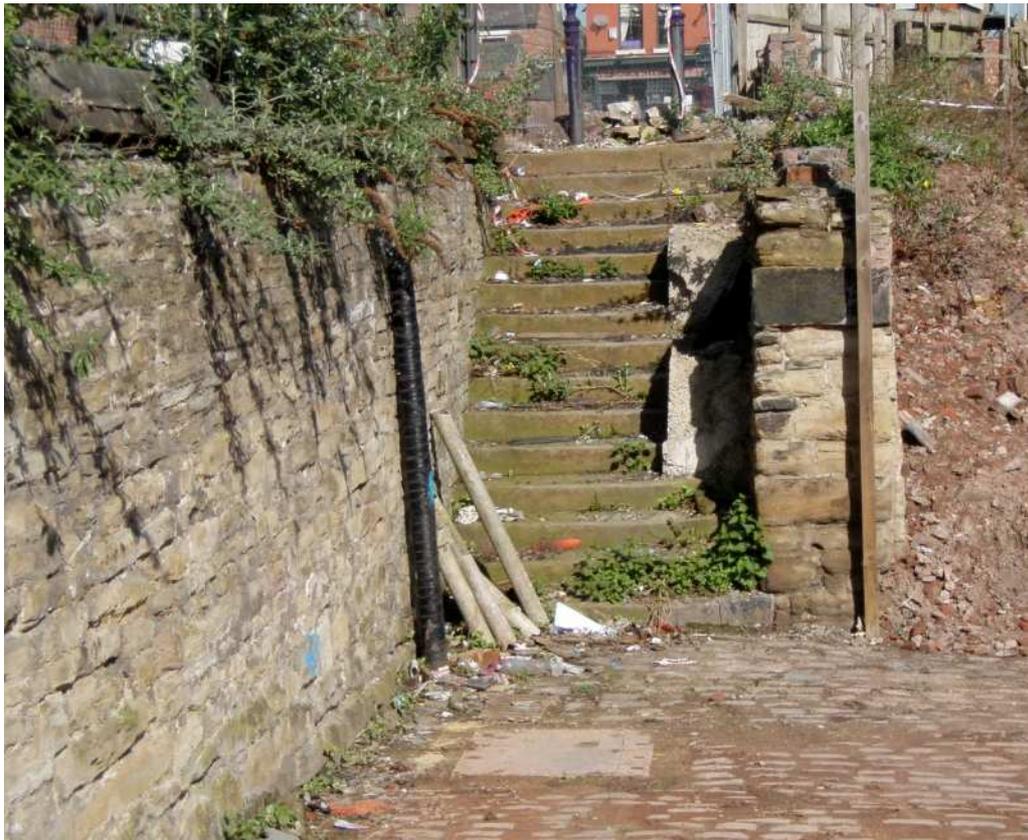
Plate 20: The stone-built steps between Hopes Carr and Lower Carr

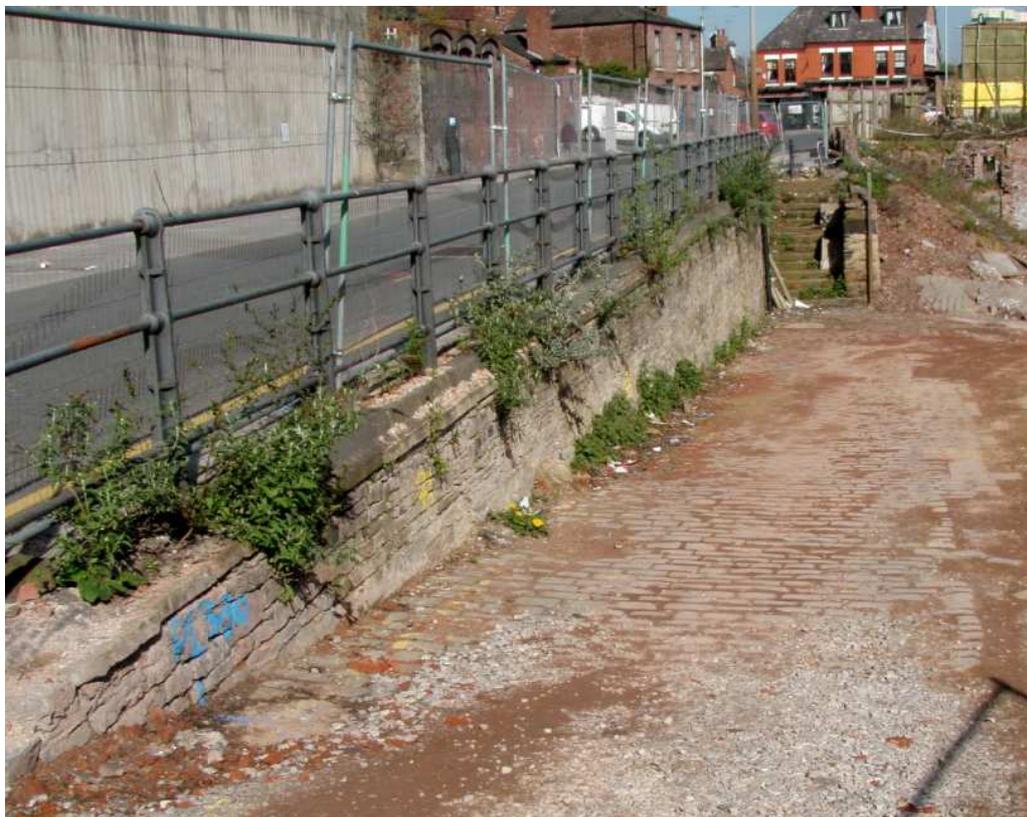
- 4.3.24 **Wall 114:** the continuation of the boundary wall between the mill complex and Hopes Carr, this wall extended to the south-east for a distance of 7.9m from the south-eastern end of wall **111** to a flight of 15 stone-built steps that afforded pedestrian access to Lower Carrs from Hopes Carr (Plate 20). Each of the steps measured 3.8 x 1.9m. Wall **114** continued to the south-east of the steps for a distance of 34.5m (Plate 21) The wall survived to a maximum height of 3.6m, and its fabric comprised sandstone blocks with capping stones. This boundary wall is likely to be contemporary with the construction of the Carr Mills complex in the first half of the nineteenth century.

Plate 21: Wall 114 looking north

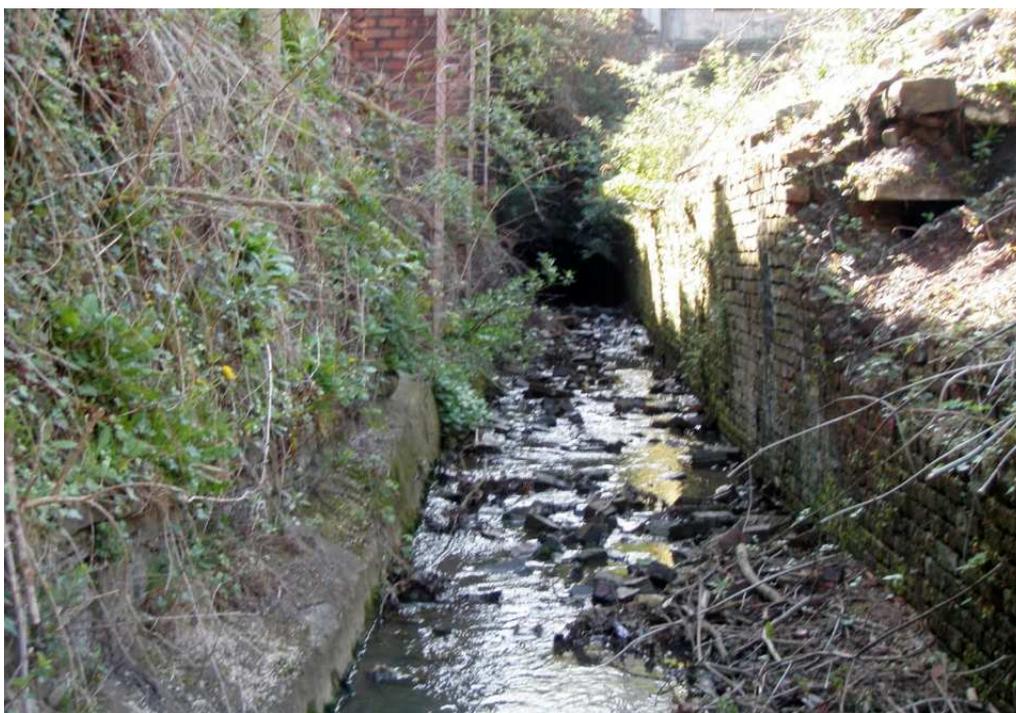
- 5.2.5 Hempshaw Brook (survey element **108**), also called Carr Brook or Mill Brook, is a natural stream, which had been culverted by 1893 (Plate 22). It flowed southwards into a circular feature depicted on the 1893 mapping as a sluice. This presently lies within the steep overgrown banking at the north side of the study area. The culvert acted as an overflow for Carr Dam Reservoir.

Plate 22: The open culvert for the Hempshaw Brook as it flows across the study area

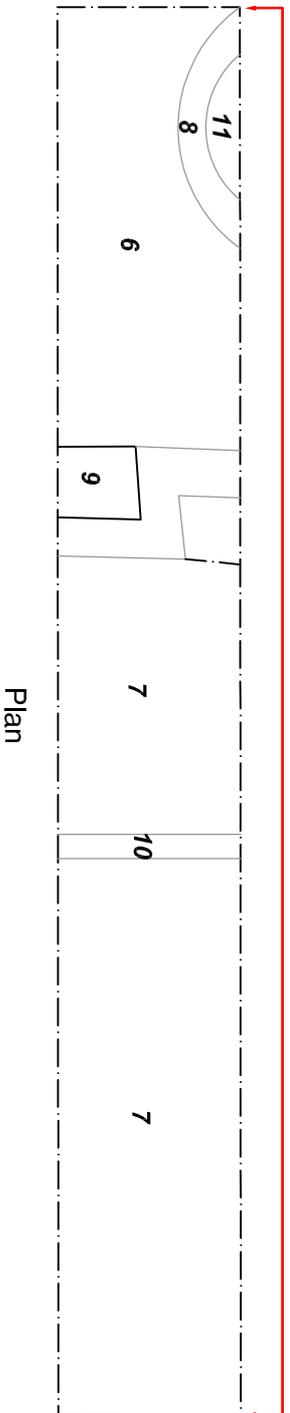
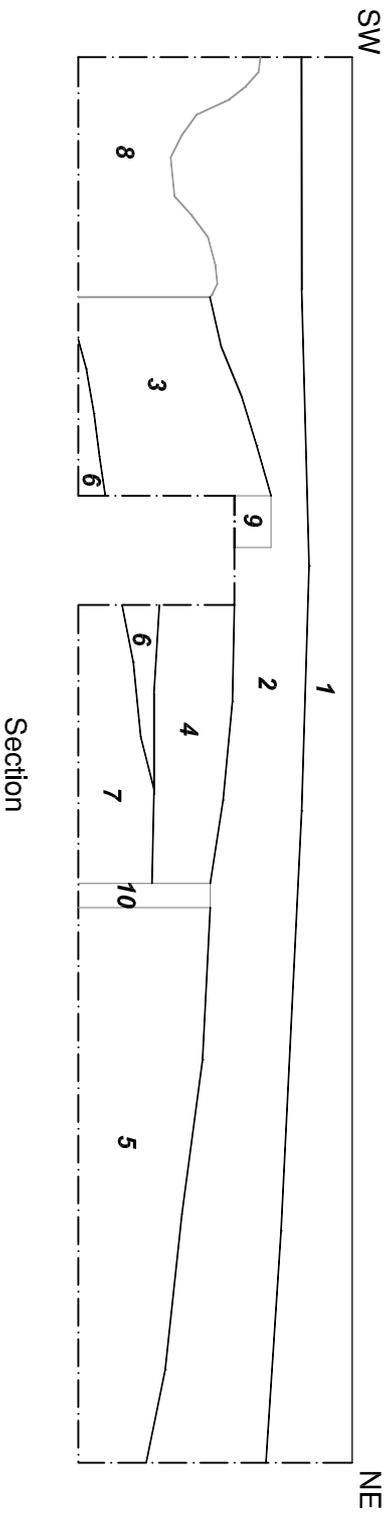
Figure 4: Plan and south-east-facing section of excavated trench

4.2.1 A 13.98m long trench was excavated across the footprint of the north-western end of the original eighteenth-century warehouse/factory building. The trench was aligned north-east/south-west, and was excavated to a maximum depth of 2.7m. A layer (7) of red clay, almost certainly representing the natural geology, was exposed at a depth of *c* 2.1m below the modern ground surface. The natural clay was overlain in the central part of the trench by a deposit of sand and gravel (6), which is also likely to have been of natural origin.
